# WATER LICENCE INSPECTION FORM

Licensee		Licensee Representative		
Hamlet of Clyde River		Bhabesh Roy , Johnathan Paulluq, Moe Kuluguktuk		
Licence No. / Expiry		Representative's Title		
3BM-CLY1924Renewal Licence		Municipal Engineer – GN- C&GS , Acting Senior		
		Administration Officer, acting Hamlet foreman		
Land / Other Authorizations		Land / Other Authorizations		
Date of Inspection		Inspector		
August 22, 2020		Joseph Monteith		
August 22, 2020 Activities Inspected		Joseph Monteith		
	☐ Drilling ☐ Mining	Joseph Monteith  Construction Reclamation Fuel Storage		
Activities Inspected	Other: Potable Source, Waste Disposal Facility,			
Activities Inspected  Camp	Other: Potable Source, Waste Disposal Facility, Solid Waste Facility, General Conditions , water	☐ Construction ☐ Reclamation ☐ Fuel Storage		
Activities Inspected  Camp	Other: Potable Source, Waste Disposal Facility,	☐ Construction ☐ Reclamation ☐ Fuel Storage

# **Inspector Statement**

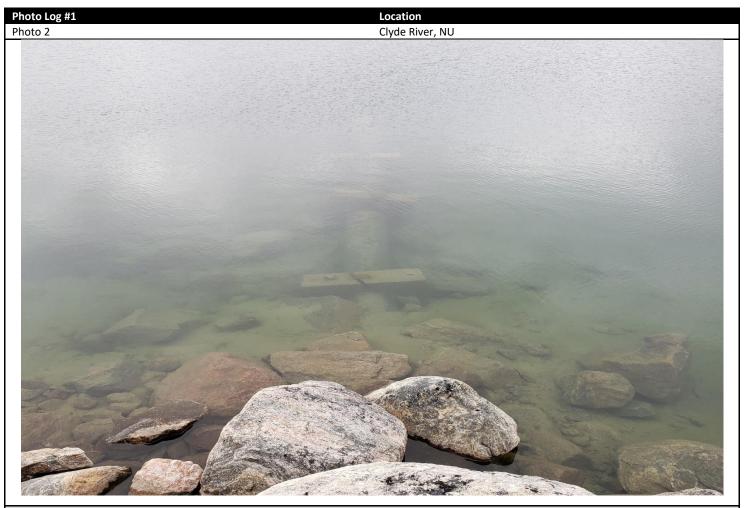
- 3. Water is withdrawn from Water Source Lake. GPS Coordinates: Lat: N70° 28' 59.339" Long: W68° 36' 48.744
- 4. The condition of the piping is questionable. The pipe may have slumped over time, any attempt to withdrawal the internal pump may cause damage to the pipes, and pump. The design and equipment is the same as Pond Inlet and may encounter the same emergency situation. The length approximately 47 metres. Diameter 8 inches, with a 4 inch internal pump housed within the intake pipe. The pipe has a fish mesh screen (photo 2).

Photo Log			
Date	Camera	Inspector	Authorization
August 22,2020	Nikon Coolpix	Joseph Monteith	3BM-CLY1924
Photo Log #1		Location	
Photo 1		Clyde River, NU	
		The second second second	
	P.		
		F	
The same			
1 1 1 1 1 1 1 1 1 1 1 1 1 1 1 1 1 1 1			
Description: Water Source Lake.	Water Extraction pipe. Similar in de	sign as the Pond inlet Water Pump I	House

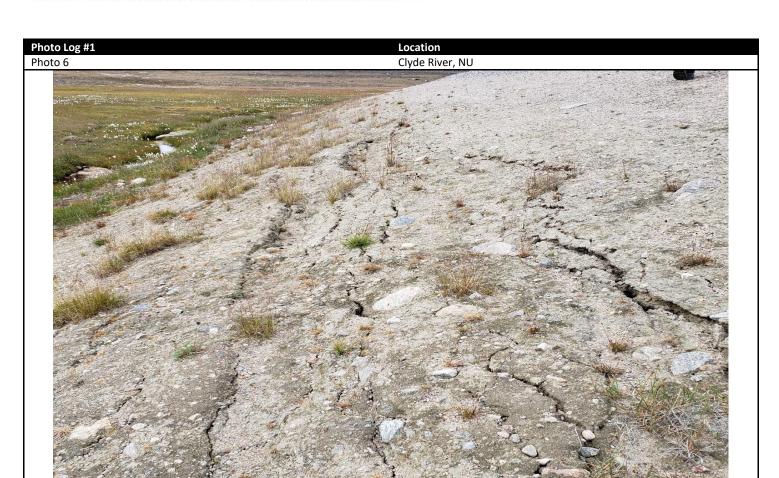
- 7. At the time of the inspection, the sewage lagoon was in-use. The walls were operating as intended, no signs of leakage, but some slumping or erosion were observed on the west side of the lagoon walls (photo 5).
- The lagoon has two cells; the first is the original lagoon with a capacity of 11,600 cubic metres, the other cell forms as an extension from the original lagoon, with no listing for the amount of sewage it can store. No issues were observed during the course of the inspection.

Description: Sign of slumping on base of sewage lagoon wall

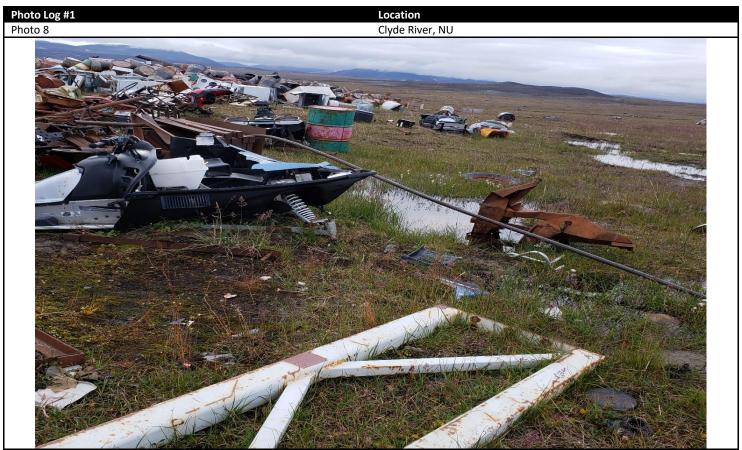
- 12. There is no berm to contain any leachate coming from the hazardous waste facility, and the bulk metal section of the land farm. Contaminants may interact with external environmental elements, and migrate downslope and eventually the receiving marine environment (photo 8).

Description: the outer extent of bulk metal section of land farm, no berm to mitigate any interaction with external environmental elements, and migration of wastes outside the facilities.
