WATER LICENCE INSPECTION FORM

Licensee	Licensee Representative
Hamlet of Clyde River	Bhabesh Roy
Licence No. / Expiry	Representative's Title
3BM-CLY1924	Regionals Engineer
Land / Other Authorizations	Land / Other Authorizations
Date of Inspection	Inspector
October 12, 2021	Joseph Monteith
Activities Inspected	
<div><div><input type="checkbox"/> Camp</div><div><input type="checkbox"/> Drilling</div><div><input type="checkbox"/> Mining</div><div><input type="checkbox"/> Construction</div><div><input type="checkbox"/> Reclamation</div><div><input type="checkbox"/> Fuel Storage</div></div> <div><div><input type="checkbox"/> Roads/Hauling</div><div><input type="checkbox"/> Other: Potable Source, Waste Disposal Facility, Solid Waste Facility, General Conditions ,</div><div><input type="checkbox"/> Other:</div></div>

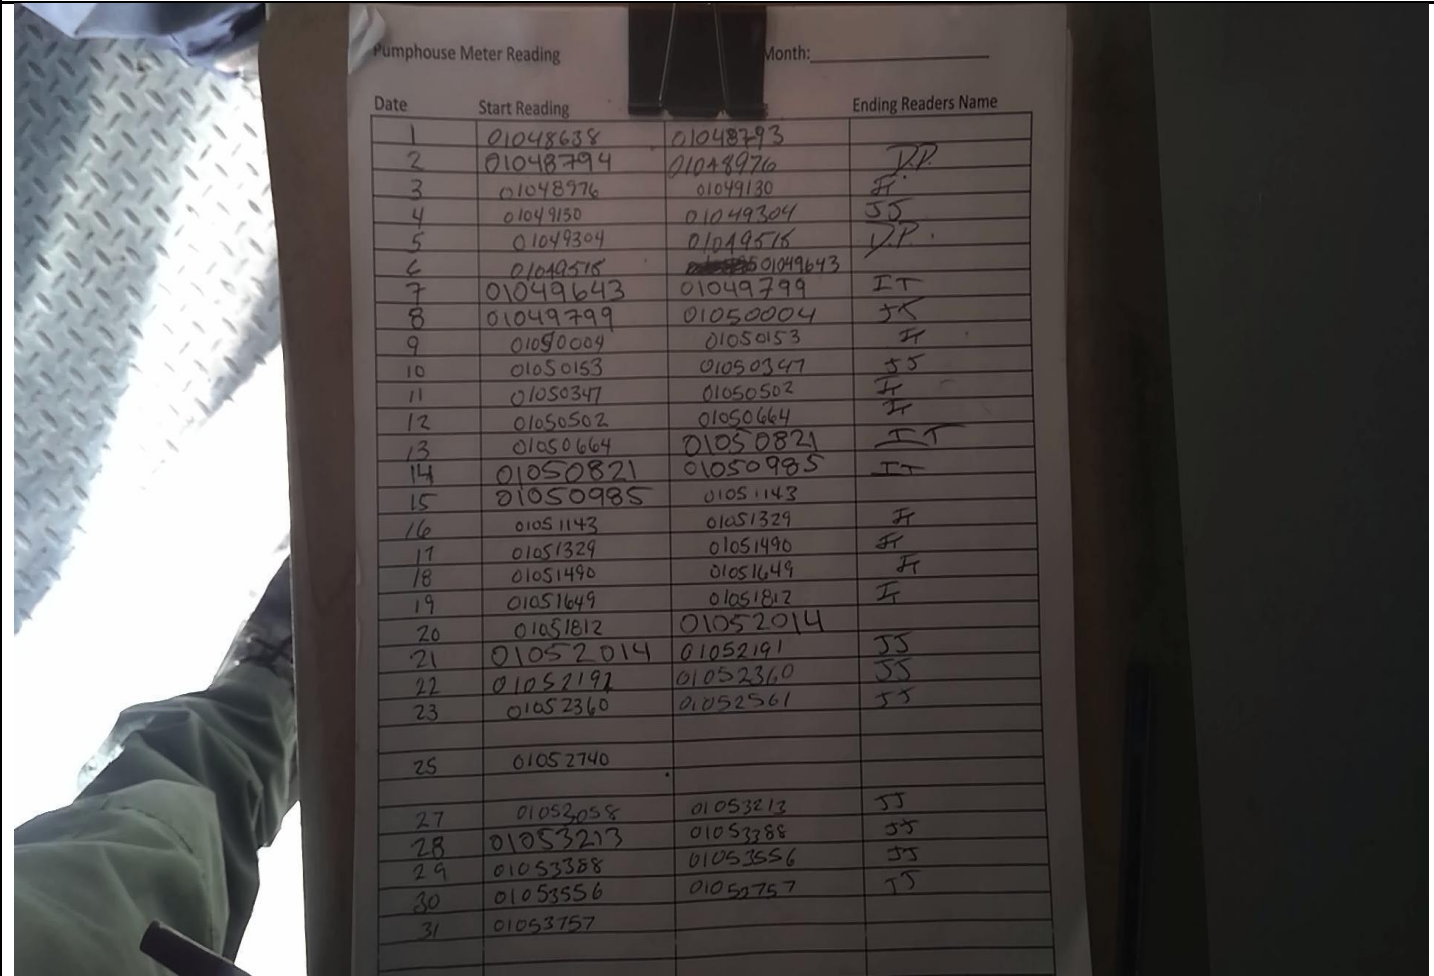
Photo 3

6. WRO Monteith also photographed the Pump Meter Readings log for August 2020 with 3 entries for the day starting on August 1, 2020 - 933996m³ starting reading and on August 3, 2020 end reading 934343 m³ (photo 4). The date of the inspection and the dates of withdrawal recordings provides questions in record keeping, and difficult to verify total water usage for the year.

Description: Water Usage Logs –Last reading on August 31, 2020 01053757. Matches Meter reading.

-Record your Annual Reports and books and records in Metres Cubed as per the Nunavut Water Regulations.

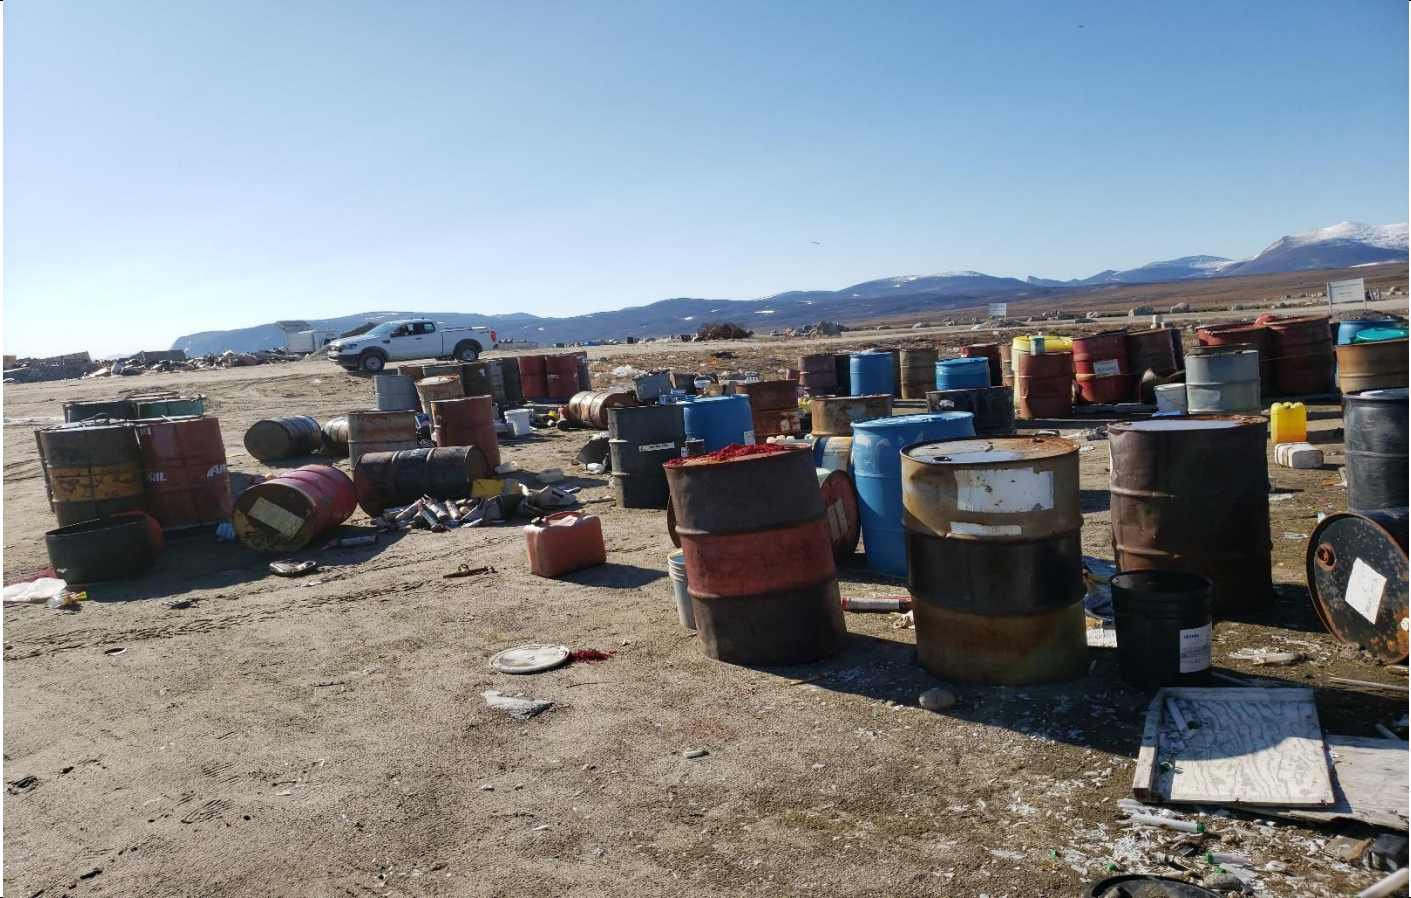
Photo 6

14. Hazardous Waste section contains a few sea cans(full), a bermed area full of waste oil drums, some packaged ready for delivery, other waste oil drums litter the inside and outside of the berm, multiple signs of leaked contents on the ground and the surrounding the area. Some of the sea cans with various forms of hazardous waste are left open to the environment.

Description: Hazardous Waste Disposal Facility. Berm is overfilled with waste oil drums. Waste oil drums deposited outside of bermed area.

-Make a plan to send out Hazardous Waste to approved Hazardous Waste Facility to make room for any future hazardous waste in the bermed section of the Hazardous Waste Facility.

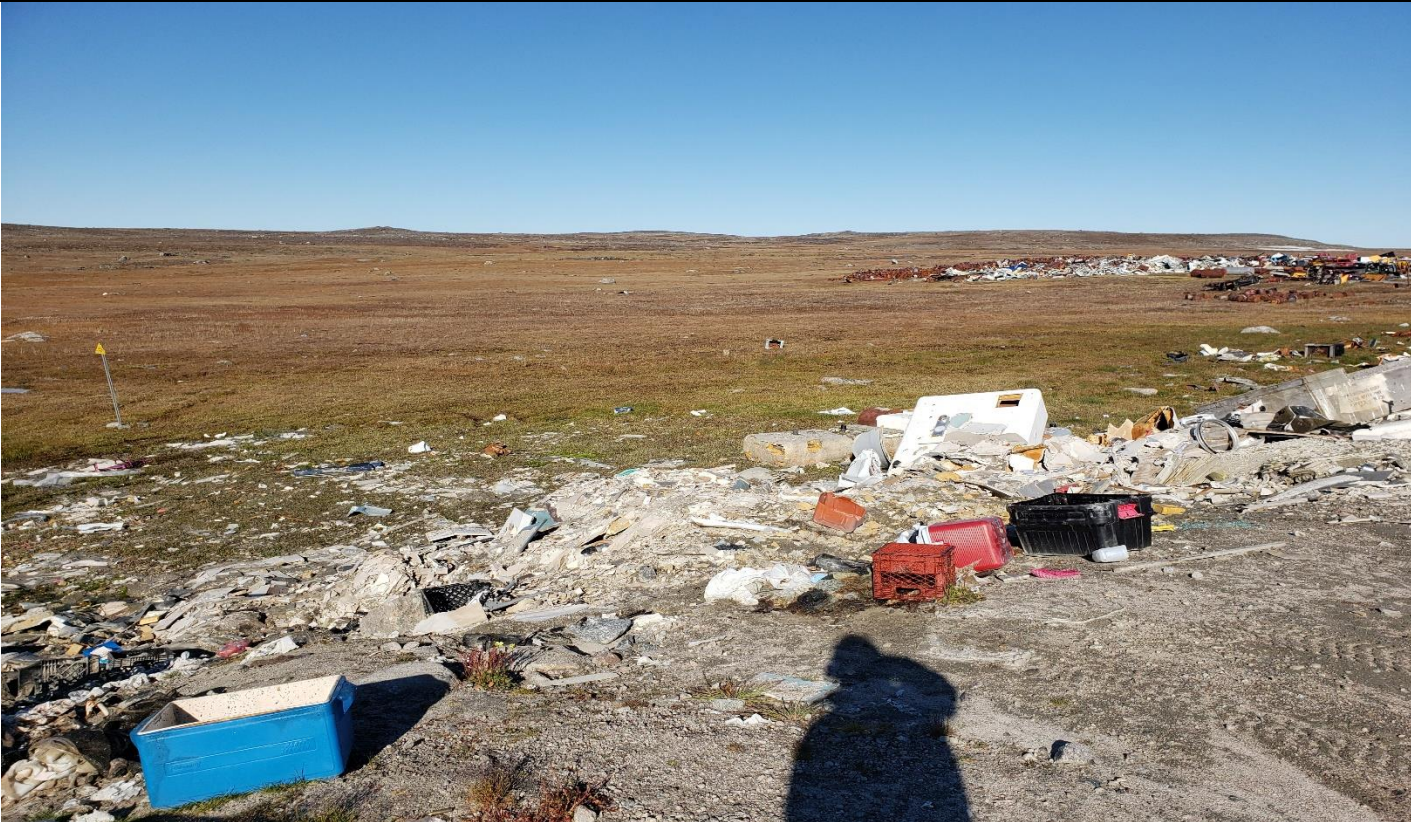
Photo 7

13. There is no berm to contain any leachate coming from the hazardous waste facility, and the bulk metal section of the land farm. Contaminants may interact with external environmental elements, and migrate downslope and eventually the receiving marine environment. (photo 8).

Description: the outer extent of bulk metal section of land farm, no berm to mitigate any interaction with external environmental elements, and migration of wastes outside the facilities. A monitoring station is observed in left hand side midground.

-The bulk metals portion is not bermed, and has the potential of releasing hazardous waste directly onto the environment. Rain has the potential washing away any hazardous waste onto the environment, which may migrate to any water bodies.

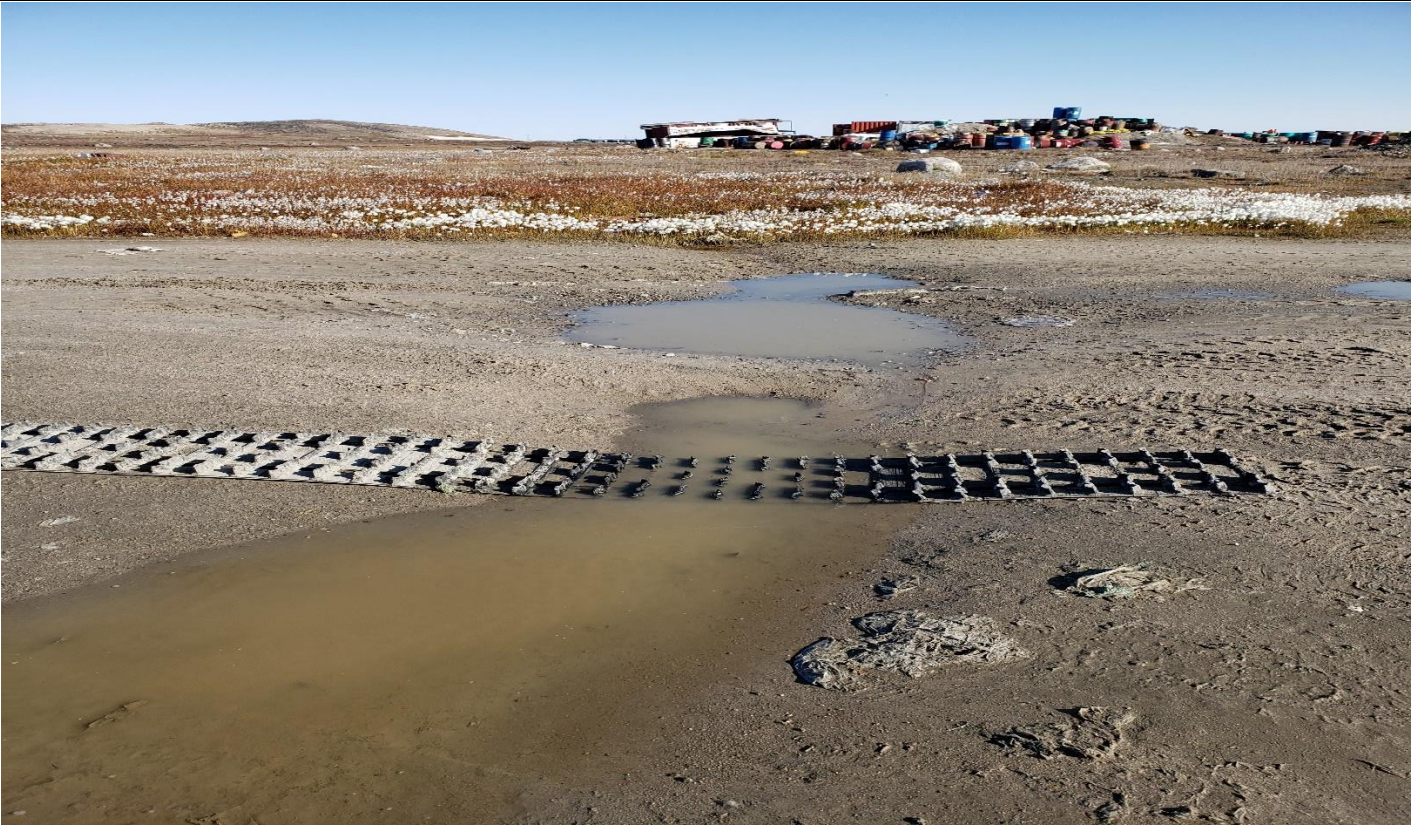
Photo 8

16. Between the bulk metal and the hazardous waste facility a puddle pooled with signs of hazardous waste. The puddle lays on the side of the road in the bulk metal section downgrade of the hazarded waste facility. It was discussed that one of the monitoring station should be moved to this site as it appears to be the natural migration of any liquids following the path of least resistance (photo 8).

Description: What was observed as a puddle along the side of the road between the Bulk Metal and the Hazardous Waste Facility has turned into a seasonal surface water creek that takes water from the Hazardous Waste Facility to through the Bulk Metal section of the Solid Waste Facility.

- Make a plan to move or create a new monitoring station to the area observed between the Bulk Metal Facility, and the Hazardous Waste Facility.
- Submit to the spill line Spill Reports for any spills regardless of size within all the Hamlet services outlined as “Relevant Structures” in the background of this report.

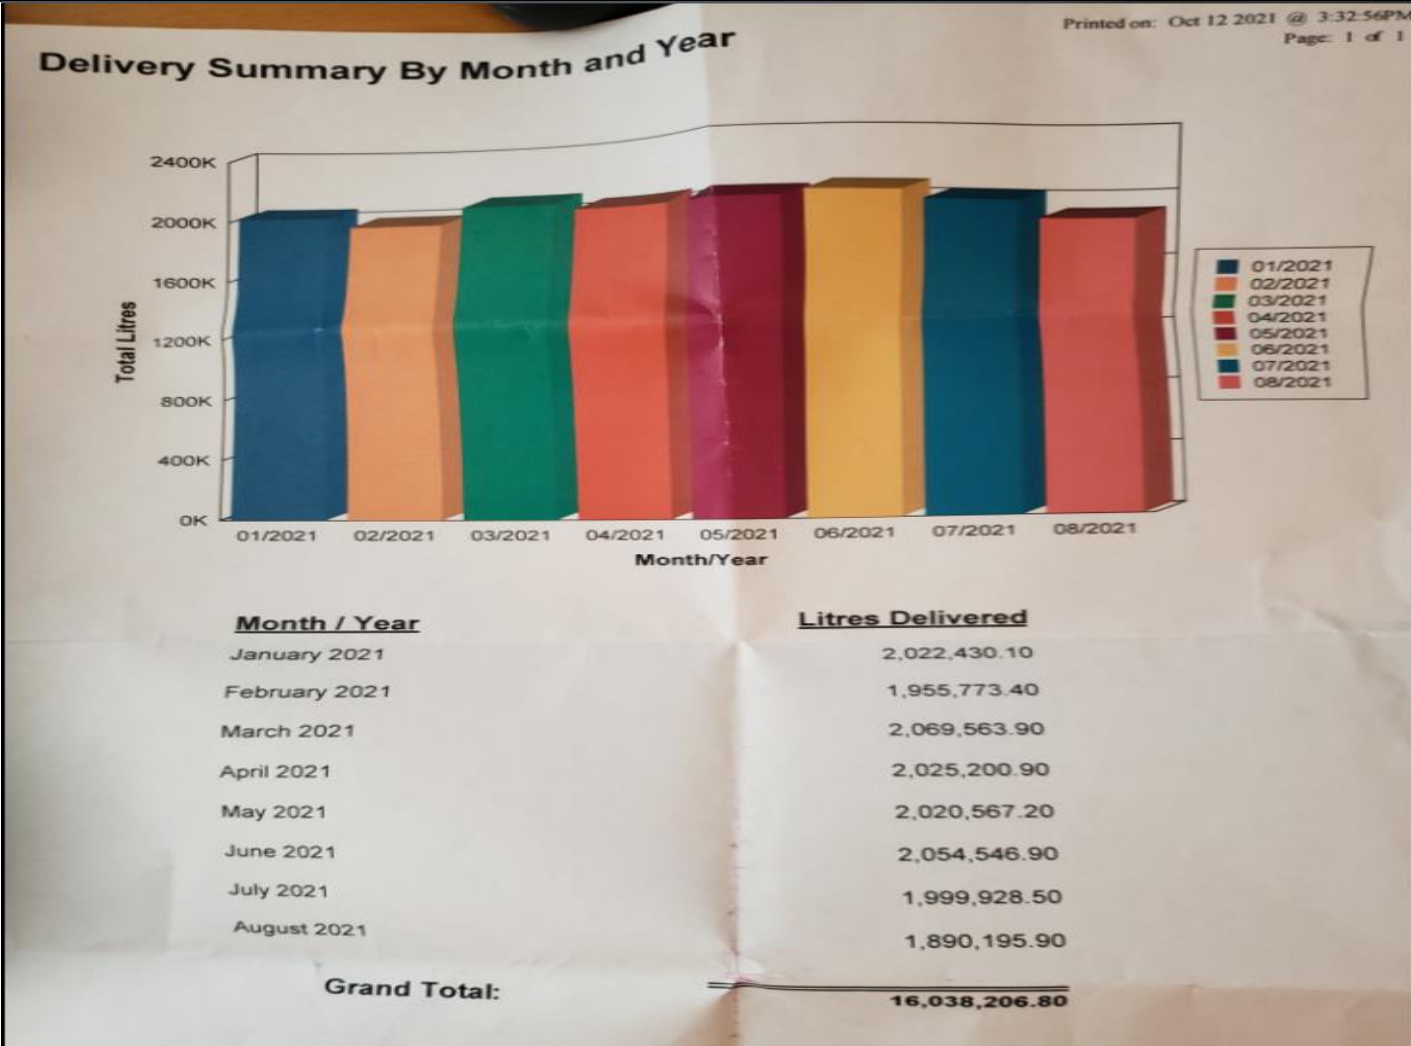
Photo 9

7. Water Consumption Rates for the Months of January to August, 2021. 16,038 cubic metres withdrawal and delivered (Photo 10).

Description: Water Consumption Rates for the Months of January to August, 2021. 16,038 cubic metres withdrawal and delivered.

-Limit the amount of water withdrawal to the authorized amount listed in the water licence, or apply to the Water Board for an amendment to increase water withdrawal amount.
