Reference: OTCD00019055A

June 3, 2008

### **Sewage Lagoon Failure Clyde River, Nunavut**

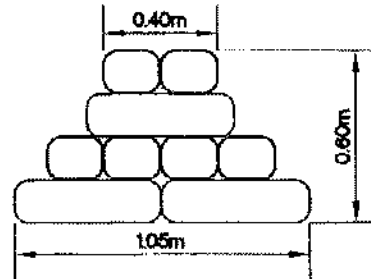
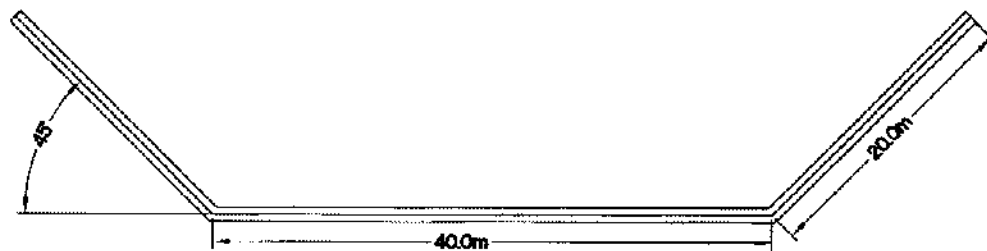
scale <b>AS SHOWN</b>	CLIENT: <b>CGS-GN</b>	project no. <b>OTCD19055A</b>
date <b>02/06/08</b>	TITLE: <b>SAND BAGS</b>	<b>SK-3</b>
drawn by <b>MMR</b>

The site visit revealed that the level of the sewage is approximately 1.15 m below the top of berms. It was observed that a crescent-shaped crack had begun to form in the area of the repaired berm. This crack is located approximately 1.5 metres from the edge of the crest of the berm. This is an indication of incipient failure of this portion of the berm. Once this section of the berm fails, the remainder of the berm may be too weak to support the lateral hydrostatic pressures and may also fail. It is recommended that this portion of the berm be immediately reinforced to prevent failure. It is noted that there is no excavator available in the Hamlet and the ground is still frozen. It is understood that the reinforcement of the berm can be undertaken through the placement of sandbags. A source of sand has been identified within the Hamlet and there are approximately 5,000 sandbags available within the Hamlet.

The sandbag reinforcement should be comprised of widening the berm at the crest level by 1.25 metre and sloping at an inclination approximately equal to 2 horizontal to 1 vertical. It is estimated that the reinforcement will require approximately 2,500 sandbags. The placement of the sandbags should be such to ensure that the bags do not have any voids or gaps and that the joints are staggered.

A preliminary sketch has been provided to the Hamlet to allow for the emergency repairs to begin. The final placement of sand bags was accomplished on June 2, 2008. Details of the repairs are provided in the attached sketch SK1.

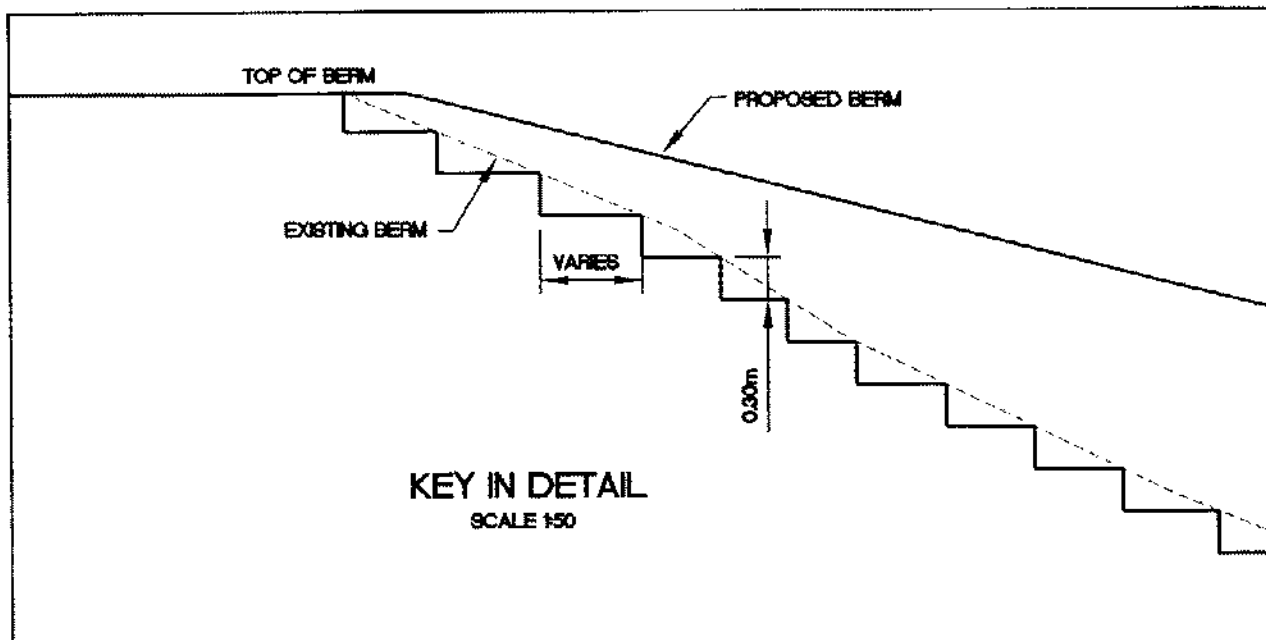
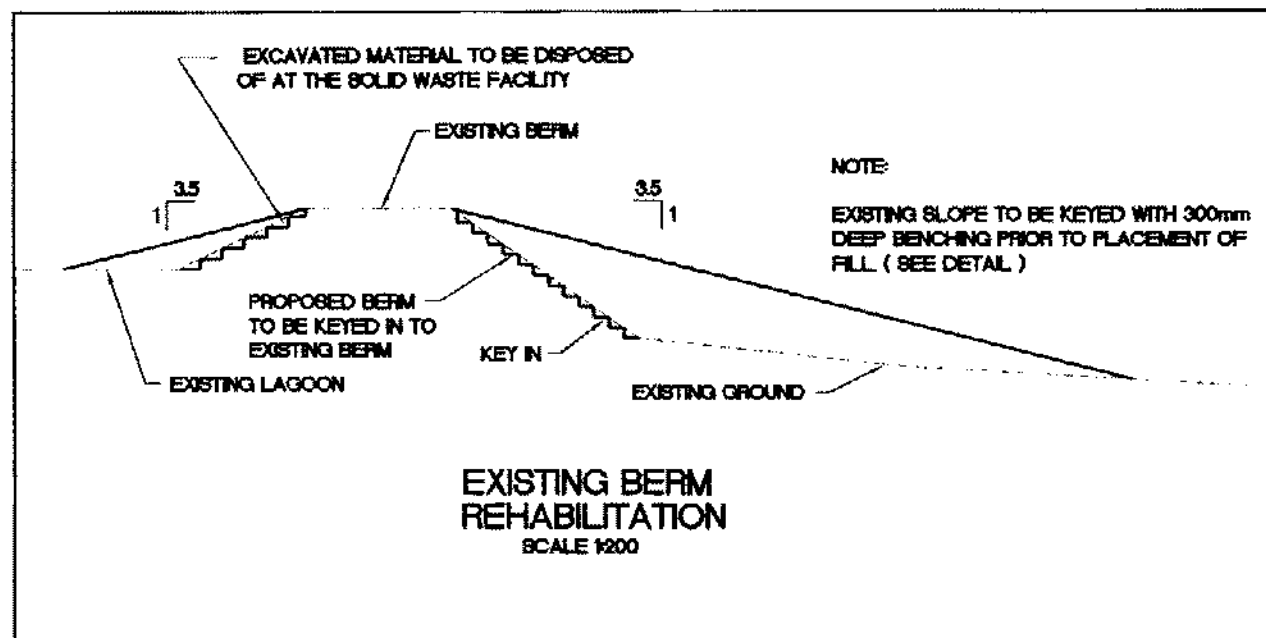
scale AS SHOWN	CLIENT: CGS-GN	project no. OTCD19055A
date 02/06/08	TITLE: BERM REHABILITATION	SK-4
drawn by MMR

As per our Geotechnical Report on the sewage lagoon berms, dated January 2008, the existing sewage lagoon berms have slope stability issues which is further evident from the recent breach. In addition, the 2003 Dillon Report noted seepage from the southwest corner of the sewage lagoon, which again indicates potential weakness in the berm. Due to the recent failure and other reported issues, we recommend that the berms slopes be stabilized as soon as possible. Our Geotechnical Report recommended that the existing sewage lagoon berms be stabilized by flattening the slopes. Details of our recommendations for slope stabilization are included in the Geotechnical Report and detail design drawings prepared for the Clyde River Sewage Lagoon Rehabilitation and Expansion, and as shown in sketches SK 4 and 5.

As previously mentioned, it is critical that the one metre freeboard be maintained to prevent overtopping and potential washout of the berms. It is recommended as part of the rehabilitation of the existing berms that an overflow device be installed to ensure that the one metre freeboard is always maintained. Details of the overflow device are included in the detail design drawings for the Rehabilitation and Expansion of the Sewage Lagoon.
