Inspection Report

License #: 3BM-CLY

RE: August 18th, 2008 Municipal Water Licence 3BM-CLY0909

Water License Inspection photos Clyde River August 18, 2008: CIDM 268991

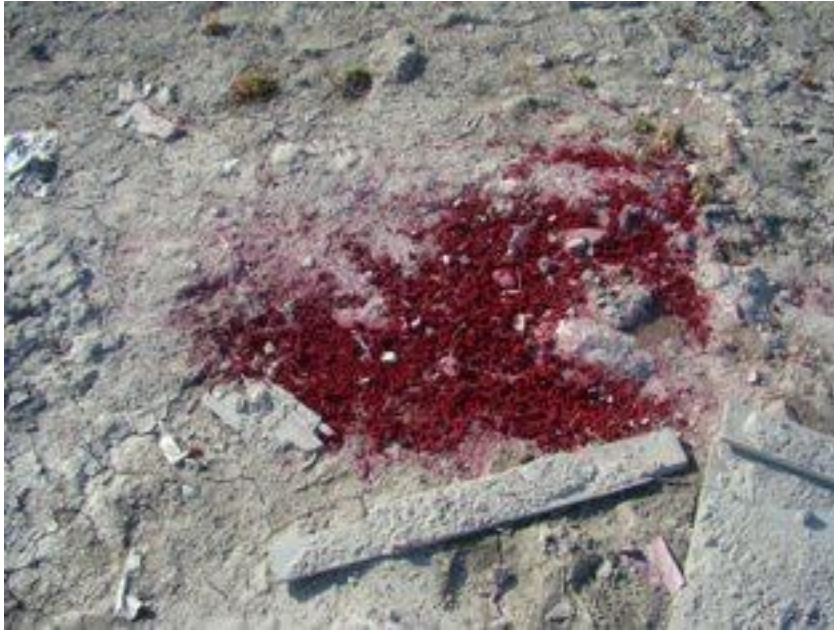
A further inspection of the hazardous wastes area found a number of 45 gallon drums containing what looked like waste oil were leaking and overturned within the area. There was no secondary containment noted and no spill kits available to address the releases. Also a red dye was found to be leaching from a sea-can containing a number of buckets of an unknown substance.

Unknown Red power in Municipal waste area

The Municipality (Mr. David Arreak) was provided a verbal direction to consolidate and remediate the area. It was suggested that some form of secondary containment was required to ensure these spills were not migrating into the environment and water was necessary and that the consolidation of the batteries found to be scattered throughout the area was also necessary.
