**Ref: INAC File No. 3BM-CLY0308, CIDM # 216017:
Clyde River Sewage Lagoon Failure May 23rd, '08**

Reference: OTCD00019055A

Sewage Lagoon Failure Clyde River, Nunavut

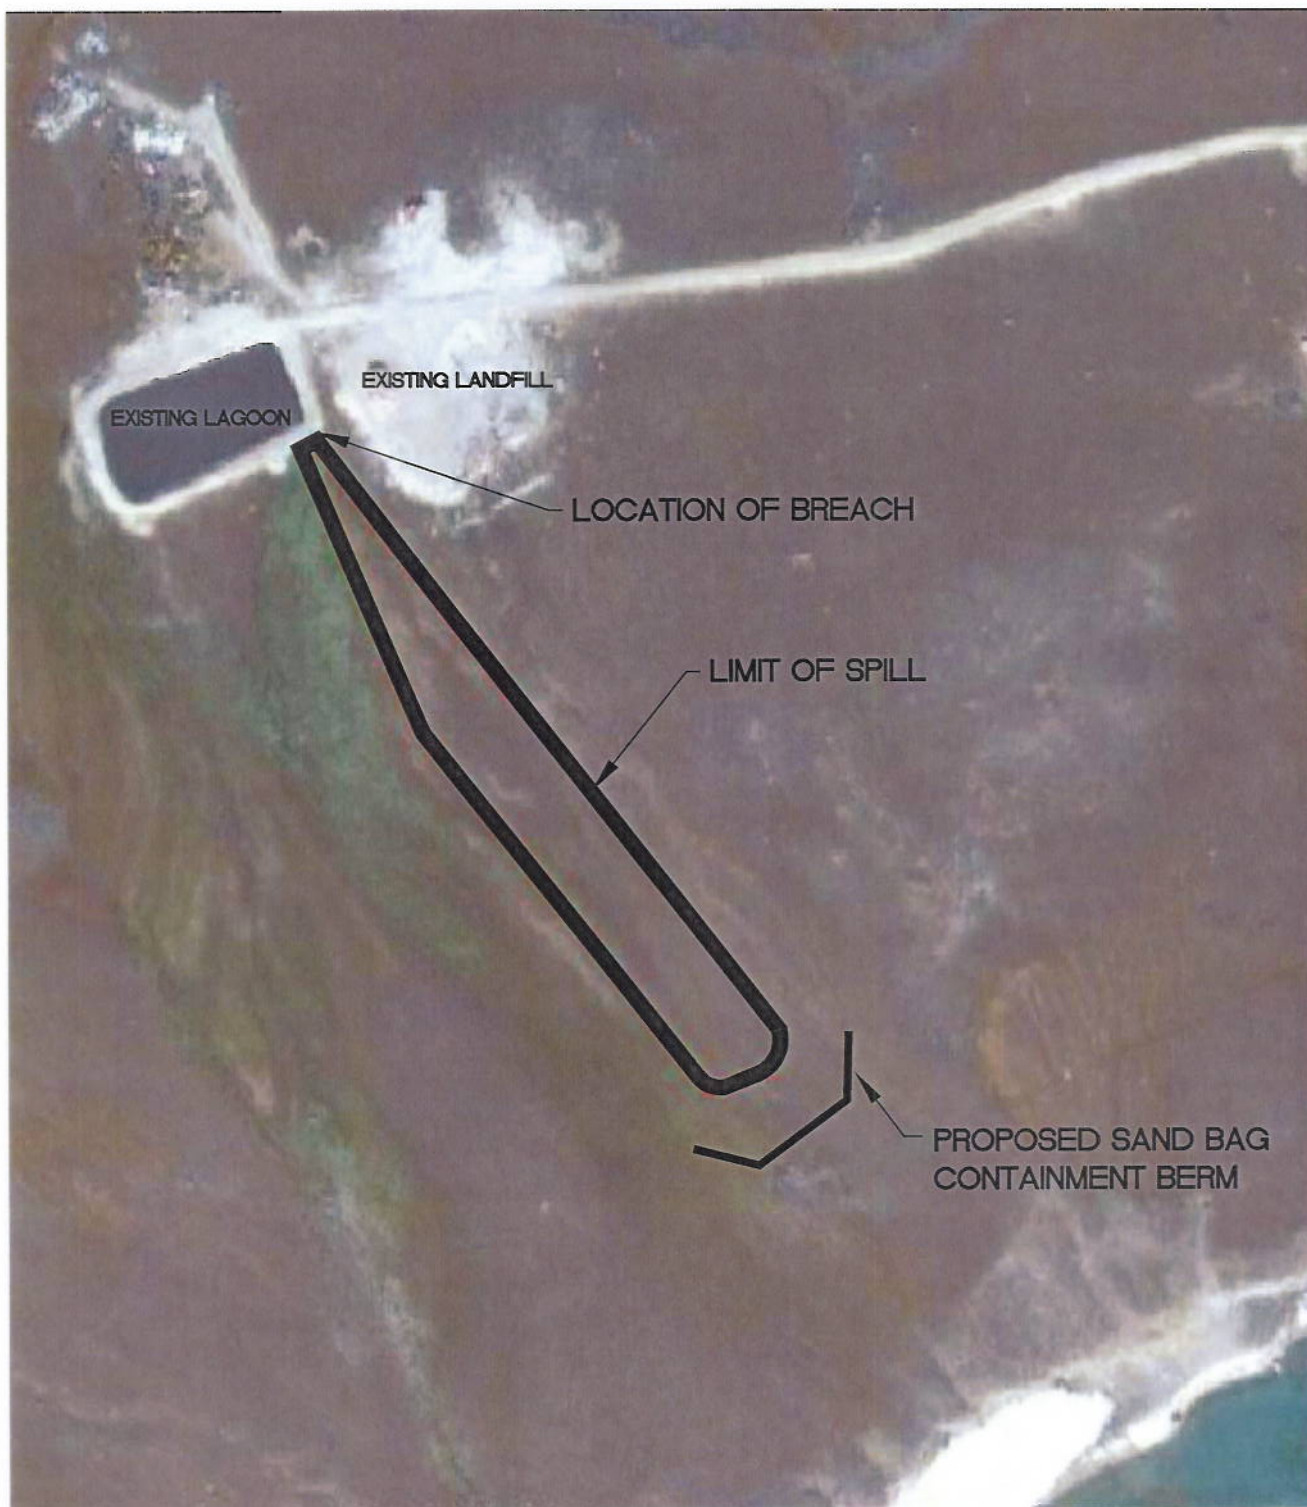
scale N.T.S.	CLIENT: CGS-GN	project no. OTCD19055A
date 02/06/08	TITLE: LIMITS OF SEWAGE SPILL	SK-2
drawn by MMR

During the site visit the extent of the area contaminated by the sewage spill was delineated with a GPS unit and is shown on sketch SK2. The area extended approximately 450 metres from the lagoon to the south east towards the ocean. It appears that the majority of the sewage released has been absorbed into the soil structure. This is evident through the melting of the snow and the soil structure being partially thawed near the surface. A portion of the contaminated area demonstrates discoloured snow and areas where the underlined snow has been melted, leaving a thin layer of ice on the surface. Generally, beneath this snow and ice there is a layer of moist and thawed soil, once again indicating much of the sewage has been absorbed into the natural vegetation and soil structure. The width of the flow path is between 30 and 60 metres, and as previously mentioned, extends approximately 450 metres along the slope.

It is felt that as the majority of the sewage has been absorbed into the soil structure, natural treatment will occur as the wetlands rejuvenates in the spring. To address containment of any contamination in the snow pack, it is recommended that a containment berm be constructed just past the extent of the sewage spill as shown on sketch SK2. This containment berm will be approximately 2-3 feet high and span across the width of the contaminated, details of the containment berm are shown on sketch SK3. The purpose of this containment berm will be to delay the release of the sewage during the spring melt. The containment berm will be located downstream of the spill area and will be constructed out of sandbags.

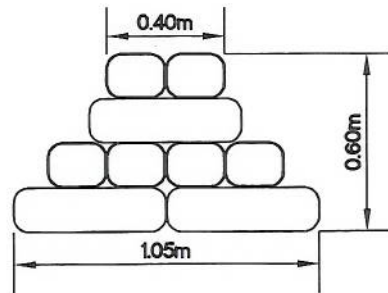
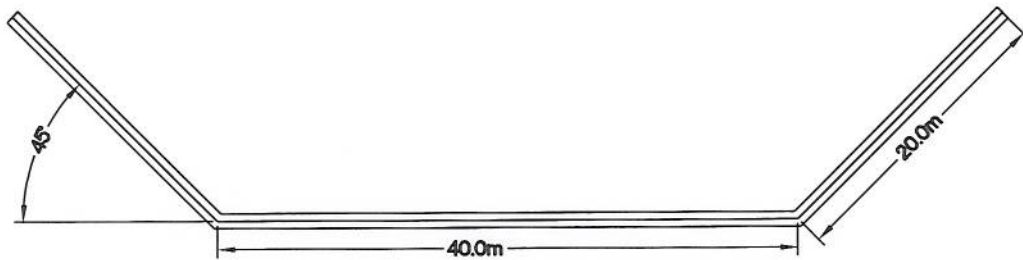
scale AS SHOWN	CLIENT: CGS-GN	project no. OTCD19055A
date 02/06/08	TITLE: SAND BAGS	SK-3
drawn by MMR

The site visit revealed that the level of the sewage is approximately 1.15 m below the top of berms. It was observed that a crescent-shaped crack had begun to form in the area of the repaired berm. This crack is located approximately 1.5 metres from the edge of the crest of the berm. This is an indication of incipient failure of this portion of the berm. Once this section of the berm fails, the remainder of the berm may be too weak to support the lateral hydrostatic pressures and may also fail. It is recommended that this portion of the berm be immediately reinforced to prevent failure. It is noted that there is no excavator available in the Hamlet and the ground is still frozen. It is understood that the reinforcement of the berm can be undertaken through the placement of sandbags. A source of sand has been identified within the Hamlet and there are approximately 5,000 sandbags available within the Hamlet.

The sandbag reinforcement should be comprised of widening the berm at the crest level by 1.25 metre and sloping at an inclination approximately equal to 2 horizontal to 1 vertical. It is estimated that the reinforcement will require approximately 2,500 sandbags. The placement of the sandbags should be such to ensure that the bags do not have any voids or gaps and that the joints are staggered.

A preliminary sketch has been provided to the Hamlet to allow for the emergency repairs to begin. The final placement of sand bags was accomplished on June 2, 2008. Details of the repairs are provided in the attached sketch SK1.

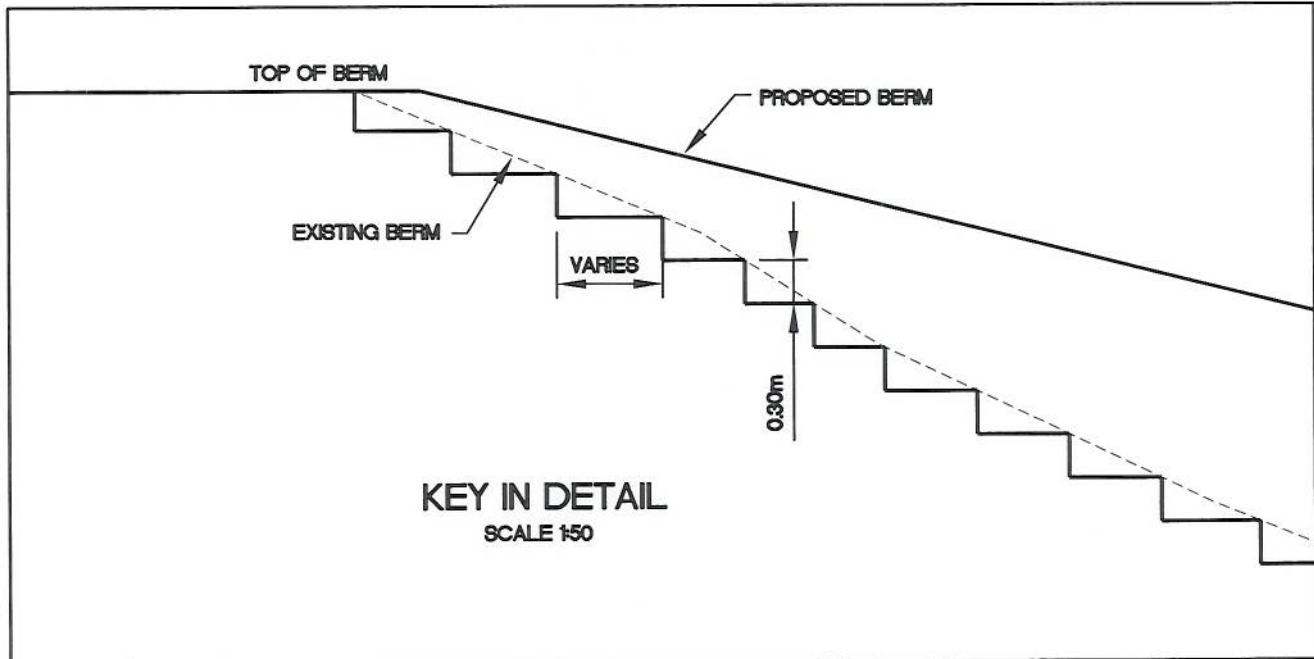
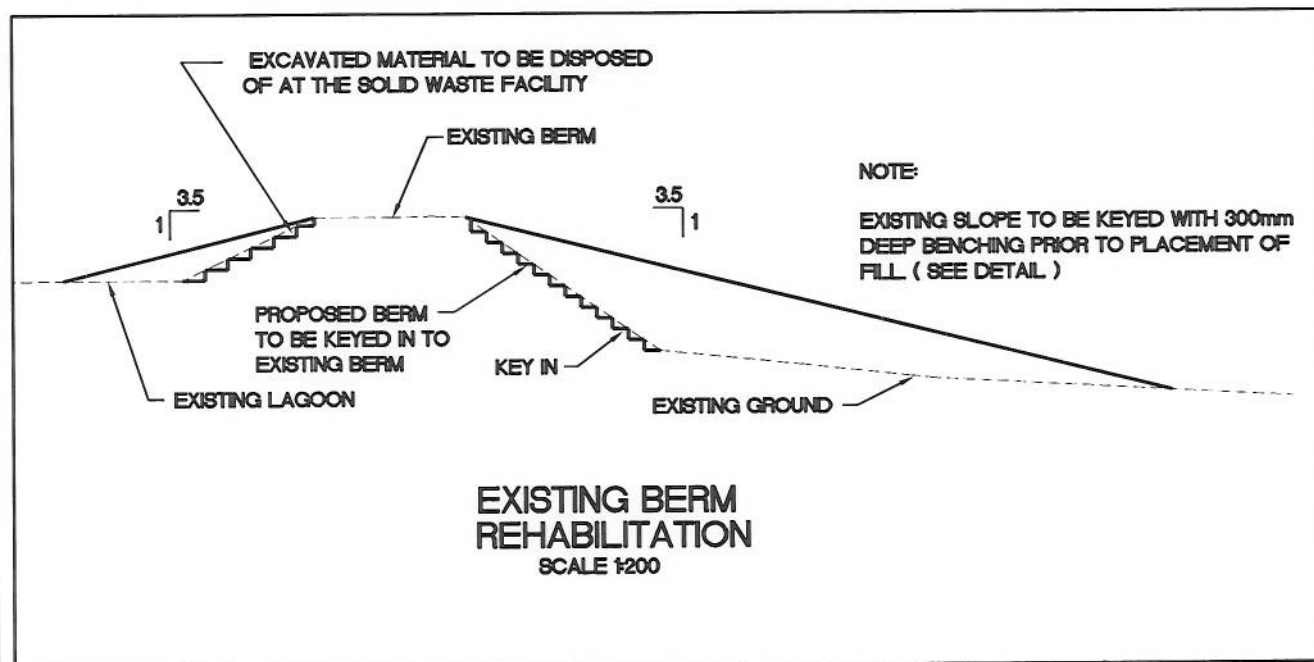
scale AS SHOWN	CLIENT: CGS-GN	project no. OTCD19055A
date 02/06/08	TITLE: BERM REHABILITATION	SK-4
drawn by MMR

As per our Geotechnical Report on the sewage lagoon berms, dated January 2008, the existing sewage lagoon berms have slope stability issues which is further evident from the recent breach. In addition, the 2003 Dillon Report noted seepage from the southwest corner of the sewage lagoon, which again indicates potential weakness in the berm. Due to the recent failure and other reported issues, we recommend that the berms slopes be stabilized as soon as possible. Our Geotechnical Report recommended that the existing sewage lagoon berms be stabilized by flattening the slopes. Details of our recommendations for slope stabilization are included in the Geotechnical Report and detail design drawings prepared for the Clyde River Sewage Lagoon Rehabilitation and Expansion, and as shown in sketches SK 4 and 5.

As previously mentioned, it is critical that the one metre freeboard be maintained to prevent overtopping and potential washout of the berms. It is recommended as part of the rehabilitation of the existing berms that an overflow device be installed to ensure that the one metre freeboard is always maintained. Details of the overflow device are included in the detail design drawings for the Rehabilitation and Expansion of the Sewage Lagoon.
