## **Design Brief**

**Project Name**  
Coral Harbour Pump House Upgrades

**Project Number**  
OTT-00203694-A0

**Date Submitted**  
July 2012

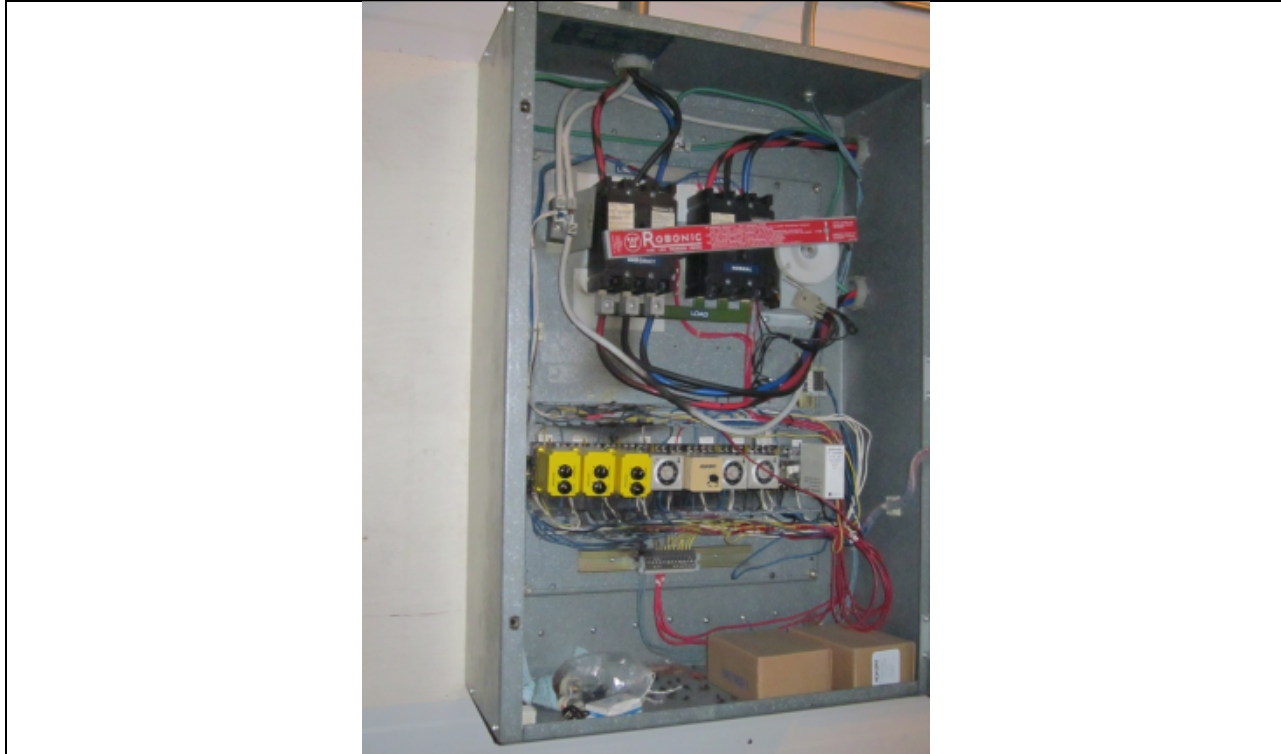
The main supply circuit breaker, a pair of panel boards and the generator automatic transfer switch are located in the generator building. All of this equipment appears to be part of the original installation. With the exception of the transfer switch, this equipment appears to be in serviceable condition. Within the transfer switch there was evidence of internal damage that included black residue on the enclosure door and blackening of the insulation on some of the internal wiring. The functionality of the transfer switch could not be confirmed as the generator could not be started.

Photo 7 – Interior of Automatic Transfer Switch with Visible Damage

The long term serviceability of the standby generator and transfer switch is questionable. Replacement of both is in order if the existing facility is to remain in service for an extended period of time. As has been noted above, provision of a water treatment process that conforms to current standards would require the construction of a larger building. This new building should incorporate a new standby generator. In the short term there are two alternative responses. The existing generator can be decommissioned. This would deprive the community of a water supply, both domestic and fire, during a power failure. The extend of freeze damage, in the event of a power failure, would likely be limited to the chlorination system as the water supply piping drains to the reservoir. Should it be concluded that the generator should remain in service, a new battery, battery blanket, block heater, transfer switch and generator controls should be acquired and the functionality of the generator must be confirmed.

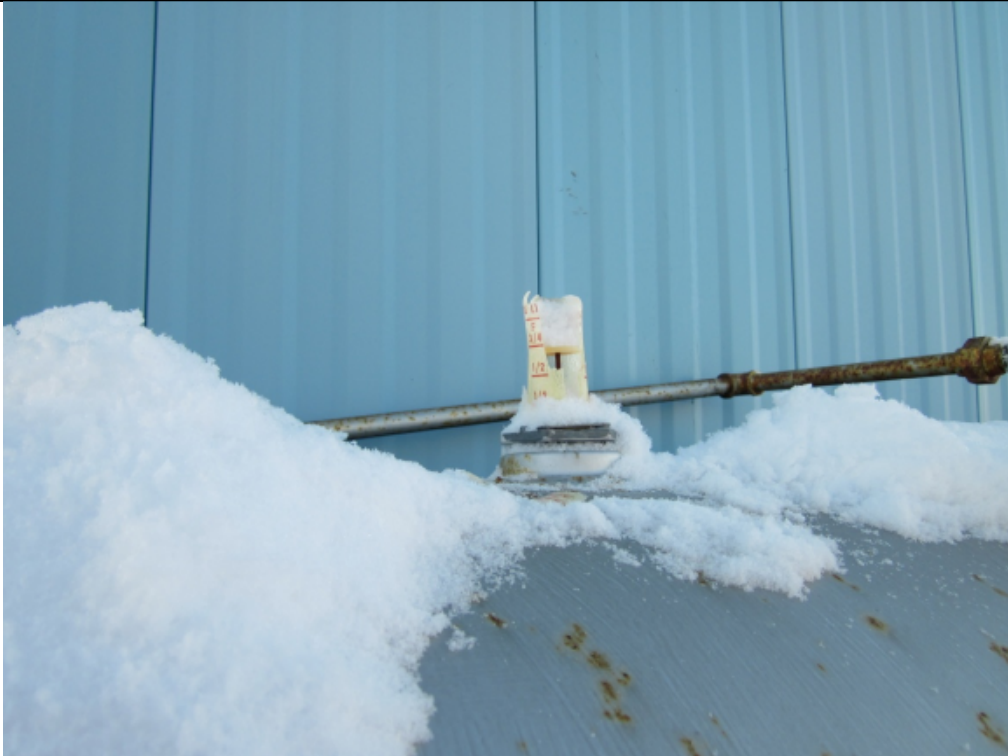
The fuel system is limited to that equipment required to provide a supply to the standby generator. The fuel system includes an external tank at the generator building and some internal piping. The external tank has been placed within a welded steel box with an open top. The box appears to be large enough to contain the tank contents, subject to the tank not being filled with ice, snow or water. During the site visit it was noted that the tank was filled with ice and snow to between  $\frac{1}{4}$  and  $\frac{1}{3}$  of its depth. It was also noted that the globe on the tank gauge was broken.

Photo 15 – Broken Fuel Tank Level Meter

The recommendations regarding the fuel system are driven by the requirement to mitigate the public health risk arising from the potential for a fuel spill in close proximity to the Hamlet water supply. There are two alternative means of managing this risk. The generator can be decommissioned and all fuel removed from the site, or a new fuel system that conforms to current code requirements can be provided. Decommissioning of the existing generator should also include a replacement method of providing electrical power in the event of a power failure.

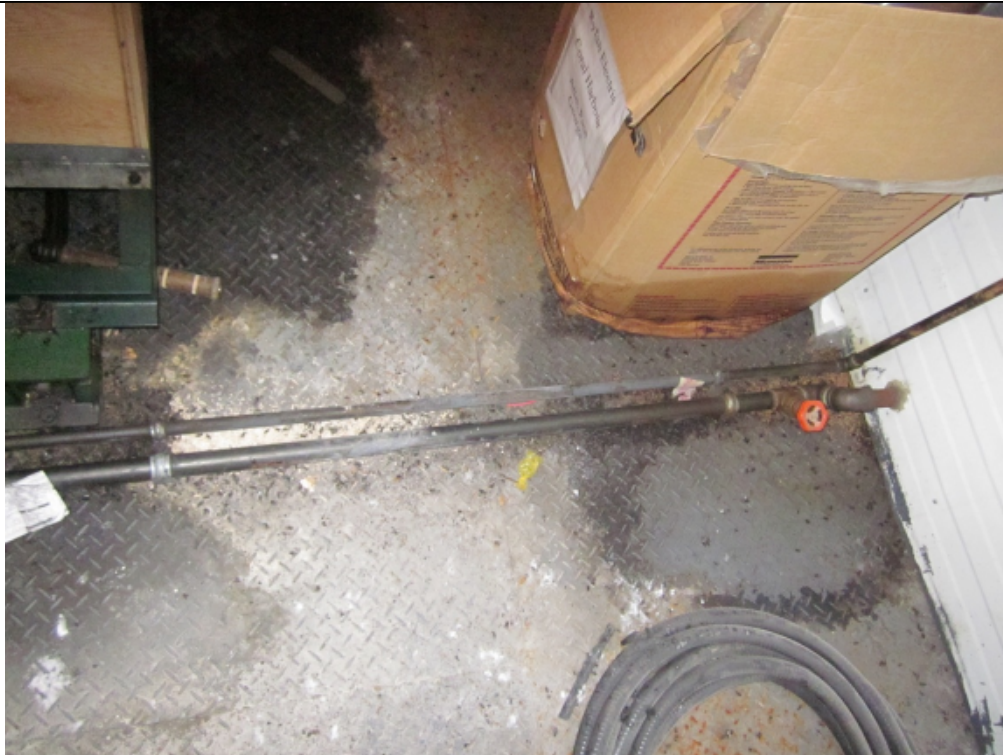
Within the generator building the fuel system is limited to piping along the building floor and flexible tubing at the generator. There is a modest amount of fuel staining on the generator building floor. There is no means to contain a fuel spill within the generator building. No spill containment materials were noted during the visit.

Photo 18 – Fuel Line to Generator with Signs of Leaking

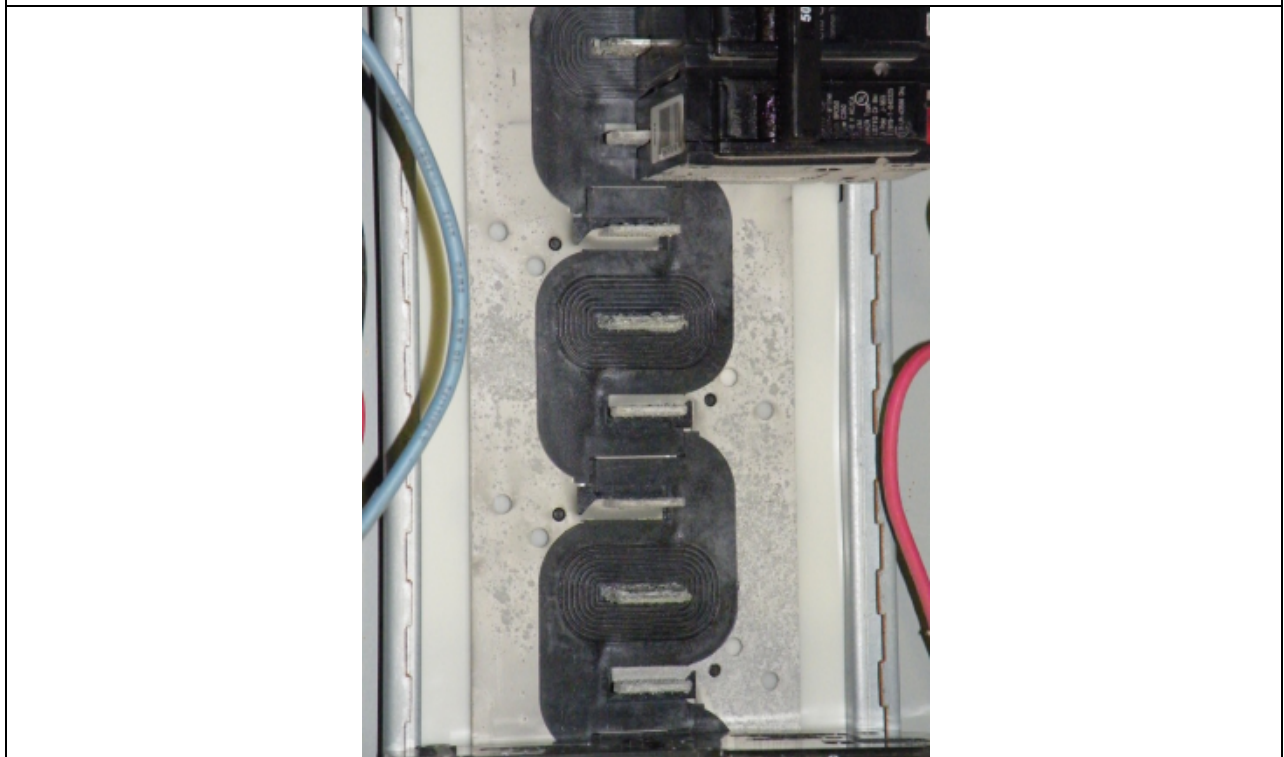
A pair of panel boards in the truck-fill station is fed from the generator building. One of these panel boards supports the heating loads within the truck-fill station, while the second supplies all of the remaining loads. A contactor has been installed, which disconnects the heating loads when the water pumps are in operation, or when the station experiences a loss of power. The panel boards and the contactor are replacements of the equipment that was originally installed. All of the electrical equipment in the truck-fill building is displaying corrosion that is likely due to the disinfection chemicals. It is reported that original equipment was replaced because of excessive internal corrosion. The existing electrical equipment has a limited remaining service life.

Photo 24 – Panel B Interior Showing Deterioration Due to Corrosion.

Surveillance of the panel board within the truck-fill building is required as corrosion within these panel boards is ongoing. Timing of the need for replacement of these panel boards is challenging as rate of corrosion and its impact upon the serviceability of this equipment is difficult to predict. A long service life should not be expected for the electrical equipment within the truck-fill building.

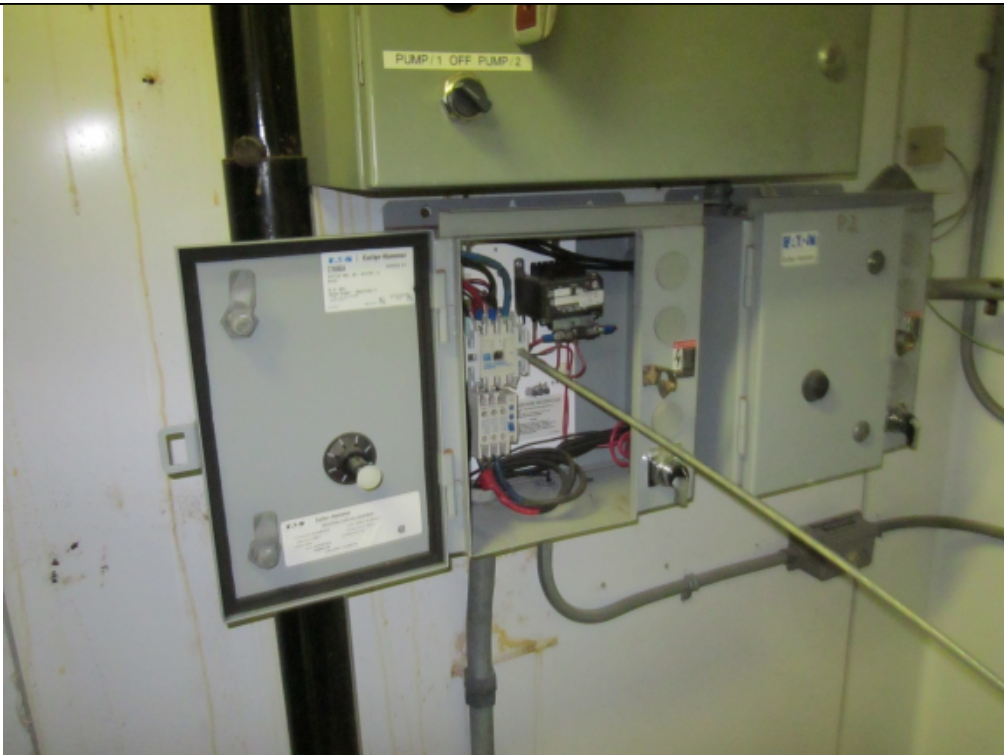
There is a pair of motor starters for pumps P1 and P2. It is reported that pump P2 is not serviceable. It was also reported that the starter for pump P1 had failed and that the internal parts from the starter for pump P2 had been transfer to the enclosure of the starter for pump P1. At the time of the site visit, the starter for pump P1 was not functionally properly. Pump operation was achieved by opening the enclosure of the starter and mechanically closing the contactor with a metal rod. The pump was then started by closing the appropriate circuit breaker. This represents a worker safety hazard that should be addressed at the first opportunity. This is independent of the risk of damage to the pump due to a lack of overload protection.

Photo 26 – Pump P1 Starter in Operation with Steel Rod Blocking Trip Unit

Repairs to the starters for both pumps P1 and P2 are required immediately. These repairs should be coordinated with repairs to the controls, which are examined in a subsequent section of this report.

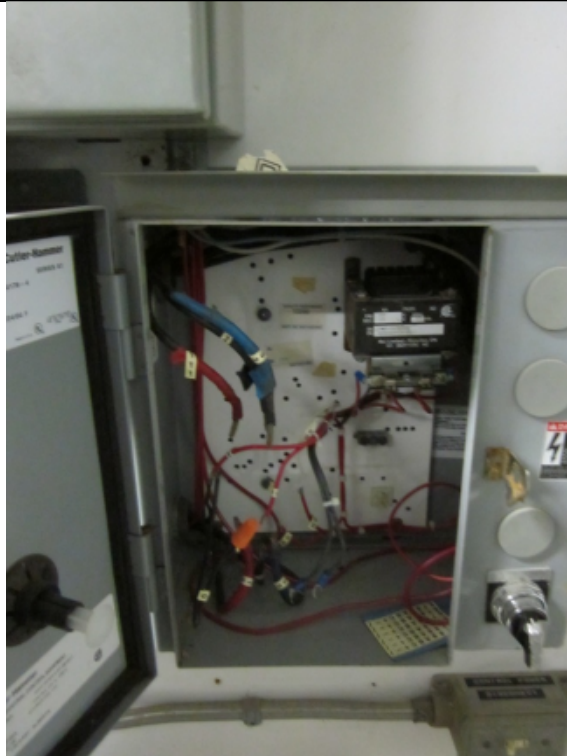
Photo 27 – Pump P2 Starter Enclosure without Starter

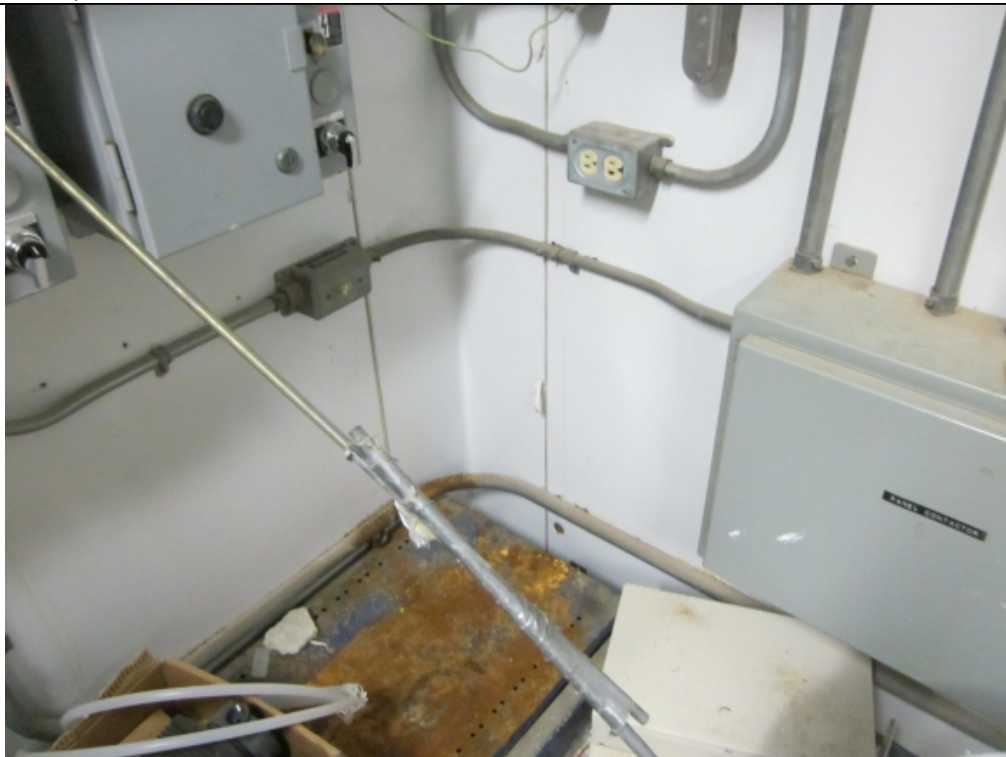
Photo 28 – Corroded Power Supply Conduit in Corner of Station

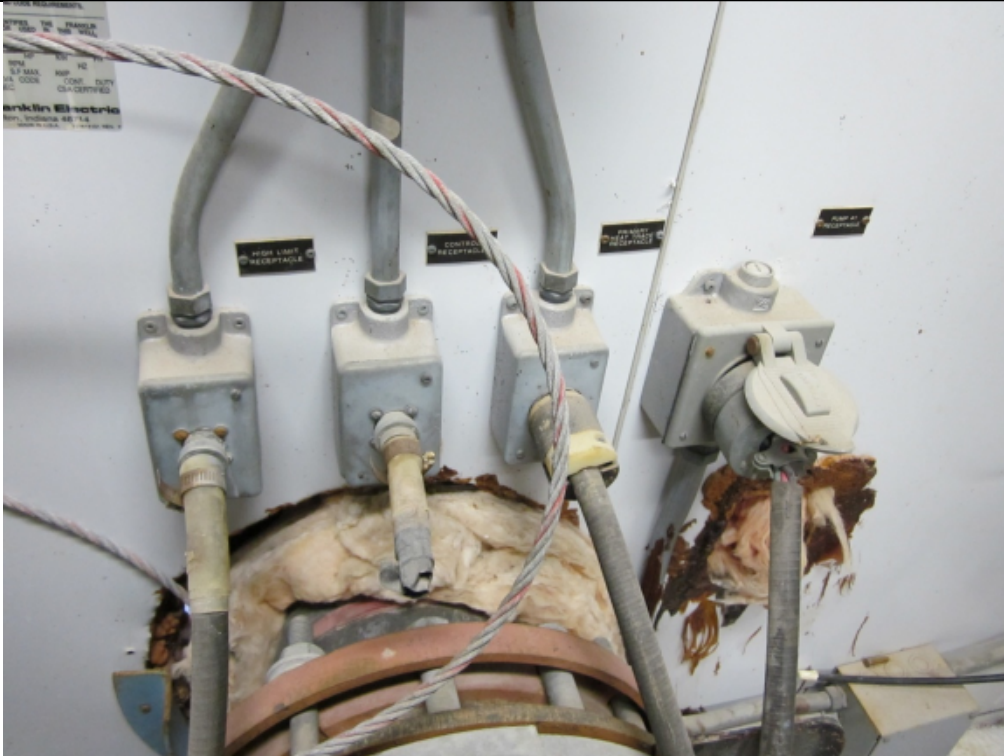
Photo 29 – Pump P1 Receptacle and Separating Flexible Plug with Exposed Wiring on Right. Heat Trace Connections to Pump P1 with Removed/Broken Control Connection

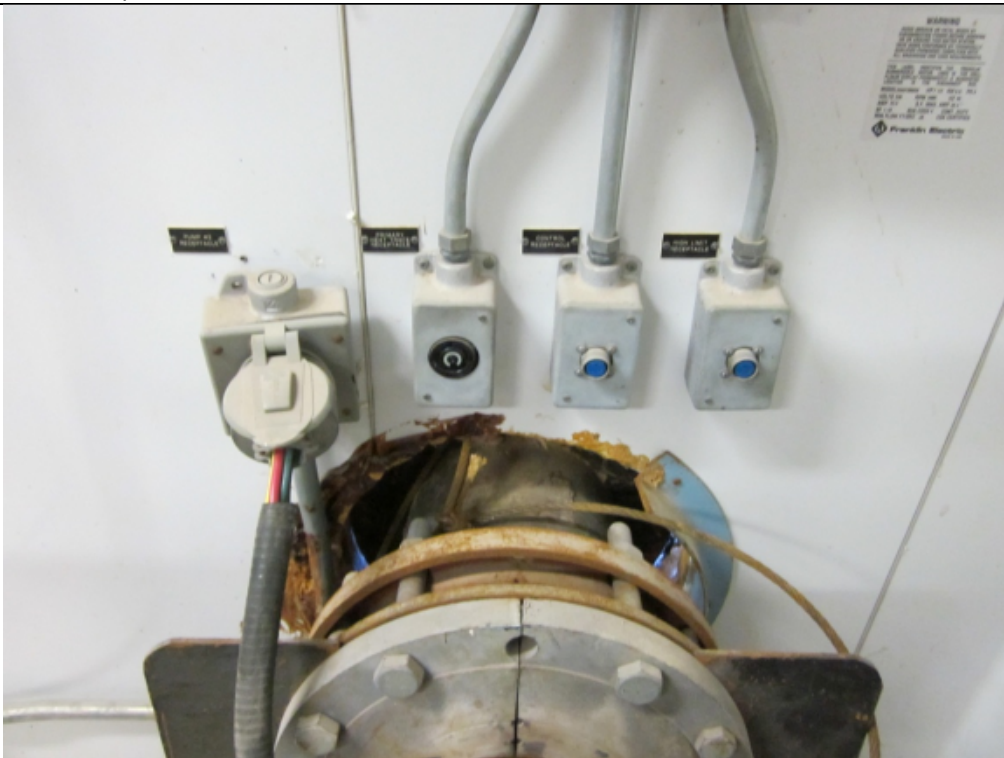
The intake for pump P2 is currently equipped with a single heat trace cable. It is likely that a single cable was provided when the pump was replaced. This cable was not in service. Measured resistance of the cable suggested that it may currently be an open circuit. During the field visit the consultant team did not connect this cable to test its function, as there was some uncertainty of the potential impact upon the heat trace controller.

Photo 30 – Pump P2 Receptacle and Separating Flexible Plug with Exposed Wiring on Left. No Heat Trace Connections for Pump P2.

New heat trace controllers should be provided for both intakes as part of the program to replace pump P2. The heat trace for pump P2 should be replaced as part of the pump replacement program.

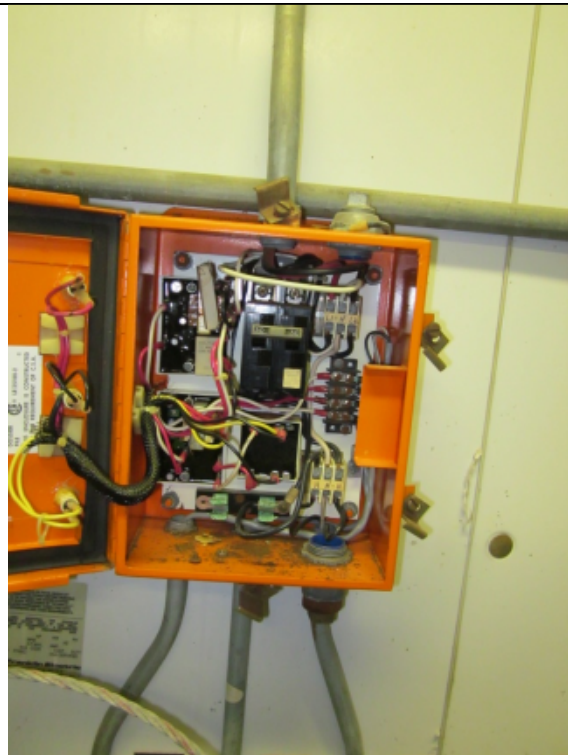
As a general observation, all of the controls located within the truck-fill building have experienced significant internal corrosion. This was observed in the form of corrosion at the various connection points. The degree of observable corrosion suggests that the internal contacts, such as those within the relays, have been affected.

Photo 32 – Interior of Pump P1 Heat Trace Controller

Although it is noted that the heat trace controllers are not functional, it is noted that the heat trace for pump P1 is still in service. This arrangement can remain in service until the various issues associated with pump P2 are resolved. At that time both heat trace controllers should be replaced as their remaining life is impossible to predict.

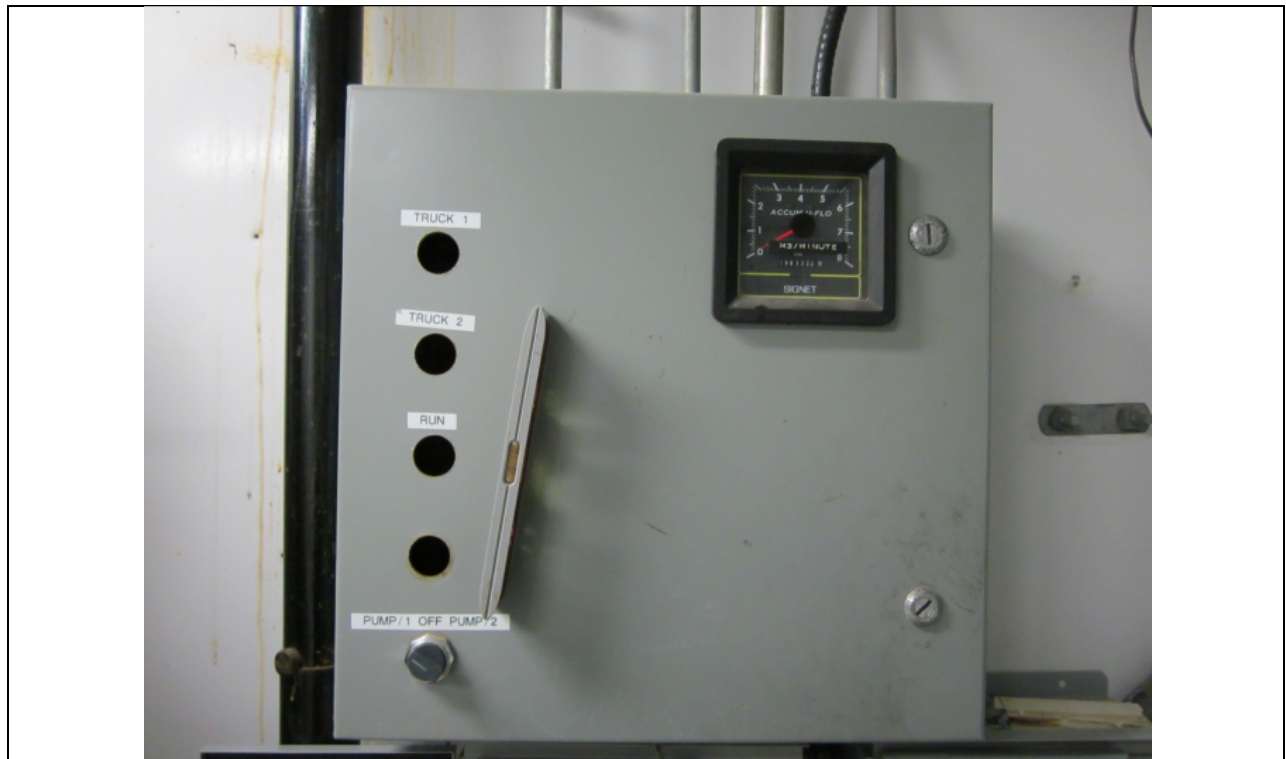
The controls associated with the water loading pumps are a relay based system that is currently not in service. The functionality and serviceability of these controls could not be confirmed during the site visit. This was due, in part, to the condition of the pump starters, which are currently engaged manually using a metal bar. This mode of operation represents a worker safety hazard that should be addressed at the first opportunity. The lack of a functioning control system requires entry into the building to start and stop the water pumps, as the external control station is no longer in service. This operating methodology has also removed the programmed time delay between pump cycles that was provided to assure complete pump drainage prior to the restarting of the pump.

Photo 35 – Pump Controller and Relay Panel with Missing Push Buttons

In the short term a rudimentary control system that resolves the worker safety hazard and permits push button starting of the pumps should be provided. This system could take the form of an external and an internal push button control station with running lights and a key lock for the external station. These works can be integrated with the repairs to the pump starters. These works should be conducted at the first opportunity to resolve the worker safety issues.

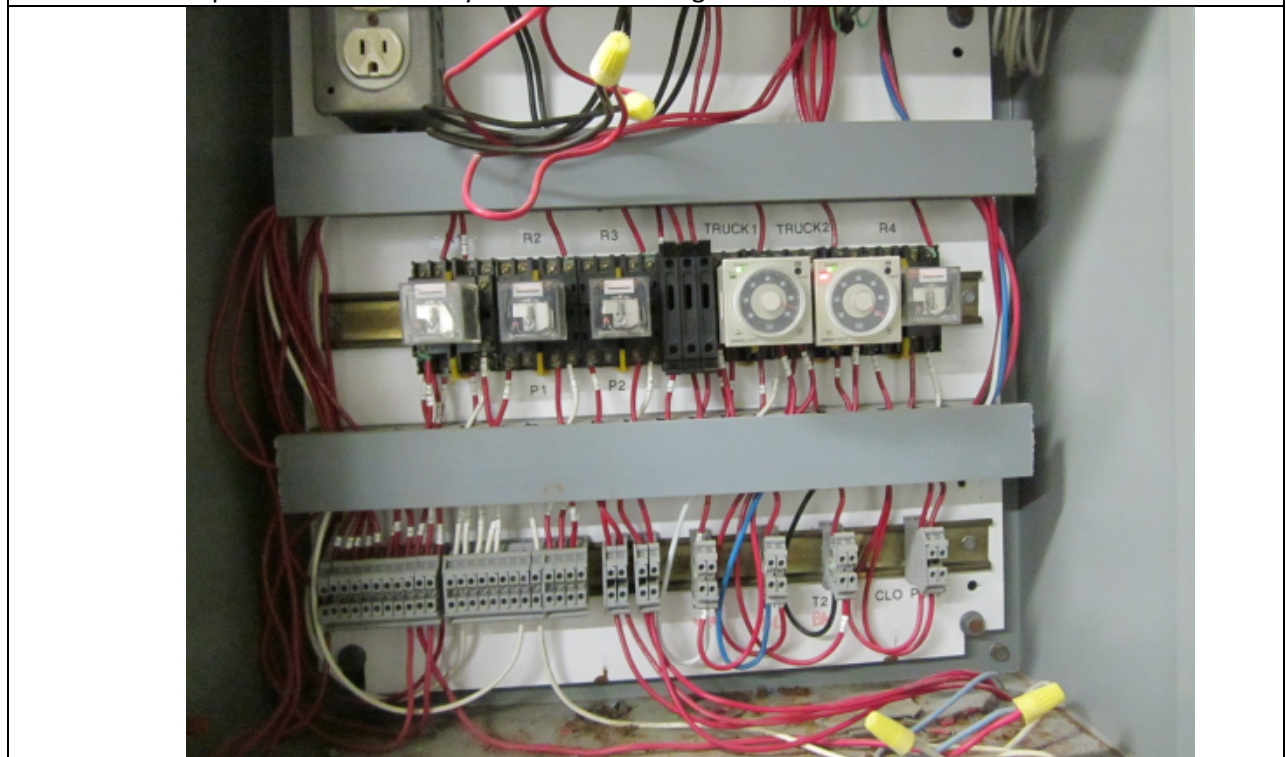
Photo 36 – Interior of Pump Station Controller and Relay Panel

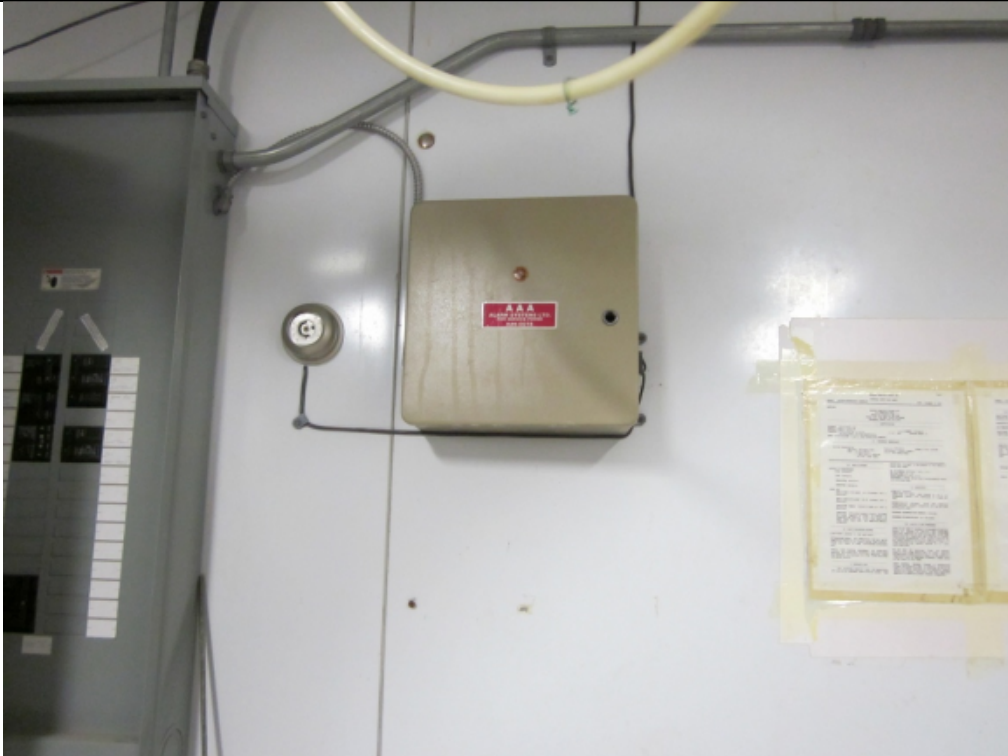
The alarm system is currently not serviceable. There is no remote indication of power status or building heating failure.

Photo 41 – Truck Fill Station Alarm Panel

- Replace the alarm system with a new alarm panel connected to Panel A. Provide a connection from the ATS and Generator to indicate when the system is on emergency power or without power.
- Provide a new low temperature thermostat designed for installation in hazardous locations for the low temperature alarm.
- Provide an autodialer and repair the telephone connection to the facility.
- Connect the new alarm system to the existing exterior strobe light.

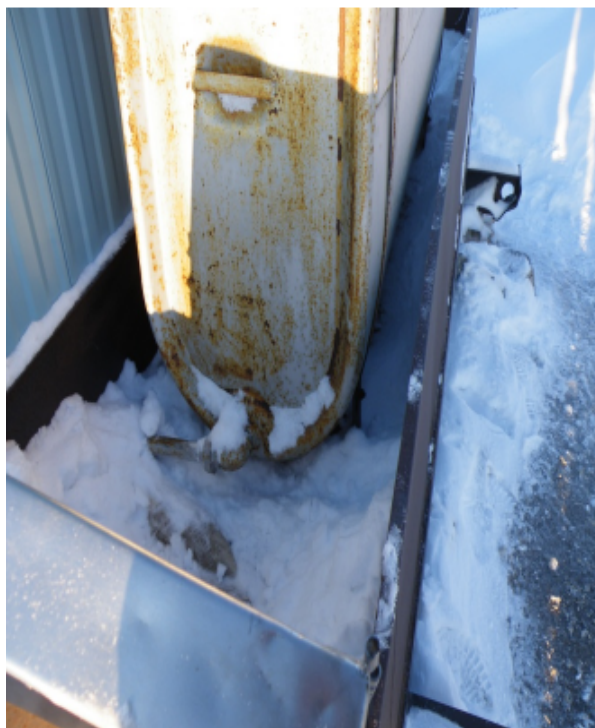
Photo 4: External Fuel Tank

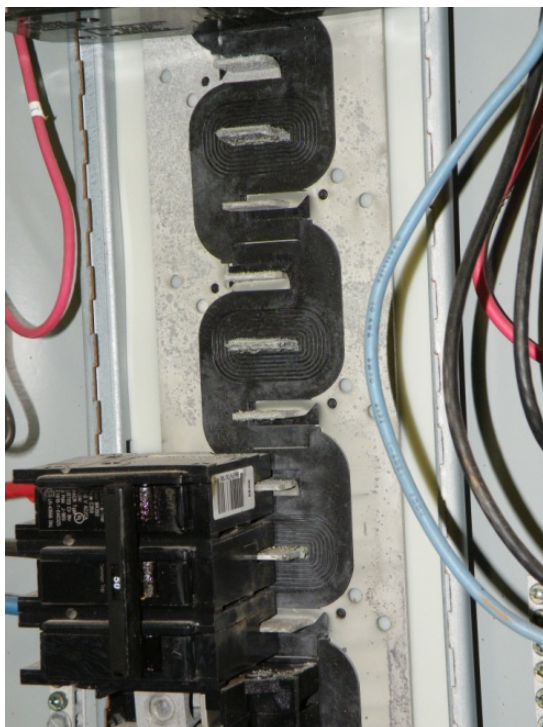
Photo 7: Internal Corrosion within Panel Board

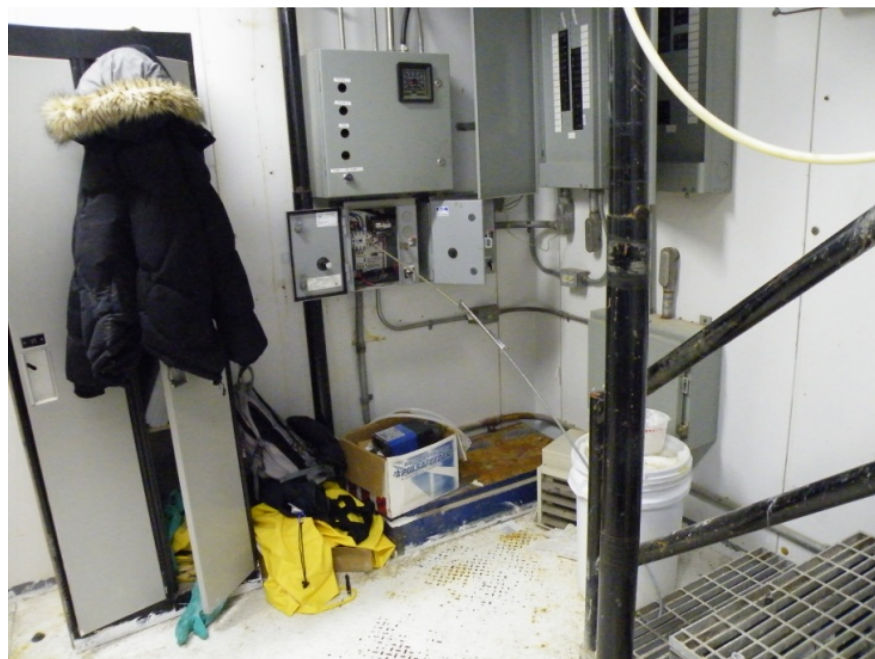
Photo 8: Operation of Contactor with Metal Rod

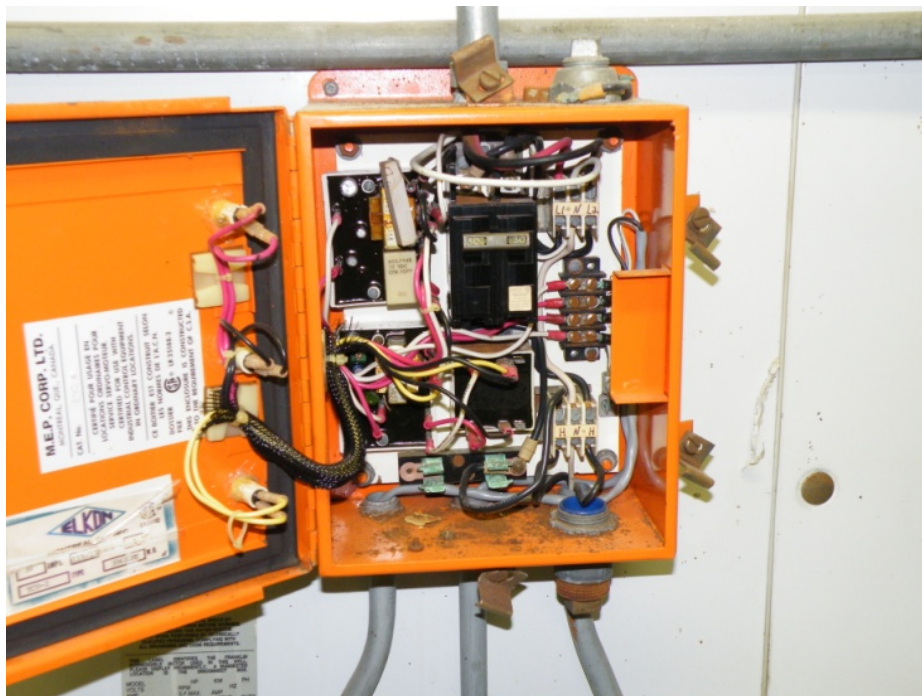
Photo 9: Heat Trace Controller Internal Conditions

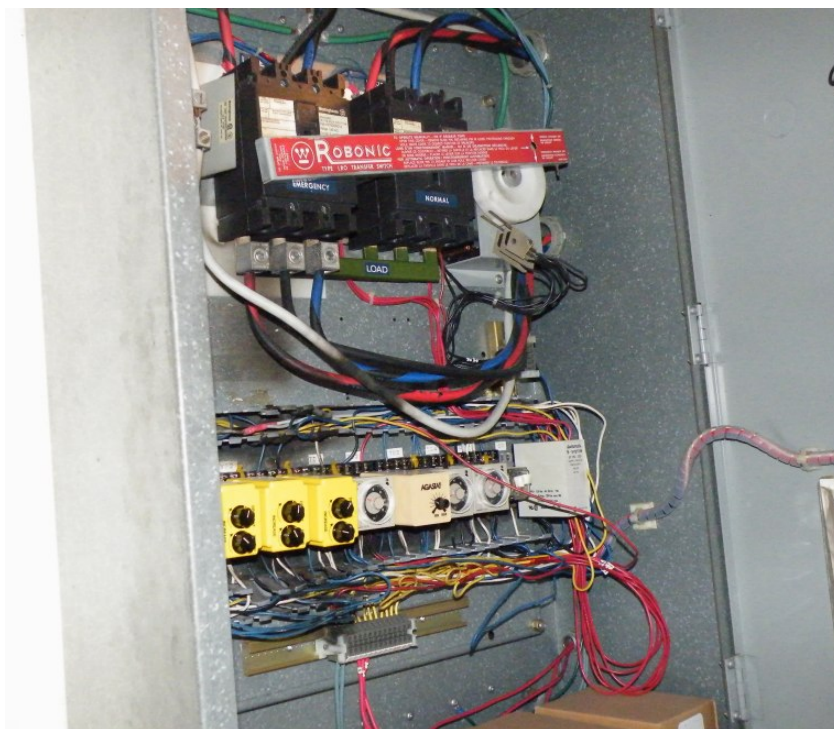
It was not possible to confirm the status of the controls for the standby generator. It is reported that the generator no longer starts automatically, but the reason for this issue could not be defined. It was noted that the generator starting battery is dead. It was also noted that the automatic transfer switch is in a questionable state, and that it no longer transfers load automatically.

Photo 10: Transfer Switch Internal Condition

Actions associated with the generator controls are driven by the decision regarding the ongoing necessity for a standby generator. Retaining the generator in service will require the replacement of the controls and transfer switch. Long term actions in regards to the controls will be driven by the long term status of the truck-fill station. The deterioration of the equipment housed in the truck-fill station, together with the water treatment issues will likely lead to the decision to replace the existing facility, which would include a new control system. Should the current facility be retained, a new control system must be provided.

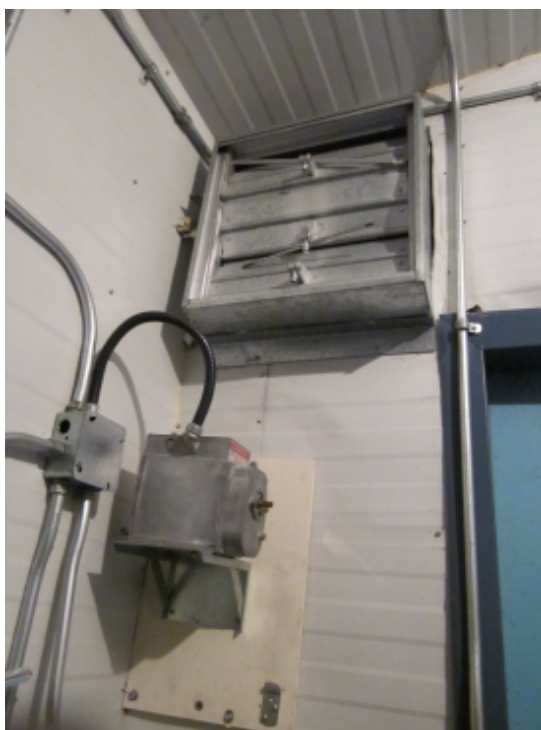
Photo 12: Unserviceable Intake Damper
