## **APPENDIX E**

### **HEAT LOSS AND BOILER SYSTEMS**

# Gjoa Haven Inspection pictures 2002

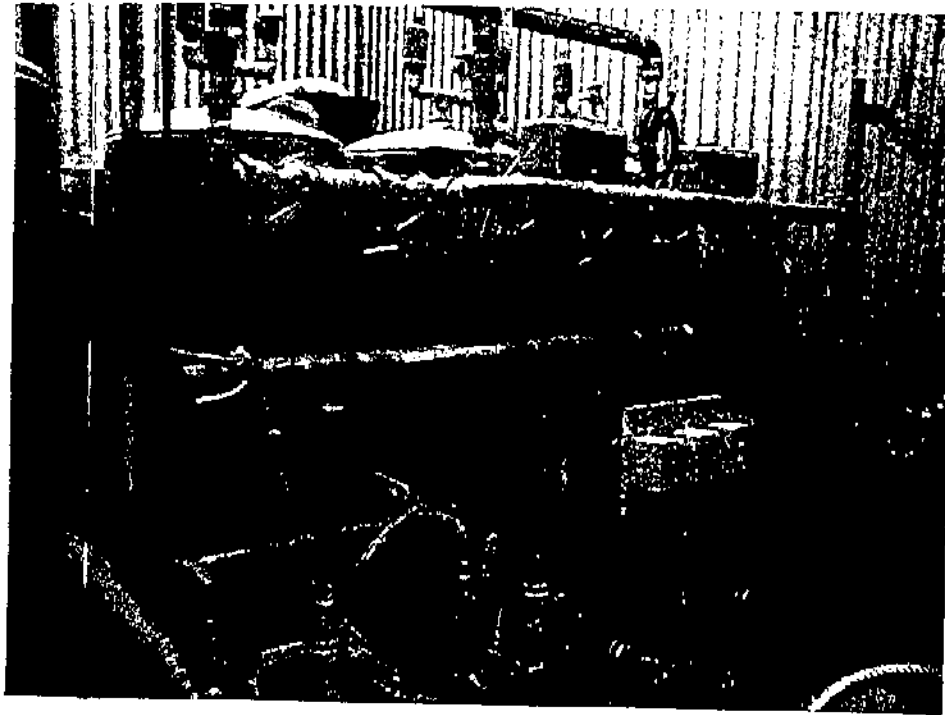
Photo # 3 Sand filters at Gjoa Haven Water Treatment Facility. Not in use at the time of this inspection.

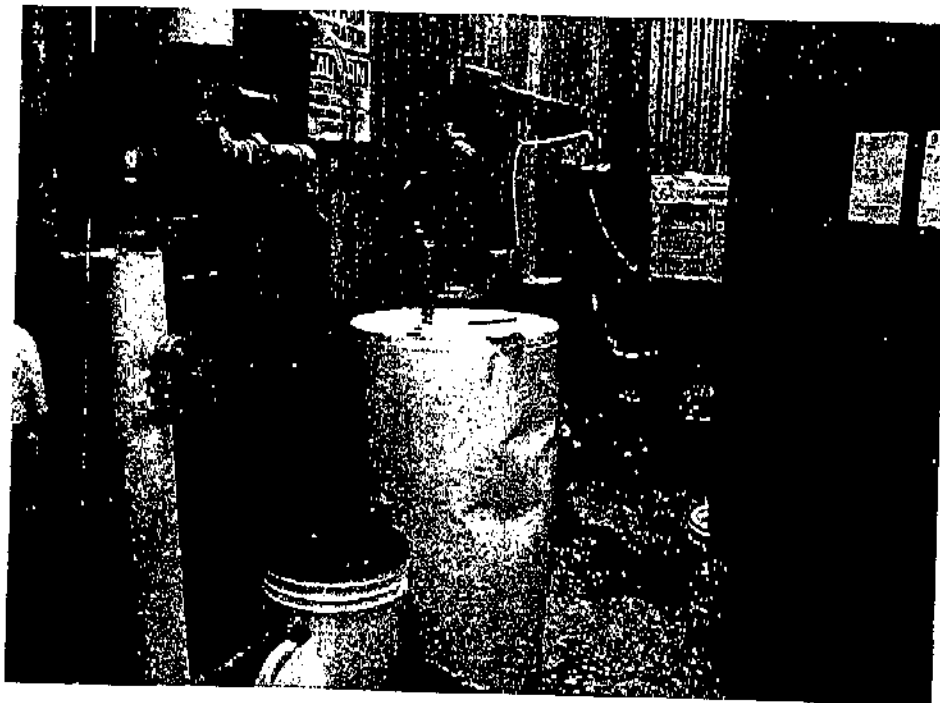
Photo # 4 Chlorination system in place at Gjoa Haven Water Treatment Facility.

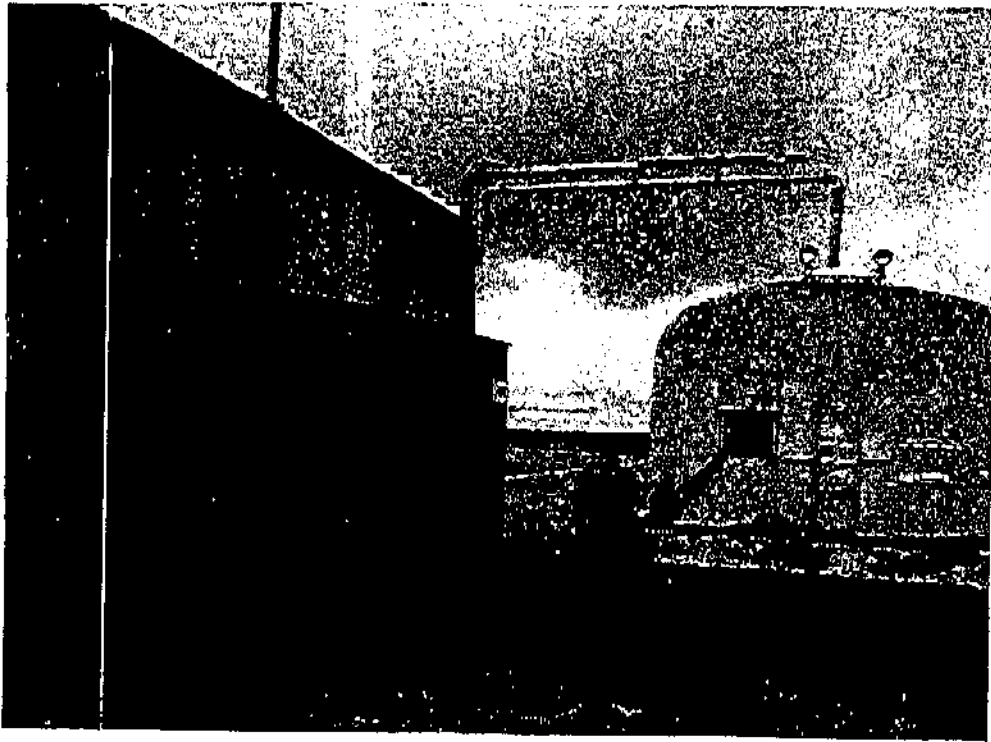
Photo # 5 Water Treatment Facility and truck fill station.

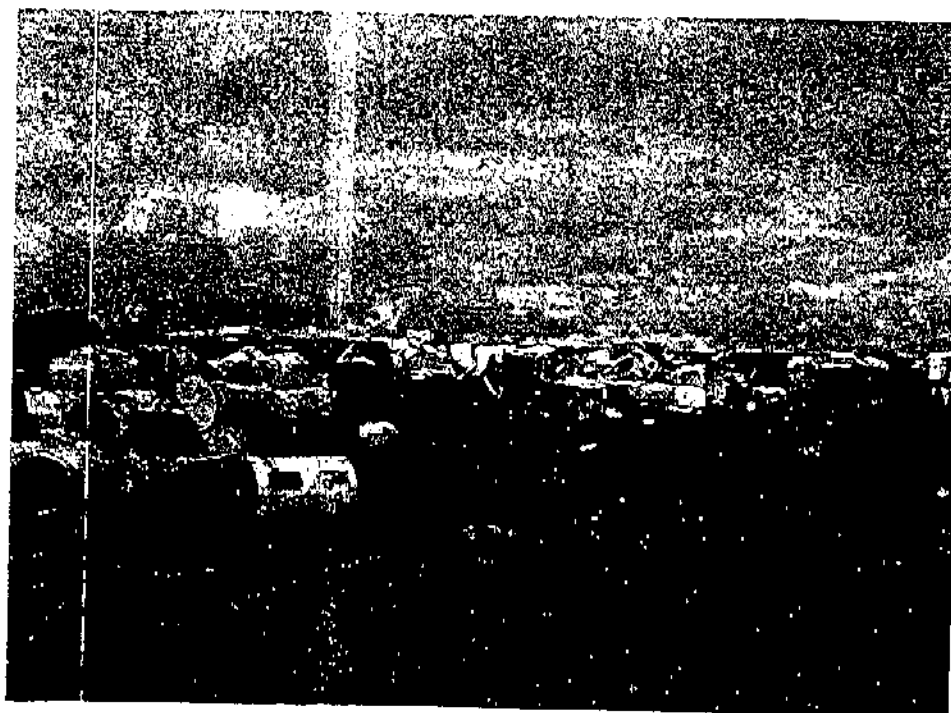
Photo # 10 Bulky metal dump showing segregation of waste streams.

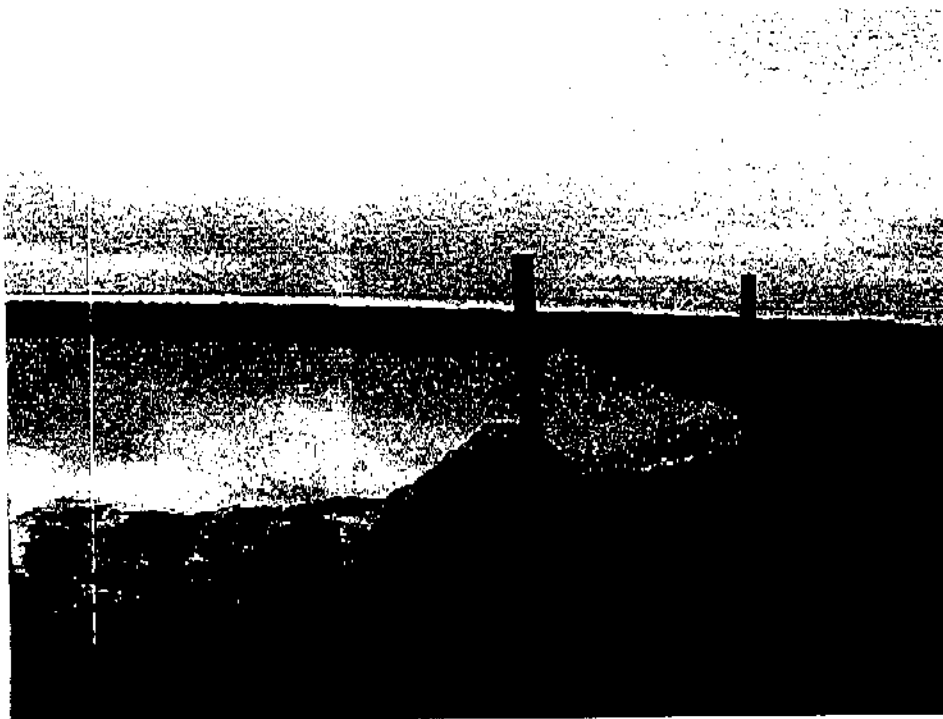
Photo # 11 Sewage truck discharge structure at Sewage Treatment Facility.

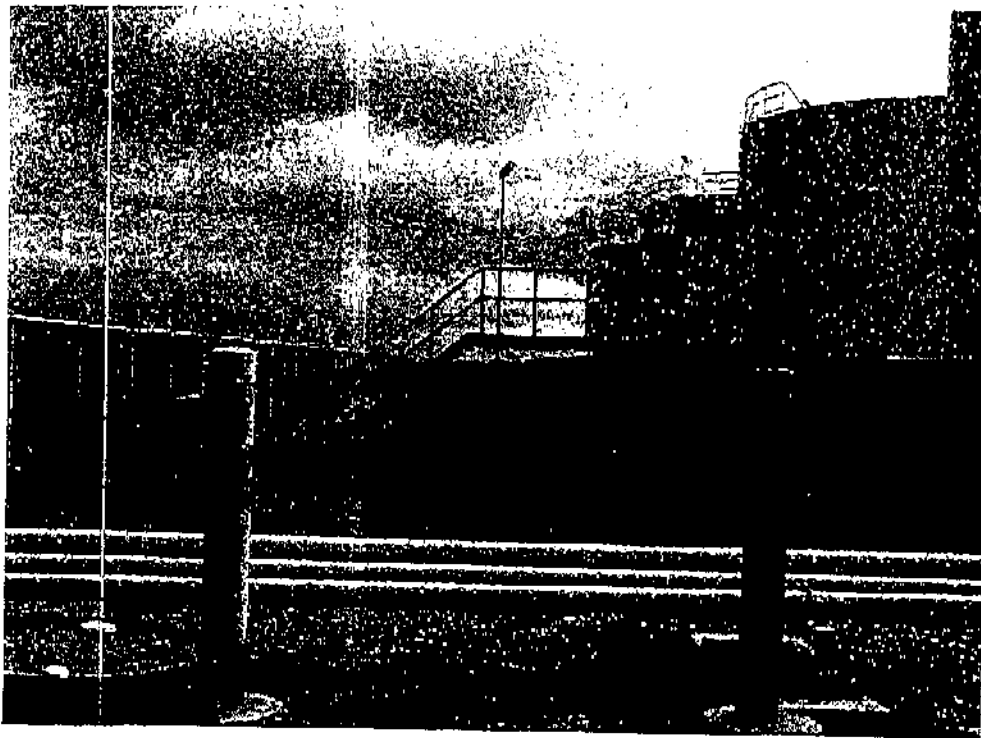
Photo # 13 Tank Farm, showing drainage hose in berm area.

**Fuel Storage:** At the time of inspection the berm surrounding the Tank Farm appeared to be in good condition with no breaches. The containment liner of the berm was not visible (Photo 14). There is a drainage hose that was left not unattended that should be removed (Photo 13).

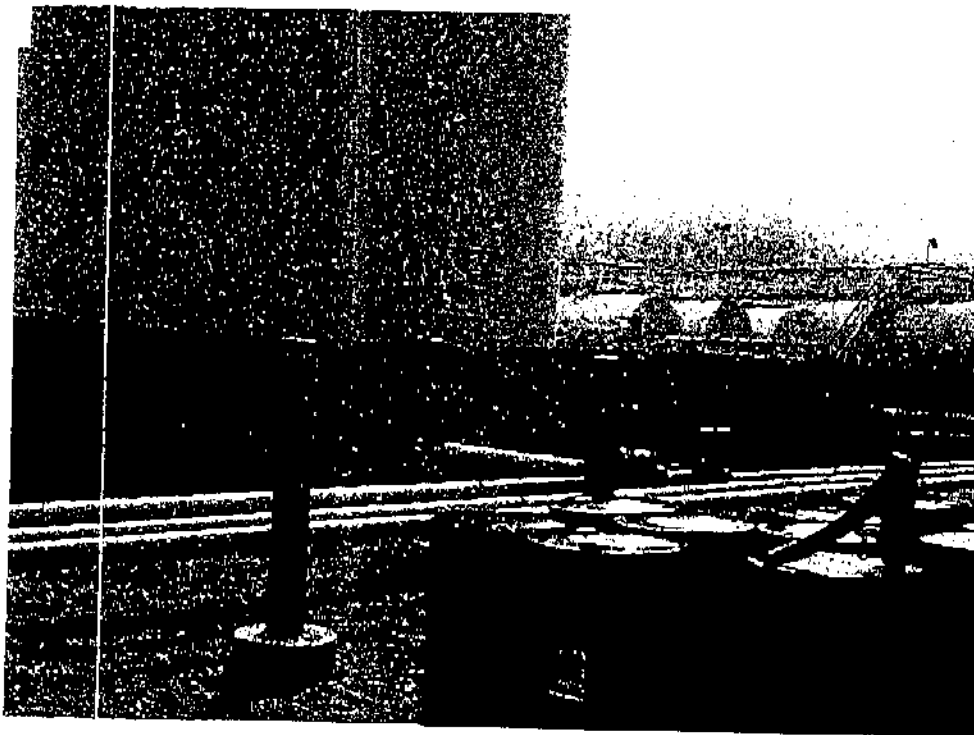
Photo # 14 Drum storage area at Tank Farm.

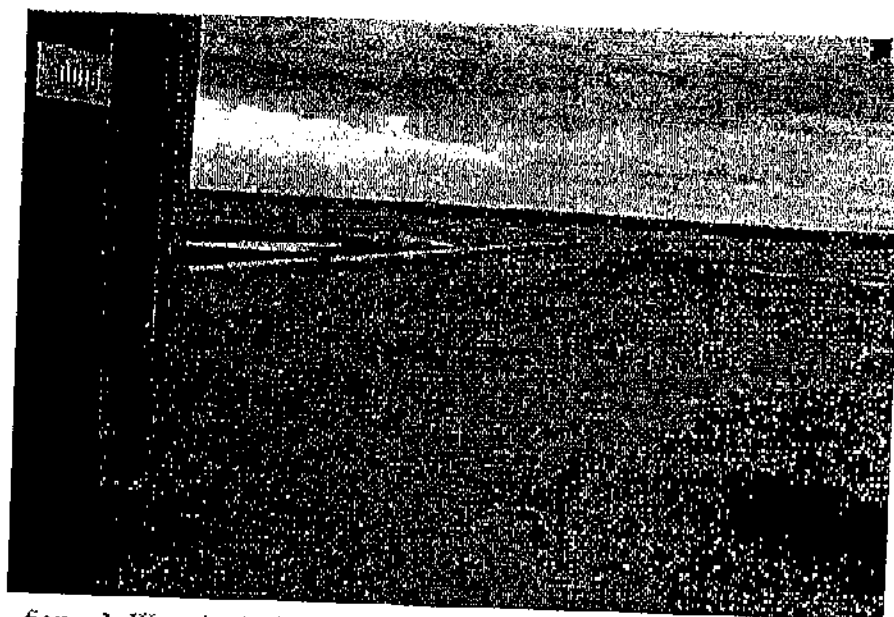
figure 1. Water intake facilities at the municipal water supply; 2001/08/13.

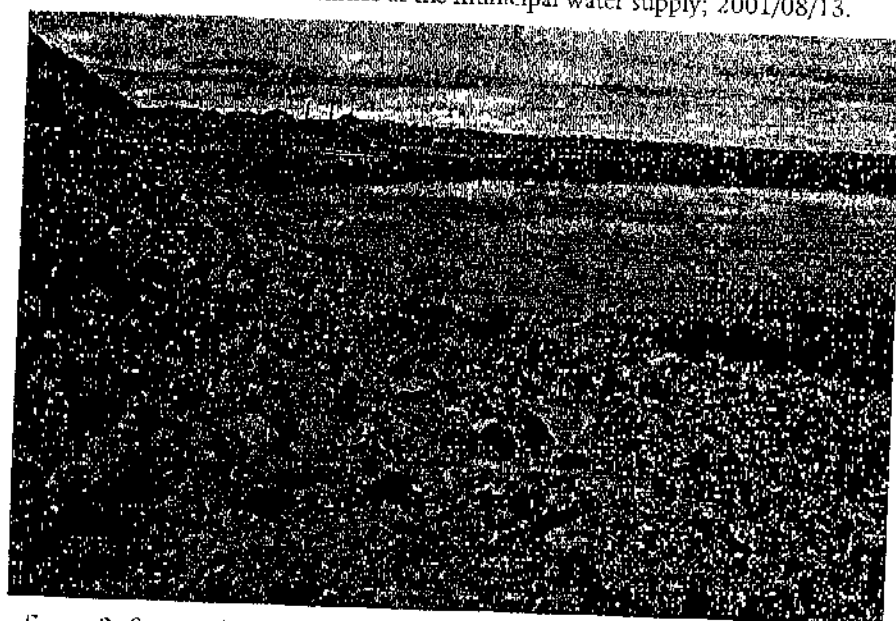
figure 2. Sewage disposal facility, from the decant area; 2001/08/13.

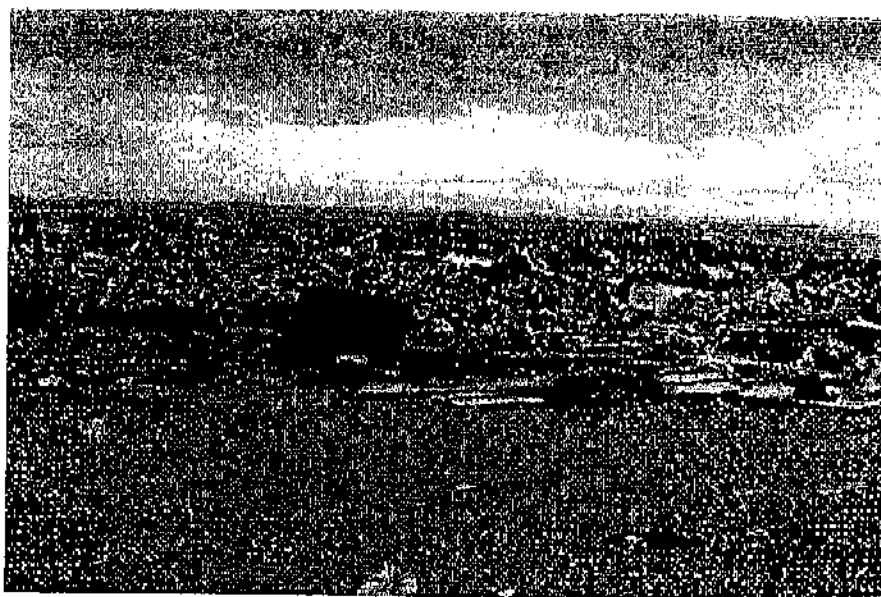
figure 4. Solid waste disposal facility; 2001/08/13.

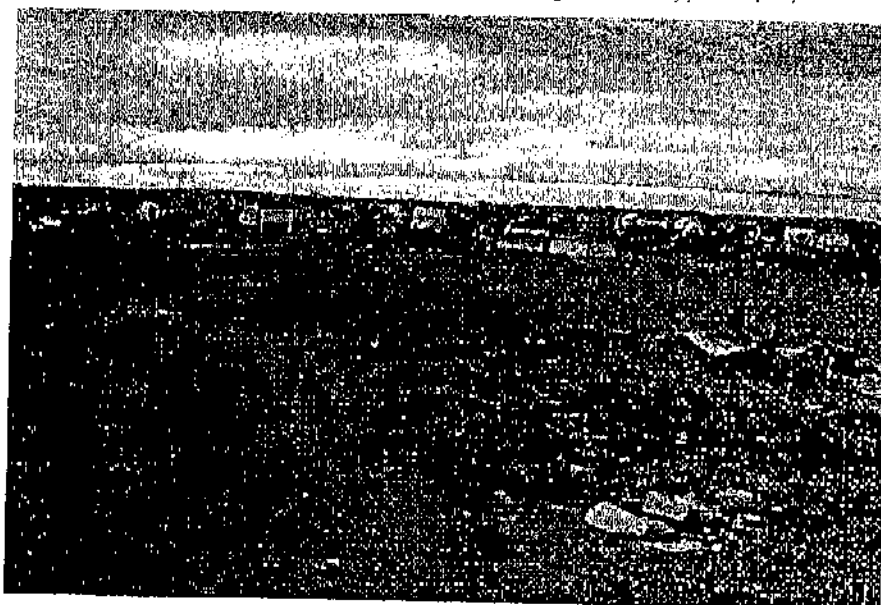
figure 8. Bulky metal wastes disposal site; 2001/08/13.
