Dam Safety Review

Dam Safety Review
Sewage Lagoons and Water Reservoir
Gjoa Haven, Nunavut

OTT-00209248-A0

October 16, 2013

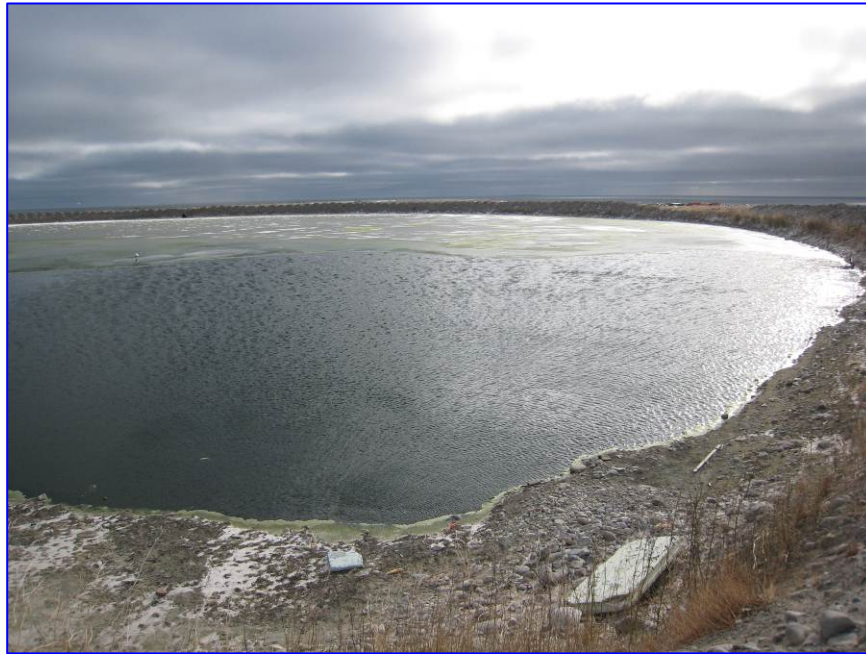
Photograph No. 1

It is understood that the existing lagoon was built in the 1970s. The lagoon is circular (Photos 1 and 2) with an estimated diameter of approximately 150 m. Based on the site observations, it appears that the initial lagoon was constructed in a conventional manner with a berm of unknown crest width and unknown side slopes. The height of the original berm was estimated to be 2.5 m to 3.0 m with side slopes of 2H:1V approximately. It is reported that a few years back, additional material was placed on top of the berm to increase its height by 1 m approximately. It appears that this material was simply dumped on top of the berm with trucks or other mechanical equipment and was not levelled or compacted. As a result, the crest of the berm is undulating and soil mounds are visible (Photos 3 and 4). It is also very narrow (approximately 1 metre) (Photo 5). The side slopes of the berm have been steepened by the dumping of the soil on top of the berm thereby resulting in steeper slopes than the original design (Photo 6) due to soil sloughing. Current berm slopes are estimated to be at an inclination of 1H:1V approximately.

View of lagoon from north looking south. Note circular shape of lagoon.

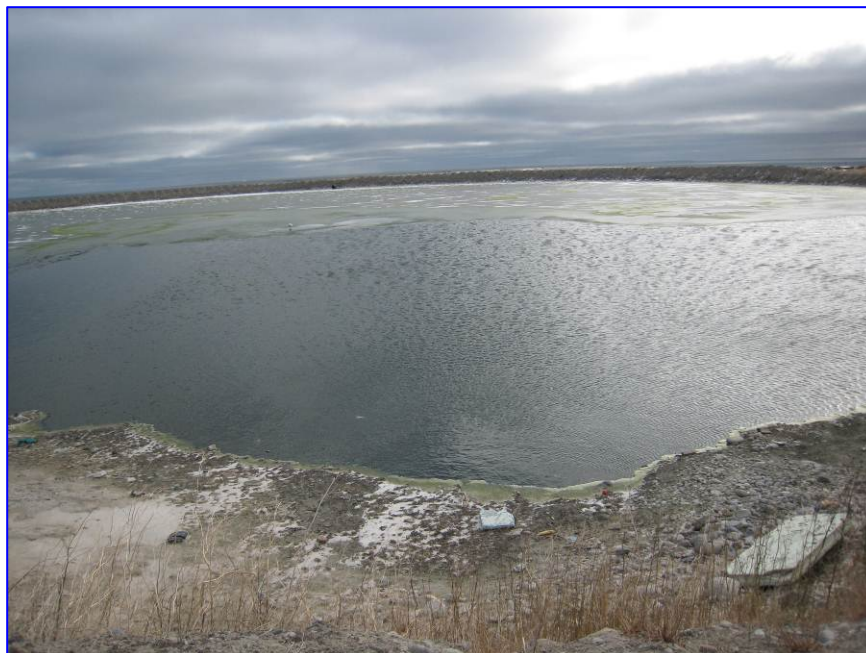
Photograph No. 2

Partial view of lagoon looking west from north.

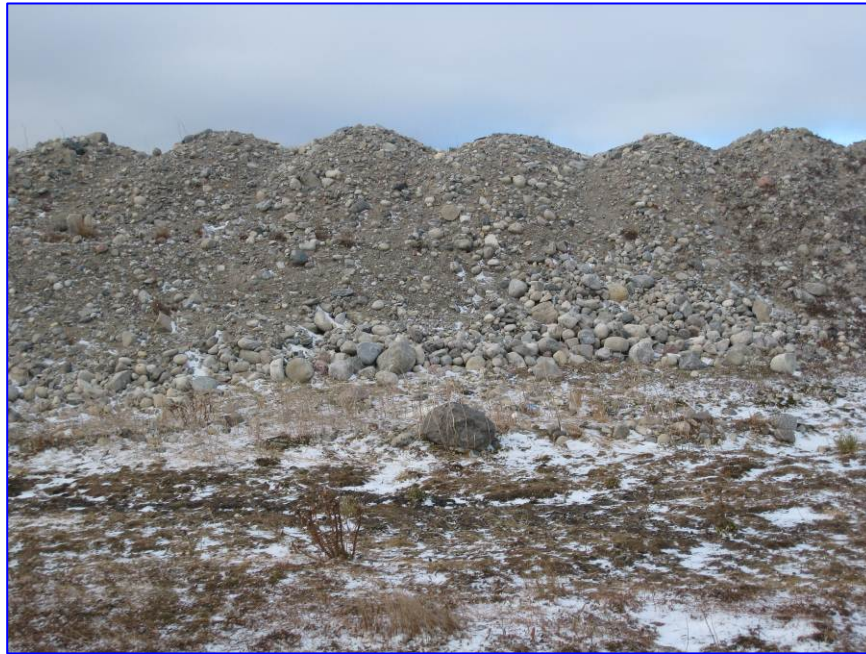
Photograph No. 3

The berm is made of sand and gravel with frequent cobbles. Generally, the material appears coarser and more permeable than normally used for construction of a facility of this type (Photos 3 and 7). The lagoon is not lined. It is not known whether the coarser material was used to increase the height of the berm or the original berm was also constructed with similar material.

View of berm looking south from north. Note coarse fill mounds.

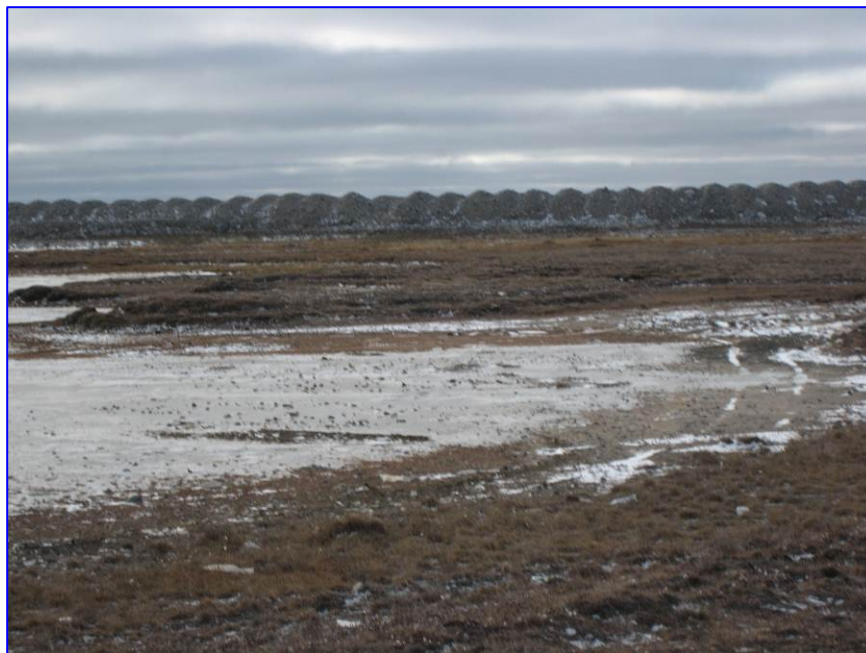
Photograph No. 4

View of berm looking north. Note fill mounds.

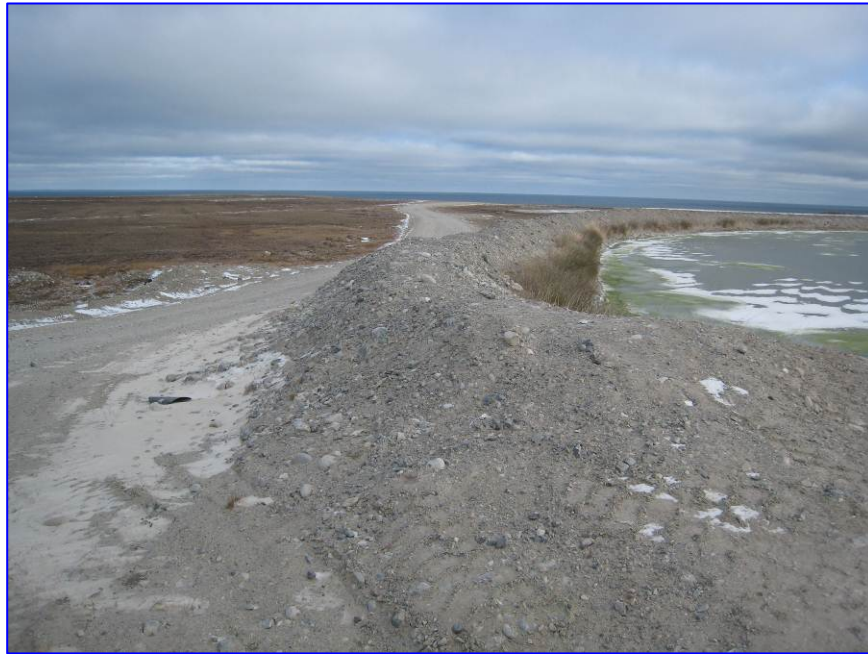
Photograph No. 5

View of top of berm looking east from north. Note narrow crest of berm.

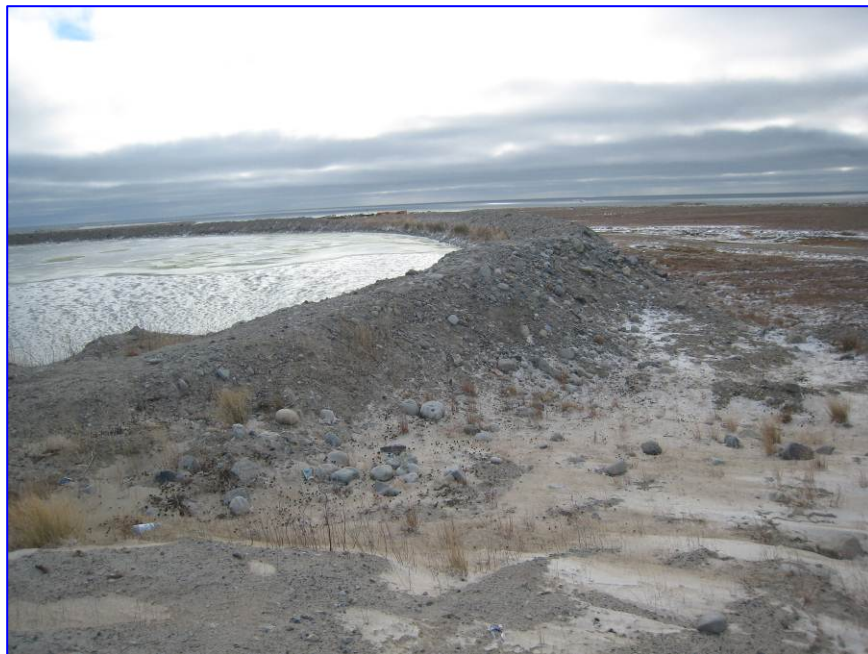
Photograph No. 6

- 1.) The lagoon slopes are much steeper than the conventional design requirements, which generally vary from 2H:1V to 3H:1V.
- 2.) The upper approximately 1 m to 1.5 m of the berm comprises of dumped sand and gravel material, which was neither levelled nor compacted. As a result, this material is loose and is also expected to be more susceptible to erosion and slope failure.
- 3.) The material used in construction of the berm is very coarse and as a result is expected to be very permeable.
- 4.) The lagoon has been leaking at the two locations for a number of years. Hence, the berm is being subjected to seepage forces. The slopes of the berm are considered to be too steep for this condition.

View of top of berm looking west from north. Note steep slopes of berm.

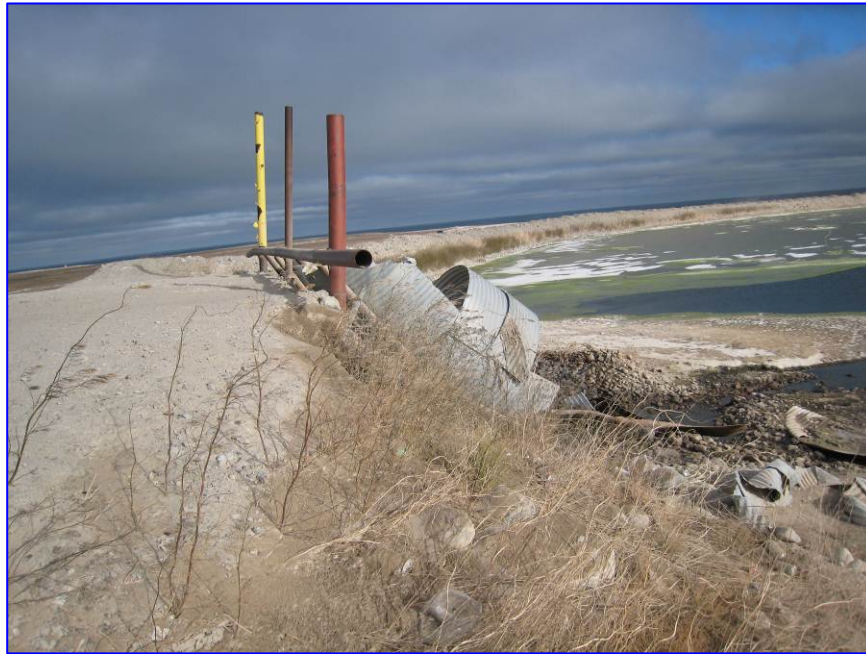
The discharge chute is located along the north part of the lagoon. The discharge chute is in a state of disrepair. There was some evidence of erosion close to the toe of the berm at this location (Photo 7).

Photograph No. 7
Discharge chute. Note erosion at toe of berm.

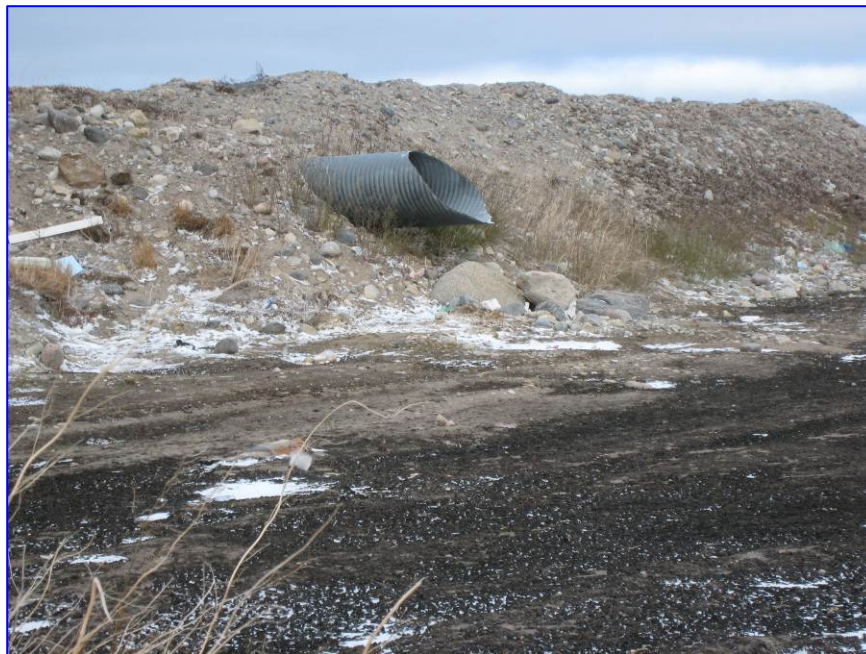
The overflow pipe is located on the south side of the lagoon (Photo 8). The overflow pipe discharges into a secondary lagoon located on the south side of the main lagoon (Photos 9 and 10). The berms of the secondary lagoon are 1.0 m to 1.5 m in height.

Photograph No. 8
Overflow pipe.

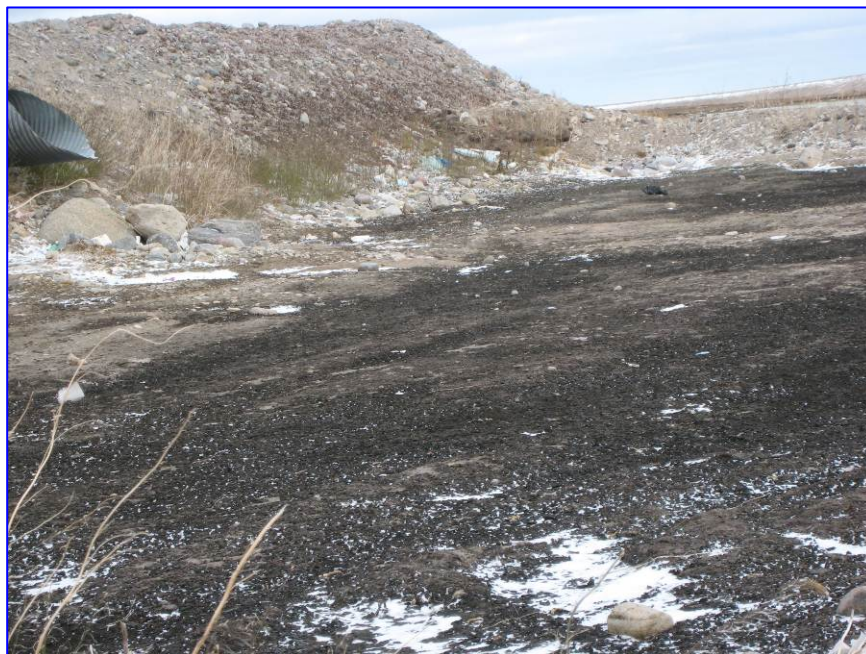
Photograph No. 9
Partial view of secondary lagoon.

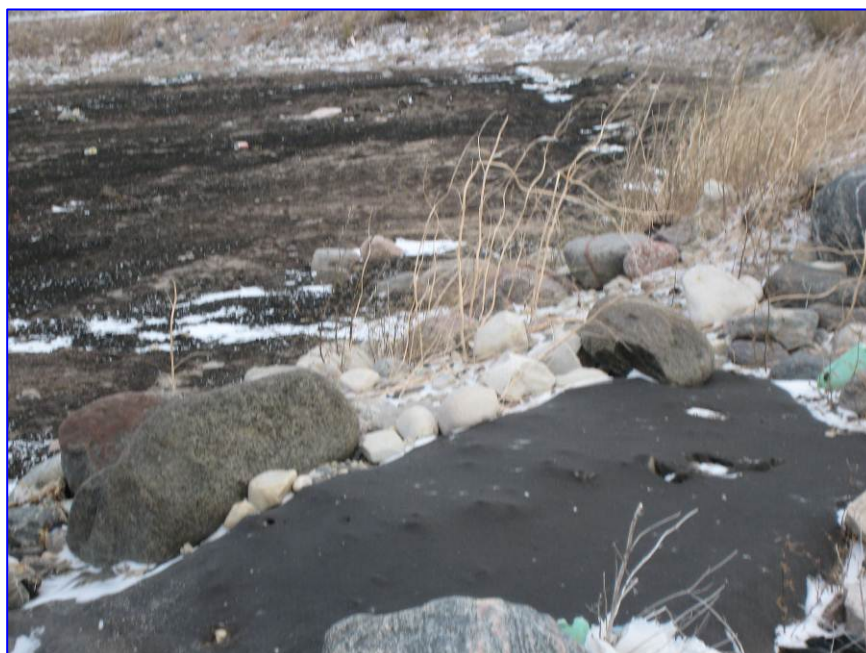
Photograph No. 10
Another view of secondary lagoon.

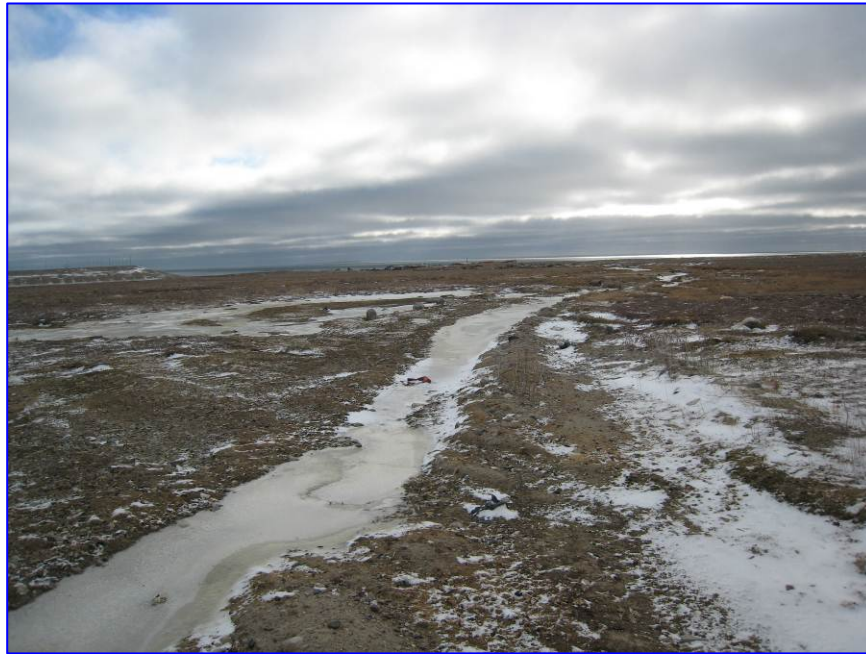
The wetlands are located on the south side and part of the west side of the lagoon (Photo 11).

Photograph No. 11
View of wetlands located south of lagoon.

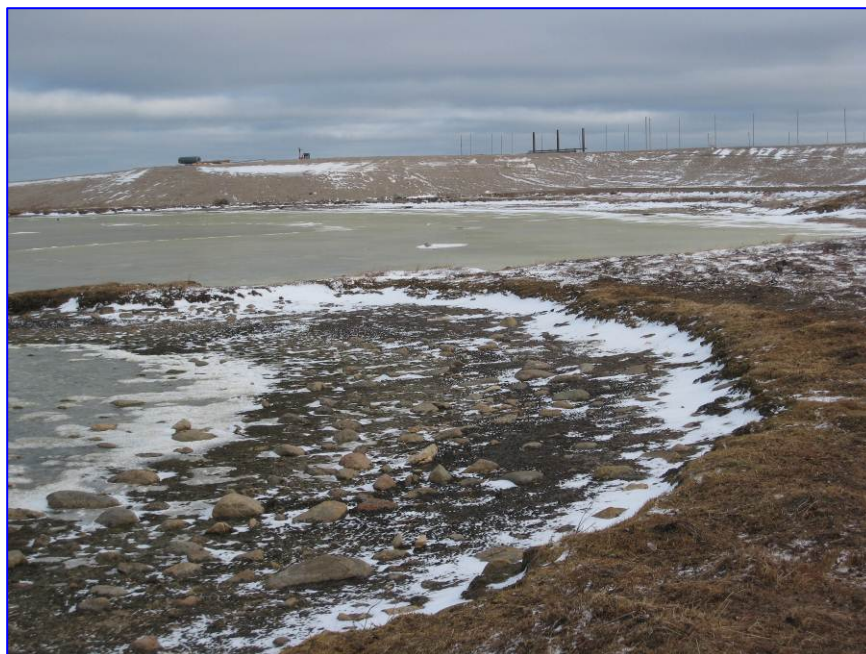
It is reported that the lagoon has been leaking for a number of years. The predominant areas of leakage are along the east to south sides of the lagoon (Photo 12) and along the west side of the lagoon (Photo 13). As a result of water leakage over the years, water has ponded adjacent to the east and west sides of the lagoon. The worst leakage takes place at the location of the previous overflow unit, which was decommissioned and the area filled with sand and gravel material without any compaction or without provision of a liner.

Photograph No. 12
View of water ponding east and south east of lagoon.

- 1.) It is recommended that the use of the present lagoon should be discontinued as soon as the new lagoon has been commissioned. The reason for this is that the existing lagoon is leaking and that its continued use may result in progressive washing out of the fines from the lagoon. The washing out of the fines will result in increased permeability of the lagoon and greater seepage of water through the lagoon. This process is expected to continue until such time that the lagoon fails.
- 2.) The present lagoon should be decommissioned once its use has been discontinued. The decommissioning may consist of removal of the sludge from the bottom of the lagoon. The sludge should be spread to dry in the sun. The lagoon may be backfilled with the berm material. Any shortfall in the material may be made up by importing material from a borrow pit.

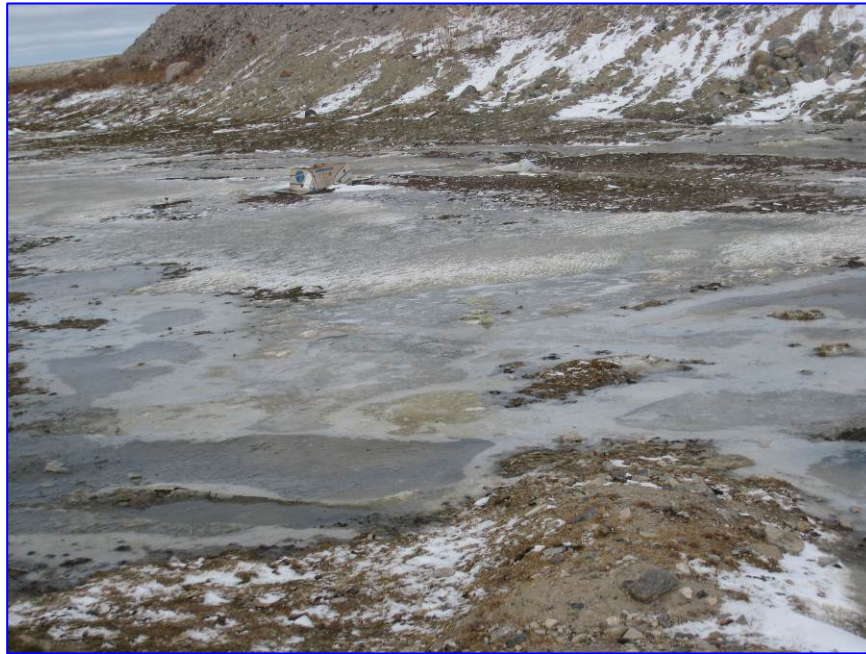
Photograph No. 13
Ponded water at west side of lagoon.

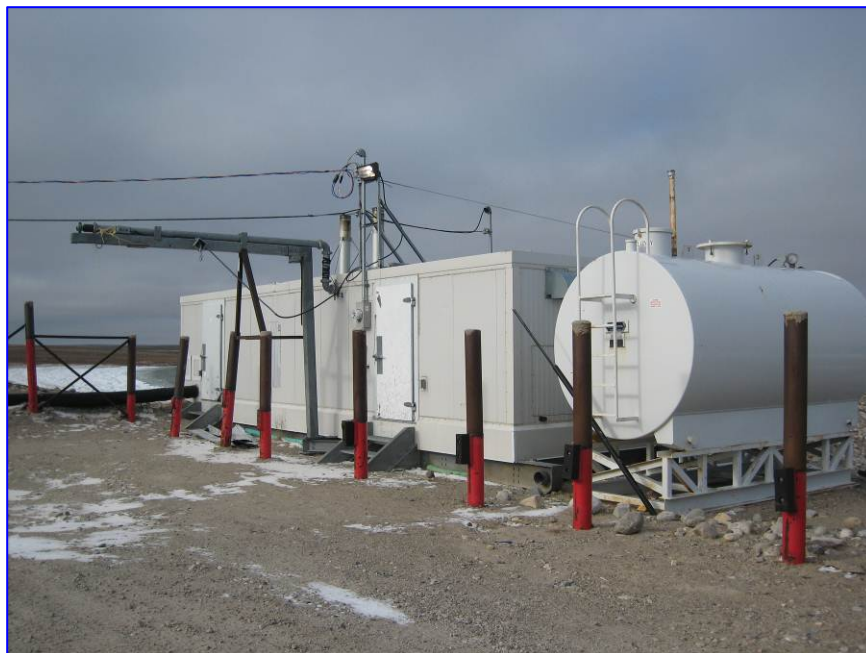
It is understood that the fuel tank located adjacent to the water treatment plant is double-walled. However, it is noted that it has not been provided with a containment unit.

Photograph No. 16
View of water pumping station, emergency truck fill station, and fuel tank.

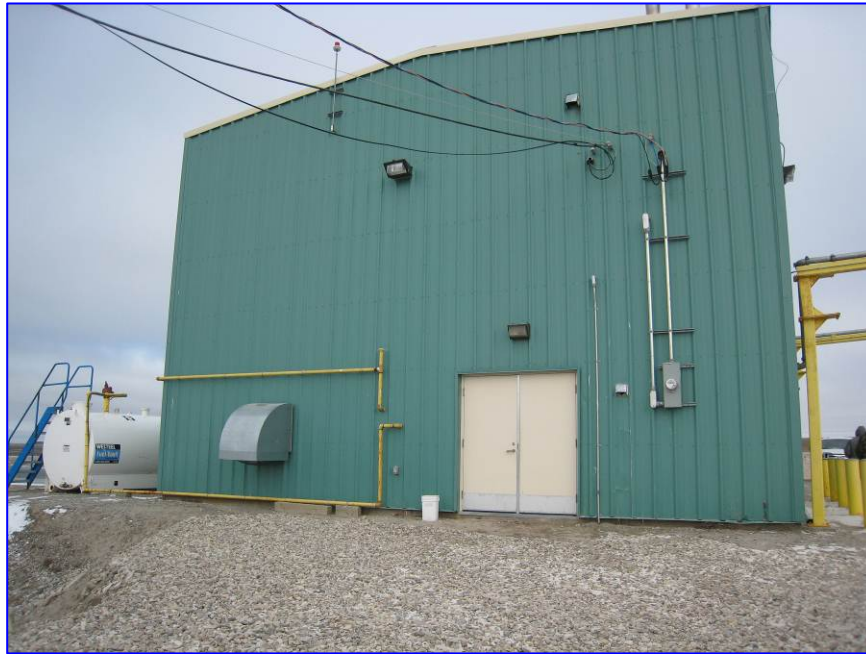
Photograph No. 17
Front view of water treatment plant and fuel tank.
