AANDC inspection Report- 2017

Water Licence: 3BM-GJO1318

WATER LICENCE INSPECTION FORM

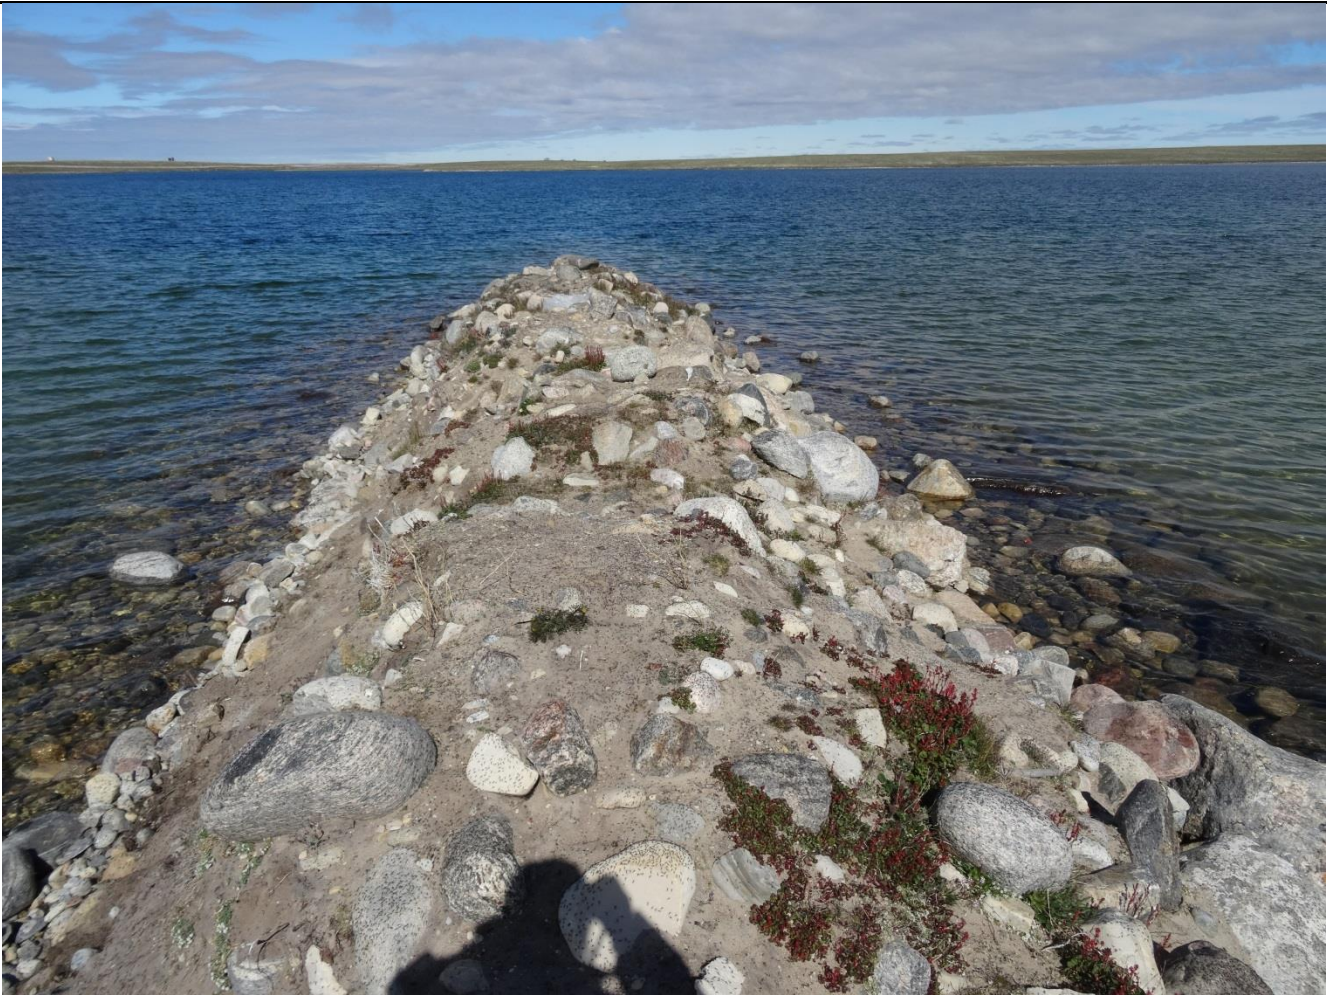
Photo 1

1. At the Swan Lake Intake and Pump House (Photos 1 & 2) @ N 68°39’24.9” W 95°55’09.8” there was no Signage to indicate where Sample Station GJO-1 was located. Hamlet Staff took Samples here. 2. At the In-Town Treatment Plant and Truck Fill Station (Photo 3) I was shown the consumption amount from January to June 2017 as 22,614 cubic meters of water, well within authorized limits. 3. At the Solid Waste Leachate Discharge Location (Photo 4) with the GJO-2 Signage @ N 68°37’02.3” W 95°50’25.3”, I found this area to be dry and unsuitable for sampling. 4. At the Solid Waste Leachate Retention Sump Pit (Photos 5 & 6) with the GJO-5 Signage @ N 68°37’02.8” W 95°50’26.5” the Hamlet Staff took Samples here. 5. At the Sewage Effluent Final Discharge Point on the Wetland (Photo 7) @ N 68°36’59.6” W 95°49’48.0” I found the Signage marked GJO-7 was wrong. Hamlet Staff took Samples here. 6. The Sample Location marked GJO-4 (Photo 8) @ N 68°37’13.7” W 95°50’23.2” was found to be the wrong number. 7. At the Main Garbage Dump (Photos 9 & 10) I found large volumes of unburnt Garbage piled up very high. 8. The Annual Report has been submitted by CG&S and the Hamlet. 9. There were no records kept of how much volume was put into the Sewage Lagoon.

Description: Swan Lake Water Intake – Sample Station GJO-1 – NO SIGNAGE

1. Signage indicating where Sample Station GJO-1 is located at the Swan Lake Intake must be installed. 3. The GJO-2 Sample Location and Signage need to be moved from it’s current location to below the Sewage Lagoon where it is marked GJO-4 @ N 68°37’13.7” W 95°50’23.2”. 5. The Signage marked GJO-7 @ N68°36’59.6” W95°49’48.0” needs to be changed to GJO-4. 6. The Signage marked GJO-4 @ N 68°37’13.7” W 95°50’23.2” needs to be changed to GJO-2. 7. The Hamlet should seriously consider conducting regular controlled burning of the Garbage Dump using a Burn Box system in order to avoid an accidental uncontrolled large scale fire. 9. Daily and Monthly Records of how many Truck Loads are dumped into the Sewage Lagoon need to be kept in order to determine annual volumes.

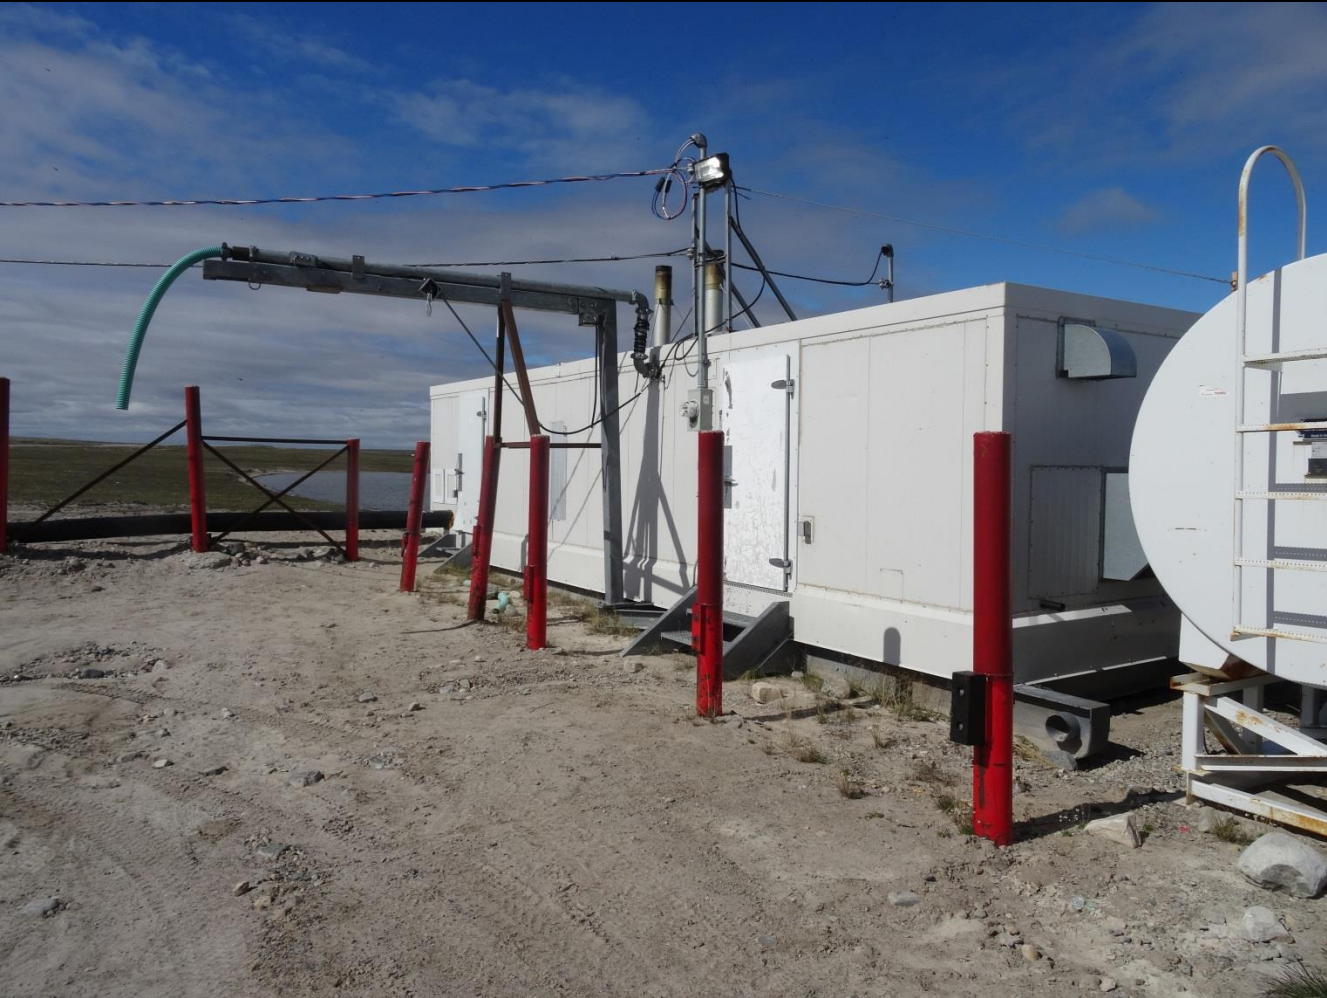
Photo 2

Description: Swan Lake Pump House and Back-up Truck Fill Station

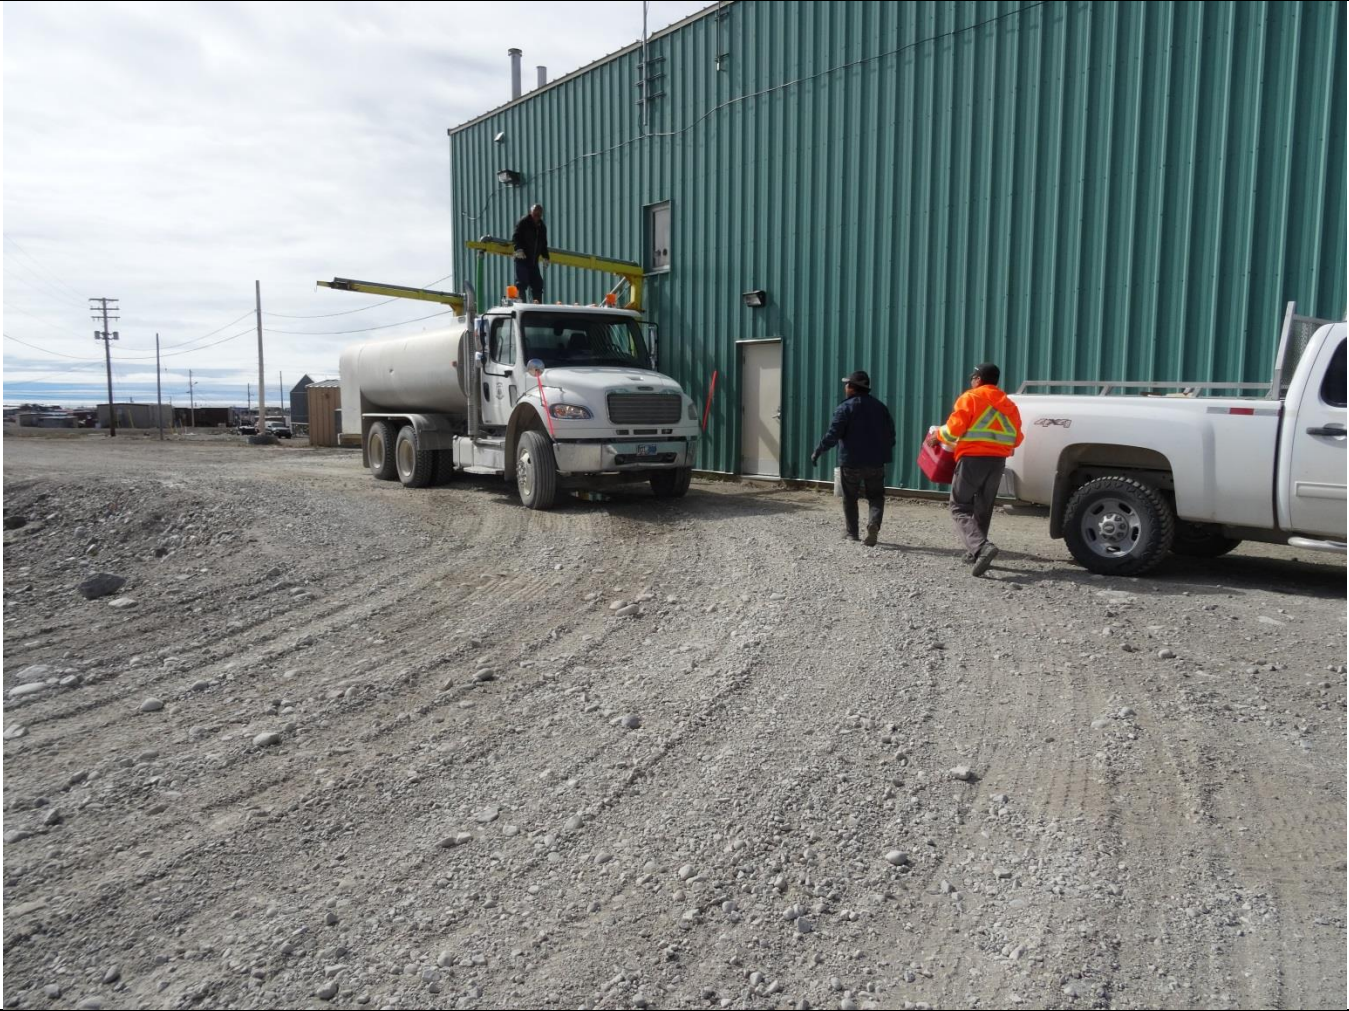
Photo 3

Description: Water Treatment Plant and In-Town Truck Fill Station

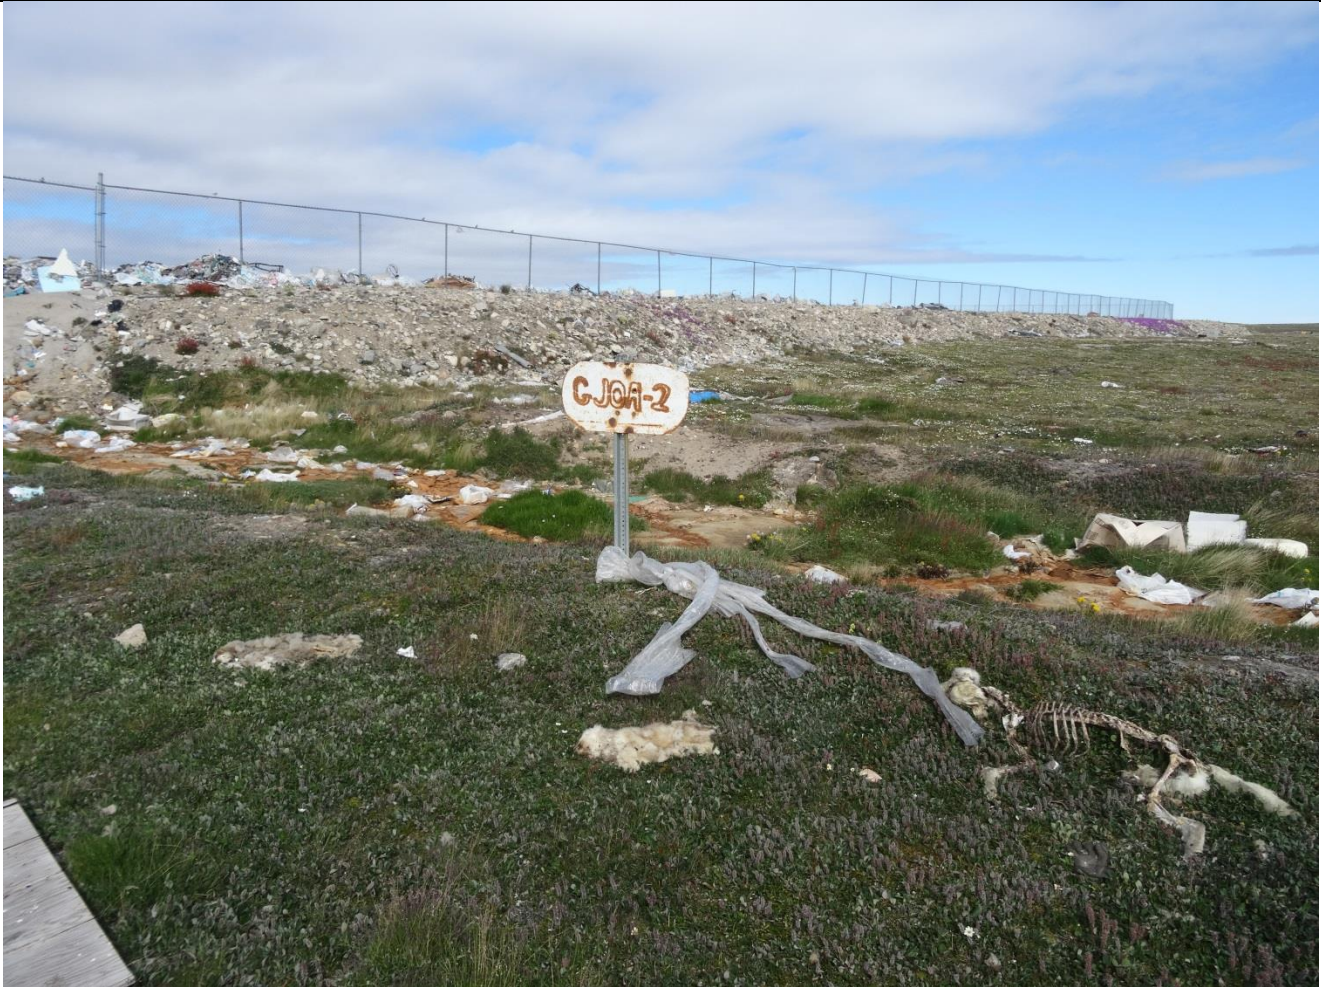
Photo 4

Description: Solid Waste Leachate Discharge location – Sample Station GJO-2 needs to be MOVED to where it is marked GJO-4

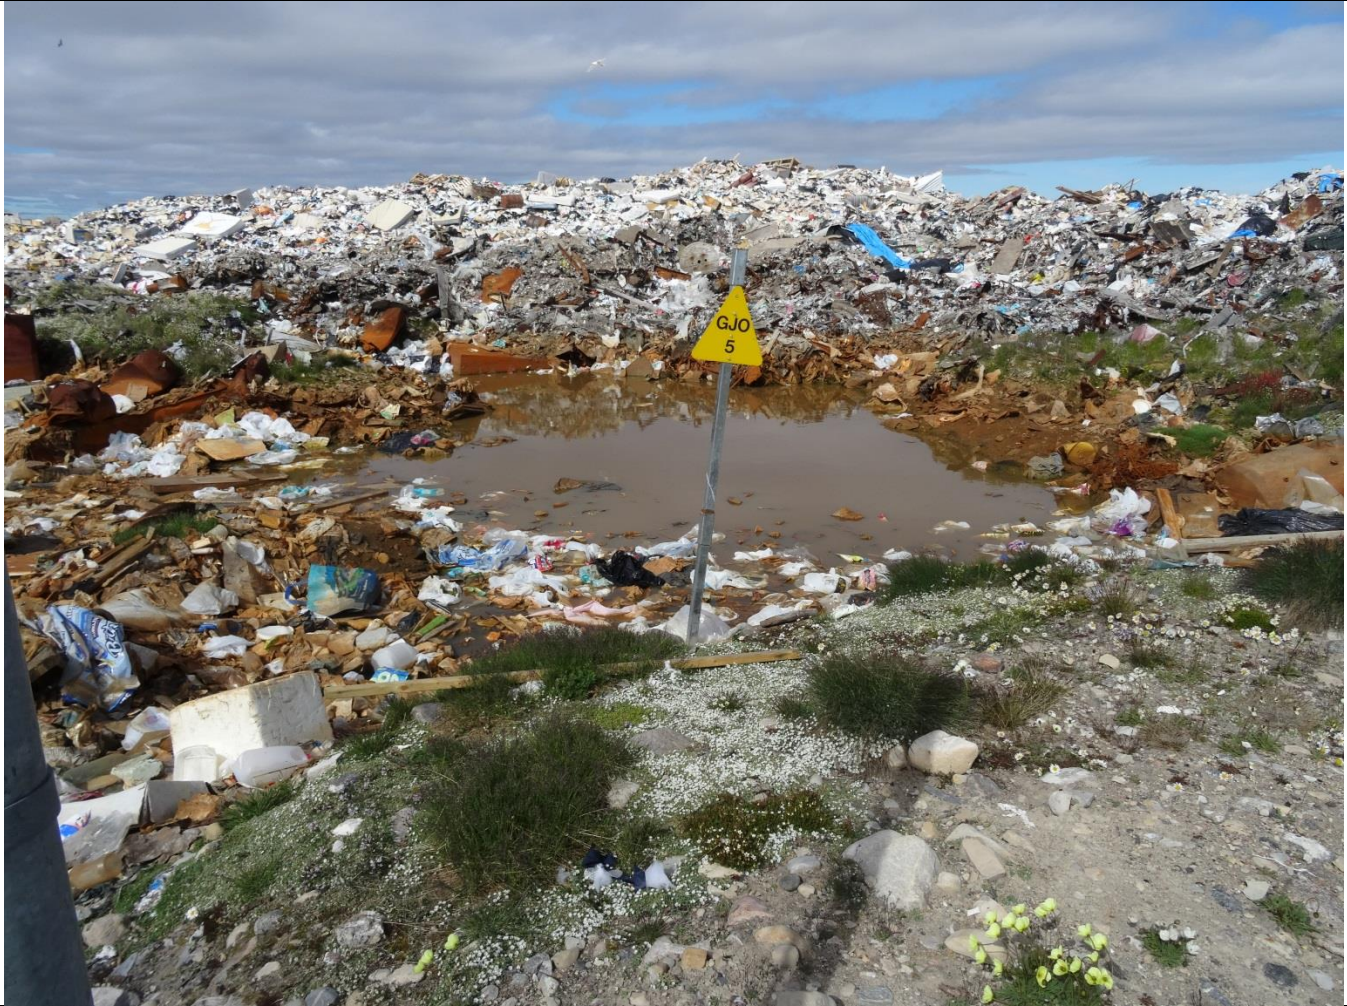
Photo 5

Description: Solid Waste Leachate Sump Pit – Sample Station GJO-5 – GOOD SIGNAGE

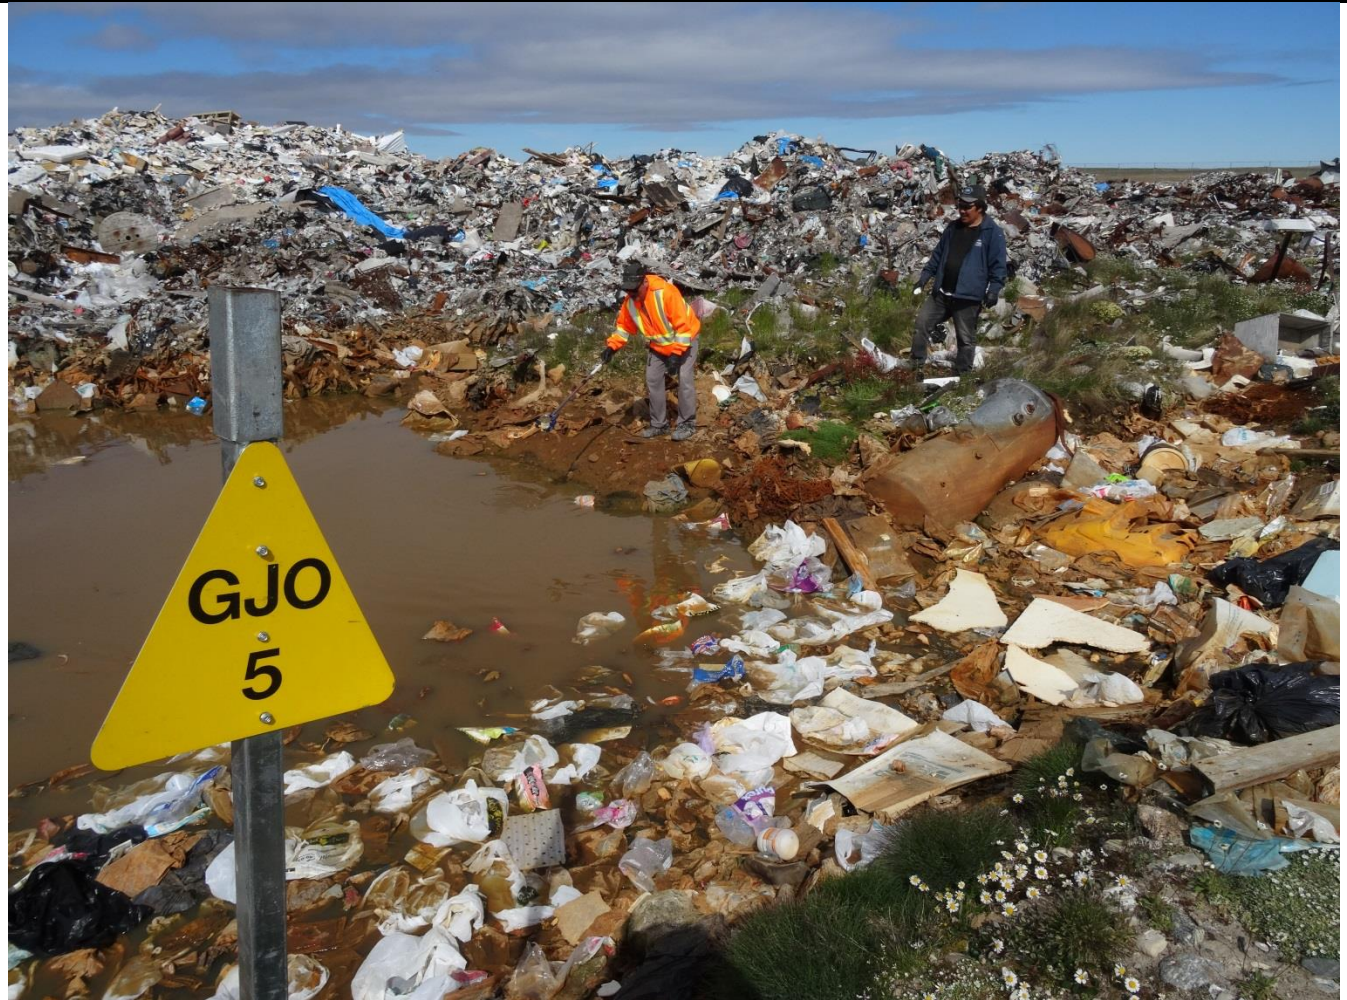
Photo 6

Description: Hamlet Staff Sampling at Solid Waste Leachate Sump Pit – Sample Station GJO-5 – GOOD SIGNAGE

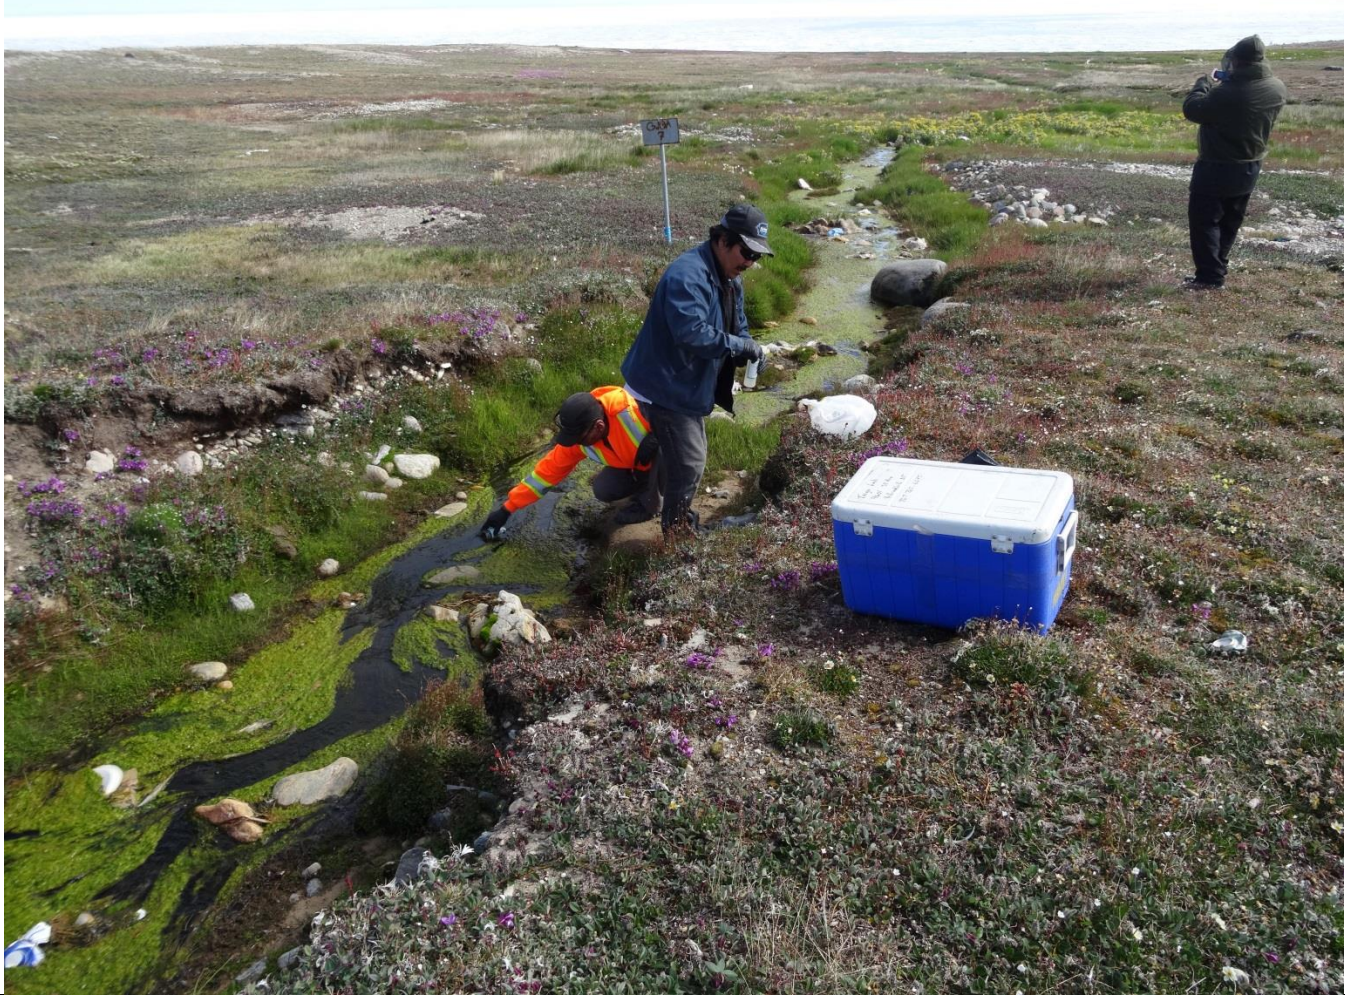
Photo 7

Description: Sewage Effluent Final Discharge Point on Wetland – Sample Station marked GJO-7 needs to be CHANGED to GJO-4

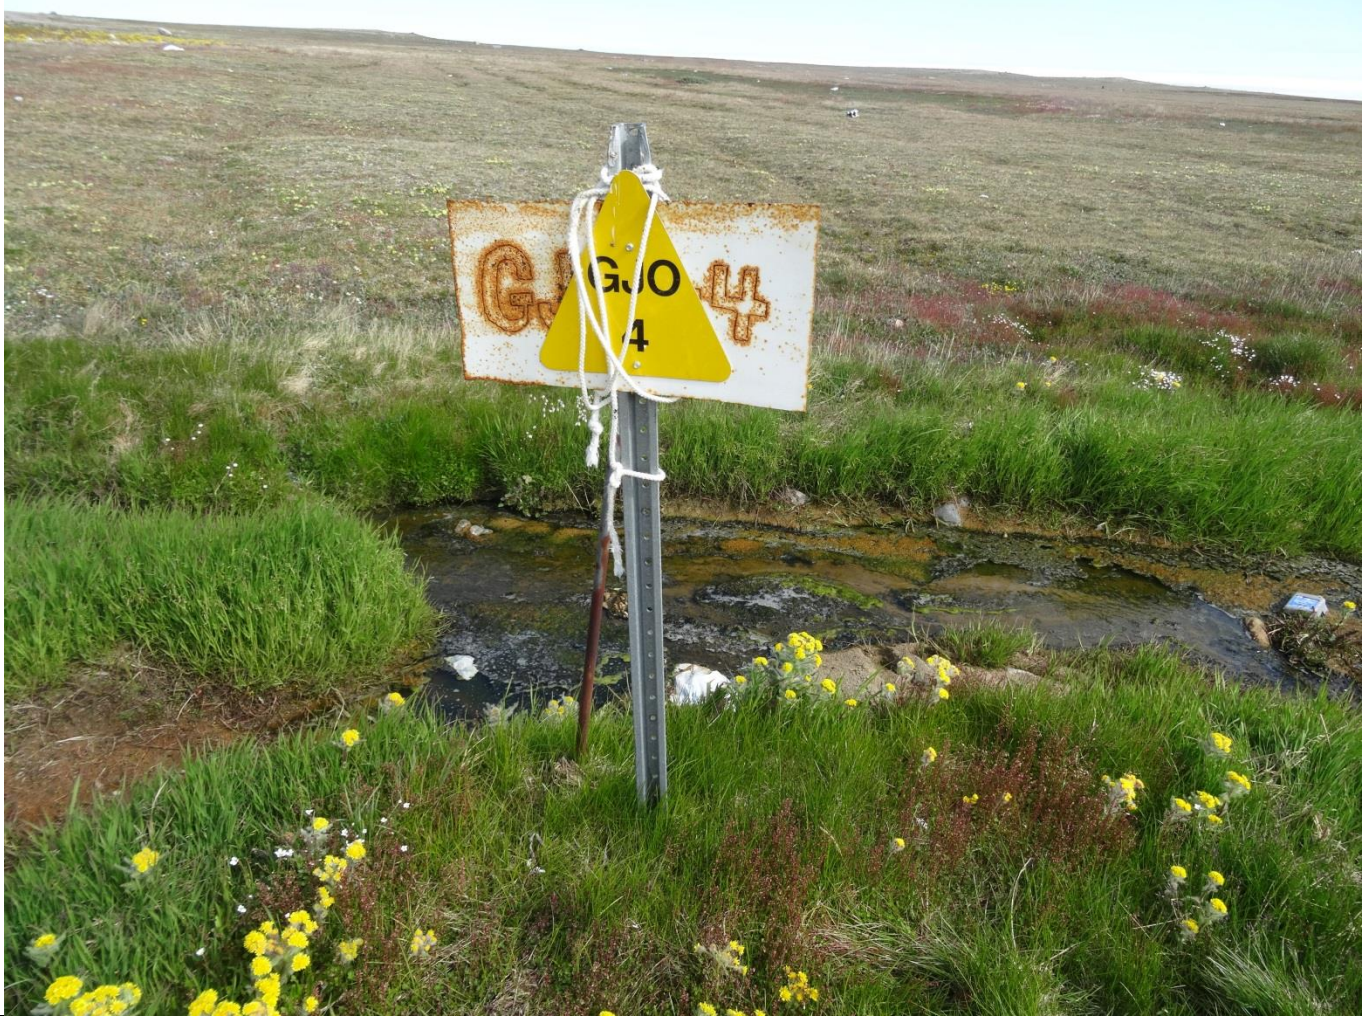
Photo 8

Description: Sample Station marked GJO-7 needs to be CHANGED to GJO-2

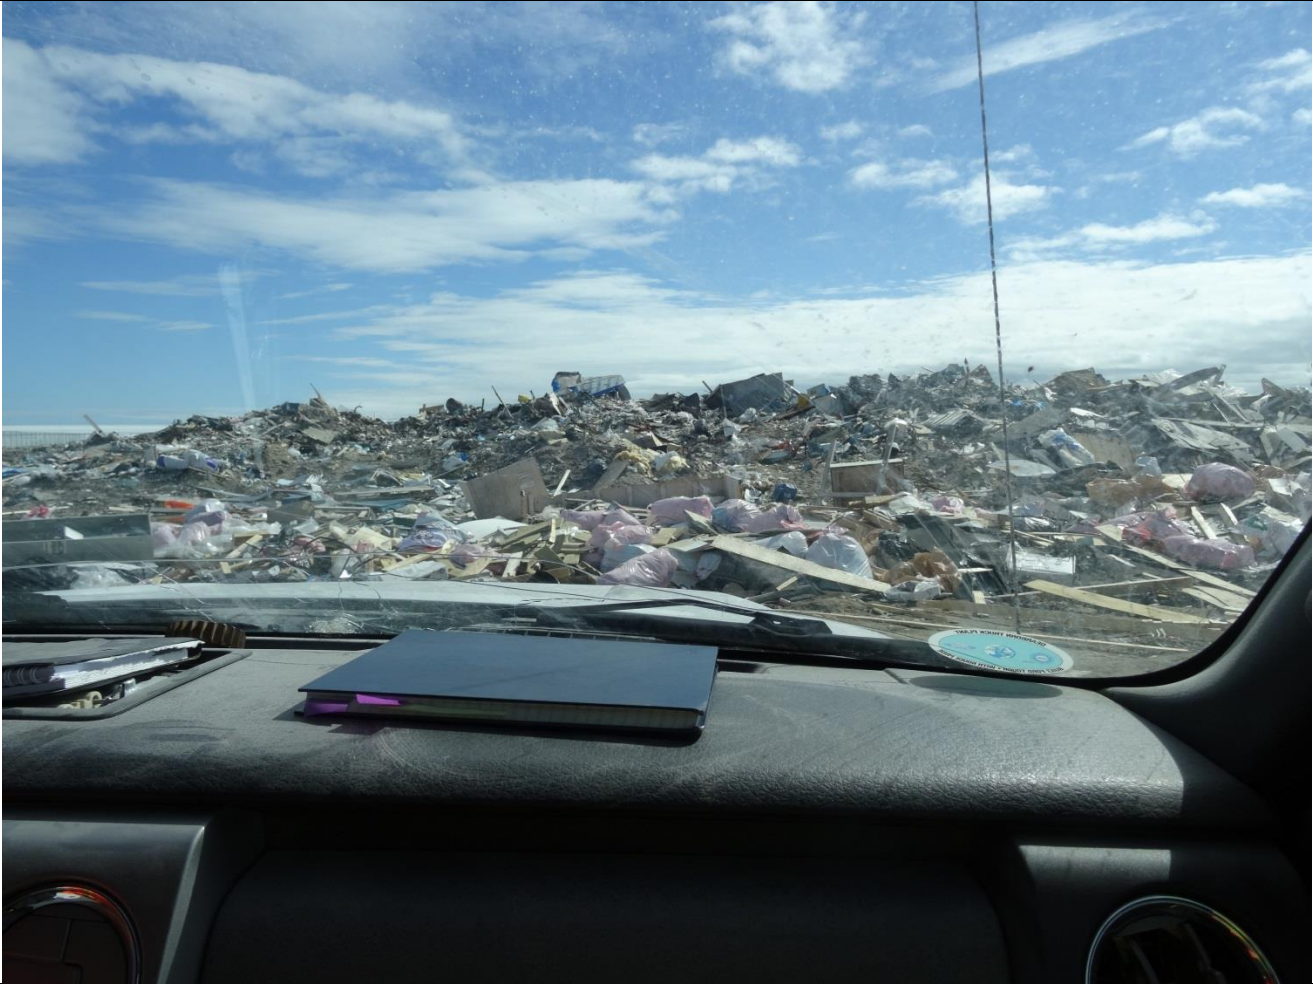
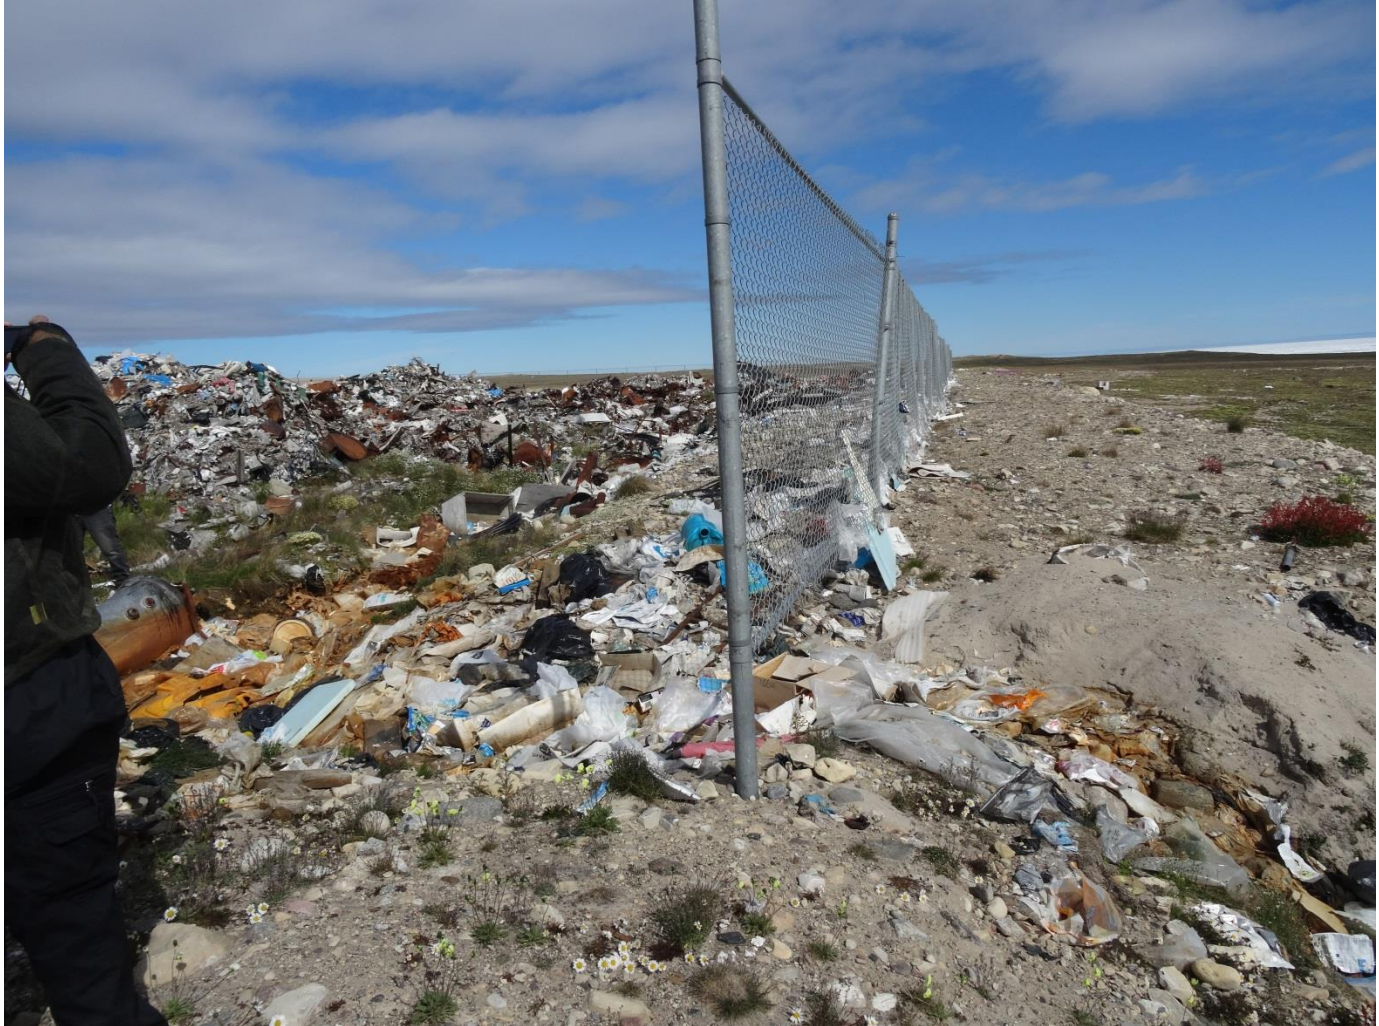
Description: Large Volume of Un-Burnt Garbage in Main Garbage Dump
