Water Management Inspection - Hamlet of Gjoa Haven: August 14, 1997

Inspection Report

Hamlet of Gjoa Haven
Unlicensed

14 August 1997

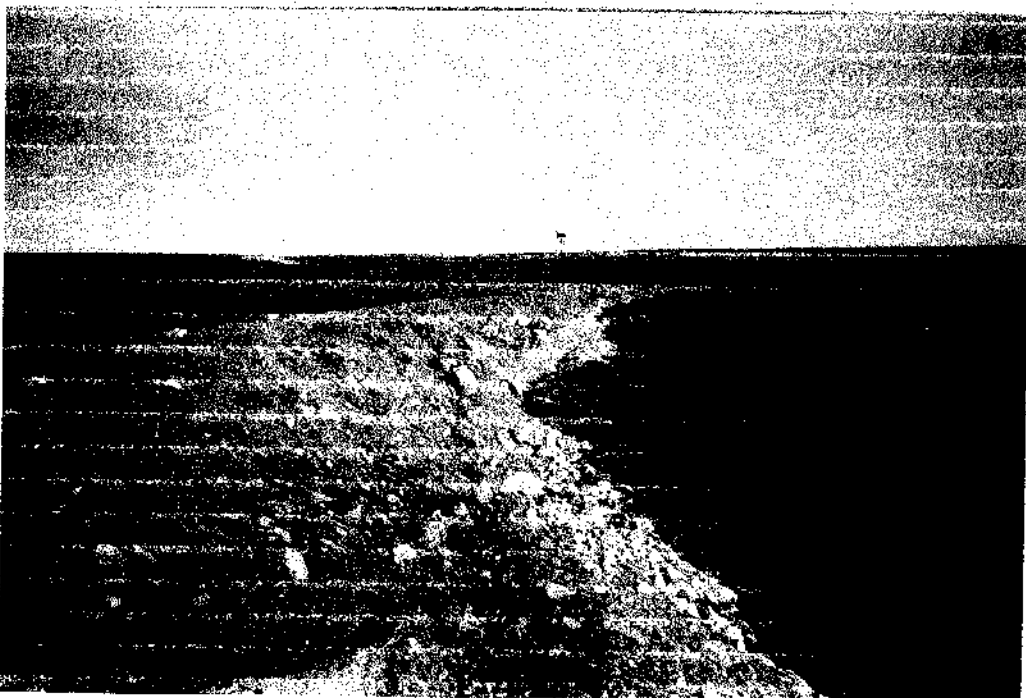
The community of Gjoa Haven almost ran out of water this past winter. There is an earthen berm at one end of the water lake that significant amounts of water were seeping through. Additional material has been added to the dyke this summer and flow has been restricted. The water level was reported to be rising (from run-off) and at the time of the inspection, Mr. Garhnam was hoping that it would not be necessary to fill the lake (via over land pipe) from Swan Lake (water supply).

The community has also encroached closer to the water lake and is now within the water shed of the lake. Fencing and warning signs are required to protect the supply from windblown garbage and human traffic over the lake during the winter.

- 1-3. 3 views of water supply lake. Note proximity of community. Earthworks are the efforts to stem the seepage through the berm (apparently successful).
4. Bagged sewage disposal area.
- 5-8. Sewage lagoon. Note disposal chute in a state of disrepair (photo #5). Note washed out outflow area and drainage path (photo's 7+8).
9. Aerial view of solid waste bulky metal disposal site.
- 10-12. Solid waste disposal site. Note uncompacted, unburned and uncovered nature of facility. Also note state fence (photo 12)
13. Constructed gap in dump berm to allow accumulated water to escape.
- 14-15. Waste oil storage area. Some drums are leaking.

- ☐ given the proximity of the water supply lake to the community, a fence should be placed to reduce the amount of wind blown garbage entering the lake. The lake should also have appropriate warning signs in place advising against littering and snowmachine travel. Consideration should be given to relocating the pumphouse to a water supply that is not threatened by human activities.

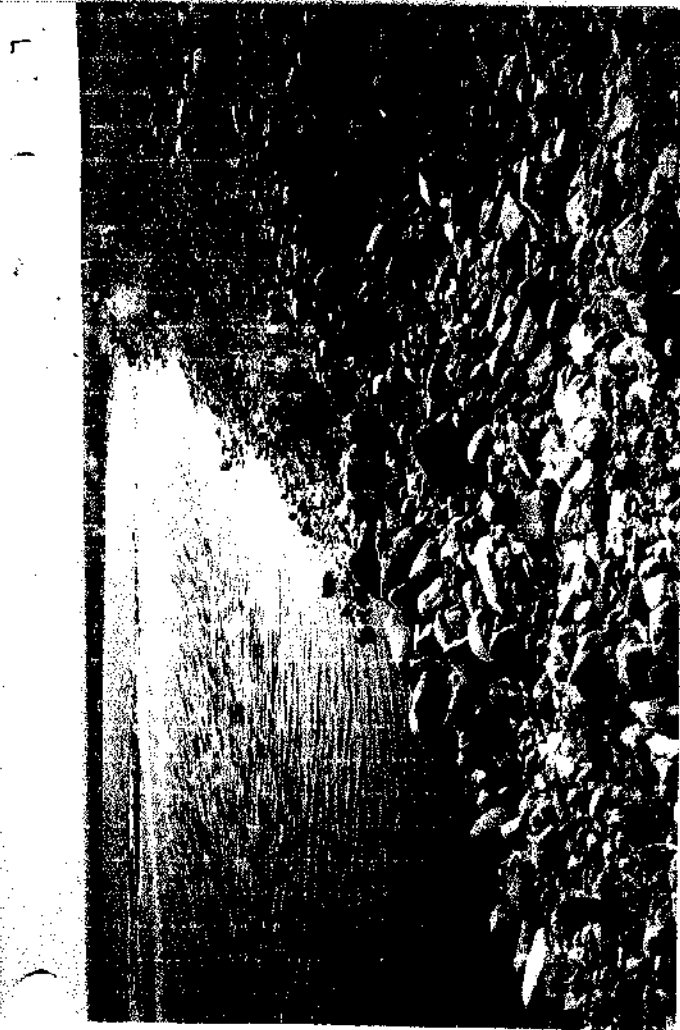
Sewage Disposal - There are both disposal facilities for bagged and trucked sewage. The bagged sewage disposal facility consists of a large bermed area. However, many of the bags are not disposed of in this area, but rather on the down slope leading from the access road into the bermed area. Given the large number of bags within the bermed area, some cover material should be used to reduce the possibility of windblown material from this area. There are 7 houses remaining on bagged sewage service. The site also requires warning signs.

- ☐ appropriate warning signs should be placed;
- ☐ bagged sewage should be placed within the pit that was built to hold the wastes;
- ☐ sewage discharge chute should be replaced/repared;

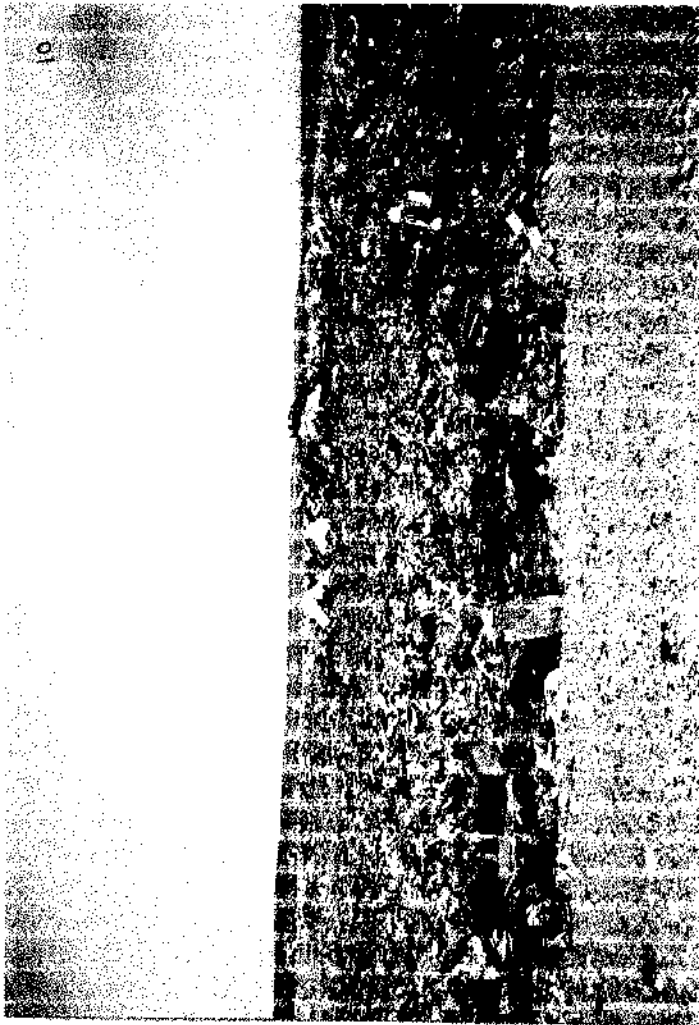
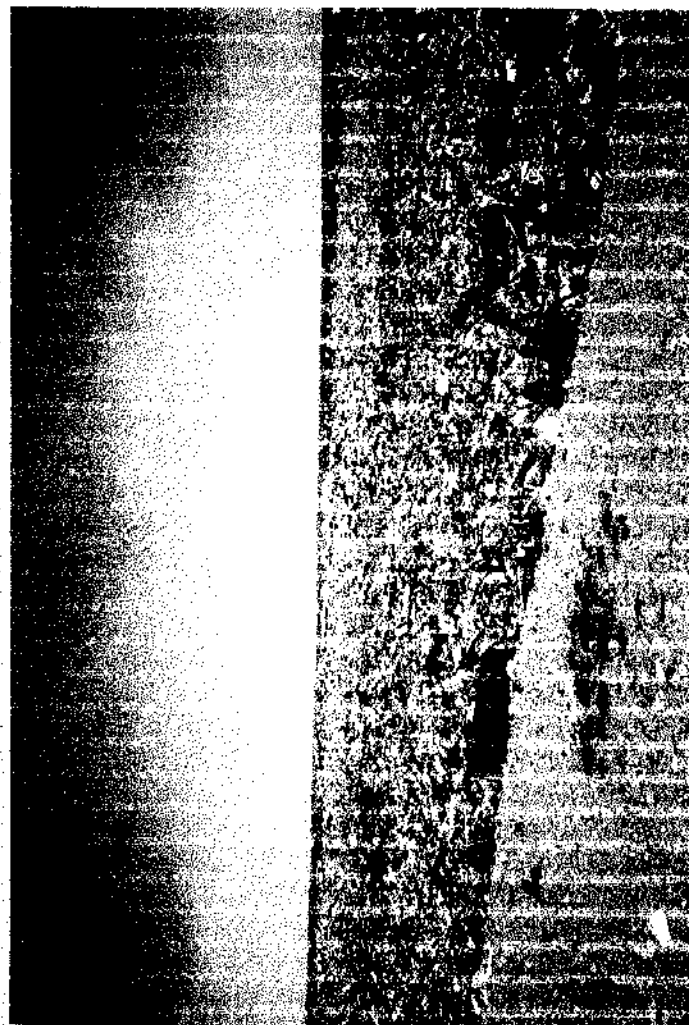
The sewage lagoon appears to be a modified natural pond to which berms have been added to increase the retention capacity. The outflow area is a simple depression of the berm from which all fine material has been washed away leaving larger stones and boulders. There are no warning signs in the area and outflow is not controlled. Given the way in which berm construction material is spread about at the discharge point, it would appear that this area washed out some time ago and has not been repaired. The site also requires warning signs. Lastly, the sewage disposal chute has collapsed. It must be repaired in order to prevent erosion which will otherwise erode the truck discharge pad.

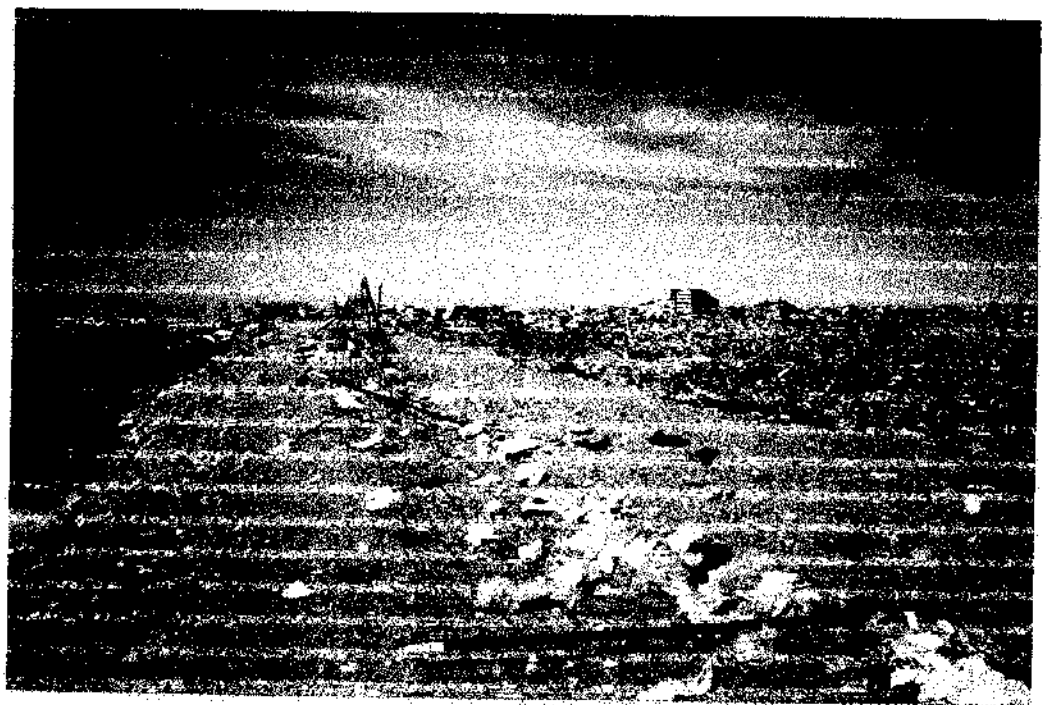
Solid Waste Disposal Facility - The waste disposal facility is bermed with the exception of its border that is the access road and one corner which is at the low point and where leachate is allowed to flow unrestricted via a constructed drainage ditch. The dump is fenced along three sides (atop the berm), but has collapsed in several places. Much of the material in the dump is unburnt and uncovered. There is much wind blown garbage in the surrounding area. Because of the rather large perimeter of the berm and the unconsolidated nature of the waste, there are both aesthetic and health concerns with the way in which this facility is operated. In addition, the way in which waste is disposed of is both inefficient and ineffective which means that the dump will have a shorter planned lifespan.

- ☐ the fencing must be repaired;
- ☐ if the dump is not going to be burned regularly, then it must be covered with sufficient granular material to prevent blown material;
- ☐ appropriate warning signs should be placed;

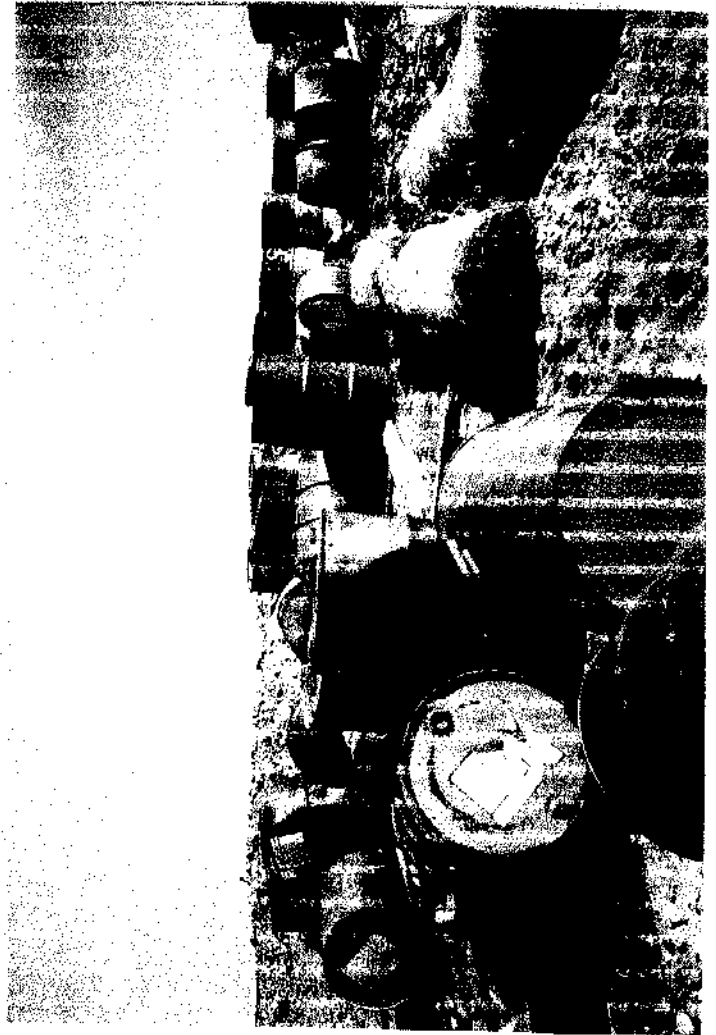
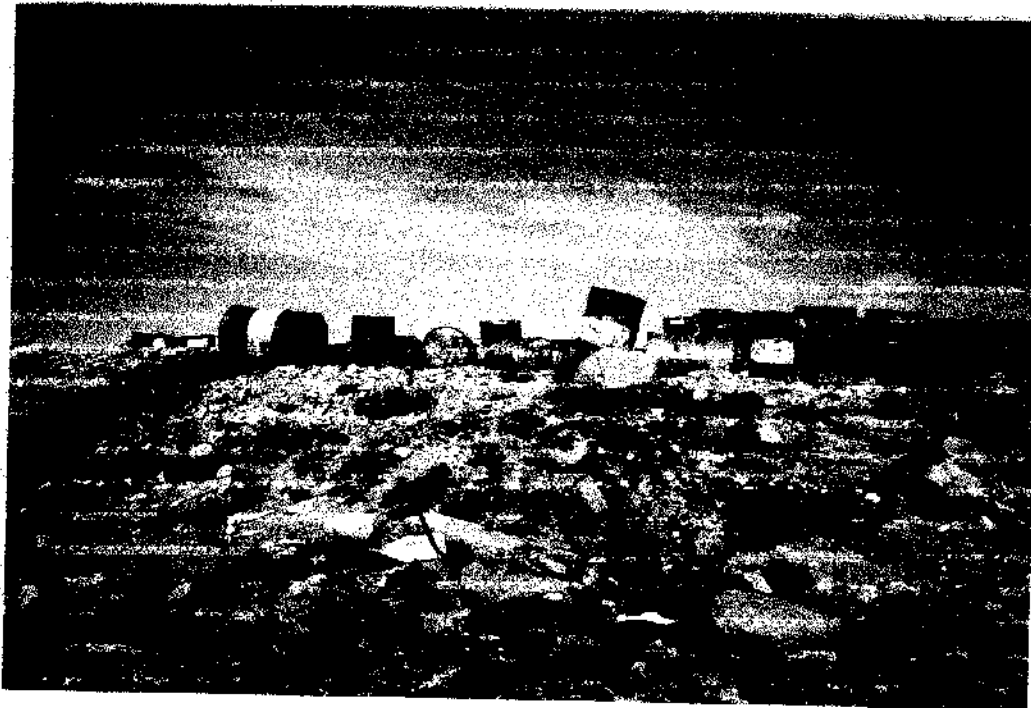
Waste oil storage is adjacent to the waste disposal site. However, many of the drums are on their sides and several were noted to be leaking. All drums should be sound and kept upright, preferably on pallets, until an acceptable means of disposal can be found (i.e. waste oil furnace).

- ☐ improvements must be made in which the way that waste oil is stored. The present situation is unacceptable.
