Indian and Northern  
Affairs Canada

**Our file - Notre référence  
NWB3GJO0409**

**RE: September 11<sup>th</sup> 2007 Gjoa Haven Municipal Water Inspection**

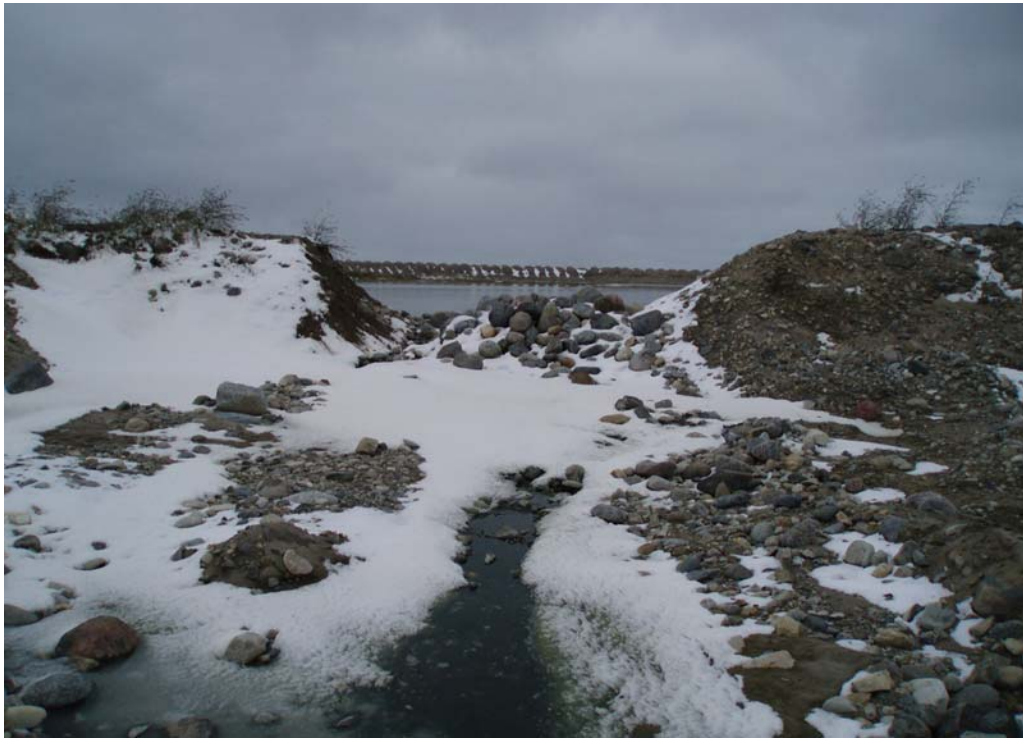
An inspection of the lagoon showed sufficient capacity and more than a metre of freeboard. The lagoon continuously discharges into a wetland treatment area before it is discharged into the ocean. The continuous discharge is through (and perhaps over) one section of the lagoon which seems to have been washed out and not sufficiently repaired. The flow from the lagoon flows past the landfill so some mixing of sewage and effluent from the landfill occurs.

Item 3. There was sufficient freeboard (1 metre) at the time of the inspection, but storage is not available due to a washed out section of the lagoon berm, lowering the lagoon's capacity.

Item 4. The washed out section of the lagoon berm was repaired to a lower level with rocks, which allows continuous discharge. The licensee should notify the NWB and INAC Field Operations when final repairs are completed on the washed out section and if continuous discharge through seepage will continue.

As noted in previous inspections, sewage is not adequately treated before flowing into the environment. This inadequate treatment is due mainly to the washed out area of the lagoon berm, which reduces available storage and retention time. This section will have to be repaired in order for the lagoon to work properly and give the sewage enough retention time before it is released for wetland treatment. The Hamlet should plan to have the berm repaired by the next inspection during the summer of 2008.

Photo 1: Continuous sewage discharge due to washed out section of berm.

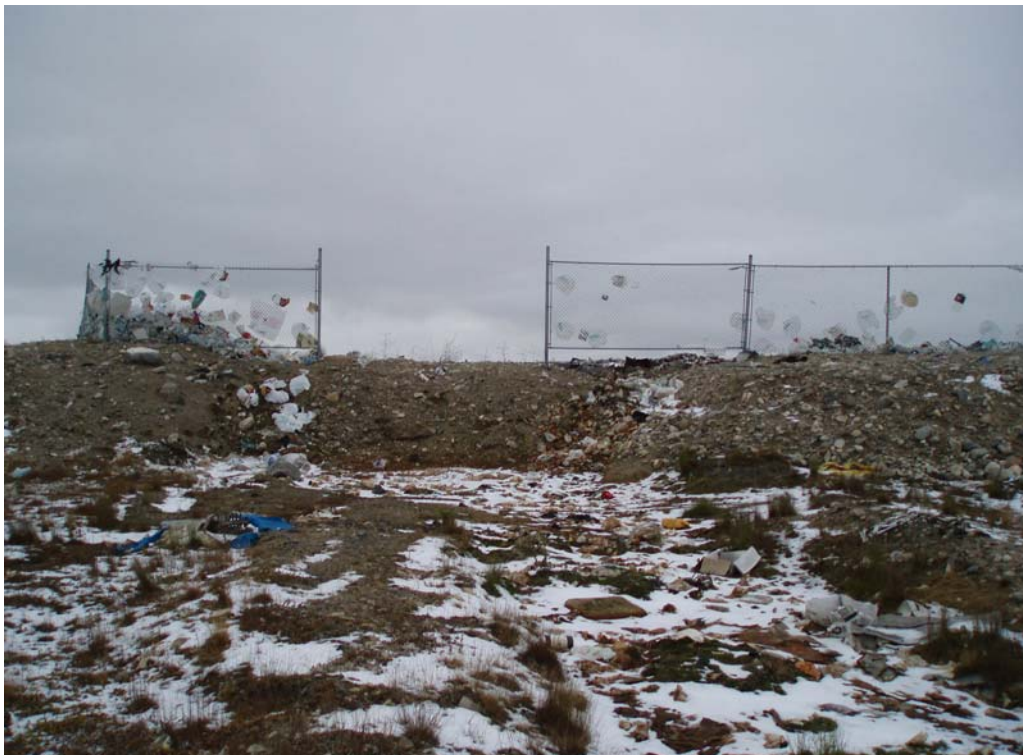
The landfill is located adjacent to the sewage lagoon. The landfill is a fenced burn and bury facility, however one section of fence is missing and needs to be repaired. Wastes are poorly segregated in the landfill, with metal wastes mixed in with the general garbage. No standing water or run-off was evident at the time of the inspection so no samples could be taken from this SNP site.

Photo 2. Section of fence missing from solid waste facility.

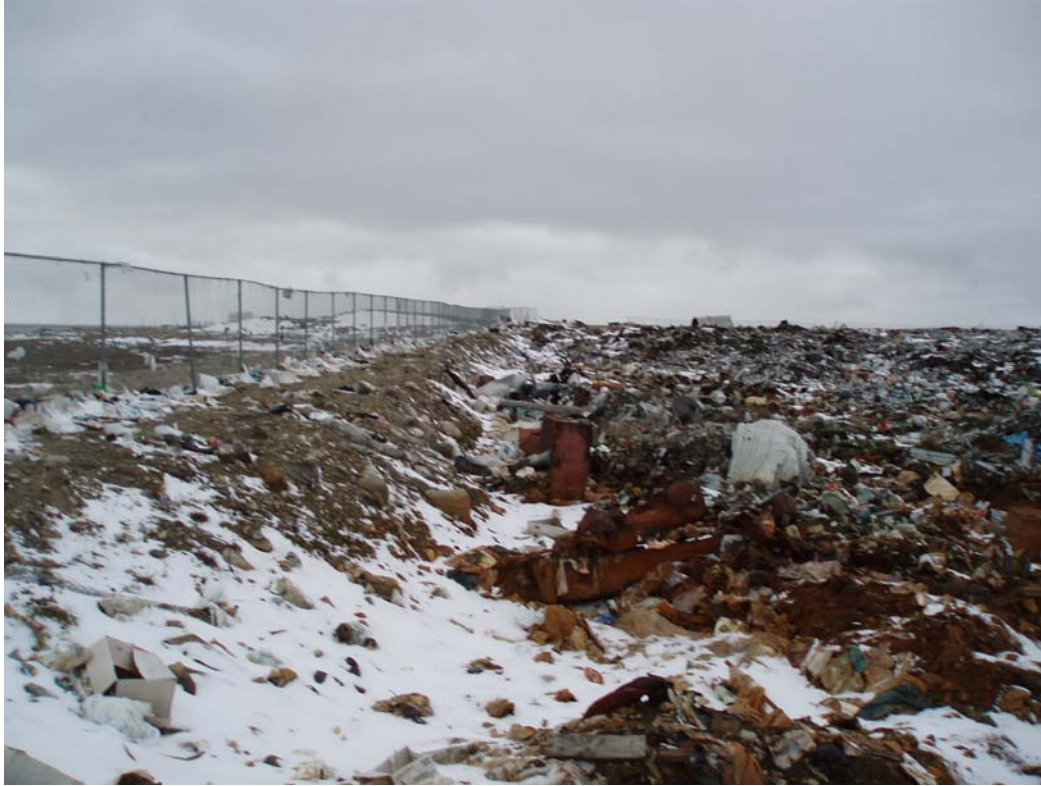
Photo 3. Poor segregation in solid waste facility. Metal waste mixed in with general garbage.

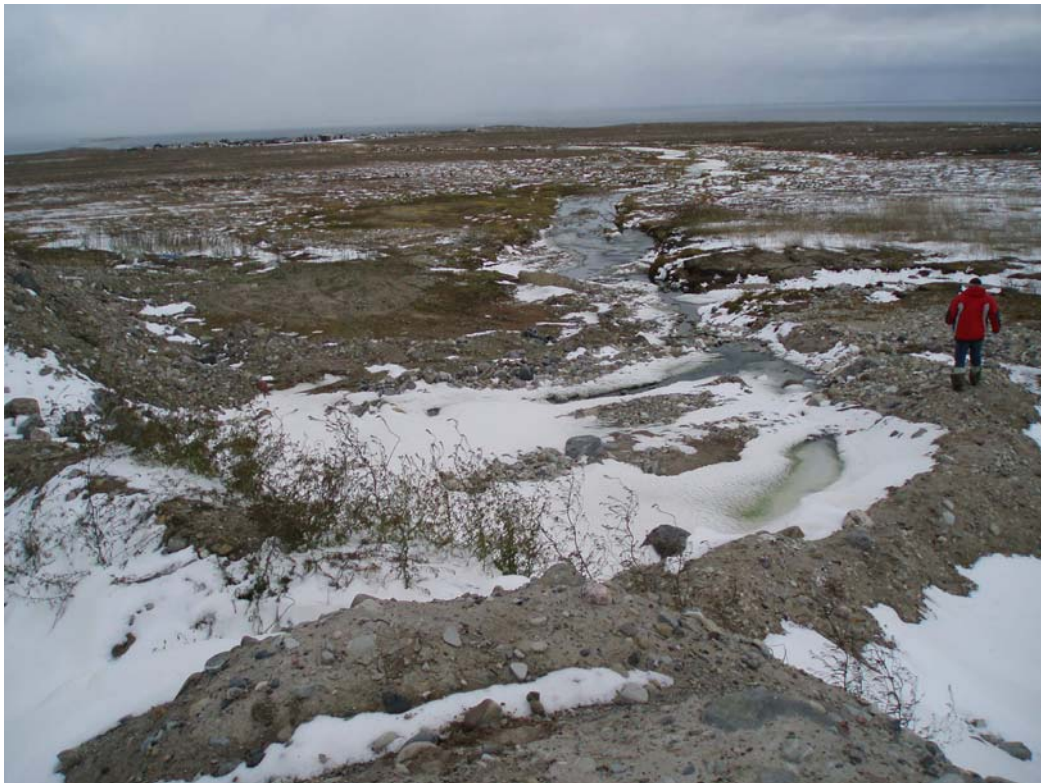
The releases from the sewage lagoon flow past the landfill and probably mix with leachate from the landfill. The Hamlet should re-align the flow-path of the lagoon releases or improve the wetland treatment of the flows from the sewage lagoon and landfill. Satellite and previous photos seem to indicate that previous lagoon releases occurred at a different location and the flows followed a different path. The Hamlet should clarify its preferred location for releases and flow path in its operation manual and annual report to the Board.

Photo 4. Pathway of sewage effluent from lagoon to ocean.
