WATER LICENCE INSPECTION FORM

| Hamlet of Gjoa Haven | | Richard Leong | |
| 3BM-GJO1828 | | A/Senior Administrative Officer | |
| 2020 August 12 | | Baba Pedersen | |

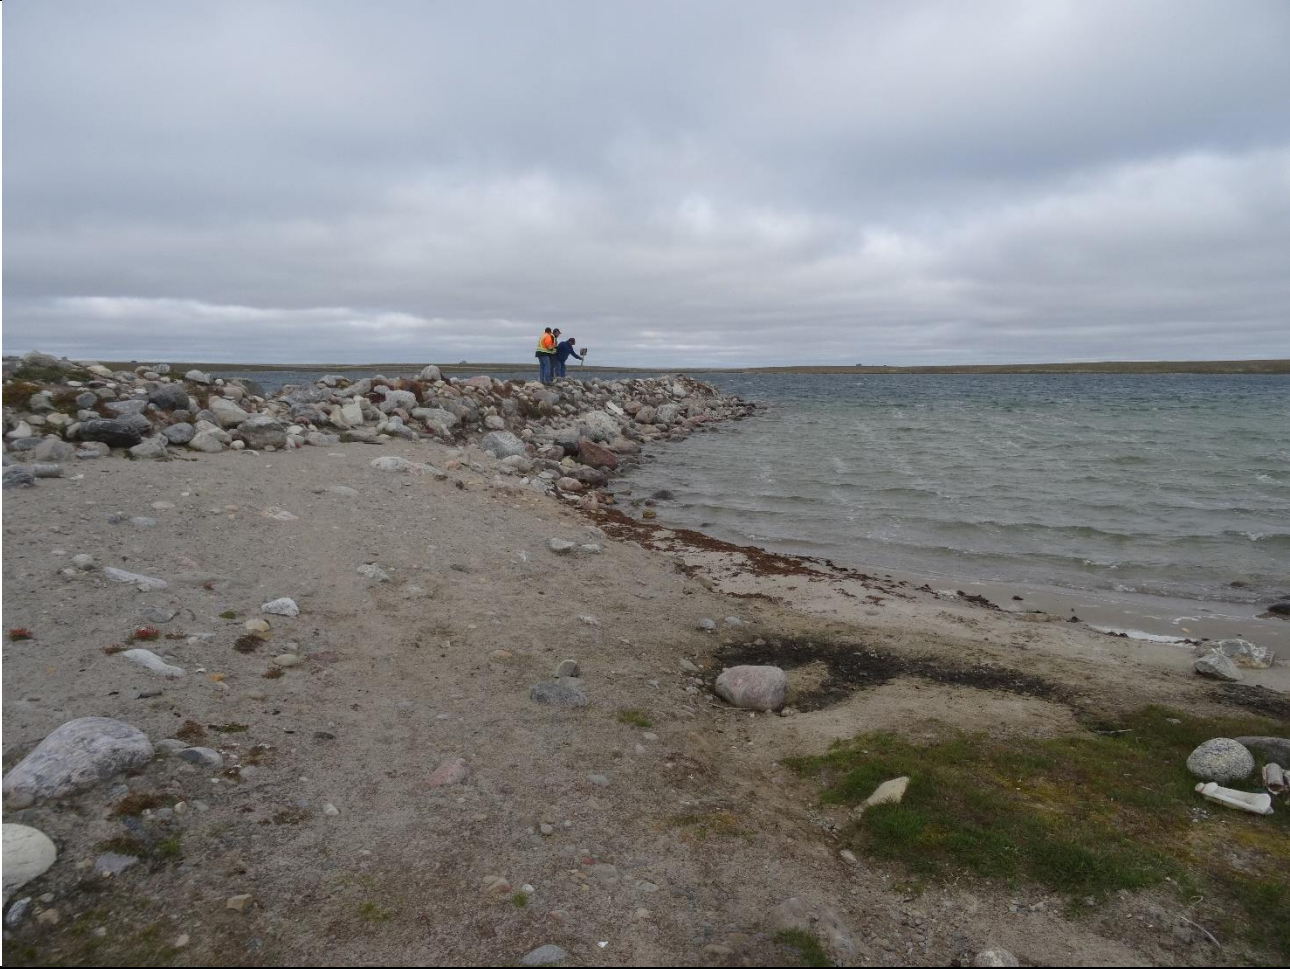
| Date | Camera | Inspector | Authorization |
|--|---|---|---|
| Photo 1 | | | |

| Date | Camera | Inspector | Authorization |
|--|---|---|---|
| Description: Installation of GJO-1 Signage at Swan Lake Raw Water Intake location | | | |

| <ol style="list-style-type: none">1. Signage for Sample Station GJO-1 at the Raw Water Intake has been installed as per the Inspector's instructions from last inspection, Thank You very much2. The Licence Holder MUST repair the Hole in the Sewage Lagoon Berm Liner at the Truck Dump Station AND provide the Inspector with Photographic Proof PRIOR TO September 30, 2020 *UPDATE* as per Photo 3, the License Holder completed | | | |

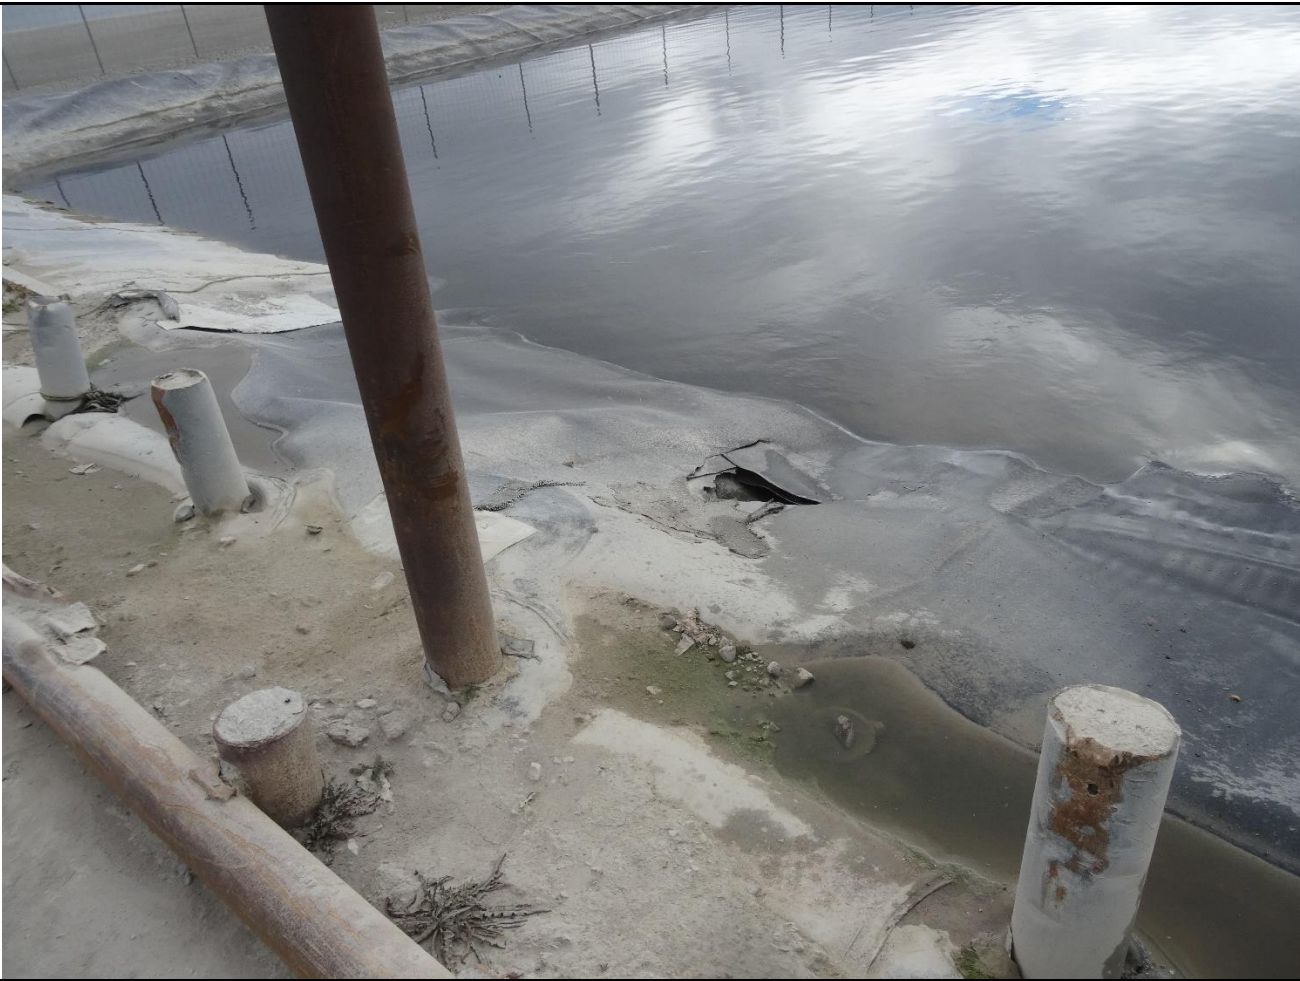
| Date | Camera | Inspector | Authorization |
|--|---|---|---|
| Photo 2 | | | |

| Date | Camera | Inspector | Authorization |
|--|---|---|---|
| Description: Hole in Sewage Lagoon Liner requiring Repair as at 2020 August 12 | | | |

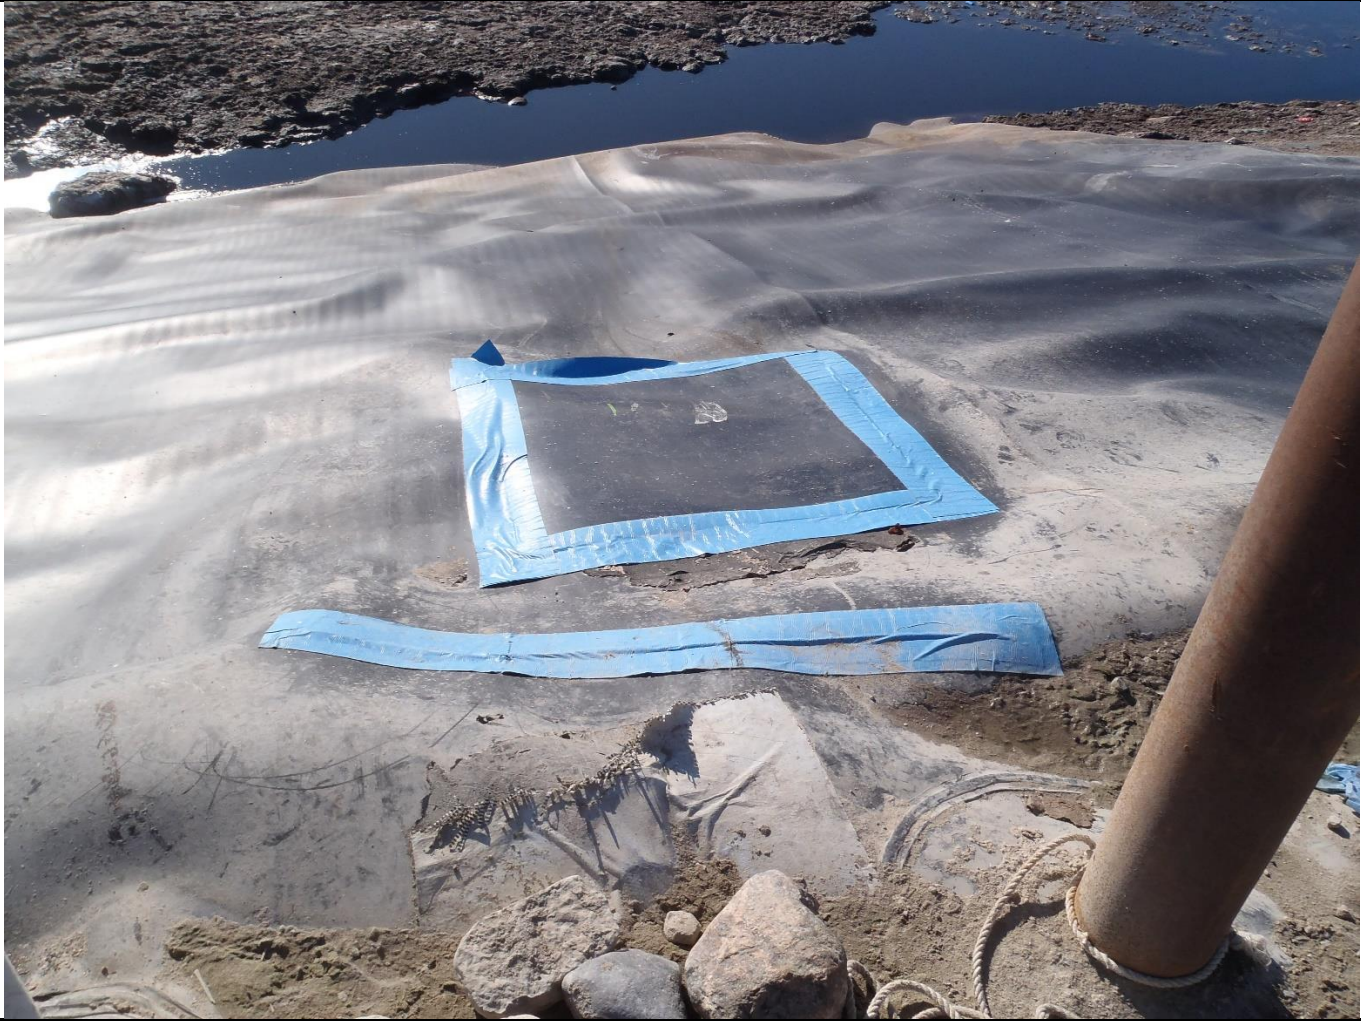
Photo 3

Description: Hole in Sewage Lagoon Liner AFTER REPAIR as at 2020 September 9

the required Repairs and submitted Photographic Proof to the Inspector on September 9, 2020. Thank you very much

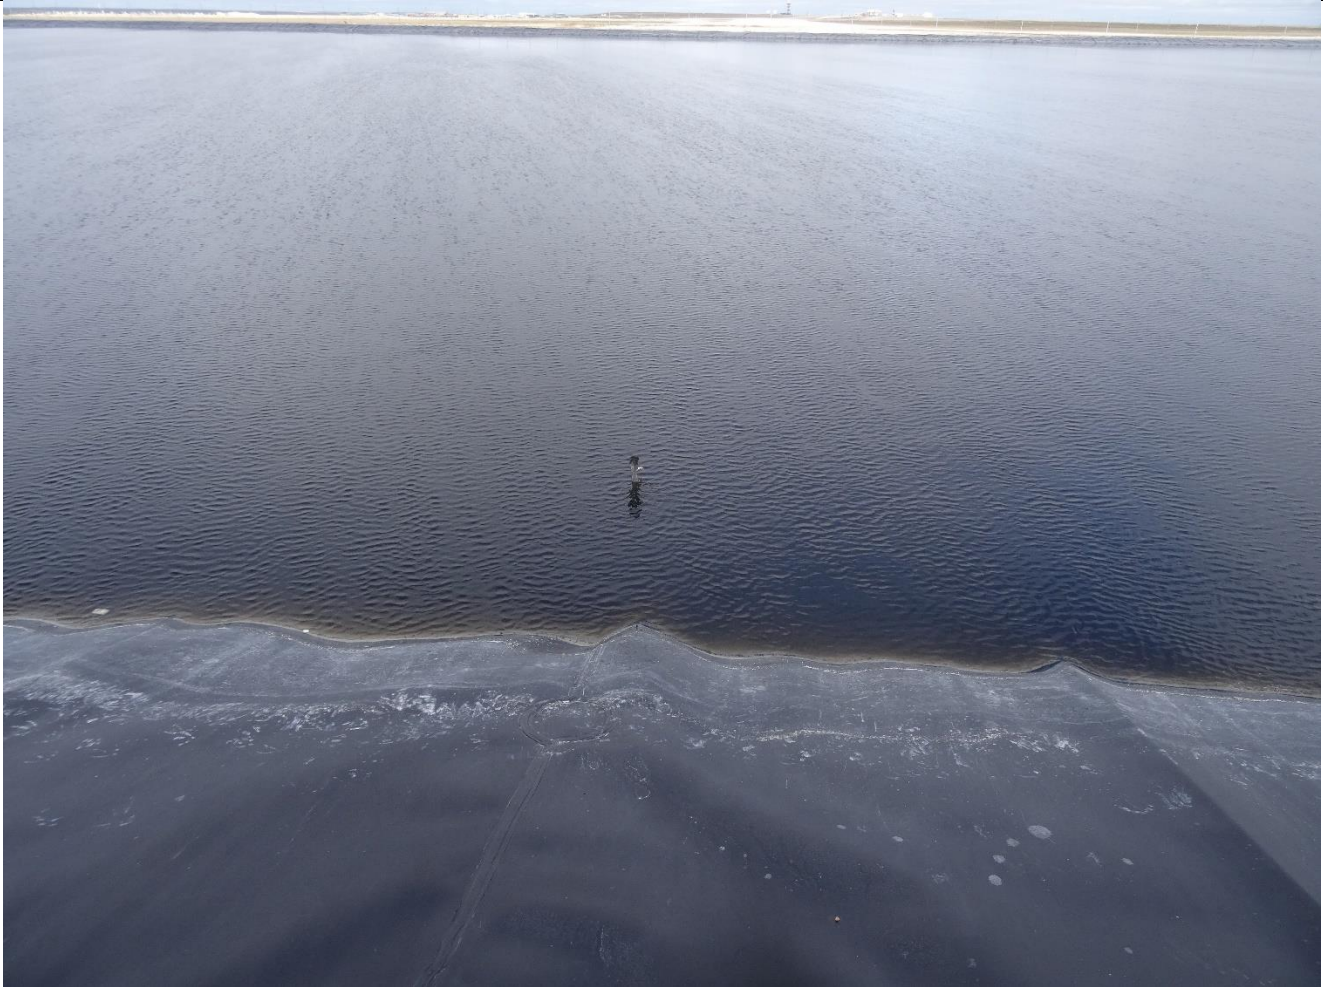
Photo 4

Description: Presumed Tear in South Side of Sewage Lagoon Liner to be verified/repared AFTER Decant Program is complete

3. The Licence Holder MUST check the presumed tear in the Sewage Lagoon Berm Liner on the South Side of the Sewage Lagoon AFTER the Decant Program is Complete and Repair as Required PRIOR to September 30, 2020

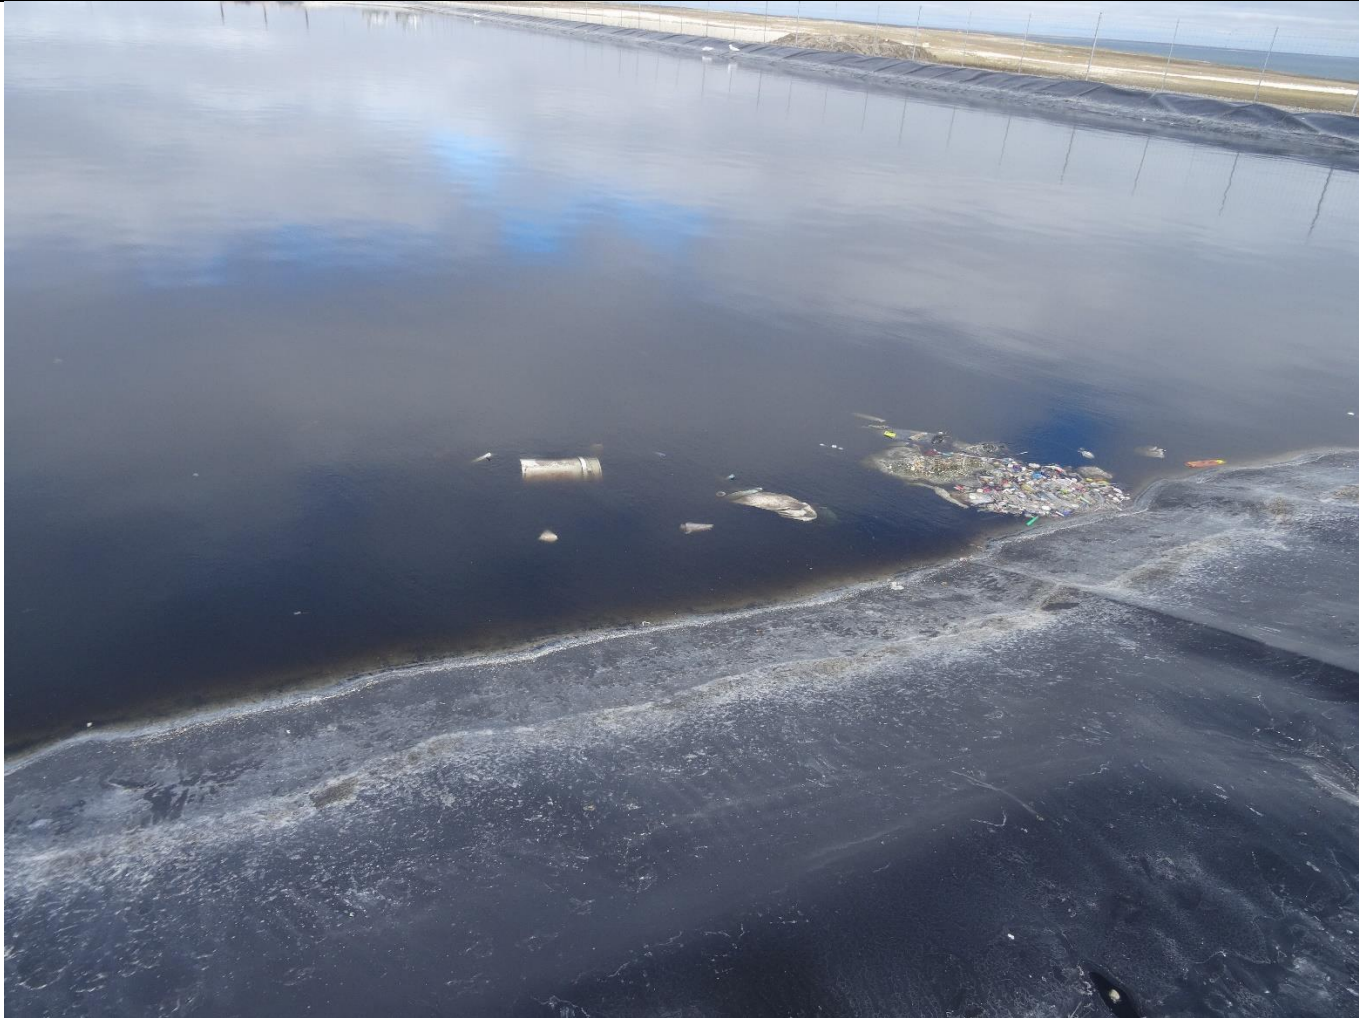
Photo 5

Description: Floating Debris on South Side of Sewage Lagoon requiring Removal

4. The Licence Holder shall remove all the Floating Debris on the South Side of the Sewage Lagoon
5. The Licence Holder has taken the required Samples and sent them to the Lab in Yellowknife for Analysis. Once received they will email them to the Inspector for Approval to Start the Decant Process

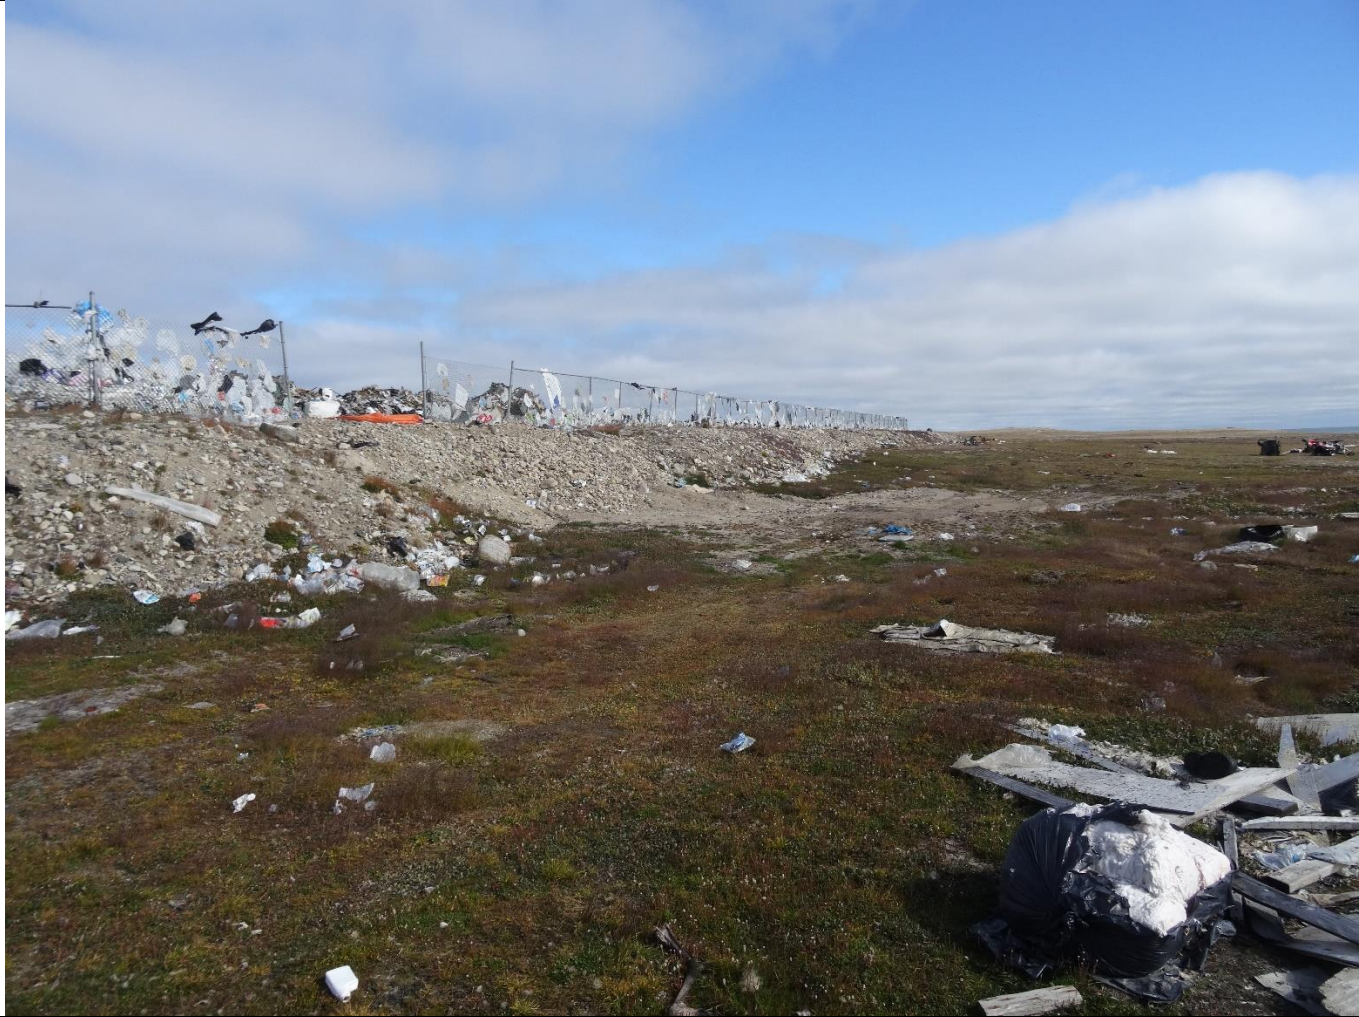
Photo 6

Description: Damaged Section of Fencing for the Garbage Dump beside Sample Station GJO-5 requiring Repair

6. The Licence Holder shall repair the Damaged Section of the Garbage Dump Fence beside Sample Station GJO-5 AND provide Photographic Proof to the Inspector PRIOR TO September 30, 2020

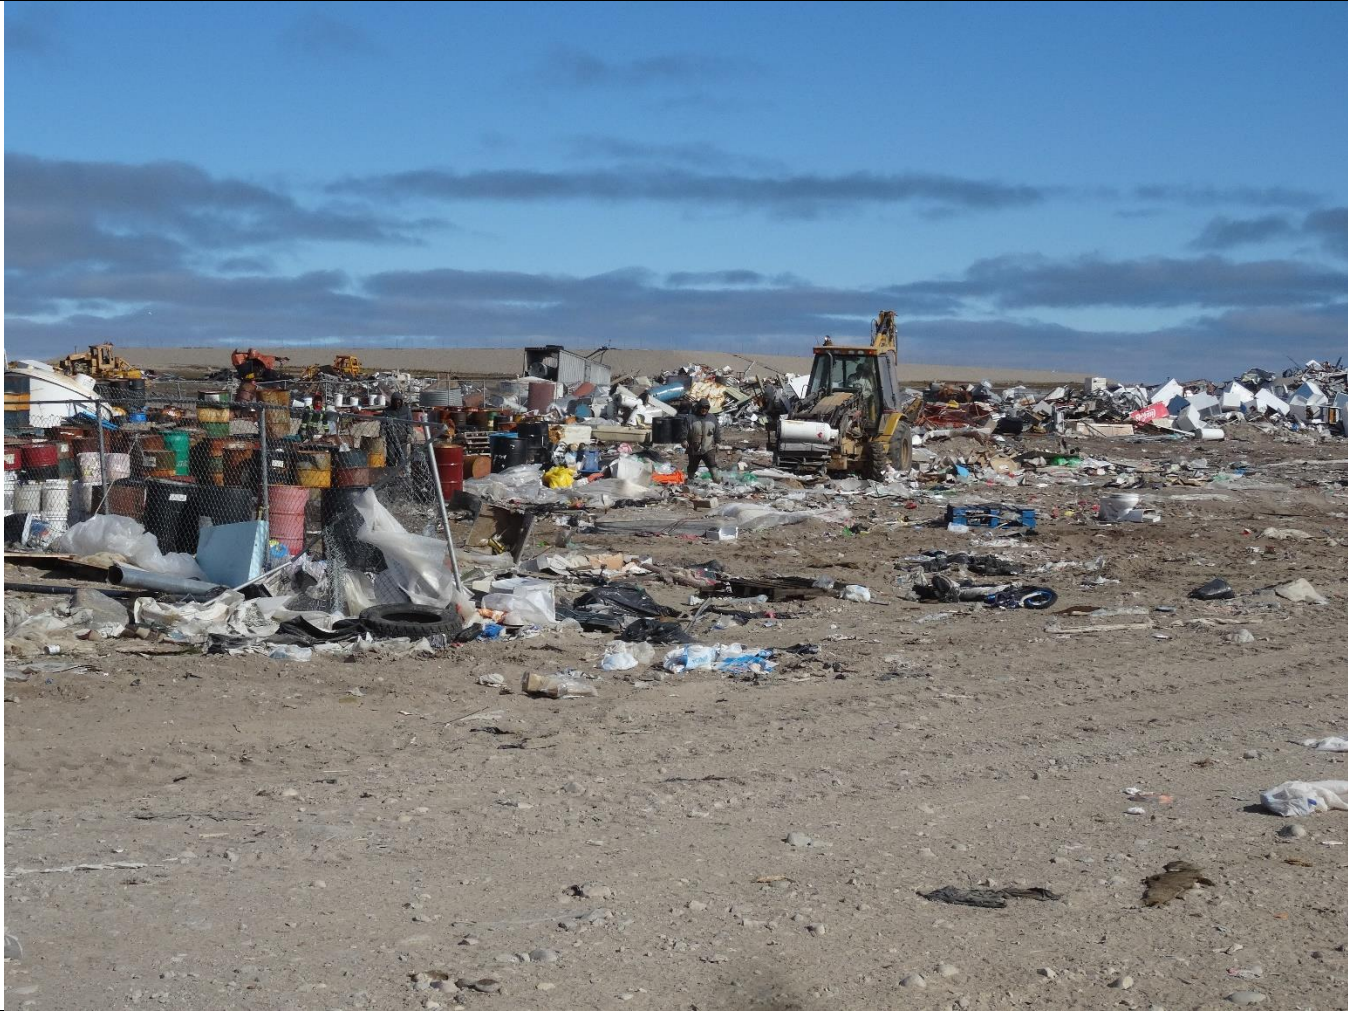
Photo 7

7. The Inspector witnessed Staff from the Licence Holder actively Cleaning and Sorting the contents of the Garbage Dump. Thank you for undertaking this much required task

Description: Hamlet Staff actively Cleaning and Sorting Contents within the Garbage Dump perimeter – Thank You for this

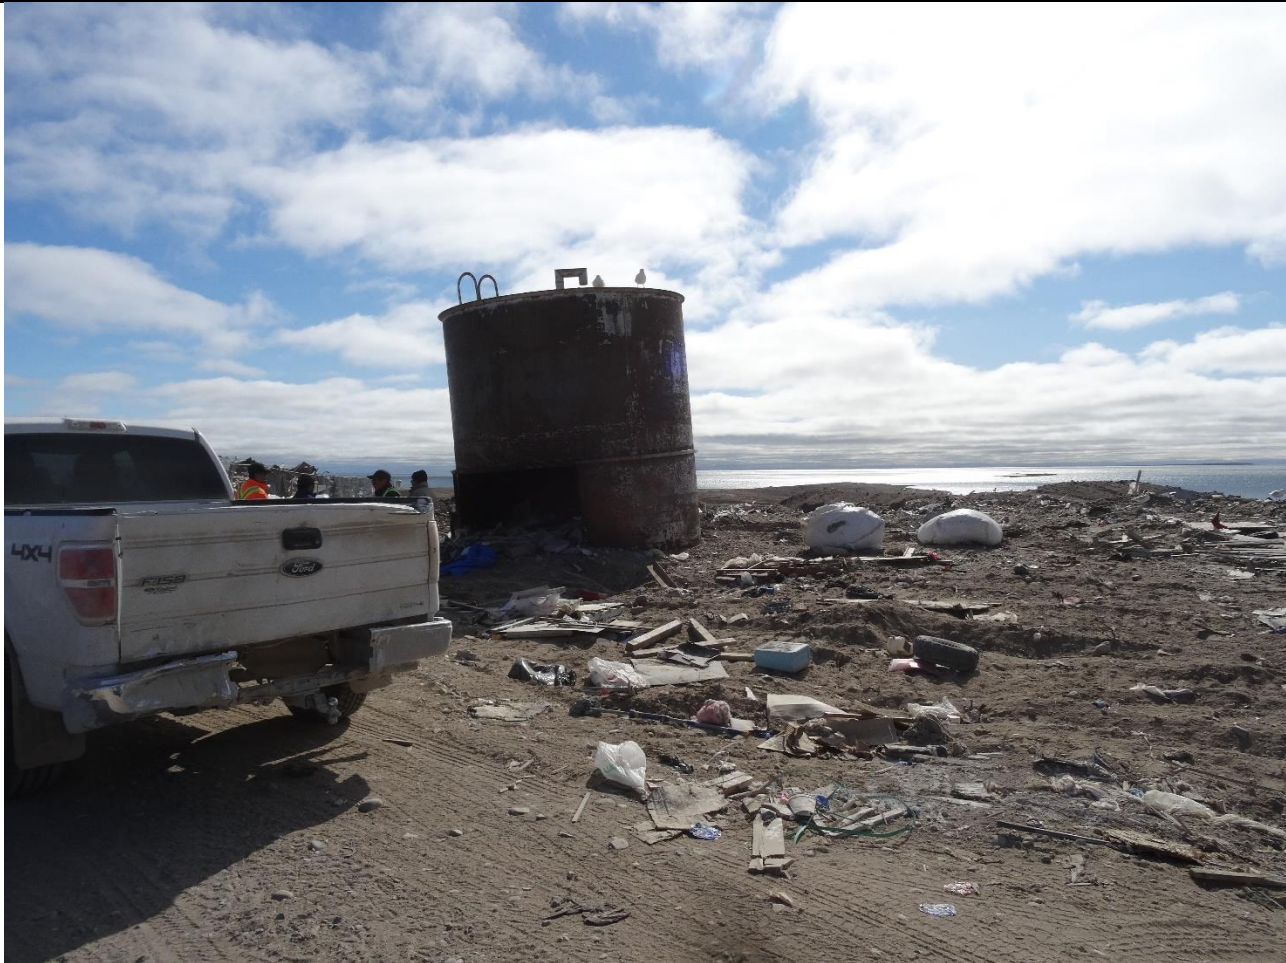
Photo 8

Description: Old Fuel Tank the Hamlet plans to modify and use as a Burn Box for Non Hazardous Materials

8. The Licence Holder shall move the old Fuel Tank within the Garbage Dump Fenced Perimeter to be used as a Burn Box for Non-Hazardous Materials
9. The Inspector witnessed the excellent job the Licence holder is doing with the Storage and Crating of Used Batteries. Thank you for this. The only recommendation the Inspector has to improve on this would be to store the Crated Batteries within a Sea Can

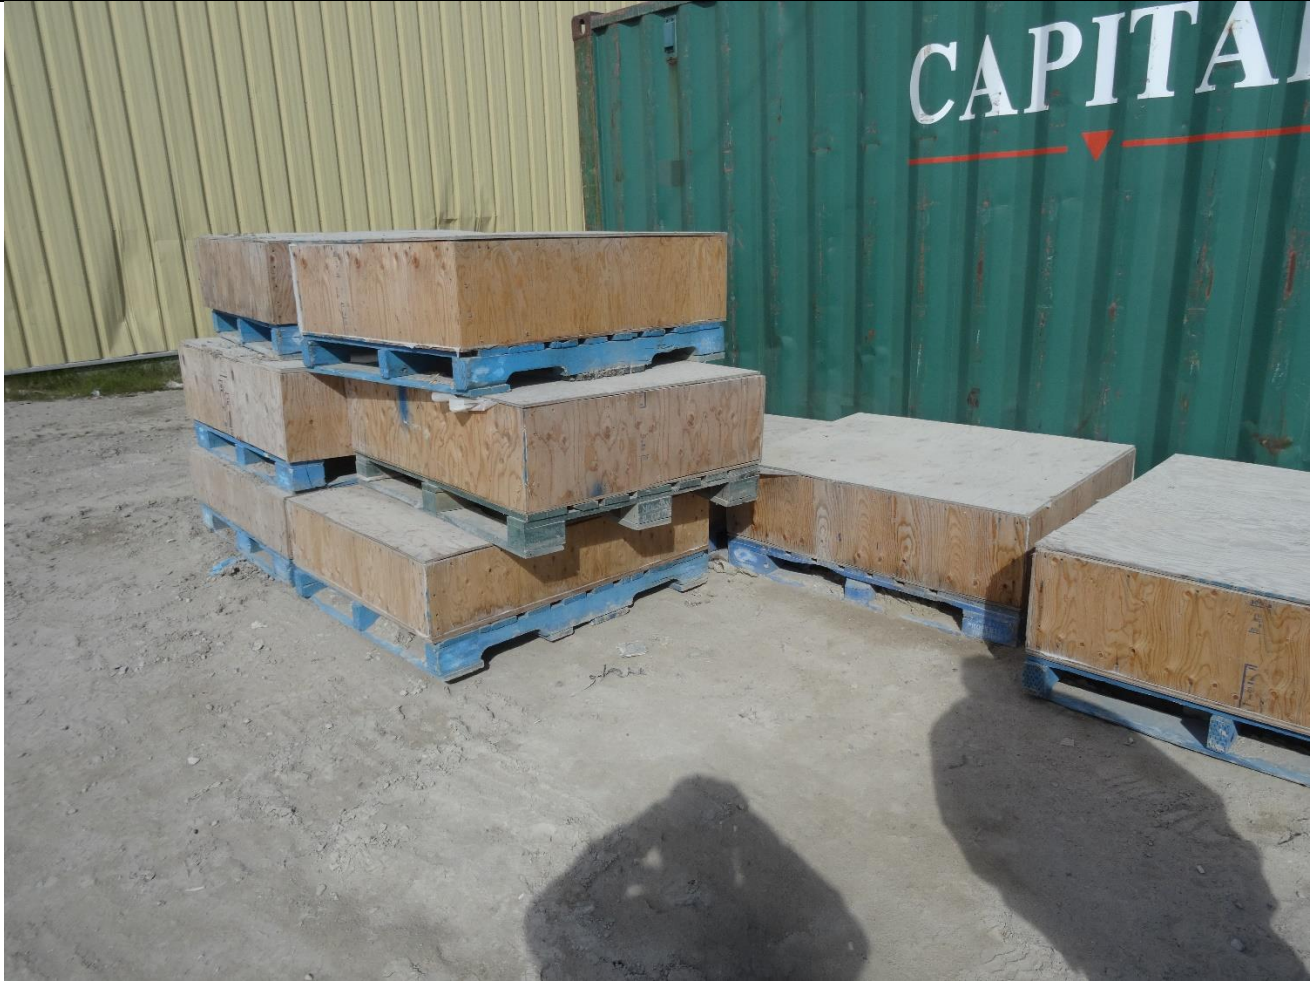
Photo 9

Description: Crates of Used Batteries waiting for shipment South for proper disposal – Very Nice Job, Thank You Very Much!

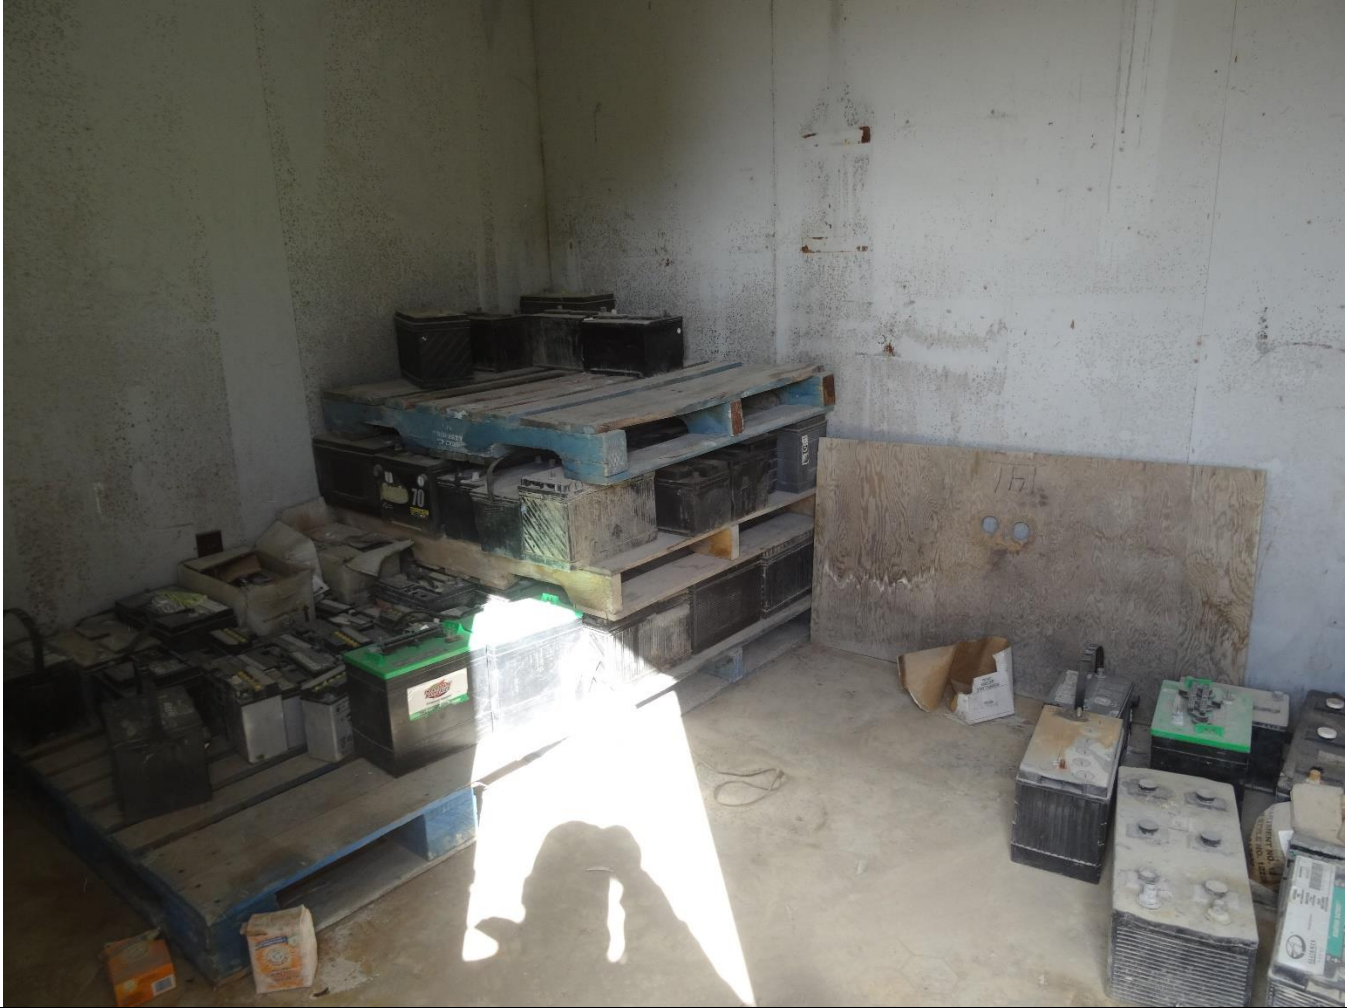
Photo 10

Description: Temporary Storage Area for Used Batteries waiting to be Crated Up – Very Nice, Thank You Very Much!
