Gjoa Haven August 24, 2012

Sewage Lagoon and Solid Waste Management Area

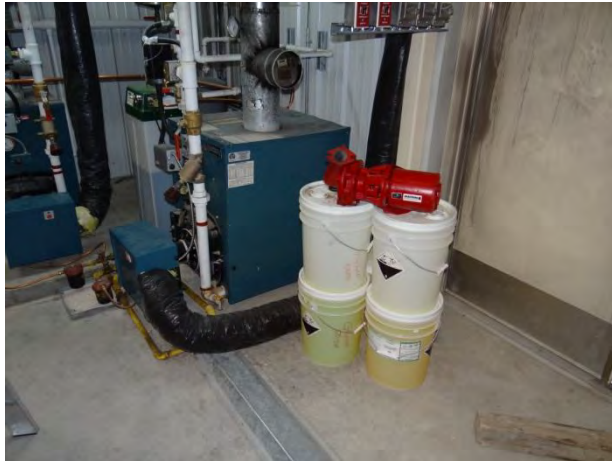
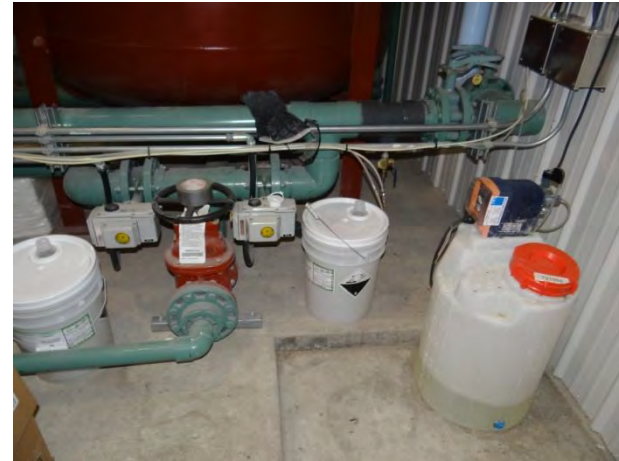
- Water Treatment Facility

- Chlorine treatment pumps in good working order. Water is chlorinated prior to entering the holding tank and re-chlorinated prior to transfer to Hamlet Water Trucks.
- Chlorine mixing tanks were found to be less than half full.
- Water is re-circulated between Swan Lake and the Holding tank on a continuous basis to keep the lines from freezing.

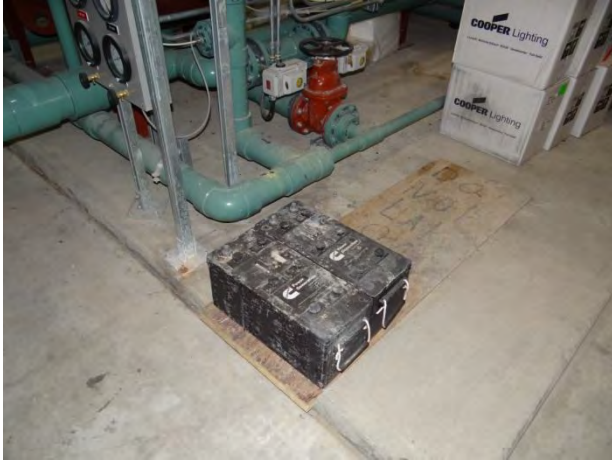
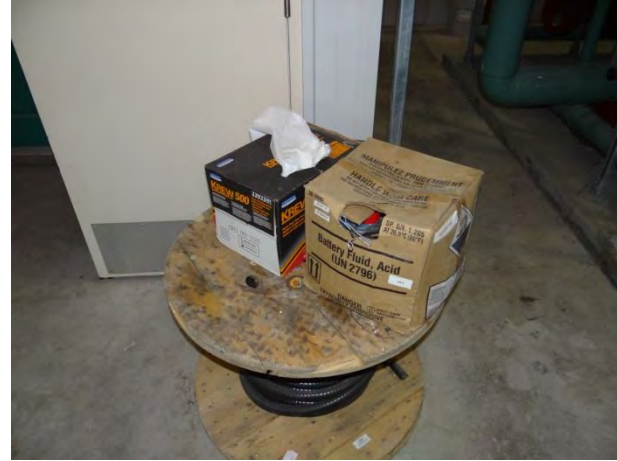
- Water Treatment Facility
- House keeping issues including the secure and safe storage of chemicals and hazardous materials should be addressed by the Licensee.

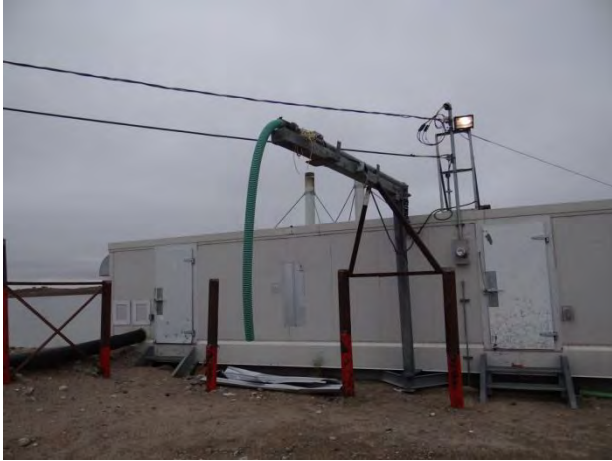
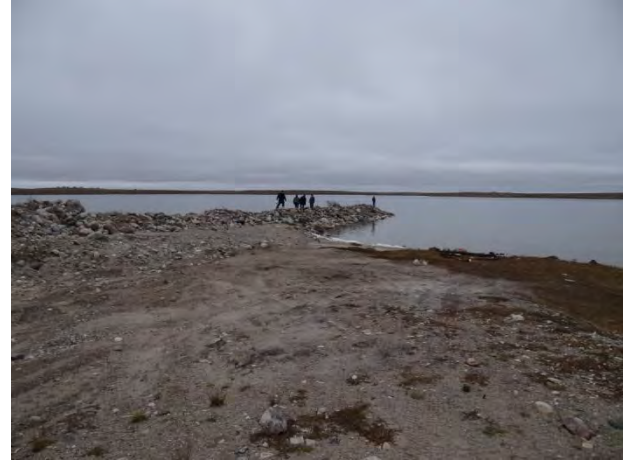
- Water Intake/ Pumping Station : Swan Lake
- Area clear of debris
- Pumping station locked
- Samples collected from Swan Lake source

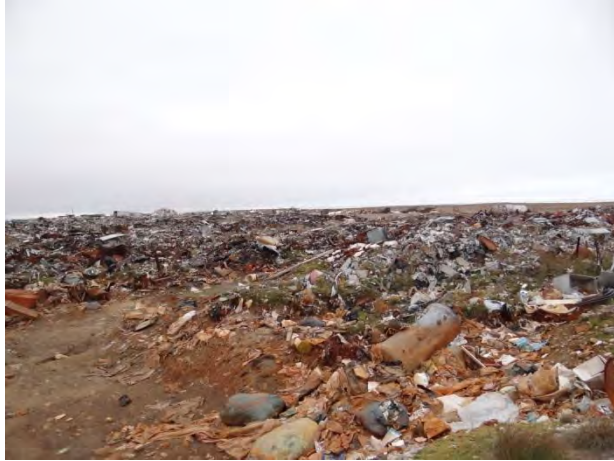
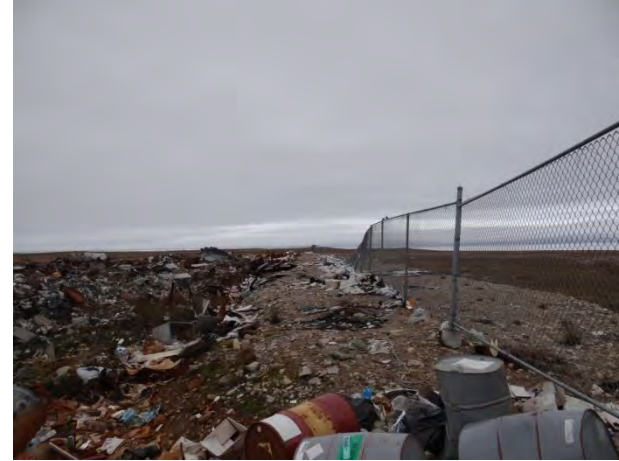
- **Solid Waste Management Area**

- Lack of cover materials in the Municipal Waste Management Area
- Fencing around the Municipal Waste Management Area has blown down in areas.
- Lack of segregation.. Metal and drums found at the site.
- Sampling location was dry .. Samples at the posted location could not be collected.

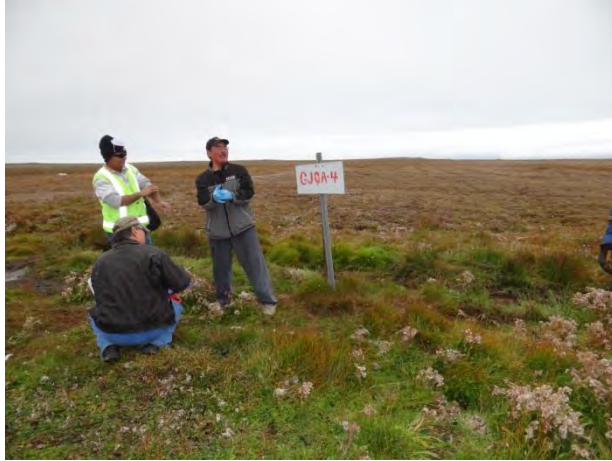
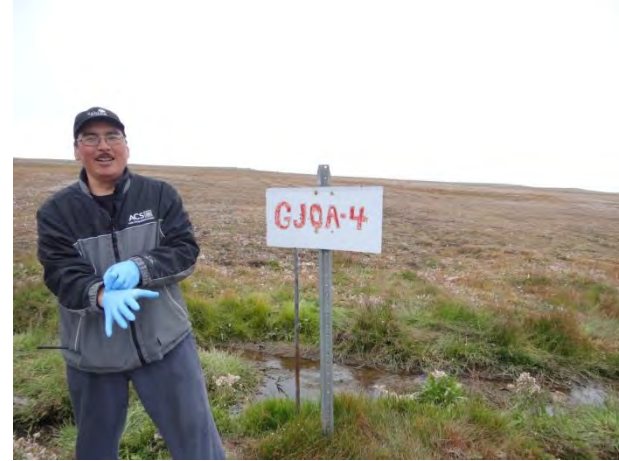
- Bulky Waste Metals Area
- Sampled effluent
- Hamlet sampled effluent at same location
- Effluent sampled 100 plus meters from sewage lagoon
- Effluent run off is naturally directed towards metal waste area at land fill

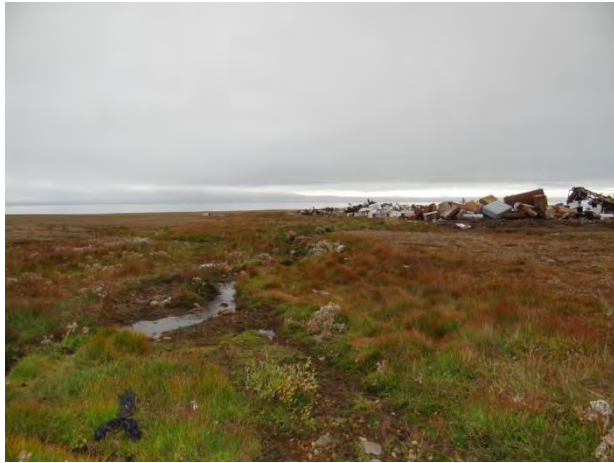
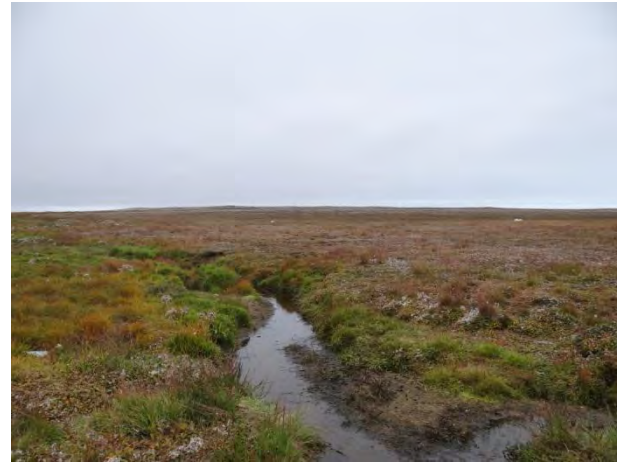
- Leachate sample

- Designated leachate sampling location at landfill was dried up, so new location was used at waste metal area of landfill.
- Hamlet sampled at same location.
- Stream littered with waste from landfill.

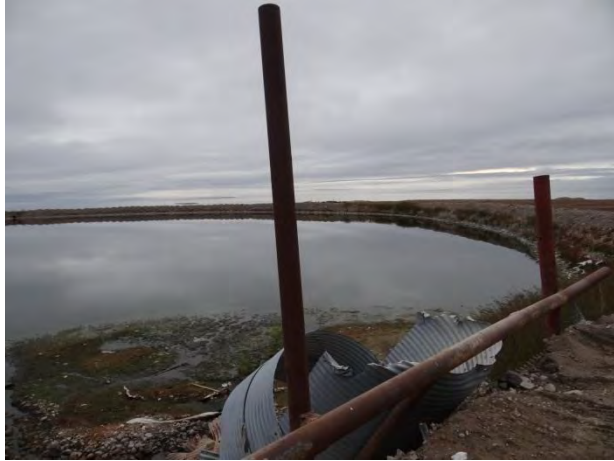
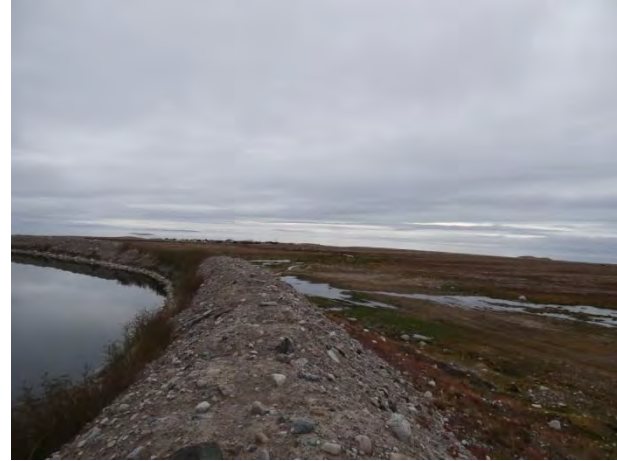
- Sewage lagoon

- Effluent is trucked to community lagoon.
- On average 10 truck loads per day
- 1 meter freeboard is maintained by culvert at the back of the lagoon.
- Effluent flows via installed pipe to secondary cell
- There is an obvious flow seen exiting the secondary cell and proceeding down gradient to the Municipal Solid Waste Management Area.
- Two ponds adjacent to the lagoon showed signs of nutrient loading. It is suspected that effluent has infiltrated these ponds.

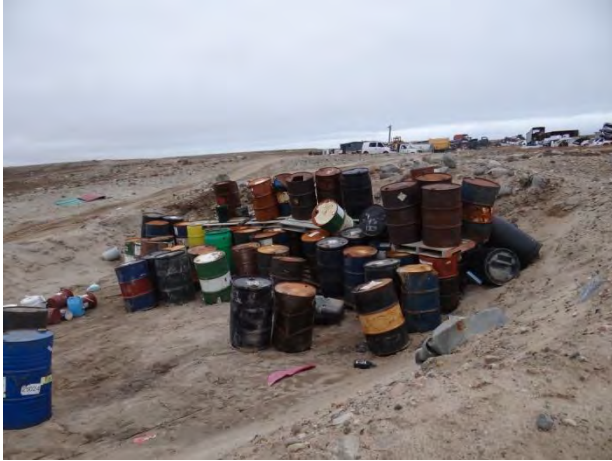
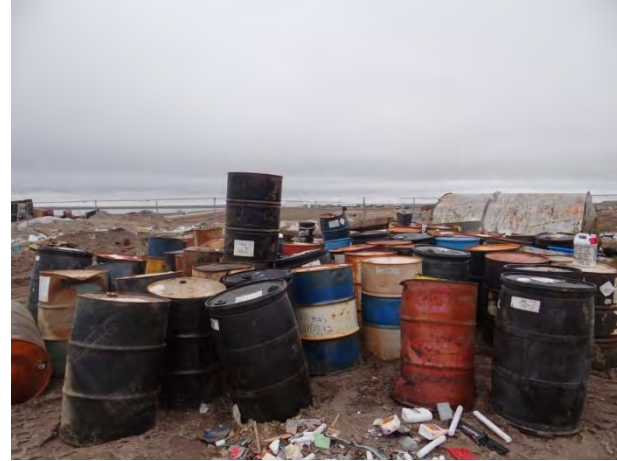
- Unlined hazardous materials area
- Drums of waste oils and other fluids continue to be stored outside the Waste Management Area.
- Batteries remain un-segregated from land fill burn area.
- Attempts to segregate hazardous waste and metals have been made by the hamlet.
- No signage noted at landfill.
