WATER LICENCE INSPECTION FORM

Licensee		Licensee Representative	
Hamlet of Gjoa Haven		Dave Stockley	
Licence No. / Expiry		Representative's Title	
3BM-GJO1318		Senior Administrative Officer	
Land / Other Authorizations		Land / Other Authorizations	
Date of Inspection		Inspector	
13 and 27 July 2018		Baba Pedersen	
Activities Inspected			
<input type="checkbox"/> Camp	<input type="checkbox"/> Drilling	<input type="checkbox"/> Mining	<input type="checkbox"/> Construction
<input type="checkbox"/> Roads/Hauling	<input type="checkbox"/> Other:	<input checked="" type="checkbox"/> Other: Municipal Water License	<input type="checkbox"/> Reclamation
<input type="checkbox"/> Fuel Storage

PHOTO LOG

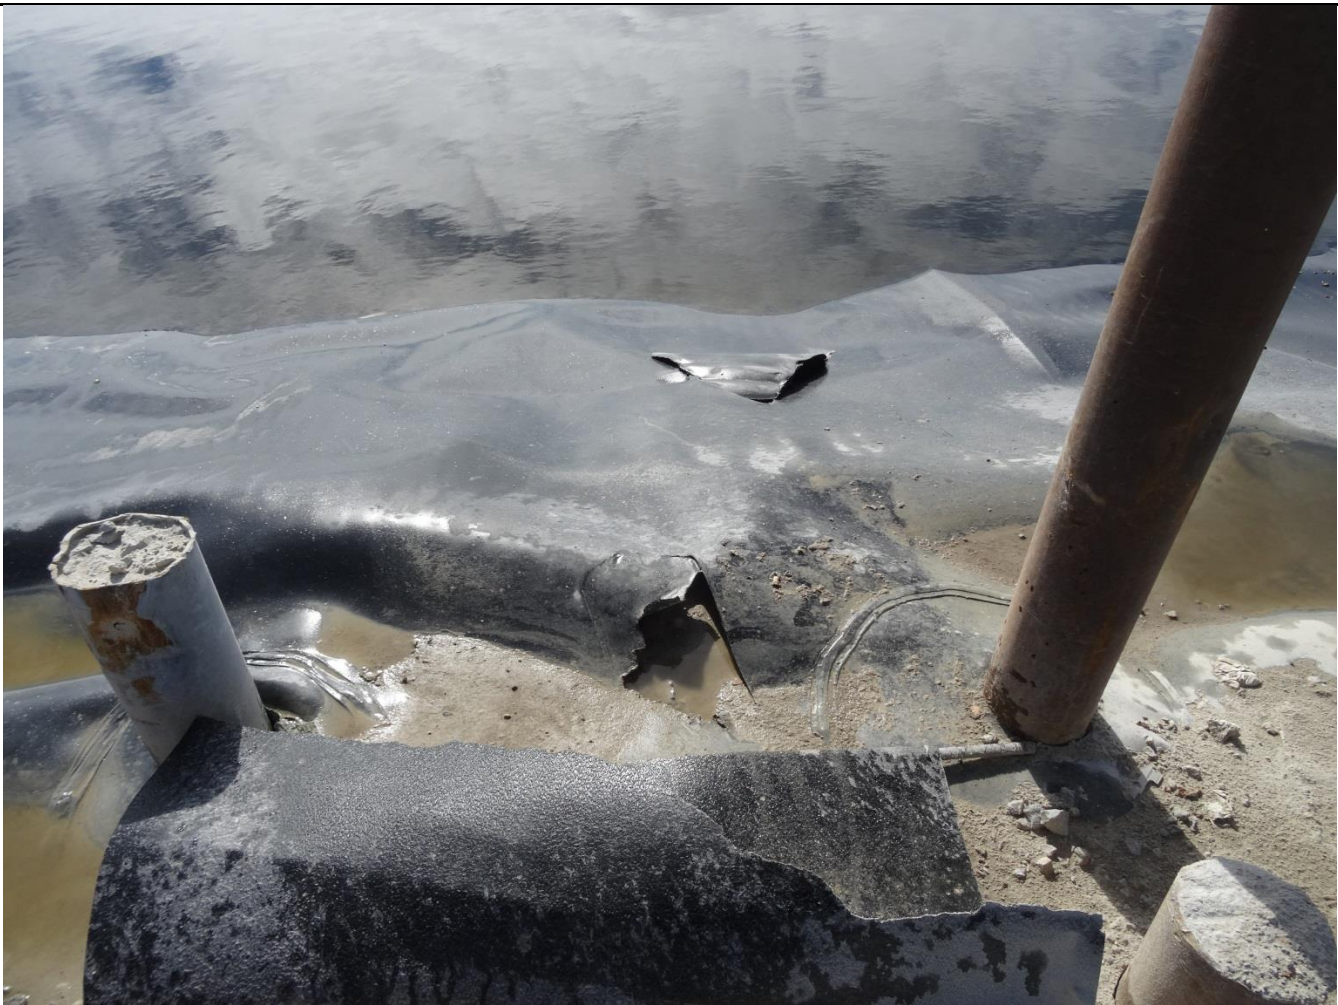
Photo 1

Description: Tear #1 and #2 in Sewage Lagoon Liner at Truck Dumping Location requiring Repair after Decanting – July 13th

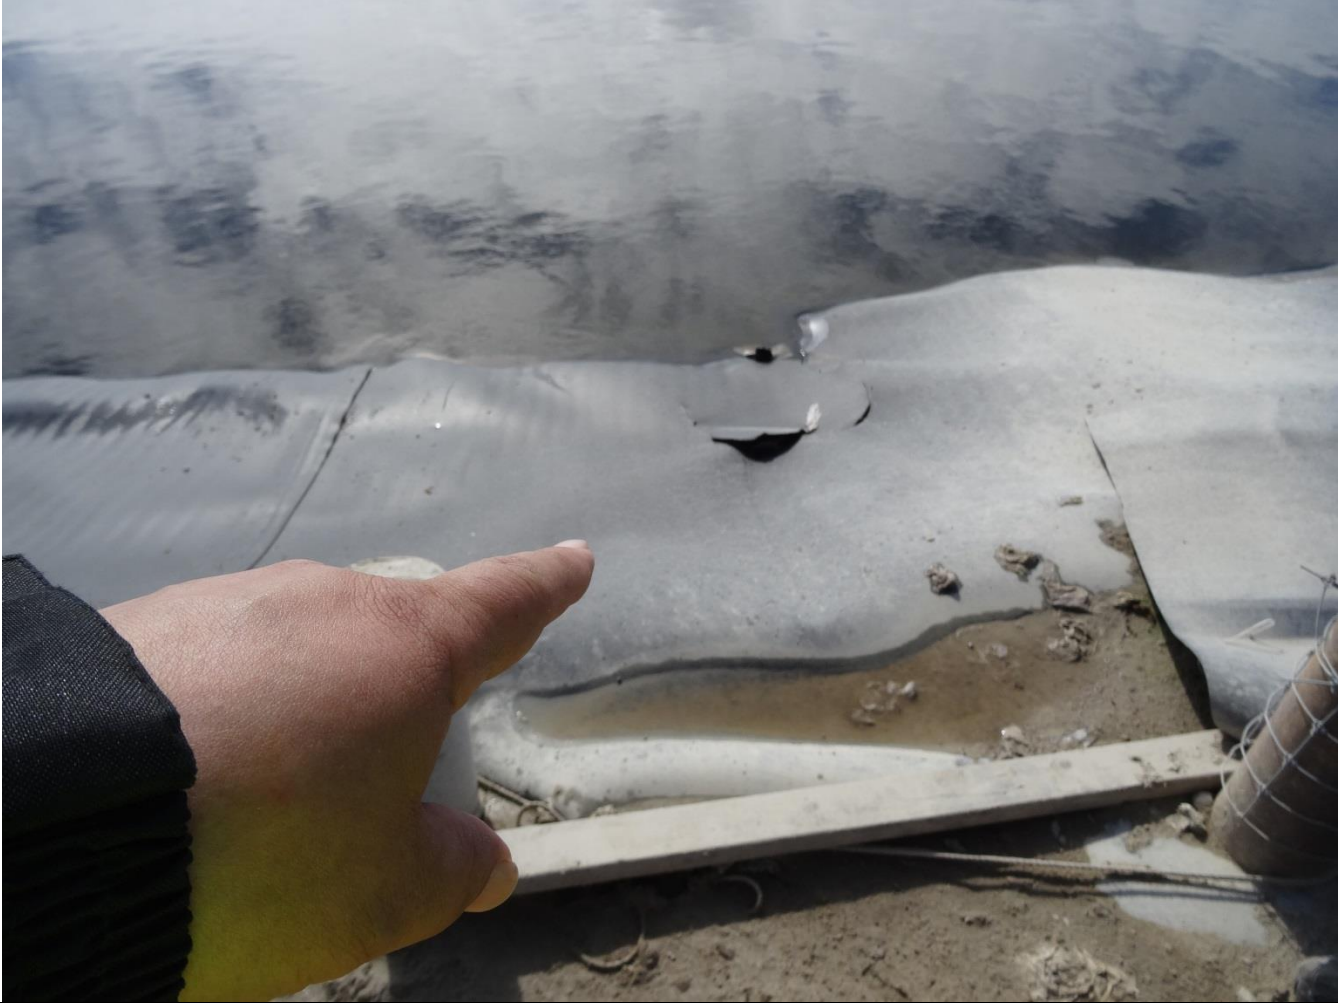
Photo 2

Description: Tear #3 and #4 in Sewage Lagoon Liner at Truck Dumping Location requiring Repair after Decanting – July 13th

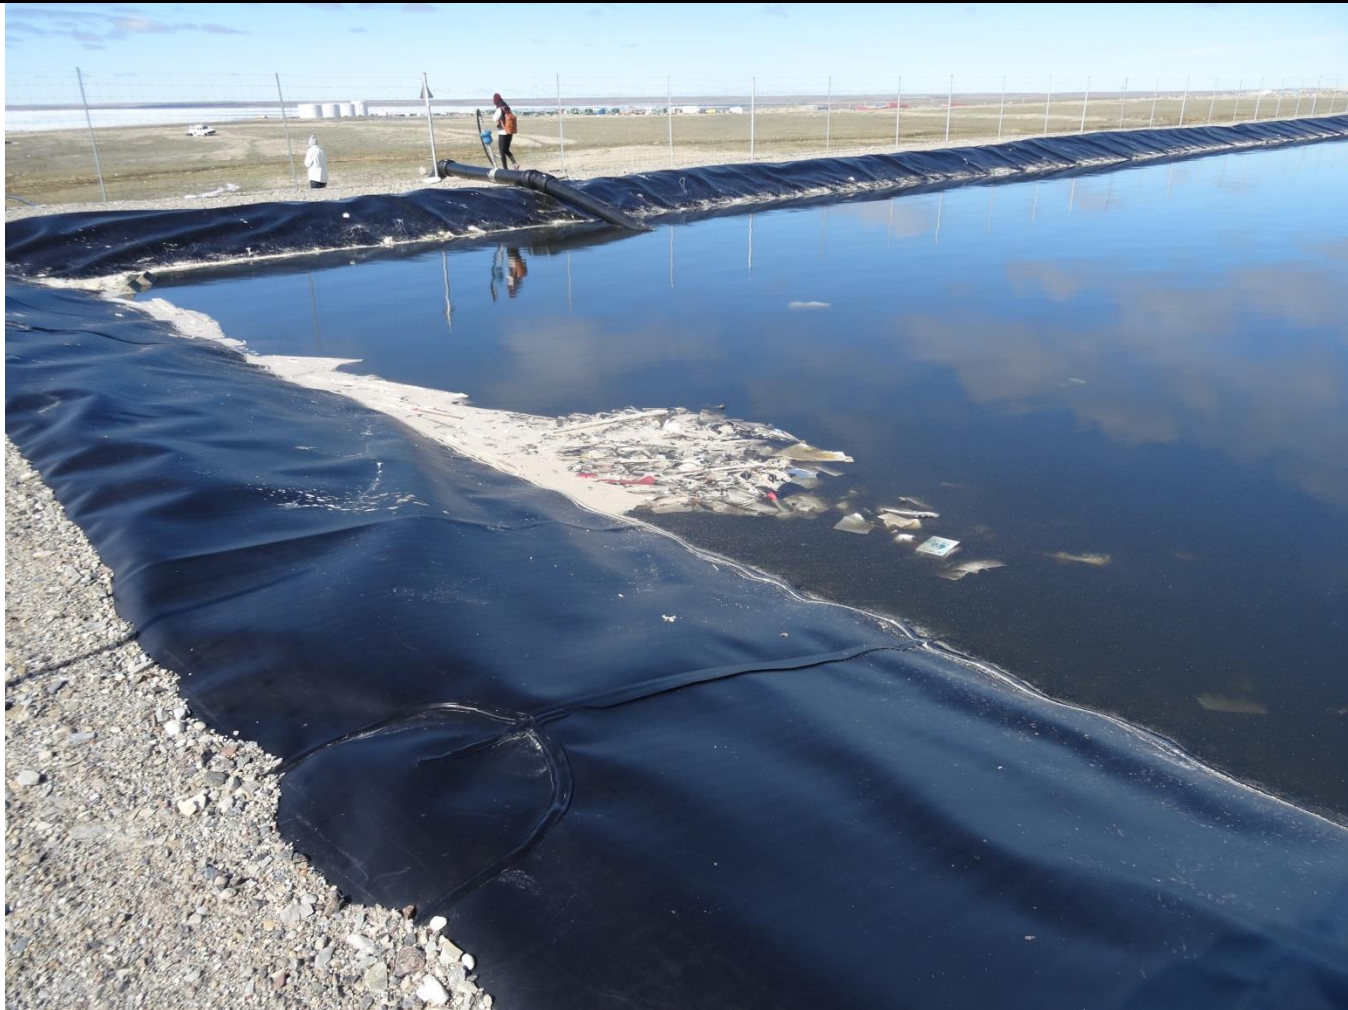
Photo 3

Description: Sewage Lagoon showing high level of Liquid Contents and Floating Debris – July 13th

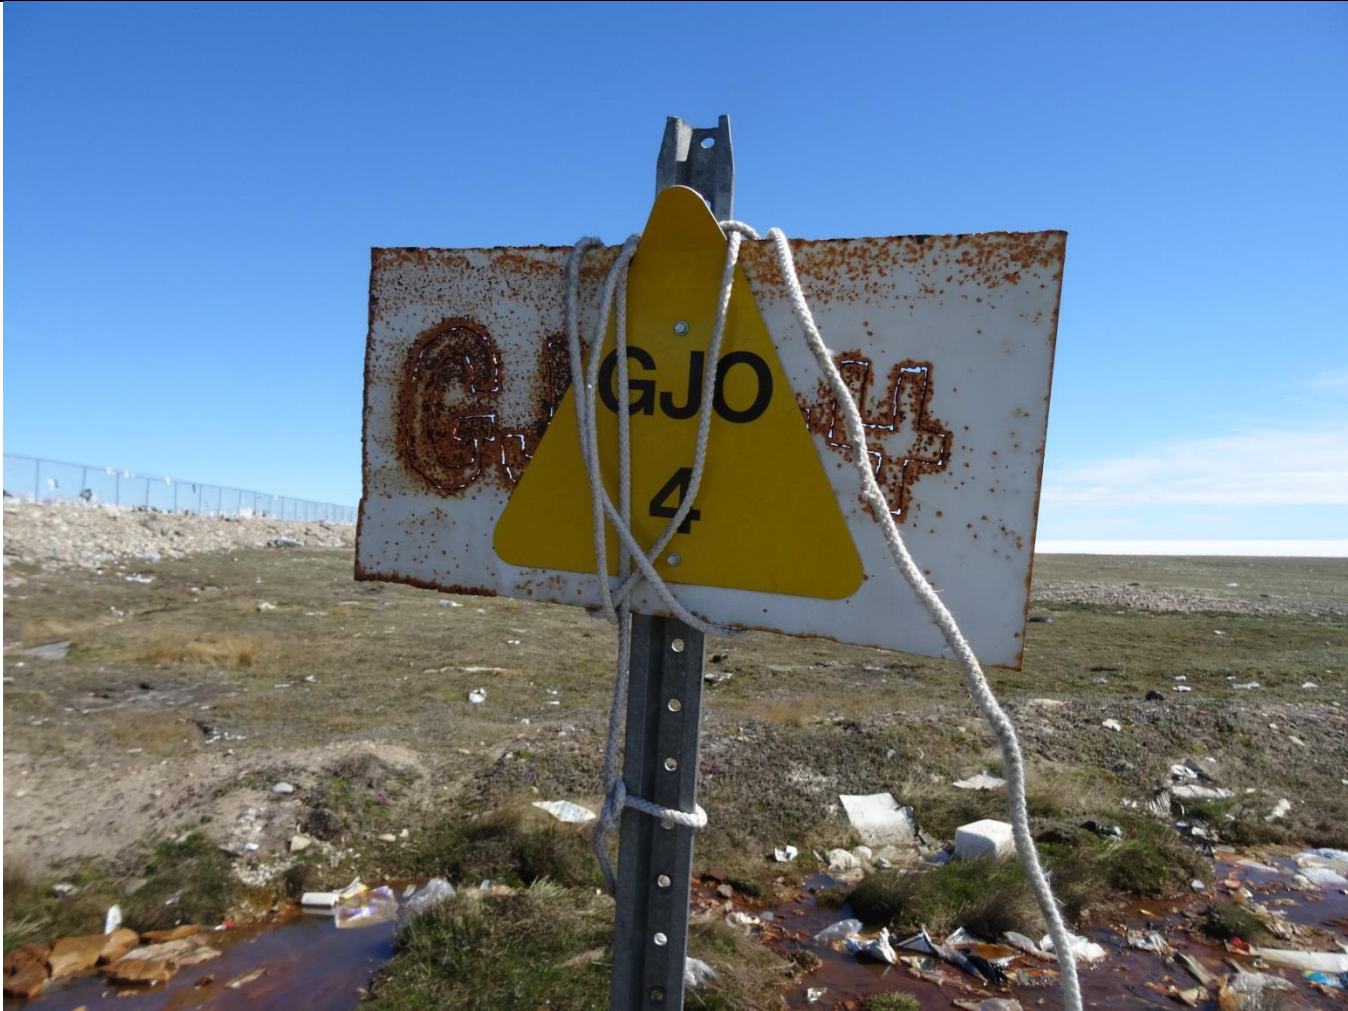
Photo 4

Description: Old Sample Station GJO-4 – Final Discharge – to be moved to new location to better reflect Final Discharge Criteria – July 13th

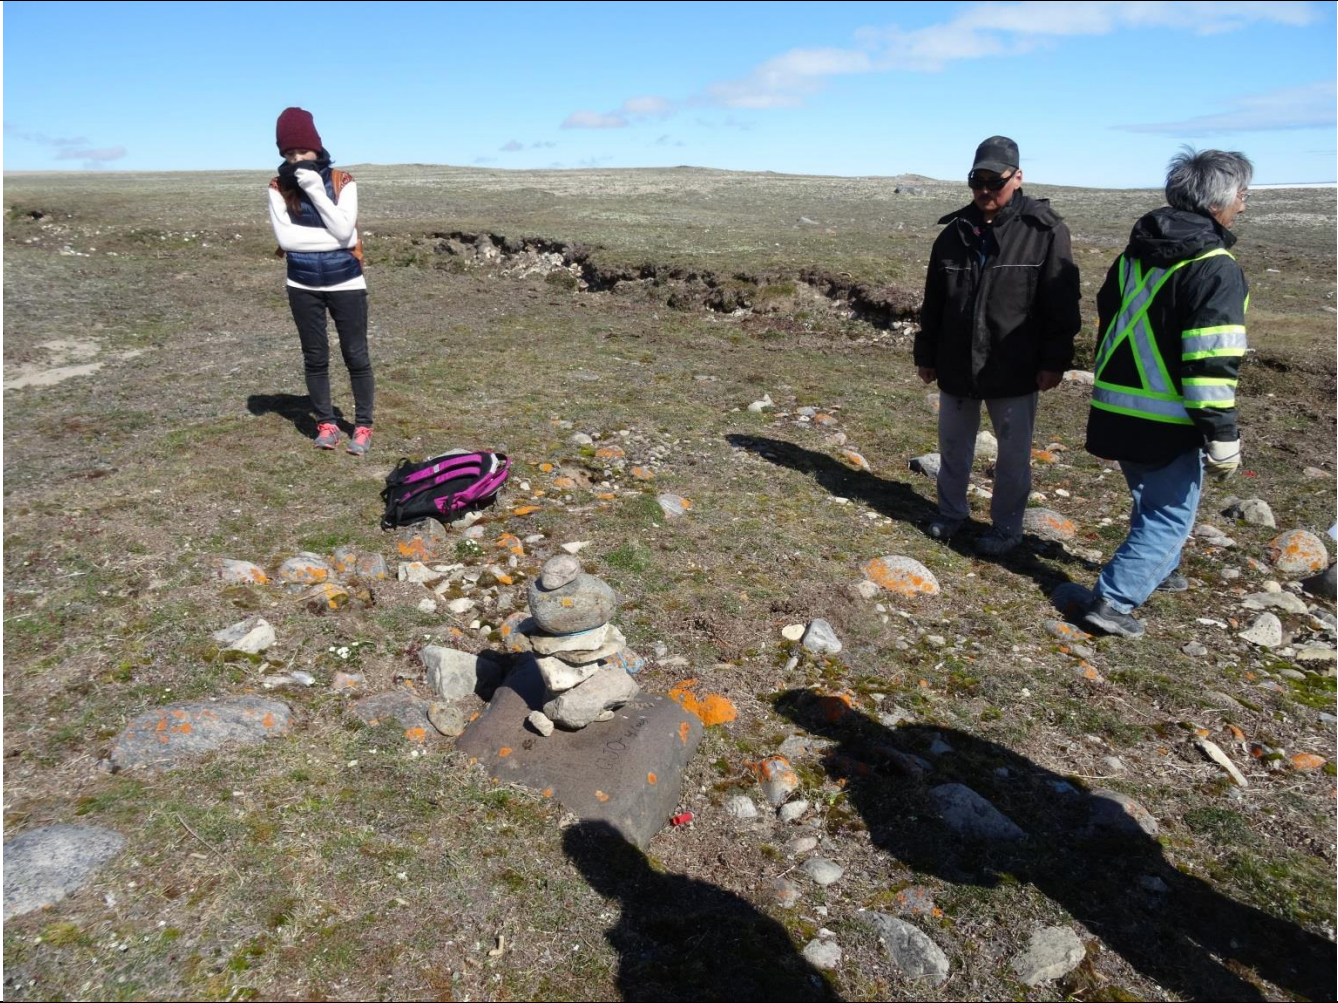
Photo 5

Description: New location of Sample Station GJO-4 to better reflect Final Discharge Criteria – July 13th

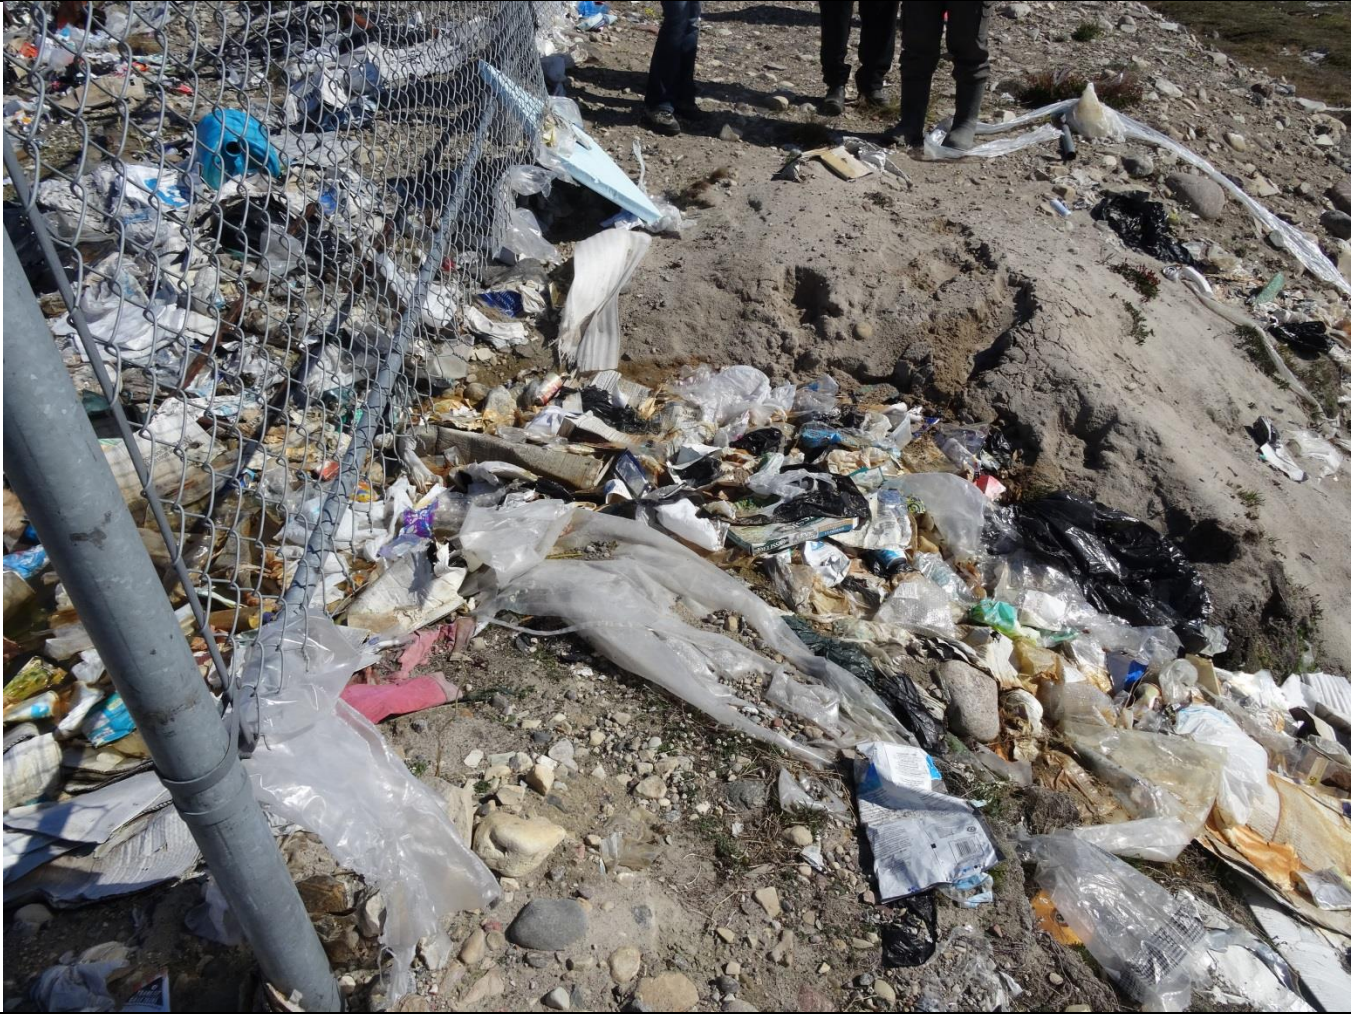
Photo 6

Description: View #1 of Breach in Dump Berm – Directed to Repair within 14 Days – July 13th

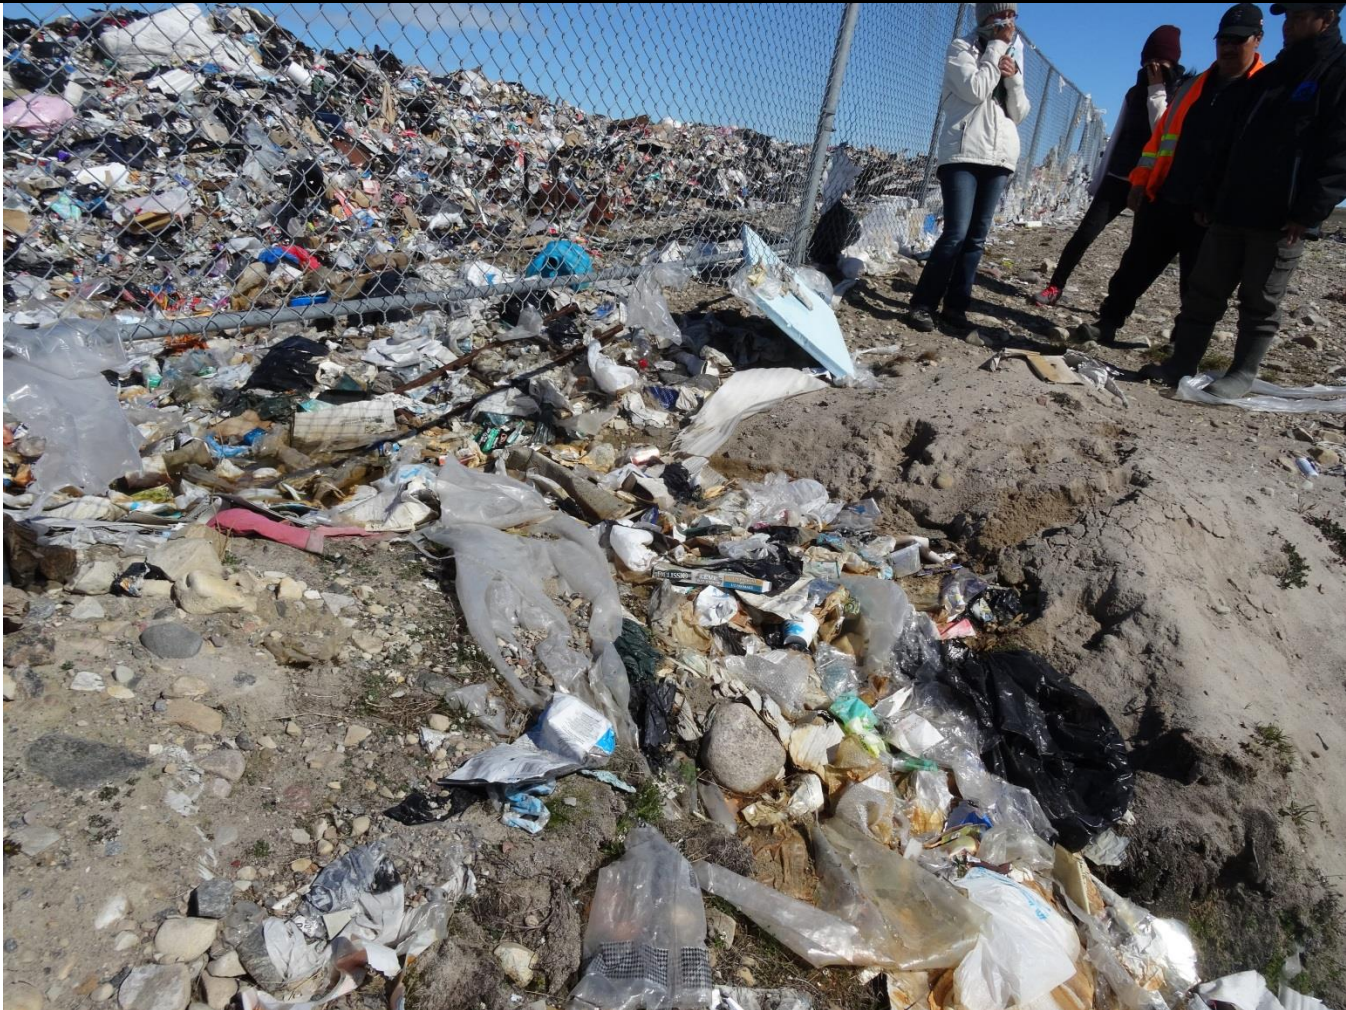
Photo 7

Description: View #2 of Breach in Dump Berm – Directed to Repair within 14 Days – July 13th

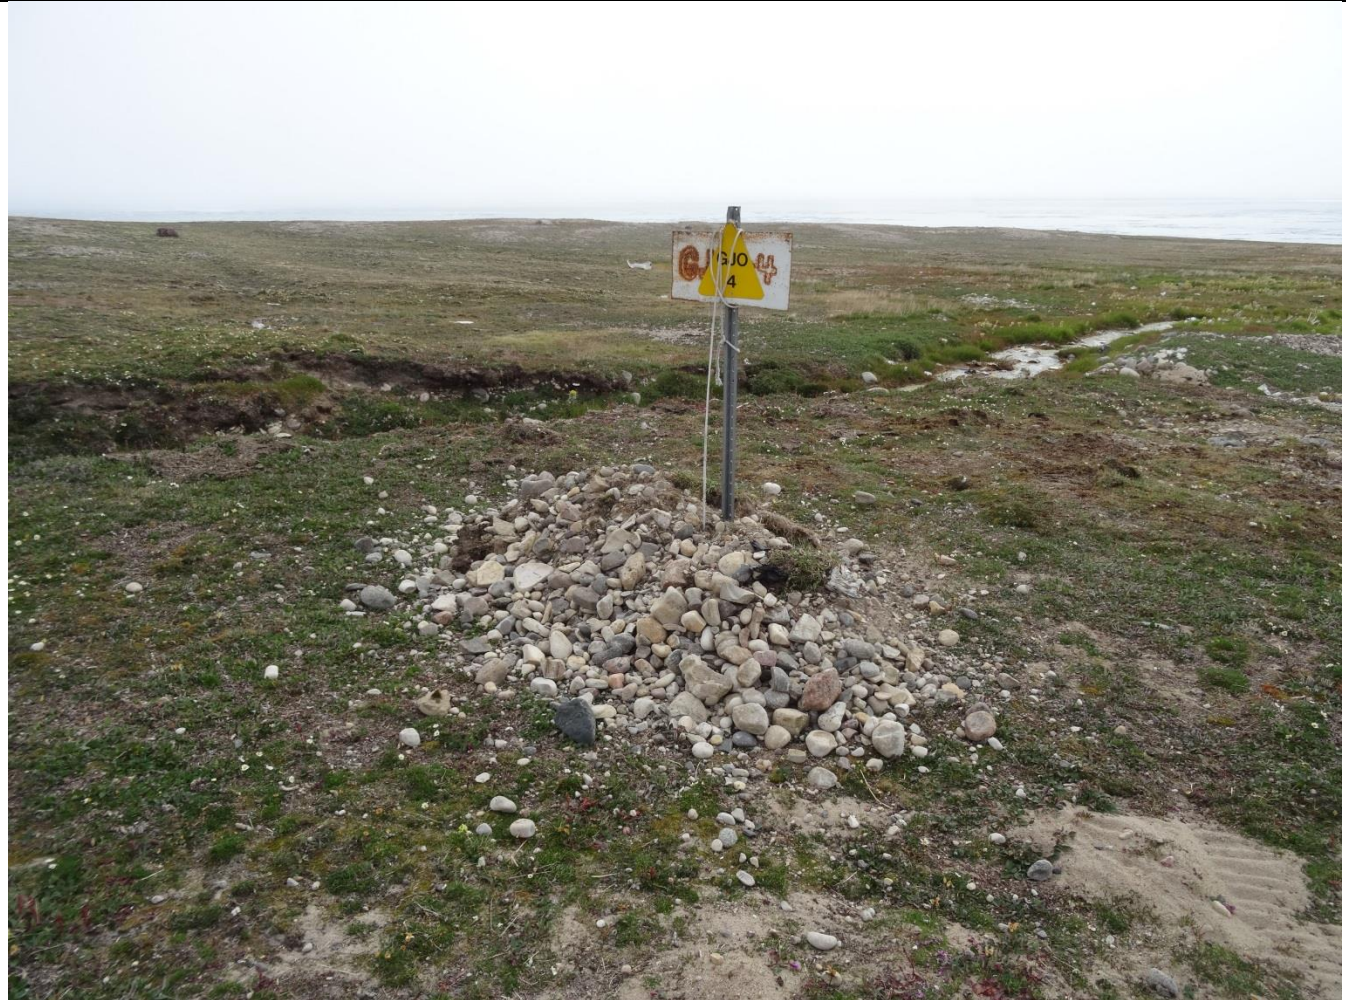
Photo 8

Description: Confirmation of New location of Sample Station GJO-4 to better reflect Final Discharge Criteria - July 27th - Thank You

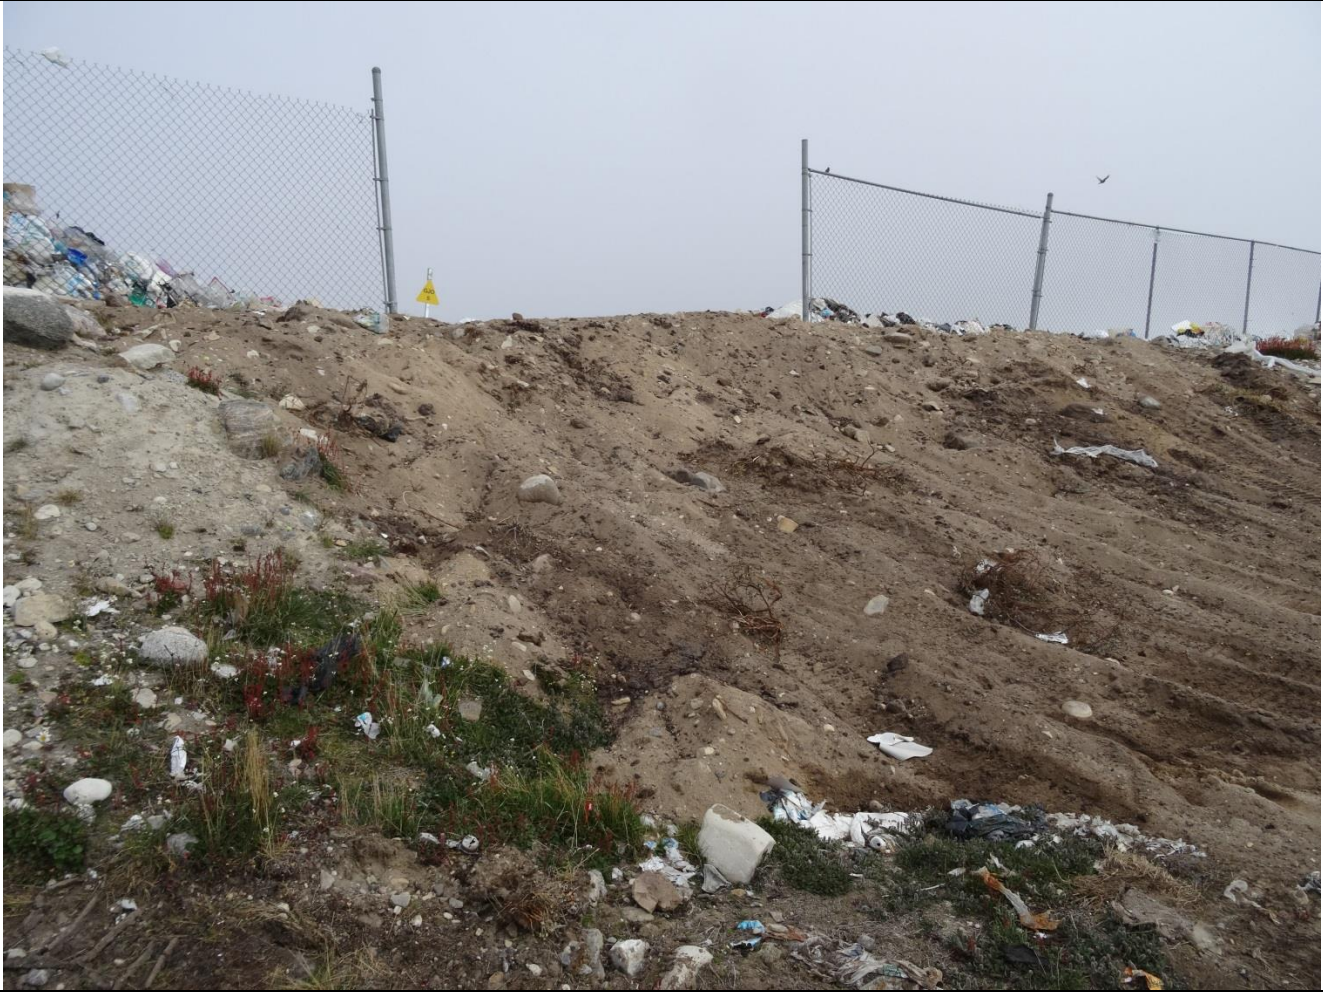
Photo 9

Description: View #1 of Repair to Breach in Dump Berm as Directed – July 27th – Very Nice Job – Thank You

SECTION 1	<input checked="" type="checkbox"/> Comments (s.)	<input type="checkbox"/> Non-Compliance with Act or Licence (s.)	<input type="checkbox"/> Action Required (s.)
<p>On July 13, 2018 I Inspected the Hamlet of Gjoa Haven’s Municipal Water License 3BM-GJO1318. I saw the Sewage Lagoon, the Garbage/Metal Dump and all associated Sampling Stations. I was accompanied by Sabrina Karnouk and Laura Kim from Environment Canada, Shah Alam from GN CGS, as well as Anthony and Dominique from the Hamlet of Gjoa Haven.</p> <p>On July 27, 2018 I did a Follow-up Inspection of the Garbage Dump Berm Repair Work and Relocation of Sample Station GJO-4. I was accompanied by Anthony from the Hamlet of Gjoa Haven for this Inspection.</p>			
SECTION 2	<input checked="" type="checkbox"/> Comments	<input type="checkbox"/> Non-Compliance with Act or Licence	<input type="checkbox"/> Action Required
<p>1. This Water License is Expiring in 2018, the Hamlet submitted the Renewal Application to the NWB last month. 2. The Hamlet has used 24,080 m3 of water in the first 6 Months of this year. 3. The Sewage Lagoon Liner was Torn in 4 places (Photos 1 & 2) at the Truck Dumping Station. 4. The Sewage Lagoon was almost full (Photo 3). 5. There was Debris Floating in one corner (also Photo 3) of the Sewage Lagoon. 6. Current Sample Station GJO-4 (Photo 4) does not reflect the best location to properly show Final Discharge Criteria in the Water License. 7. At the back corner of the Garbage Dump I found a Breach in the Containment Berm (Photos 6 & 7). 8. During my July 27th follow-up Inspection, I saw where the Hamlet relocated Sample Station GJO-4 (Photo 8) as per my previous Instructions. 9. Also during my July 27th follow-up Inspection, I saw the repairs to the Garbage Dump Containment Berm (Photos 9 & 10).</p>

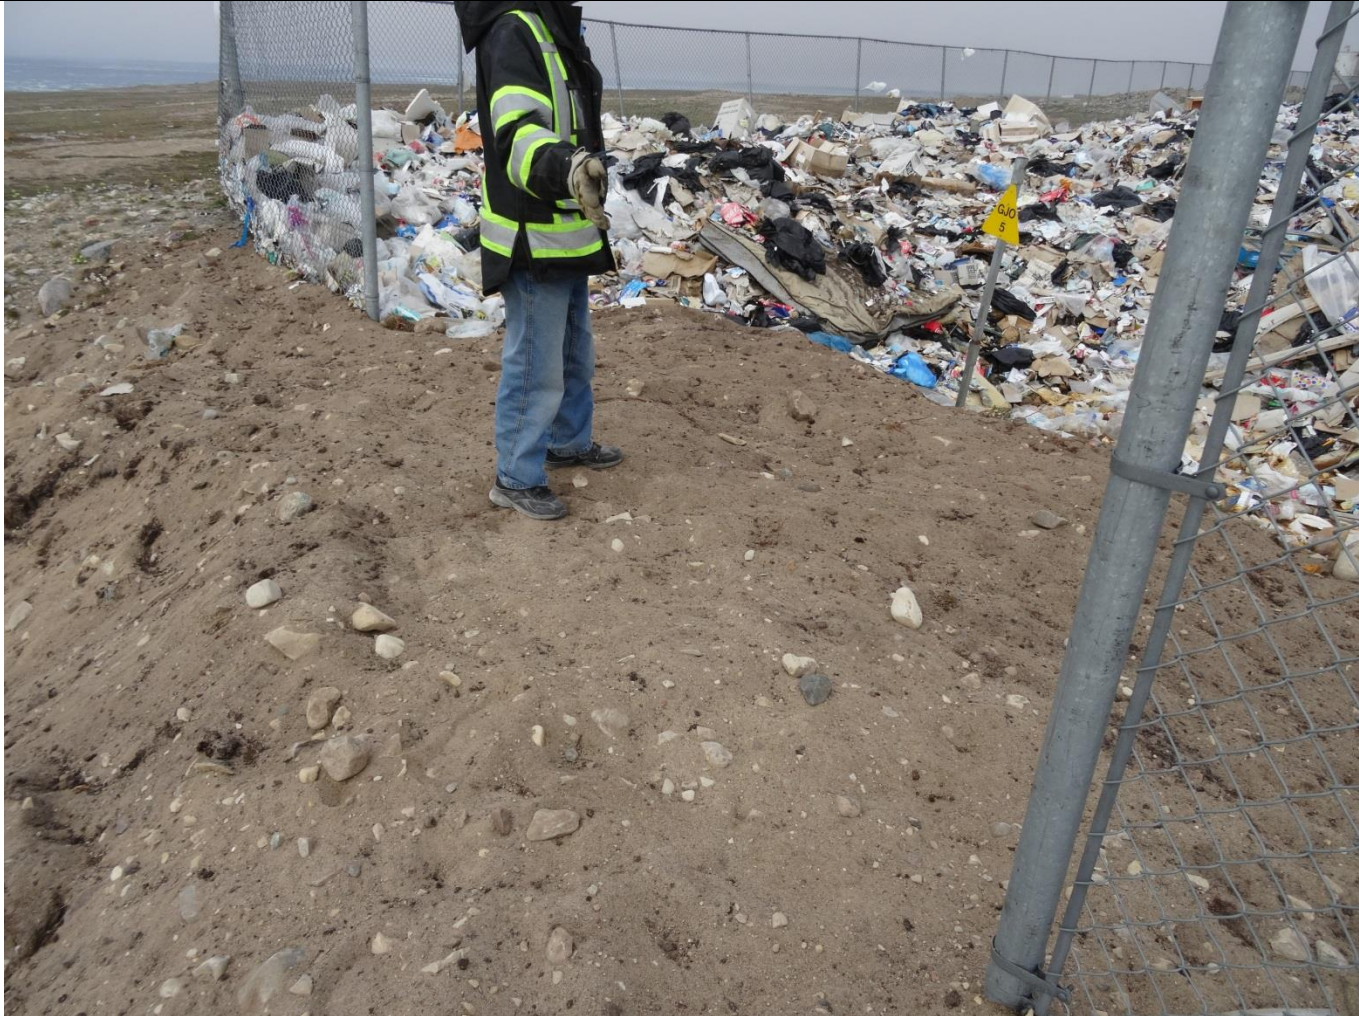
Photo 10

Description: View #2 of Repair to Breach in Dump Berm as Directed – July 27th – Very Nice Job – Thank You
