WATER LICENCE INSPECTION FORM

Licensee		Licensee Representative	
Hamlet of Gjoa Haven		Ed Deveroux	
Licence No. / Expiry		Representative's Title	
3BM-GJO1828		Senior Administrative Officer	
Land / Other Authorizations		Land / Other Authorizations	
Date of Inspection		Inspector	
2019 July 5		Baba Pedersen	
Activities Inspected			
<input type="checkbox"/> Camp	<input type="checkbox"/> Drilling	<input type="checkbox"/> Mining	<input type="checkbox"/> Construction
<input type="checkbox"/> Roads/Hauling	<input type="checkbox"/> Other:	<input checked="" type="checkbox"/> Other: Municipal	<input type="checkbox"/> Reclamation
<input type="checkbox"/> Fuel Storage

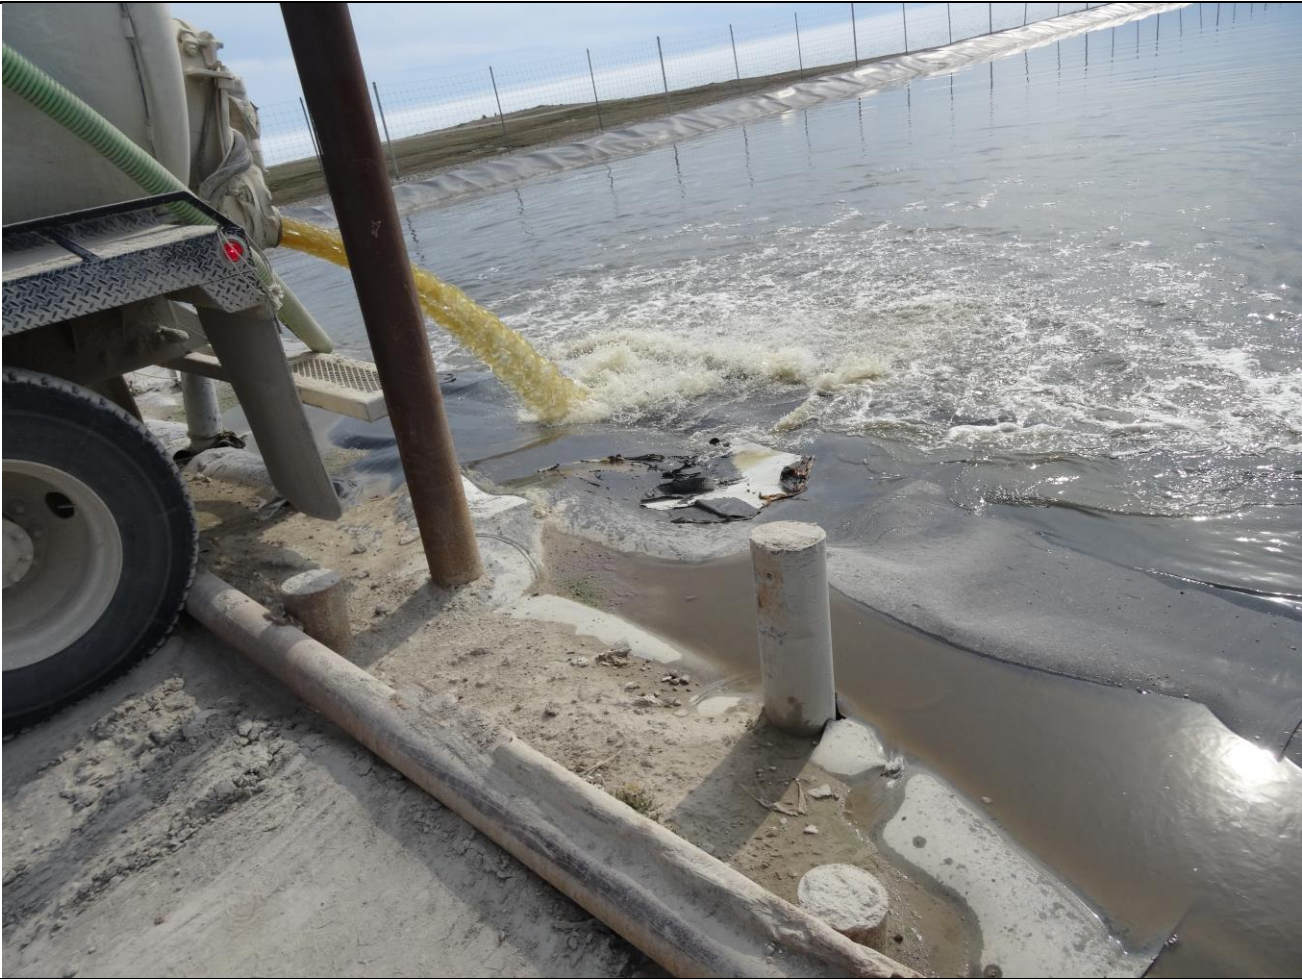
Photo 1

Description: Tear in Lagoon Liner requires Repair after Decant Program is complete

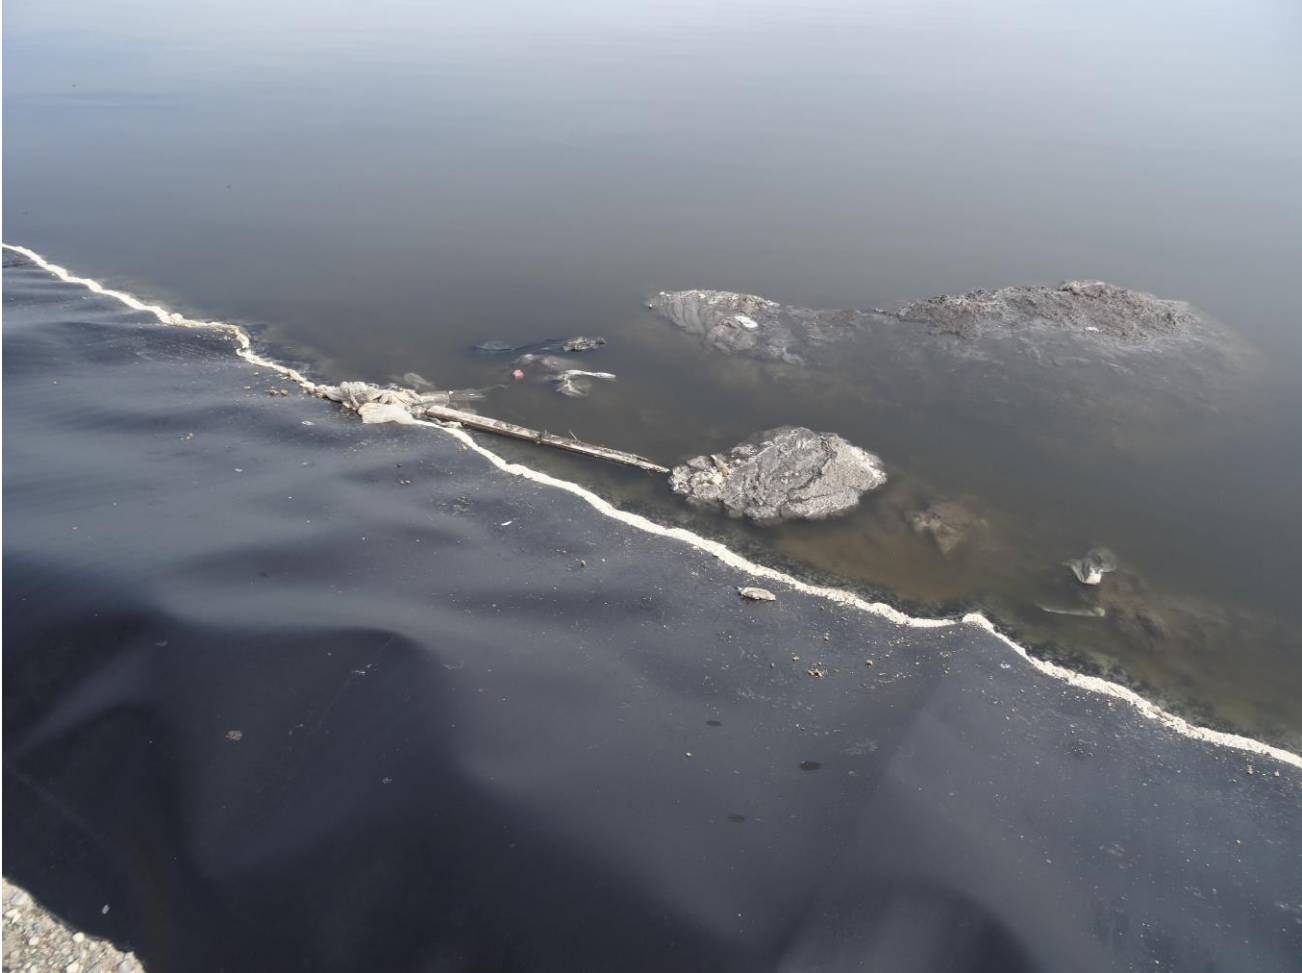
Photo 2

Description: Floating Debris within Sewage Lagoon requires Removal

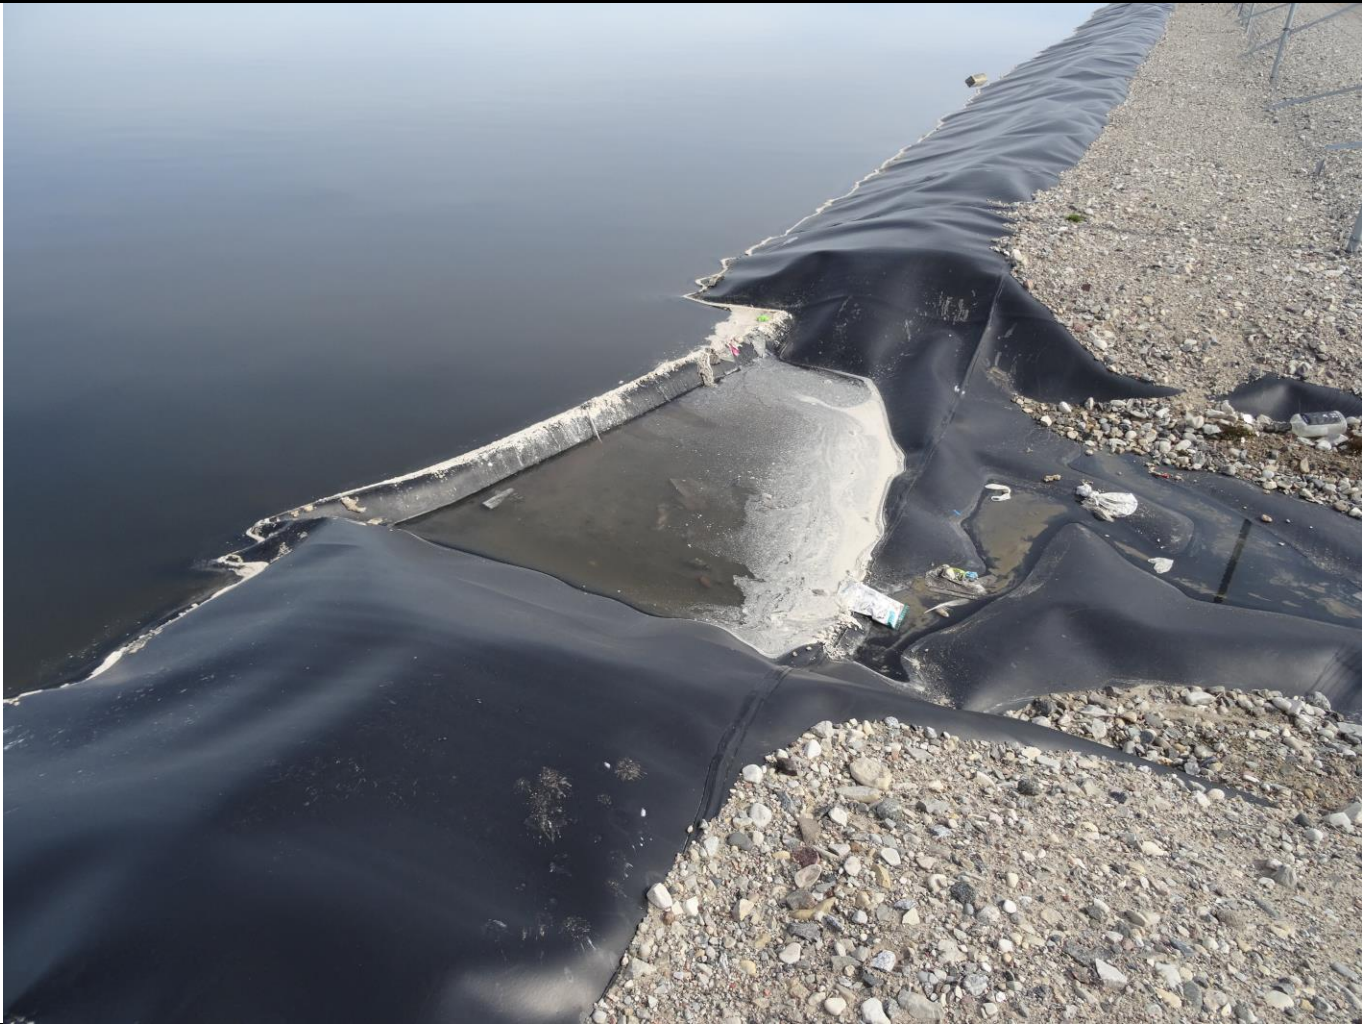
Photo 3

Description: No Freeboard at Emergency Runoff, Lagoon requires Decant

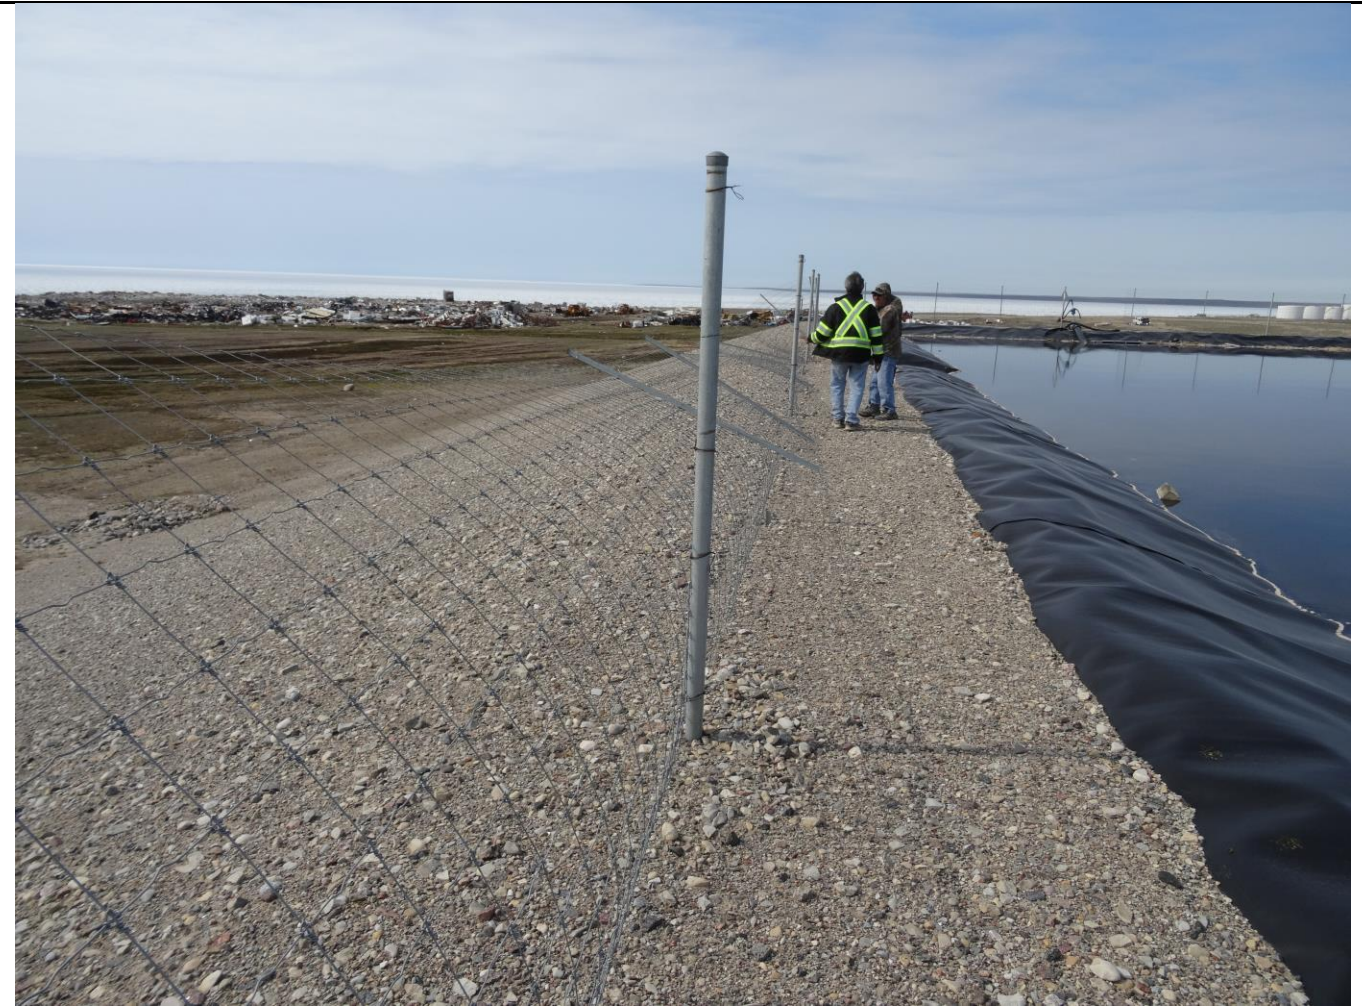
Photo 4

Description: Fencing Requires Repair on both the East and North Sides

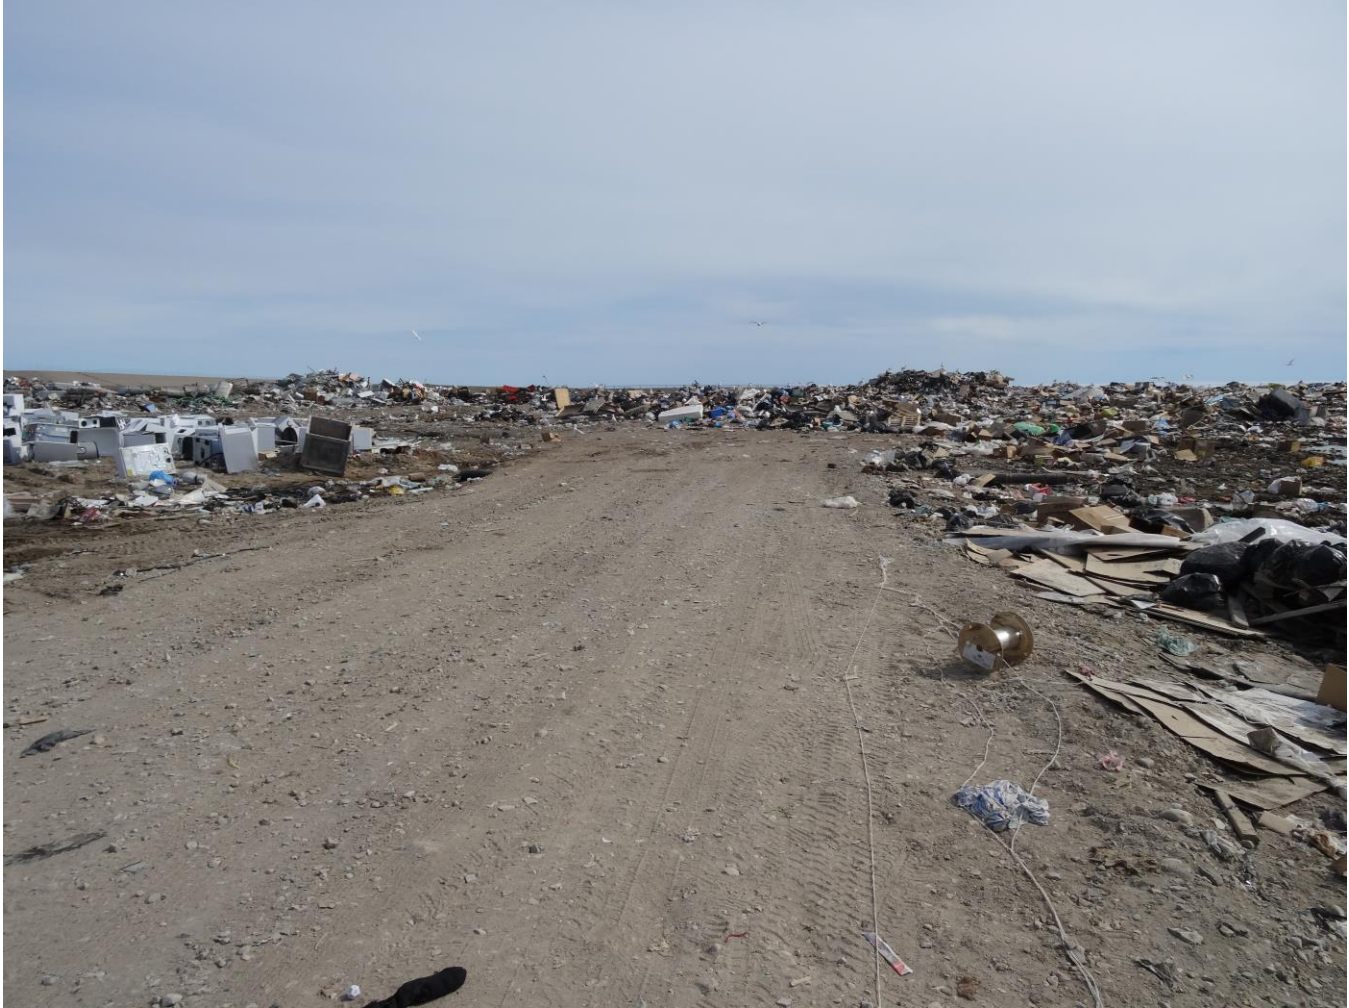
Photo 5

Description: Dump needs better Sorting/Segregation and Routine Controlled Burning

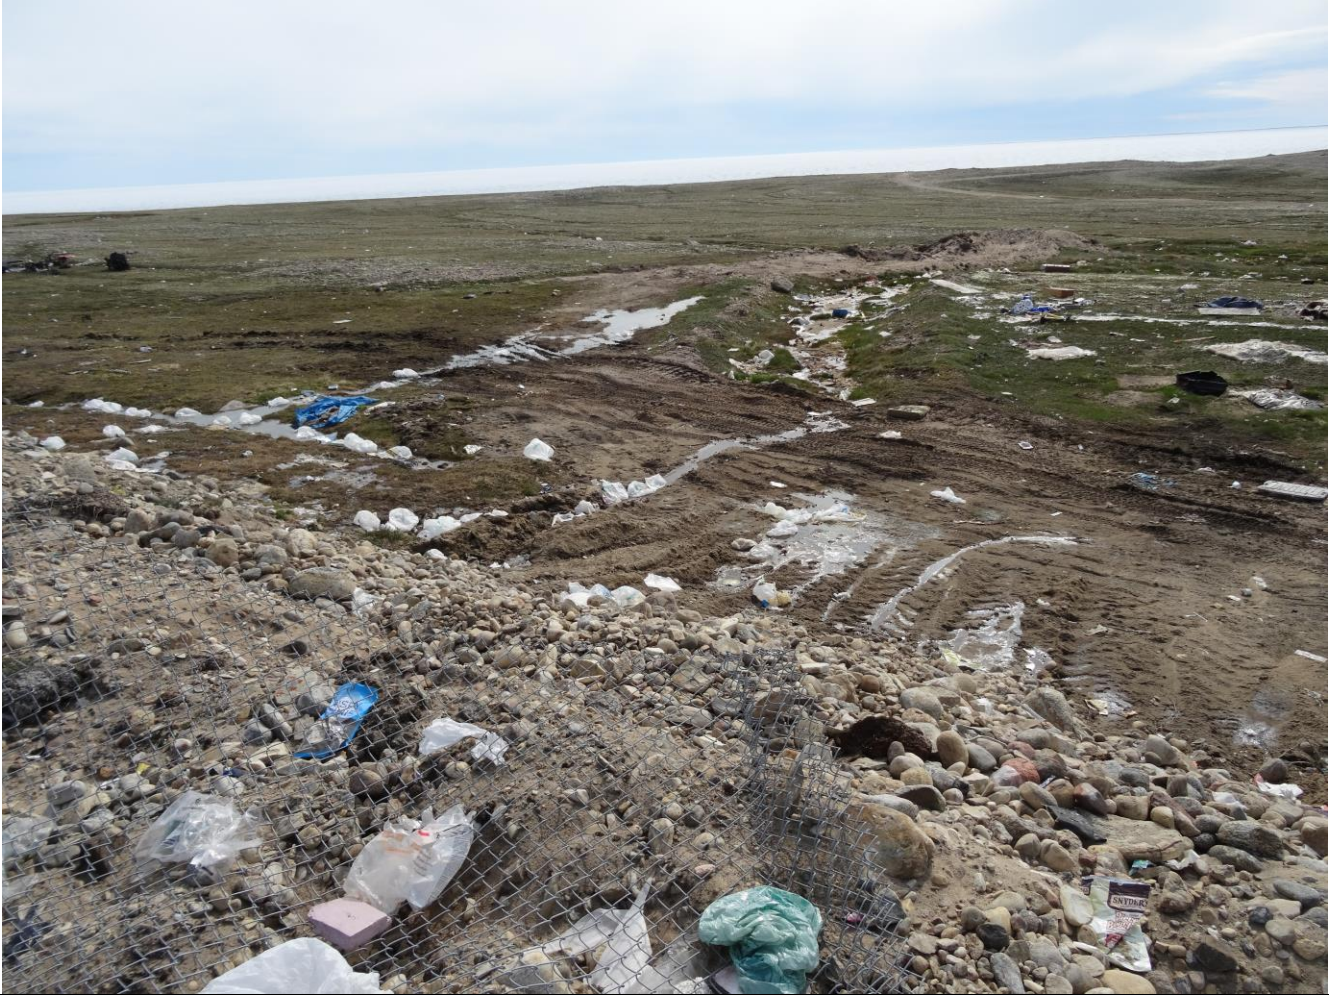
Photo 6

Description: Noticeable Leakage under Garbage Dump Berm

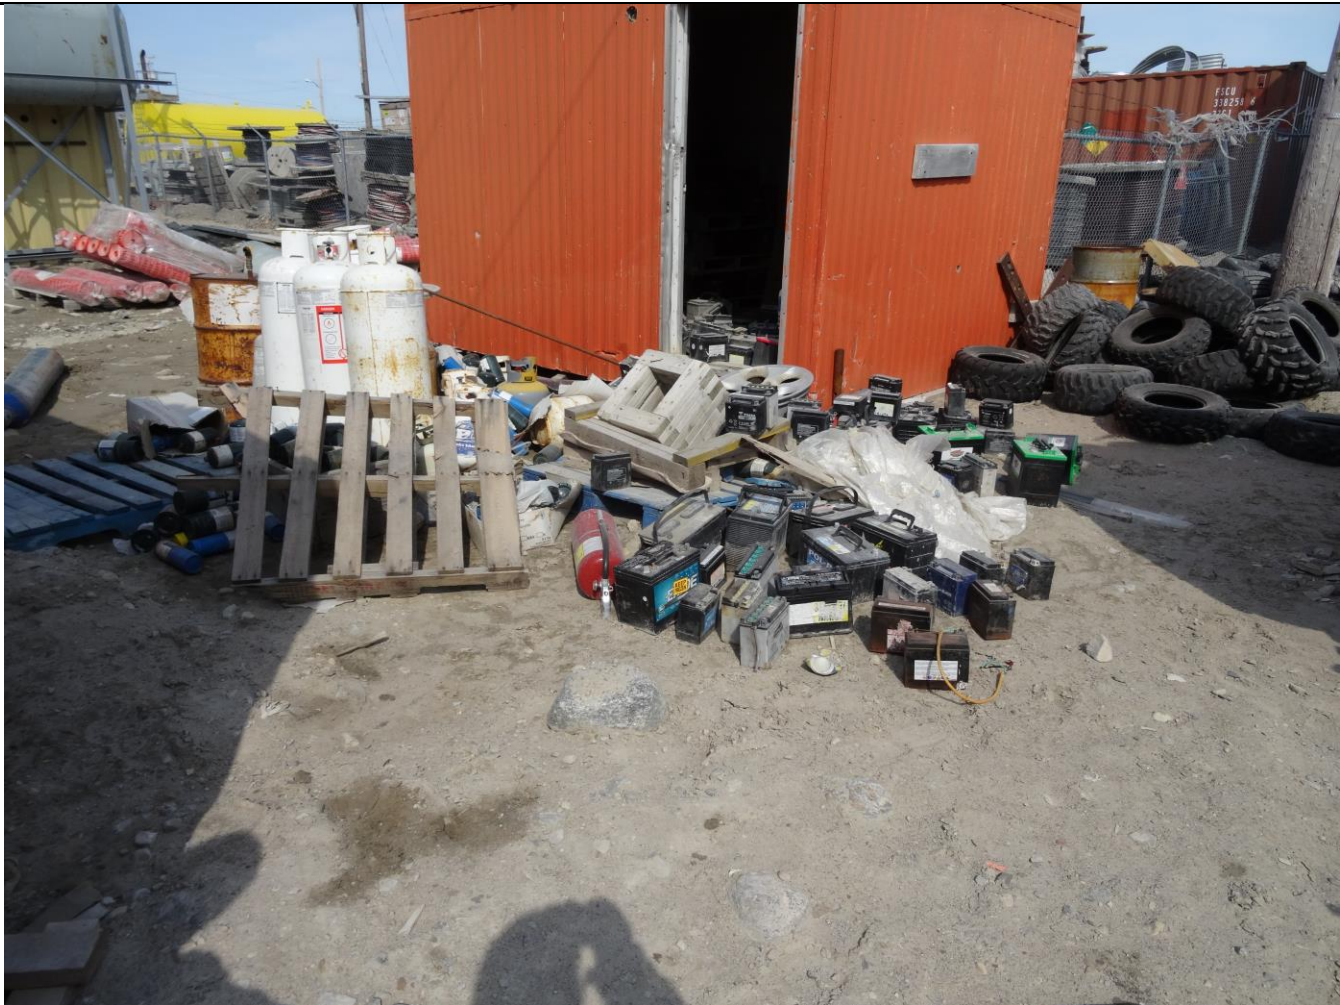
Photo 7

Description: Battery Storage Outside Shed on bear ground with No Secondary Containment

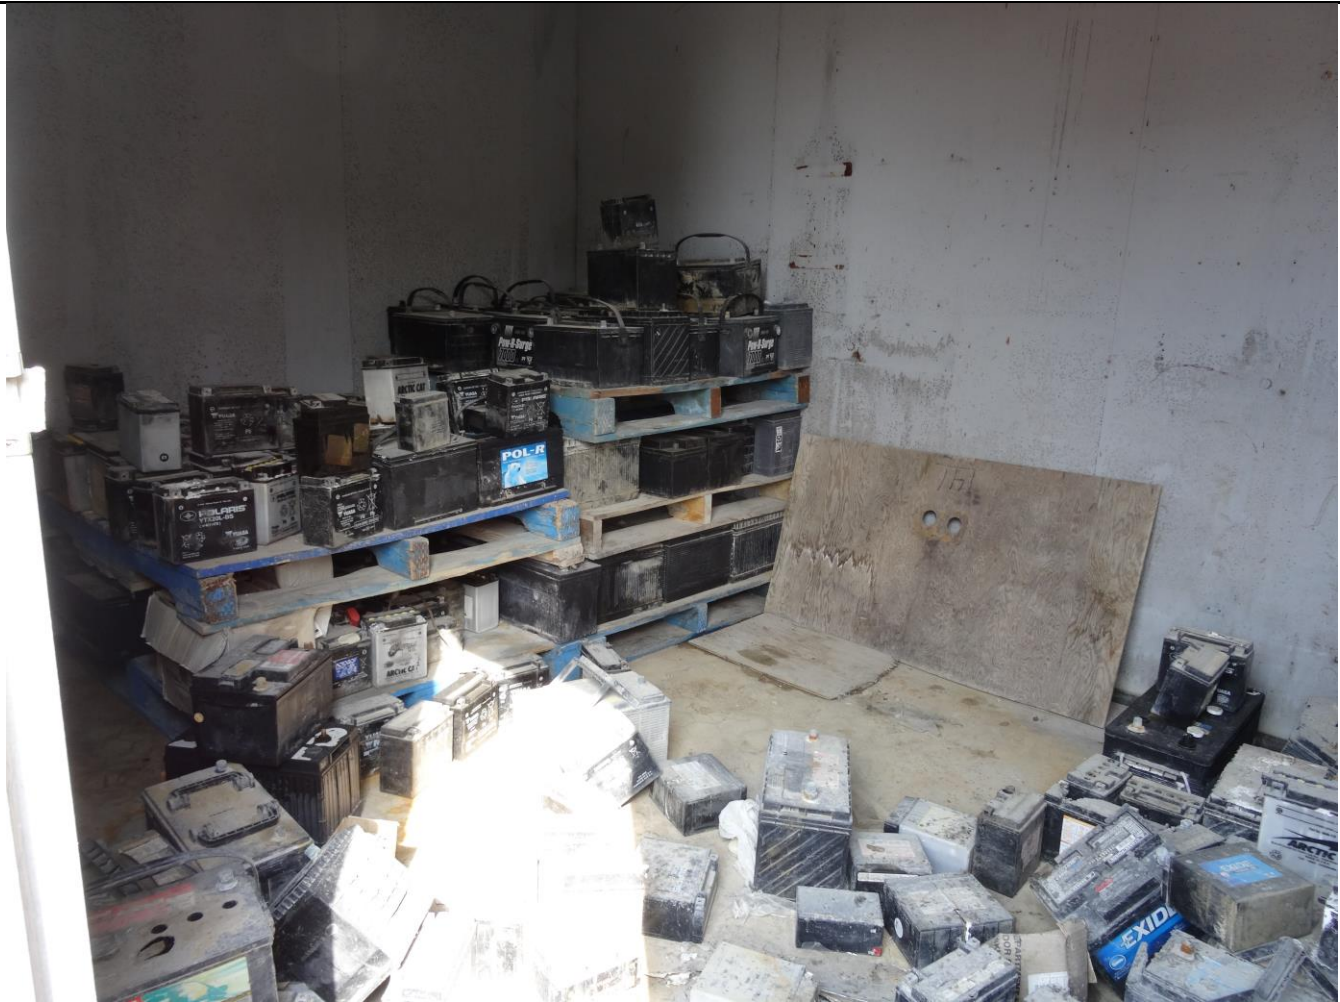
Photo 8

Description: Battery Storage Inside Shed with No Secondary Containment

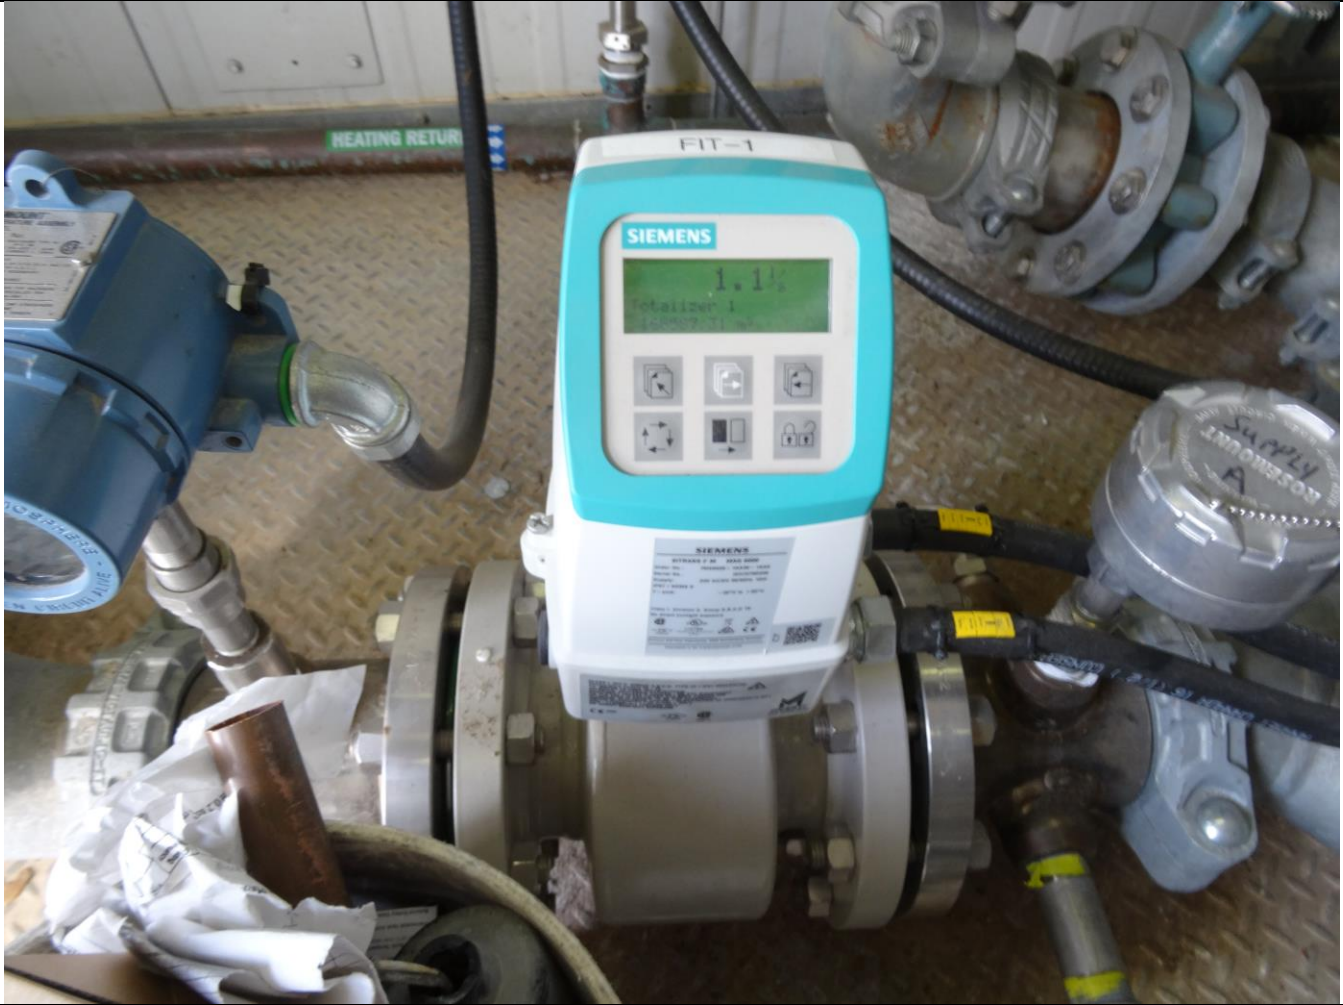
Photo 9

Description: Raw Water Flow Meter inside Swan Lake Pump House – Very Nice

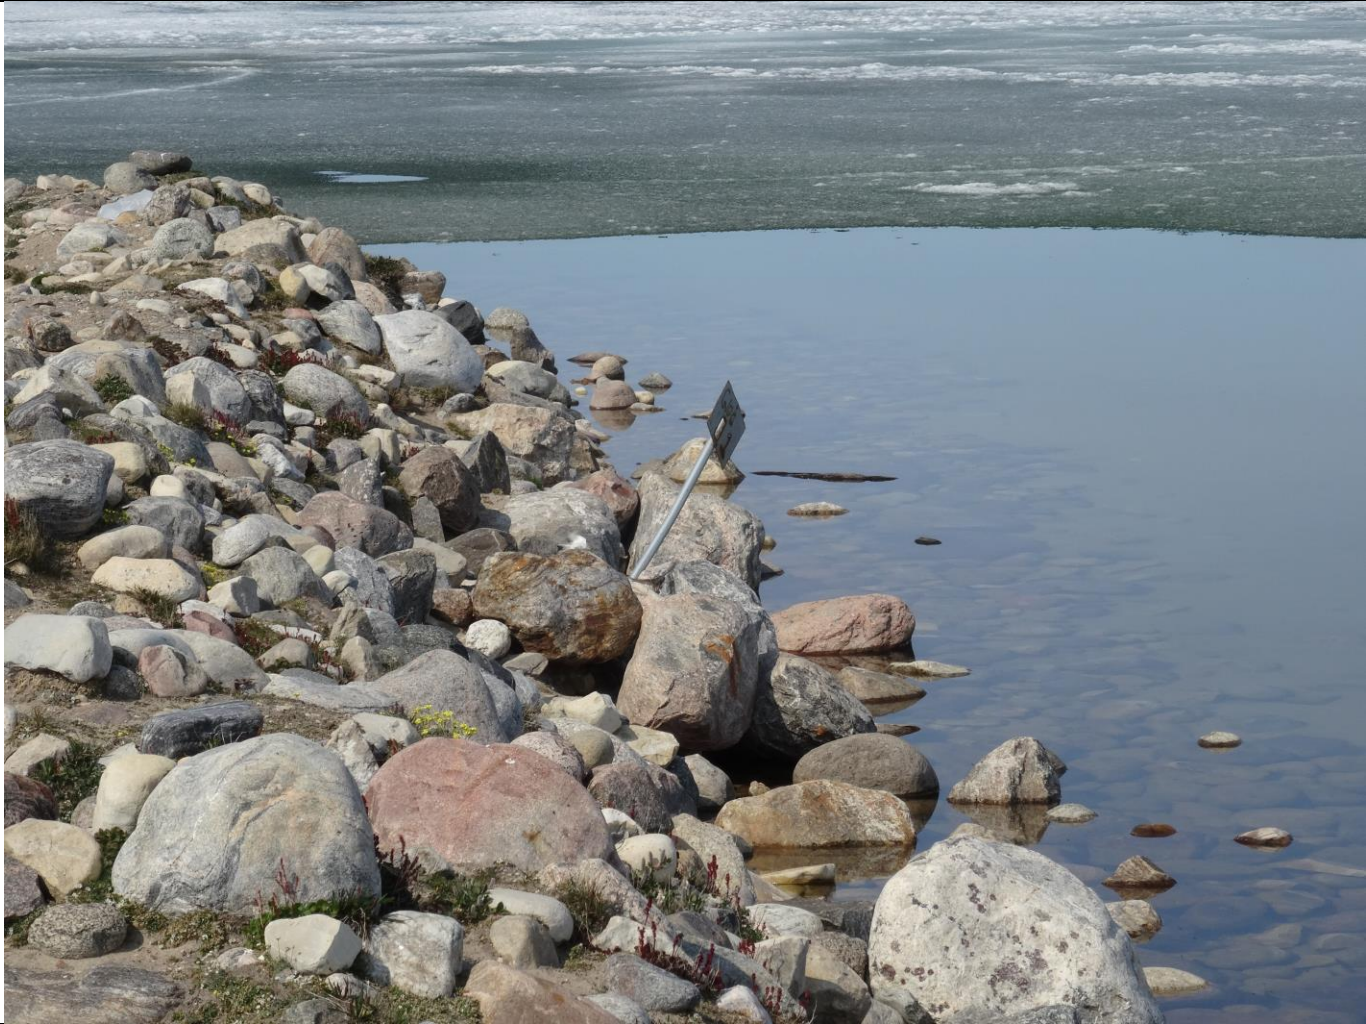
Photo 10

Description: Sample Station GJO-1 Signage requires Repair
