## **Dam Safety Review**

Dam Safety Review  
Sewage Lagoons and Water Reservoir  
Gjoa Haven, Nunavut

OTT-00209248-A0

October 16, 2013

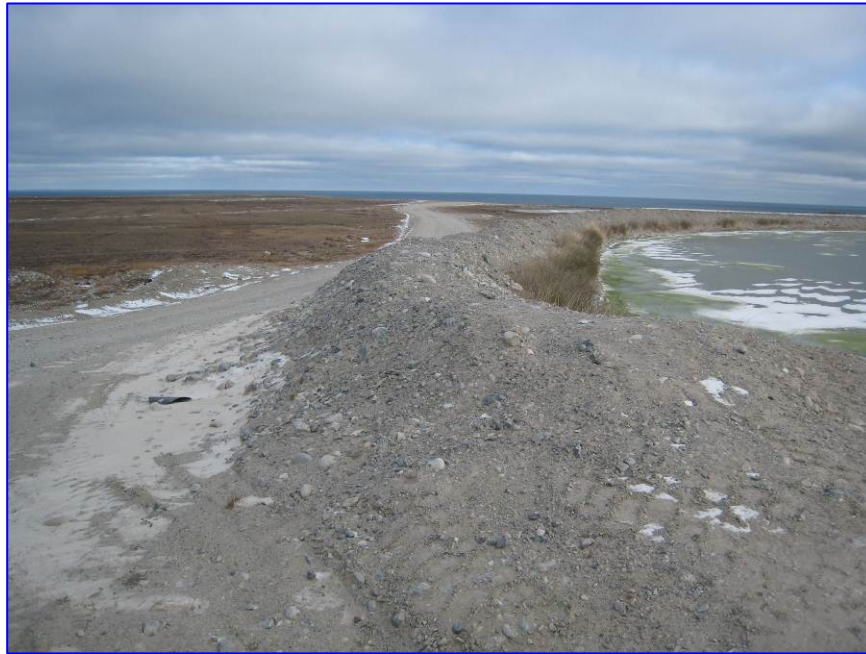
**Photograph No. 5**

There is no walk-way on top of the berm since the crest of the berm is very narrow and undulating due to placement of soil mounds to increase the height of the berm.

View of top of berm looking east from north. Note narrow crest of berm.

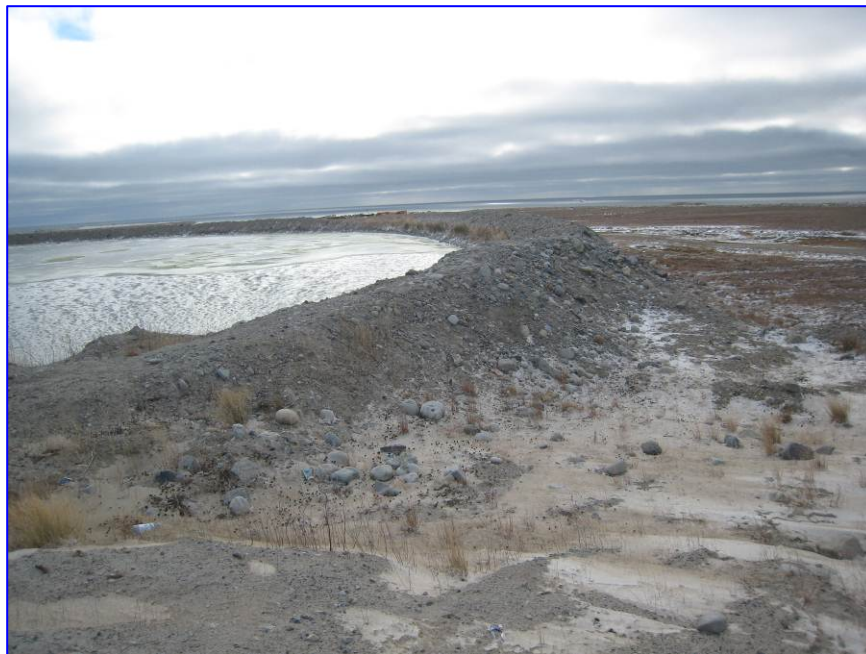
**Photograph No. 6**

- 1.) The lagoon slopes are much steeper than the conventional design requirements, which generally vary from 2H:1V to 3H:1V.
- 2.) The upper approximately 1 m to 1.5 m of the berm comprises of dumped sand and gravel material, which was neither levelled nor compacted. As a result, this material is loose and is also expected to be more susceptible to erosion and slope failure.
- 3.) The material used in construction of the berm is very coarse and as a result is expected to be very permeable.
- 4.) The lagoon has been leaking at the two locations for a number of years. Hence, the berm is being subjected to seepage forces. The slopes of the berm are considered to be too steep for this condition.

View of top of berm looking west from north. Note steep slopes of berm.

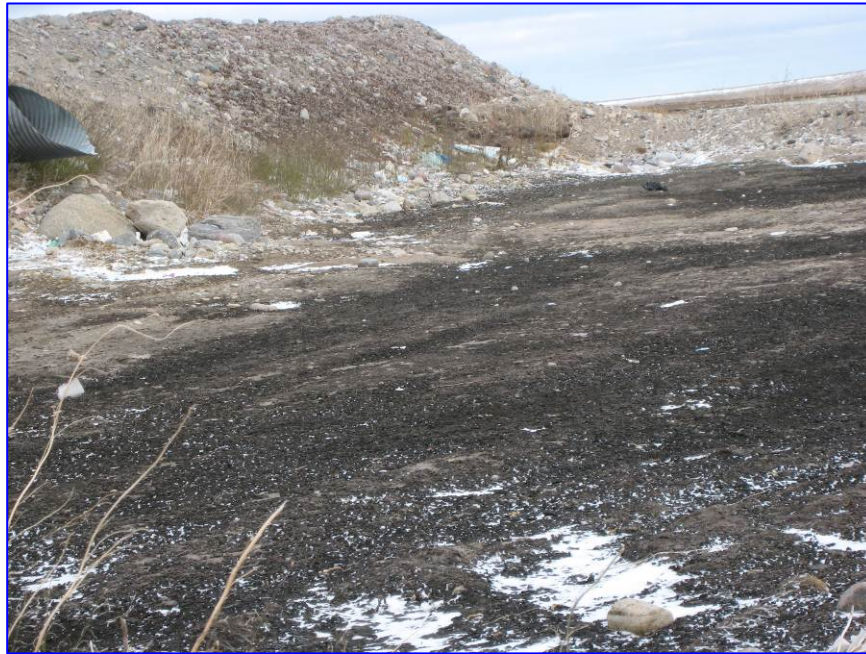
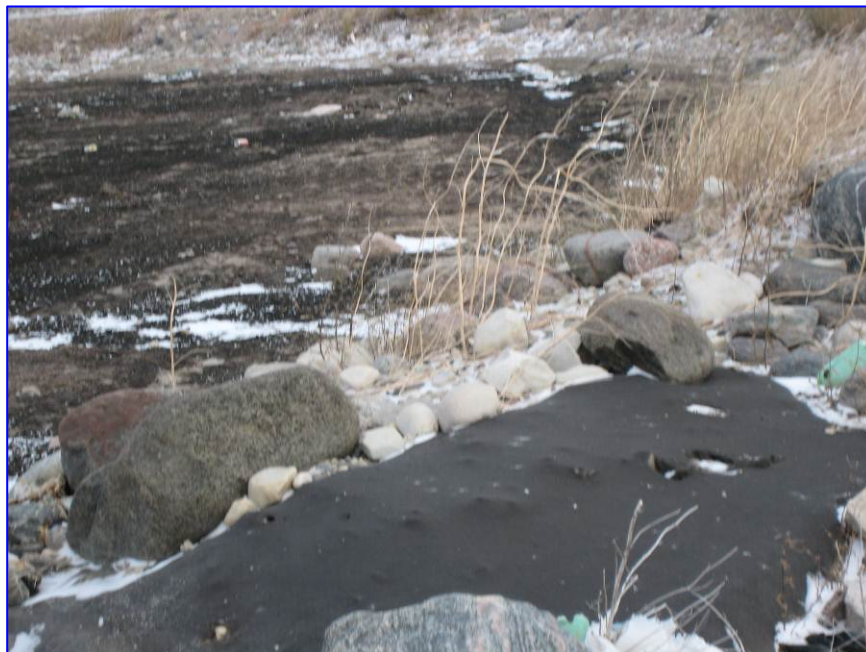
The overflow pipe is located on the south side of the lagoon (Photo 8). The overflow pipe discharges into a secondary lagoon located on the south side of the main lagoon (Photos 9 and 10). The berms of the secondary lagoon are 1.0 m to 1.5 m in height.

**Photograph No. 9**  
Partial view of secondary lagoon.

**Photograph No. 10**  
Another view of secondary lagoon.
