WATER LICENCE INSPECTION FORM

Licensee		Licensee Representative	
Senior Administrative Officer Hamlet of Grise Fiord, Baffin Region,		David Watsko- Hamlet foreman Bhbesh Roy – Regional Engineer – GN	
Licence No. / Expiry		Representative's Title	
3BM-GRI Exp. Jan 29, 2011		Hamlet Foreman	
Land / Other Authorizations		Land / Other Authorizations	
Date of Inspection		Inspector	
July 6,2016		A.Keim	
Activities Inspected			
<input type="checkbox"/> Camp	<input type="checkbox"/> Drilling	<input type="checkbox"/> Mining	<input type="checkbox"/> Construction
<input type="checkbox"/> Roads/Hauling	<input type="checkbox"/> Other: Water Discharge	<input checked="" type="checkbox"/> Other: Municipal	<input type="checkbox"/> Reclamation
<input type="checkbox"/> Fuel Storage

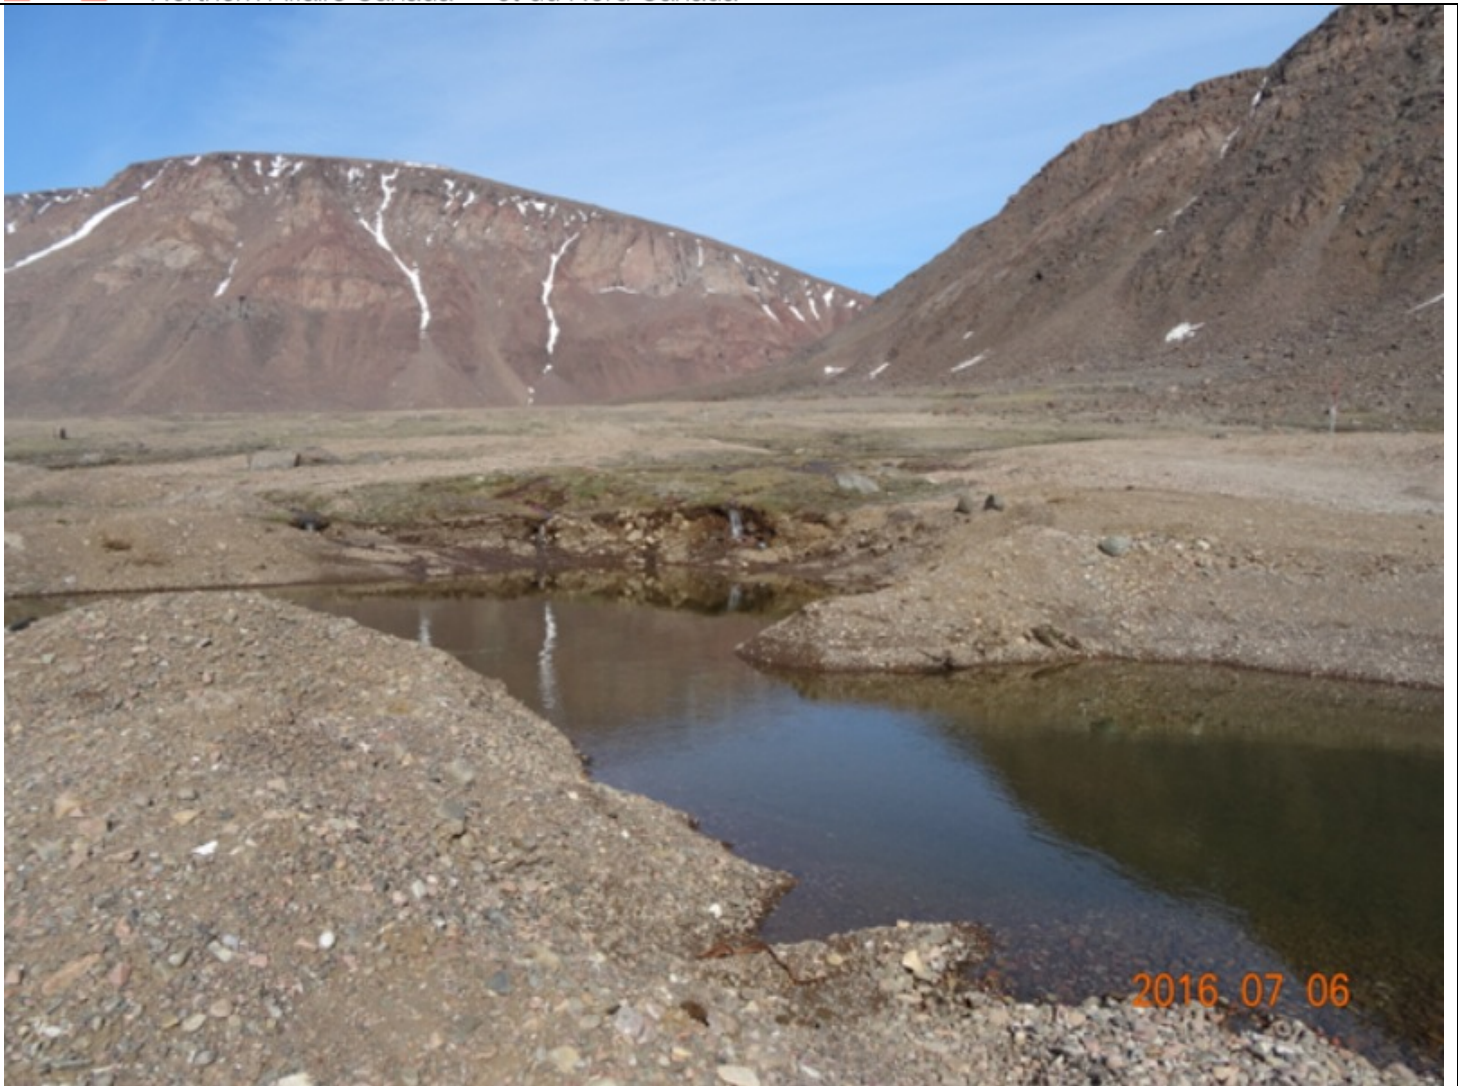
Figure 1 Raw water intake. Pond has been expanded to create a new cell

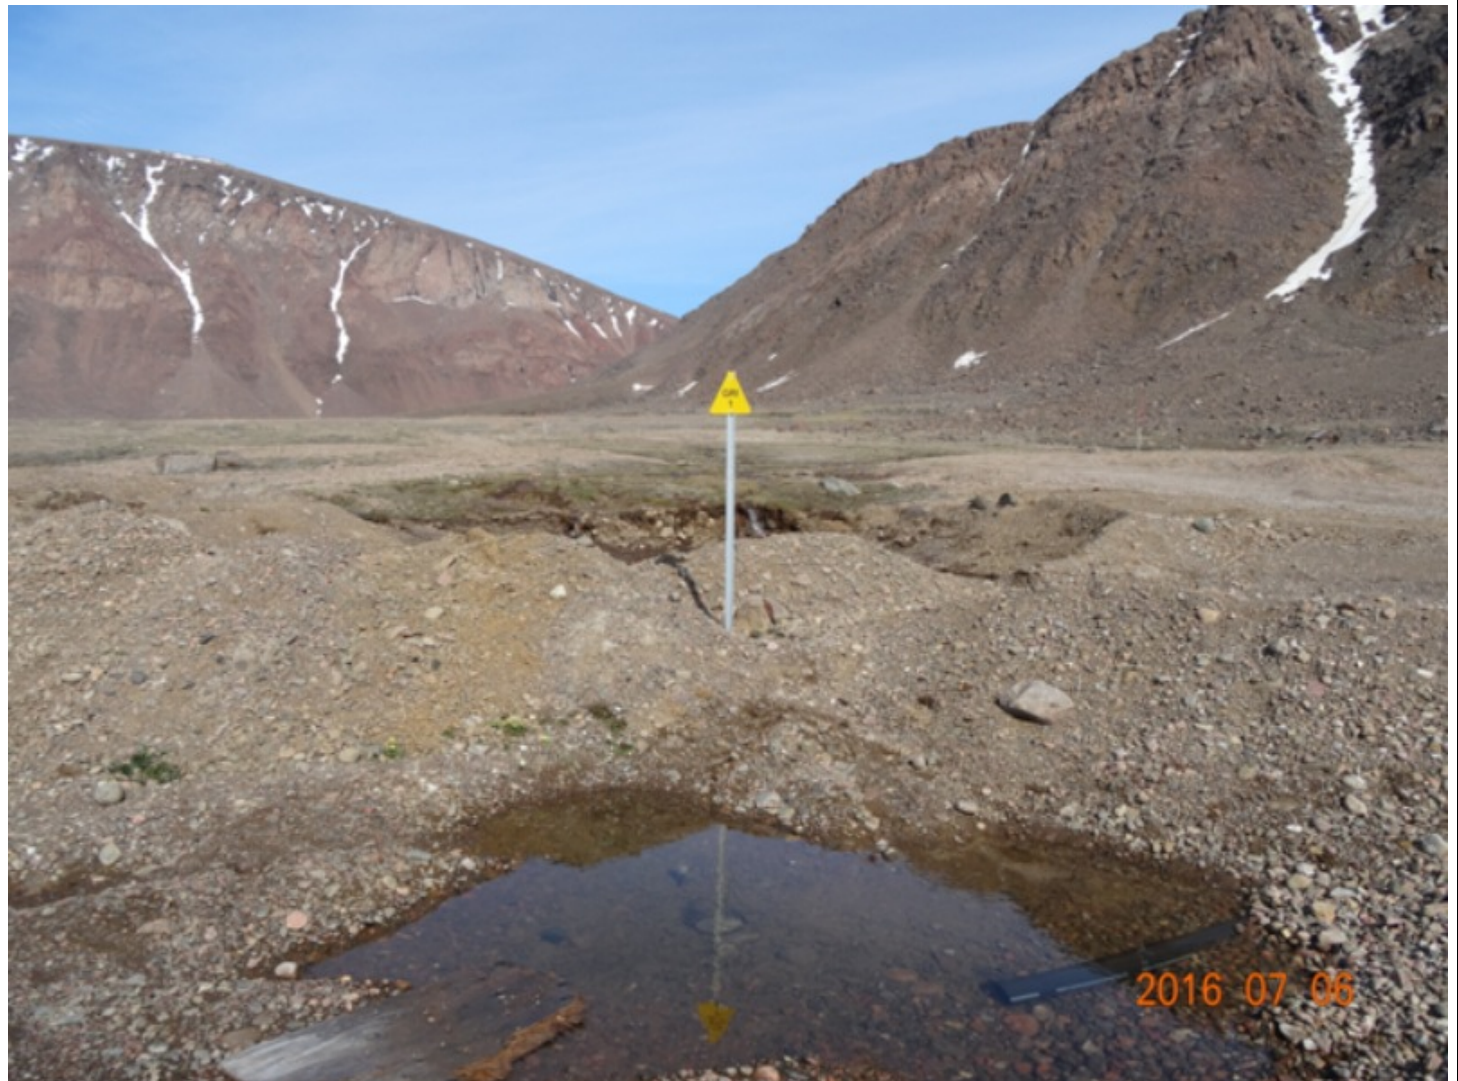
Figure 2 signage at Raw water intake

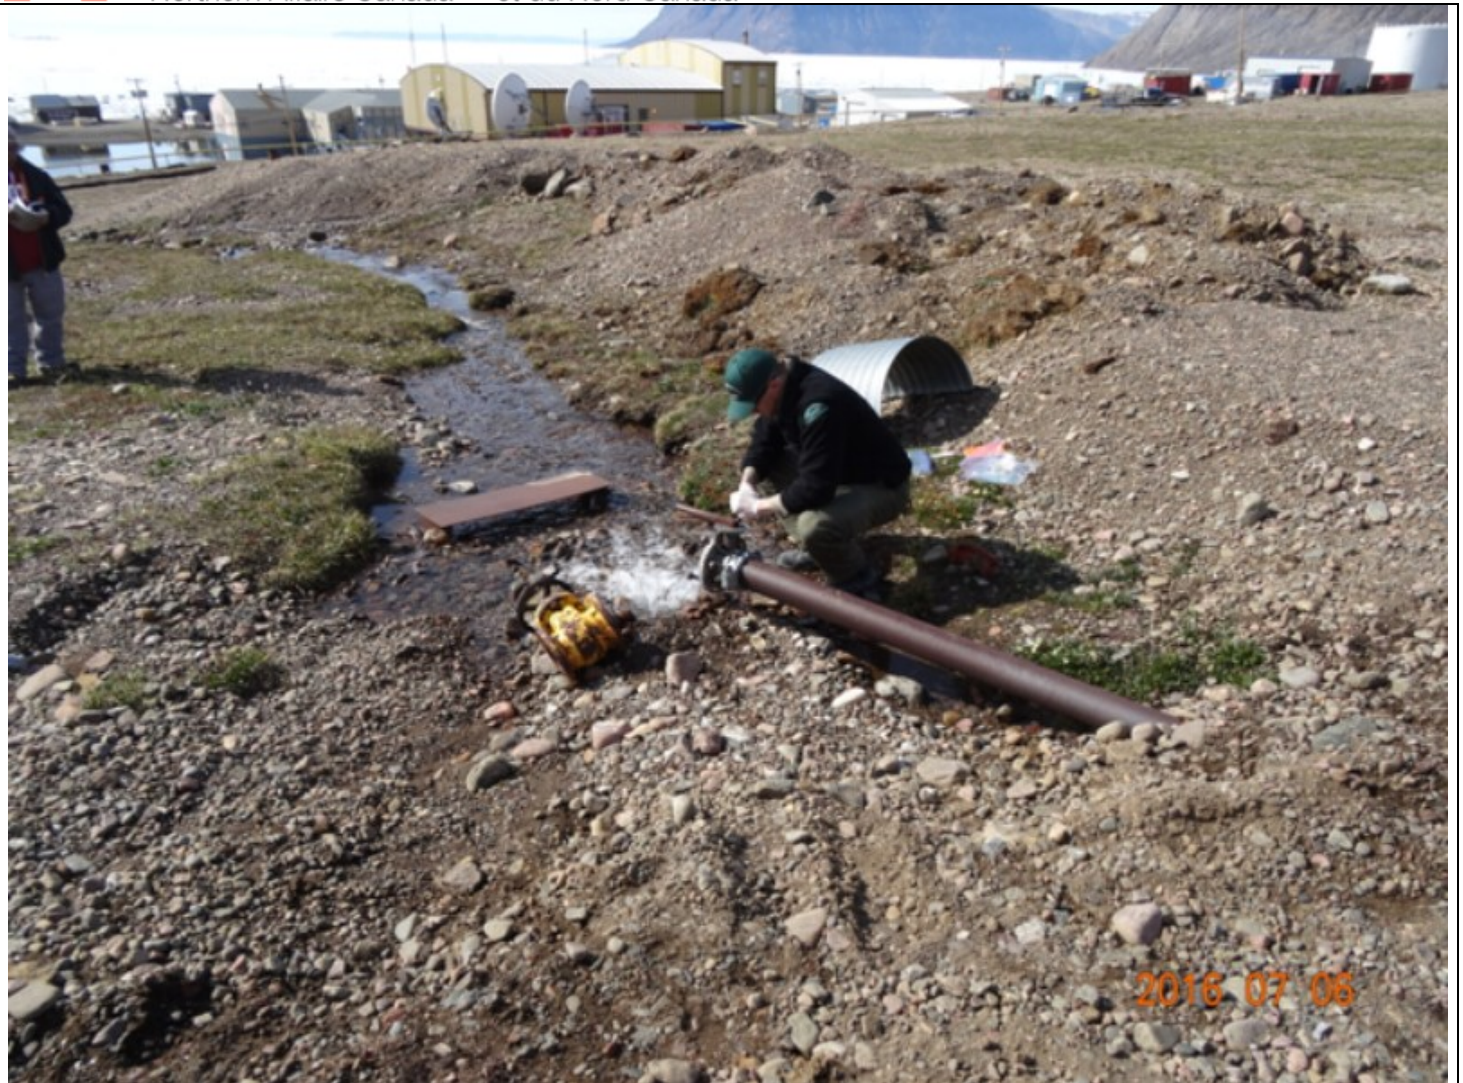
Figure 3 Pipe to fill tanks. tanks just recently filled so pipe is disconnected . Samples collected

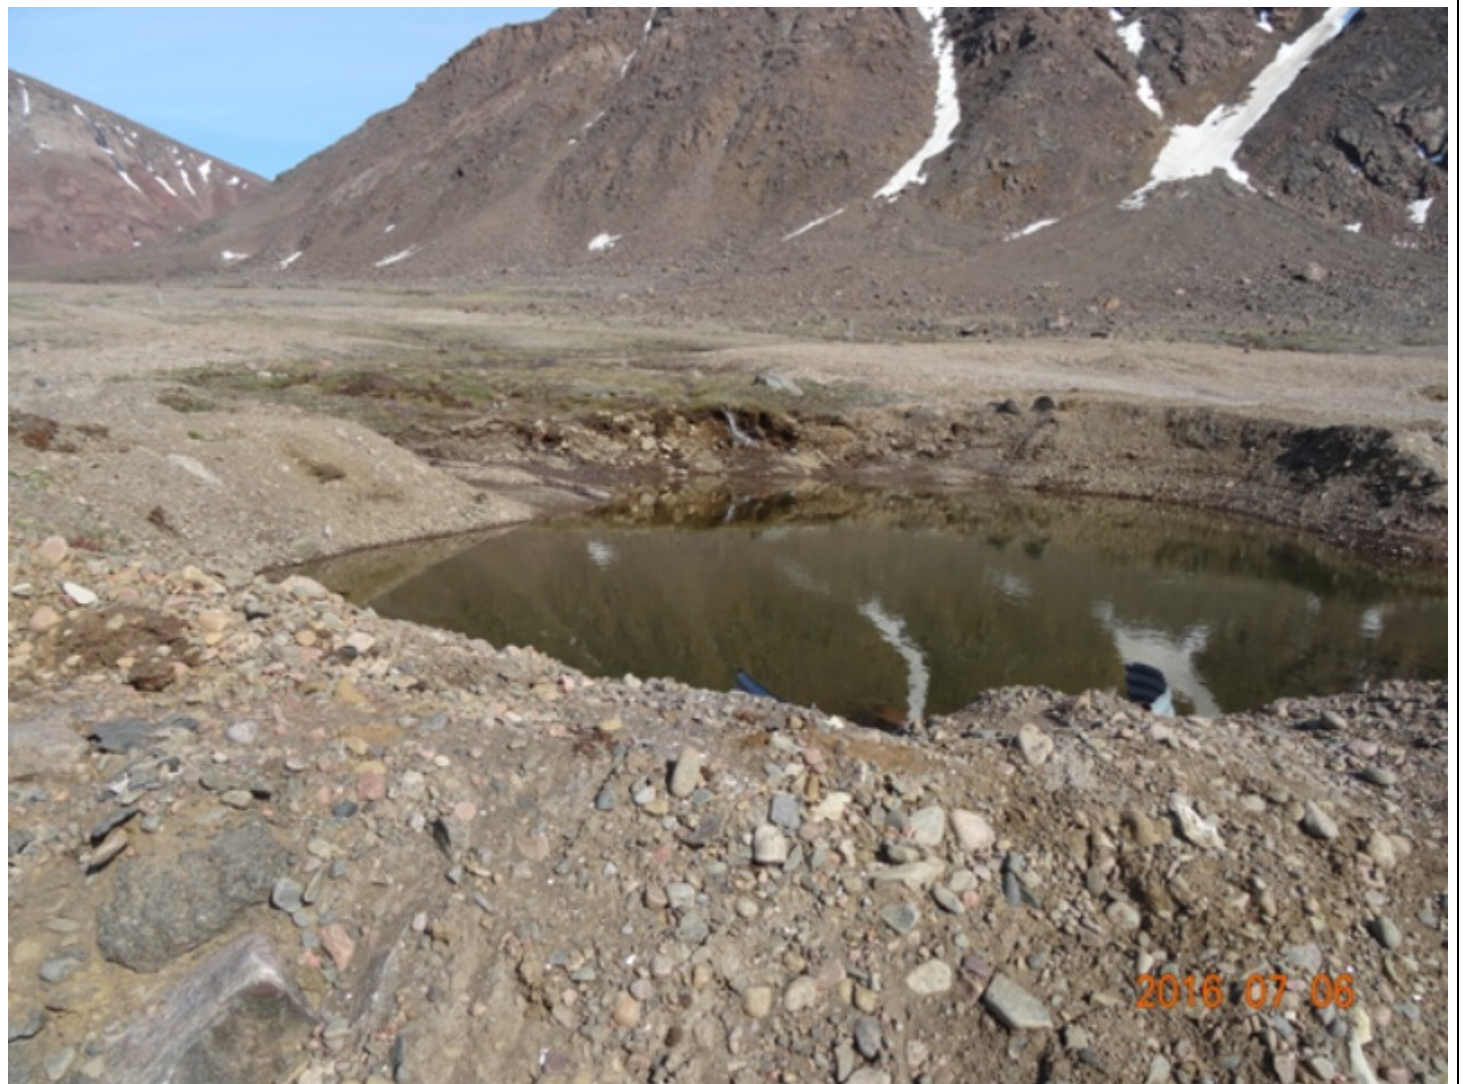
Figure 4 Original cell at intake location. expansion to left

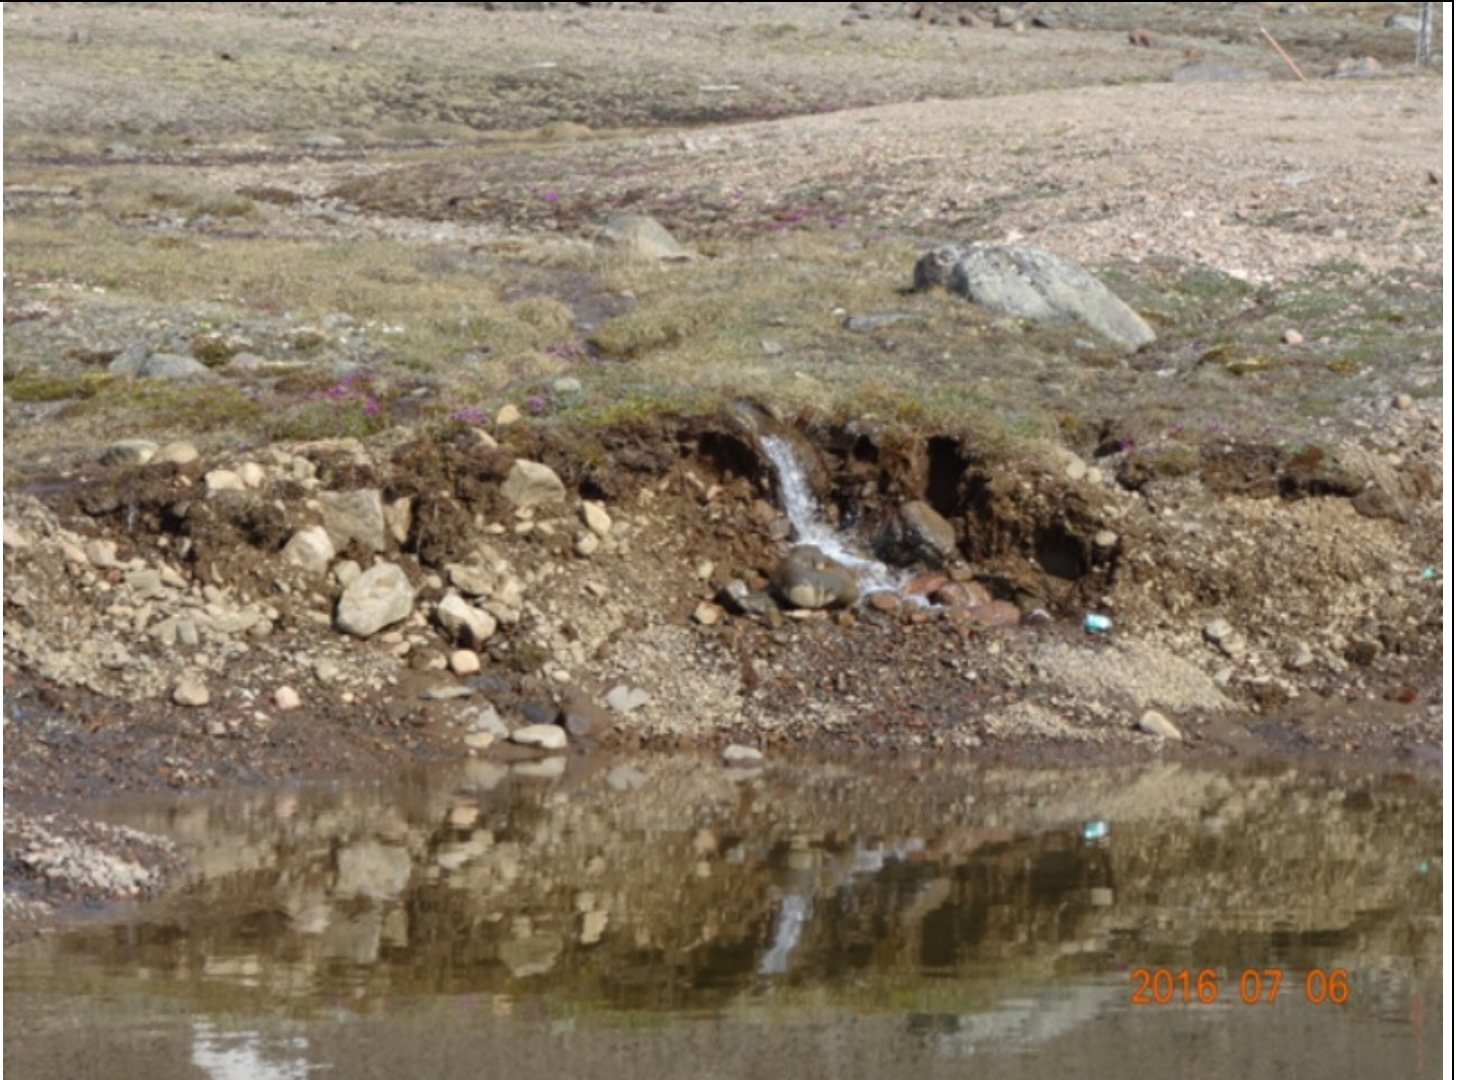
Figure 5 cell is filled via three small streams from glacial melt

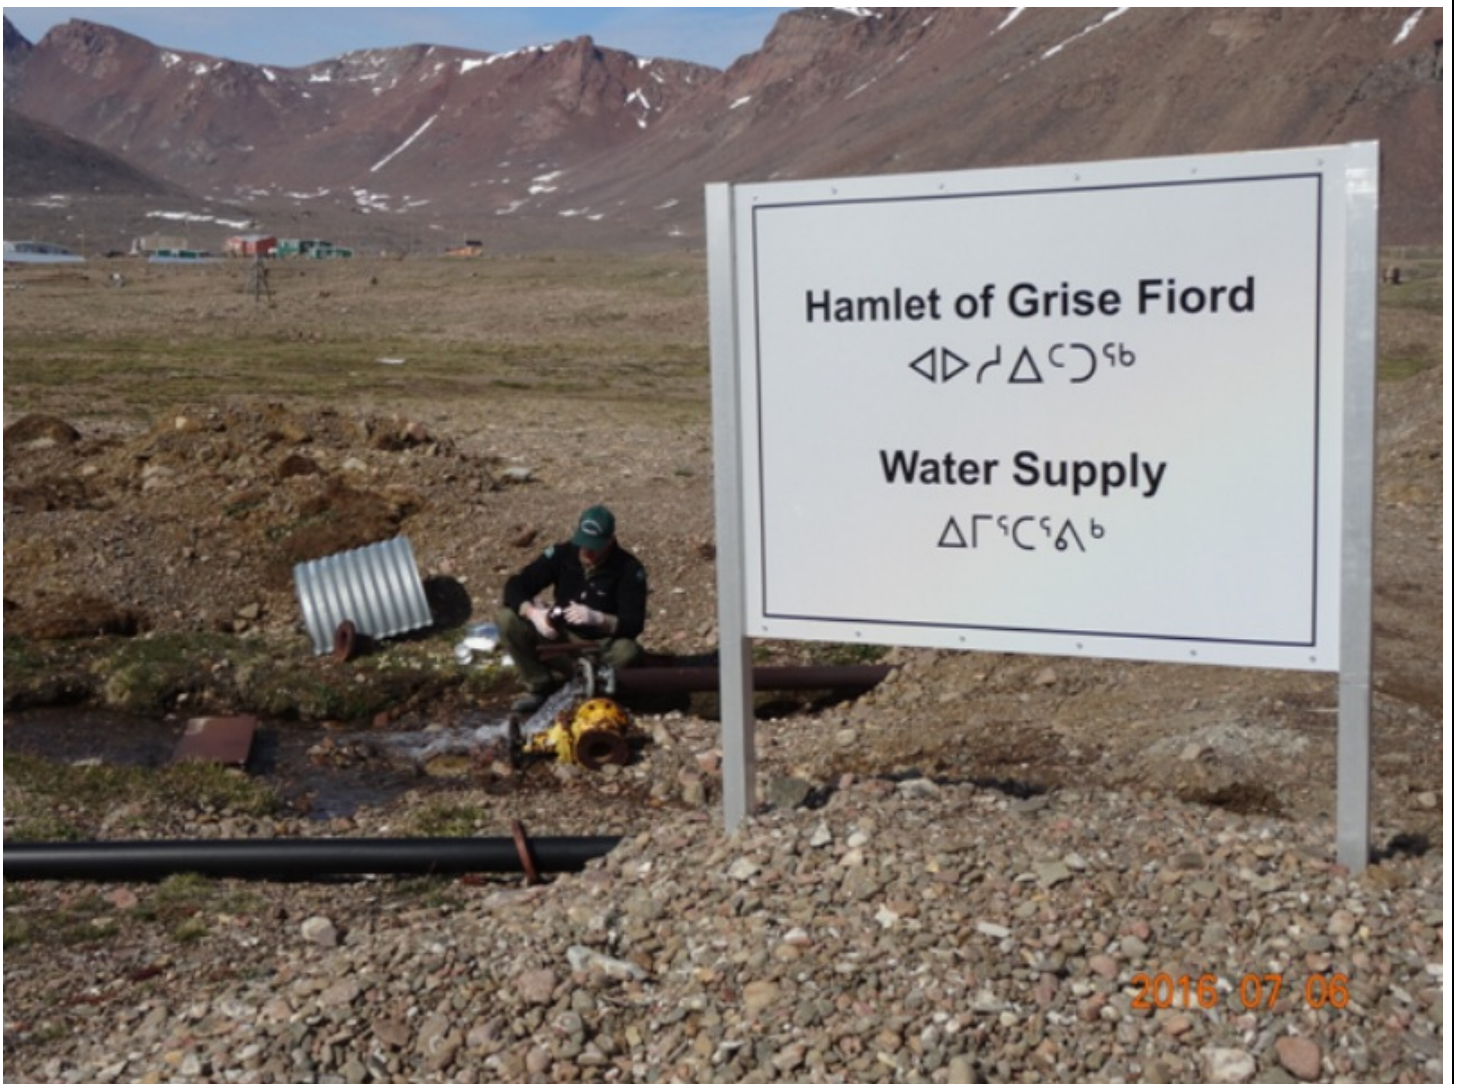
Figure 6 Signage

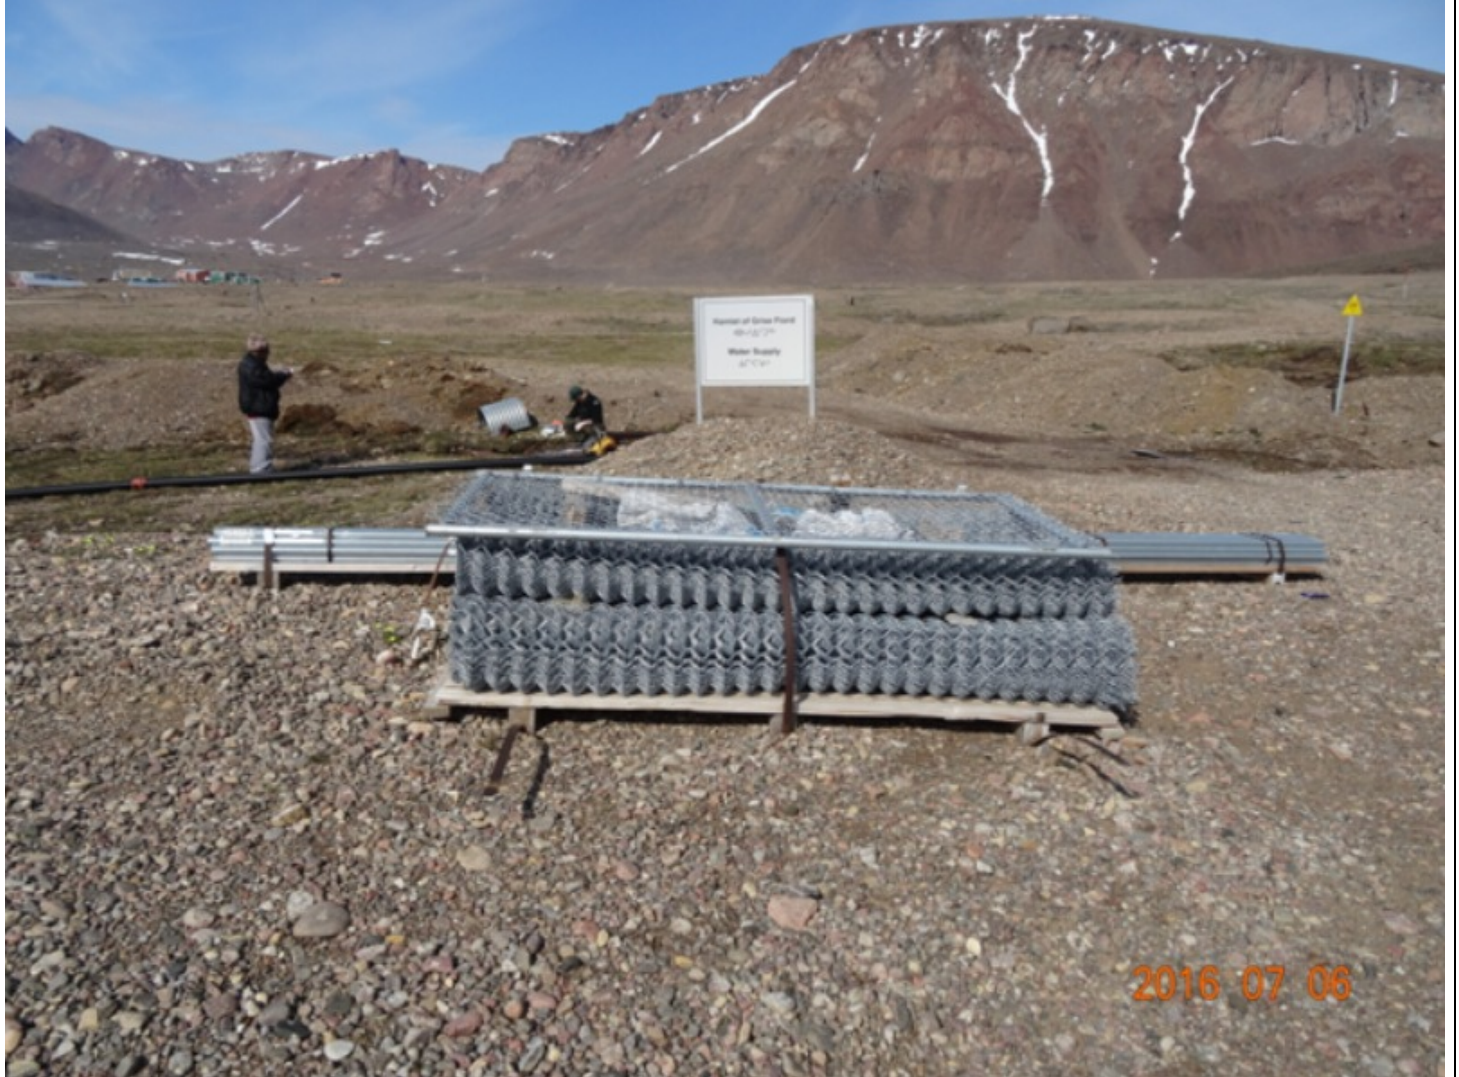
Figure 7 Fencing for cell remains unerected

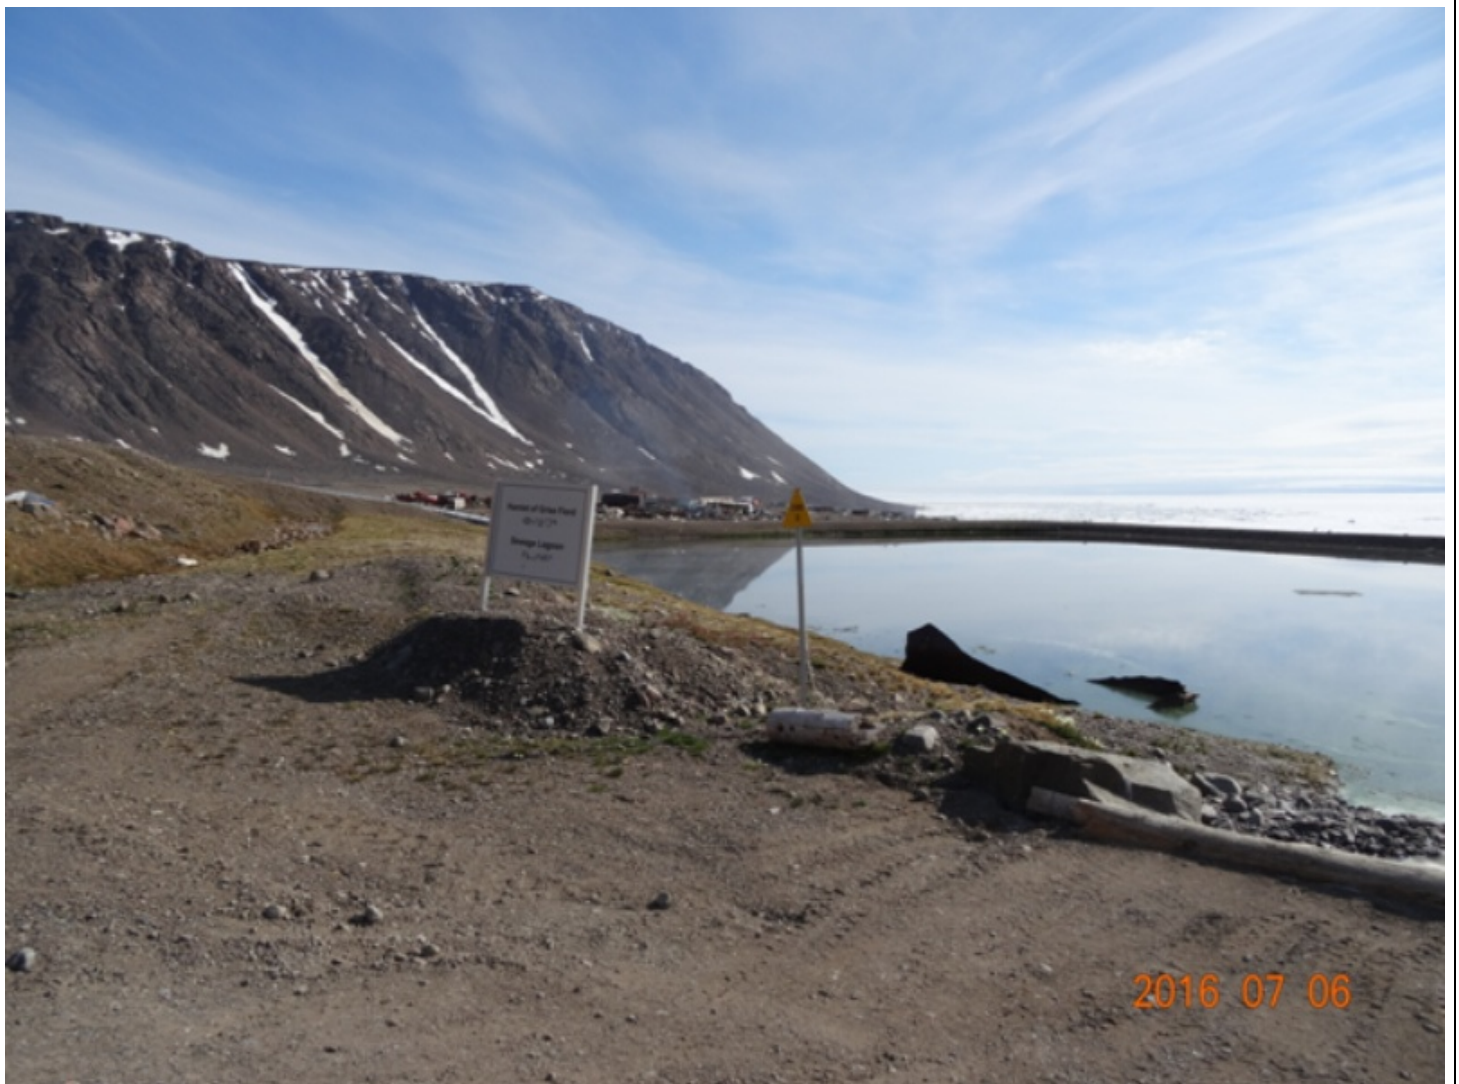
Following the Raw water Intake location we attended the Sewage treatment lagoon site. Sewage treatment is provide, as most communities by an engineered lagoon and decanting. There was sufficient freeboard identified during the period of inspection and no seepage was visible from the toe of the lagoon. The annual decant was not on-going during the period of the Inspection so no samples were collected. It was noted that a large metal object, possible from the Bulk metals area immediately adjacent to the lagoon has fallen or been blown into the lagoon. This object should be removed. And the required fences be installed at the Lagoon and the Solid Waste Management Area.

Figure 8 Lagoon and signage

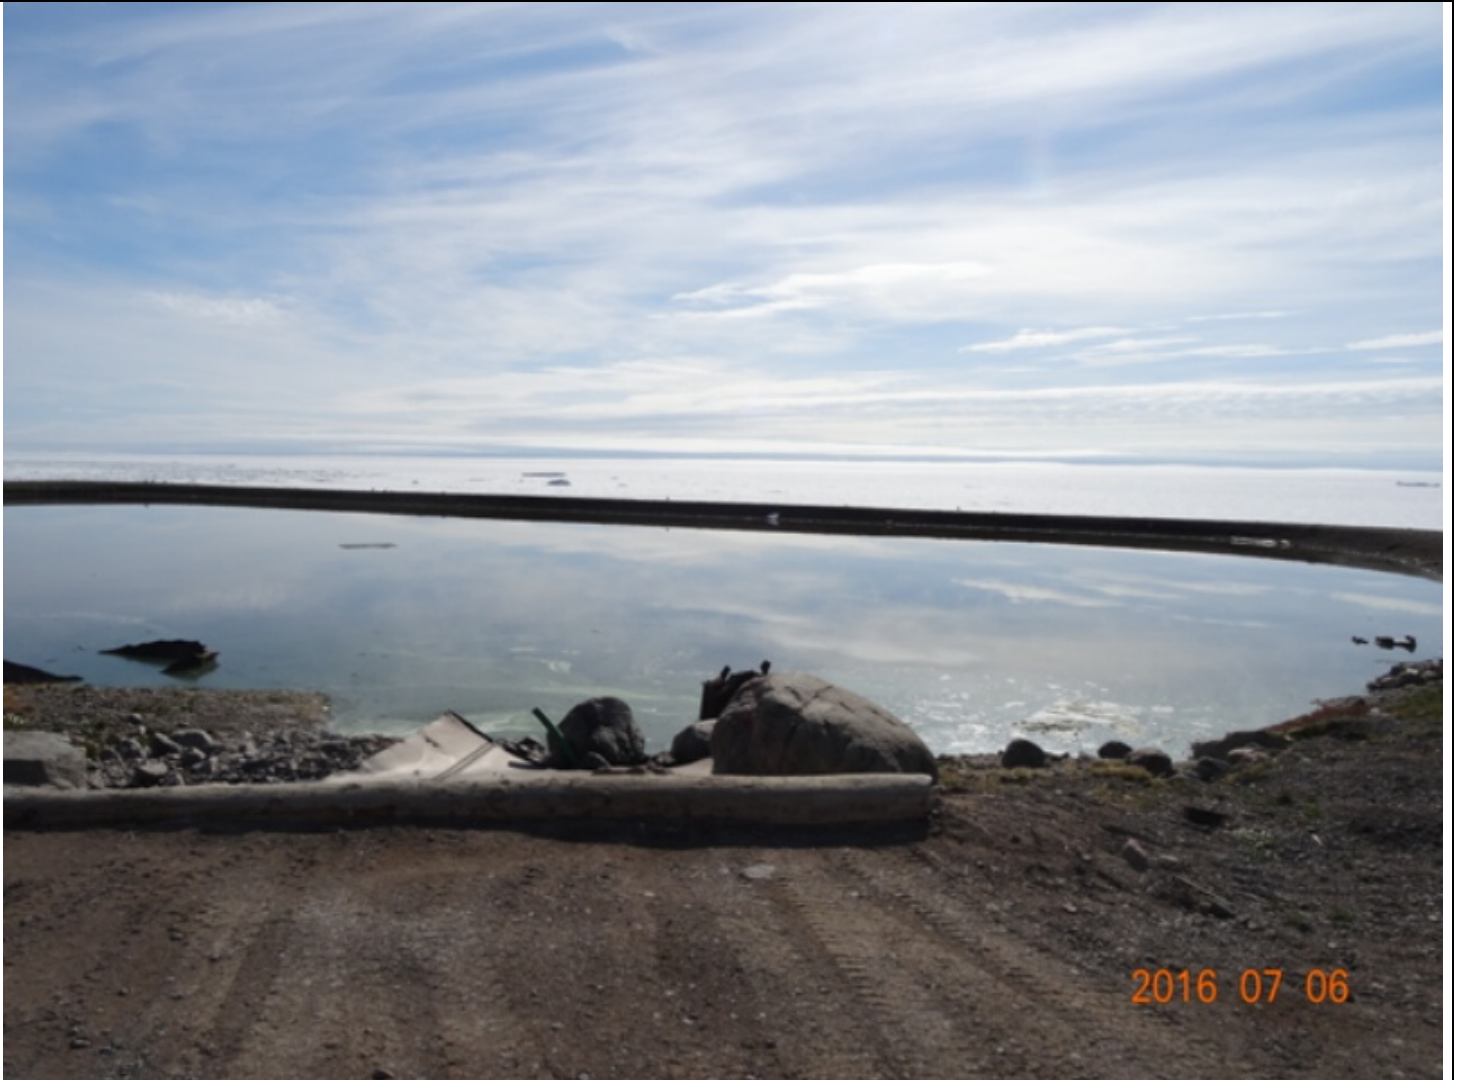
Figure 9 Lower lagoon truck drop off

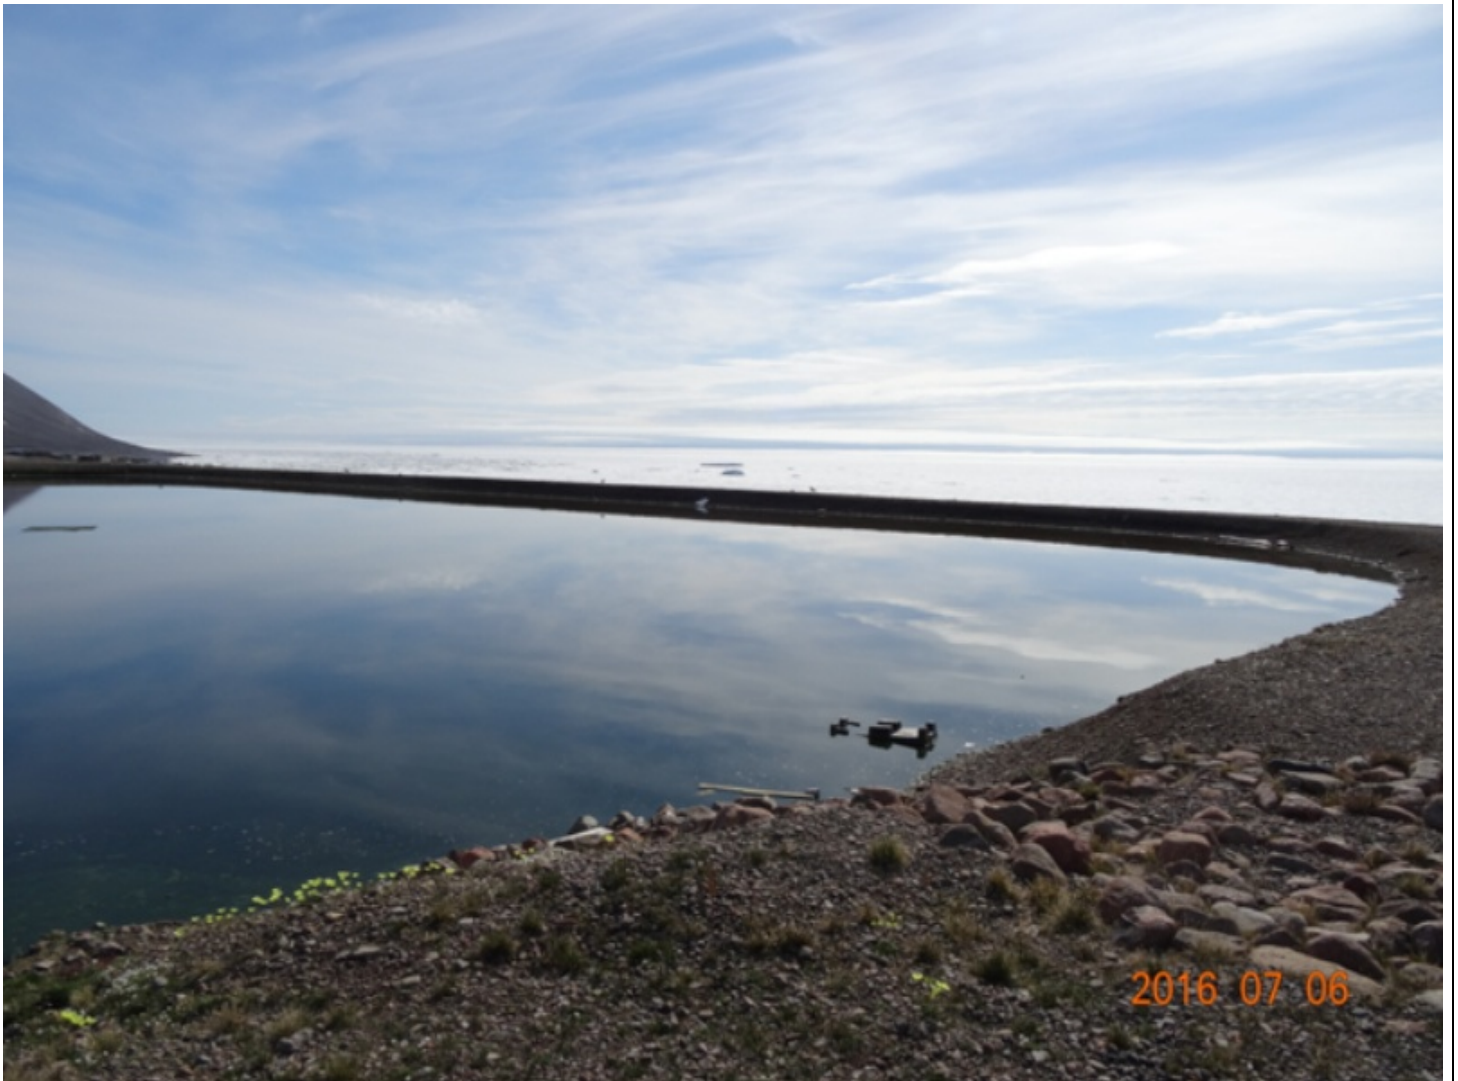
Figure 10 Lagoon is nearing capacity

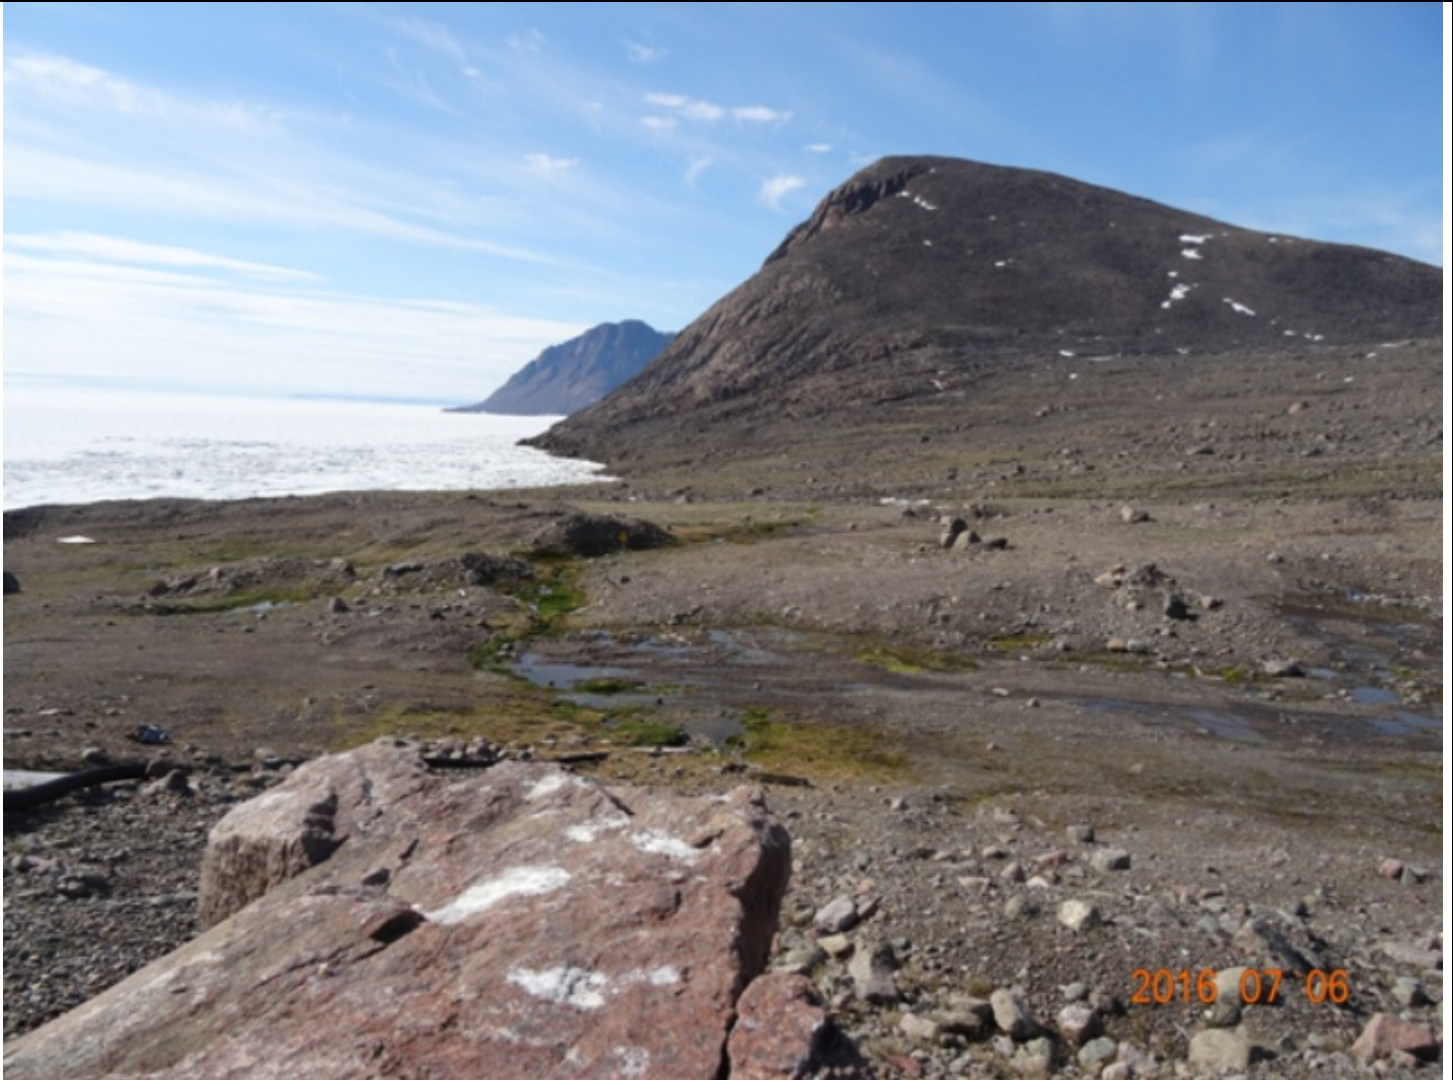
Figure 11 Decant pathway to ocean . note hose in lower left

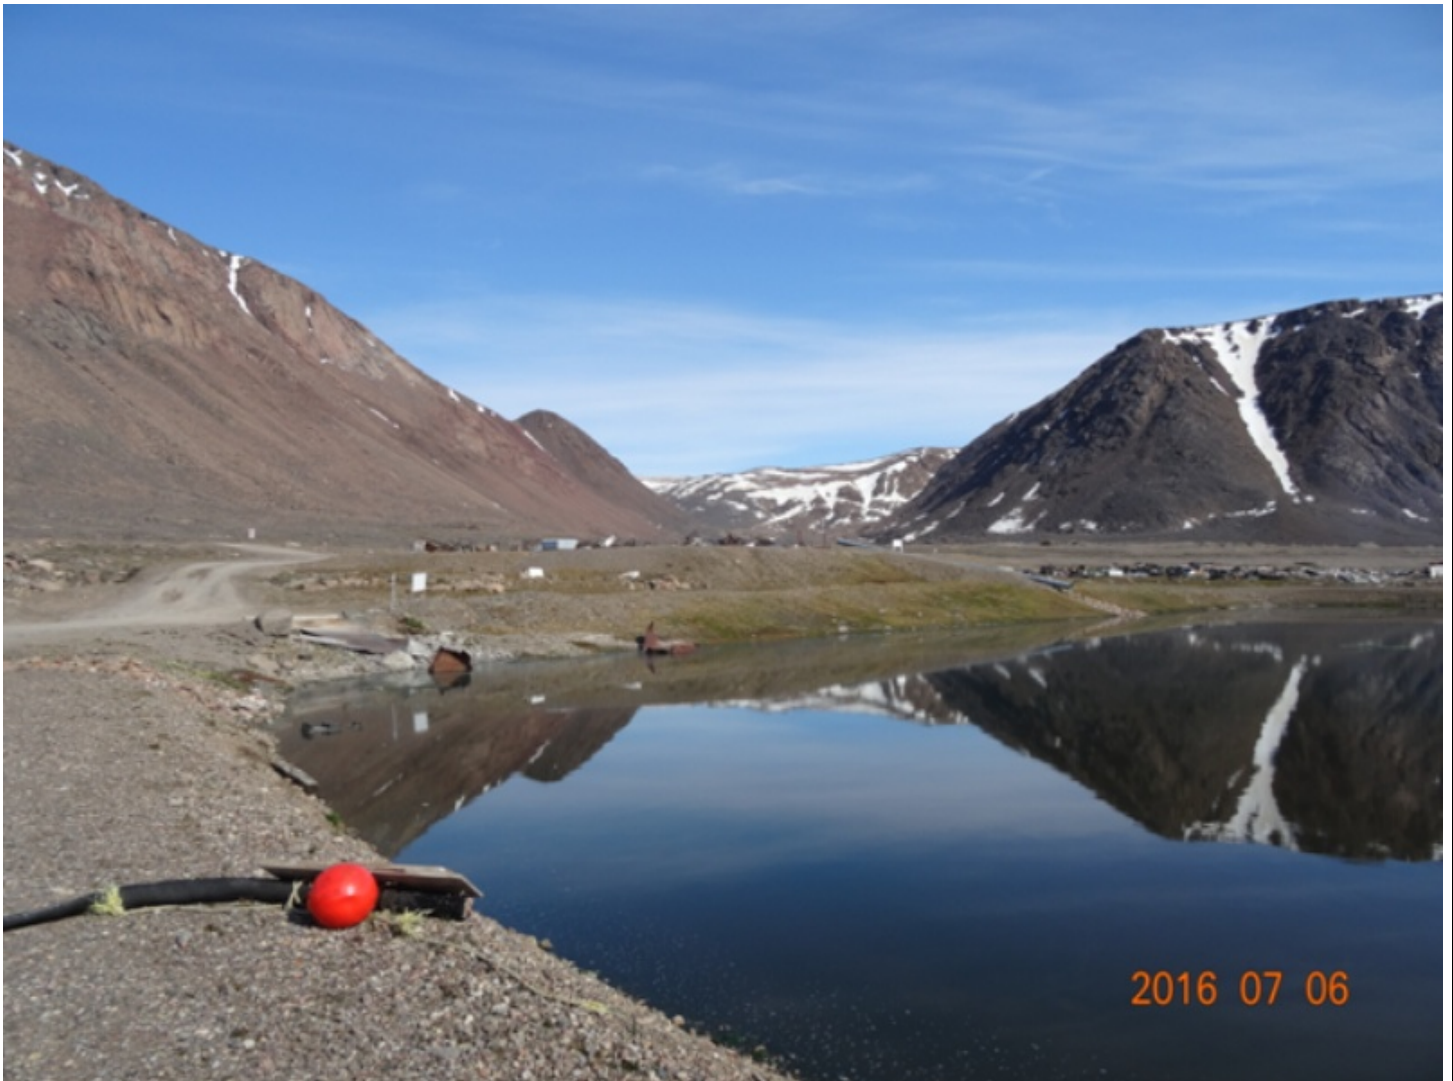
Figure 12 Decant hose on top of berm wall

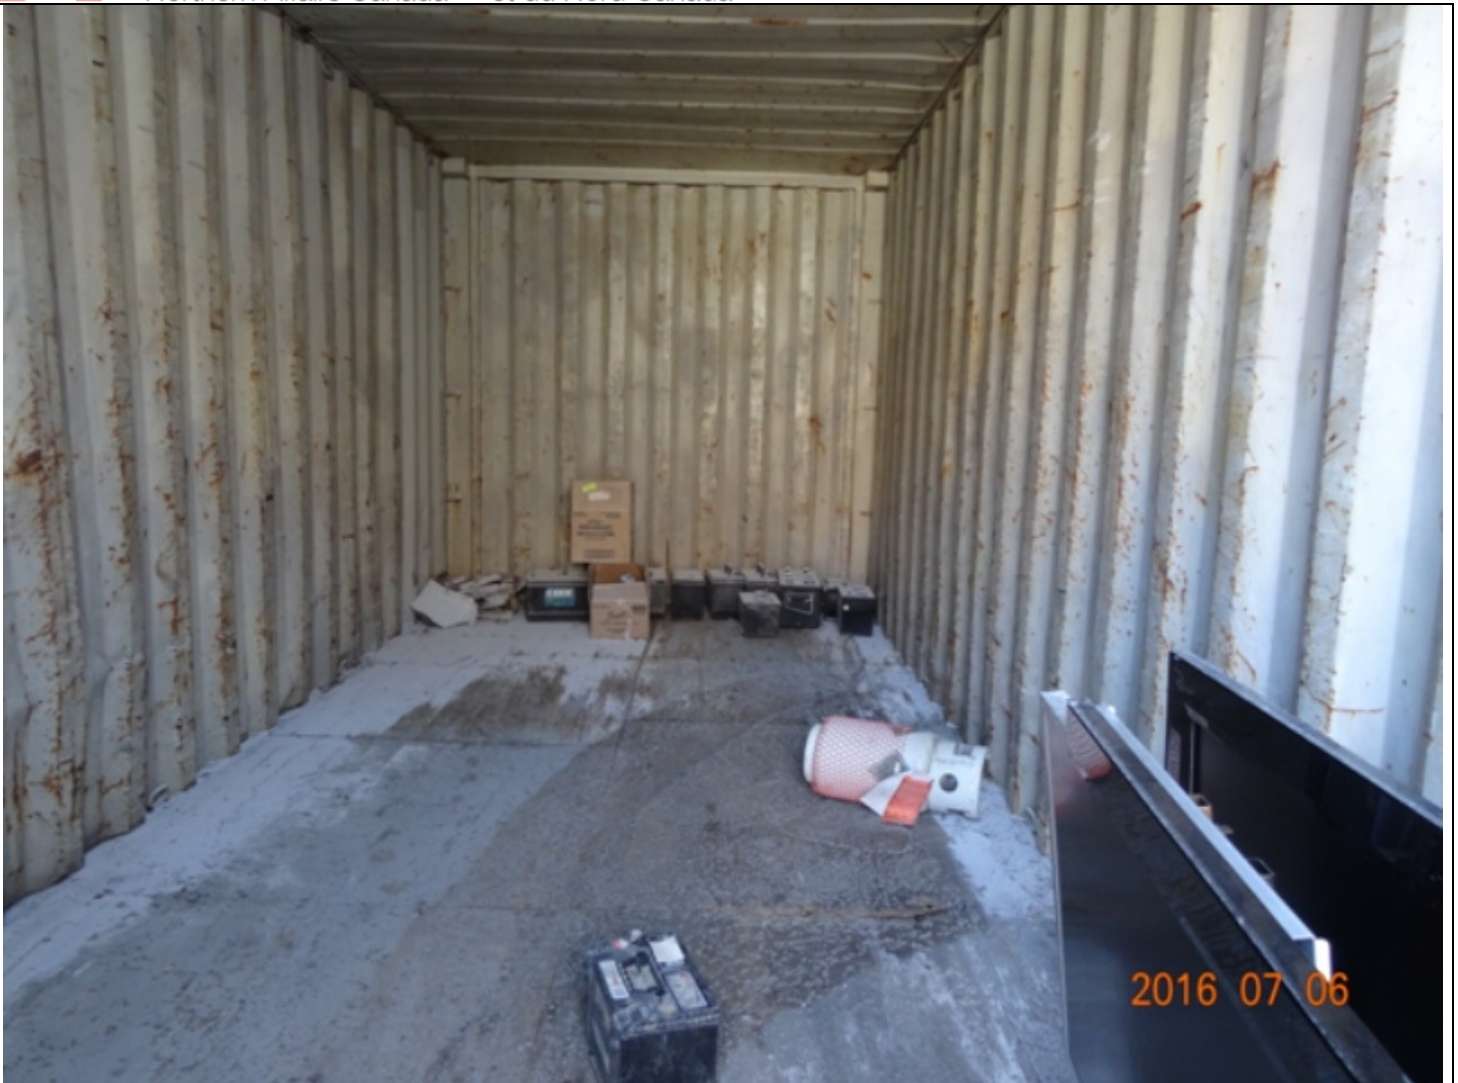
During the period of Inspection in July 2016, ten years after the initial request to begin segregation and to consolidate hazardous wastes was provided to the Licensee and the Government of Nunavut, there are now over 400 barrels (many leaking) of unknown content and hundreds of batteries, paint cans, aerosols, electronics, and florescent lightbulbs scattered throughout the facility. It was noted however that the Municipality had installed a sea-can at the facility but had not consolidated any of the hazardous wastes into it.

Figure 13 Battery and haz mat storage sea-can placed at solid waste management area

The Municipality and the Government of Nunavut have committed in the past to undertake a project to consolidate hazardous wastes including drums of waste oil, batteries, paint cans and other materials. This work has not been done.

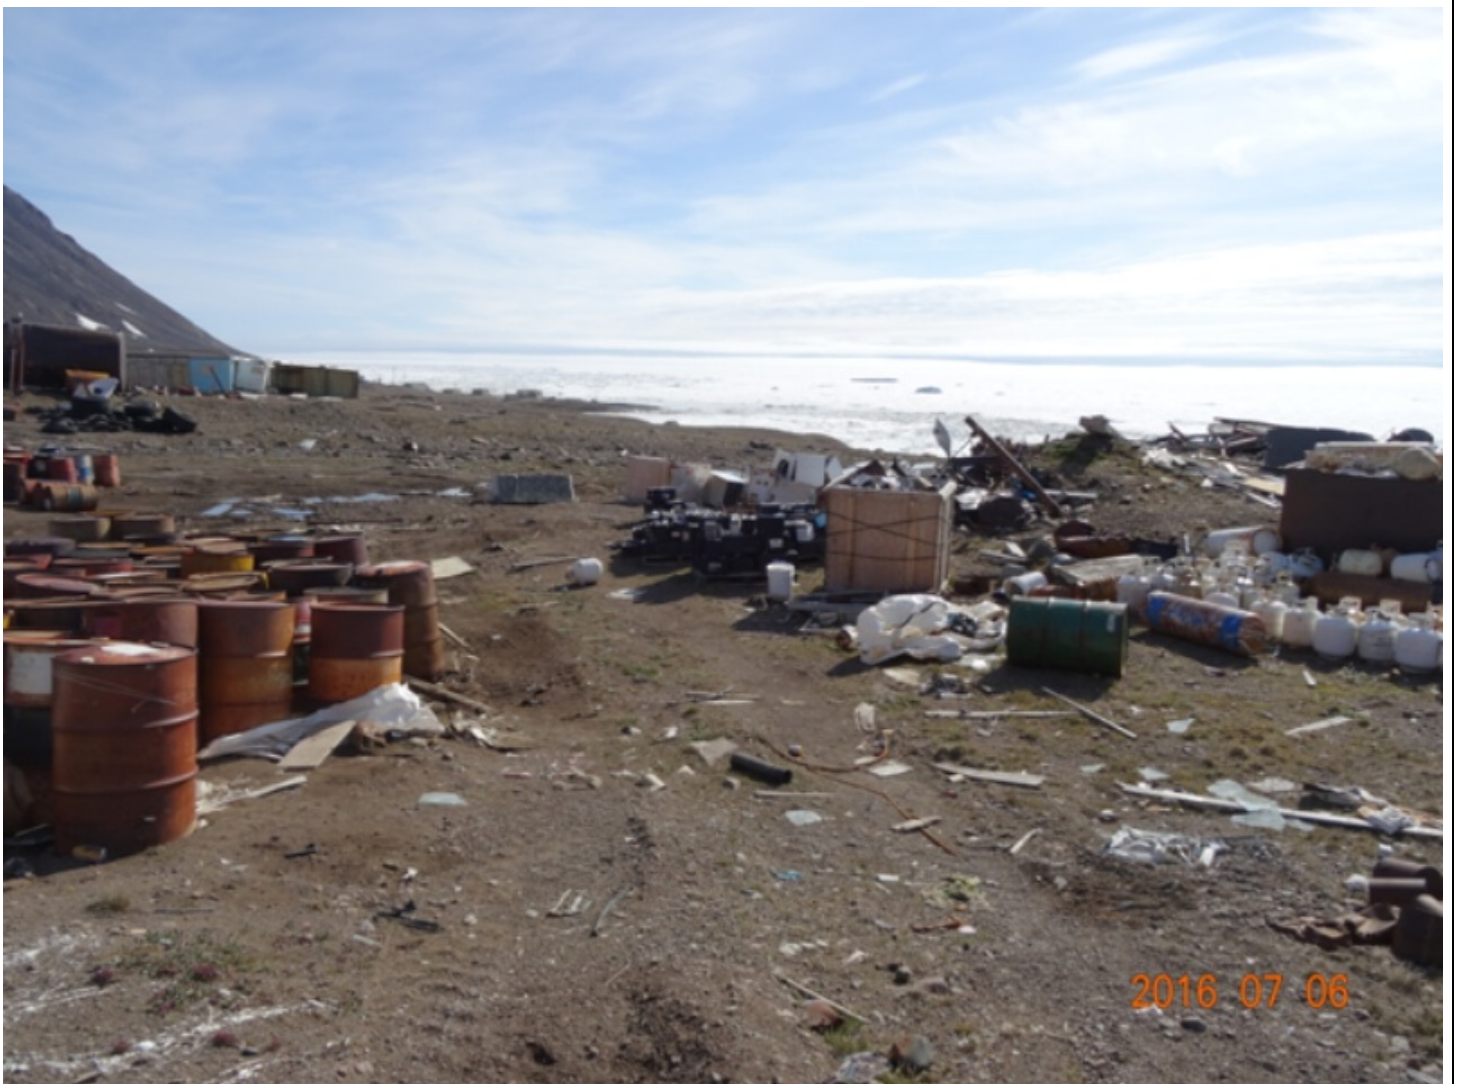
Figure 14 Pallets of batteries and waste oil drums at solid waste management area
