WATER LICENCE INSPECTION FORM

Licensee		Licensee Representative	
Senior Administrative Officer Hamlet of Grise Fiord, Baffin Region,		David Watsko- Hamlet foreman Bhbesh Roy – Regional Engineer – GN	
Licence No. / Expiry		Representative's Title	
3BM-GRI Exp. Jan 29, 2011		Hamlet Foreman	
Land / Other Authorizations		Land / Other Authorizations	
Date of Inspection		Inspector	
July 6,2016		A.Keim	
Activities Inspected			
<input type="checkbox"/> Camp	<input type="checkbox"/> Drilling	<input type="checkbox"/> Mining	<input type="checkbox"/> Construction
<input type="checkbox"/> Roads/Hauling	<input type="checkbox"/> Other: Water Discharge	<input checked="" type="checkbox"/> Other: Municipal	<input type="checkbox"/> Reclamation
<input type="checkbox"/> Fuel Storage

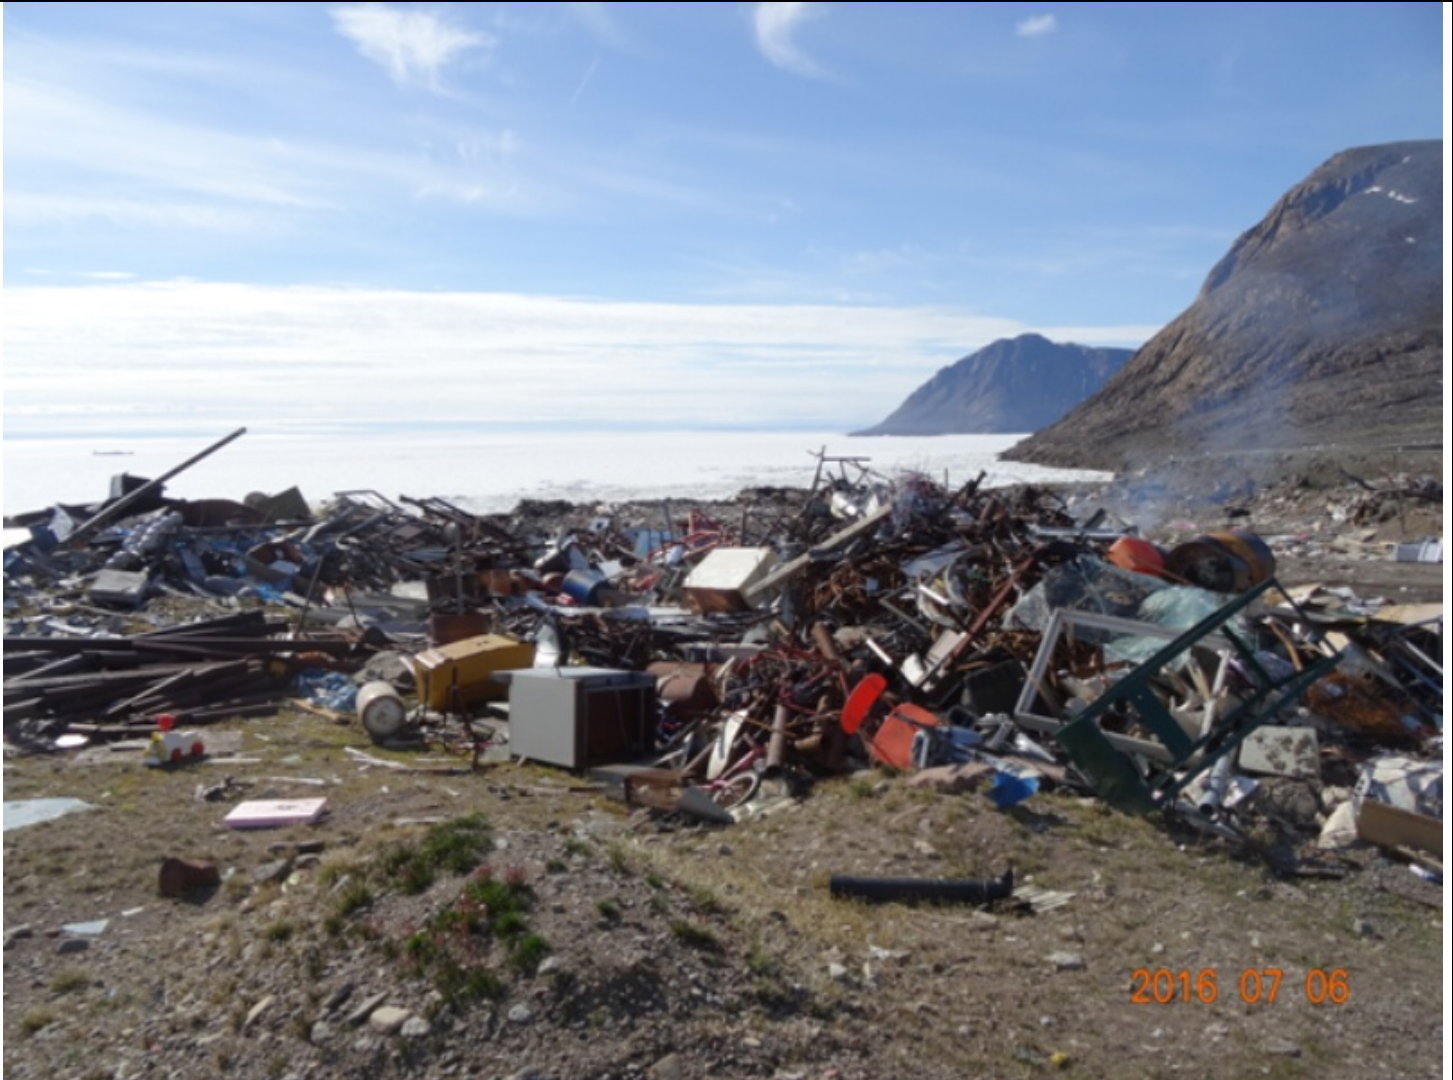
The Inspector found that very little improvement to the Solid Waste Management Area has been undertaken by the Licensee since the period of the last Inspection in 2014. If anything it appears to be progressively getting worse since 2006 when first identified by the Inspector to the Licensee has a priority item to be addressed.

Figure 15 Bulk metal at solid waste management area

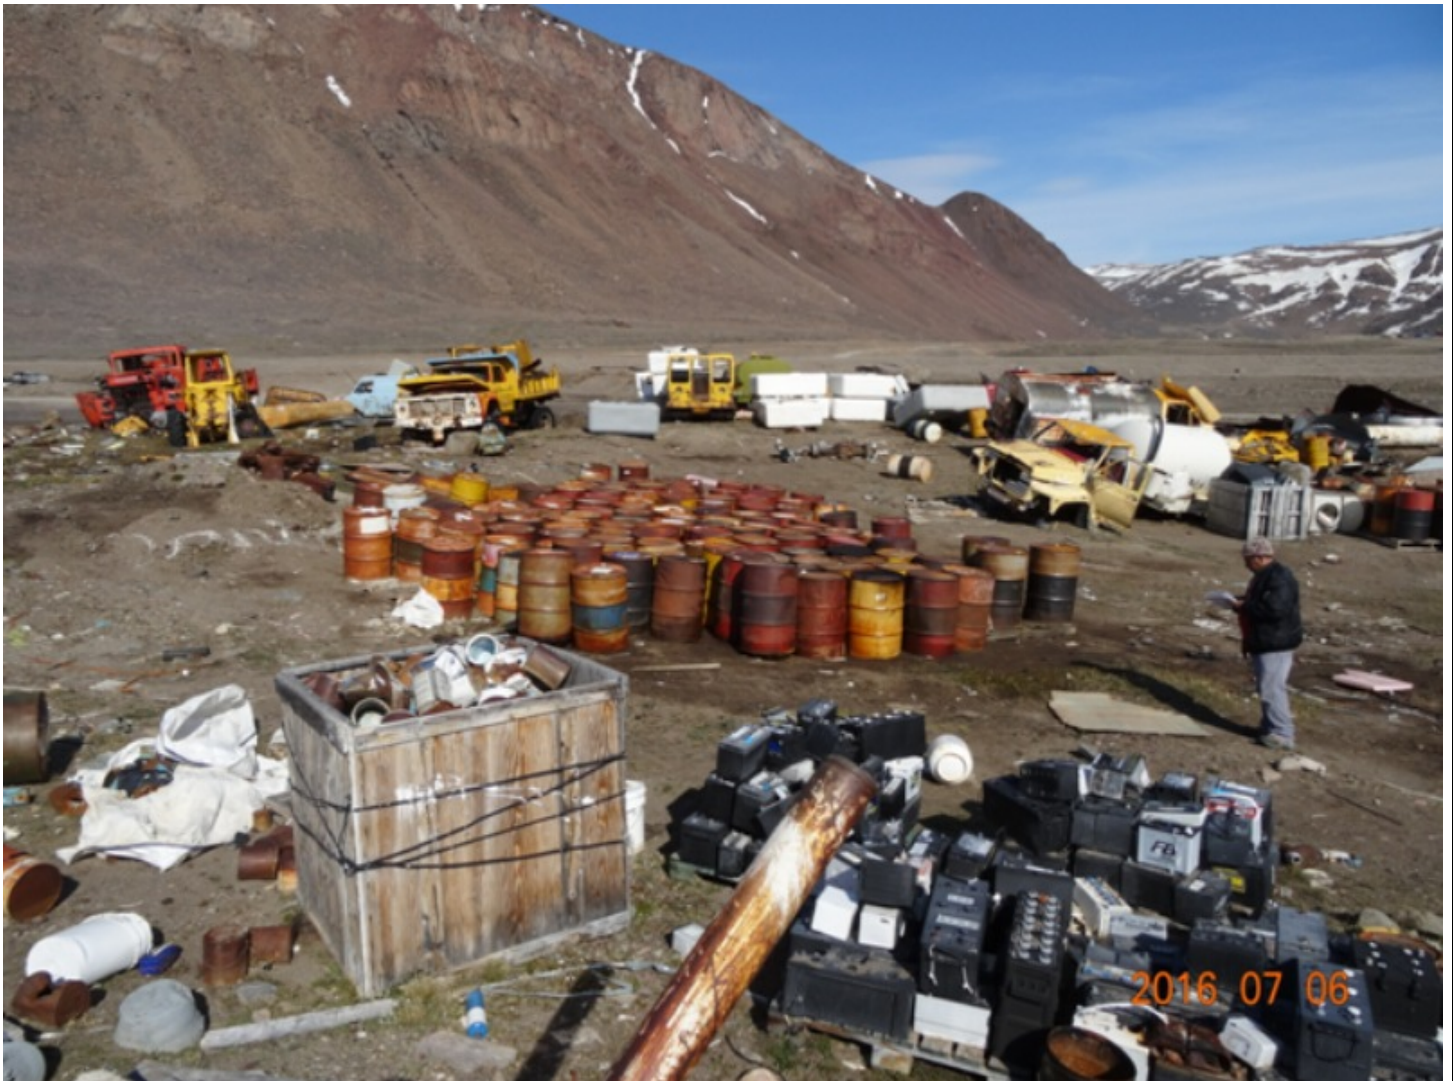
During the period of Inspection in July 2016, ten years after the initial request to begin segregation and to consolidate hazardous wastes was provided to the Licensee and the Government of Nunavut, there are now over 400 barrels (many leaking) of unknown content and hundreds of batteries, paint cans, aerosols, electronics, and florescent lightbulbs scattered throughout the facility. It was noted however that the Municipality had installed a sea-can at the facility but had not consolidated any of the hazardous wastes into it.

Figure 16 Waste oils and batteries

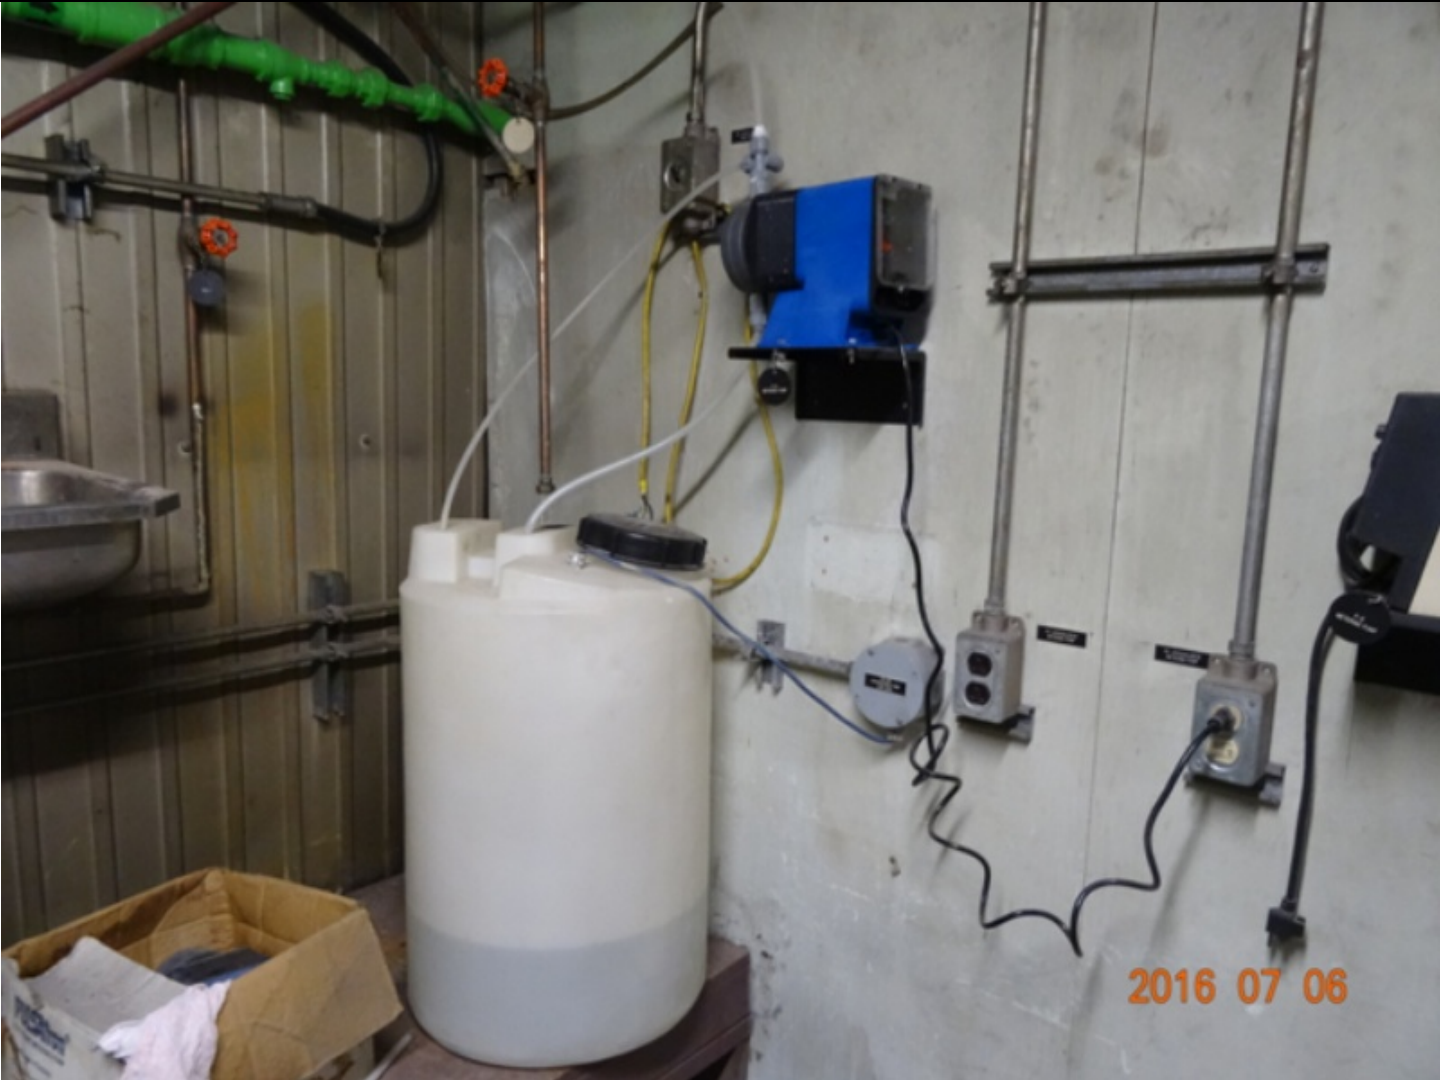
Figure 17Water treatment system at garage. Noted corrosion/oxidation of metals and fittings in room.
