WATER LICENCE INSPECTION FORM

Licensee		Licensee Representative	
Hamlet of Grise Fiord		David Watsko	
Licence No. / Expiry		Representative's Title	
3BM-GRI1520		Hamlet Foreman	
Land / Other Authorizations		Land / Other Authorizations	
Date of Inspection		Inspector	
June 28, 2017		Jonathan Mesher	
Activities Inspected			
<input type="checkbox"/> Camp	<input type="checkbox"/> Drilling	<input type="checkbox"/> Mining	<input type="checkbox"/> Construction
<input type="checkbox"/> Roads/Hauling	<input type="checkbox"/> Other: Water Discharge	<input checked="" type="checkbox"/> Other: Municipal	<input type="checkbox"/> Reclamation
<input type="checkbox"/> Fuel Storage

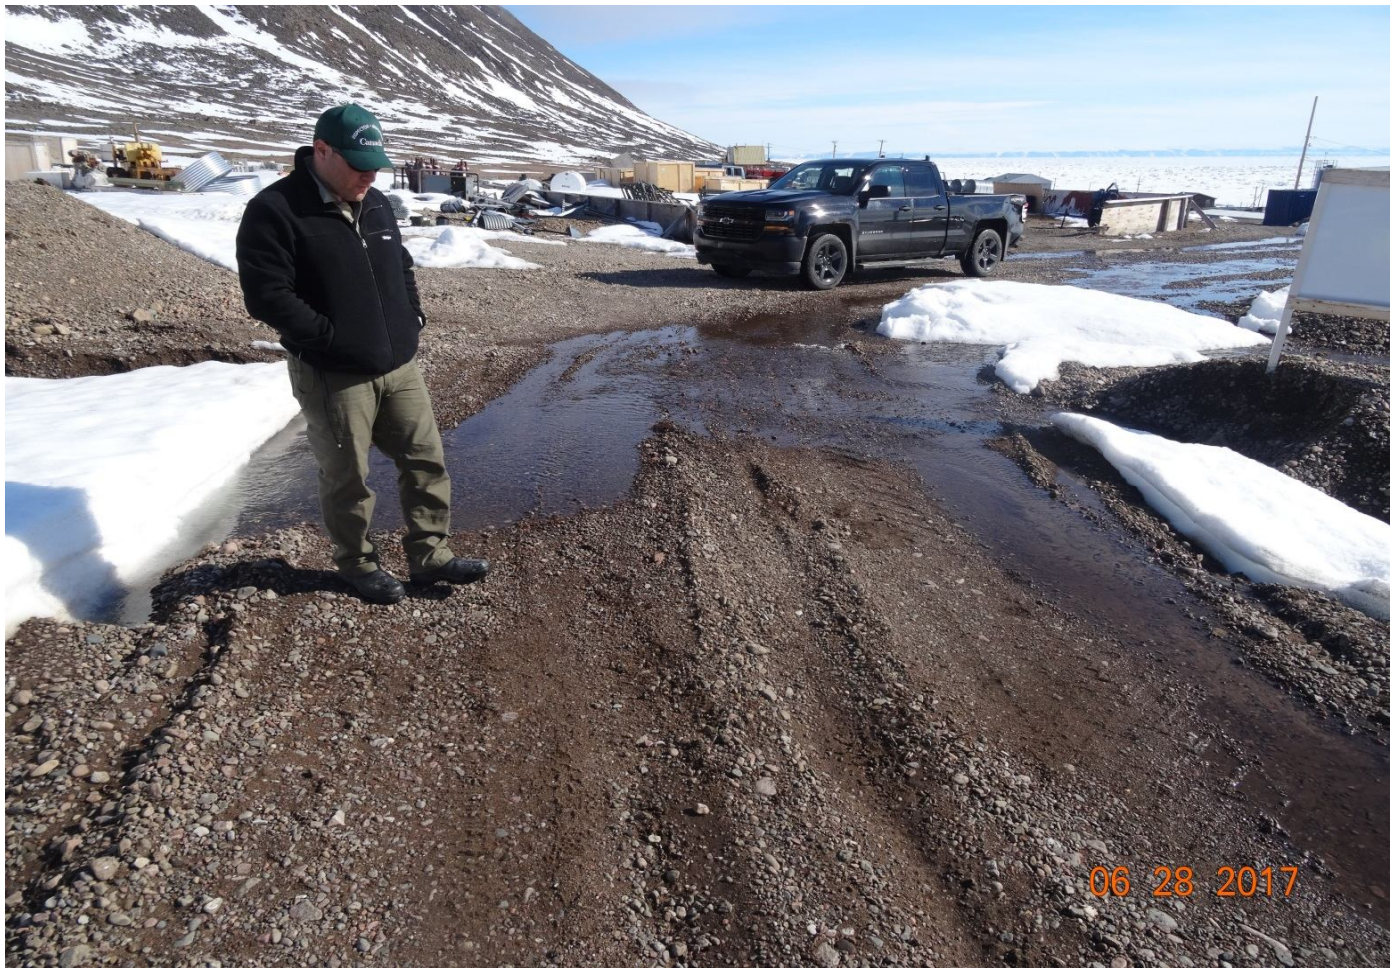
Figure 1: WSF overflow

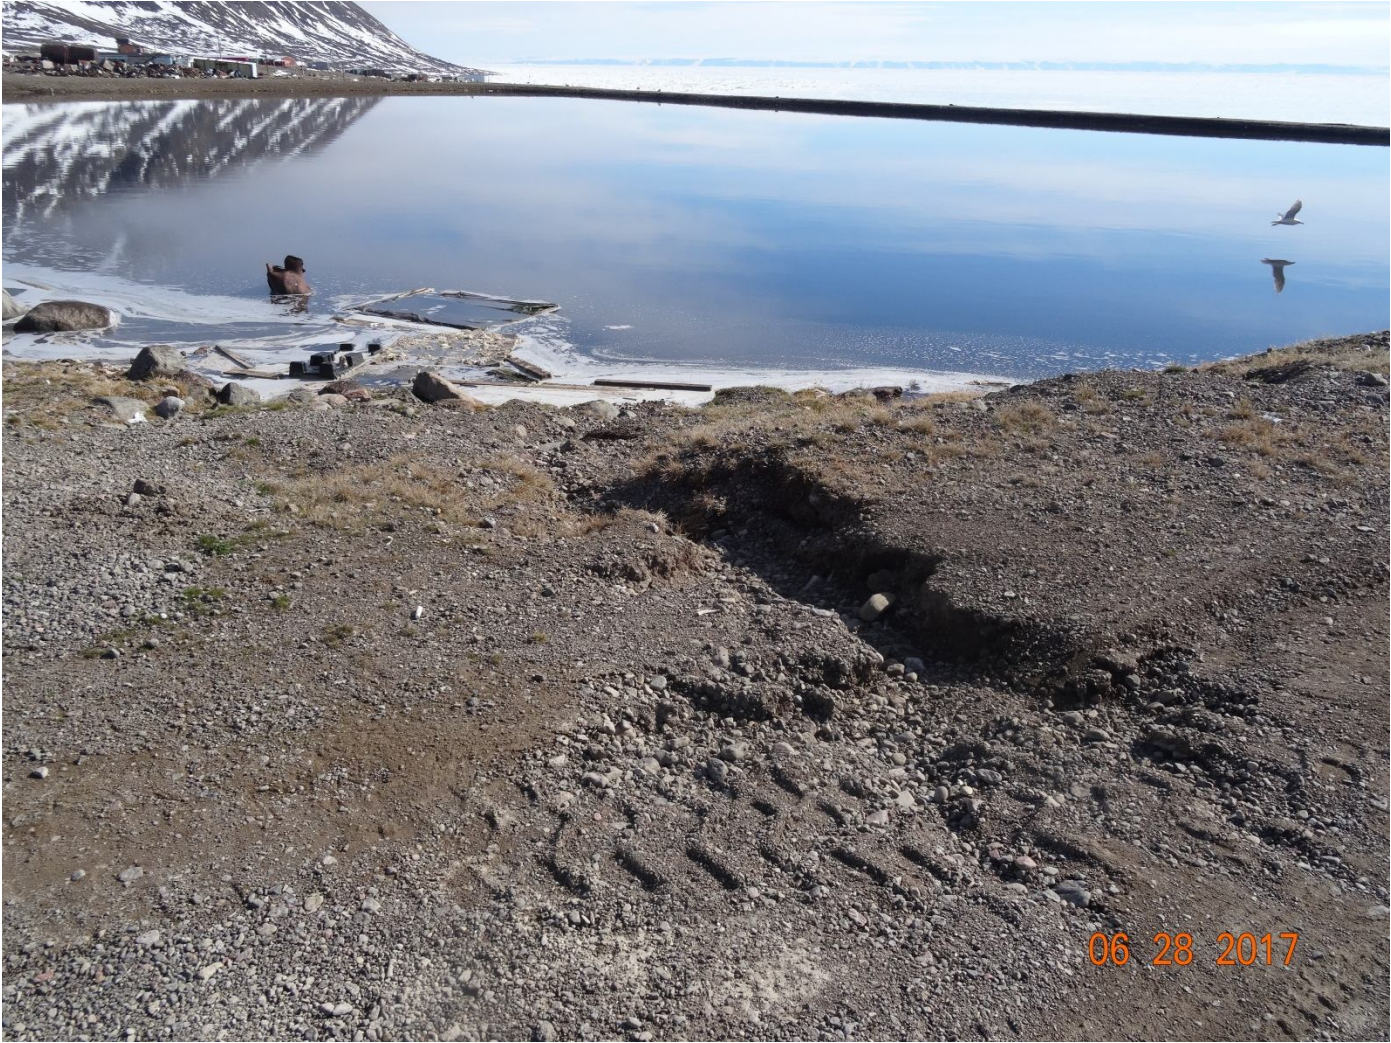
- a) On the North West corner of the SDF there appeared water had been flowing into the facility causing erosion. (See figure 2).
- b) A concern about this facility is the culvert that diverts water along the East berm wall. This culvert is diverting water that may cause erosion on the berm wall.
- c) The inspector is requesting that this facility be inspected by an engineer in order limit erosion and properly divert water away from this facility.

Figure 2: SDF infiltration and erosion

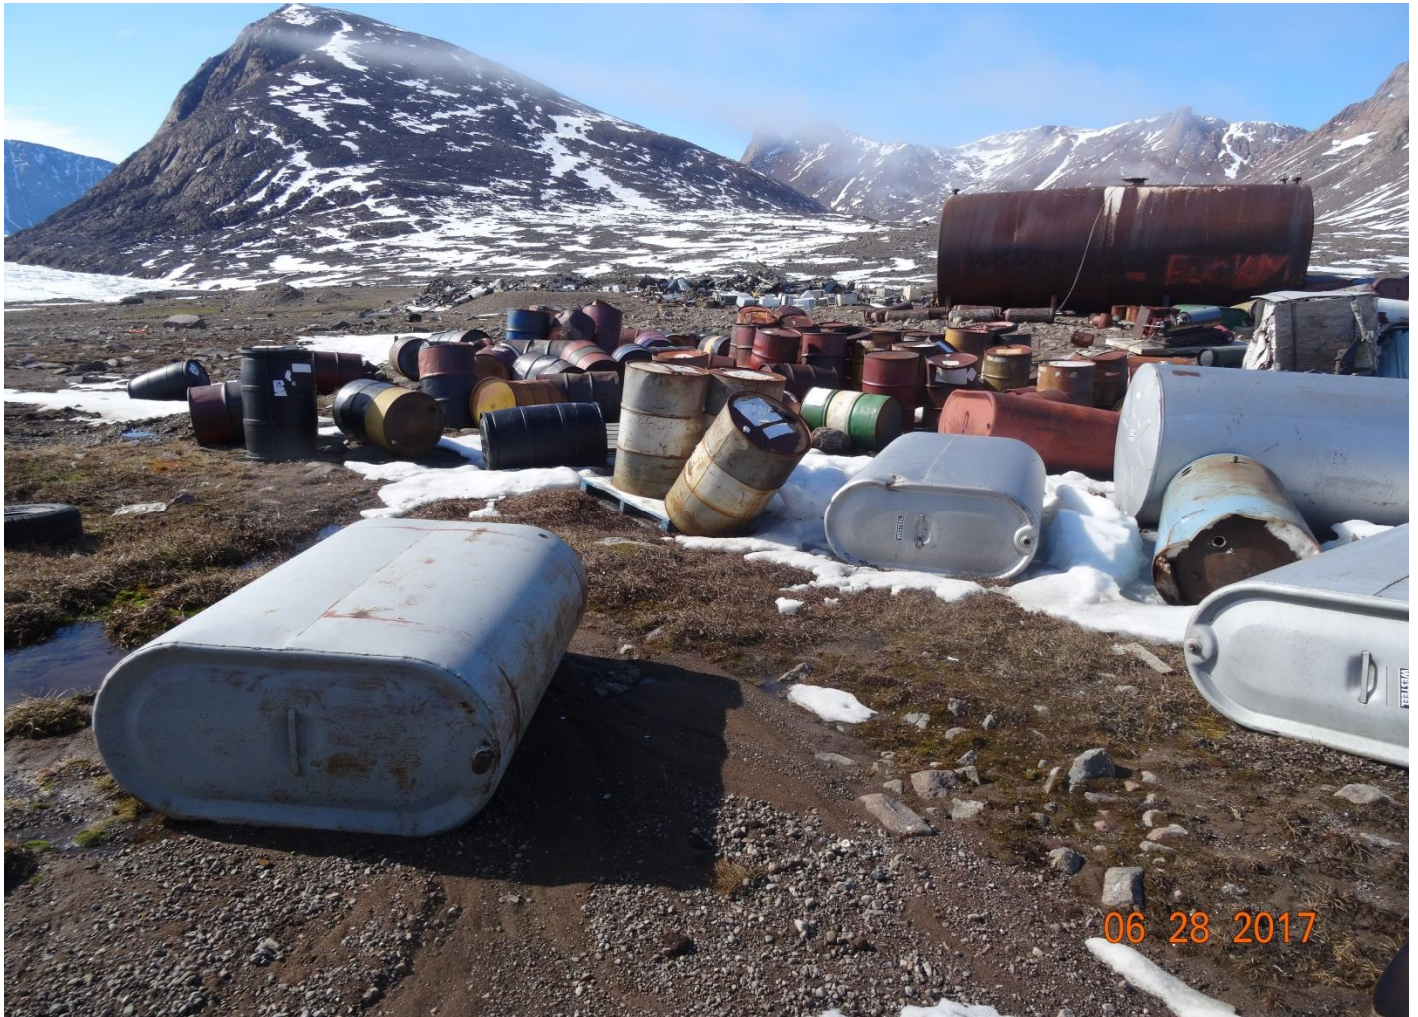
- ii. Barrels of hazardous waste do not appear to be segregated or stored in such a manner as to prevent the deposit of deleterious substances into any Water. See figure 3 to 5 for examples of unsegregated hazardous waste.

Figure 3: unsegregated hazardous waste

- d) The inspector is requesting that this facility be inspected by an engineer in order to develop a plan to; segregate hazardous waste, remove hazardous waste from the site, and divert water away from this facility.

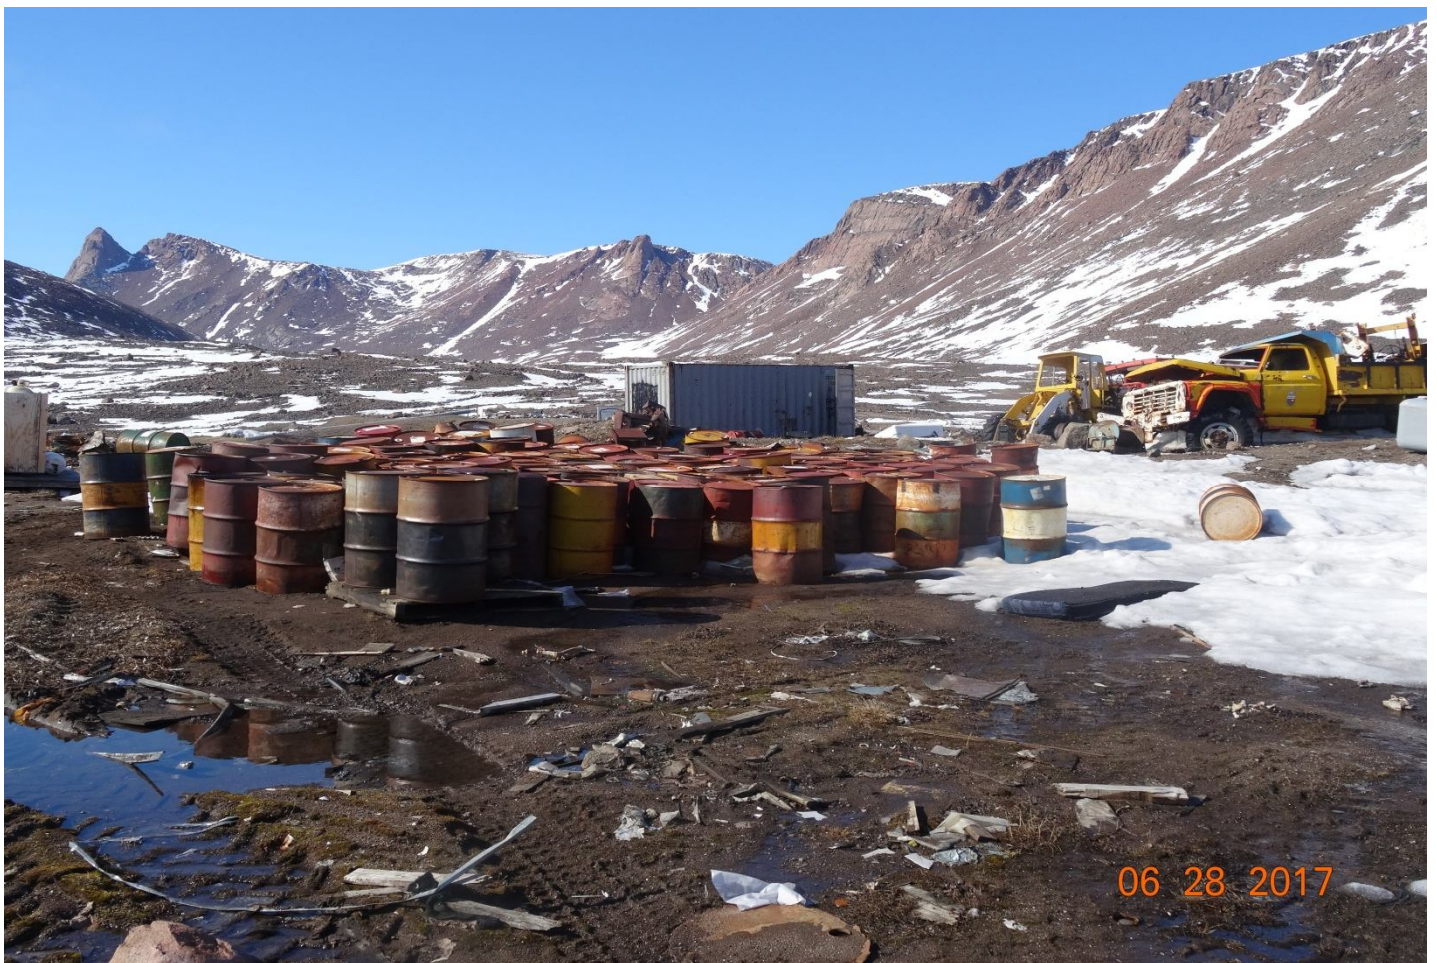
Figure 4: unsegregated hazardous waste

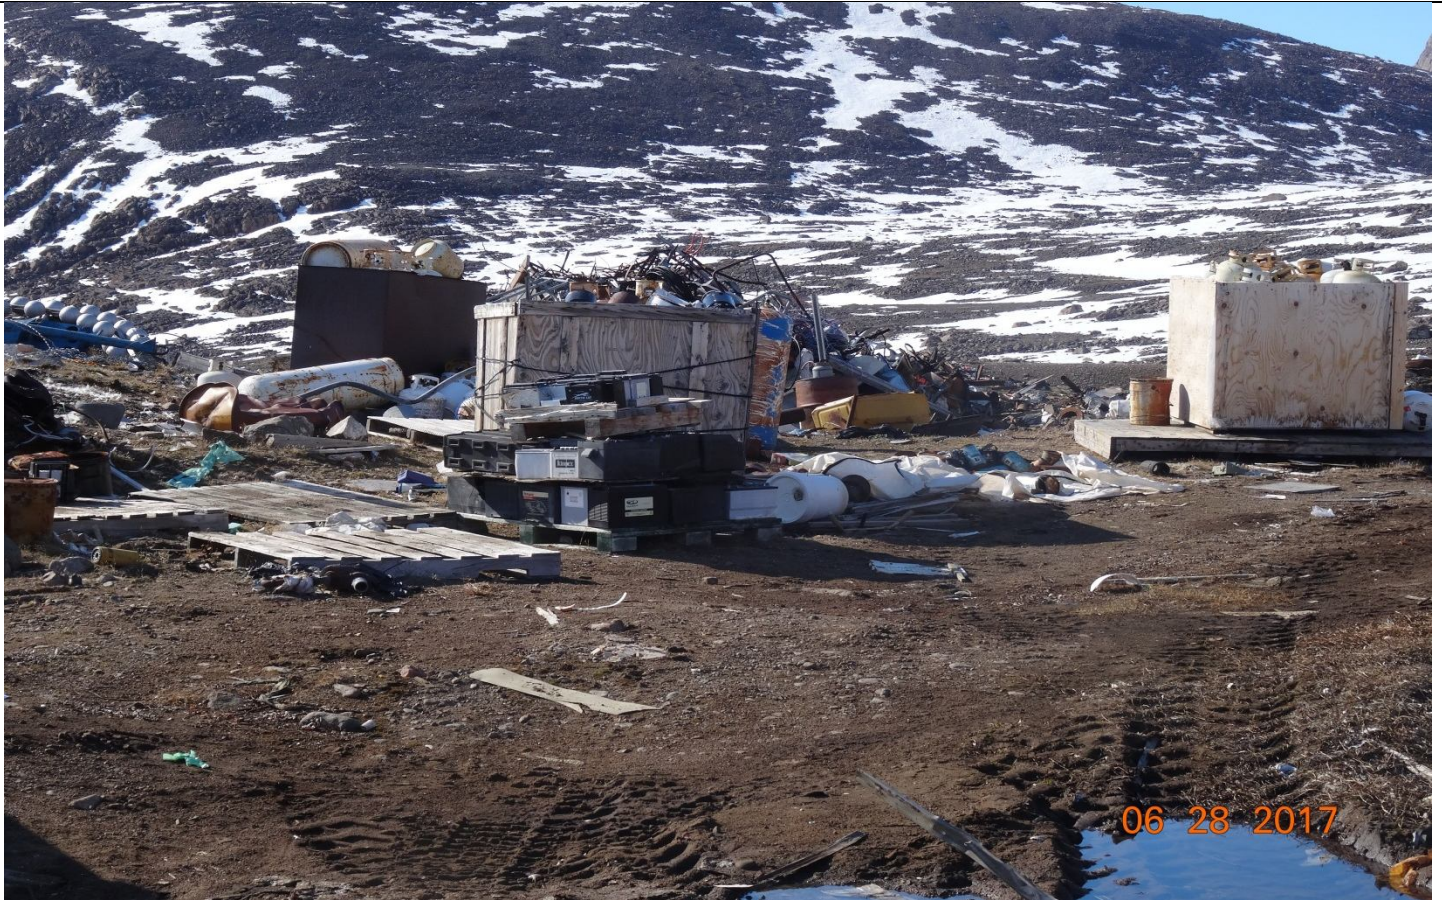
Figure 5: unsegregated hazardous waste

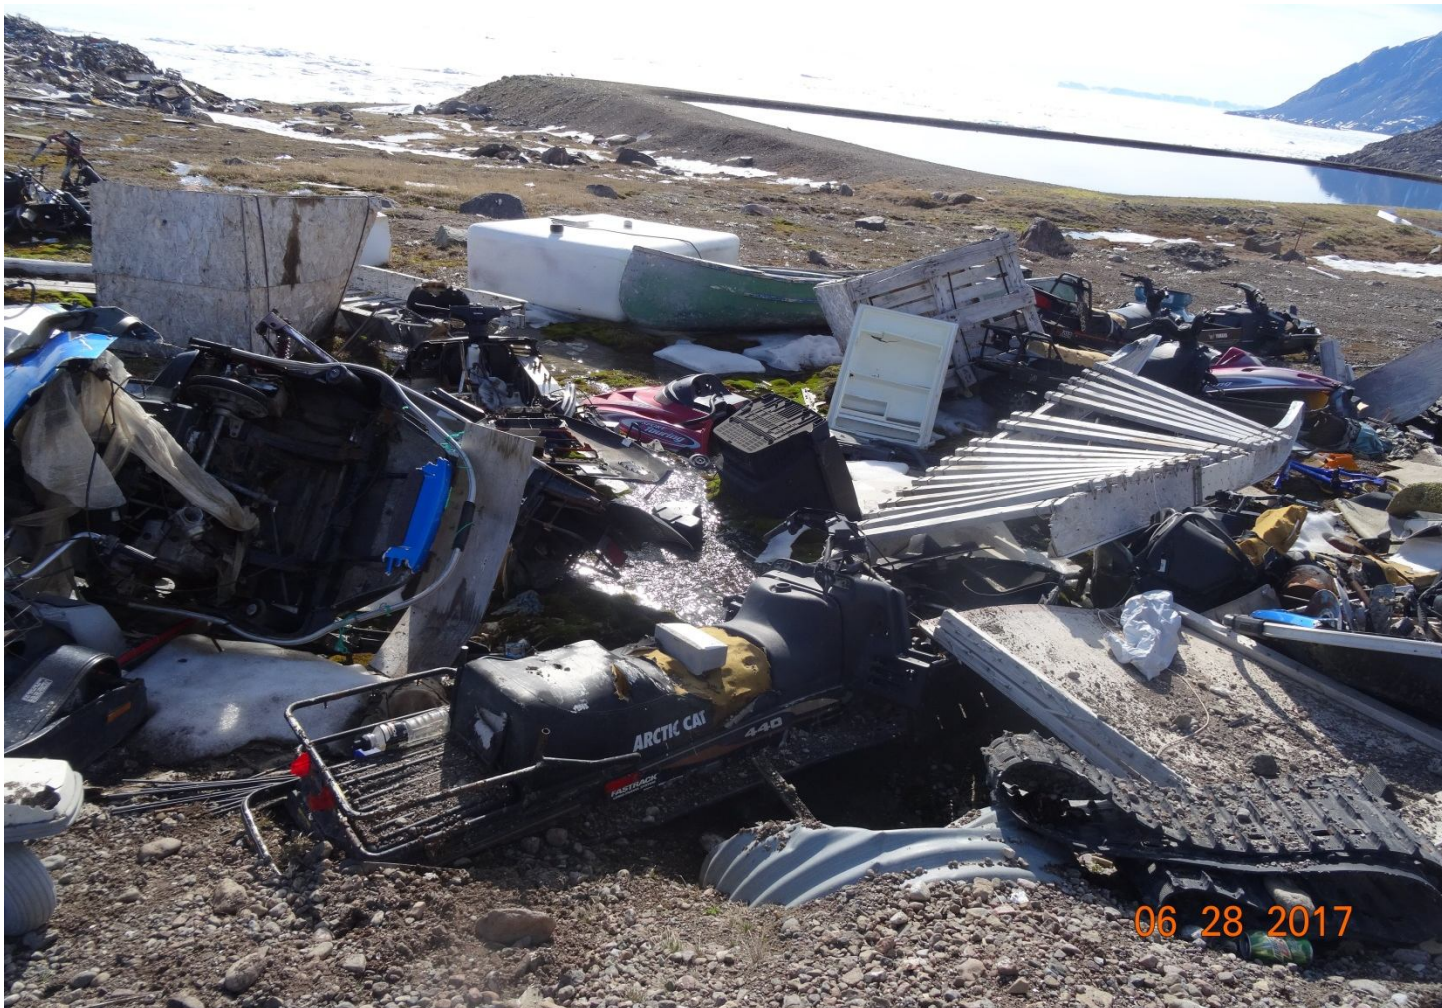
- iii. Culverts and ditches up gradient of the facility divert water directly through the SWF instead of around the SWF. See figure 6 for a photo of a water management structure diverting water into the municipal refuse.

Figure 6: water diverted through the SWF

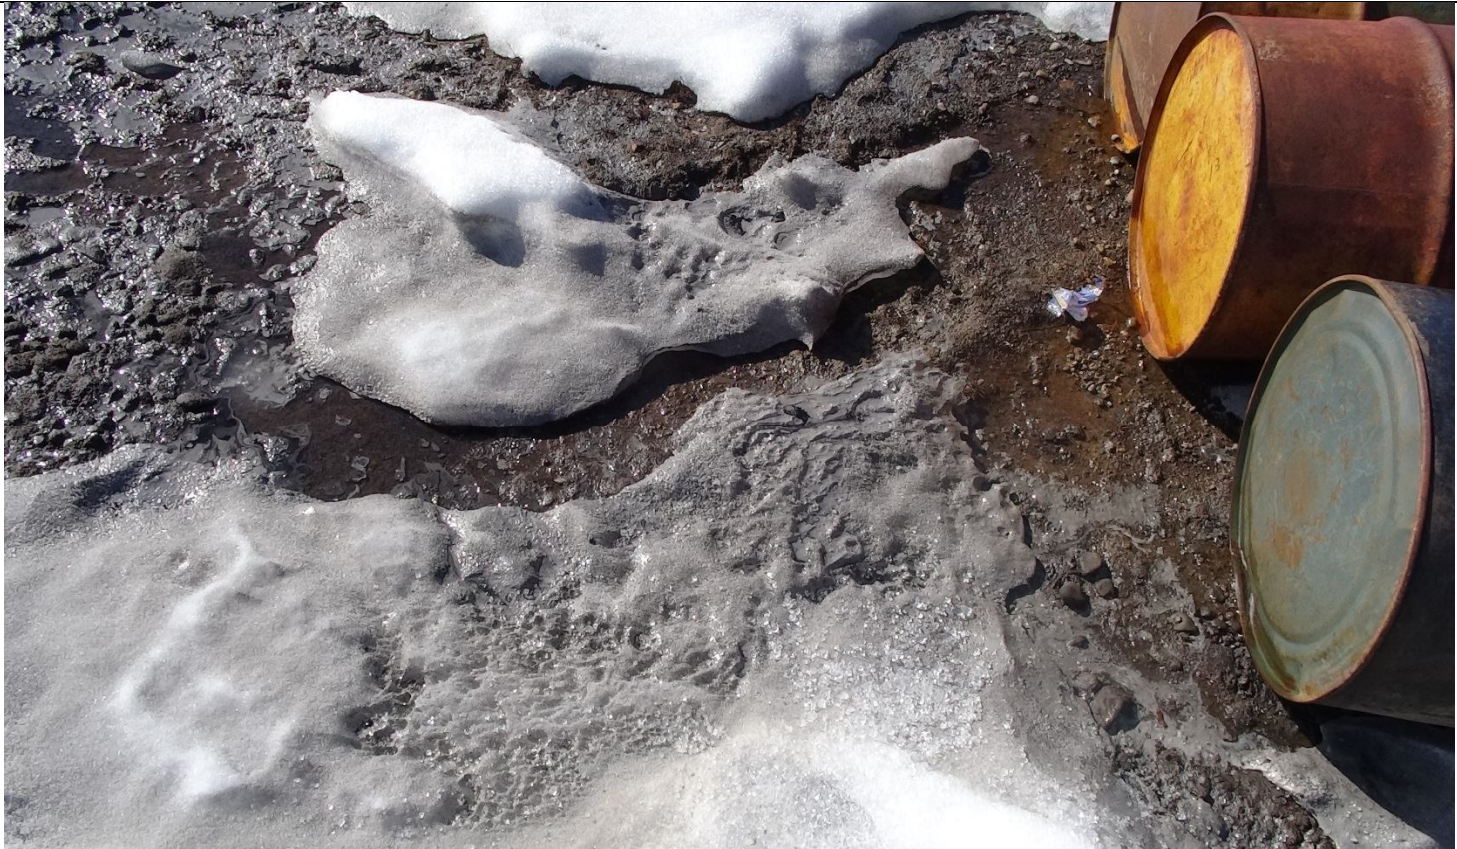
Figure 7: hazardous material leaking into the environment.

- iv. Barrels of Hazardous material were found to be leaking on to the ground at the time of the inspection. This is to be cleaned up as soon as possible and remediated as set out in the solid waste operations and maintenance plan.

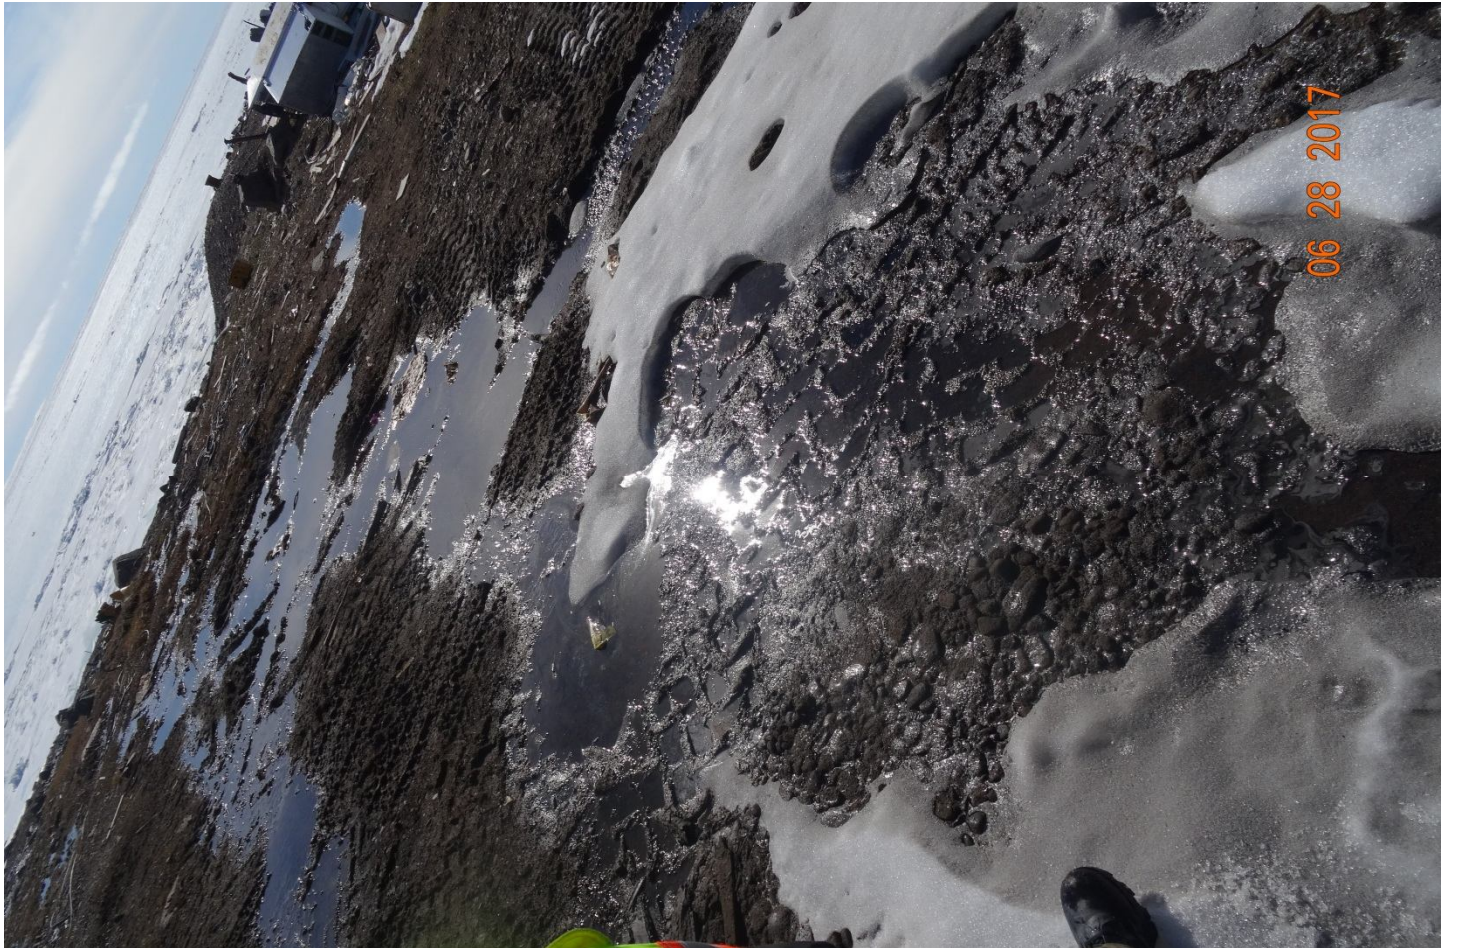
Figure 8: hazardous material flowing into the environment.
