WATER LICENCE INSPECTION FORM

Licensee		Licensee Representative	
Hamlet of Grise Fiord		Bhabesh Roy	
Licence No. / Expiry		Representative's Title	
3BM-GRI1520 Renewal Expires Dec. 8, 2020		Municipal Engineer	
Land / Other Authorizations		Land / Other Authorizations	
Date of Inspection		Inspector	
July 23, 2018		Joseph Monteith & Jonathan Mesher	
Activities Inspected			
<input type="checkbox"/> Camp	<input type="checkbox"/> Drilling	<input type="checkbox"/> Mining	<input type="checkbox"/> Construction
<input type="checkbox"/> Roads/Hauling	<input checked="" type="checkbox"/> Other: Potable Water Source, Waste Treatment Facility, and Solid Waste Facility	<input type="checkbox"/> Other:	<input type="checkbox"/> Reclamation
<input type="checkbox"/> Fuel Storage

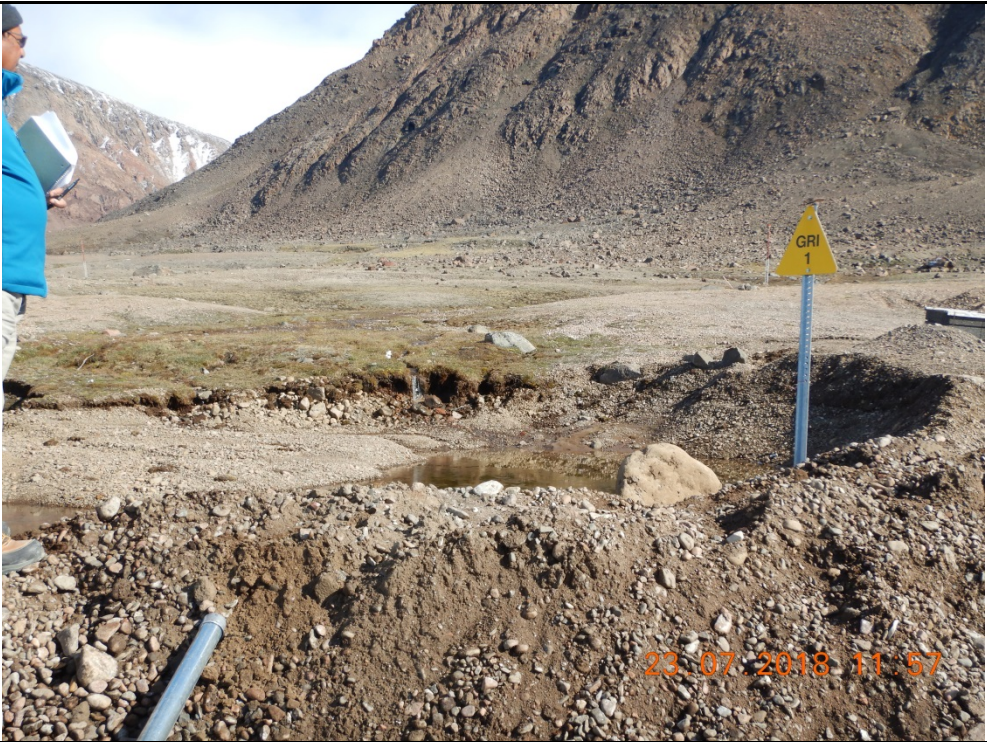
Date	Camera	Inspector
July 23, 2018	Nikon Coolpix N16D3-52000738	Joseph Monteith
Photo Log #1	Location	
Photo 1	Grise Fiord

2. At the time of the inspection a yellow triangle sign was observed titled GRI-1. A monitoring station as listed in the water licence (Photo #1).
3. A 4 inch HDPE piping with a Fish Mesh Screen extends into the pond through the pond walls (Photo #2).

Description: Yellow Triangle Sign titled GRI 1 monitoring station – Water runs down the mountain in the background, and fills up ditch.

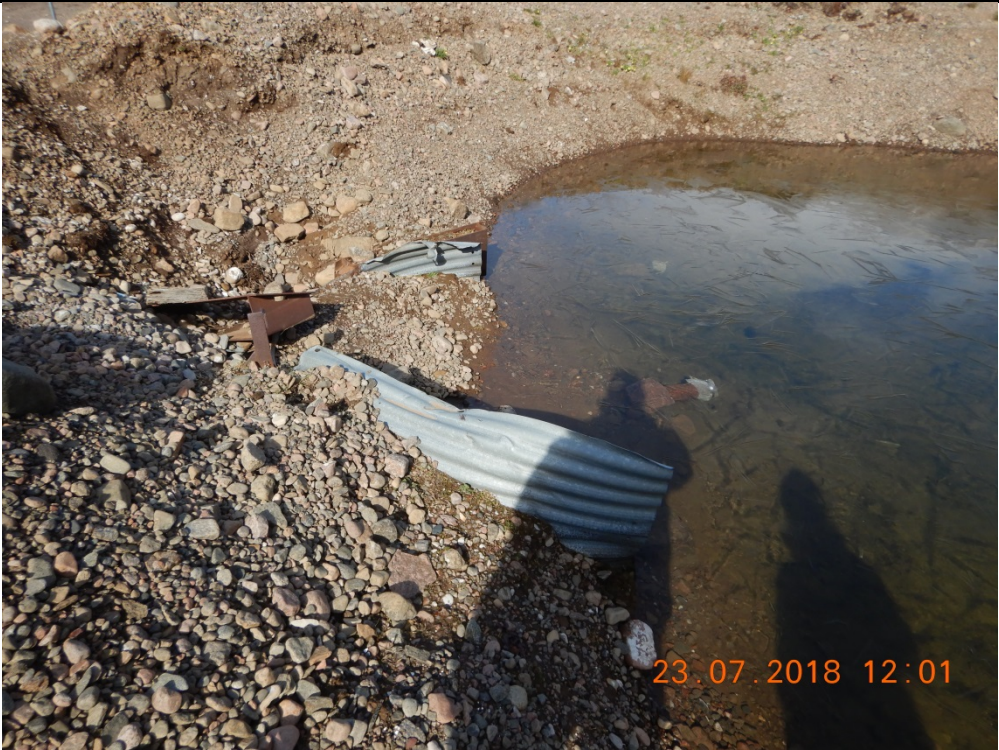
Photo Log #1	Location
Photo 2	Grise Fiord

Description: Intake Pipe within water reservoir with fish mesh screen

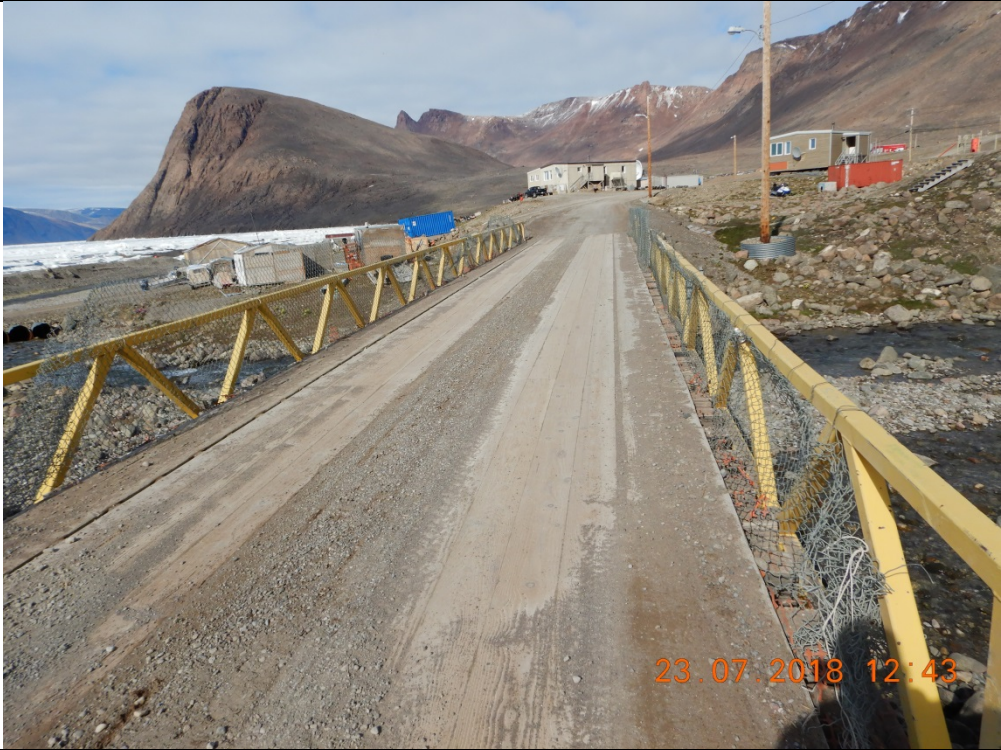
Photo 5

8. A bridge crossing was inspected within the community. No signs of erosion on the banks or sedimentation were observed in the fresh water. Buildup of sand was observed on the bridge. This buildup has the potential to spill over into the fresh water. A containment wall should be fixed onto the bridge, and maintained (Photo #5).

Description: Soil build up on bridge. No walls on bridge to prevent soil from falling into fresh water.

- Consolidate Hazardous Waste from Solid Waste Facility and deposit into Hazardous Waste section (See Photo #9)
- Build a containment wall on the bridge to mitigate the amount of soil falling into the river and causing sedimentation. (See Photo # 5)
- Erect fencing around the open pit burning section of the Solid Waste Facility to manage wind-blown litter(See Photo #8)
- Repair the roads around the culvert that has been exposed due to erosion (See Photo # 6)
- Remove scrap metal within the sewage lagoon. (See photo # 7)

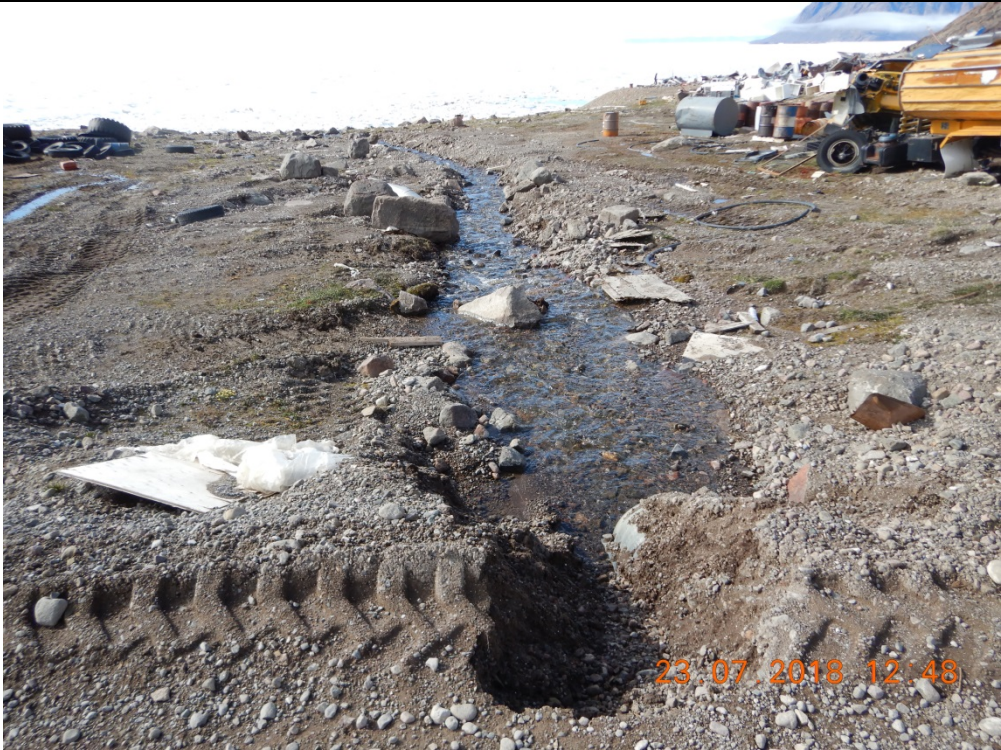
Photo 6

9. Culverts were inspected and some showed signs of erosion along the culvert on the road above it (Photo #6).

Description: Erosion around the culvert ahead of the Solid Waste Facility

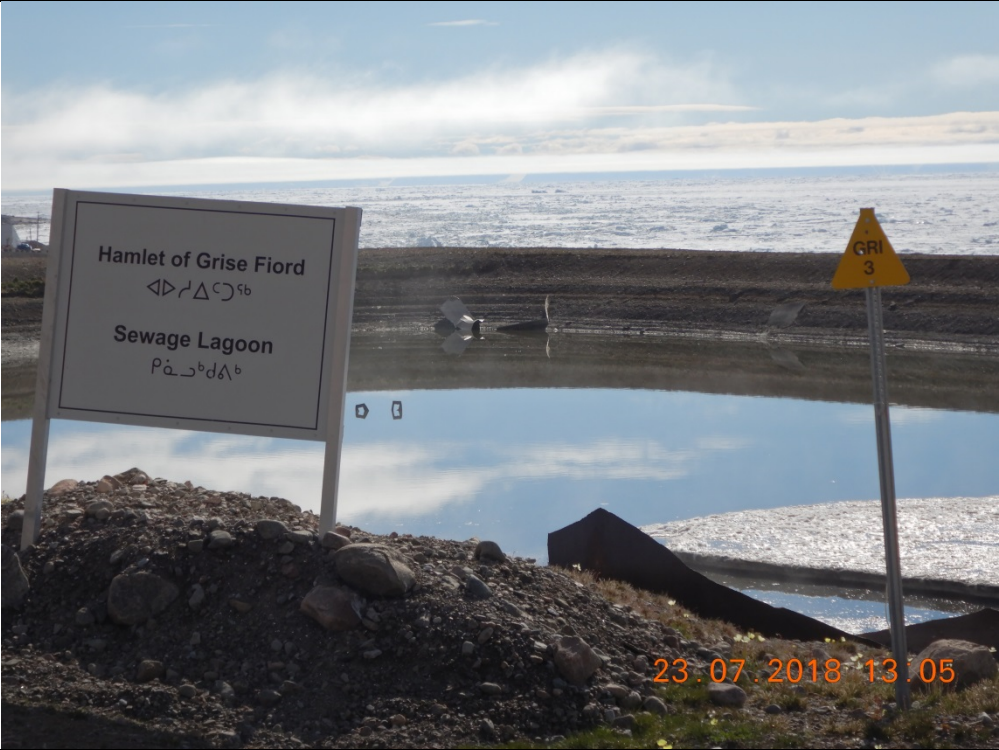
Photo 7

13. Metal waste was observed within the lagoon (Photo #7).
14. There was fencing packed away next to the lagoon which appeared to be ready to construct.

Description: bulk metal within the sewage lagoon

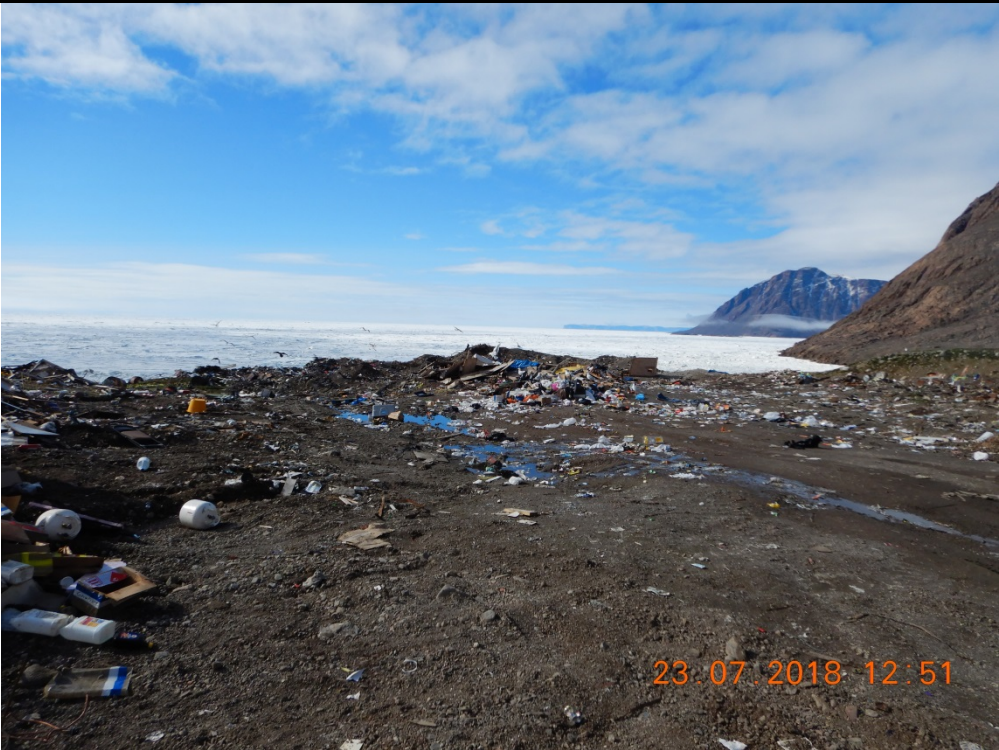
Photo 8

16. The land farm was segregated into Woods, Metals, Hazardous Wastes and Burnable Wastes.
17. The burnable waste is open pit burned, pushed off the end of that section then capped with soil. No fencing around the burnable waste (Photo#8).
18. The bulk metals contain white waste, and metal from construction. Hazardous Waste was observed at this site.
19. Wood waste was segregated, probably for the purpose of allowing the community help themselves to the wood wastes.
20. The Hazardous Waste sea can is mixed with the bulk metal waste. Lots of hazardous waste observed within the bulk metals (Photo # 9).
21. A yellow triangle sign titled GRI-2 was observed, which indicated a monitoring site. No Samples were taken on this inspection.

Description: No fencing to control wind-blown litter

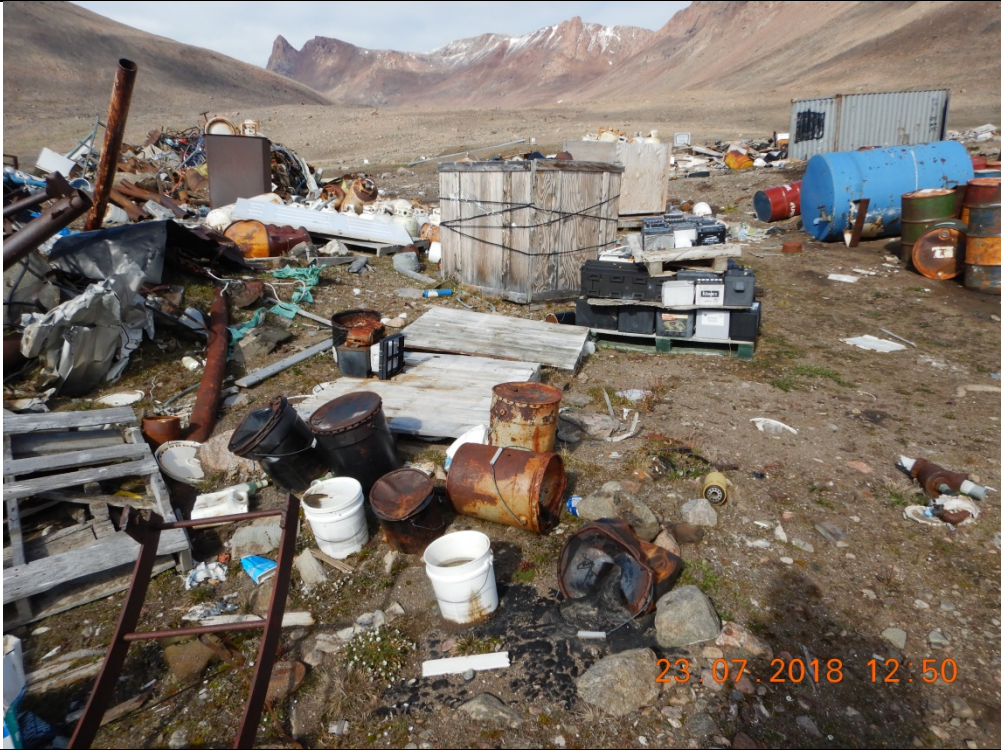
Photo Log # 1
Photo 9

Description: Hazardous Waste Batteries exposed to the elements within the Solid Waste Facility

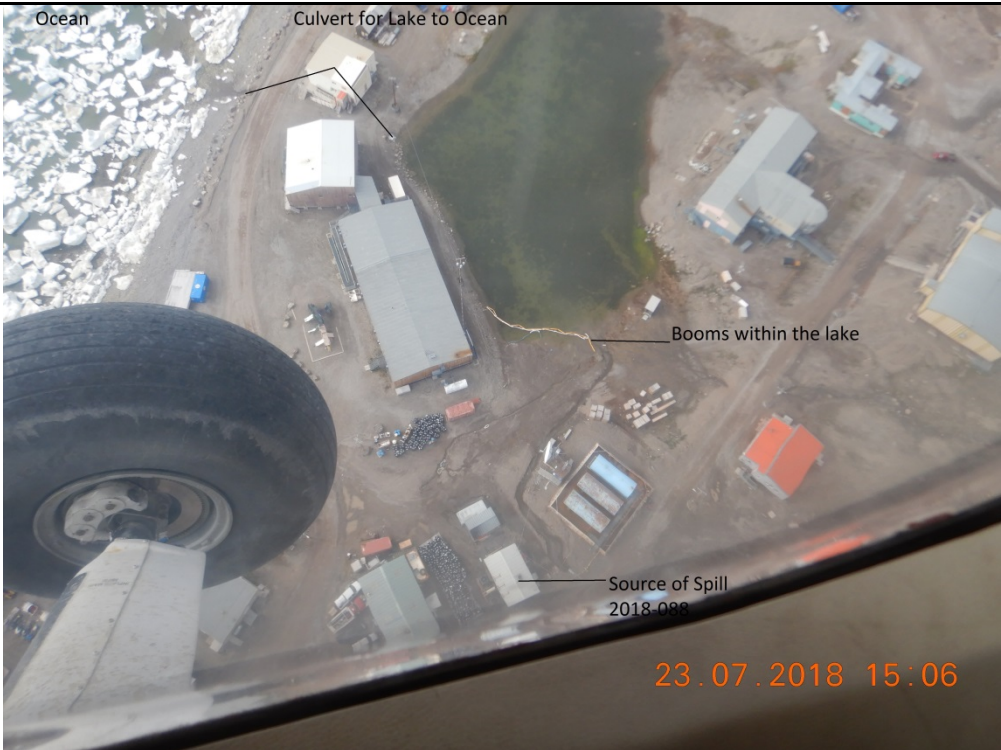
Photo Log # 1
Photo 10

- 22. Samples were taken at site of Spill Report N2018-088 – Qulliq Energy Corporation Power Plant Spill to verify if the spill did impact the fresh water lake within the community. (photo #10)
- 23. Samples were damaged enroute to Lab.
- 24. Observations were documented by photograph of the extent of the spill, and its migration to the fresh water lake. Notes and GPS Coordinates were taken. Further sampling will be required to verify if the fuel did migrate to the lake and sampling will conducted in the summer of 2019. Qulliq had deployed their spill contingency plan, although the Government of Nunavut – Environmental Protection Directorate is the lead on the spill report, there is a body of fresh water downgrade of the spill source, which triggers our participation in monitoring the spill in case the spill makes contact with the fresh body of water.

Description: Aerial Photograph of the spill site for Spill Report 2018-088
