WATER LICENCE INSPECTION FORM

Licensee		Licensee Representative	
Hamlet of Grise Fiord		Meghan Lusty	
Licence No. / Expiry		Representative's Title	
3BM-GRI2025			
Land / Other Authorizations		Land / Other Authorizations	
Date of Inspection		Inspector	
July 10, 2023		Joseph Monteith	
Activities Inspected			
<input type="checkbox"/> Camp	<input type="checkbox"/> Drilling	<input type="checkbox"/> Mining	<input type="checkbox"/> Construction
<input type="checkbox"/> Roads/Hauling	<input checked="" type="checkbox"/> Other: Potable Water Source, Waste Treatment Facility, and Solid Waste Facility	<input type="checkbox"/> Reclamation	<input type="checkbox"/> Fuel Storage

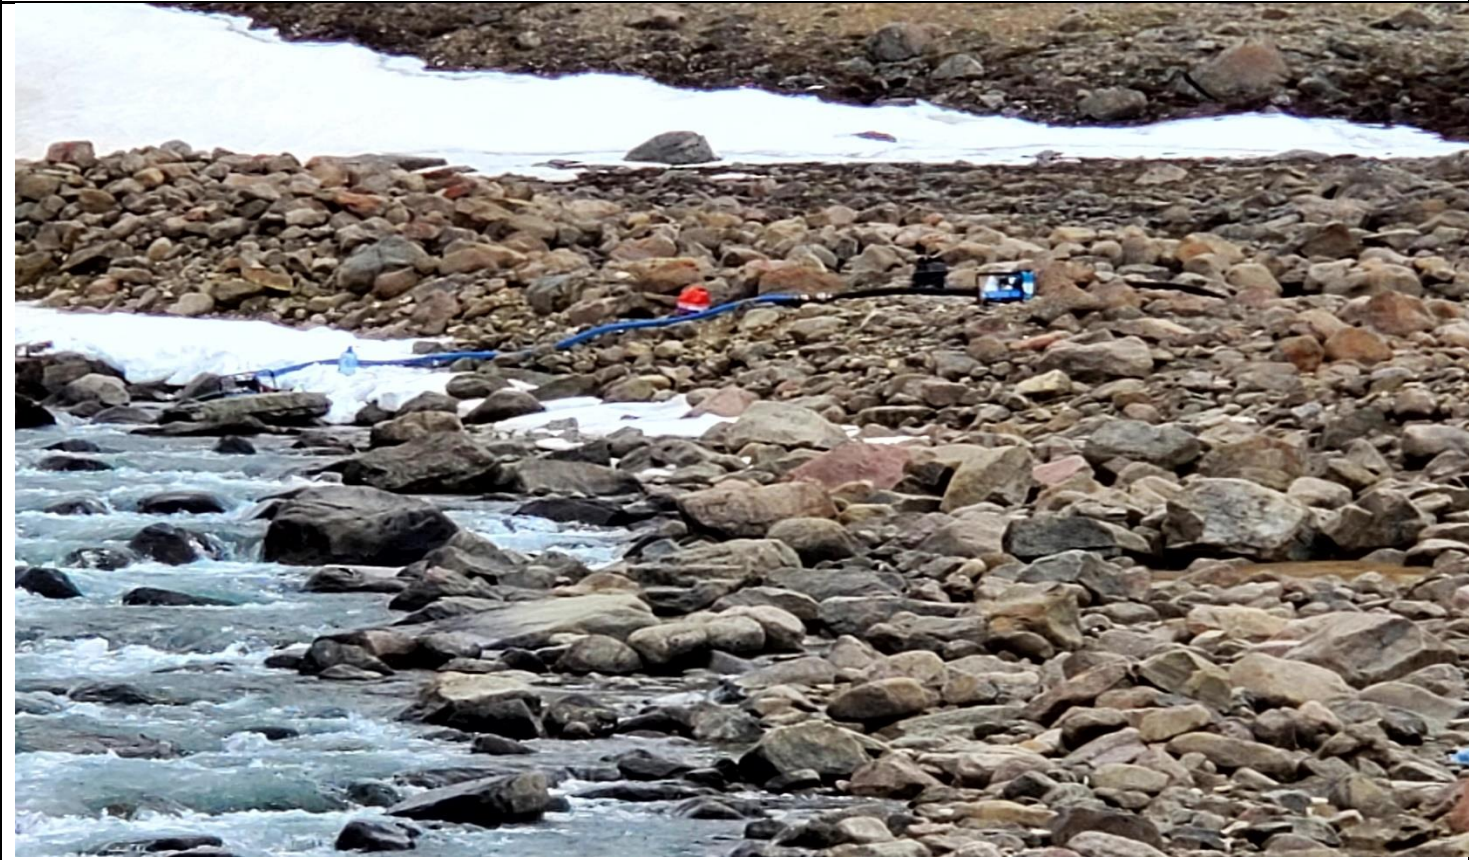
Photo Log	Location
Photo 2	Grise Fiord, NU

The secondary water source at airport river was observed with a water pump and hose (photo 2). The hose from the water pump deposited the water in the water reservoir.
4.

Description: Secondary Water Withdrawal from Airport River. Water pumps and hoses observed in place. Hose goes from Water pump to Water Reservoir. This was required after the damages to the water storage tank. An amendment to the water licenses has since made this apart of the water license.

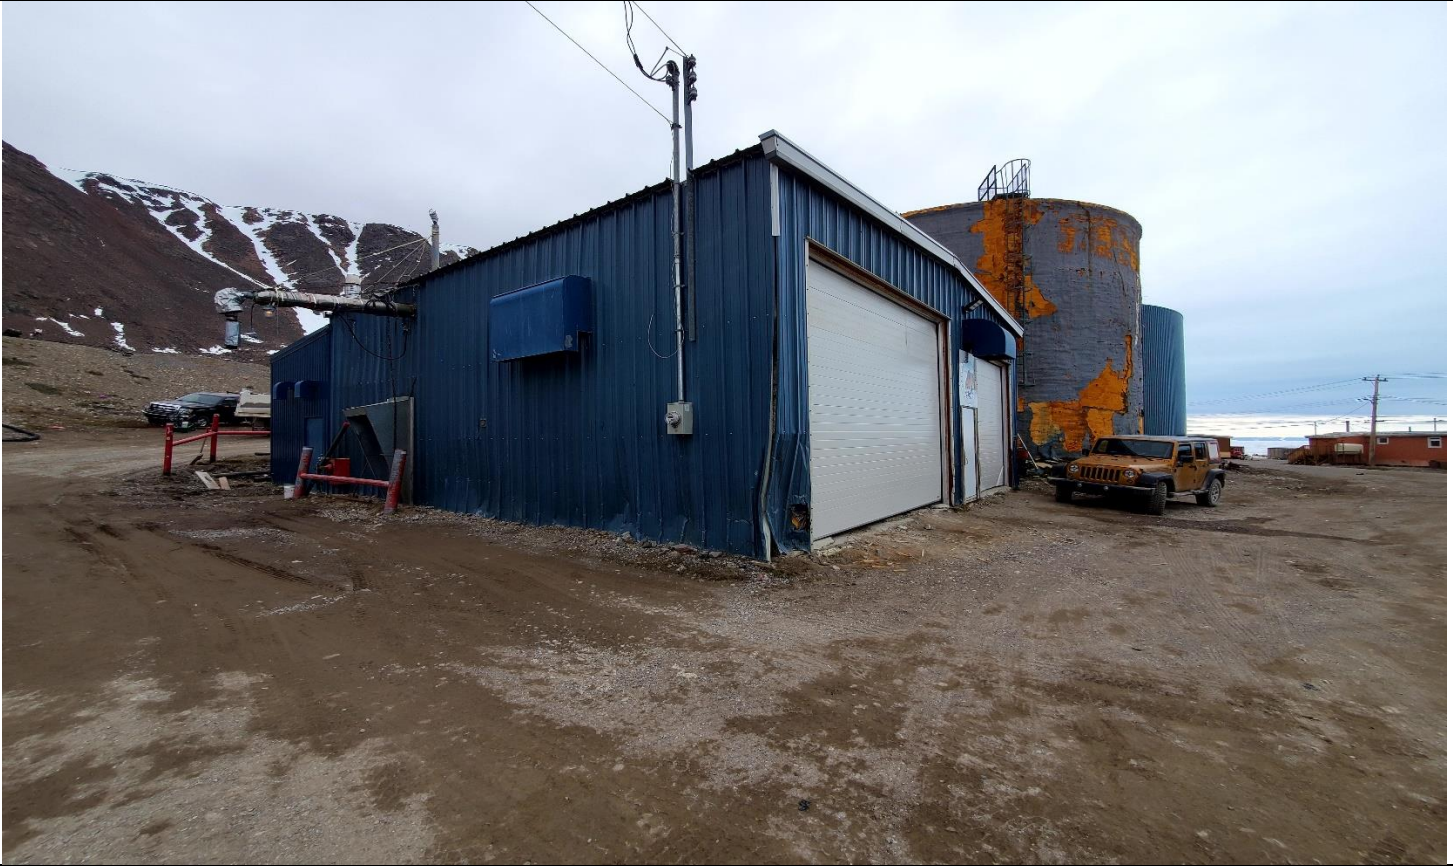
Photo Log  
Photo 5

The Water Treatment Plant, and its inner pipes (photo 5 &6).
7.

Description: 3x Water Storage Tanks. 1 of 3 Water Storage Tanks damaged, and decommissioned. Truck refill station.

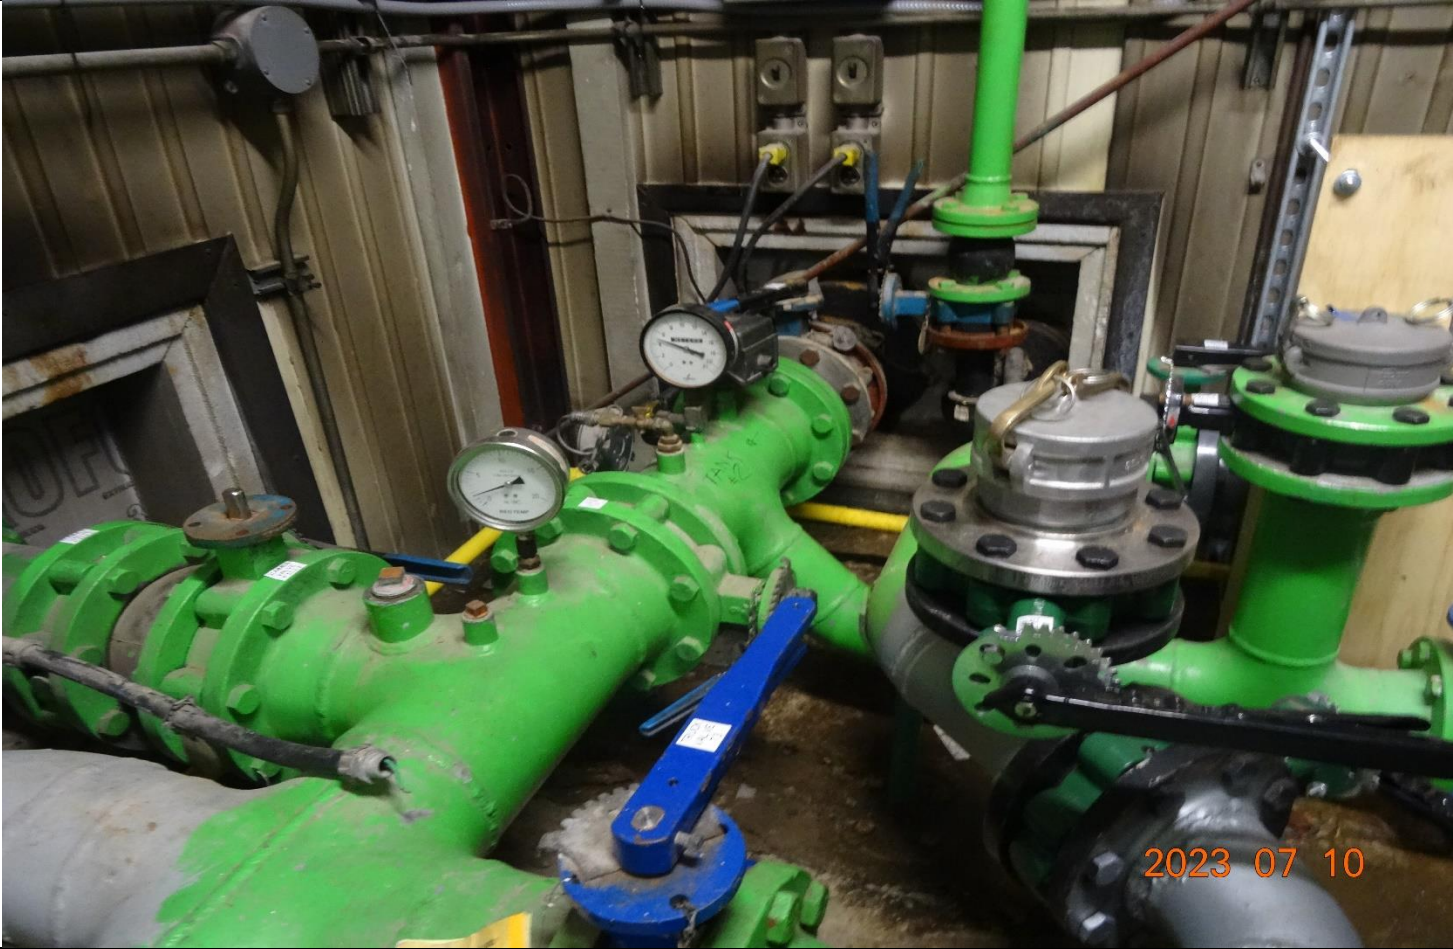
Photo Log  
Photo 6

Description: Internal piping to distribute water to the 3 different water storage tanks. Water comes in from the reservoir on the left, and is distributed to the two working water storage tanks.

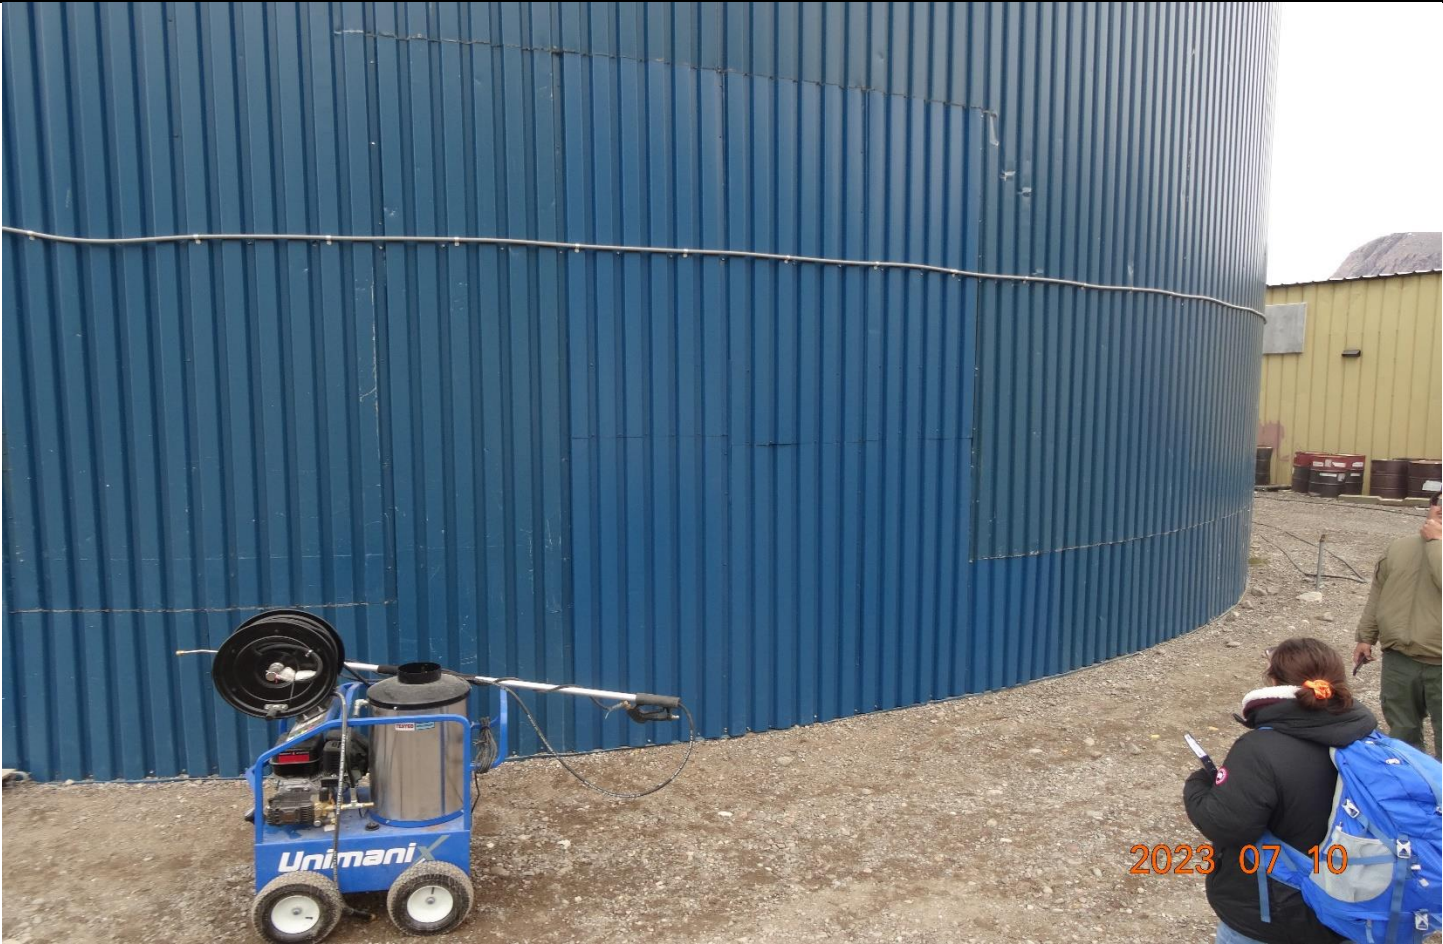
Photo Log  
Photo 8

Water Storage Tank damaged in 2018 was repaired in 2023. Equipment outside of tank (photo 8).
9.

Description: Water Storage Tank repair complete.

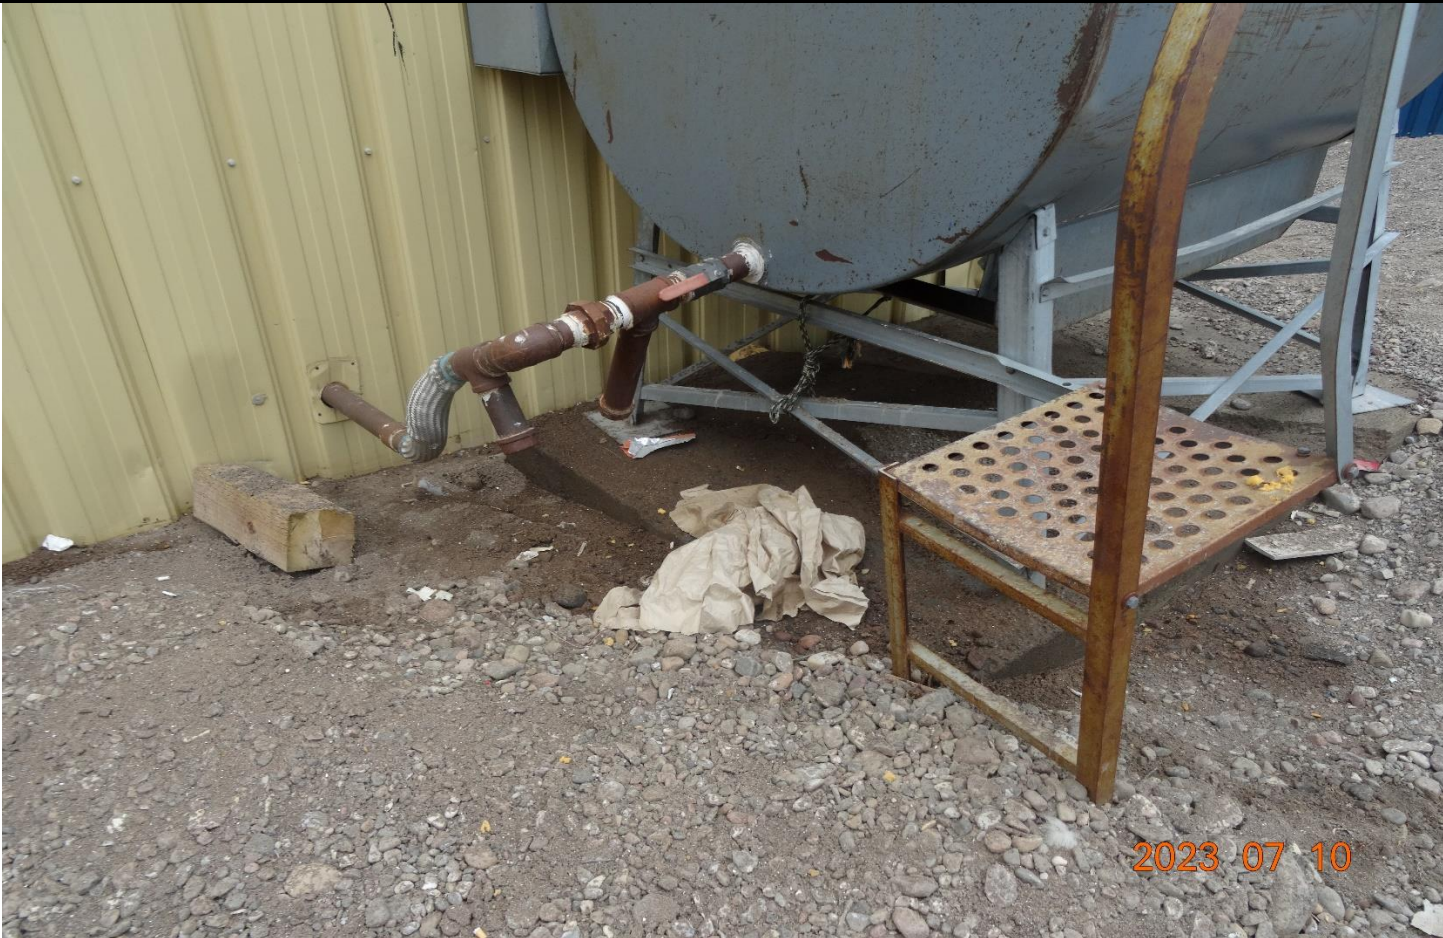
Photo Log  
Photo 9

Spill observed in 2022, not reported and covered in gravel(photo 9).

Description: Spill observed in 2021, covered with gravel.

- Item 6. The Licensee shall, during the term of this Licence, undertake the following activities in addition to any other required action should an unauthorized discharge of waste occur or if such a discharge is foreseeable:

- a. Employ the appropriate contingency measures as approved under the Spill Contingency Plan for the Hamlet of Grise Fiord;
  - b. Report the incident immediately via the NWT/NU 24-Hour Spill Reporting Line at (867) 920-8130 and to the Inspector at (867) 975-4295; and

- c. Submit to the Inspector, a detailed report on each occurrence, not later than thirty (30) days after initially reporting the event, that provides the necessary information on the location (including the GPS coordinates), initial response action, remediation/clean-up, status of response (ongoing, complete), proposed disposal options for dealing with contaminated materials and preventative measures to be implemented.

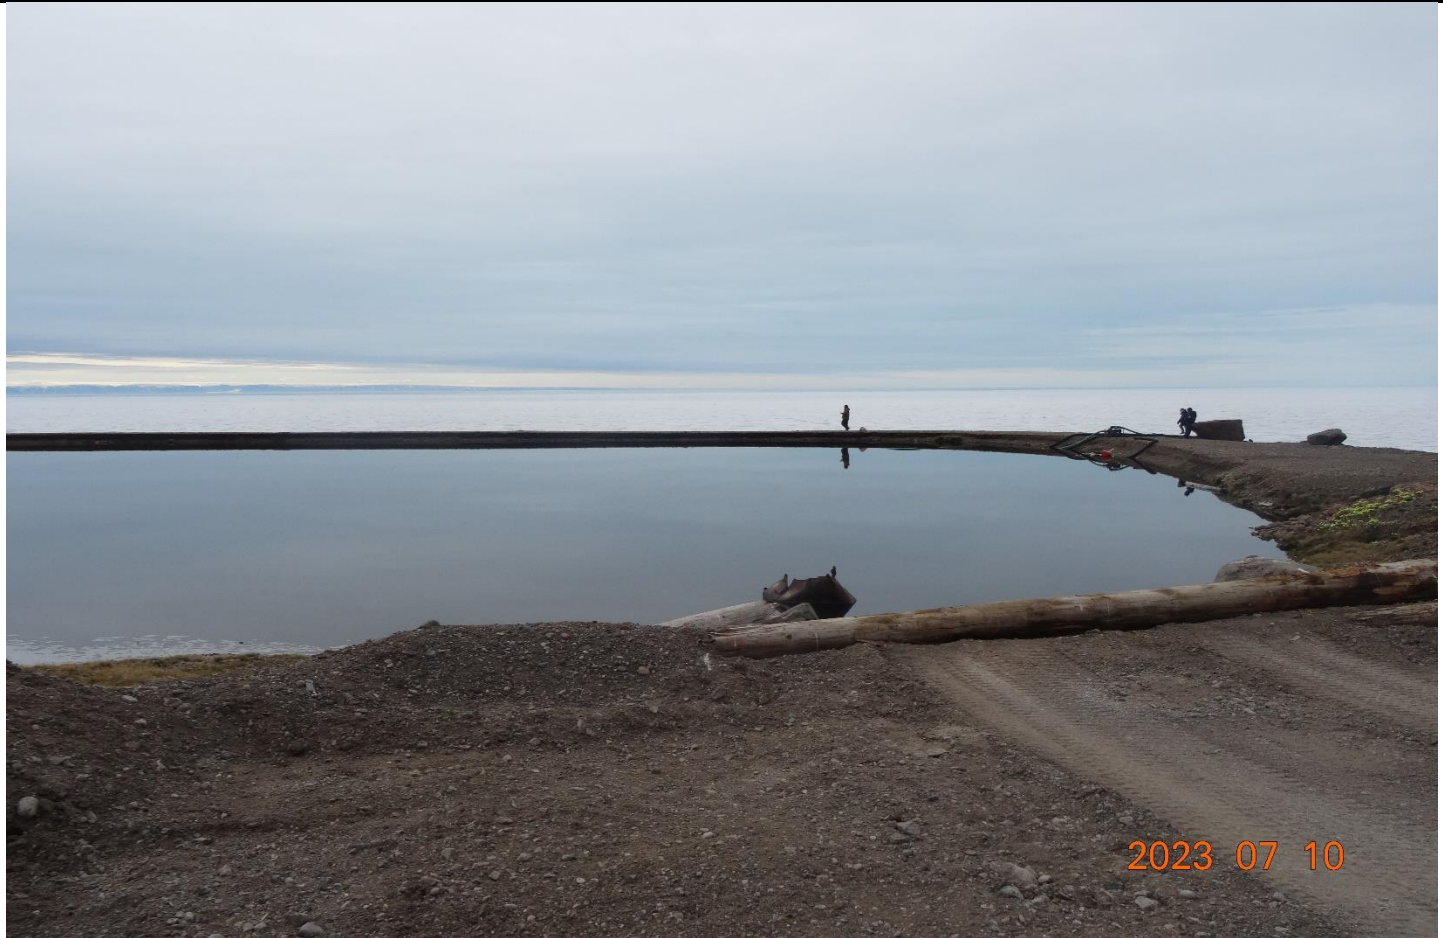
Photo Log  
Photo 10

The walls of the sewage lagoon appeared to be working as intended, with no signs of erosion or leaks. The freeboard was below the 1 metre freeboard (photo 10).
13.

Description: The sewage lagoon Freeboard less than 1 metre

Item 4. The Licensee shall maintain at all times, a Freeboard of at least 1.0 metre, or as recommended by a qualified Geotechnical Engineer and as approved by the Board in writing, for all dams, dykes or other structures intended to contain, withhold, divert or retain Water or Waste.

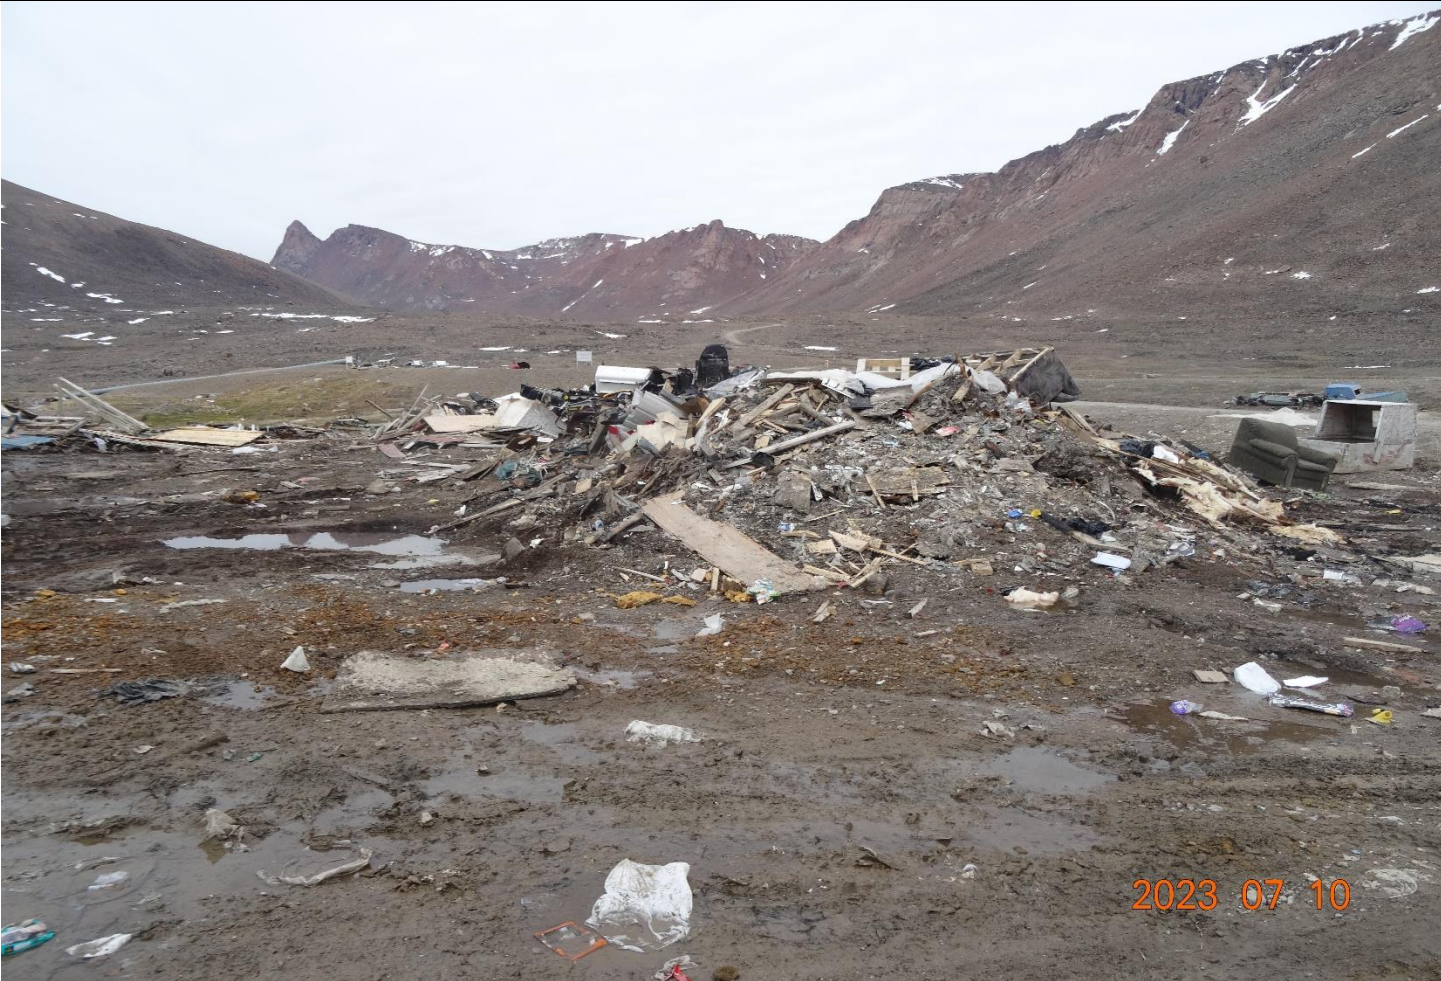
Photo 11

Wood waste was segregated, probably for the purpose of allowing the community help themselves to the wood wastes ( photo 11).
19.

Description: Pile of bulk wood, in the Bulk Woods Section of the Solid Waste Facility

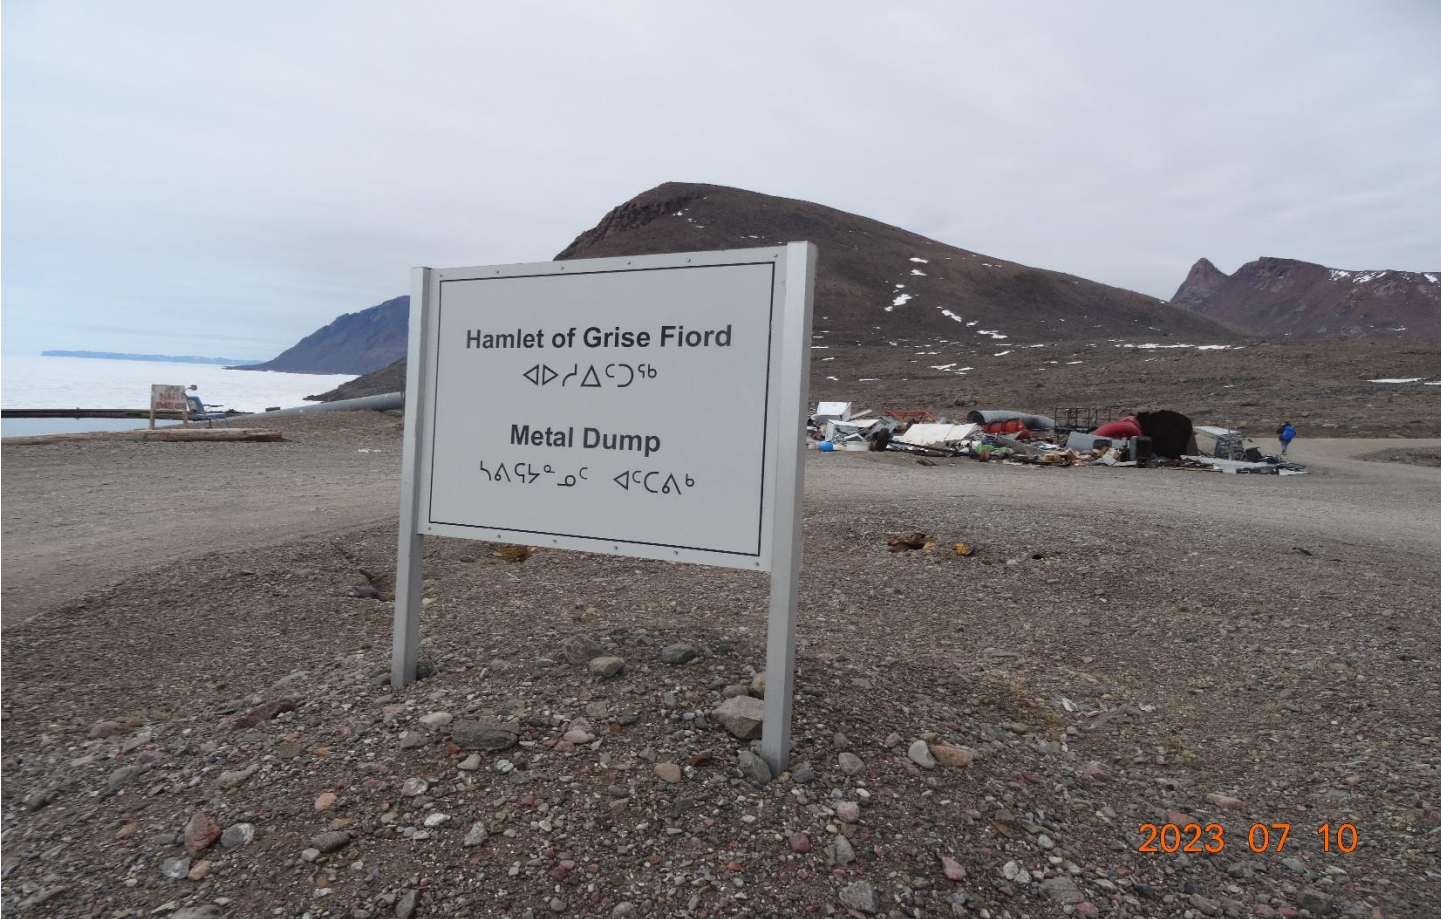
Photo 12

Description: Bulk Metals section of the Solid Waste Facility

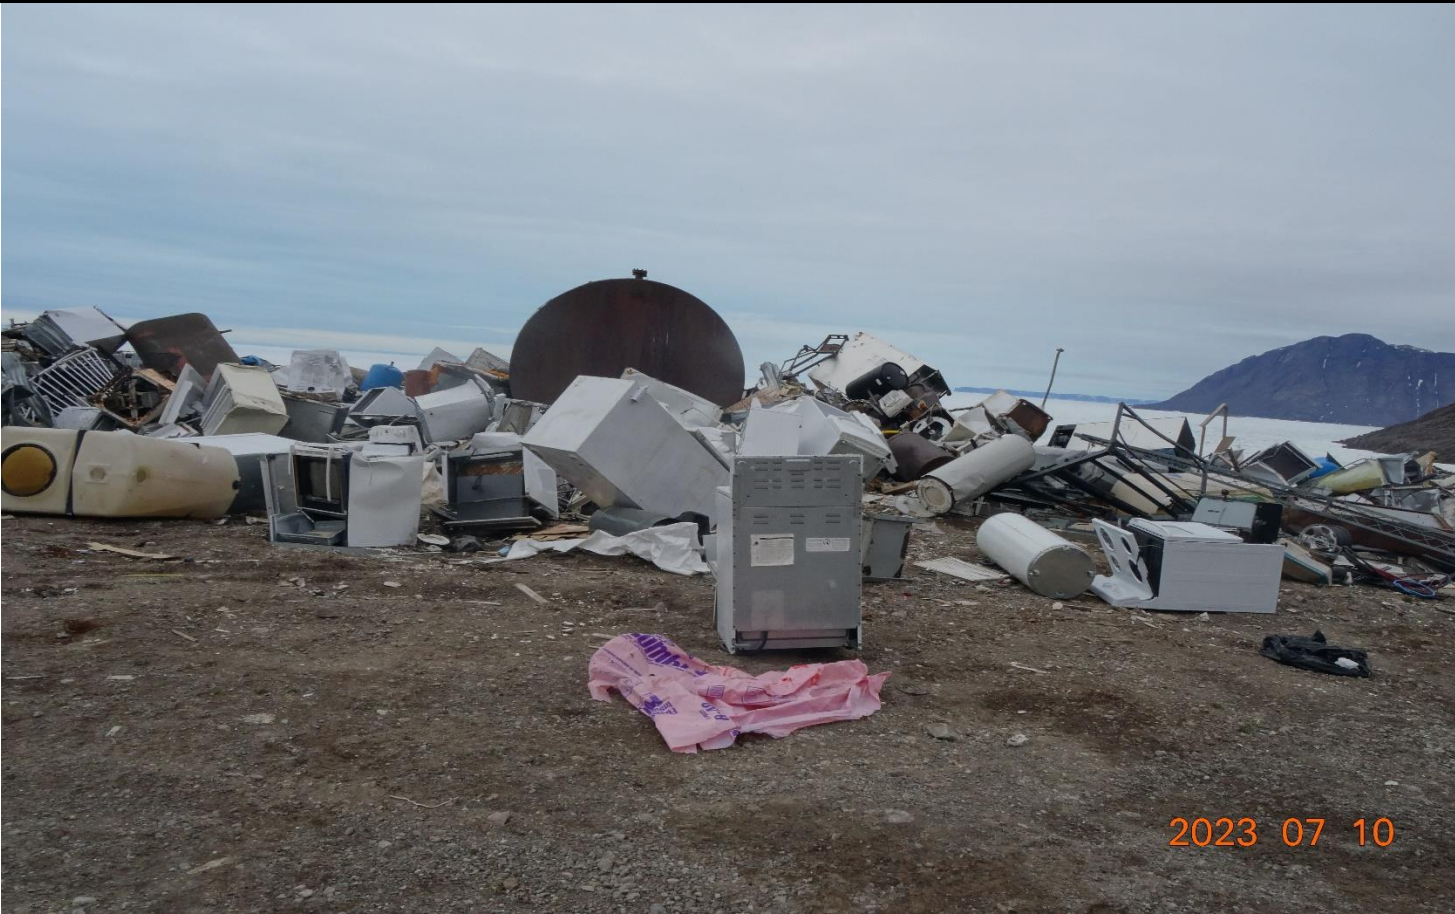
Photo 13

The bulk metals contain white waste, and metal from construction. Hazardous Waste was observed at this site (photo 13).
18.

Description: Bulk Metal waste. White waste includes freezers, fridges, washers and dryers. Segregated from other wastes.

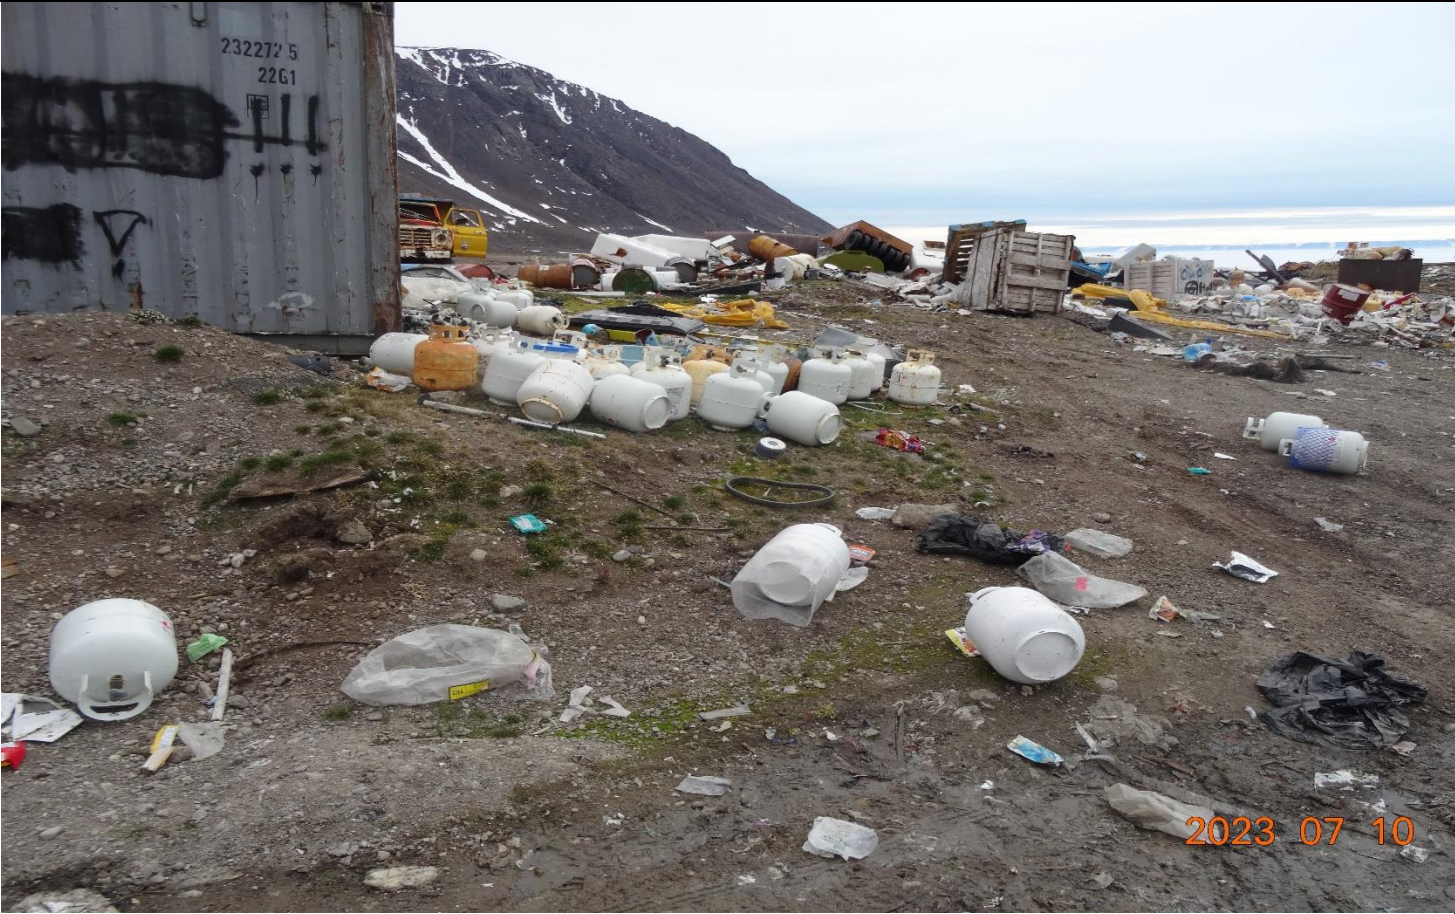
Photo 14

The Solid Waste Facility was loosely segregated into Woods, Metals, Hazardous Wastes and Burnable Wastes (photo 14).
16.

The Hazardous Waste sea can is mixed with the bulk metal waste. Lots of hazardous waste observed within the bulk metals (photo 14,15,16 ).
20.

Description: Empty Propane tanks segregated away from the other wastes.

- Separate bulk metals, bulk wood, domestic waste, and hazardous waste to be in line with National Standards for the management of Solid Waste Facilities.
- Divert surface water run off away from Solid Waste Facility to mitigate the amount of wastes migrating to the receiving marine environment.
- Email [joseph.monteith@rcaanc-cirnac.gc.ca](mailto:joseph.monteith@rcaanc-cirnac.gc.ca) notifying the inspector the intent to decant the sewage lagoon.
- Send WRO Monteith sample results ahead of a decant of the sewage lagoon.
- Maintain a 1 metre freeboard at the sewage lagoon.
- Verify whether there is Fish Mesh Screen on the intake hose at Airport River secondary water source, and the water source with the green hose.

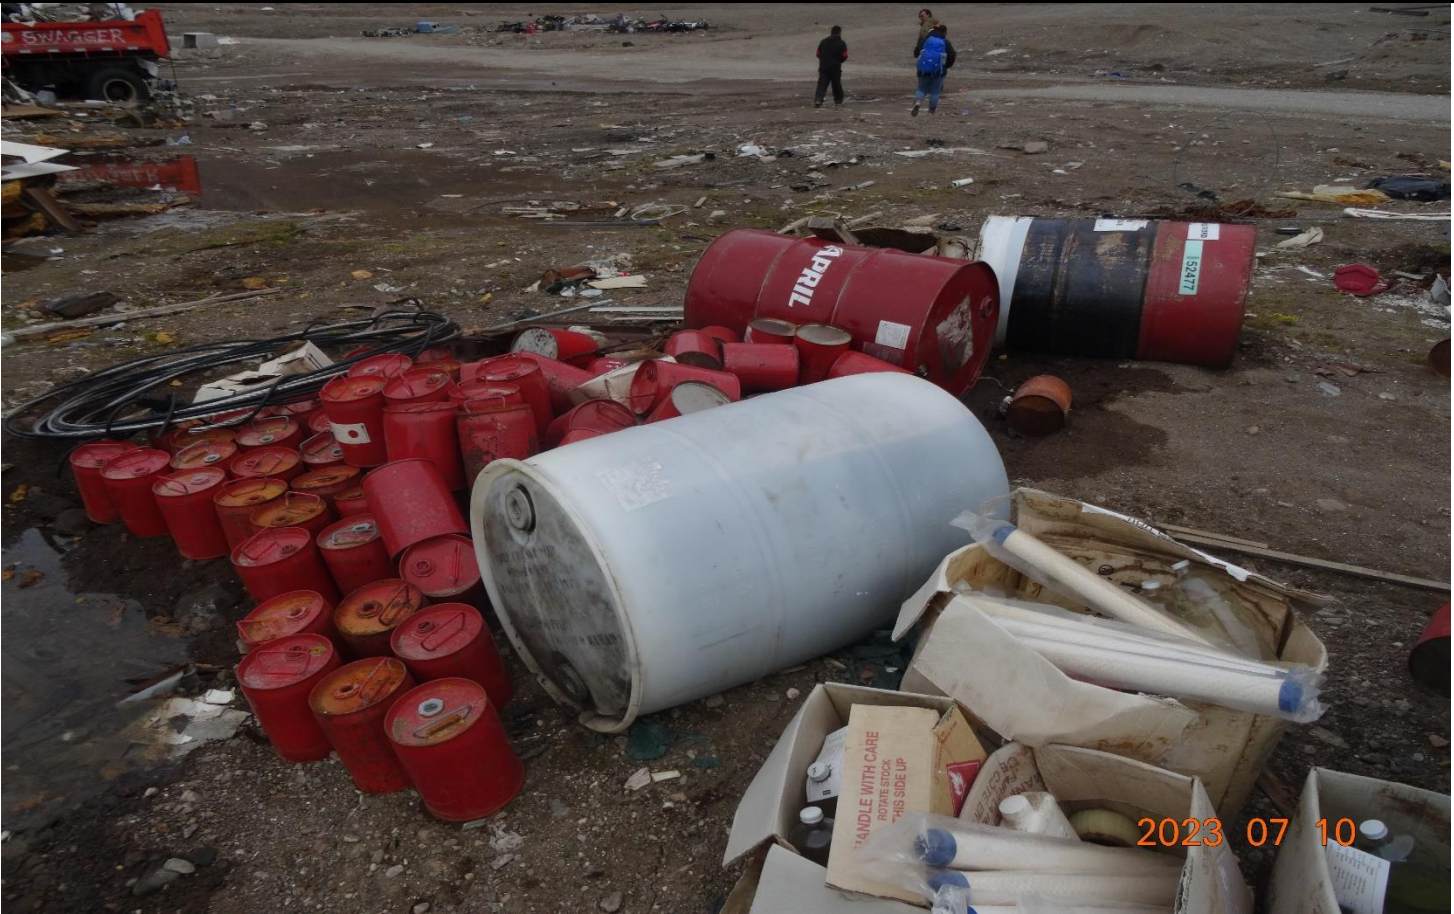
Photo 15

Description: empty fuel test containers. Signs of spills from larger drums.

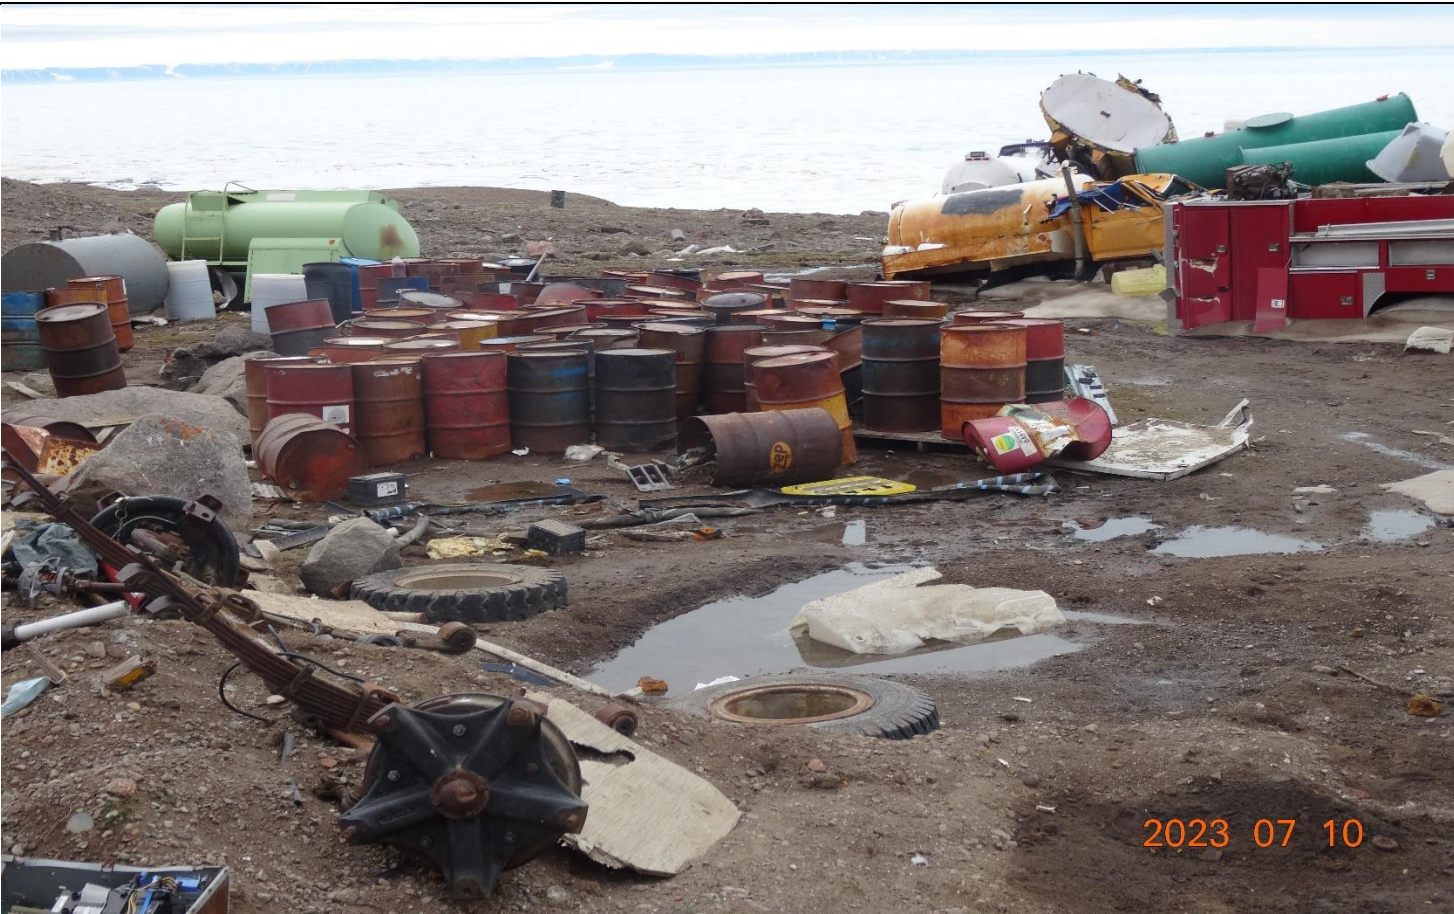
Photo 16

Description: Hazardous waste drums not in secondary containment.

Item 8. The Licensee shall segregate and store all hazardous materials and/or hazardous Waste within the Solid Waste Disposal Facility in such a manner as to prevent the deposit of deleterious substances into any Water, until such a time that the materials have been removed for proper disposal at an approved facility.

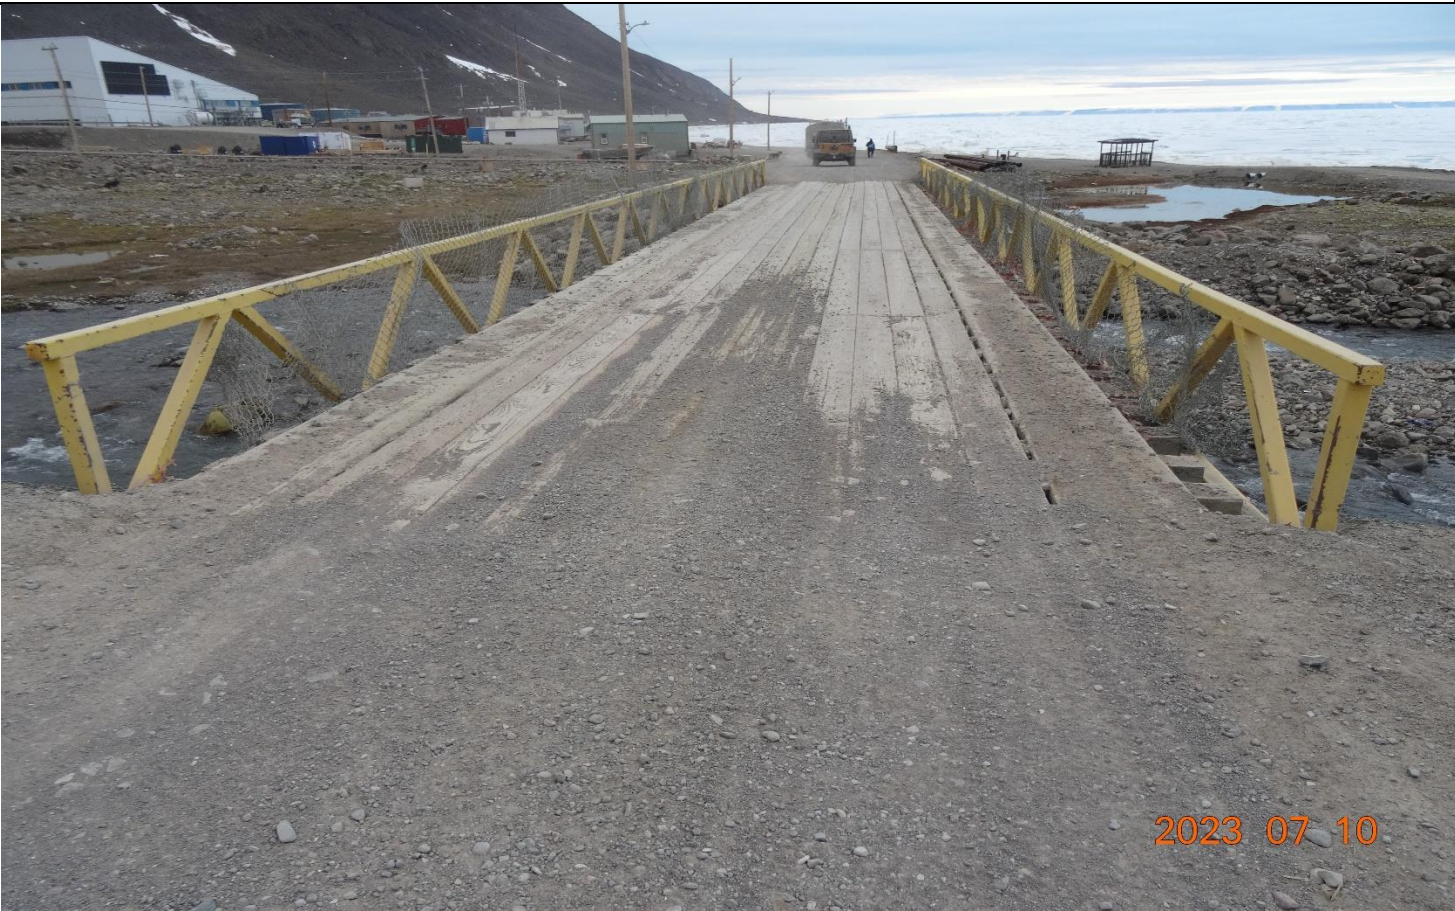
Photo 17

A bridge crossing was inspected within the community. No signs of erosion on the banks or sedimentation were observed in the fresh water. Buildup of sand was observed on the bridge. This buildup has the potential to spill over into the fresh water. A containment wall should be fixed onto the bridge, and maintained to prevent sedimentation into the river (photo 17).
10.

Description: Soil build up on bridge. No walls on bridge to prevent soil from falling into fresh water.

Item 5. The Licensee shall implement sediment and erosion control measures, prior to and during operations, to prevent entry of sediment into Water.
