WATER LICENCE INSPECTION FORM

Licensee		Licensee Representative	
Hamlet of Grise Fiord		Gord Marinic	
Licence No. / Expiry		Representative's Title	
3BM-GRI2025		Regional Engineer	
Land / Other Authorizations		Land / Other Authorizations	
Date of Inspection		Inspector	
July 5, 2022		Joseph Monteith	
Activities Inspected			
<input type="checkbox"/> Camp	<input type="checkbox"/> Drilling	<input type="checkbox"/> Mining	<input type="checkbox"/> Construction
<input type="checkbox"/> Roads/Hauling	<input checked="" type="checkbox"/> Other: Potable Water Source, Waste Treatment Facility, and Solid Waste Facility	<input type="checkbox"/> Reclamation	<input type="checkbox"/> Fuel Storage

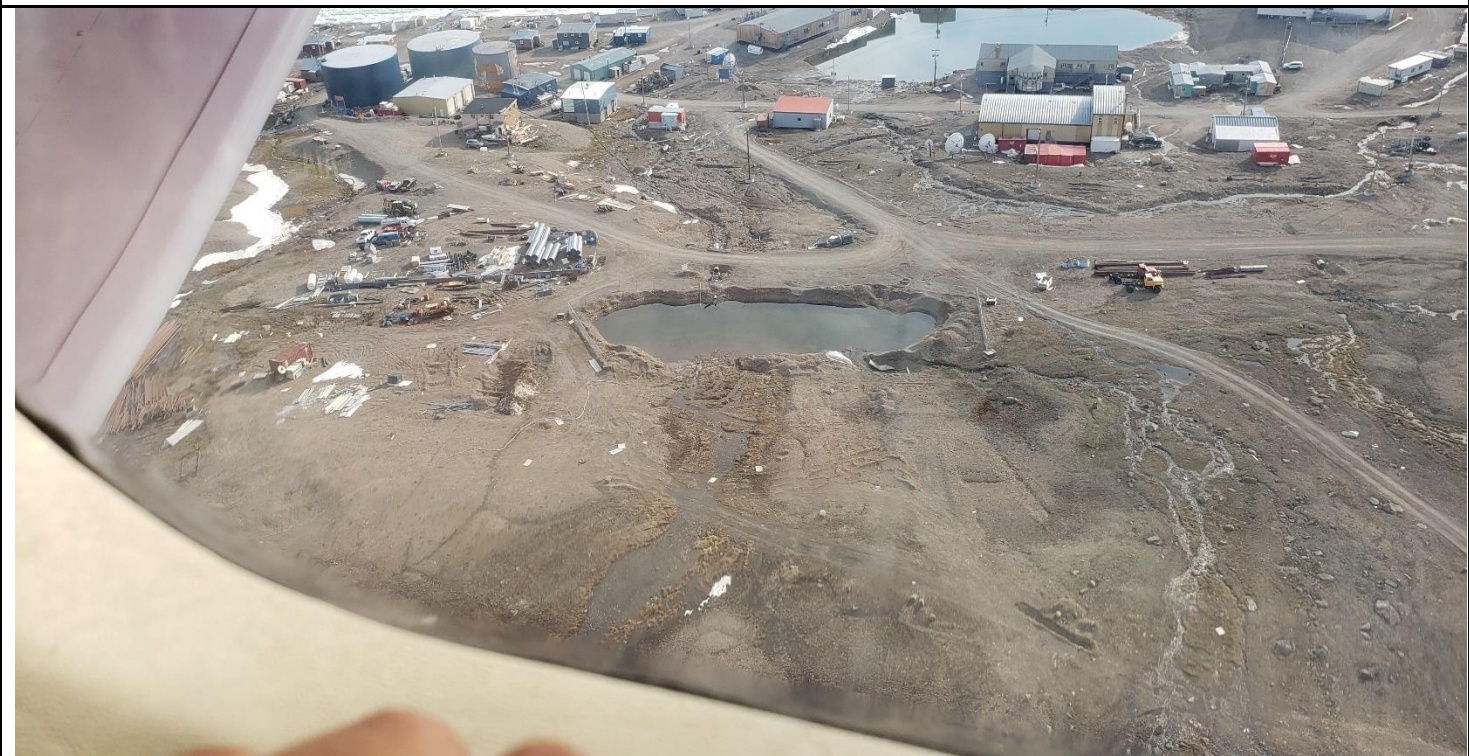
Date	Camera	Inspector	
July 5, 2022	Galaxy S9	Joseph Monteith	
Photo Log #1		Location	
Photo 1		Grise Fiord, NU

1. Water withdrawal is conducted from a glacier run-off stream that meanders down to the Hamlet of Grise Fiord from the mountain above Grise Fiord. A pond with walls that extend up approximately a metre and a half catches water run-off, and pools up. Fencing was being erected around the ponds at the time of the inspection. Due to the repairs to the storage tank, water truck withdrawal was required. No sign of fish mesh screen (photo 1,3,4).

Description: Water Source, Non-Engineered water reservoir. Water Treatment Plant, and Water Storage Tanks top left of photo.

- Verify whether there is Fish Mesh Screen on the intake hose at Airport River secondary water source, and the water source with the green hose.

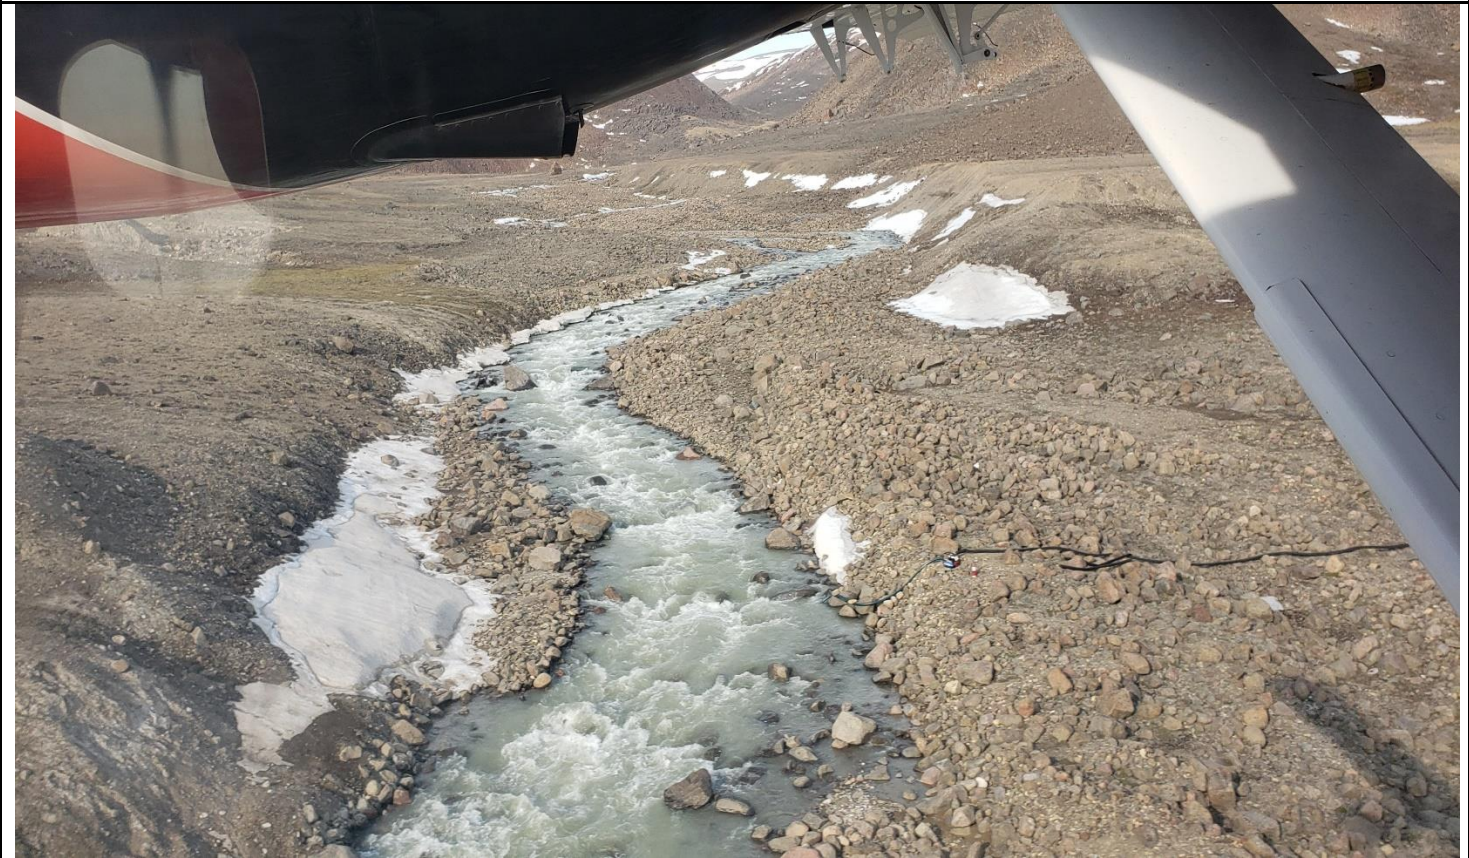
Photo 2	Grise Fiord, NU
---------	-----------------

2. At the time of the inspection a yellow triangle sign was observed titled GRI-1. A monitoring station as listed in the water licence.
3. The secondary water source at airport river was observed with a water pump and hose (photo 2). The hose from the water pump deposited the water in the water reservoir.

Description: Secondary Water Withdrawal from Airport River. Water pumps and hoses observed in place. Hose goes from Water pump to Water Reservoir.

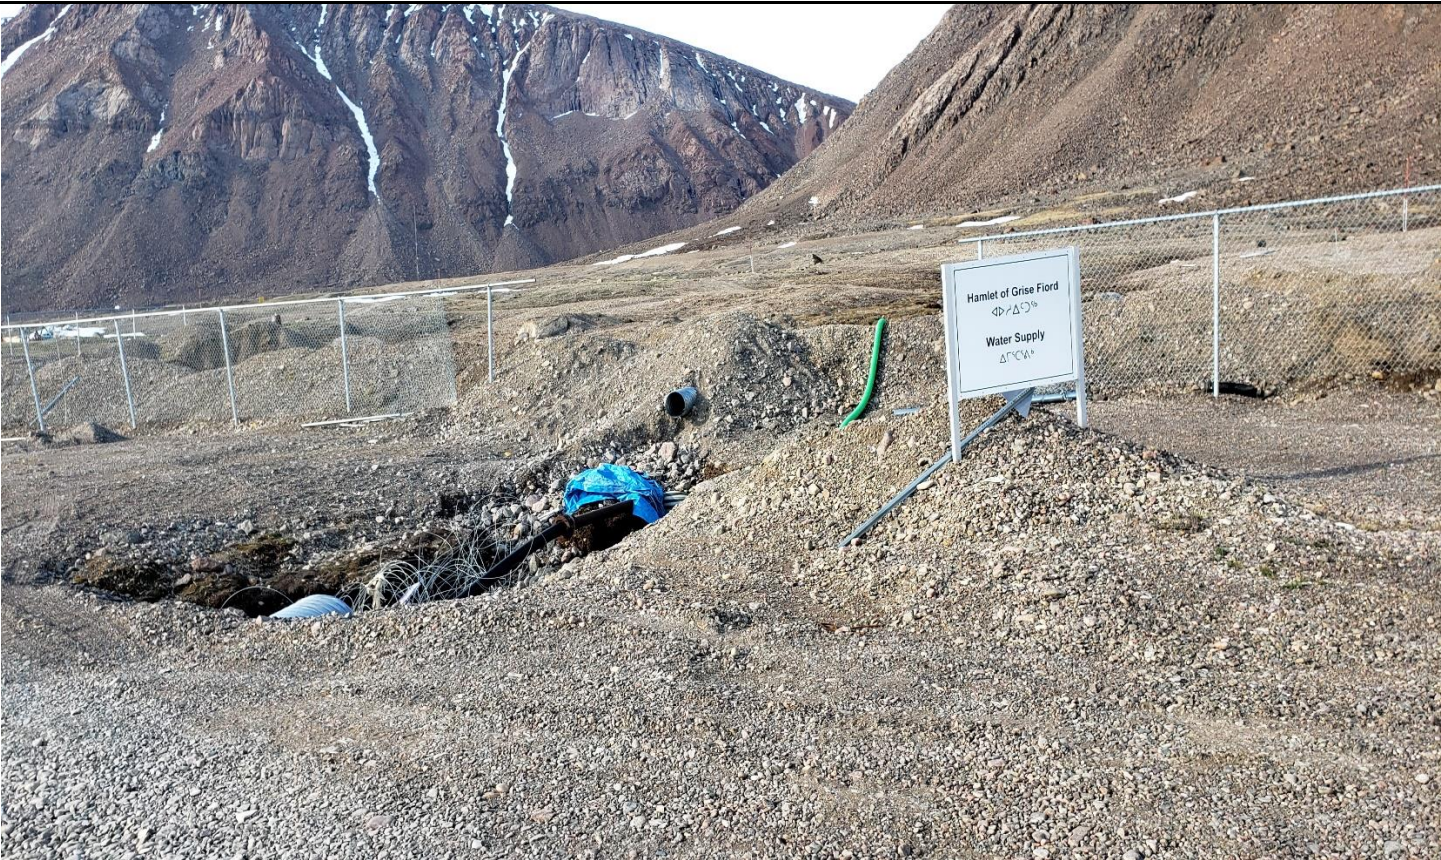
Photo 3

Description: Sign Reads Hamlet of Grise Fiord, Water Supply

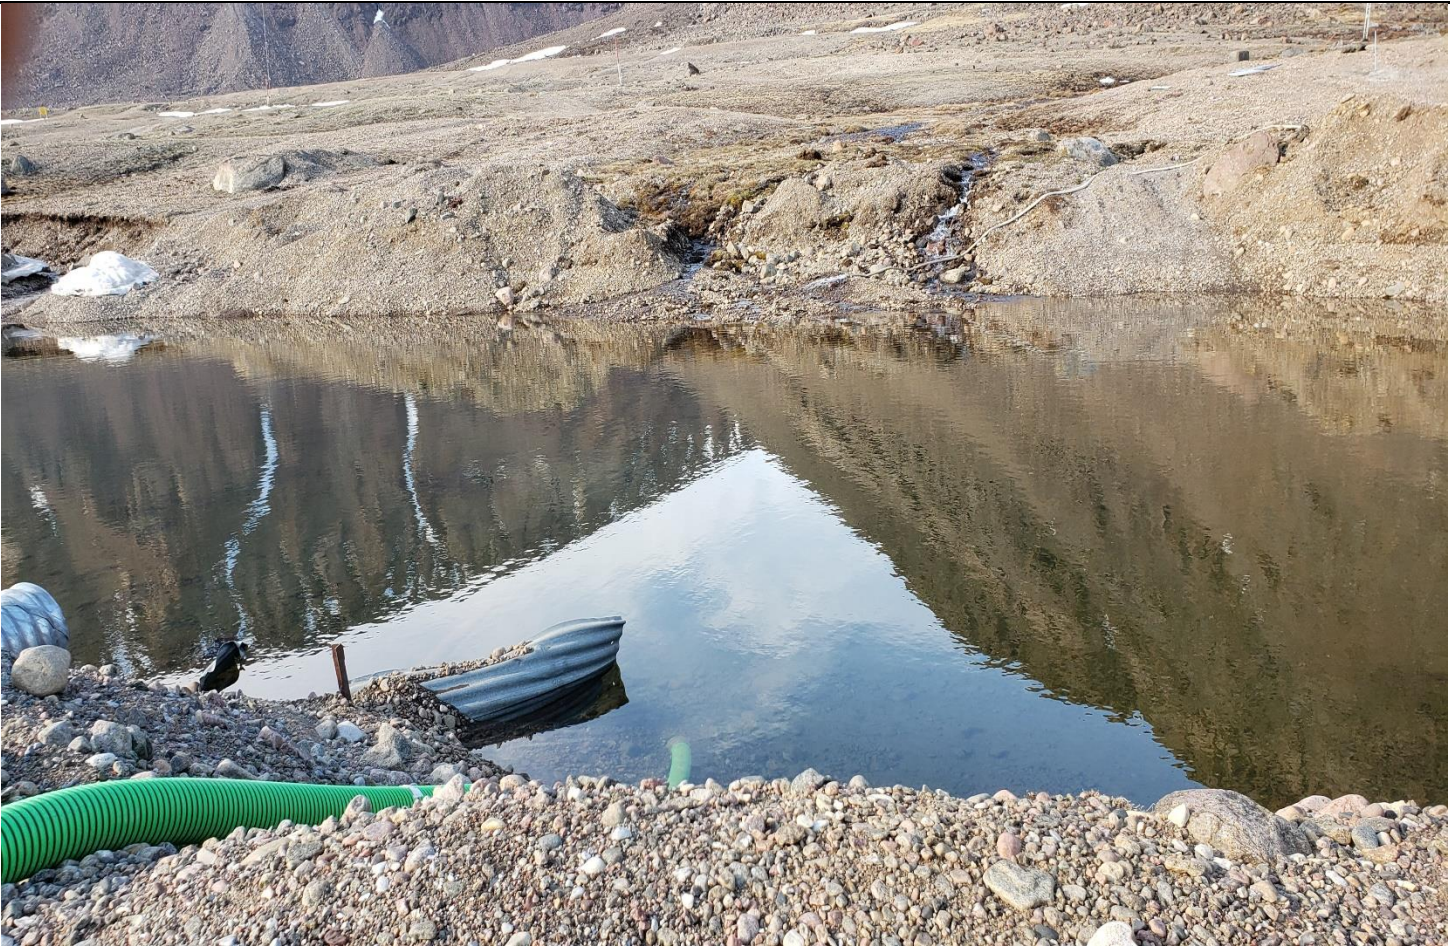
Photo 4

Description: Green Hose may have been used to withdrawal water while the water storage tanks are repaired.

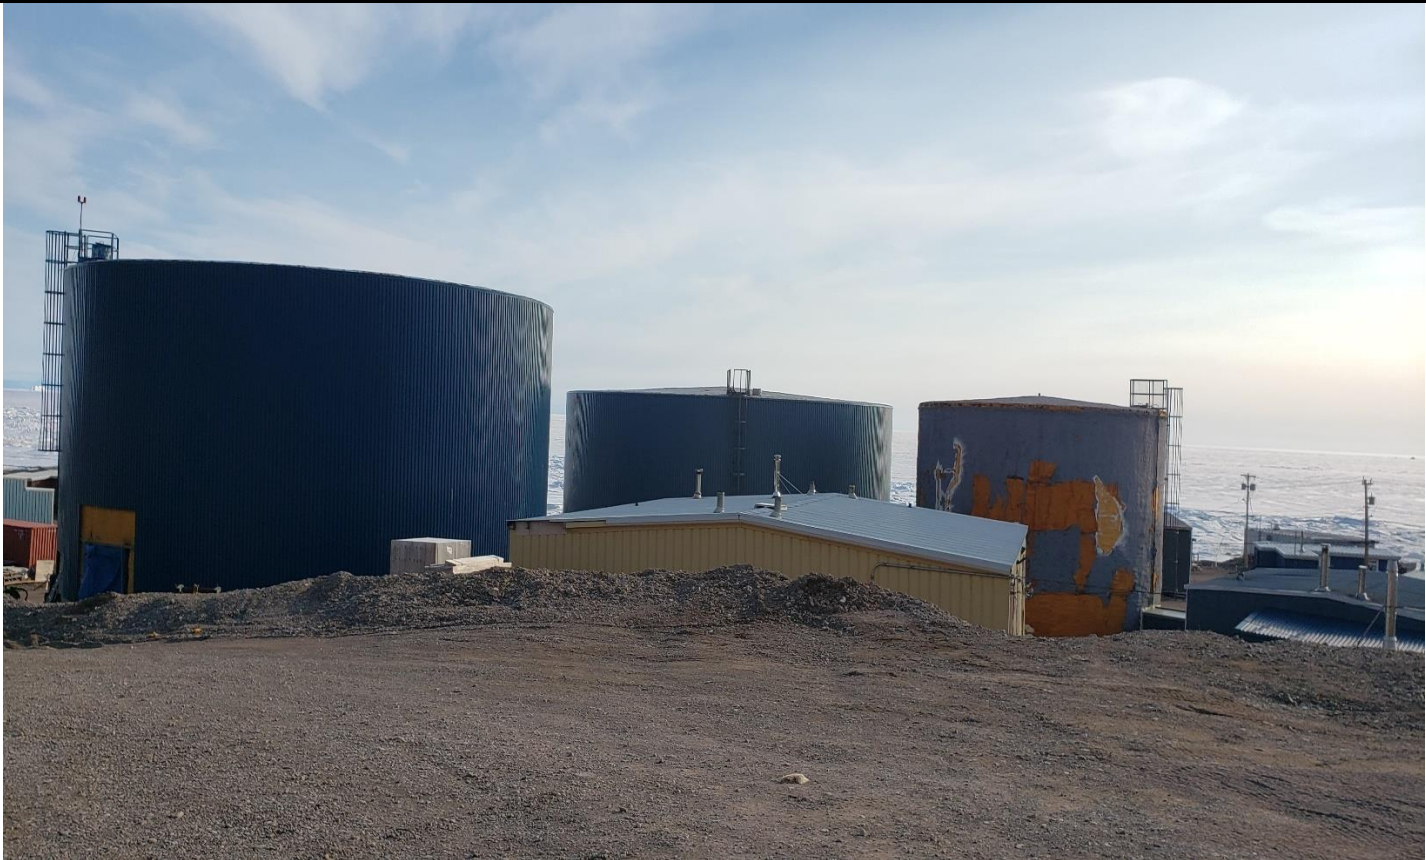
Photo 5

Description: 3x Water Storage Tanks. 2 of 3 Water Storage Tanks damaged. Of the 2 damaged storage tanks, 1 was being repaired (left tank). The other decommissioned (right tank).

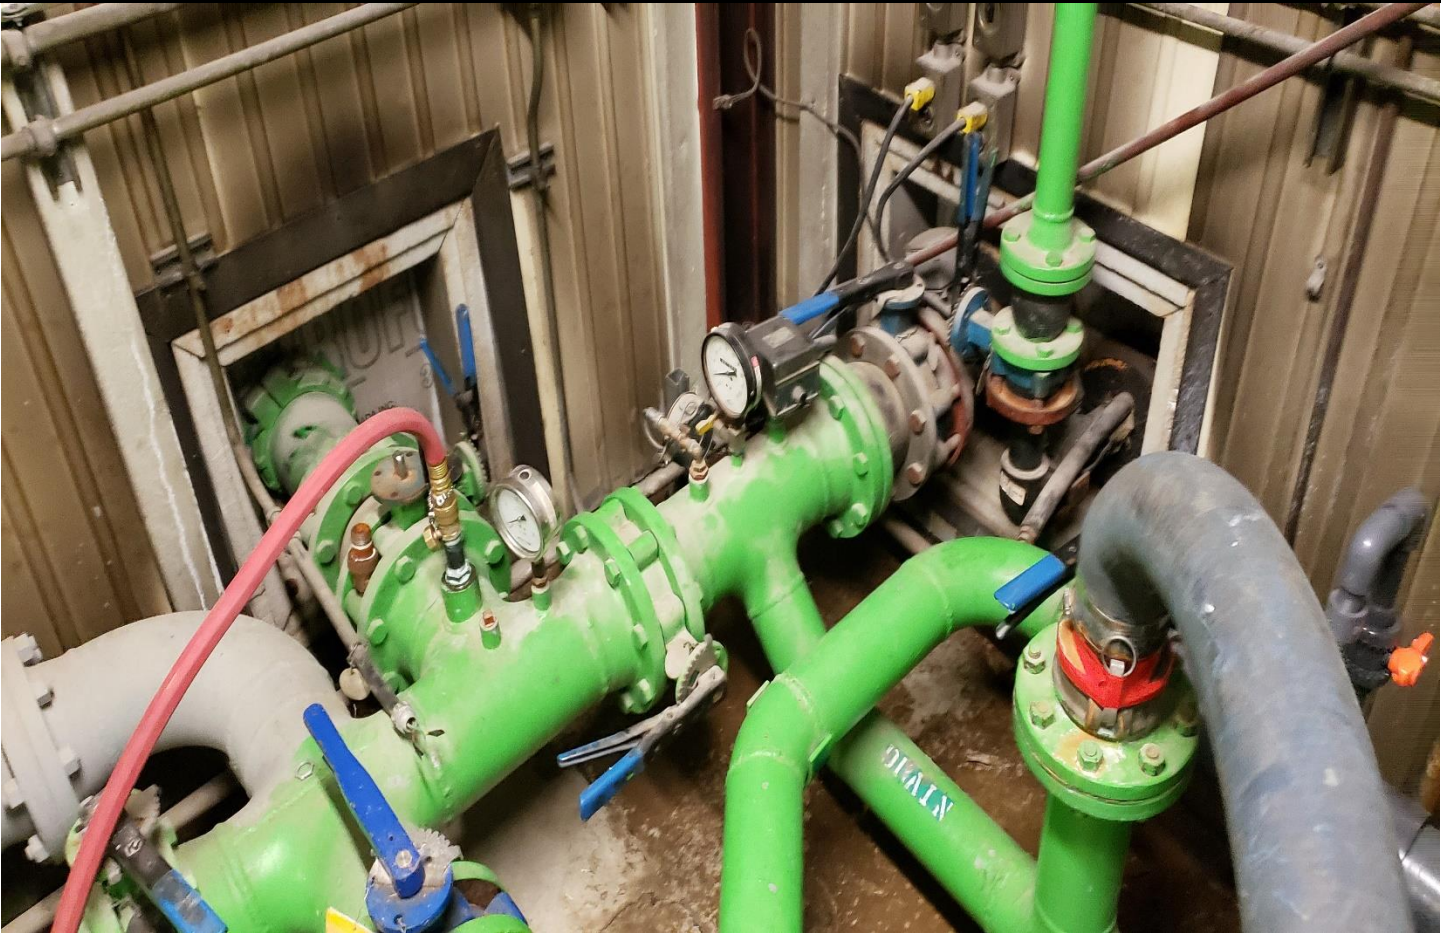
Photo Log
Photo 7

Description: Water meter observed on site.

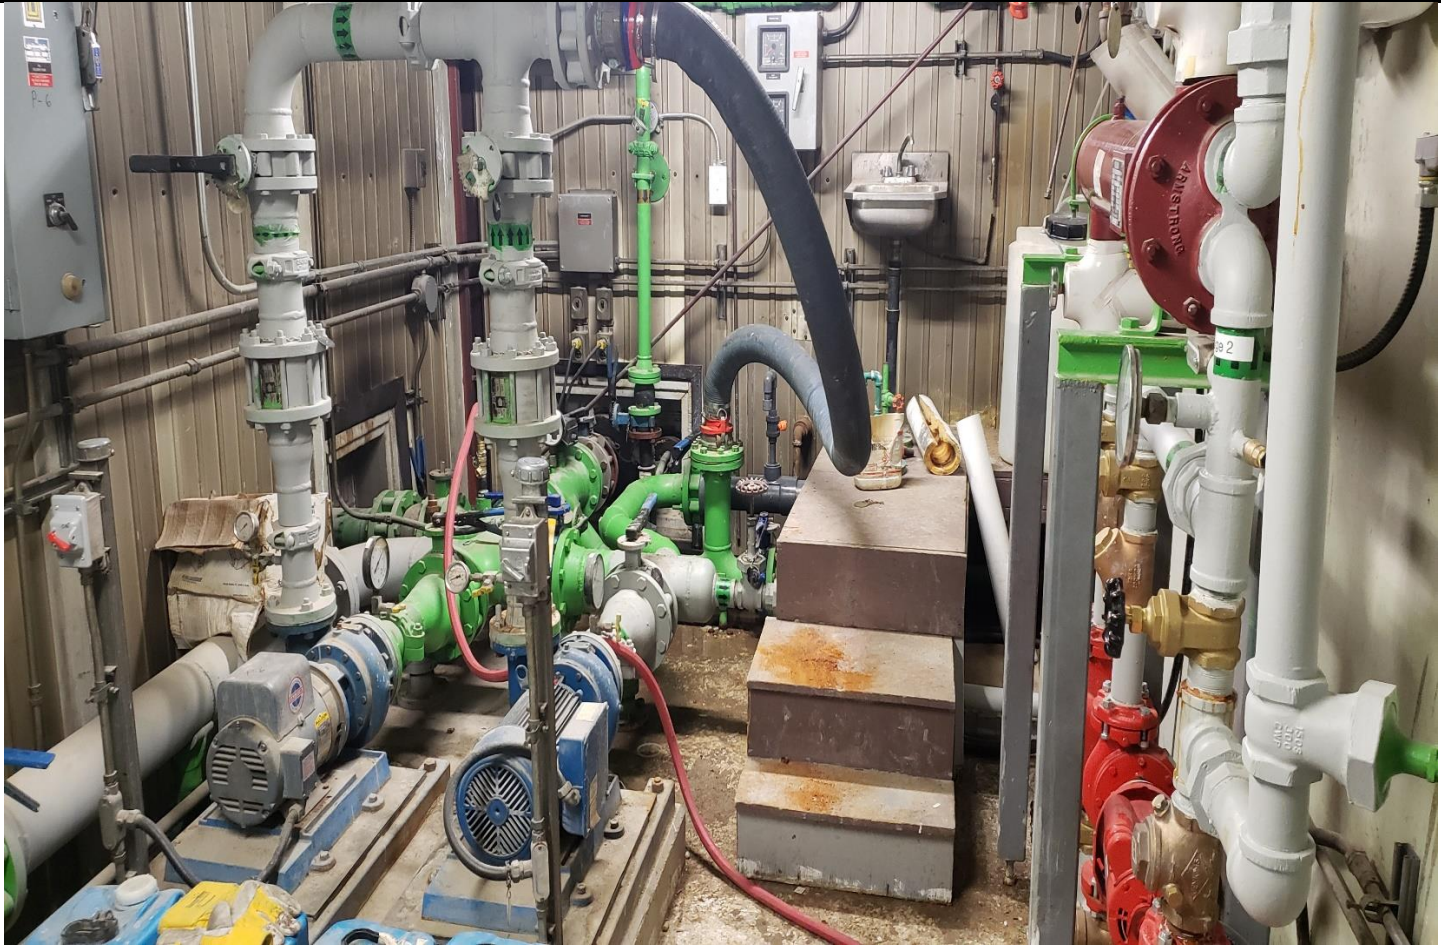
Photo Log
Photo 8

Description: Internal piping to distribute water to the 3 different water storage tanks.

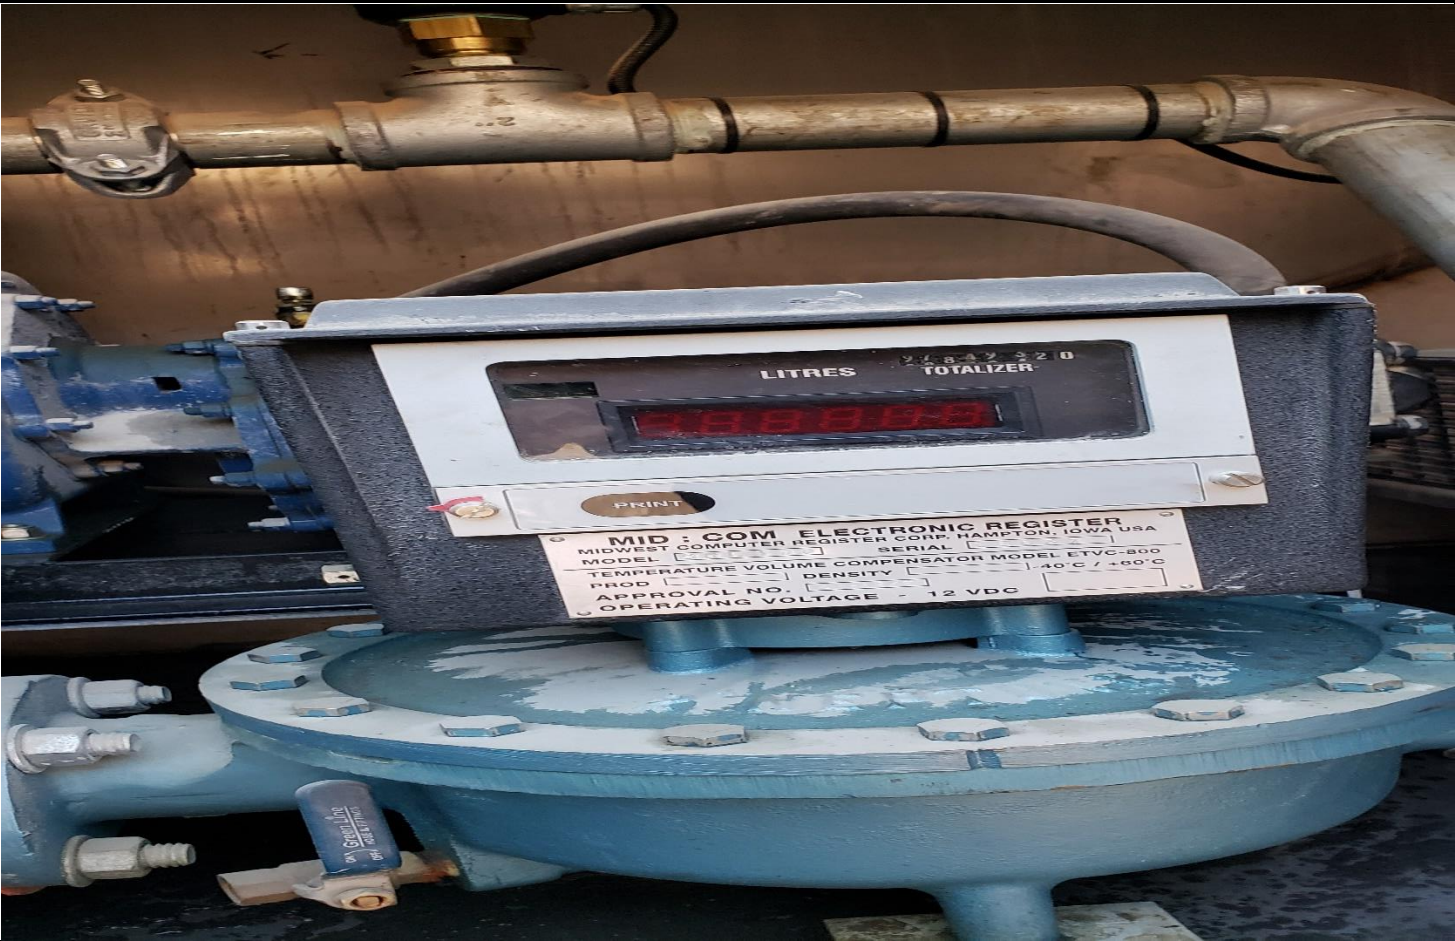
Photo 9

6. The Water Treatment Plant , and its inner pipes (photo 5,6,7,8).
7. Couldn't get flow meter readings in the water treatment plant. Got Totalizer amount on the community water truck (photo 9).

Description: Water Meter on the Water Delivery Truck.. Totalizer reads

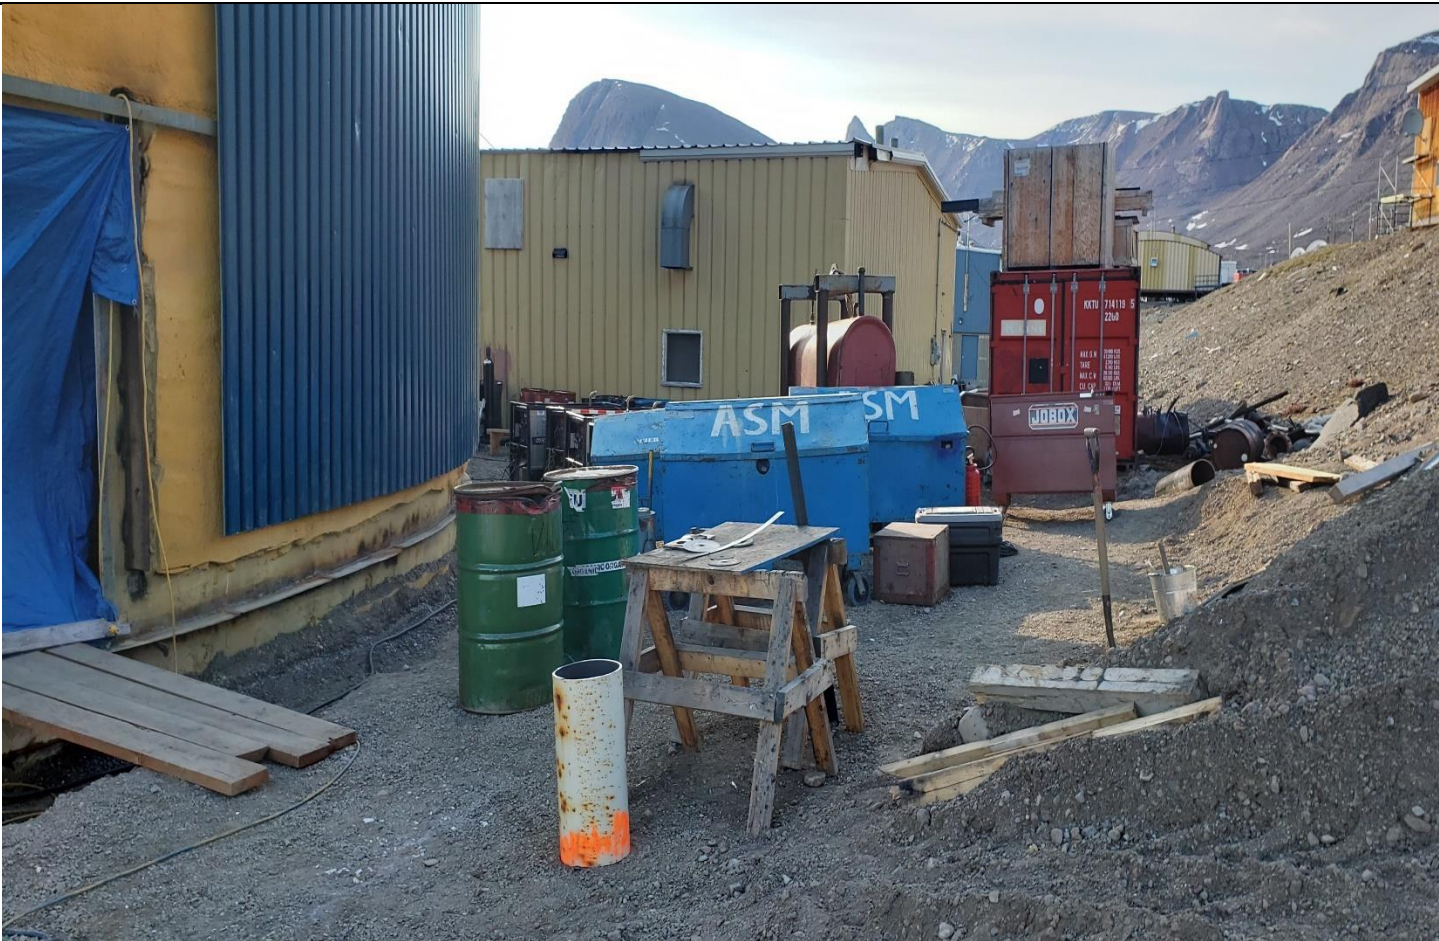
Photo 10

9. Water Storage Tank under repair. Equipment outside of tank (photo 10,11).
10. A bridge crossing was inspected within the community. No signs of erosion on the banks or sedimentation were observed in the fresh water. Buildup of sand was observed on the bridge. This buildup has the potential to spill over into the fresh water. A containment wall should be fixed onto the bridge, and maintained to prevent sedimentation into the river. (photo 17).

Description: Outside the Storage Tank, Storage Tank under repairs.

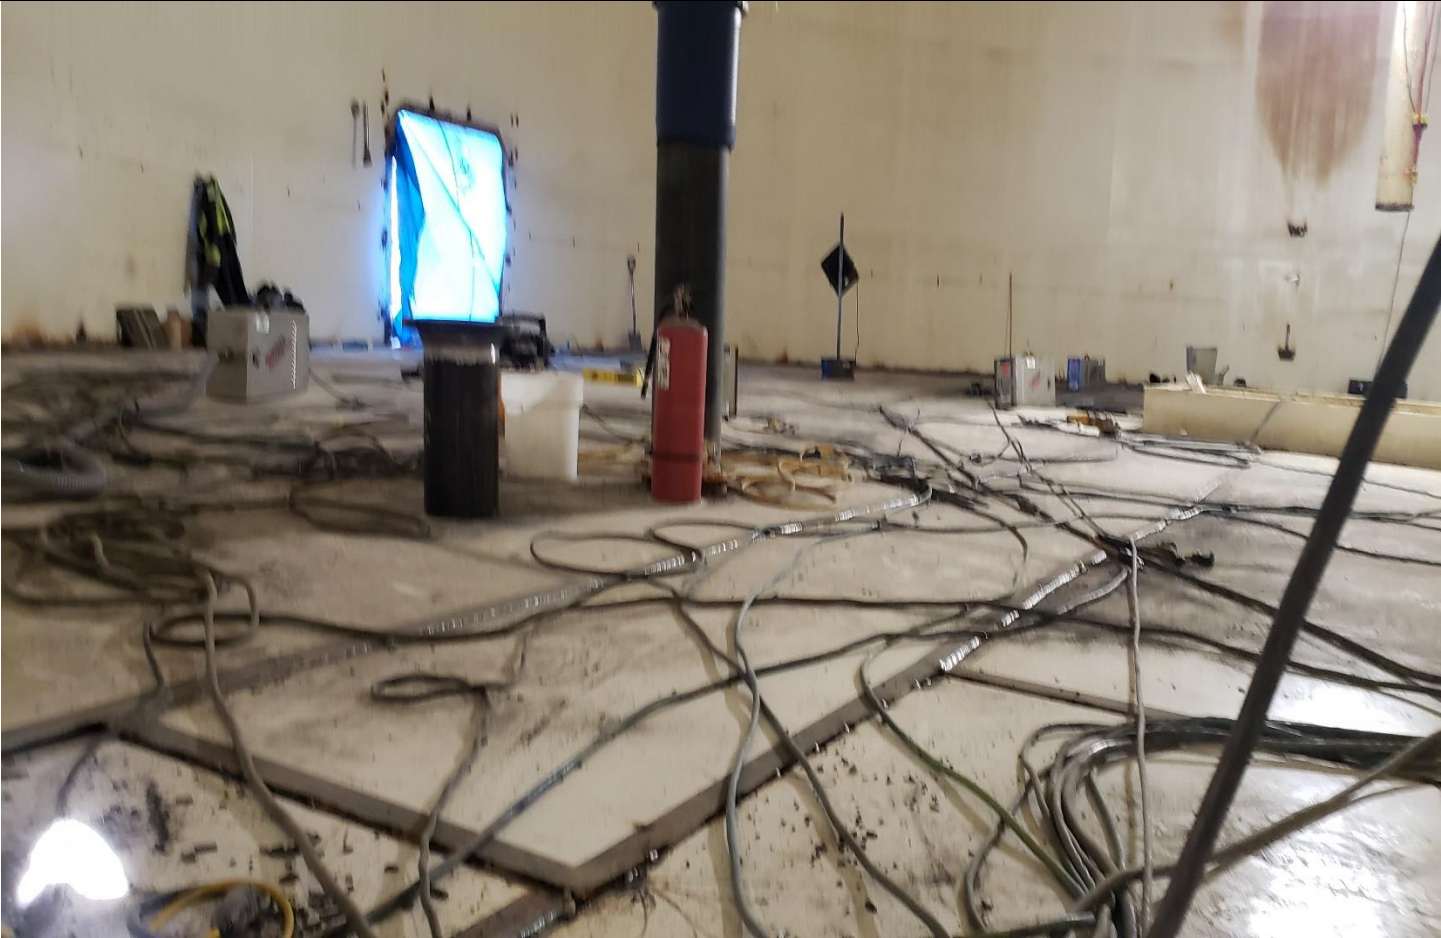
Photo 11

Description: Inside the Water Storage Tank. Storage Tank under repairs.

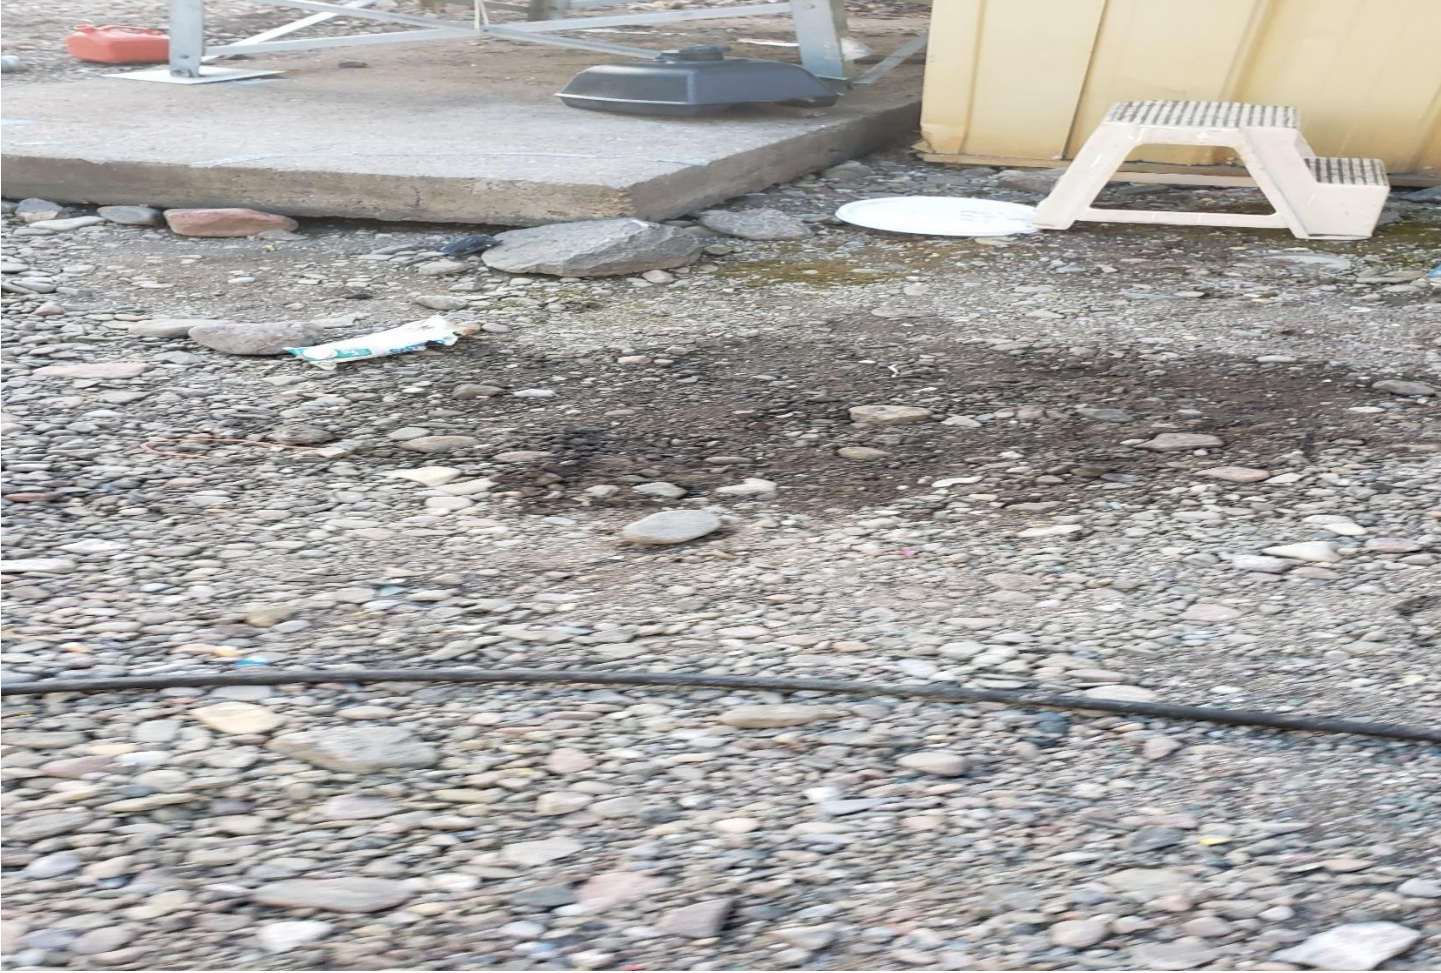
Photo 12

within the property of facilities authorized by this water license. The spill isn't in close proximity to a water body (photo 12).

Description: spill observed behind building adjacent to storage tank construction.

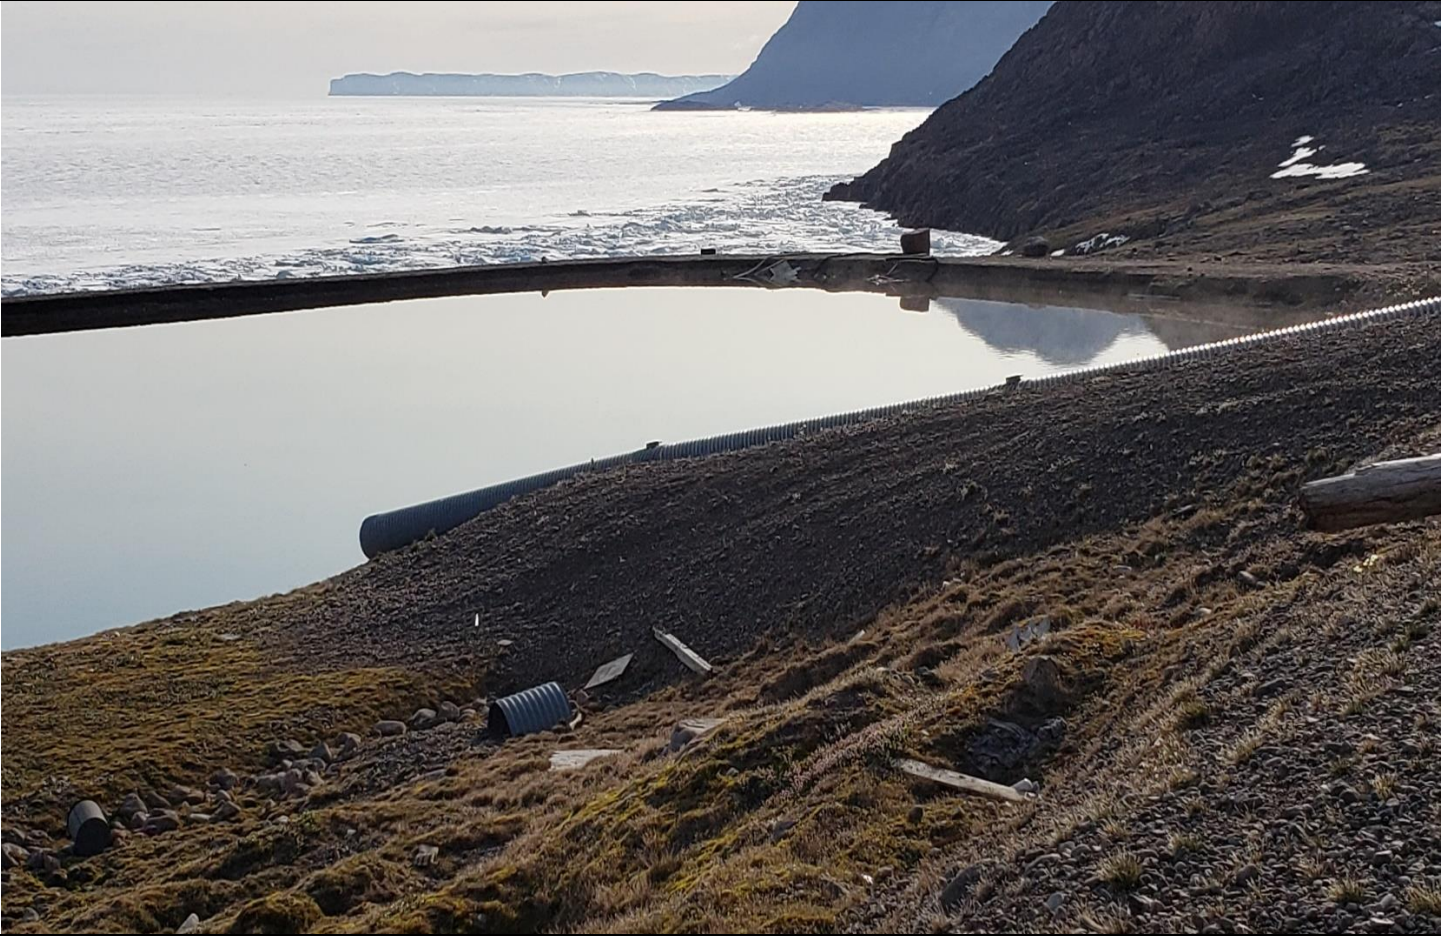
Photo 13

11. The amount of waste deposited at the sewage lagoon should match the amount withdrawn from the potable water source, but doesn't take into account the amount water use such as dust suppression, which cannot be calculated as the same amount discharged at the sewage lagoon waste water. At the time of the inspection no record of waste deposited at the lagoon was observed (photo 13).

12. The walls of the sewage lagoon appeared to be working as intended, with no signs of erosion or leaks. The freeboard was above the 1 metre freeboard on the south wall (photo 13).

Description: bulk metal within the sewage lagoon

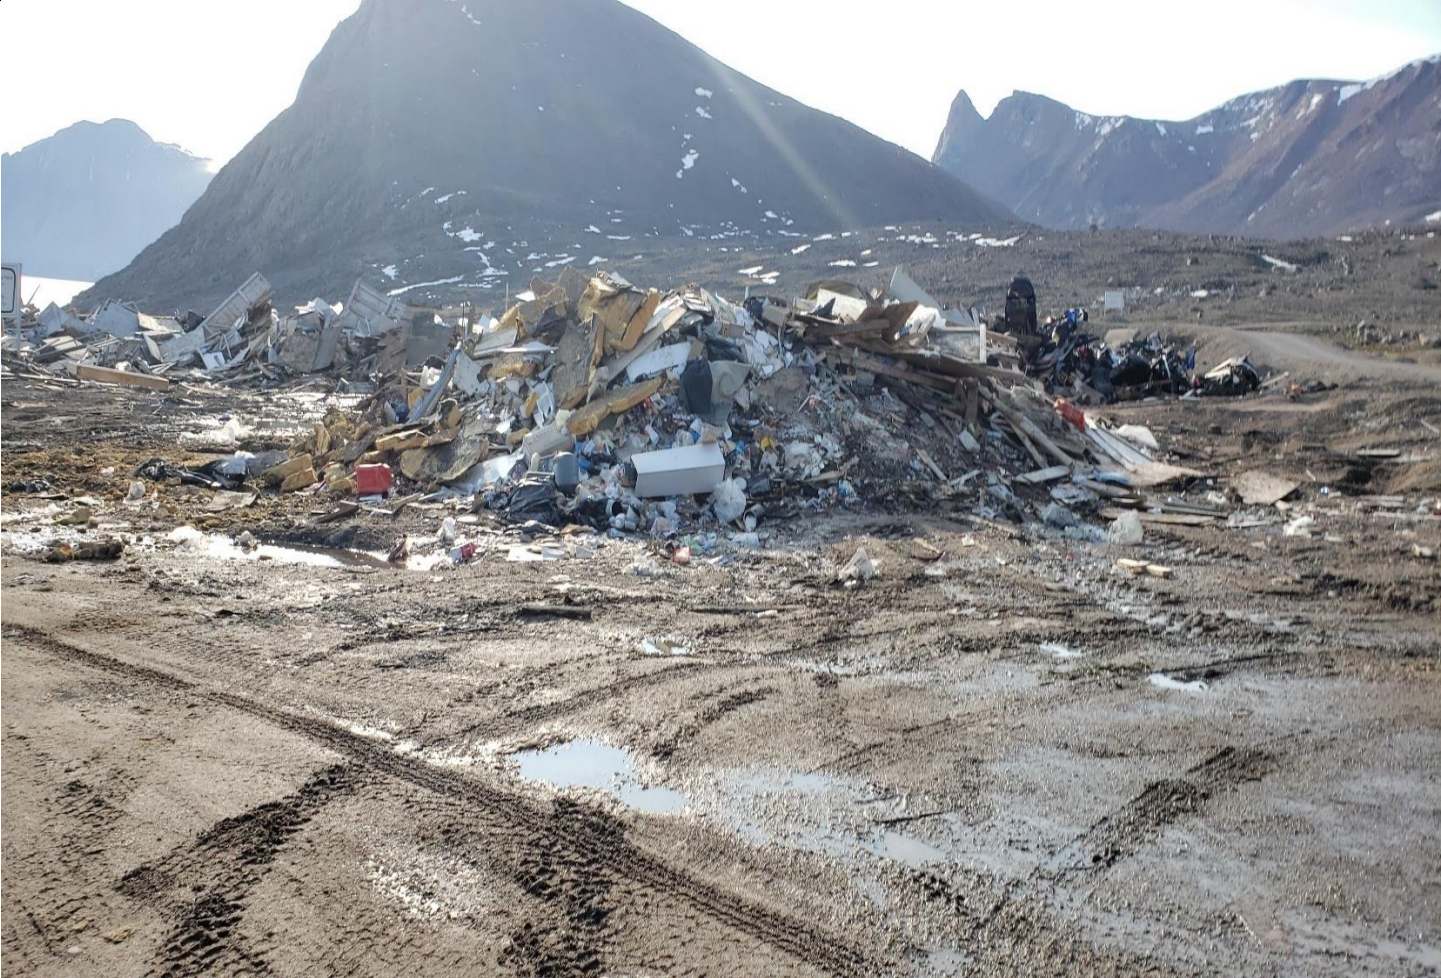
Photo 14

15. The Solid Waste Facility was loosely segregated into Woods, Metals, Hazardous Wastes and Burnable Wastes (photo 14).
16. The burnable waste is open pit burned, pushed off the end of that section then capped with soil. No fencing around the burnable waste.
17. The bulk metals contain white waste, and metal from construction. Hazardous Waste was observed at this site (photo 16).
18. Wood waste was segregated, probably for the purpose of allowing the community help themselves to the wood wastes (photo 15).
19. The Hazardous Waste sea can is mixed with the bulk metal waste. Lots of hazardous waste observed within the bulk metals (photo 16).
20. A yellow triangle sign titled GRI-2 was observed, which indicated a monitoring site. No Samples were taken on this inspection.

Description: Pile of waste. Bulk woods, mixed with Styrofoam, bulk metals, petroleum carrying jerry cans, and domestic waste. Surface water observed.

- Erect fencing around the open pit burning section of the Solid Waste Facility to manage wind-blown litter (photo 8).
- Separate bulk metals, bulk wood, domestic waste, and hazardous waste to be in line with National Standards for the management of Solid Waste Facilities.

- Consider a plan to divert surface water run off away from Solid Waste Facility to mitigate the amount of wastes migrating to the receiving marine environment.

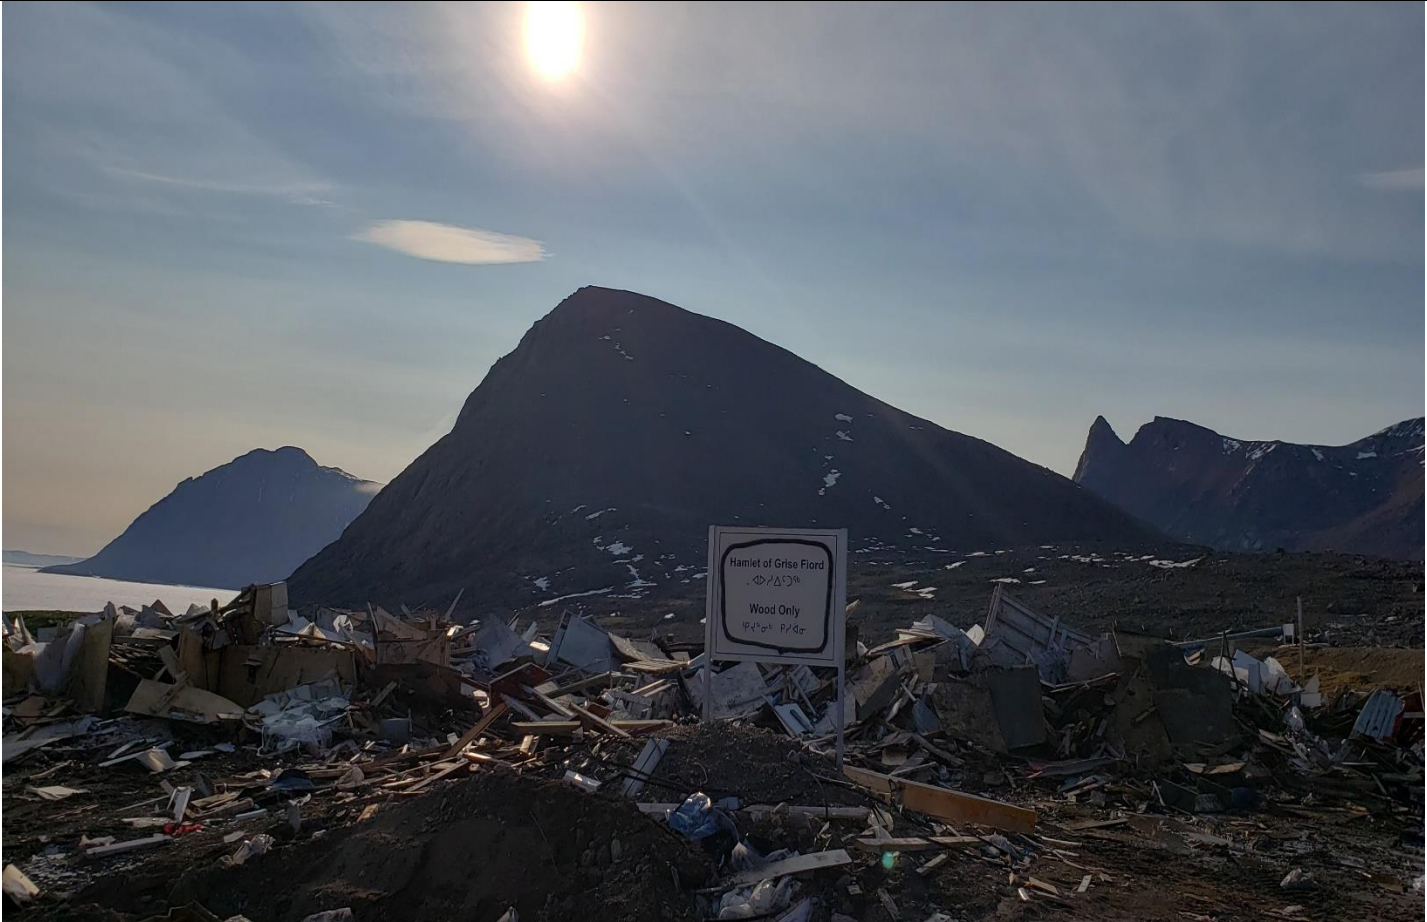
Photo 15

Description: Bulk woods section of the solid waste facility

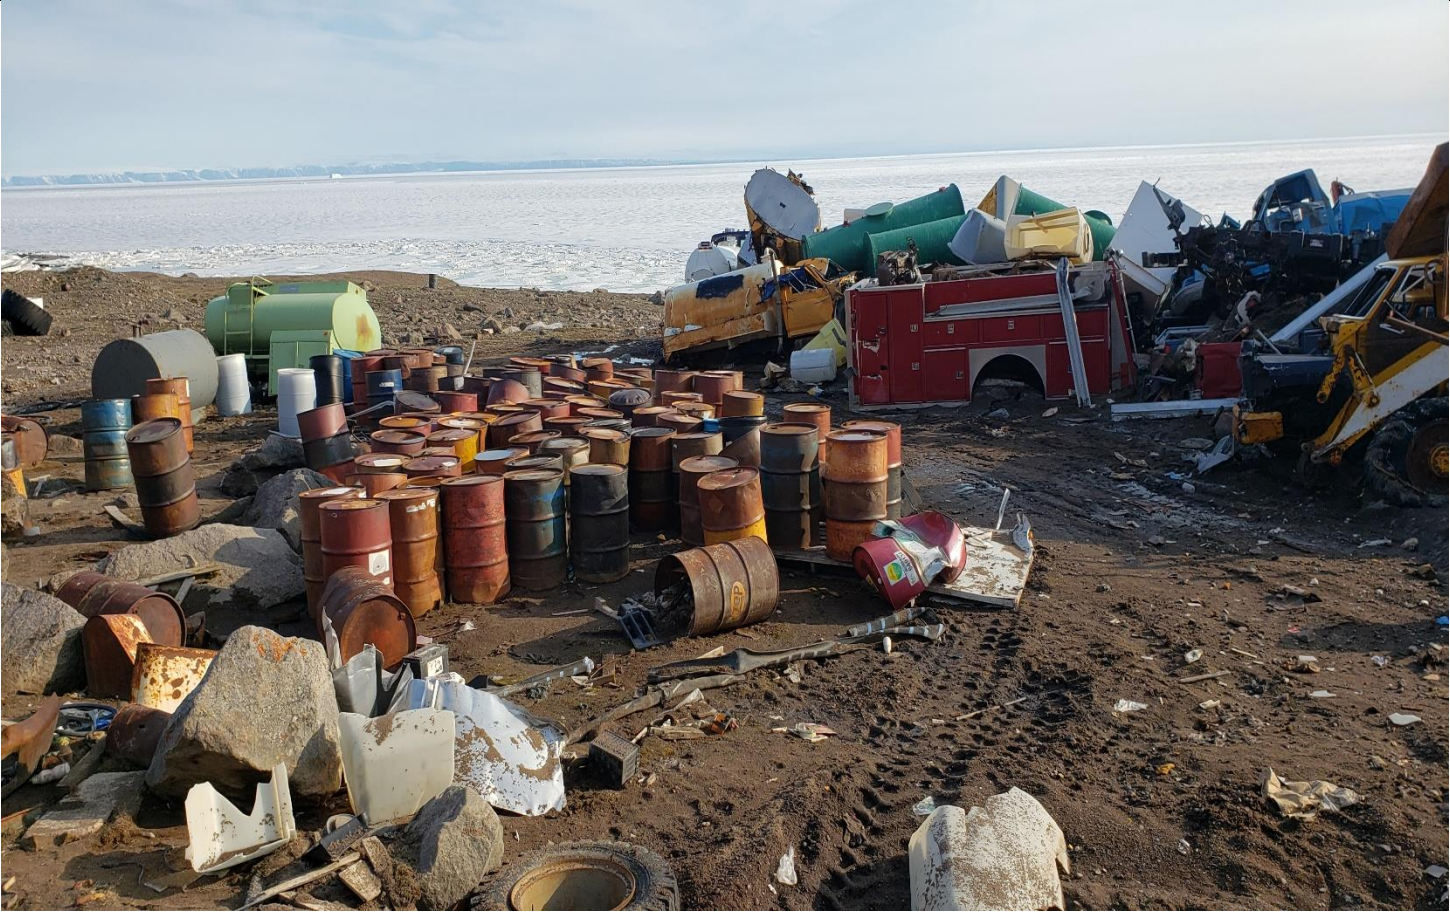
Photo 16

Description: Bulk Metal waste. Waste drums not in secondary containment.

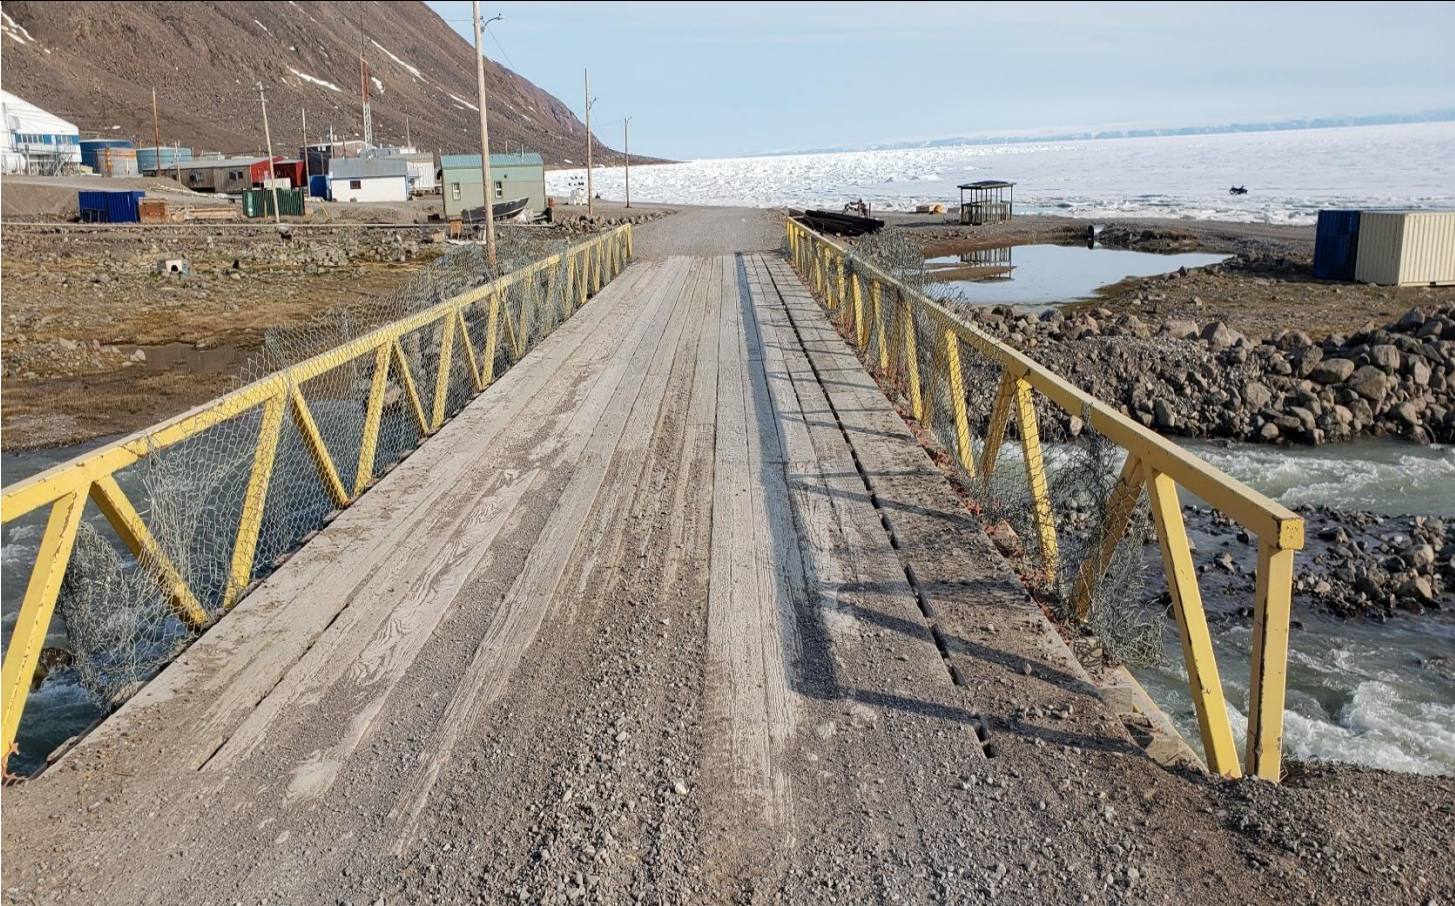
Photo 17

Description: Soil build up on bridge. No walls on bridge to prevent soil from falling into fresh water.

- Consolidate Hazardous Waste from Solid Waste Facility and deposit into Hazardous Waste section (photo 9).
- Build a containment wall on the bridge to mitigate the amount of soil falling into the river and causing sedimentation (photo 5).
