August 2-8/12 Hall Beach Inspection of licence number 3BM-HAL0810 – *Expired*

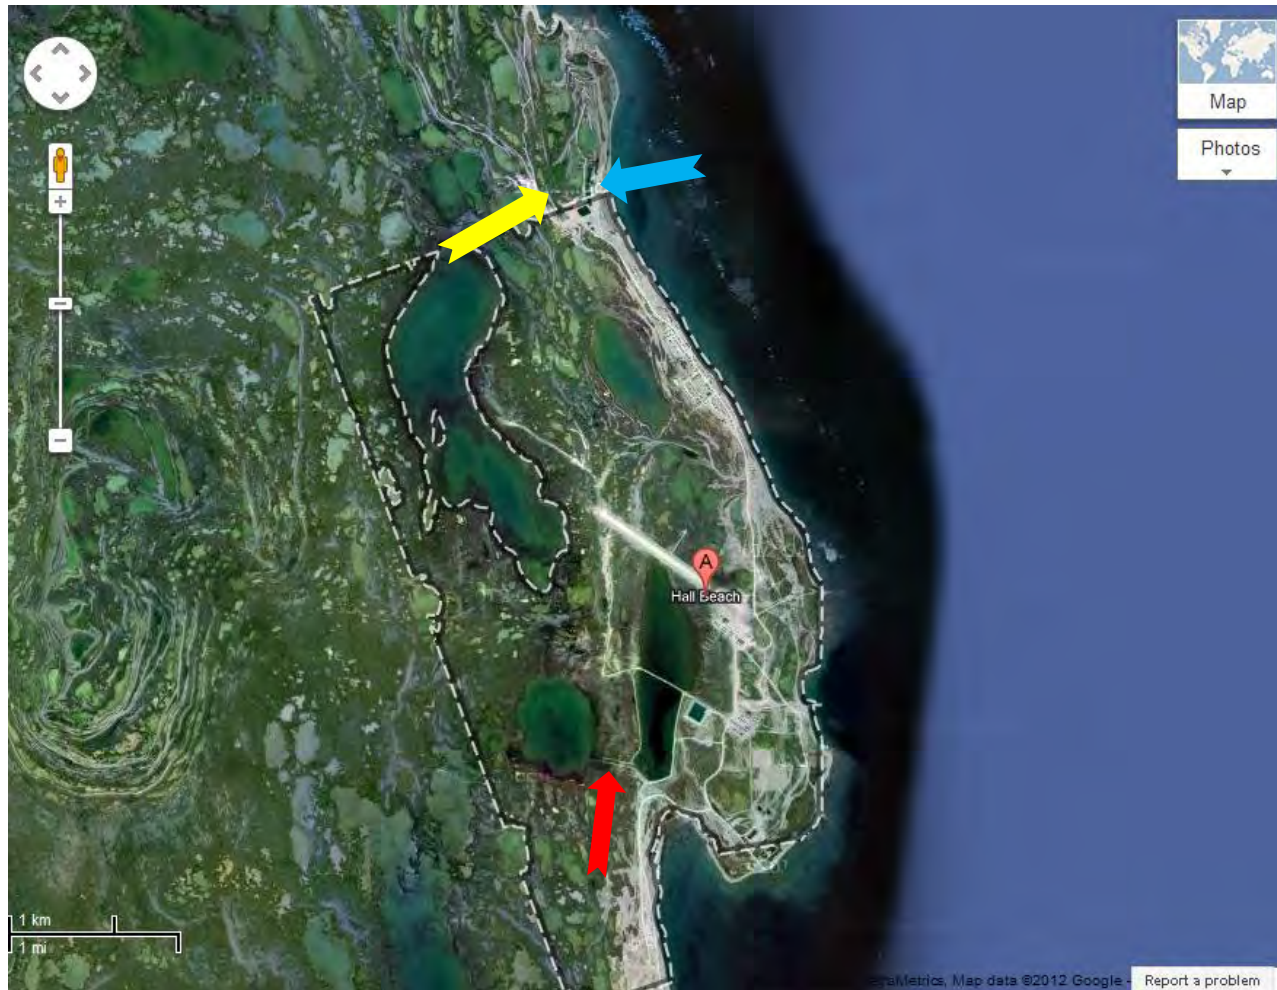
Samples taken near the water supply lake/reservoir (red arrow), effluent outfall (blue arrow) and small pond near the metal dump (yellow arrow).

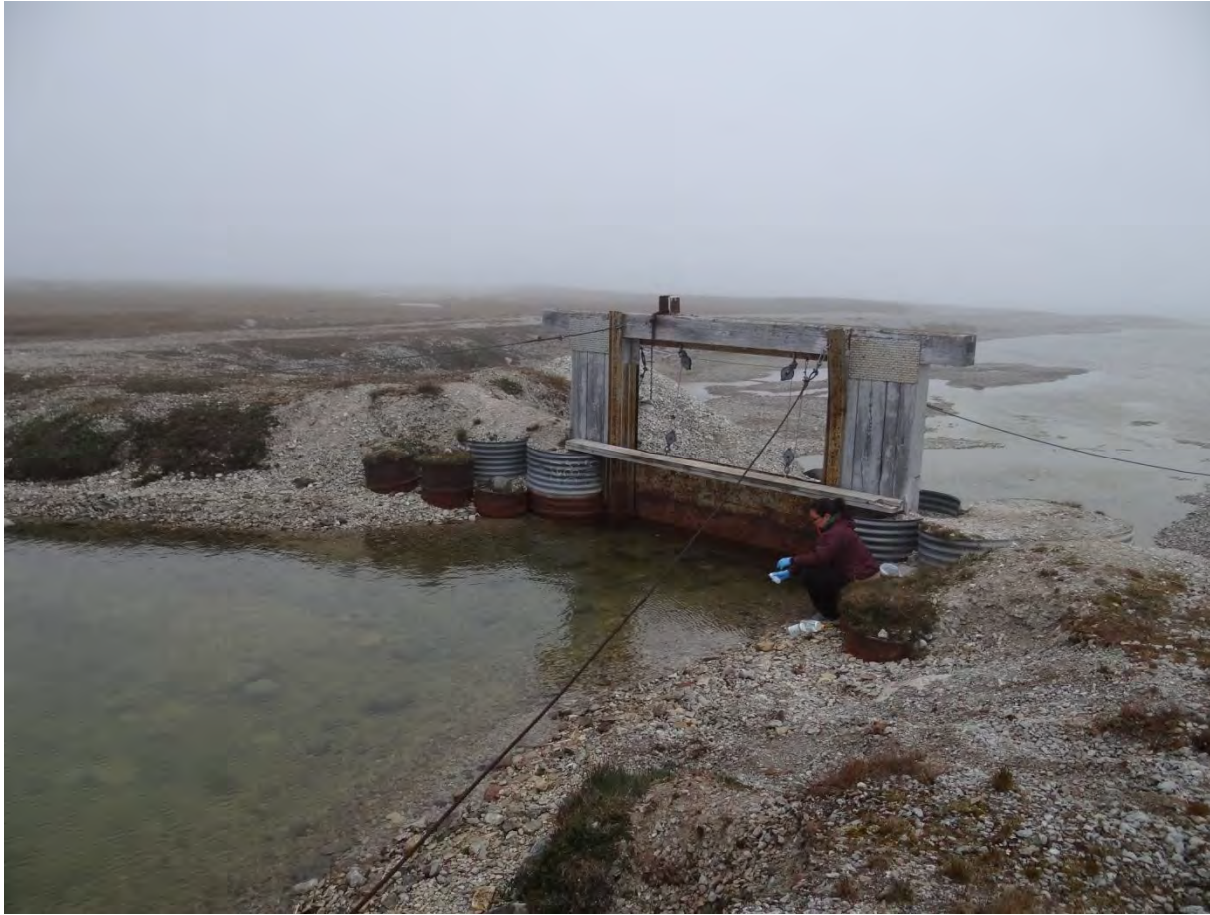
Water Supply Lake (Reservoir)

- A visual inspection was conducted of the water supply lake and samples collected near the release door.

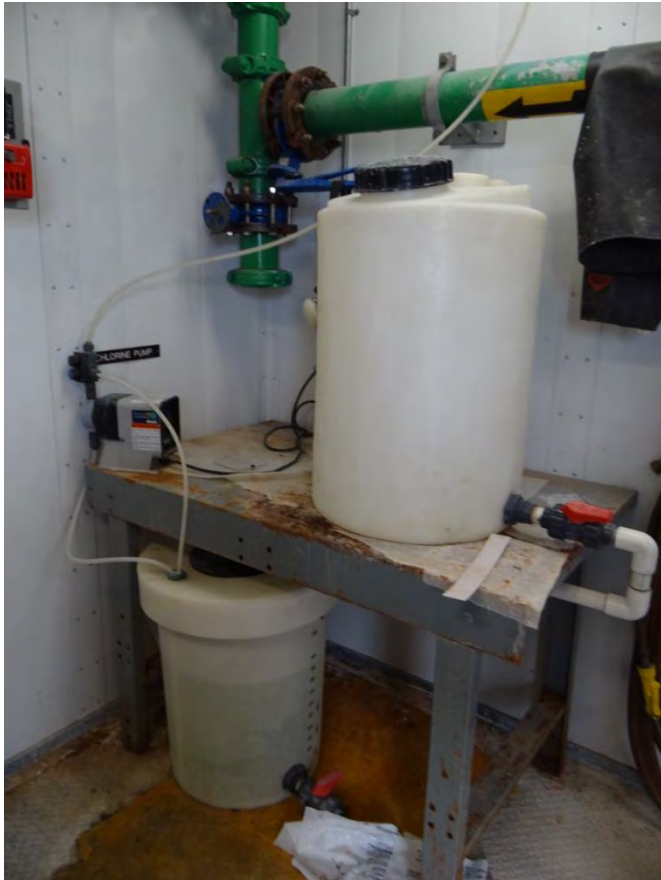
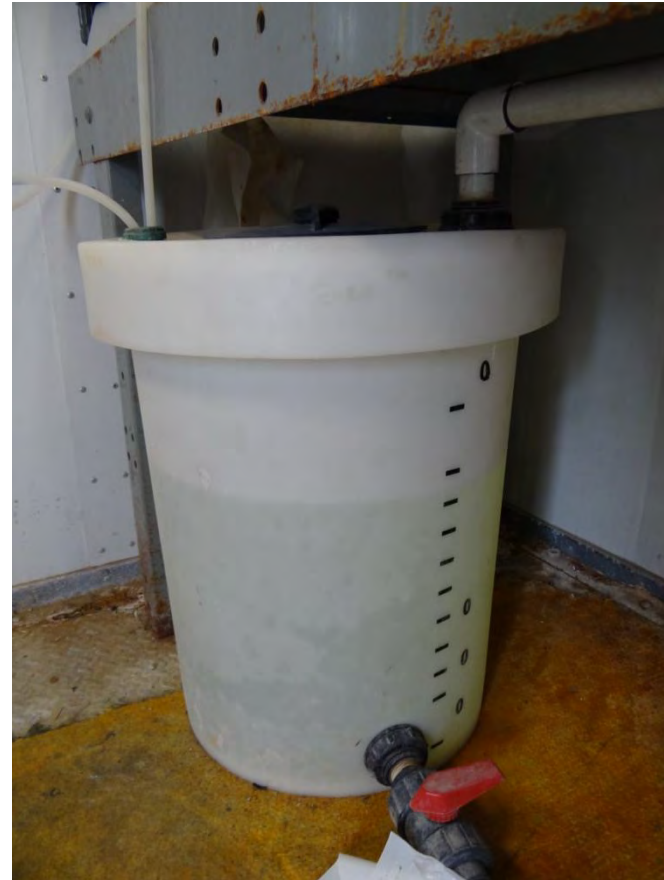
Water Treatment Facility

- Chlorination system found in good working order, chlorine tank was $\frac{3}{4}$ full at the time of inspection.
- Truck sampling records were available for review at Hamlet garage

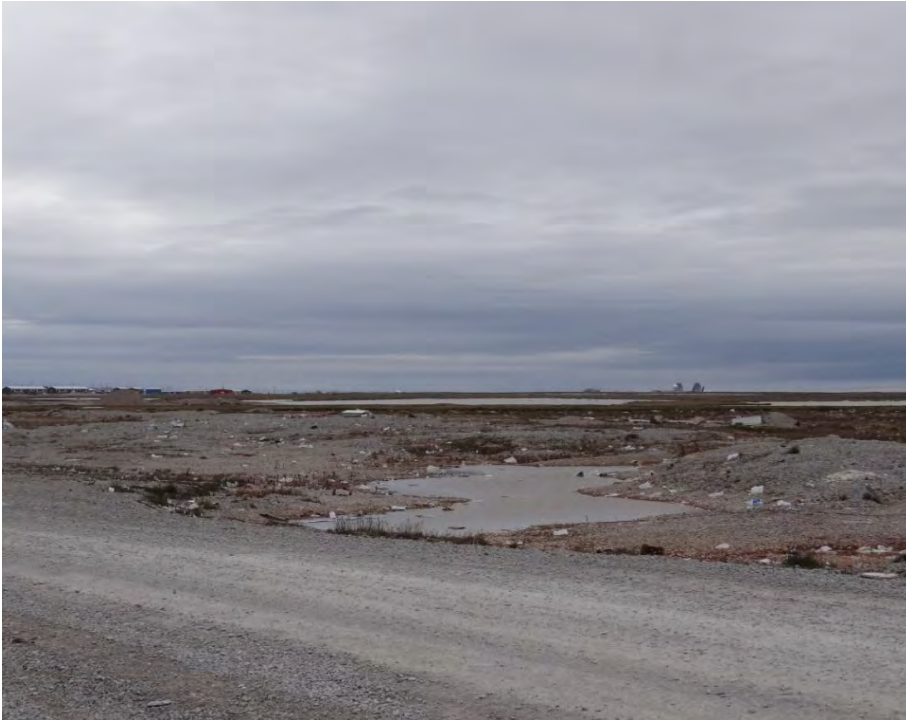
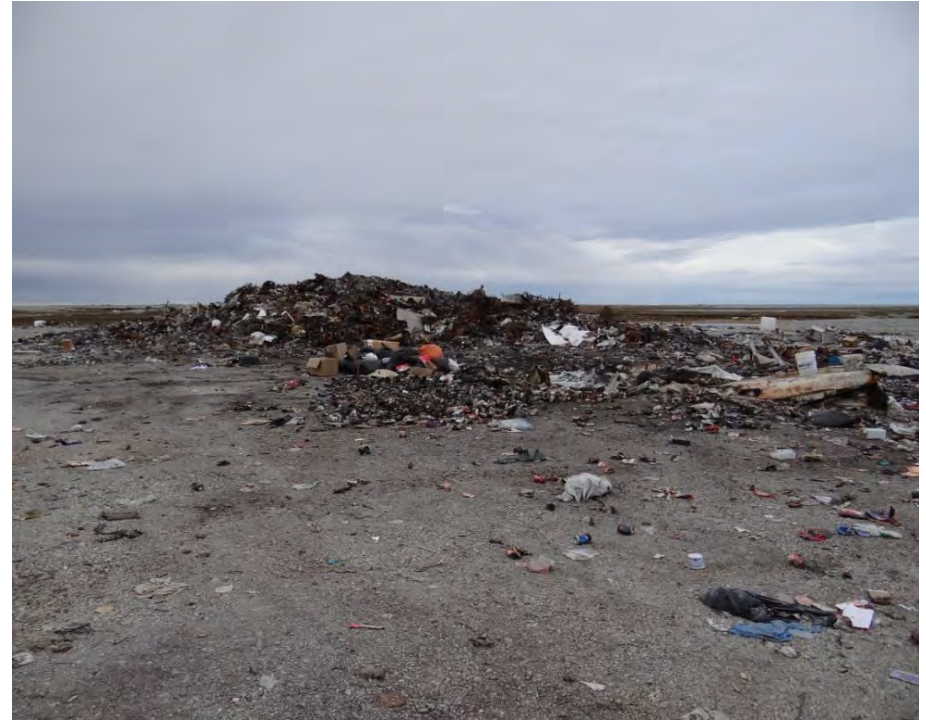
Municipal Waste Management Area

- The Municipal burn and bury area requires a fence to completely enclose the facility. Wind blown garbage noted throughout the area.
- This was an issue has been identified in previous inspections.
- No evidence of the use of cover material

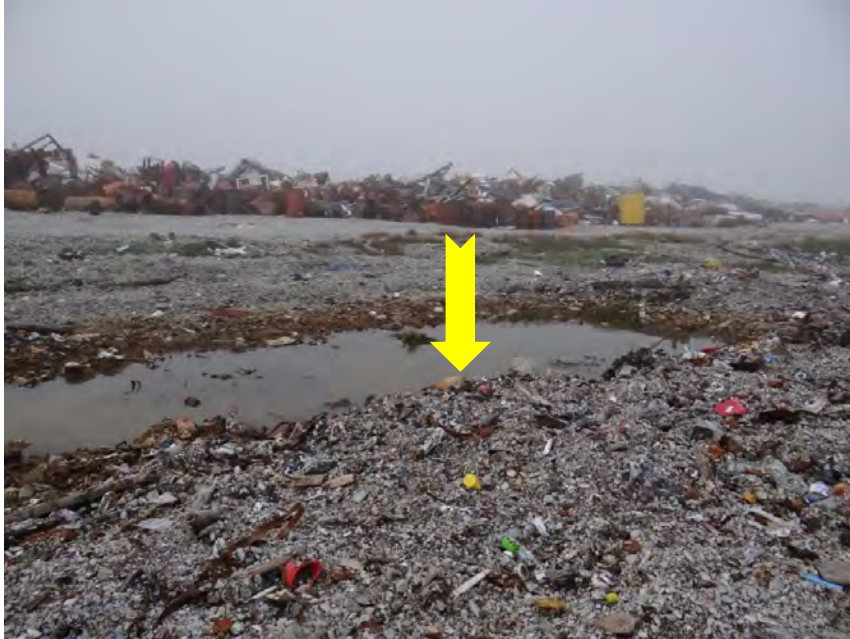
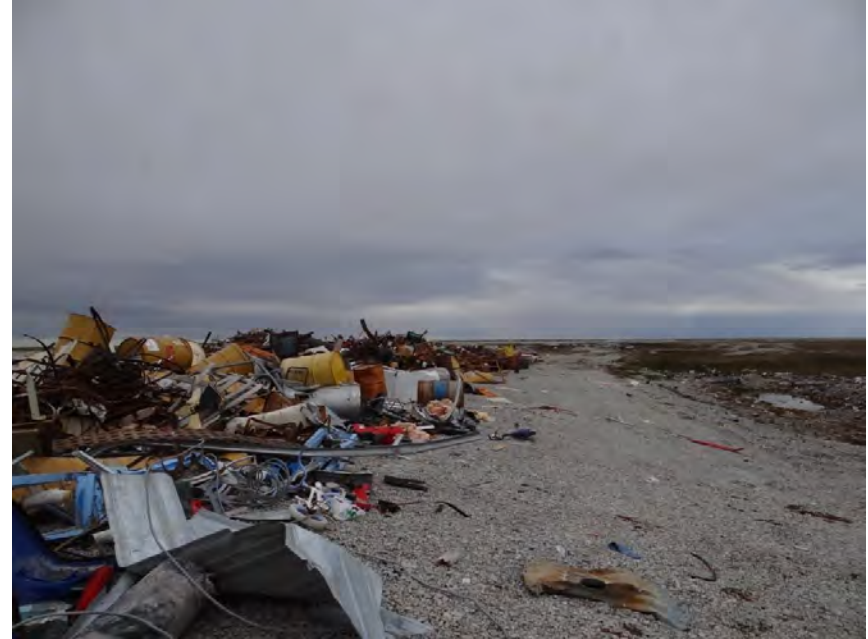
Bulk Waste Management Area Metal Dump

- A site for the segregation of hazardous materials has not yet been designated by the Municipality.
- The waste metals were found to be stored in 3 different locations within the community.
- Samples were collected in a small pond in the metal waste/dump site (yellow arrow).

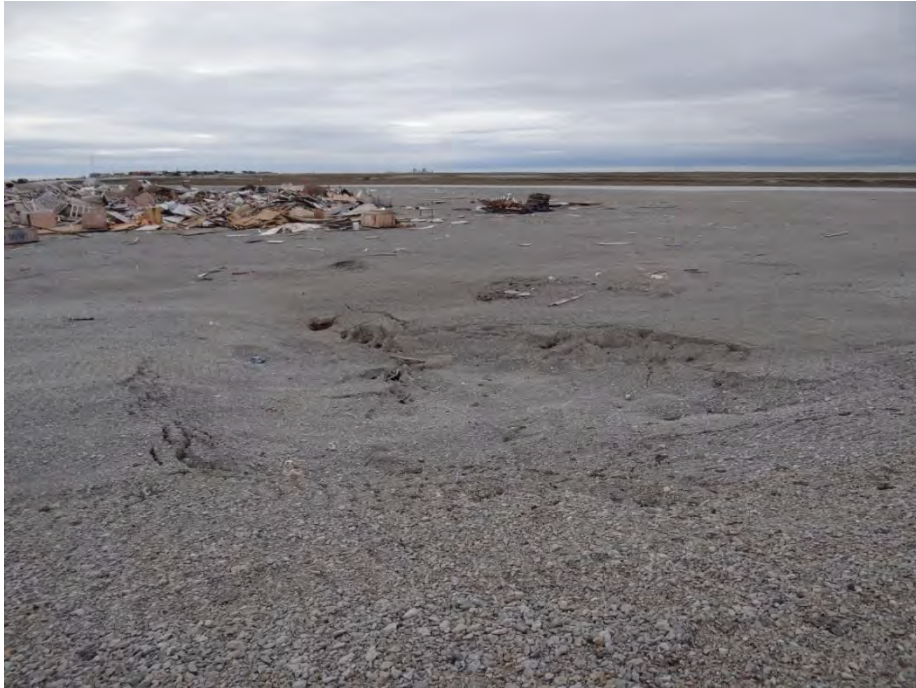
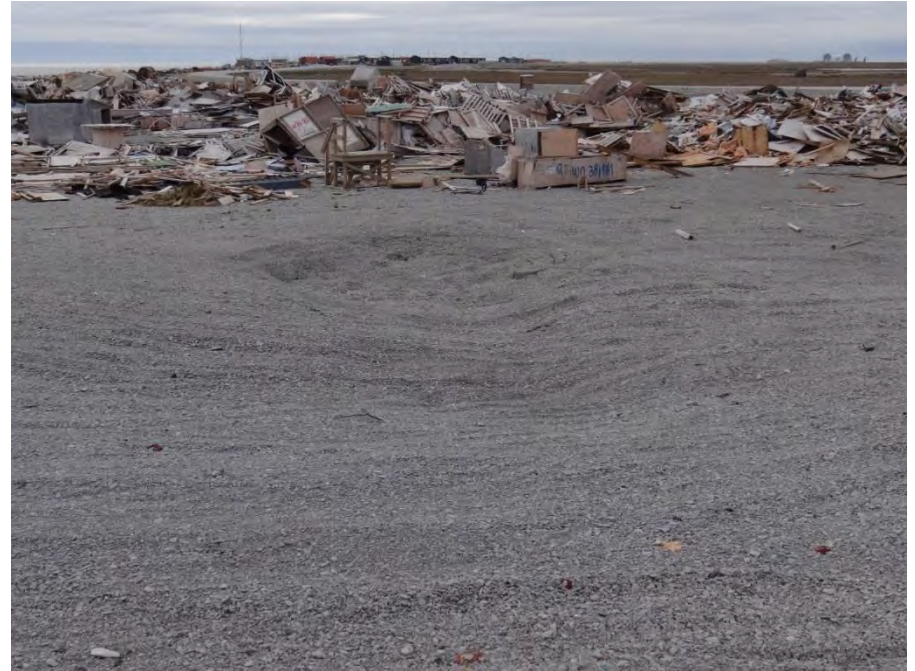
Sewage Lagoon: Cell 1

- A visual inspection of the 2 cell lagoon. Cell 1 had no effluent present but the formation of 2 large sink holes immediately adjacent to the cell wall nearest the community were found. These are newly developed and not previously identified during earlier inspections.
- Orange rusty effluent stains were noted to be along the outside of the berm, going down slope towards the ocean. The loss of cell 1 in 2012 again went unreported to the spill line. No reports were filed with the inspector

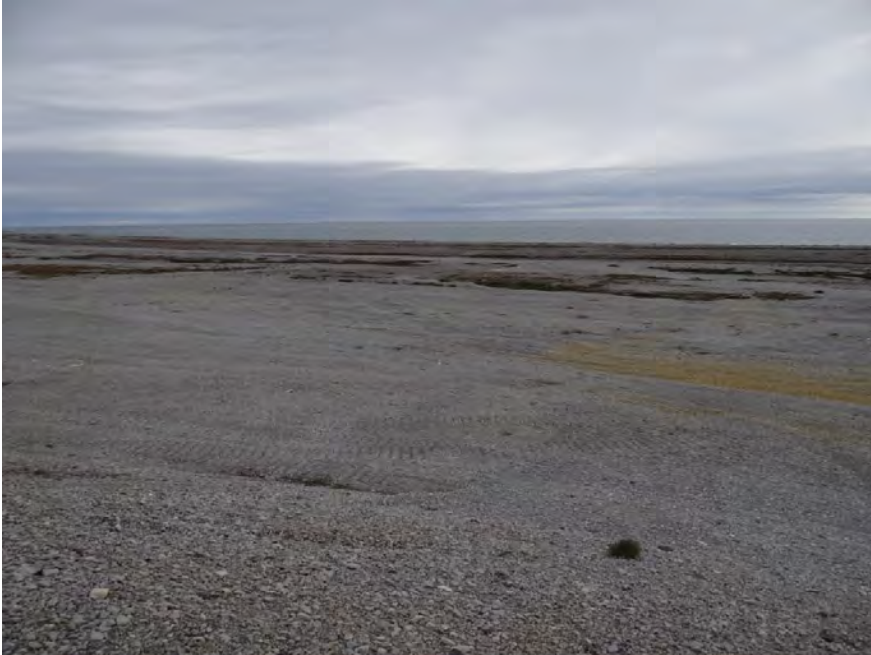
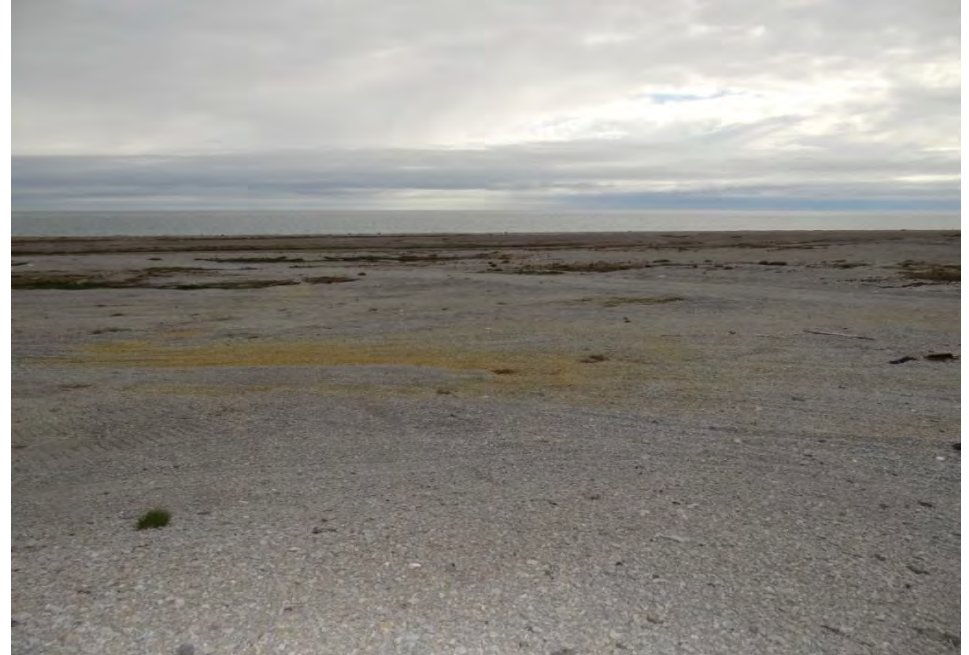
Effluent Stains

- A spill report was not submitted by the Licensee or the Government of Nunavut – CGS engineer as required.

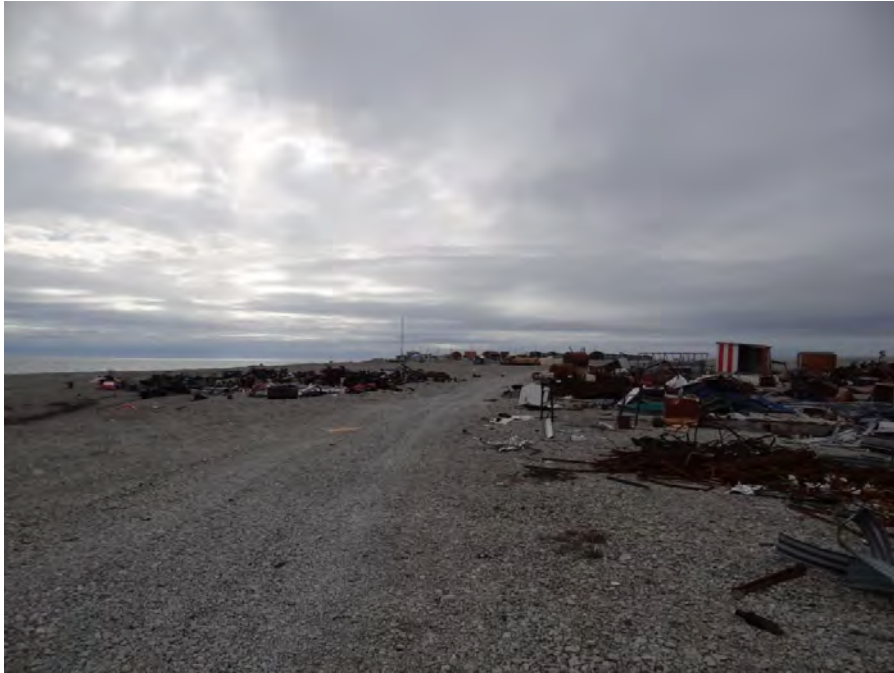
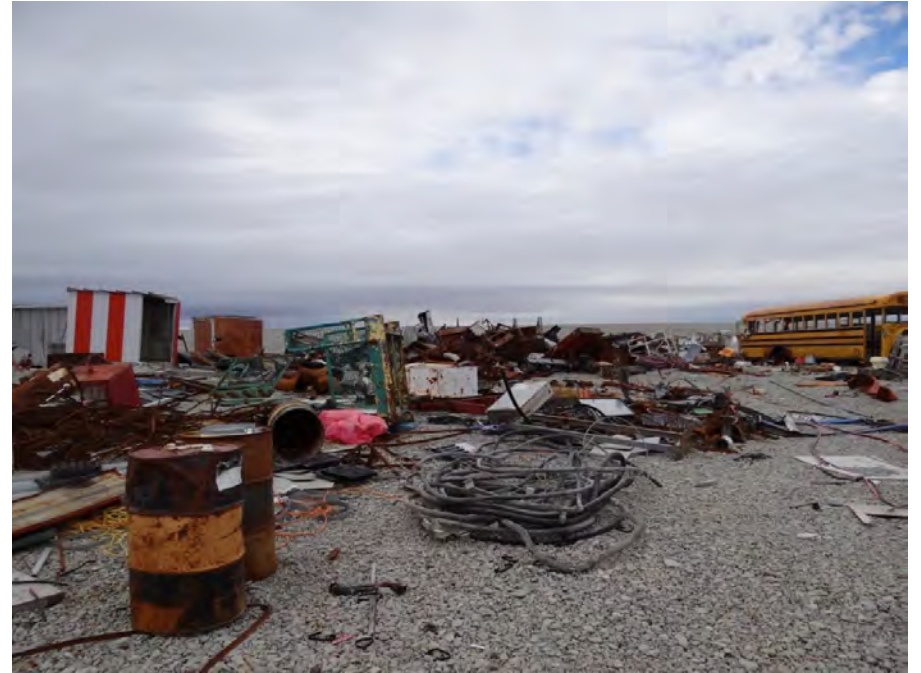
Second Metal Waste Site

- Located next to Cell 1 of the sewage lagoon, looking towards the community.

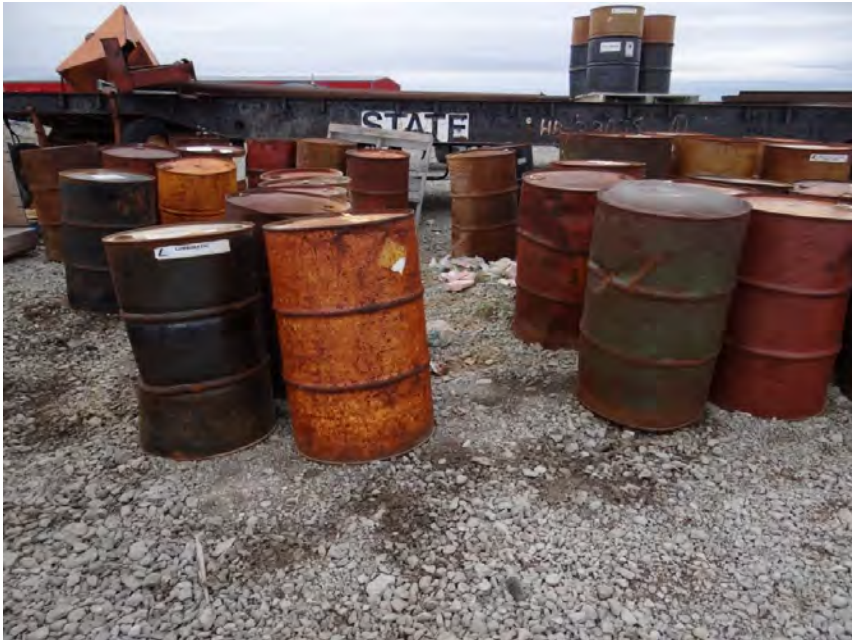
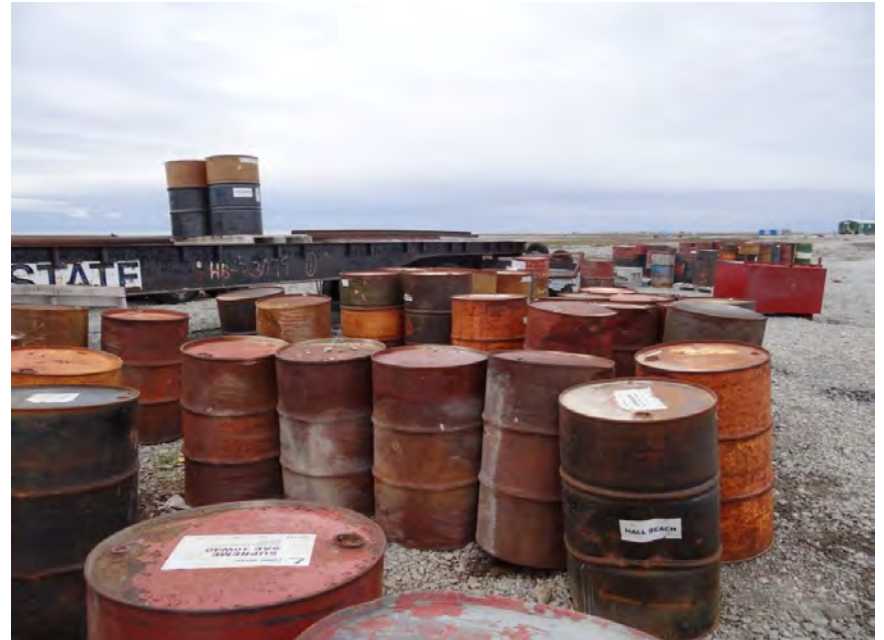
Waste oil storage area

- Waste oil and other barrels of unknown liquids were found unsecured within the community near the arena.
- Evidence of past leaks were found at the site.
- No secondary containment was found
- This was previously identified to the licensee has an issue by the Inspector
