WATER LICENCE INSPECTION FORM

Licensee	Licensee Representative
Hamlet of Hall Beach	Bhabesh Roy
Licence No. / Expiry	Representative's Title
3BM-HAL2025	Municipal Engineer
Land / Other Authorizations	Land / Other Authorizations
Date of Inspection	Inspector
August 12, 2019	Joseph Monteith
Activities Inspected	
<div><div><input type="checkbox"/> Camp</div><div><input type="checkbox"/> Drilling</div><div><input type="checkbox"/> Mining</div><div><input type="checkbox"/> Construction</div><div><input type="checkbox"/> Reclamation</div><div><input type="checkbox"/> Fuel Storage</div></div> <div><div><input type="checkbox"/> Roads/Hauling</div><div><input checked="" type="checkbox"/> Other: Potable Water Source, Waste Water Treatment Facility, and Solid Waste Facility</div><div><input type="checkbox"/> Other:</div></div>

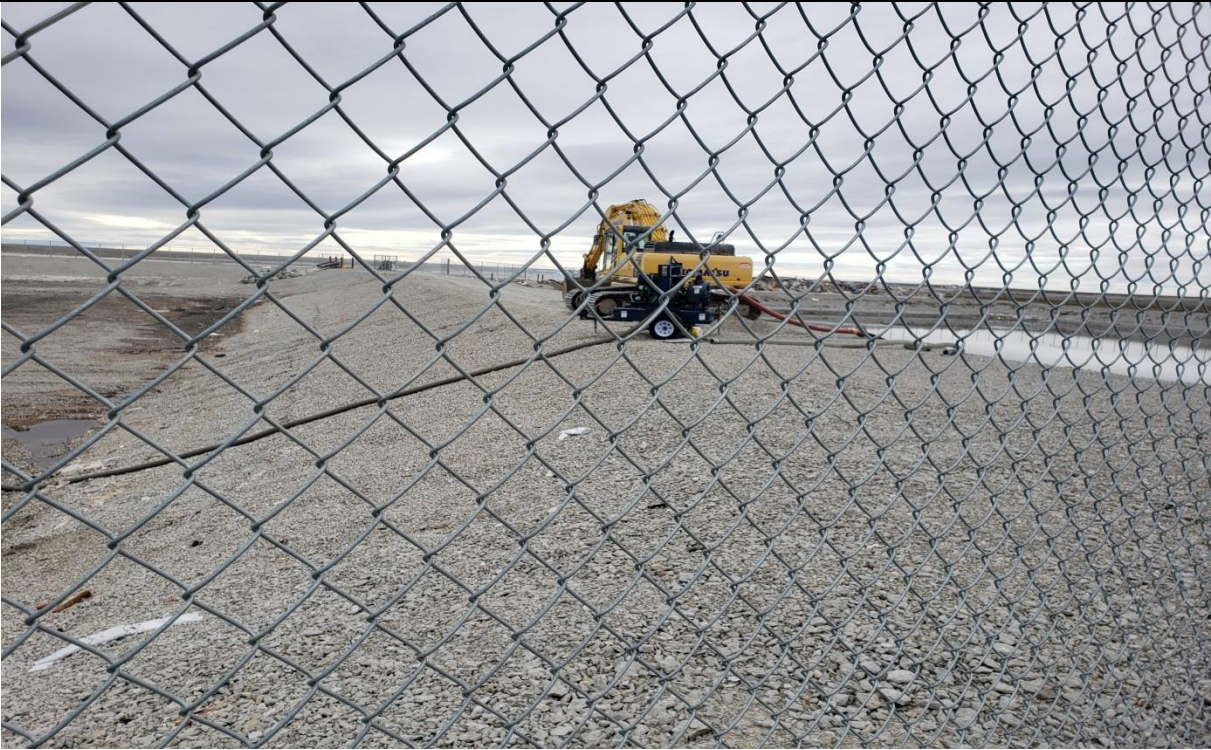
Photo Log	Location
Photo 5	Hall Beach

6. The Water Treatment Facility consists of two cells. Cell #1 is the south side cell of the two; whereas, Cell #2 is the north side of the two cells. At the time of the inspection their was testing of the repairs, so sewage was transferred from one lagoon to the other (photo 5).

Description: Testing the completion of the repairs to the sewage Lagoon, by pumping sewage from the other lagoon into the newly repaired lagoon.

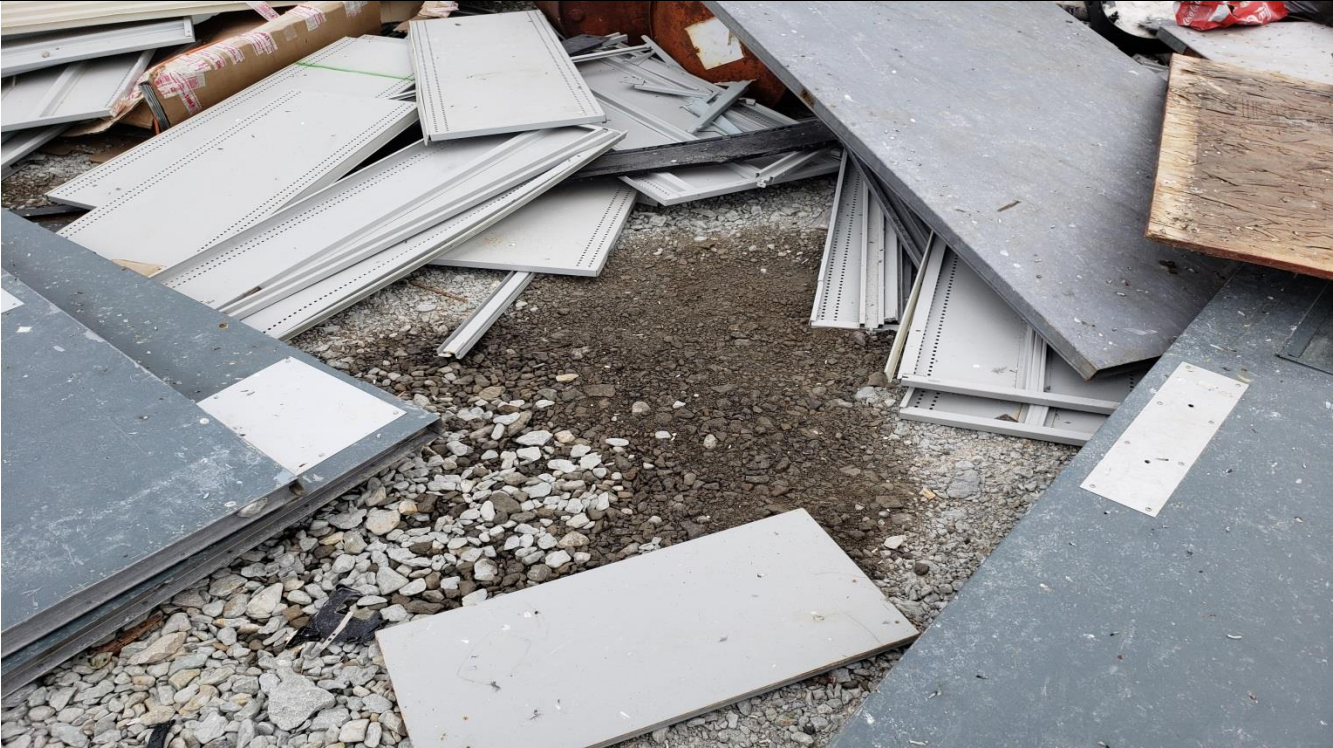
Photo Log	Location
Photo 12	Hall Beach

Description: Unreported spills observed throughout the Solid Waste Facility.

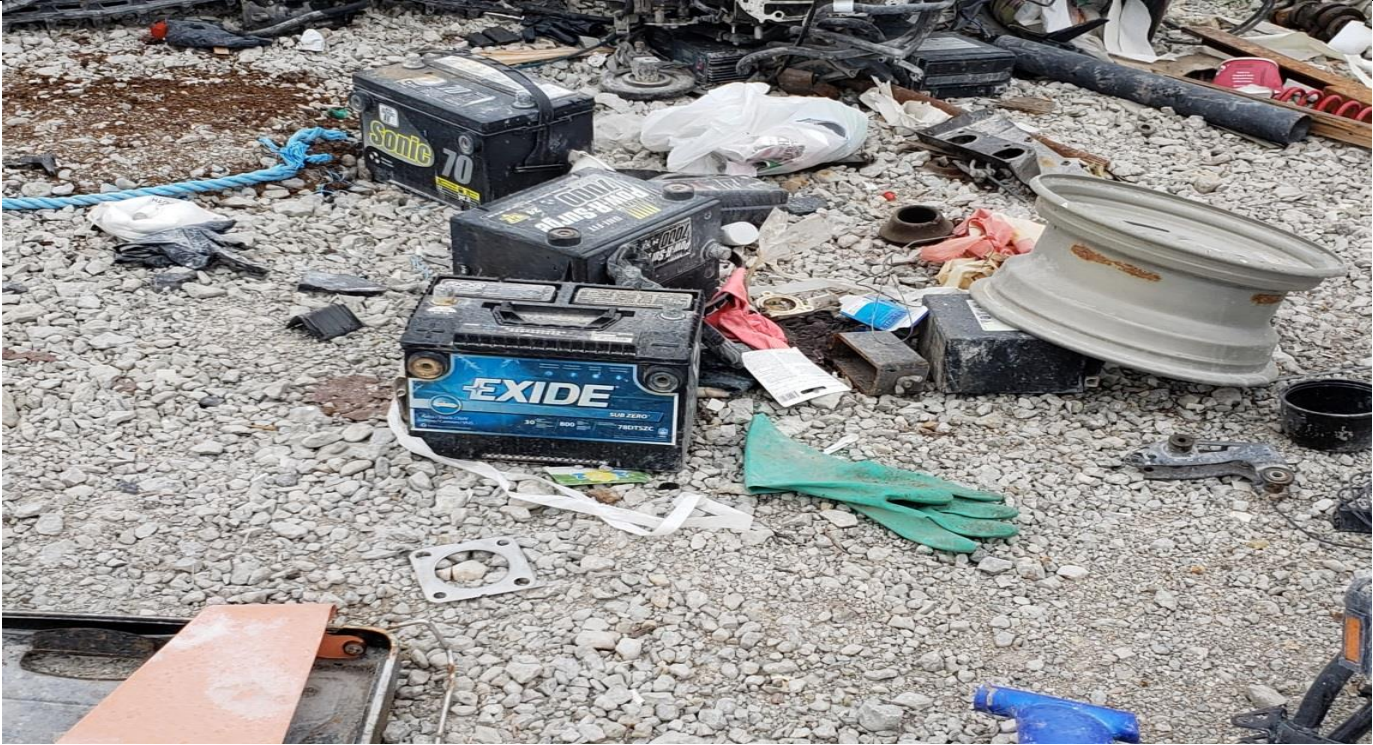
Photo Log	Location
Photo 15	Hall Beach

Description: Hazardous Waste: Battery within the bulk metals section. Hazardous Waste should be segregated from the rest of the domestic and metal waste.

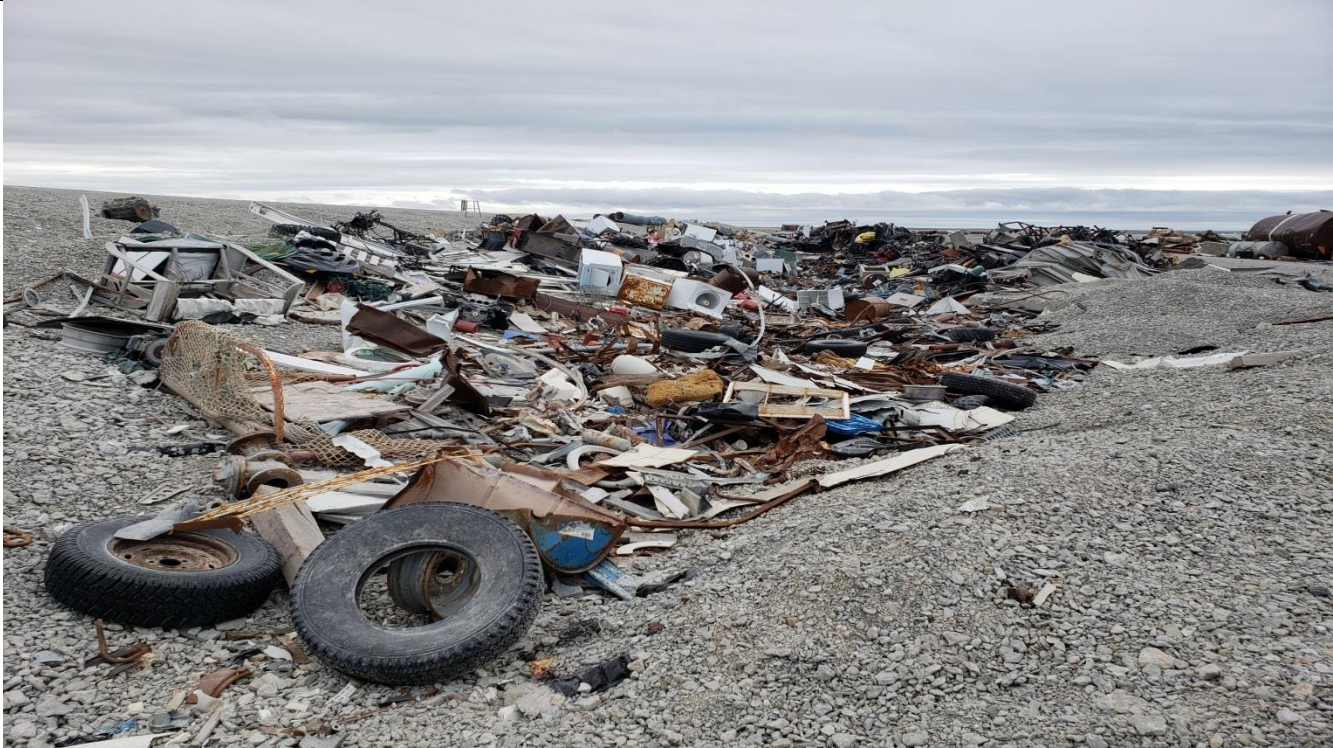
Photo Log	Location
Photo 17	Hall Beach

Description: Bulk Metal Storage. A separate Bulk Metal Storage Facility, with Government of Nunavut vehicles in it.
