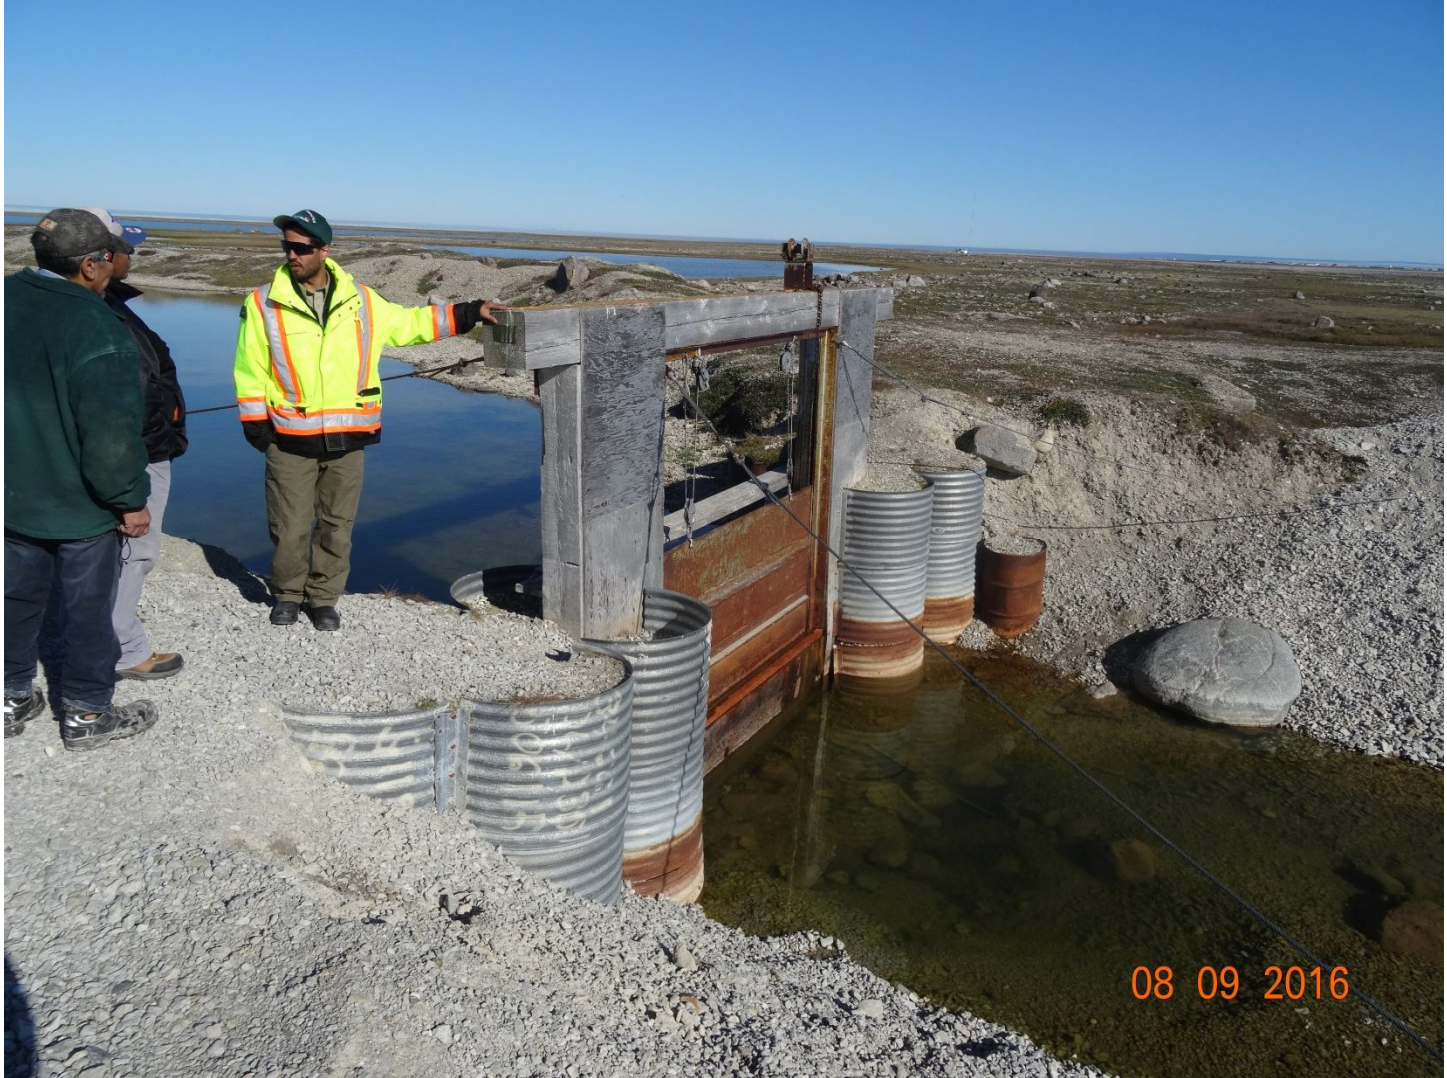
Figure 1: dam at the southwest corner of the water supply lake

The Hamlet uses this facility to recharge Water Supply Lake from an inflowing stream; however, when asked about ownership of this structure, the Hamlet said it does not belong to them (see *Figure 1*).
- d.

Given the date of construction and location of the structure, this facility was likely built by the military and should be authorized within a water licence.
- e.

At the time of inspection, erosion was evident on this structure and may affect its integrity.
7.

Follow-up regarding this structure will be done with the North Warning System site located in Hall Beach and with the Hamlet.
- f.

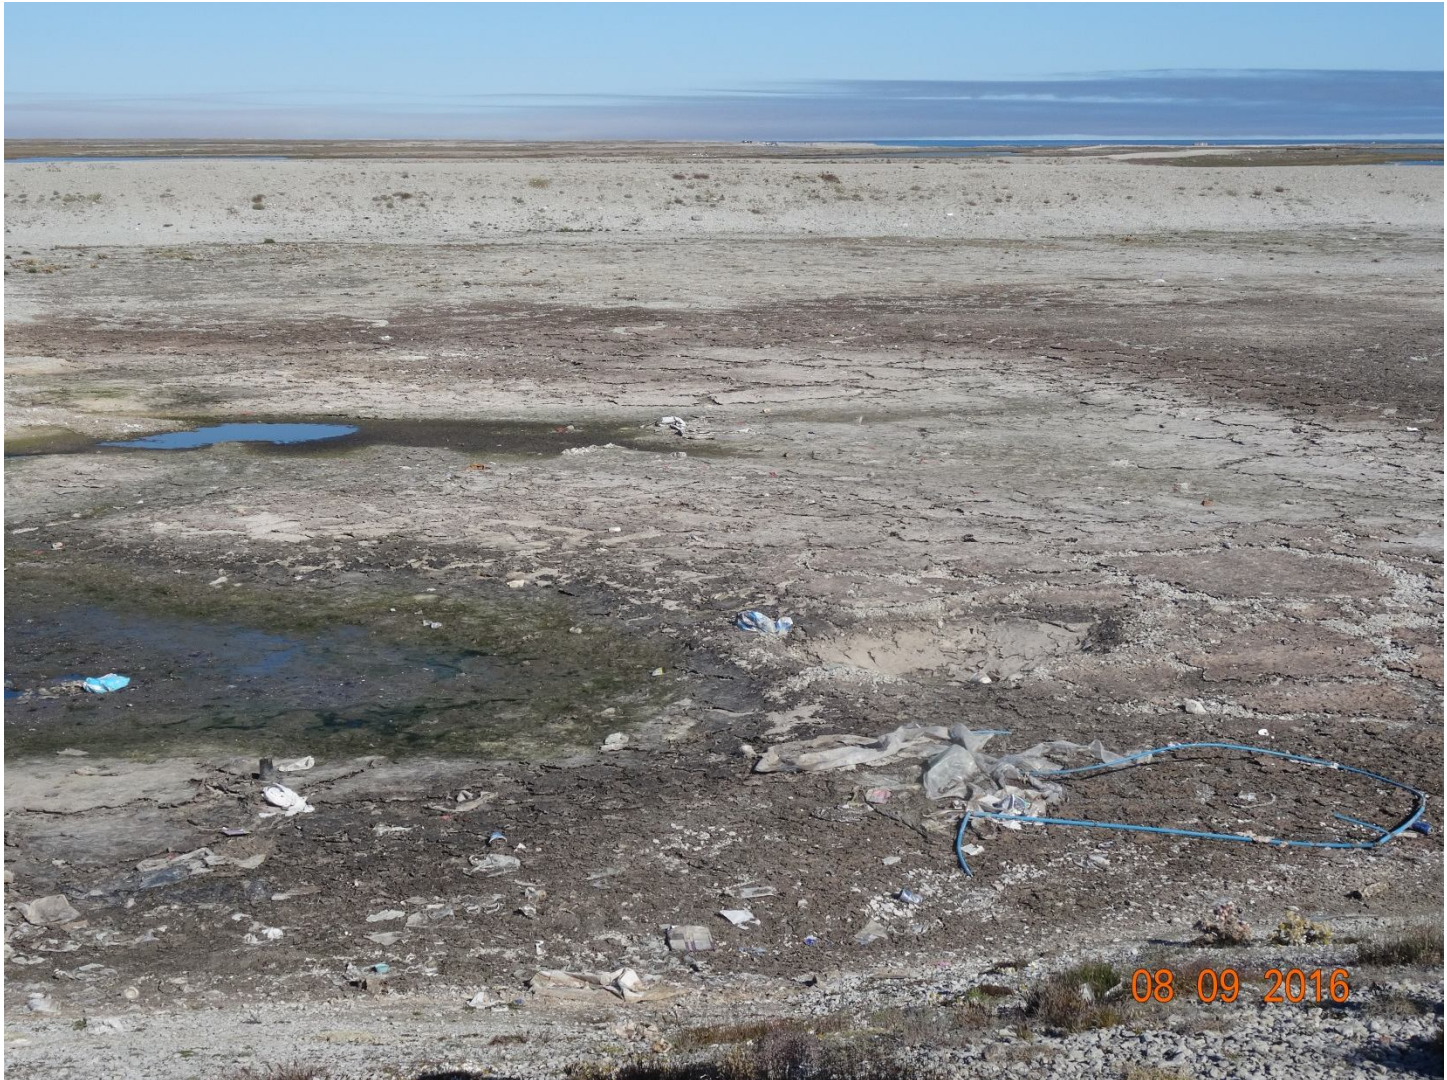
Figure 2: Cell 1 of the old lagoon

At the time of inspection, cell 1 was completely empty due to a leak in the facility (see *Figure 2*)

The hamlet is working on constructing a new lagoon which should be operational in 2017.
10.

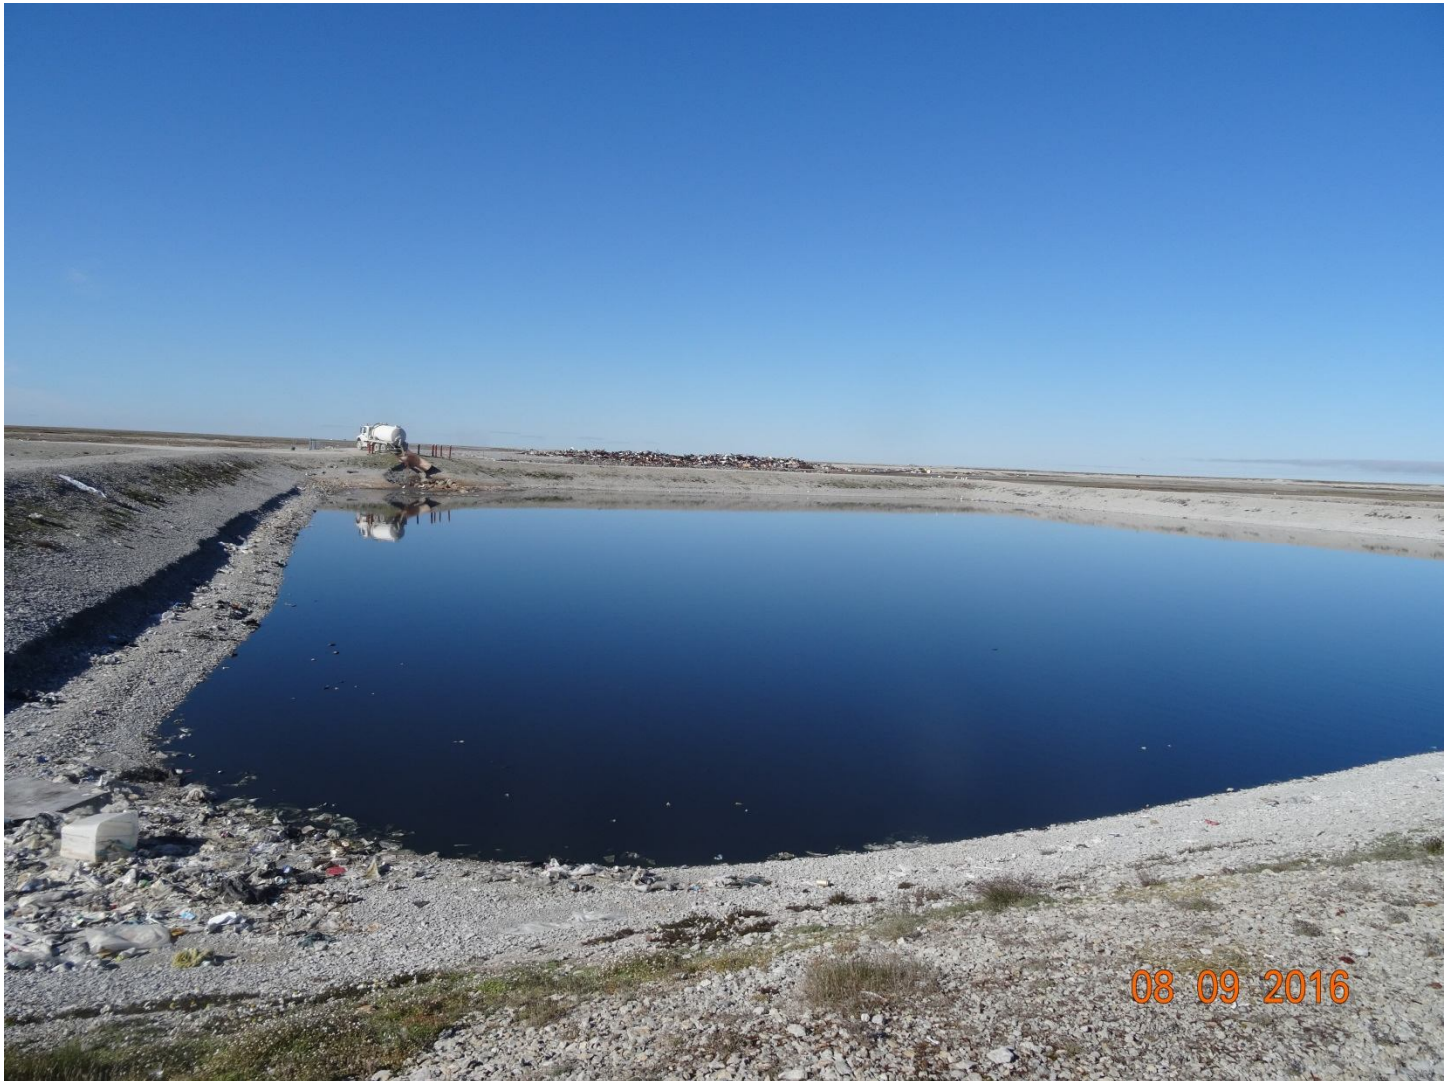
Figure 3: Cell 2 of the old lagoon

Berm walls surrounding Cell 2 appeared to be in good condition, no signs of slope instability, leakage, cracking were evident (see *Figure 3*).
11.

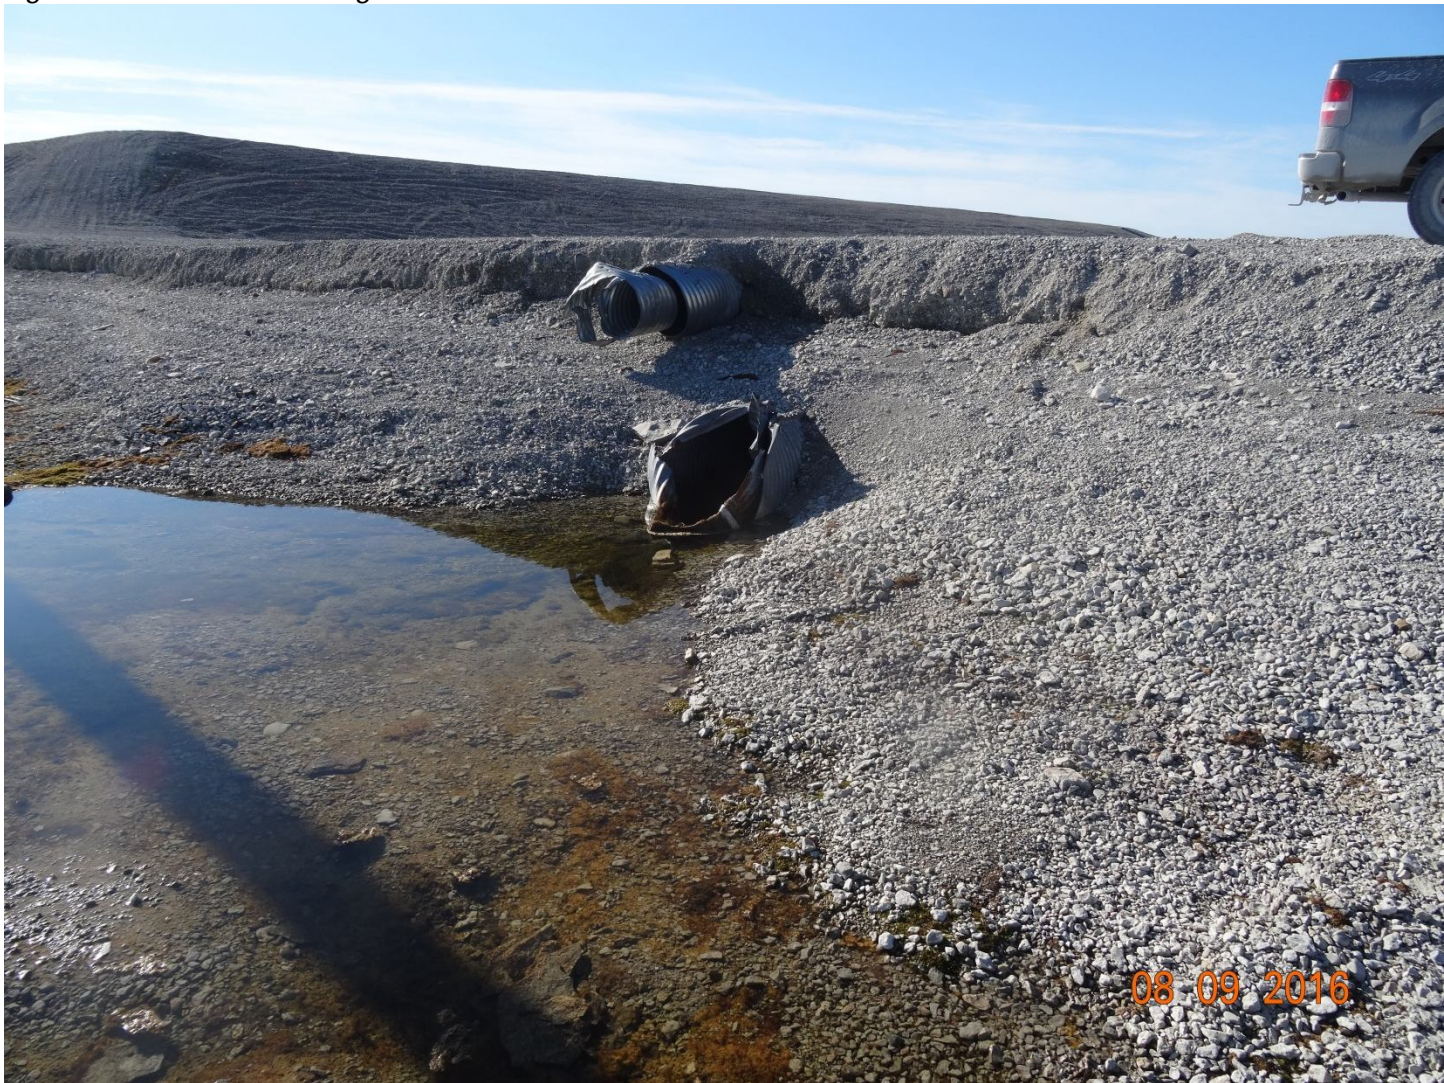
Figure #4 (Culverts near the water reservoir)

Culverts are installed around this facility to divert contact water from the municipality and airport from entering Water Supply Lake (Figure 4).

From information provided in the water licence application and the water licence, it does not appear that these culverts have been authorized by the Nunavut Water Board to divert water.

During the inspection, it was communicated that these culverts wash-out every few years and are re-installed by the airport.
