WATER LICENCE INSPECTION FORM

Licensee	Licensee Representative
Hamlet of Hall Beach	Johnny Kadlutsiak
Licence No. / Expiry	Representative's Title
3BM-HAL1520	Foreman
Land / Other Authorizations	Land / Other Authorizations
Date of Inspection	Inspector
October 4, 2017	Jonathan Mesher
Activities Inspected	
<div><input type="checkbox"/> Camp<input type="checkbox"/> Drilling<input type="checkbox"/> Mining<input type="checkbox"/> Construction<input type="checkbox"/> Reclamation<input checked="" type="checkbox"/> Fuel Storage</div> <div><input type="checkbox"/> Roads/Hauling<input type="checkbox"/> Other: Water Discharge<input checked="" type="checkbox"/> Other: Municipal</div>

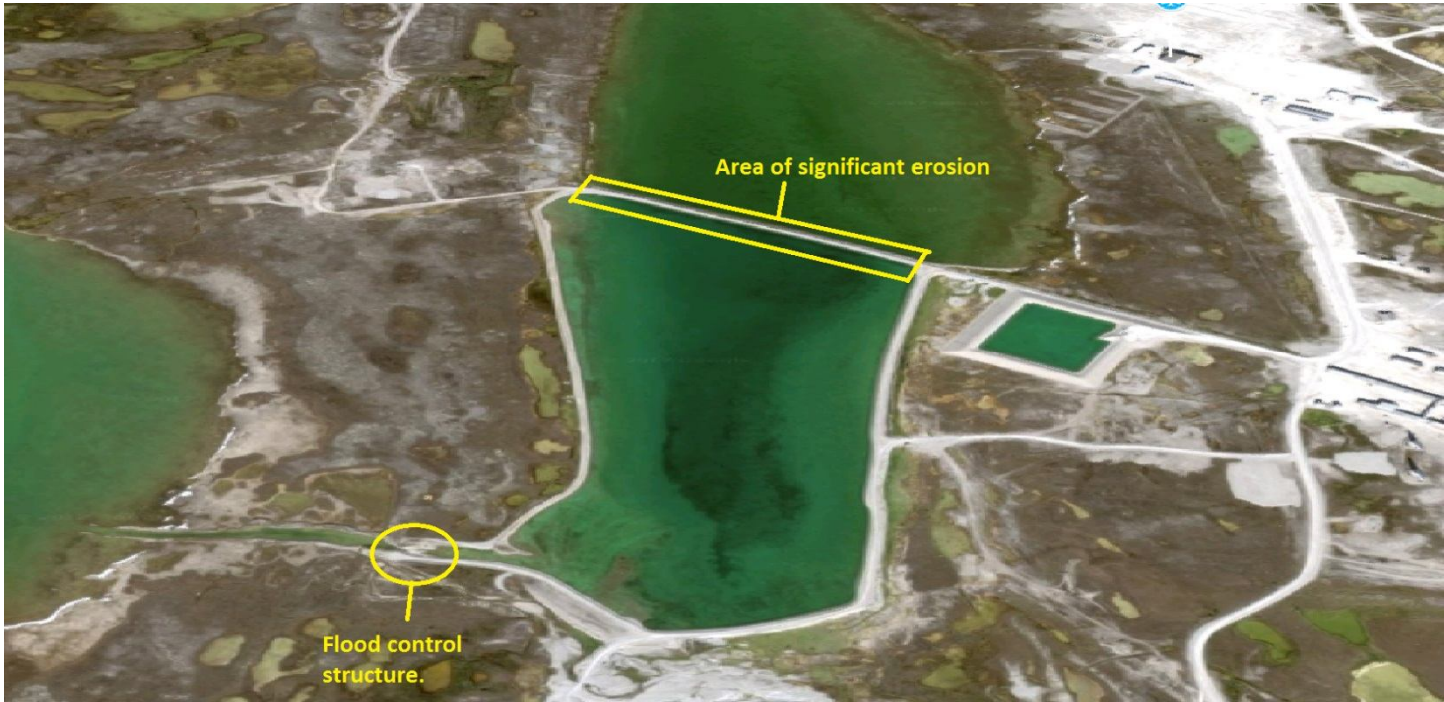
4. During the last Inspection the inspector had identified Water Supply Lake as a use of water because, the lake is surrounded by, culverts and has a flood control structure located at the South-West corner of the lake. See figure 1 for a picture of Water Supply Lake.
- i. INAC is requesting that the Licensee obtain the appropriate approval from the NWB for the water management structures surrounding Water Supply Lake.
5. The licensee is in contradiction of PART C, Item 4 of the water Licence 3BM-HAL1520 which states; “The Licensee shall not cause erosion to the banks of any body of water and shall provide necessary controls to prevent such erosion.”
- i. This dam is eroded to the point where it is now unusable as a road.

ii. It does not appear to the inspector that the licensee has implemented the necessary controls to prevent such erosion.

Figure 1: Water Supply Lake

iii. The inspector is requesting that the dams surrounding Water Supply Lake be reviewed and regulated by the NWB.
