WATER LICENCE INSPECTION FORM

Licensee		Licensee Representative	
Hamlet of Hall Beach		Bhabesh Roy	
Licence No. / Expiry		Representative's Title	
3BM-HAL1520		Municipal Engineer	
Land / Other Authorizations		Land / Other Authorizations	
Date of Inspection		Inspector	
July 11, 2018		Joseph Monteith & Jonathan Mesher	
Activities Inspected			
<input type="checkbox"/> Camp	<input type="checkbox"/> Drilling	<input type="checkbox"/> Mining	<input type="checkbox"/> Construction
<input type="checkbox"/> Roads/Hauling	<input checked="" type="checkbox"/> Other: Potable Water Source, Waste Water Treatment Facility, and Solid Waste Facility	<input type="checkbox"/> Reclamation	<input type="checkbox"/> Fuel Storage

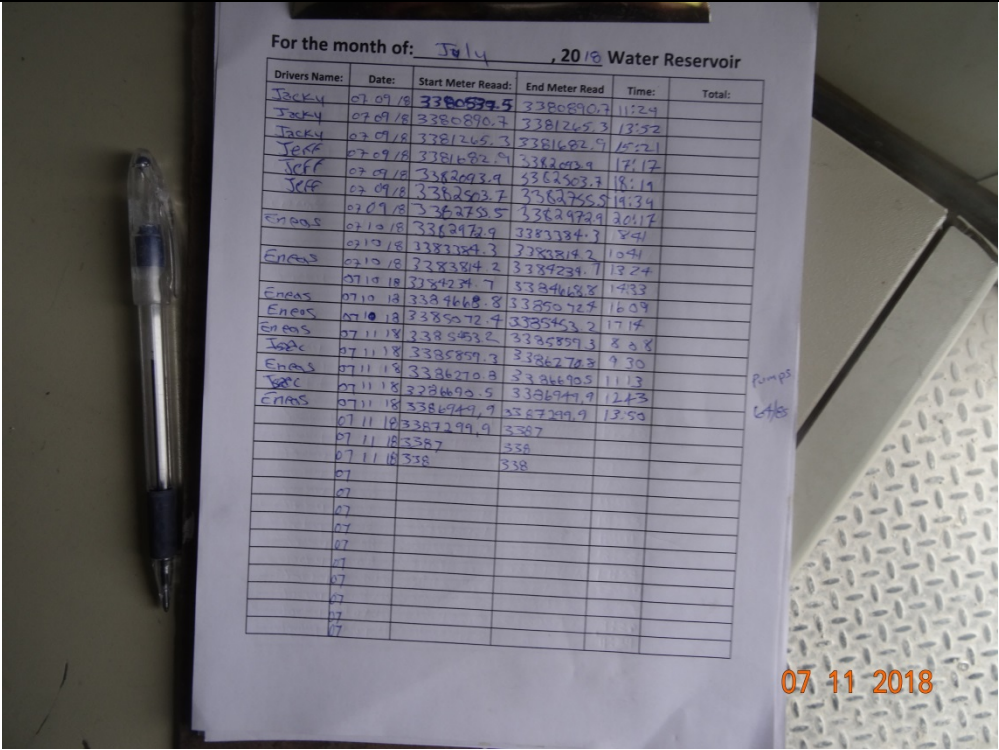
Photo 3

5. It was suggested that the flow metre wasn't working at the time of the inspection. But, upon closer inspection the flow metre appeared to be working, and used to record usage amounts. At the time of the inspection the flow metre read 3,387,299.9 Litres, and the logs read the same amount as of July 11, 2018 on the log sheet (See Photo #2 & 3). The monthly water consumption report recorded 3,026,455.7 Litres used for the month of July in 2018.
6. On October 25, 2018, William Koonoo, Municipal Technical Clerk, Government of Nunavut (GN), Community Government and Services (CGS) emailed WRO Monteith the Water Consumption records for Hall Beach for January 2018, to September 2018 which showed a total amount of 25,321,989.3 Litres. Well below their authorized amount listed in the water licence (See Photo #4).

Description: Water Usage Logs from Water Pump House – 3387299.9 on July 11, 2018
