WATER LICENCE INSPECTION FORM

Licensee	Licensee Representative
Hamlet of Hall Beach	Bhabesh Roy
Licence No. / Expiry	Representative's Title
3BM-HAL2025	Municipal Engineer
Land / Other Authorizations	Land / Other Authorizations
Date of Inspection	Inspector
September 8, 2021	Joseph Monteith
Activities Inspected	
<div><div><input type="checkbox"/> Camp</div><div><input type="checkbox"/> Drilling</div><div><input type="checkbox"/> Mining</div><div><input type="checkbox"/> Construction</div><div><input type="checkbox"/> Reclamation</div><div><input type="checkbox"/> Fuel Storage</div></div> <div><div><input type="checkbox"/> Roads/Hauling</div><div><input checked="" type="checkbox"/> Other: Potable Water Source, Waste Water Treatment Facility, and Solid Waste Facility</div><div><input type="checkbox"/> Other:</div></div>

PHOTO LOG

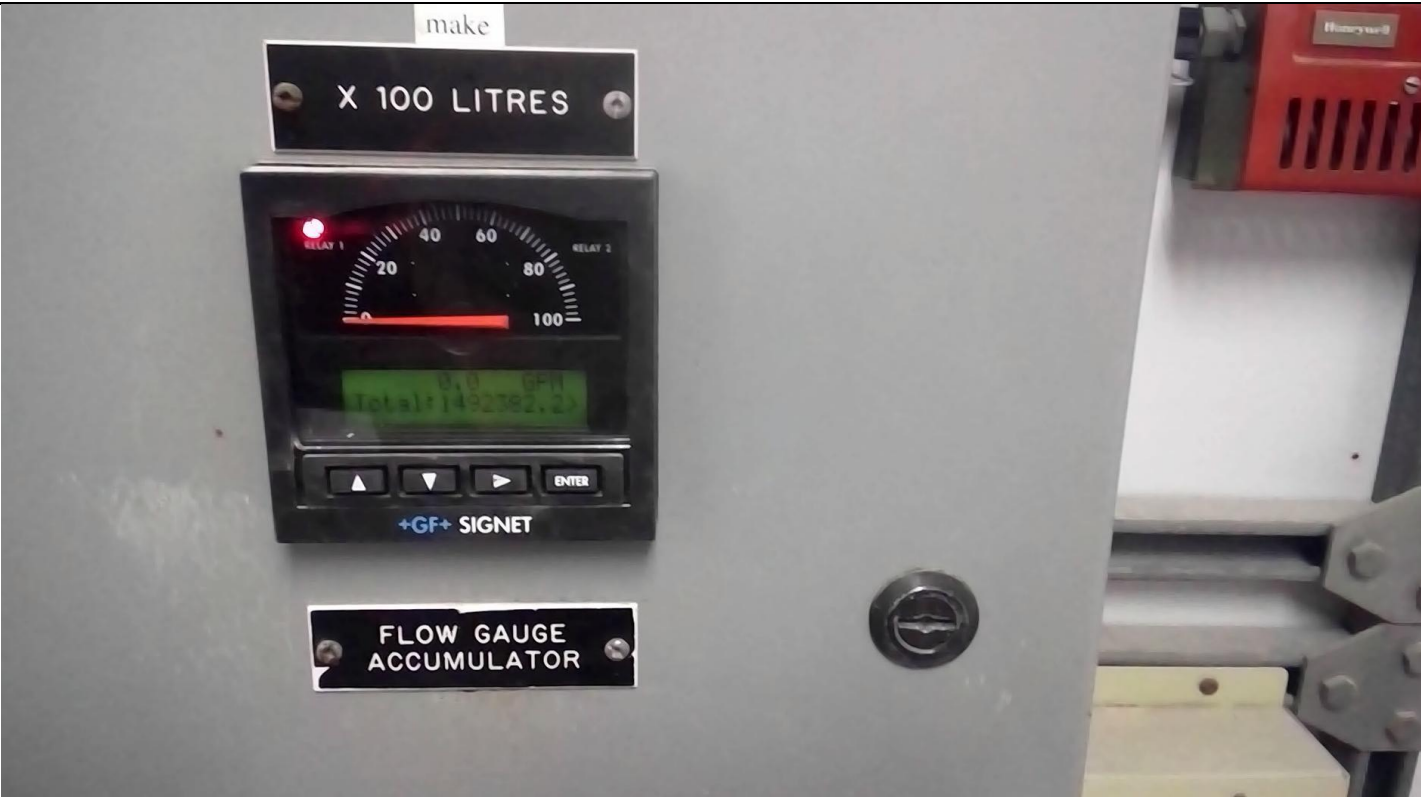
Photo 2

Description: Water Meter – reads 1492382.2 x 100 litres. Signet Flow Gauge Accumulator

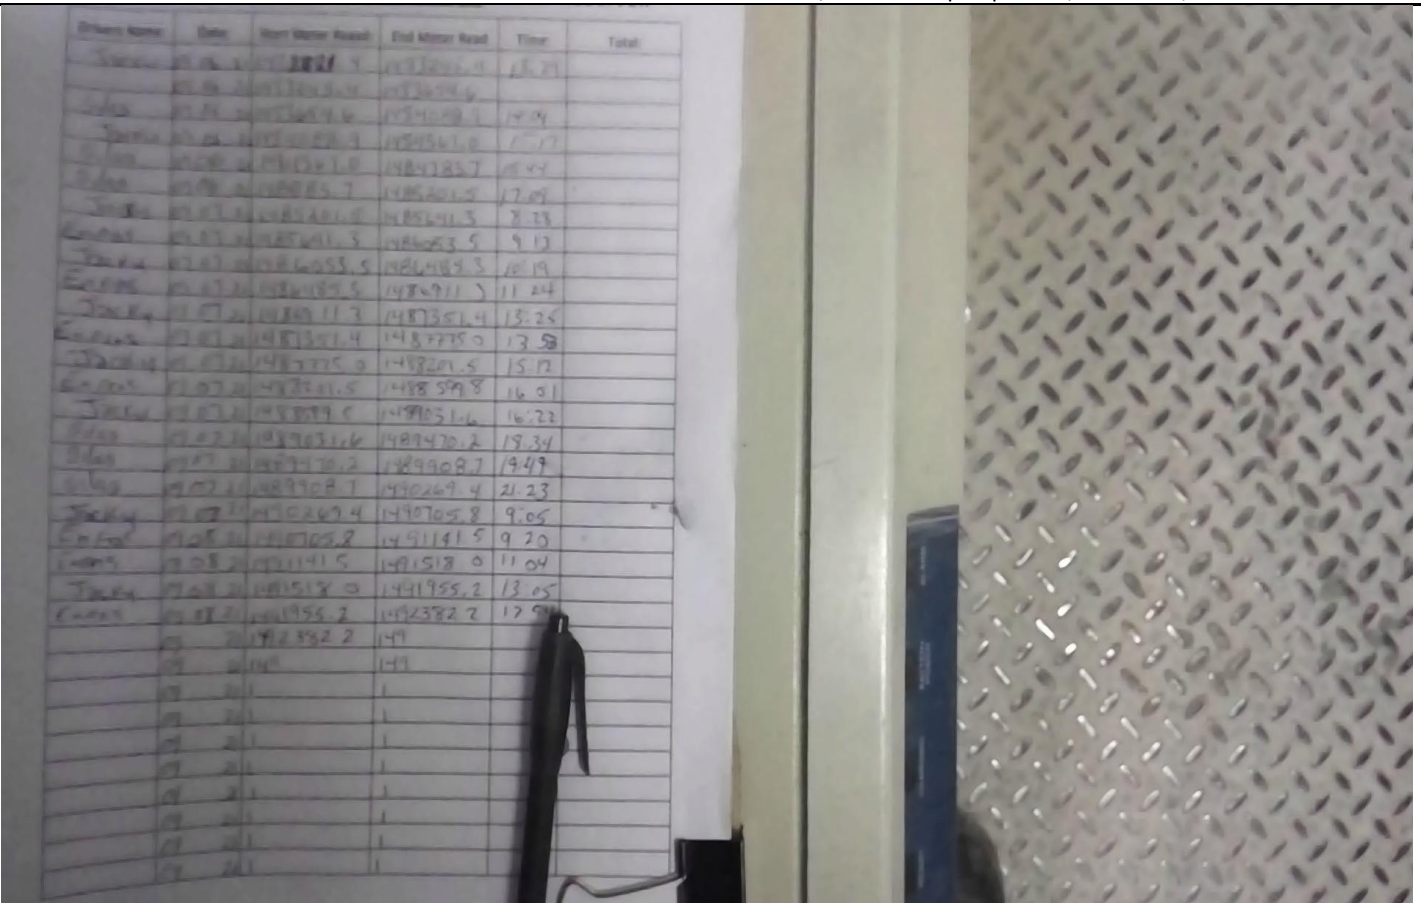
Photo 3

Description: Water Usage Logs from Water Pump House – “end meter read” “1492382.2” on September 8, 2021 at 17:04pm

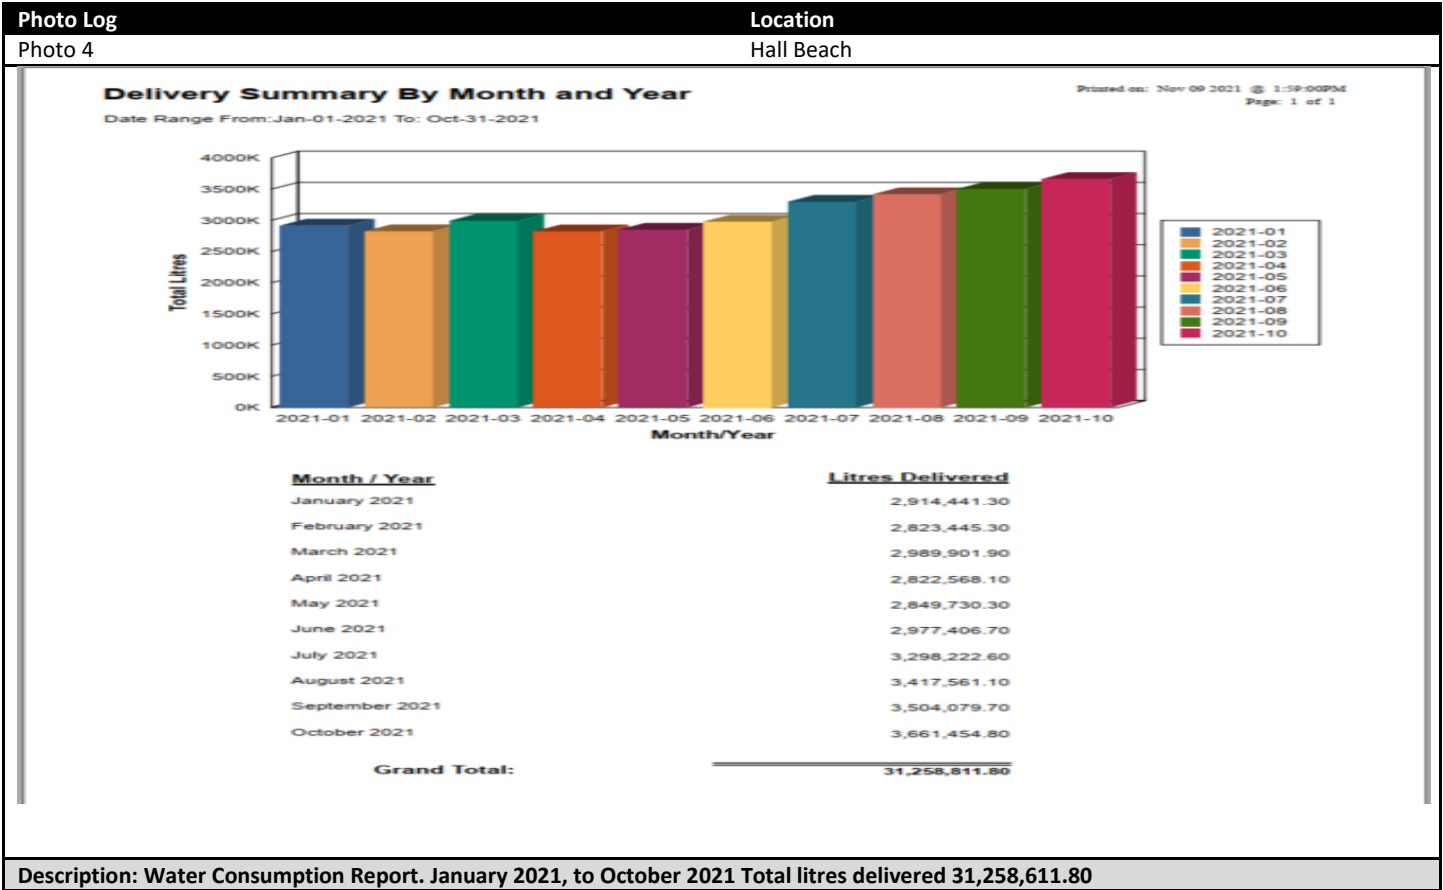
- by Raytheon. Discussions with CGS is ongoing into see who is responsible to maintain the road/dyke.
- At the time of the inspection a yellow triangle sign was observed titled HAL 1 at the pump house of the water treatment facility indicating a monitoring site at Fundo Lake.
 - The water reservoir appeared to be working as intended(photo 5).
 - Two pumping stations at the Water Storage Reservoir. One for community, and another for the North Warning Site.
 - Water meter used to record usage amounts . At the time of the inspection the flow metre read 1492382.2m³ (photo 2), and the logs read the same amount as of July 11, 2018 on the log sheet (See photo 3).
 - The monthly water consumption report recorded 0053422.8m³ used for September 12, 2021 totals for the month (photo 4).

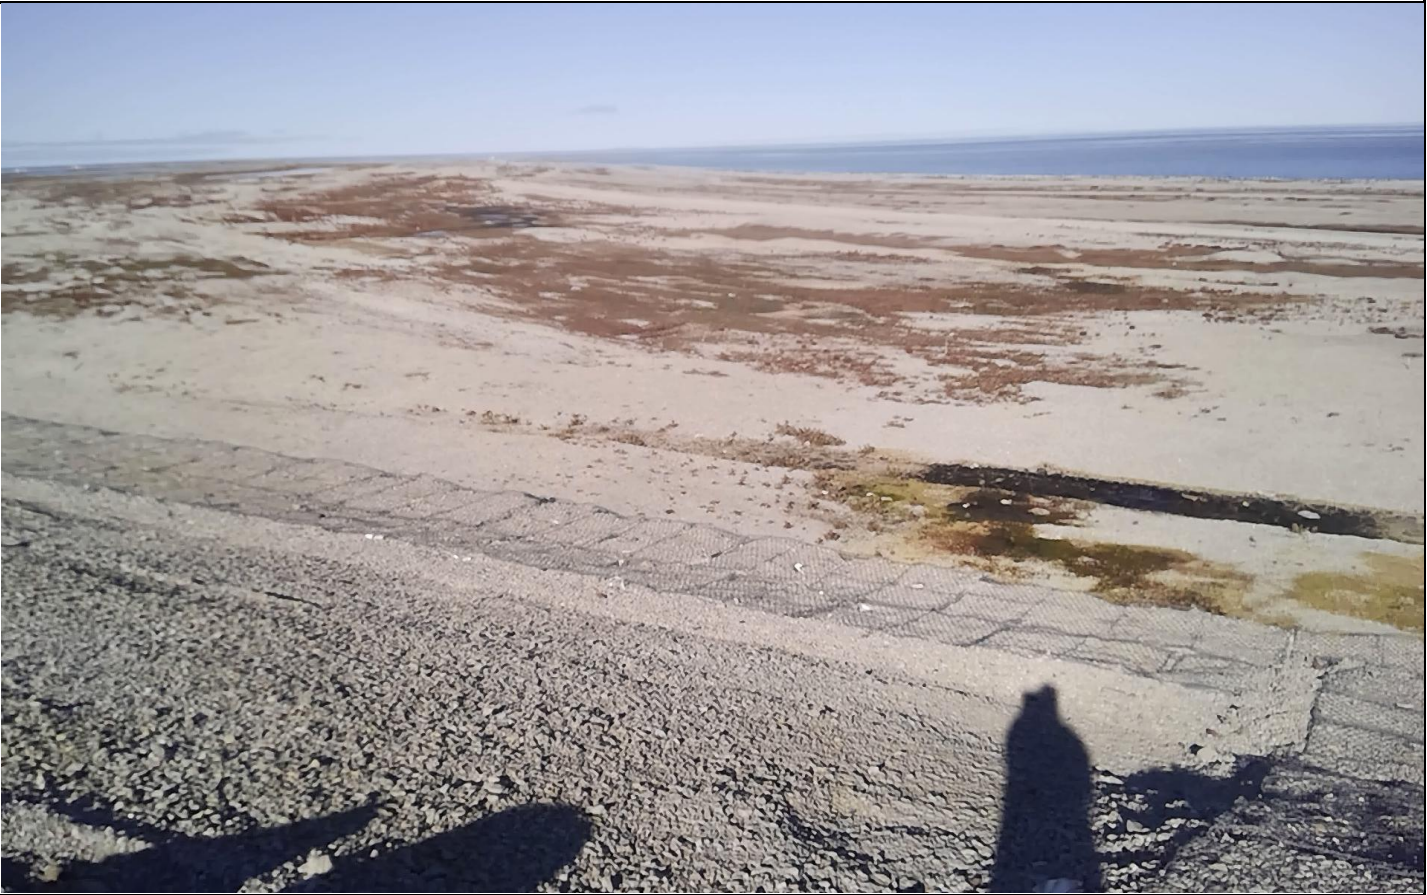
Photo Log	Location
Photo 7	Hall Beach

- Spill Report 2021-289 submitted July 8, 2021 informs the spill of 181,52m³ sewage spill from a breakage in the walls of the sewage lagoon. Follow up report after 30 days hasn’t been provided. (photo 7,8,&9)).

Description: Spill appears to have migrated from under the supports installed at the base of the sewage lagoon. Spill migrated top left of the photo. Distance from

SECTION 2	<input type="checkbox"/> Comments	<input type="checkbox"/> Non-Compliance with Act or Licence	<input checked="" type="checkbox"/> Action Required
<p>The following information is a summary of the actions Required by the licensee to promote and ensure compliance:</p> <ul style="list-style-type: none">Maintain fencing at burnable waste facilityRemove hazardous waste from bulk metal storage facility, deposit in the Hazardous Waste Storage Facility (see photo 11).Seek consultation about the interaction of wildlife at the water reservoir.Report all spills within hazardous waste facility, the solid waste facility, the 2 cell sewage lagoons, the water source, water storage, and water treatment/pump house facility as per conditions of water license.Follow up with Spill reporting requirements as per the water license terms and conditions Part F: 8.(c) for spill reports 2019-253, 2020-198, and 2021-289Provide accurate GPS Coordinates of actual location of spills for 2019-253, 2020-198, 2021, 289.As Per Part F: section 7. 7. The Licensee shall perform more frequent inspections of the engineered facilities at the request of an Inspector. Due to the frequency, and large amount of product being spilled over the last 3 years, we request more frequent inspections of the engineered facility in Hall Beach.Provide Engineers Report, or Contractors Report indicating the work conducted to repair the sewage lagoon walls
