Summary of Work – Hall Beach 2020 Field Season

Final Report

Hall Beach Sewage Lagoon
Change Order No. 5 & Leak Detection/Resolution

OTT-220382

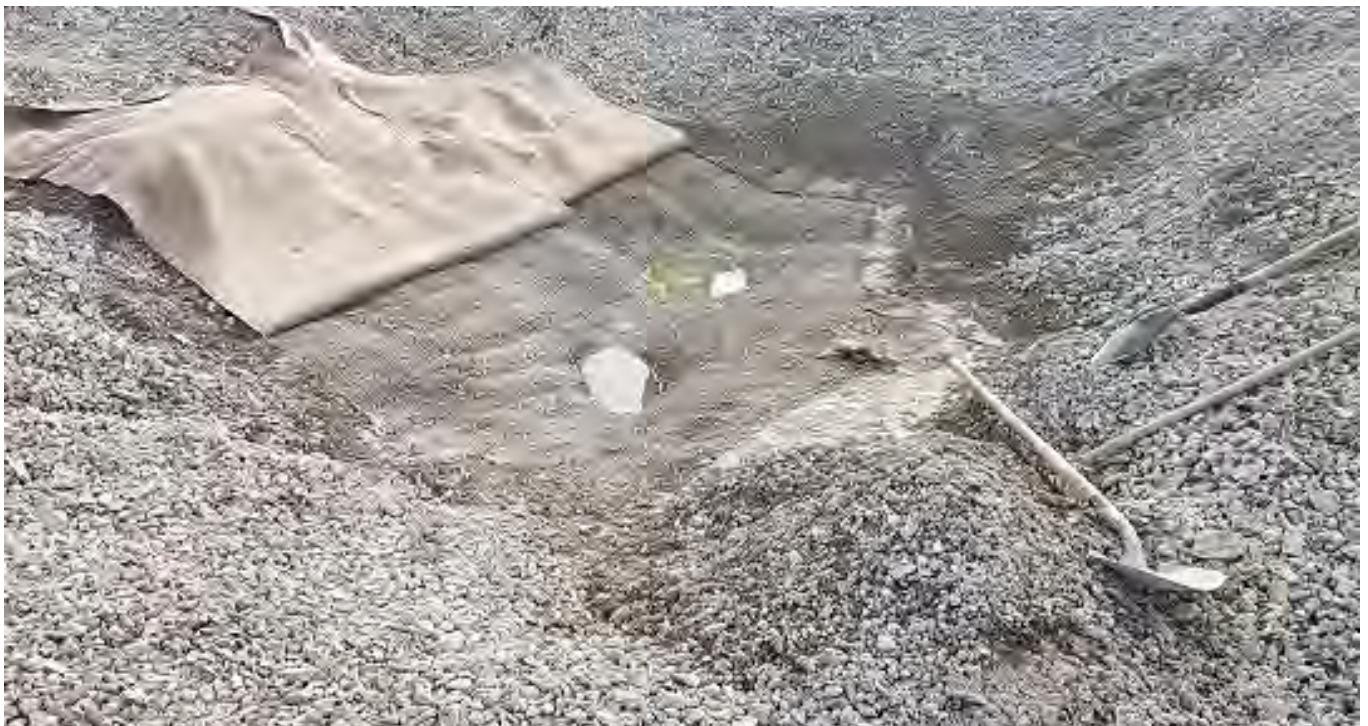
Photo 2: Area 1 upon removal of GCL. Standing water and depressions noted. Evidence of bulldozer tracks at the surface.

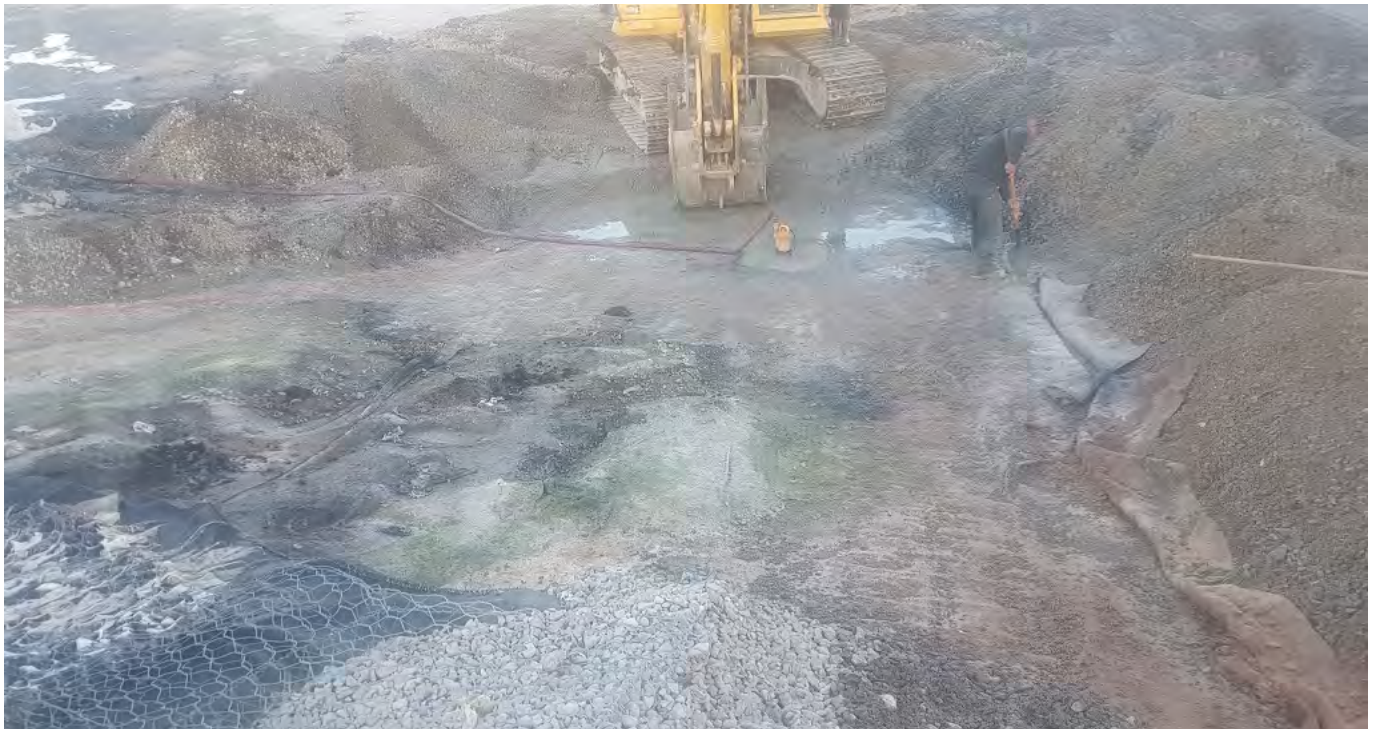
Photo 3: Limits of excavation on August 29. Seams on right side of photo had about 150mm of granular between layers, with no evidence of bentonite. Repairs to GCL evident in this area.

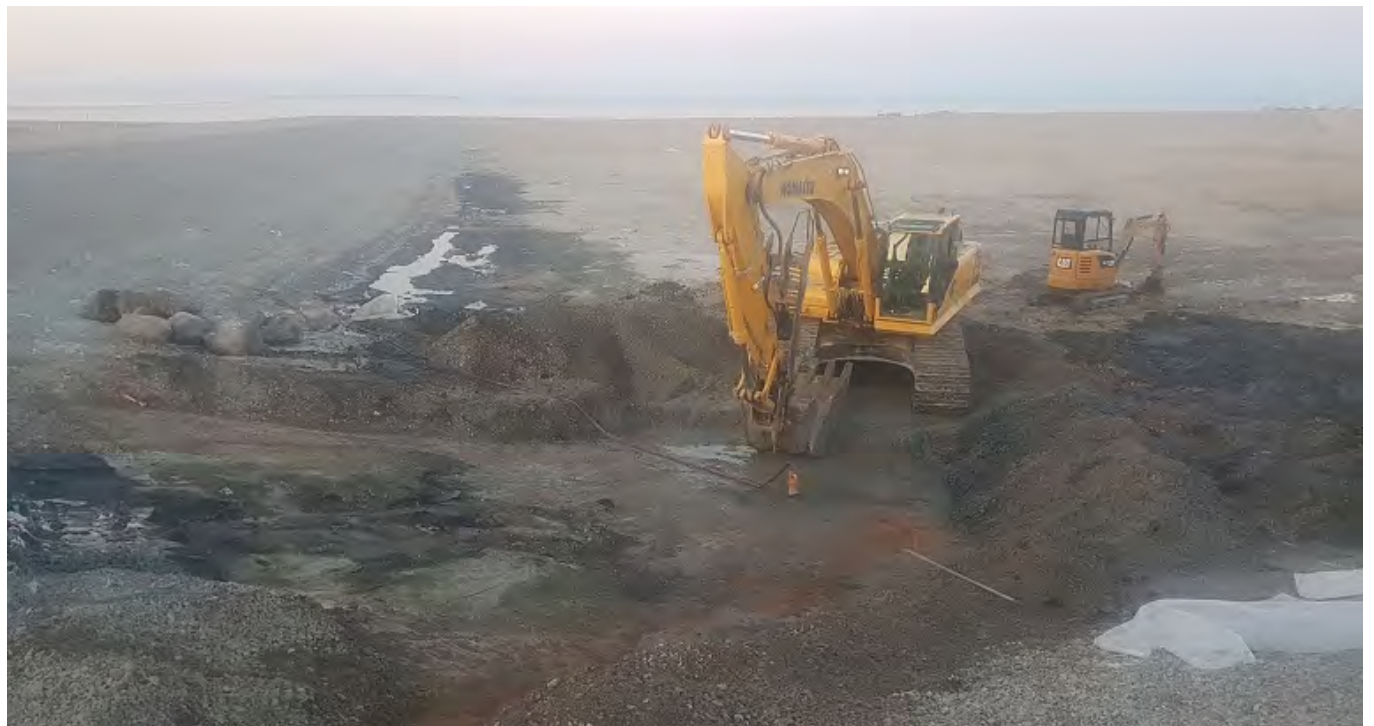
Photo 4: Water pumped from the bottom of the exposed area. Bentonite placed on the GCL seam and closed.

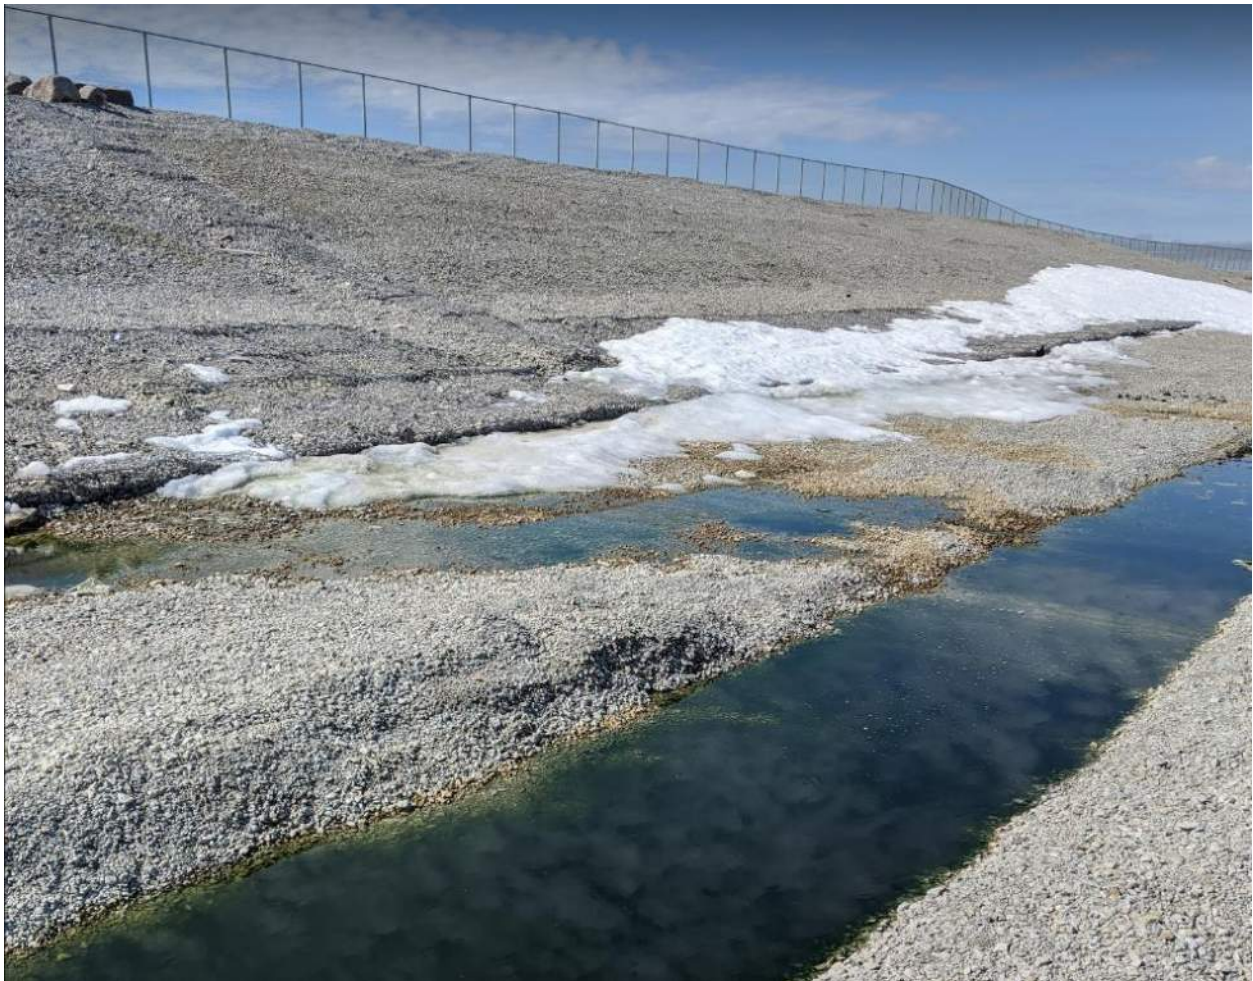
Photograph #1: Potential leak at east side of lagoon.

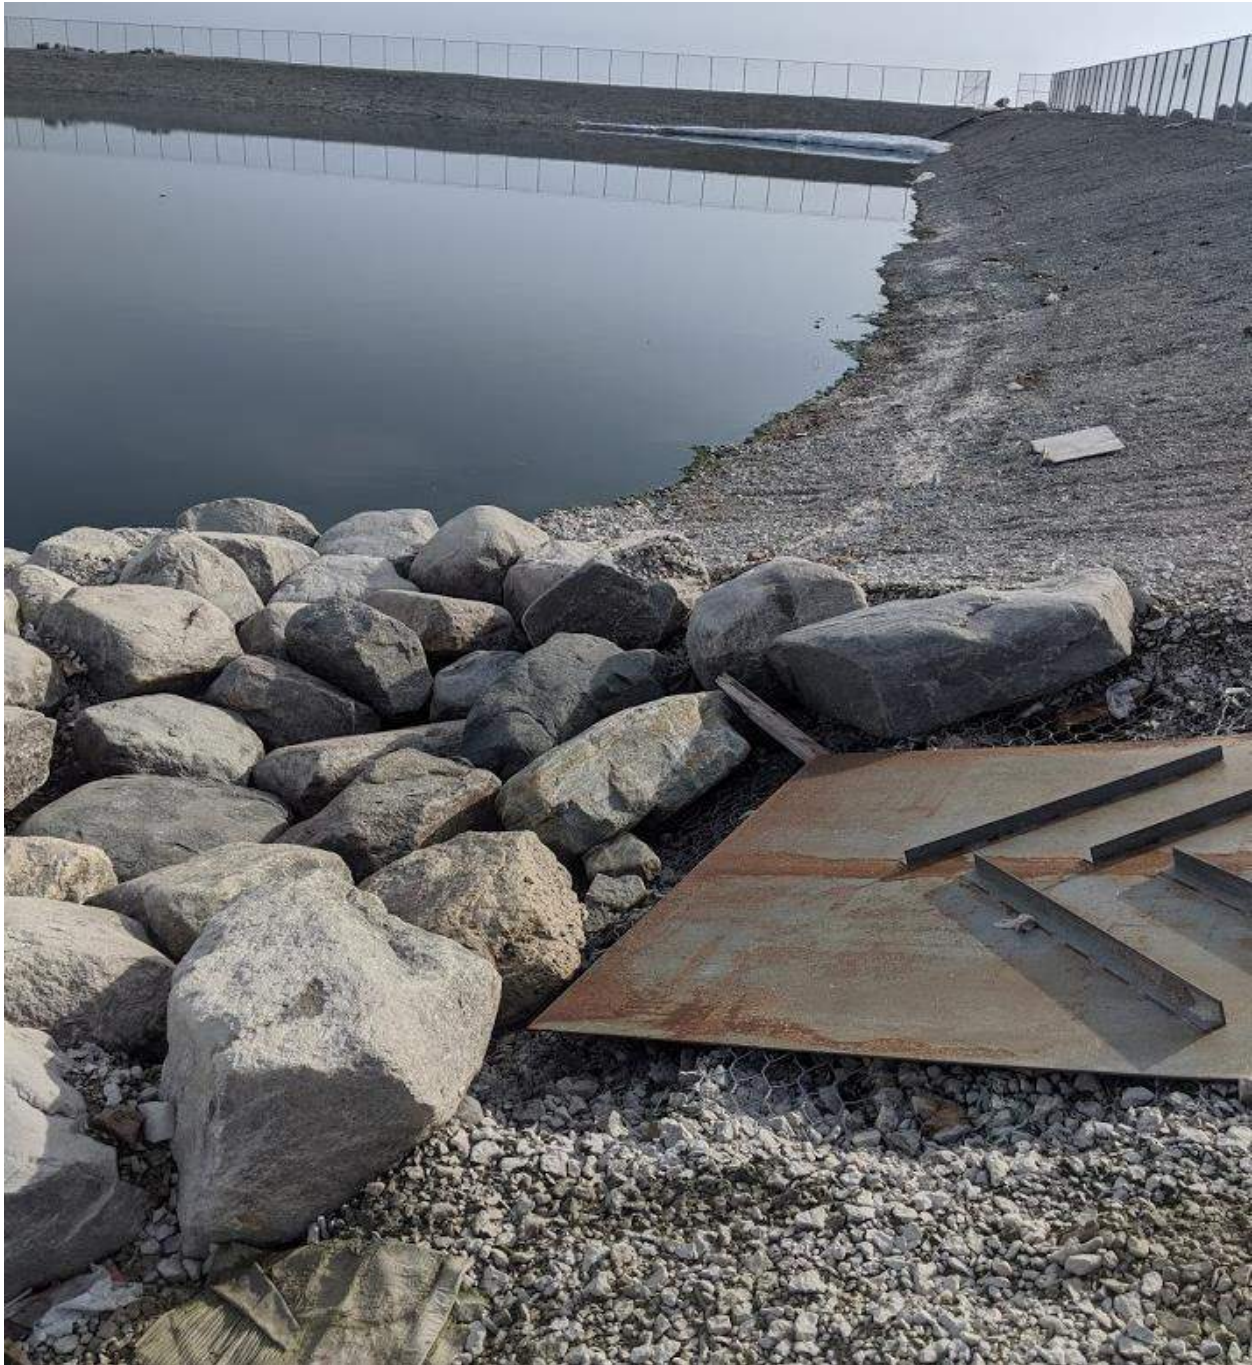
Photograph #2: South discharge station, showing significant erosion of fines between larger rocks.

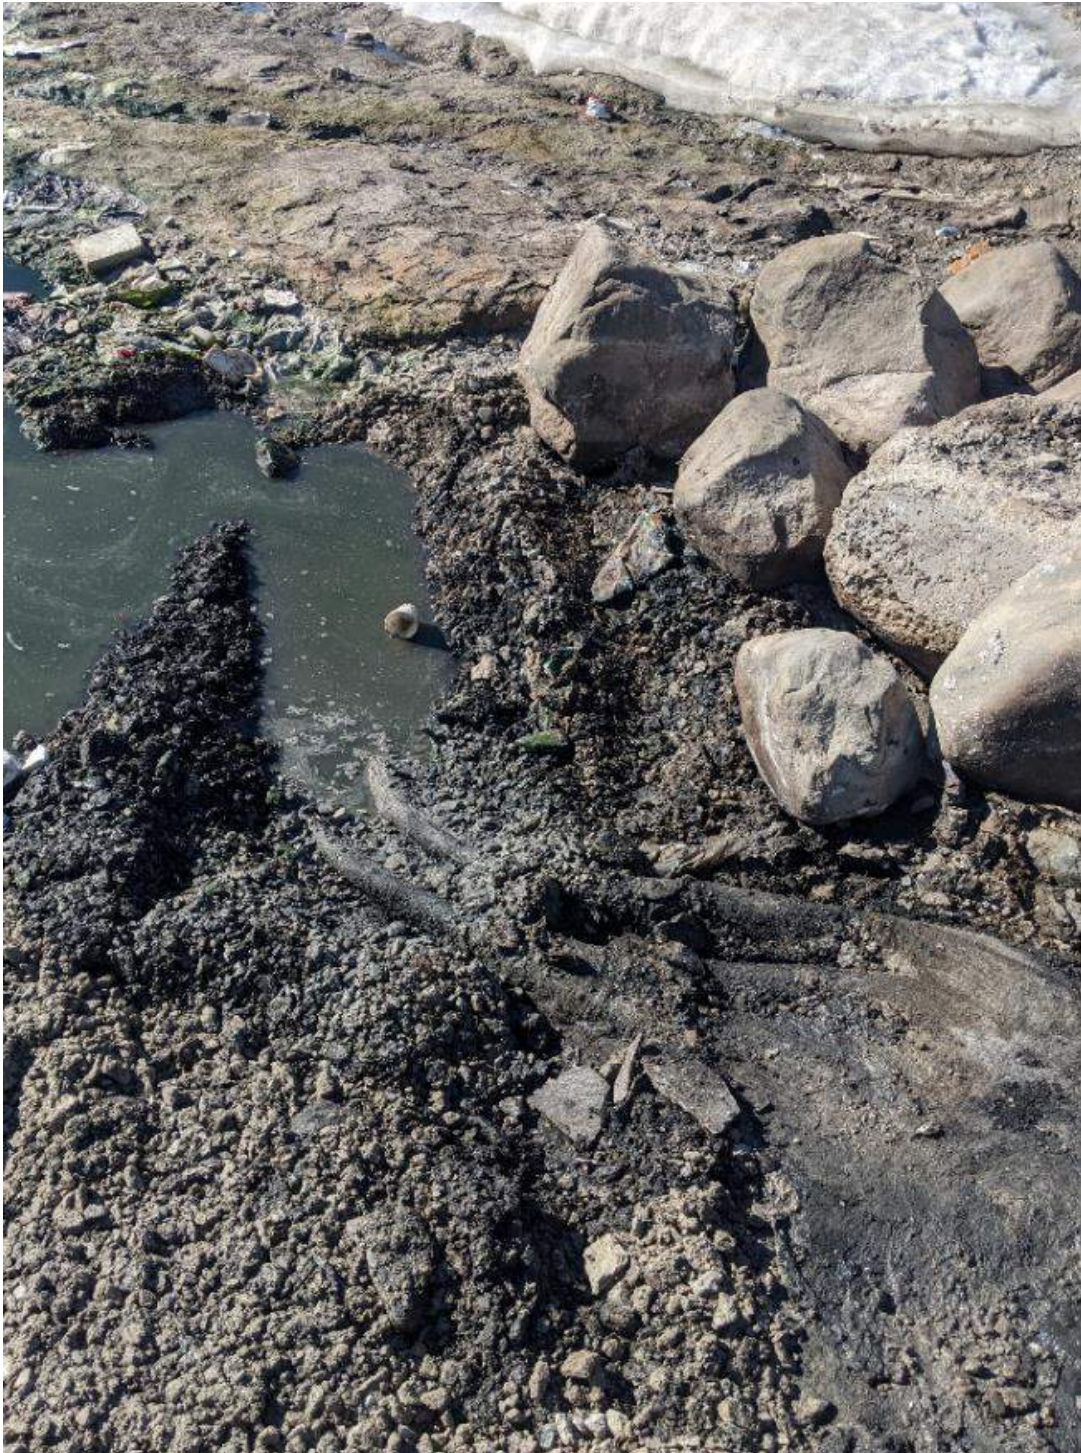
Photograph #2: Several of the large rocks were resting directly on the liner. Once the rocks were removed, the liner can clearly be seen to be folded over and damaged. A clearer picture will be obtained once the fines are removed, which will occur once the water within the lagoon is drained (seen here at left).

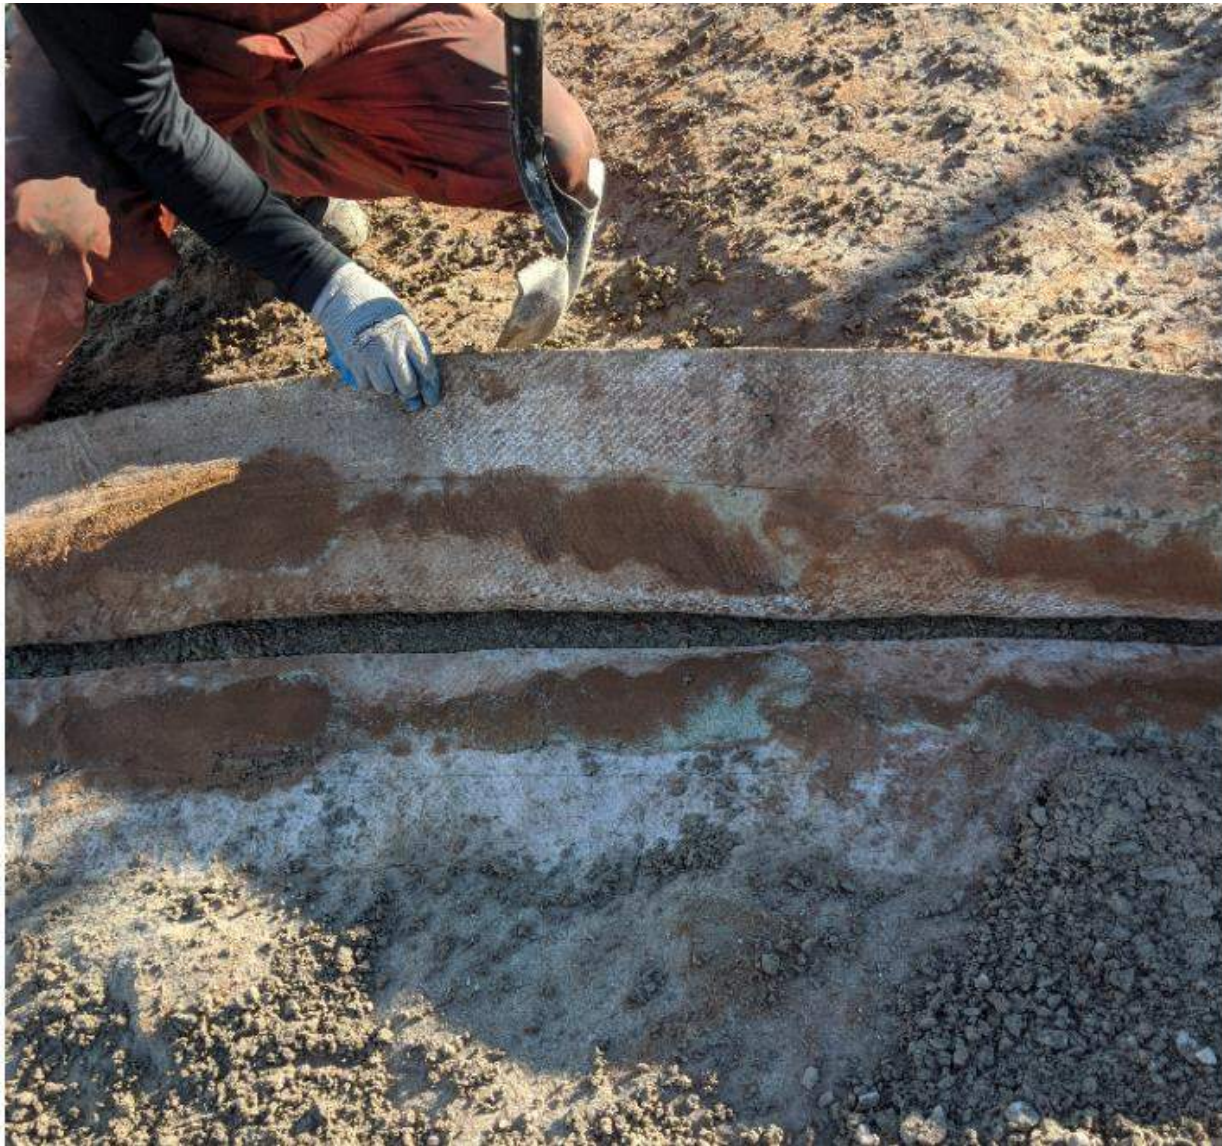
Photograph #1: Existing liner seam, showing bentonite staining within lap joint.

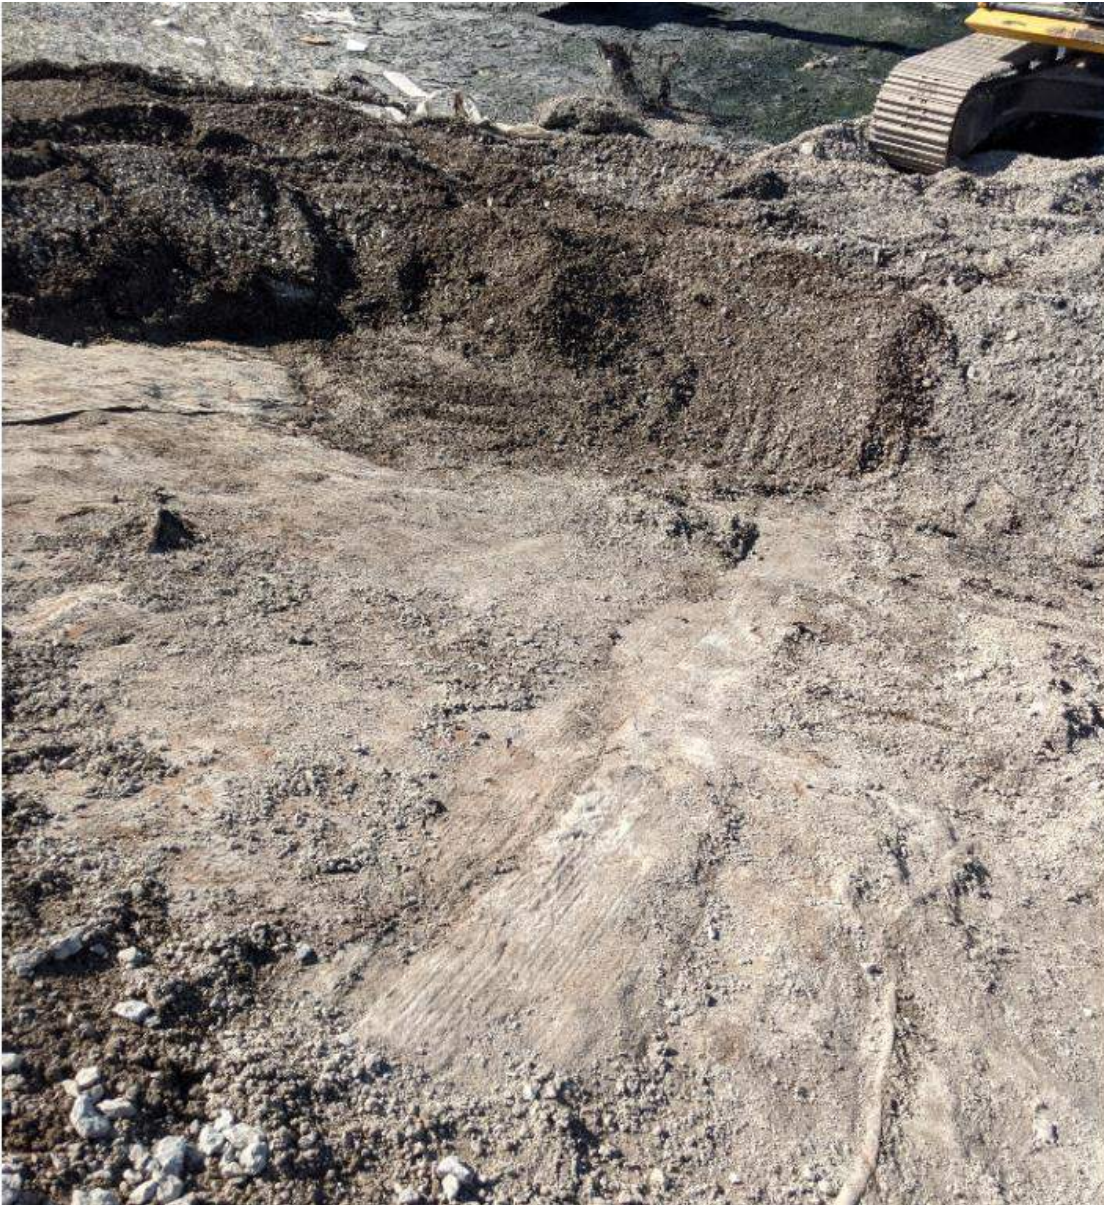
Photograph #2: Exposed liner, seen from top. Liner is largely intact. Minor damage due to process of exposing. A second liner will be applied over this one, thereby patching the holes.

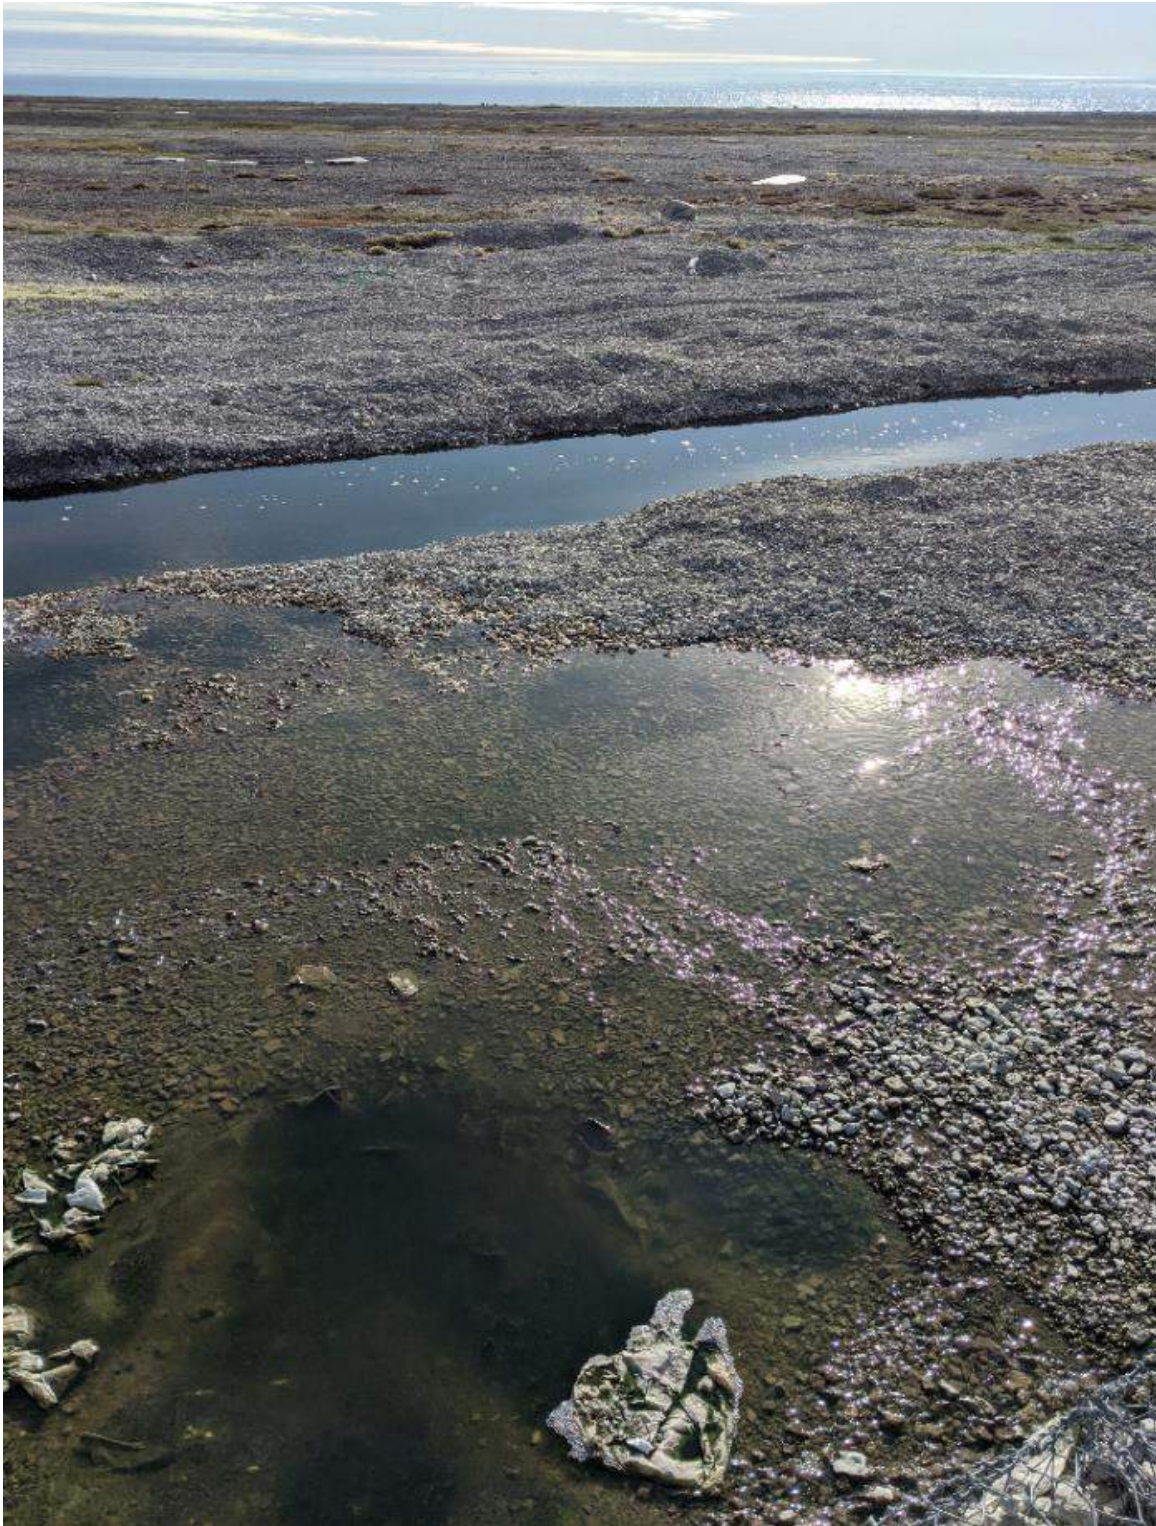
Photograph #1: Area of leak, with swale in background. All water in swale originated from leak.

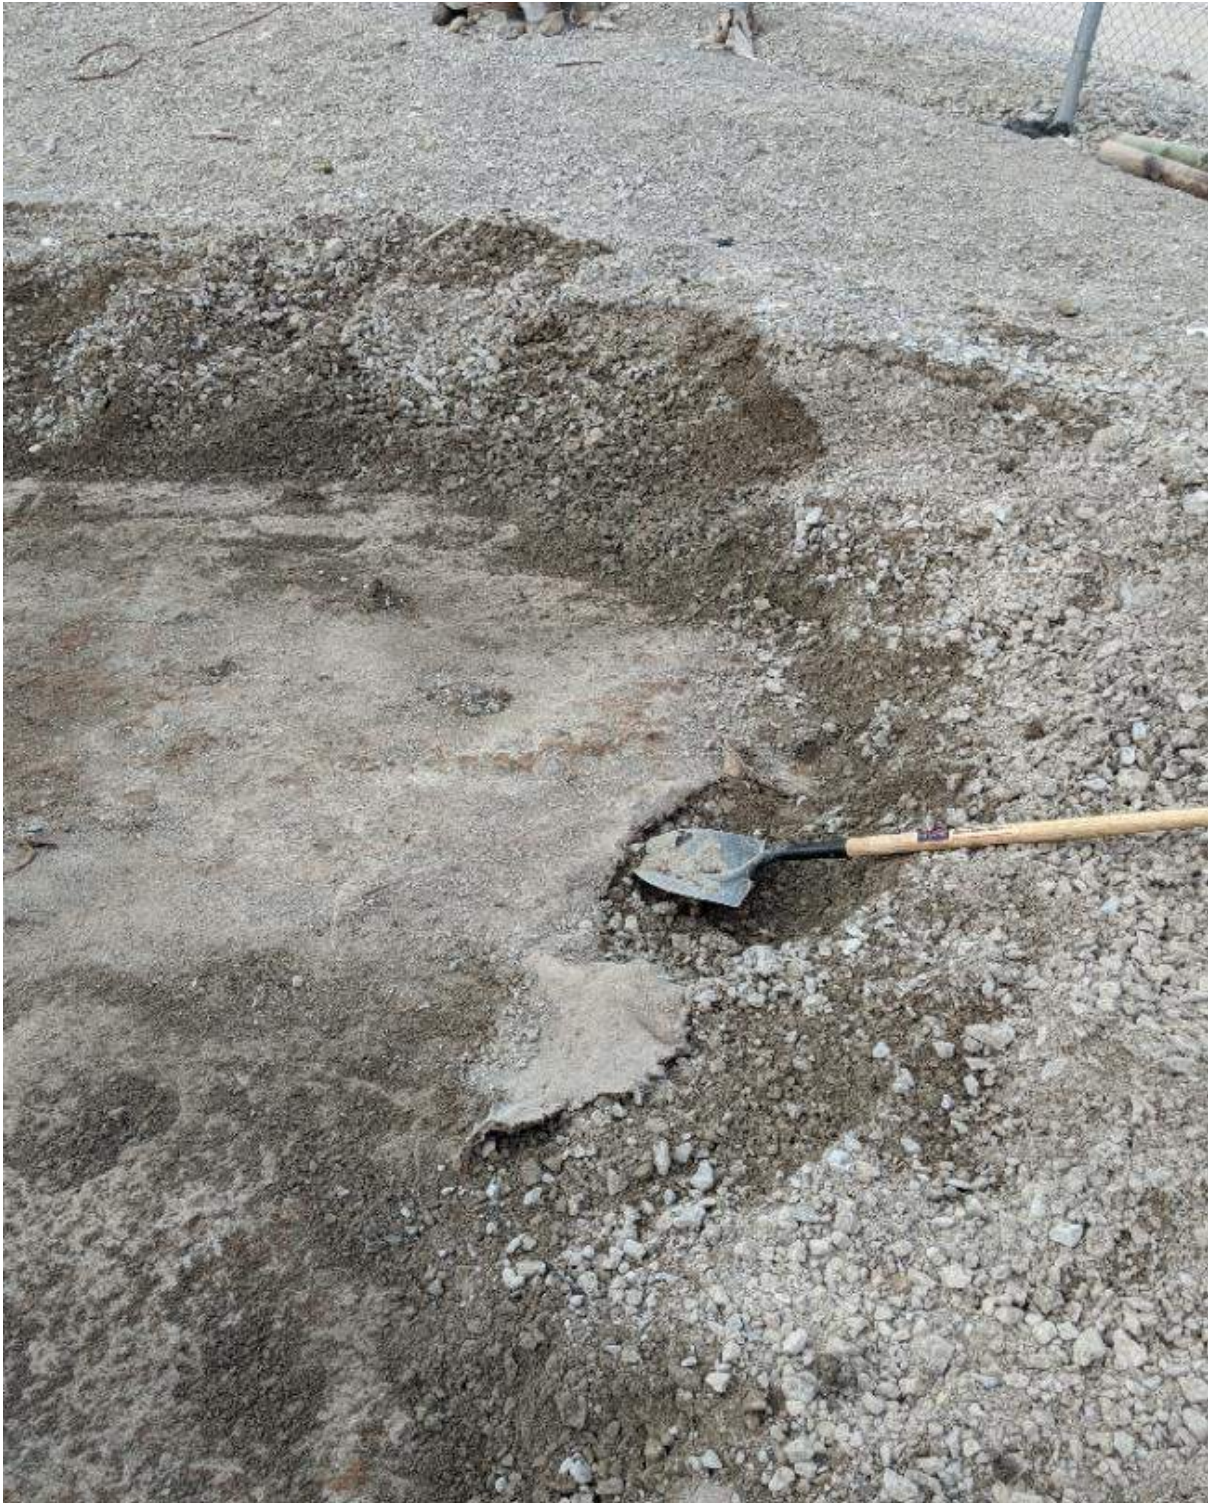
Photograph #1: Damaged existing liner at the top of the embankment, north discharge station.

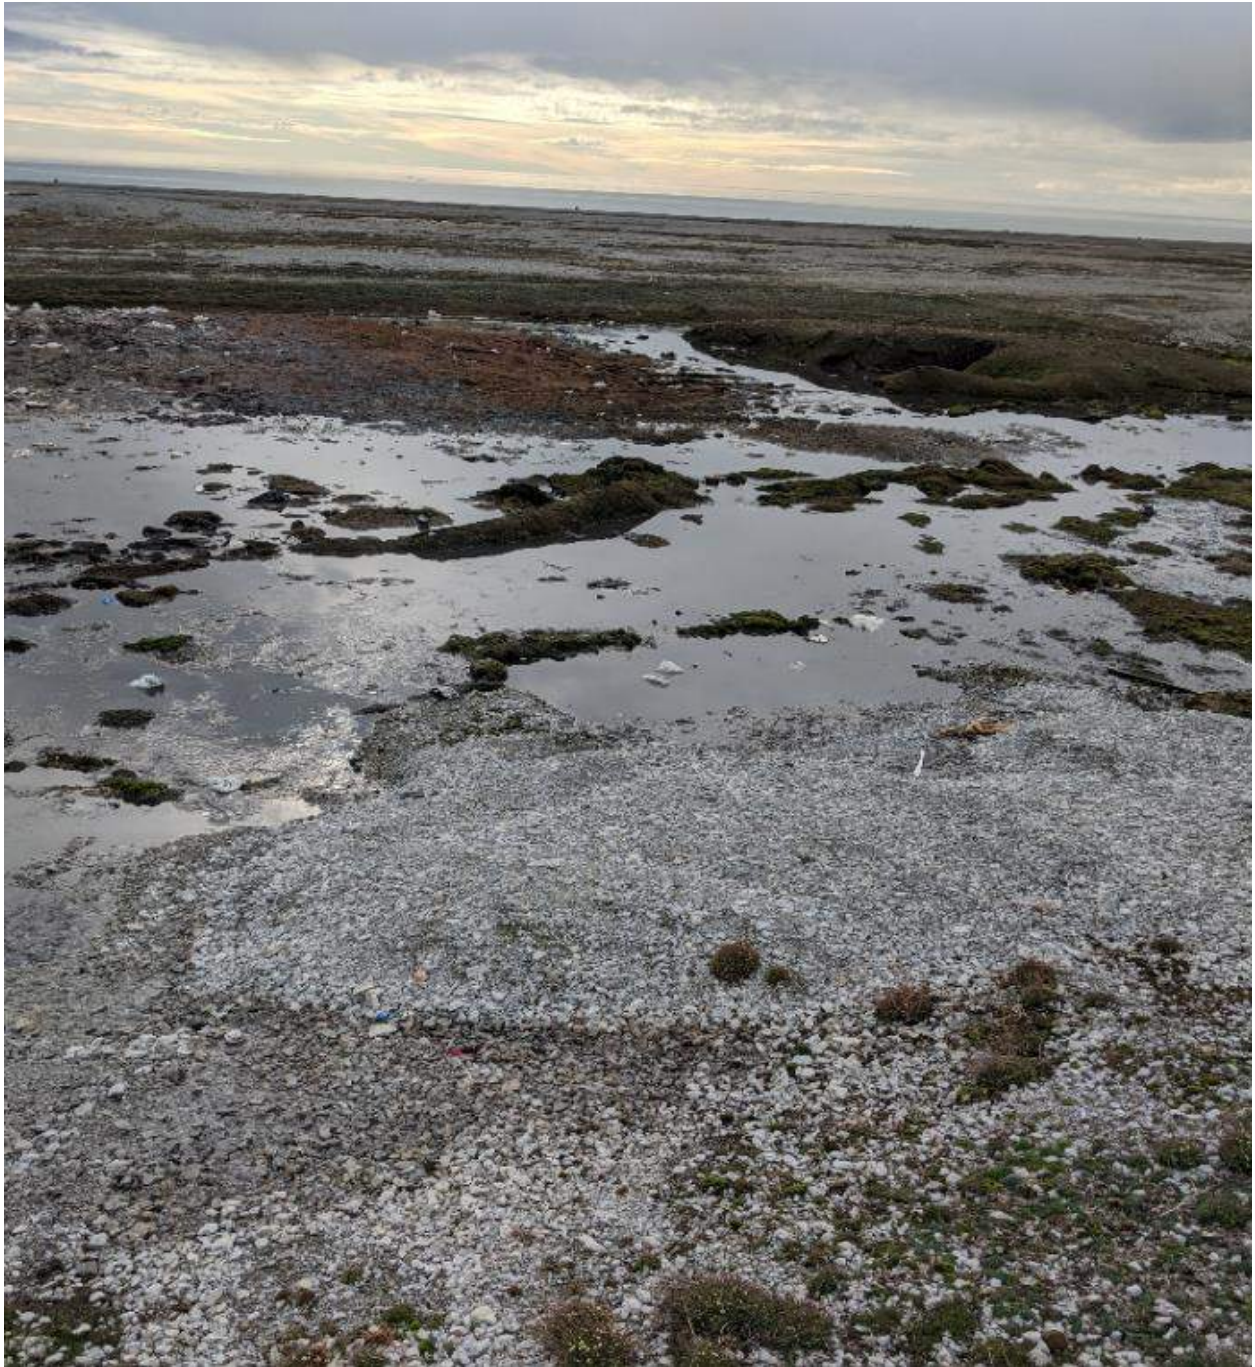
Photograph #2: Water coming out of the ground on the outside of the lagoon berm. This picture was taken at the bottom of the berm at the northeast corner of the lagoon's north cell, looking northeast.

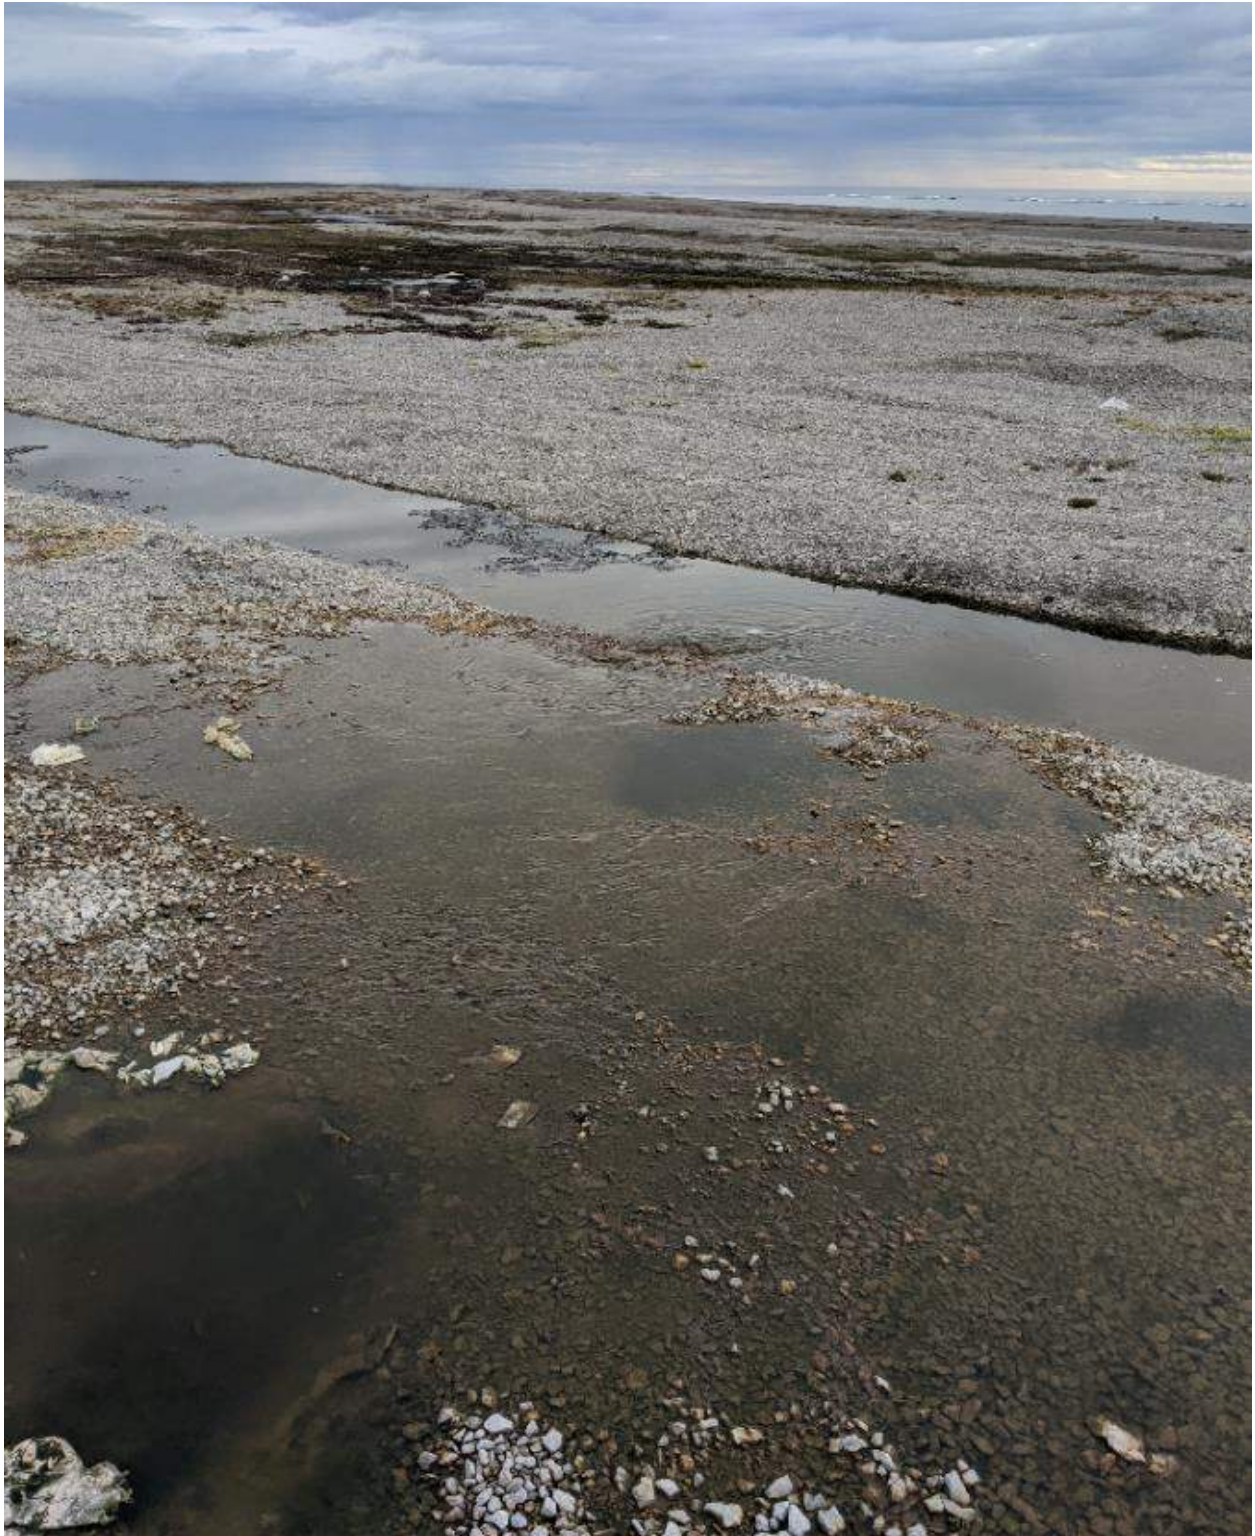
Photograph #4: Leak at east side of lagoon's south cell is still flowing at a significant rate.

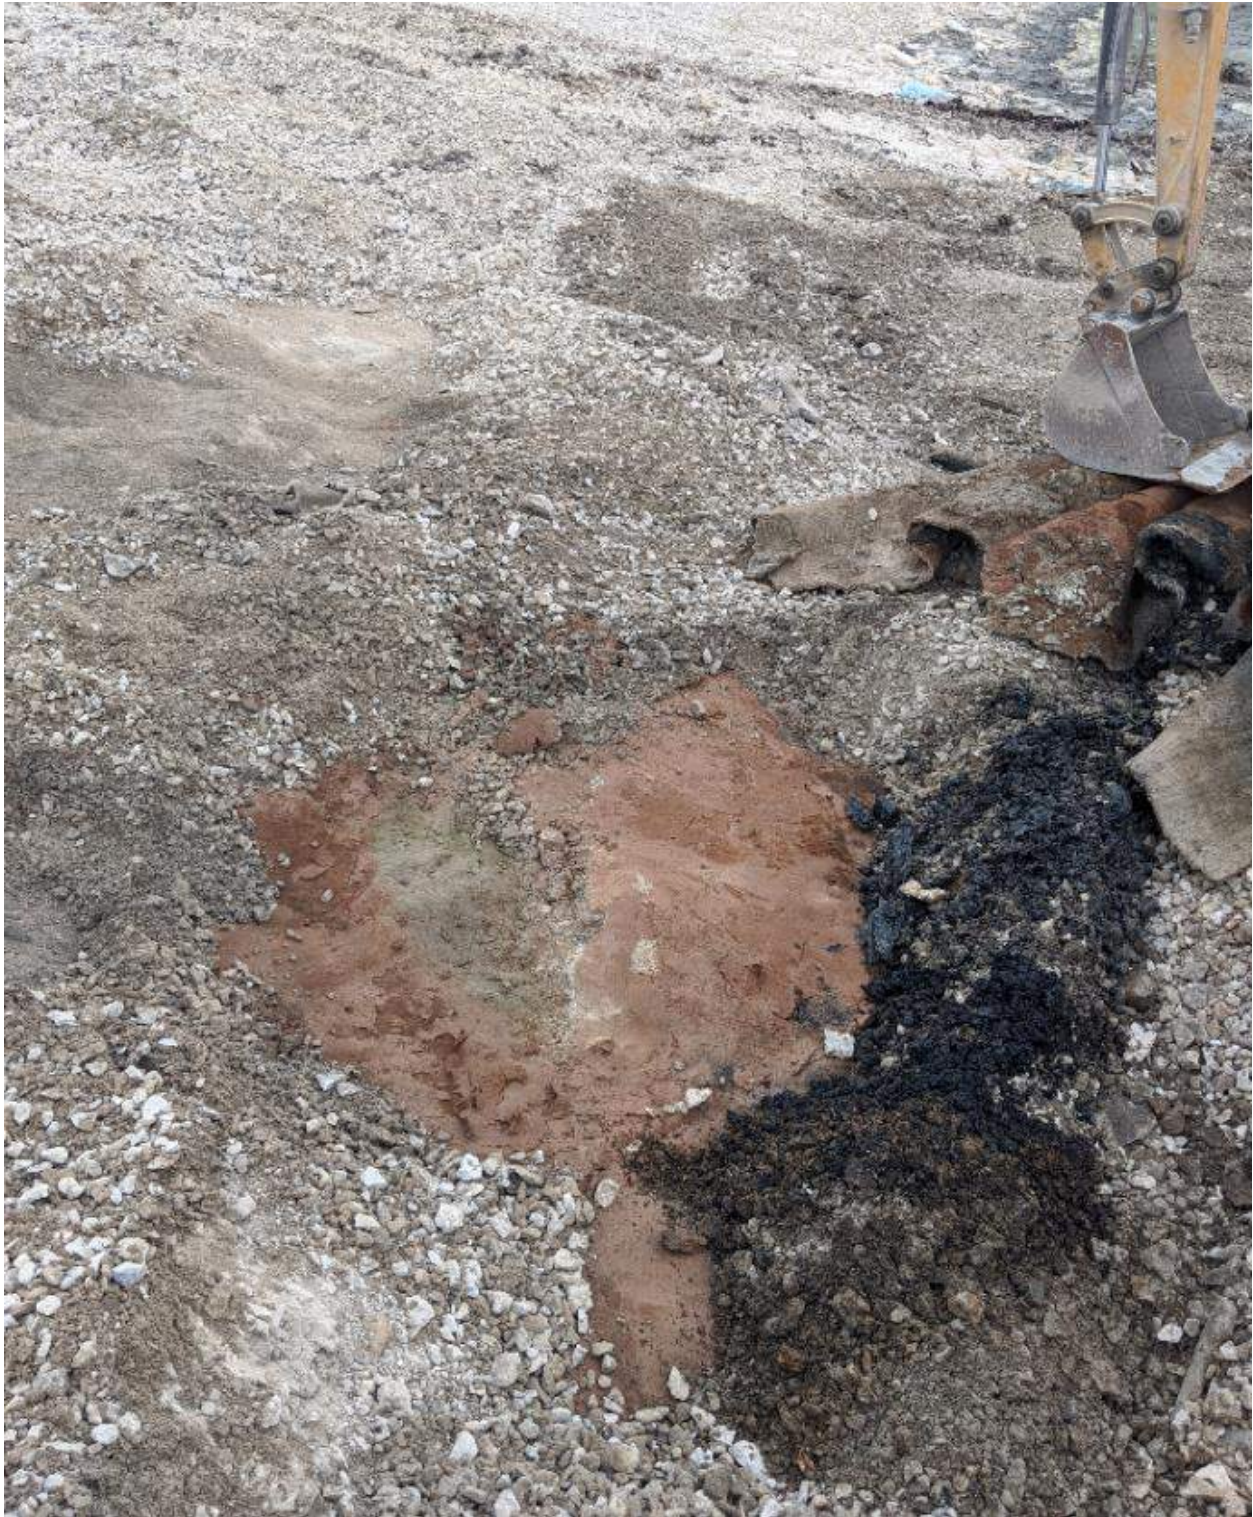
Photograph #5: Patch on embankment at north discharge station was removed. Patch was not sealed onto underlying liner.

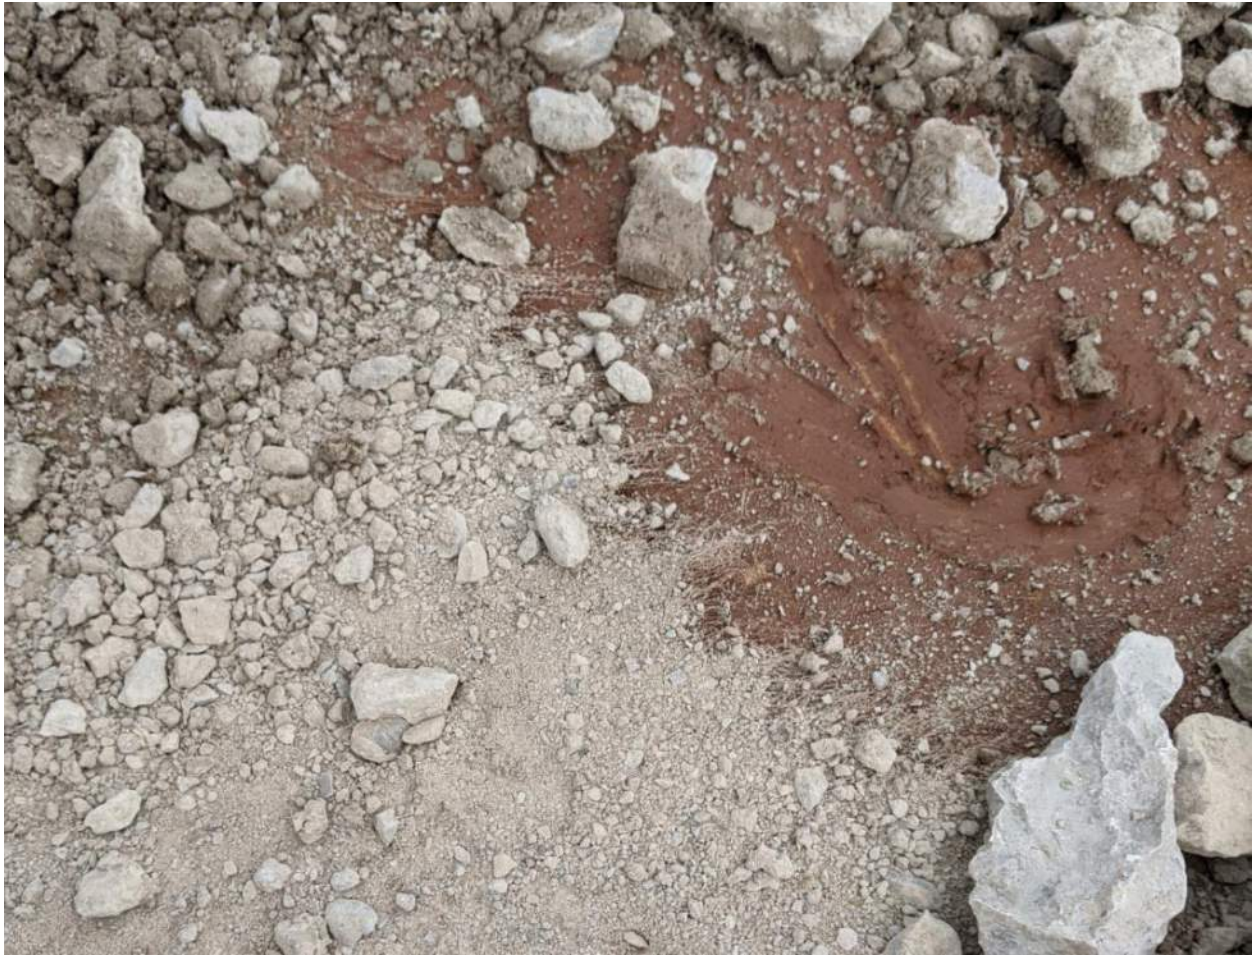
Photograph #6: Liner in some areas is delaminating, with the frayed and worn top geotextile coming apart to expose the bentonite within the liner. In areas where this is occurring, a new liner will be placed.

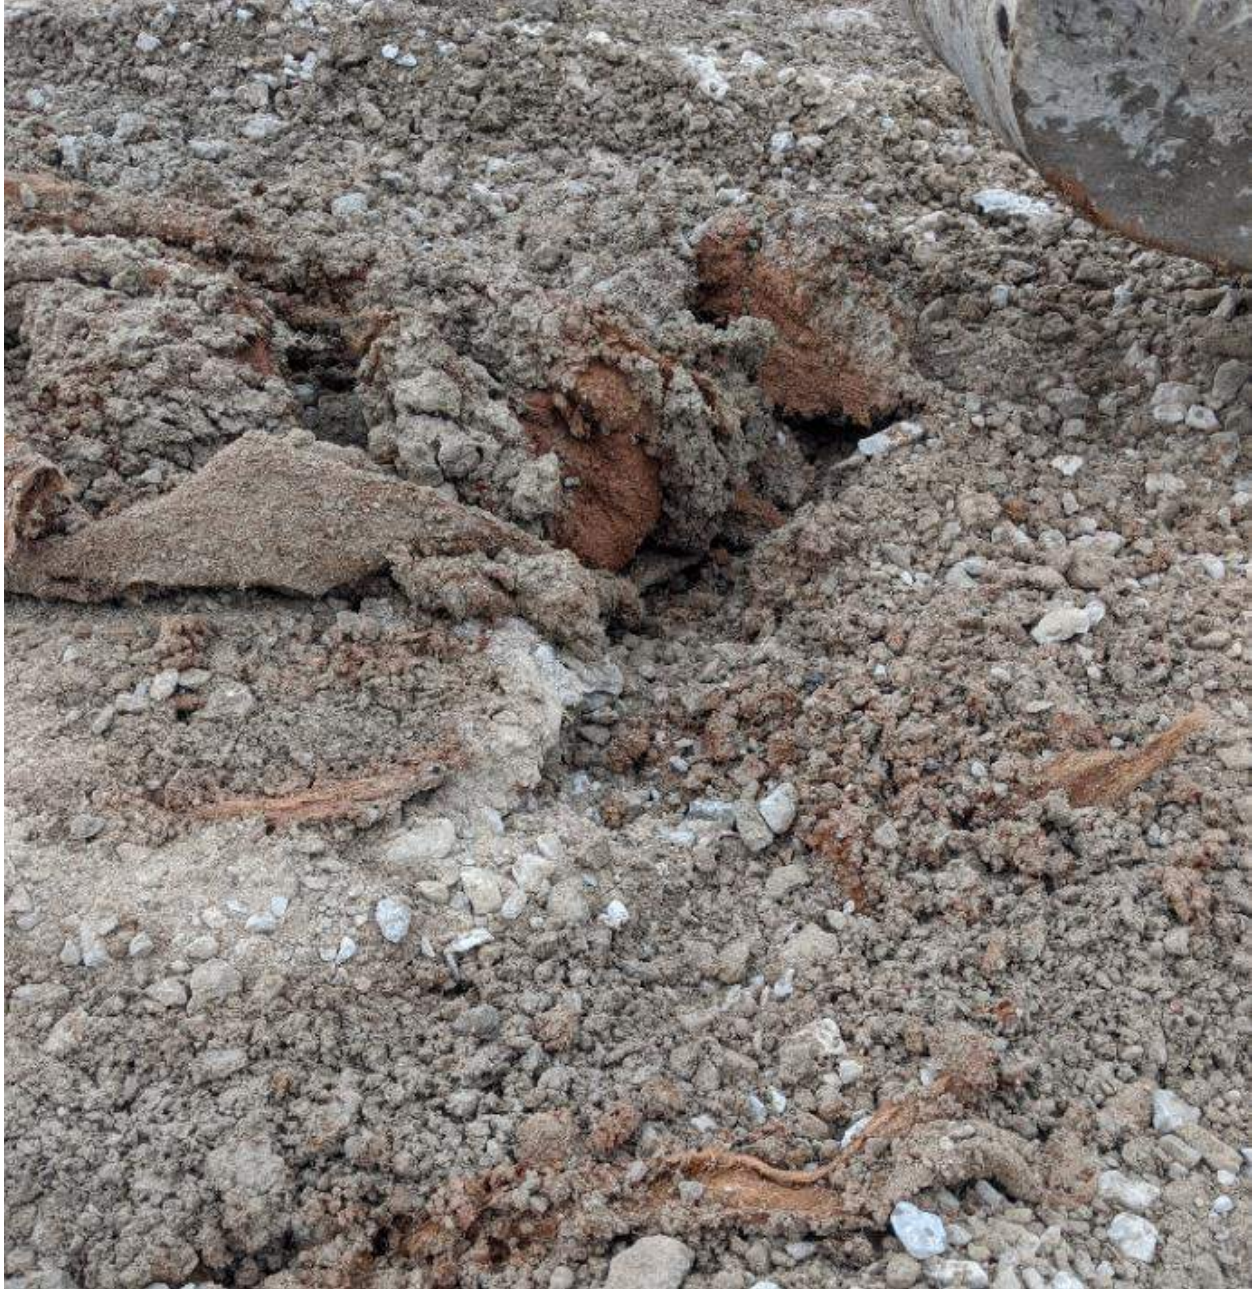
Photograph #7: Liner in some areas at the north discharge station is rolled and torn, and no longer sealed to underlying liner.
