Summary of Work – Hall Beach 2020 Field Season

Final Report

Hall Beach Sewage Lagoon
Change Order No. 5 & Leak Detection/Resolution

OTT-220382

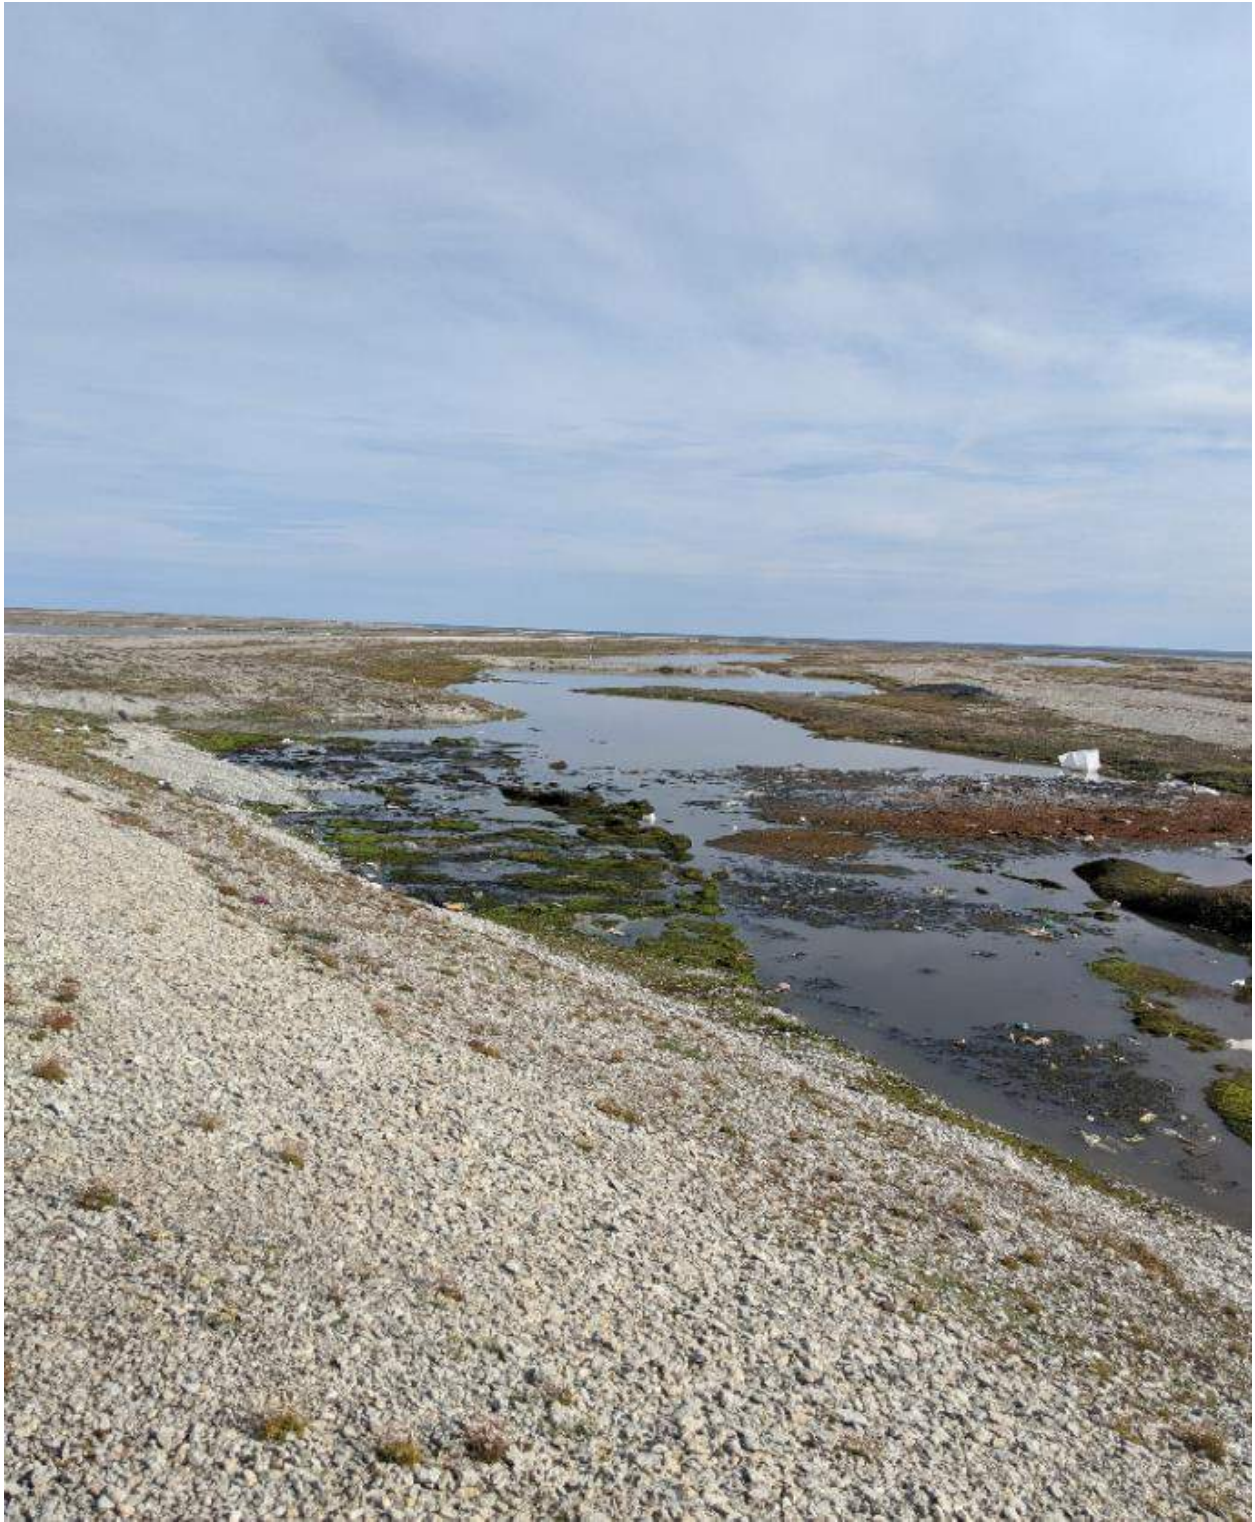
Photograph #2: The water coming out the ground near the northeast corner of the north cell is still flowing. The water level of the pond into which it is discharging is rising.

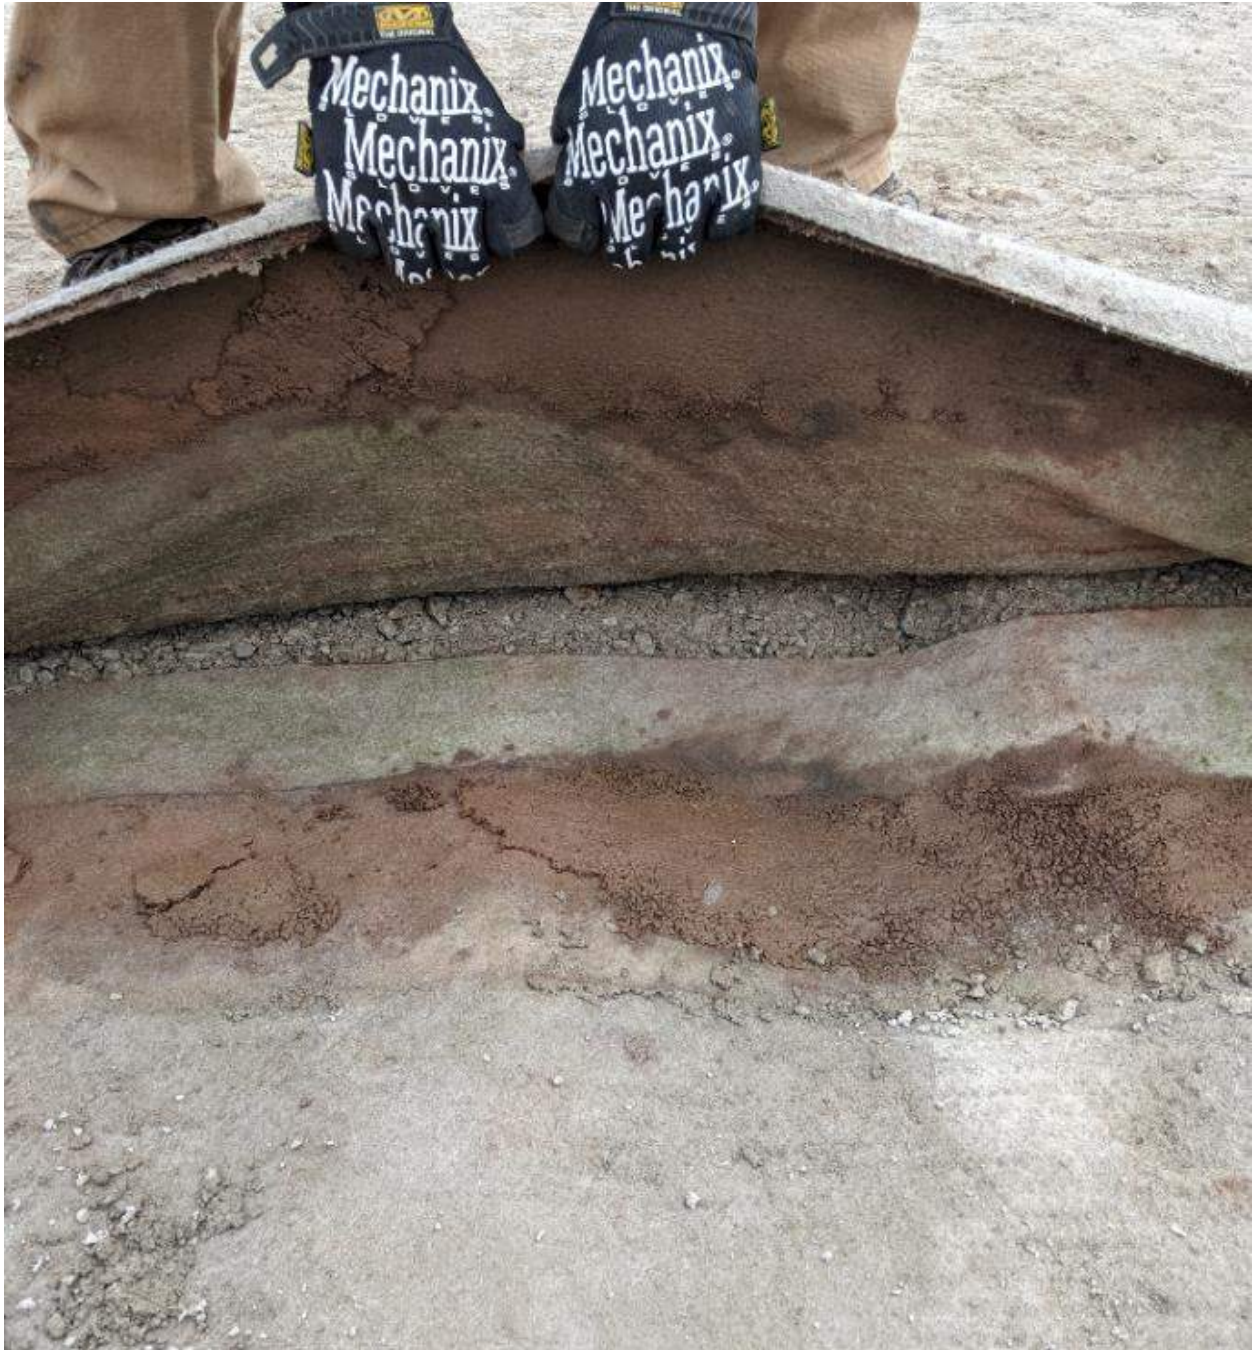
Photograph #4: The seam that was exposed was opened to examine the overlap and bentonite. The bentonite missing on the bottom flap is present on the top flap. It appears that a continuous strip of bentonite is formed.

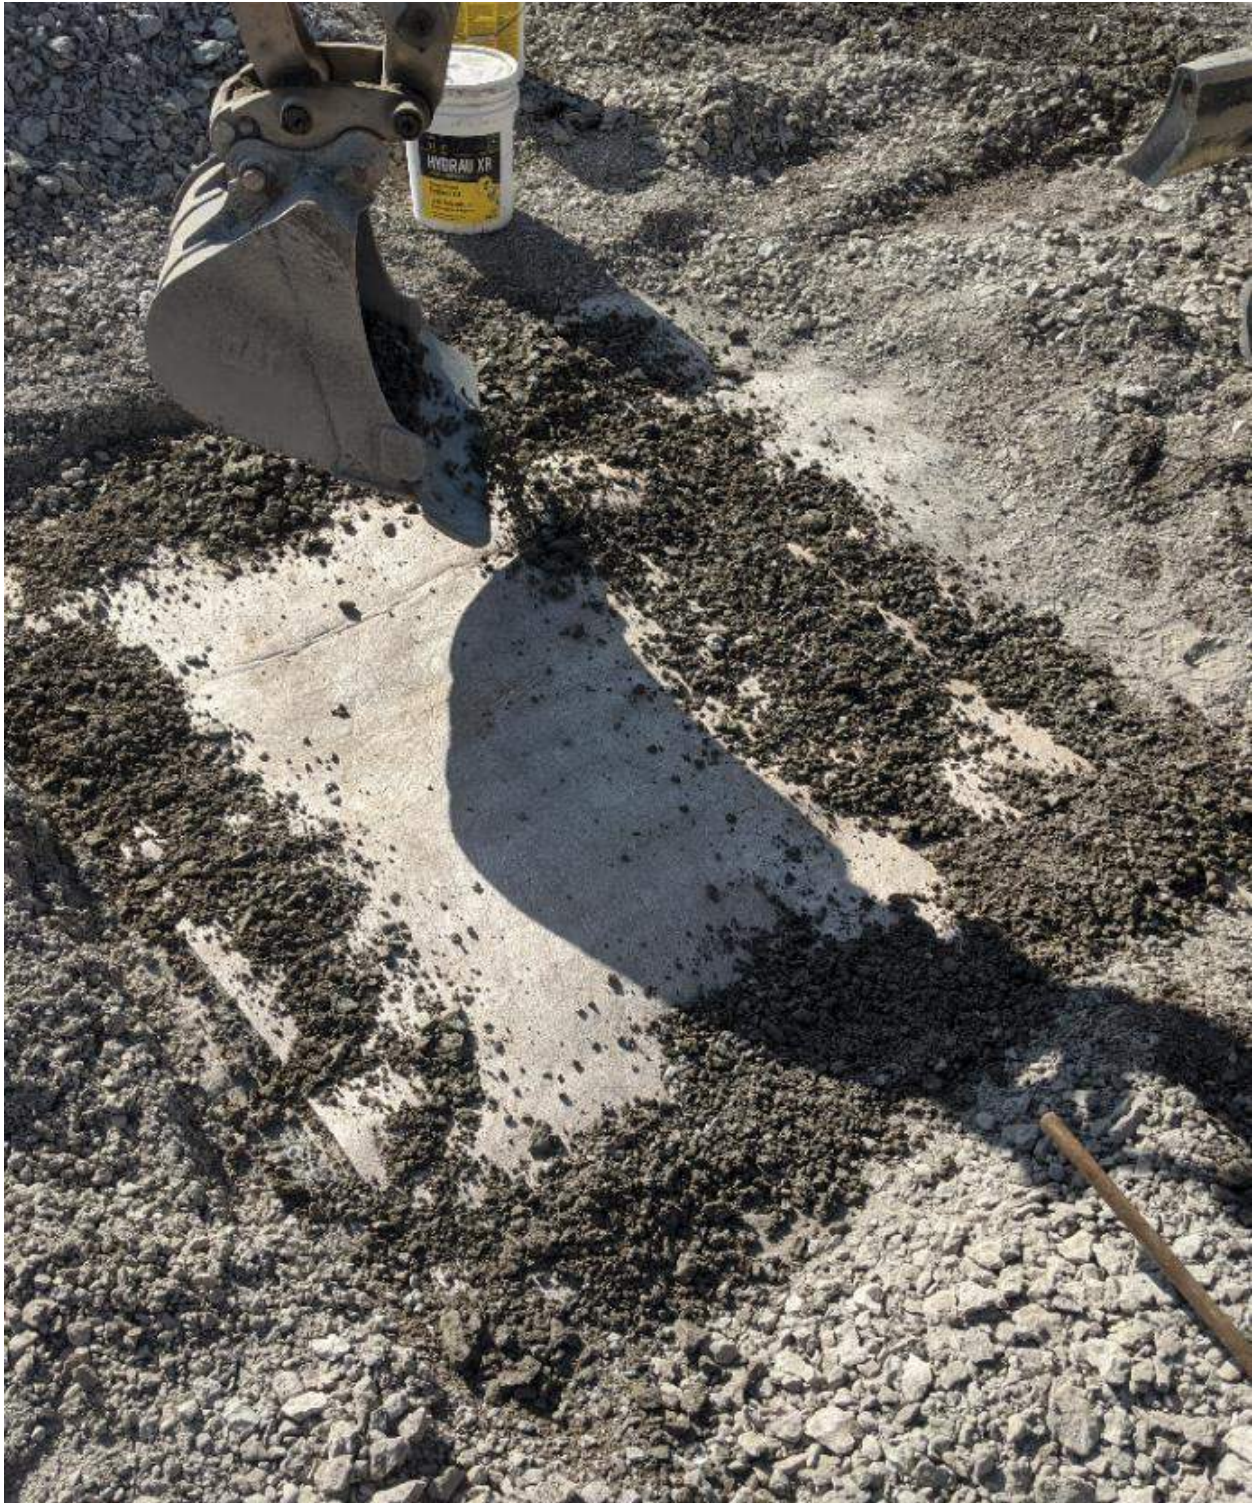
Photograph #1: A patch was placed over the damaged area in the liner, and covered with small-diameter aggregate.

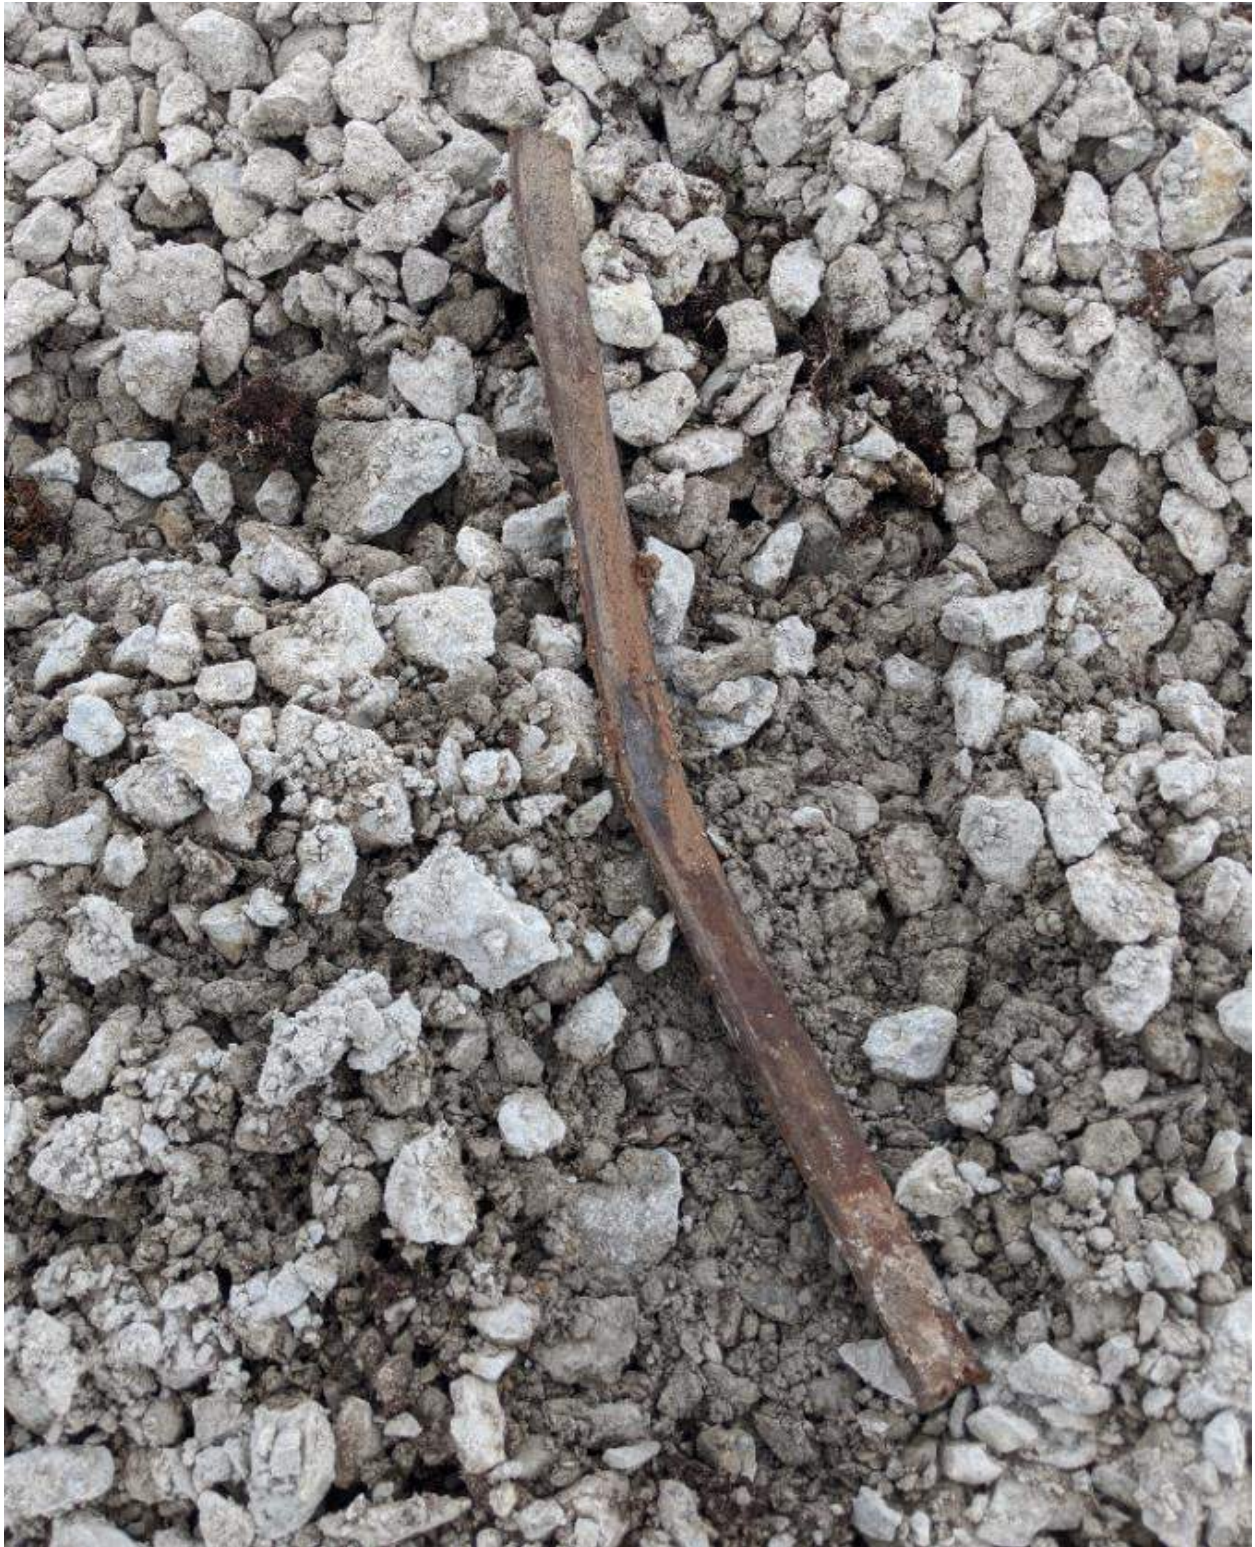
Photograph #2: Piece of steel found within a seam during excavation and removed. Length is approximately 40cm.

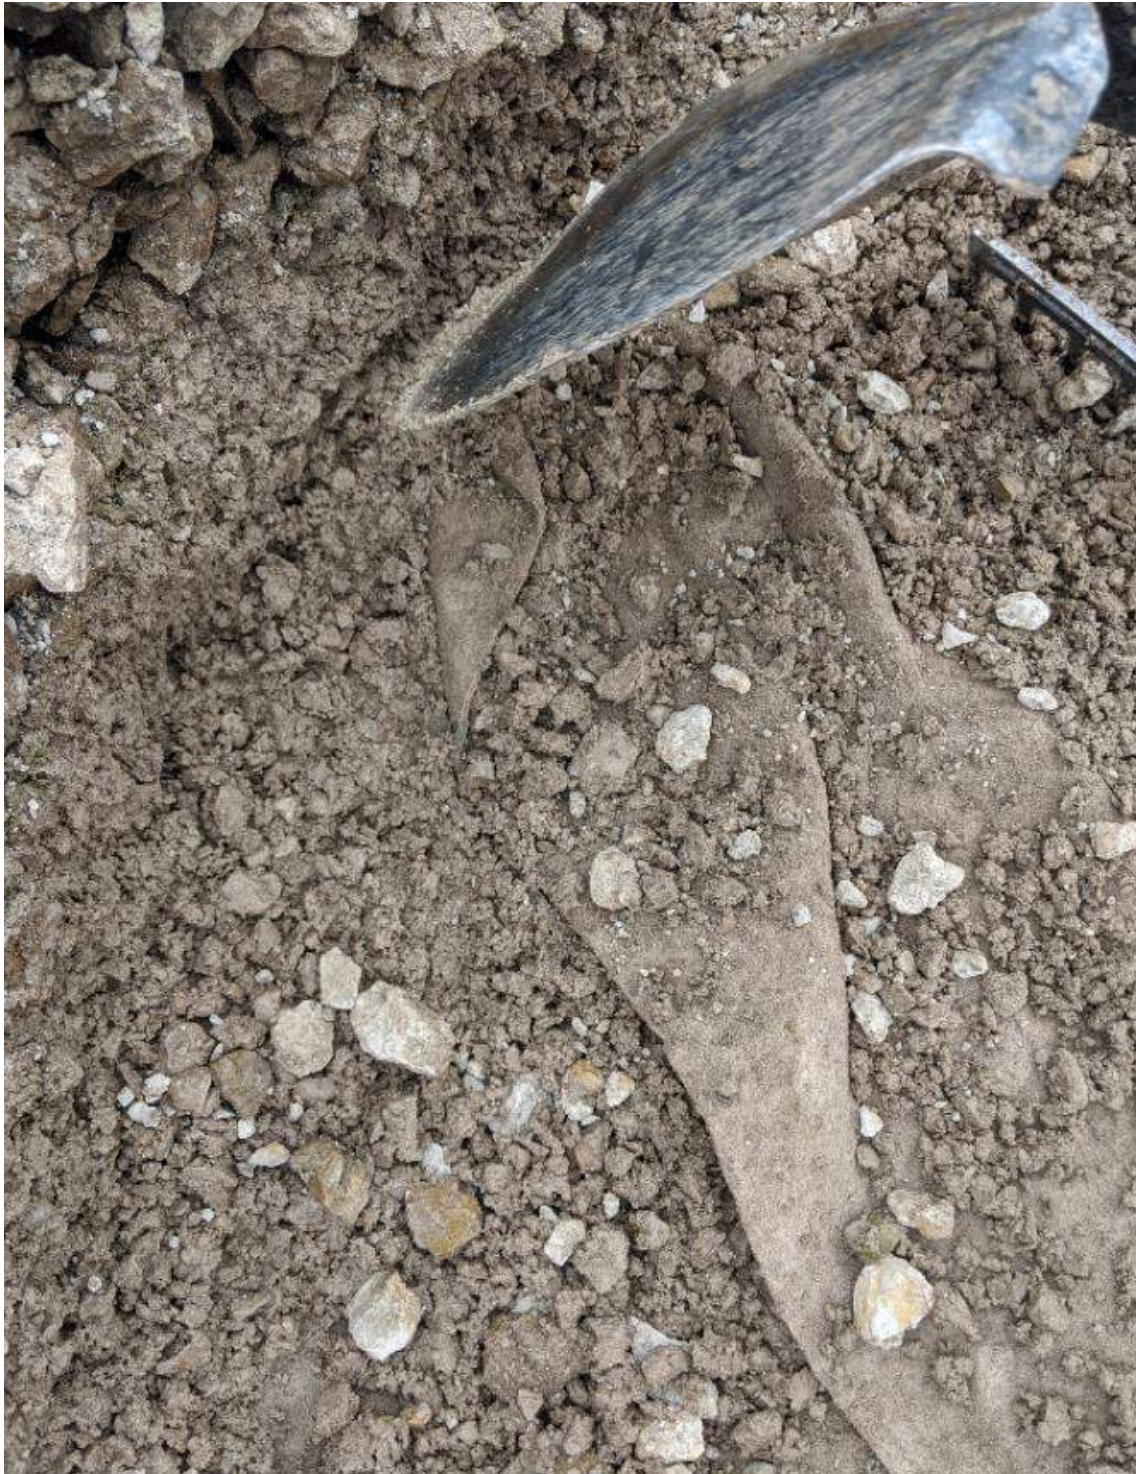
Photograph #1: Uncovering a wrinkle in a vertical seam on the lagoon's east embankment. This issue is directly across the berm from the area from which water was leaking.

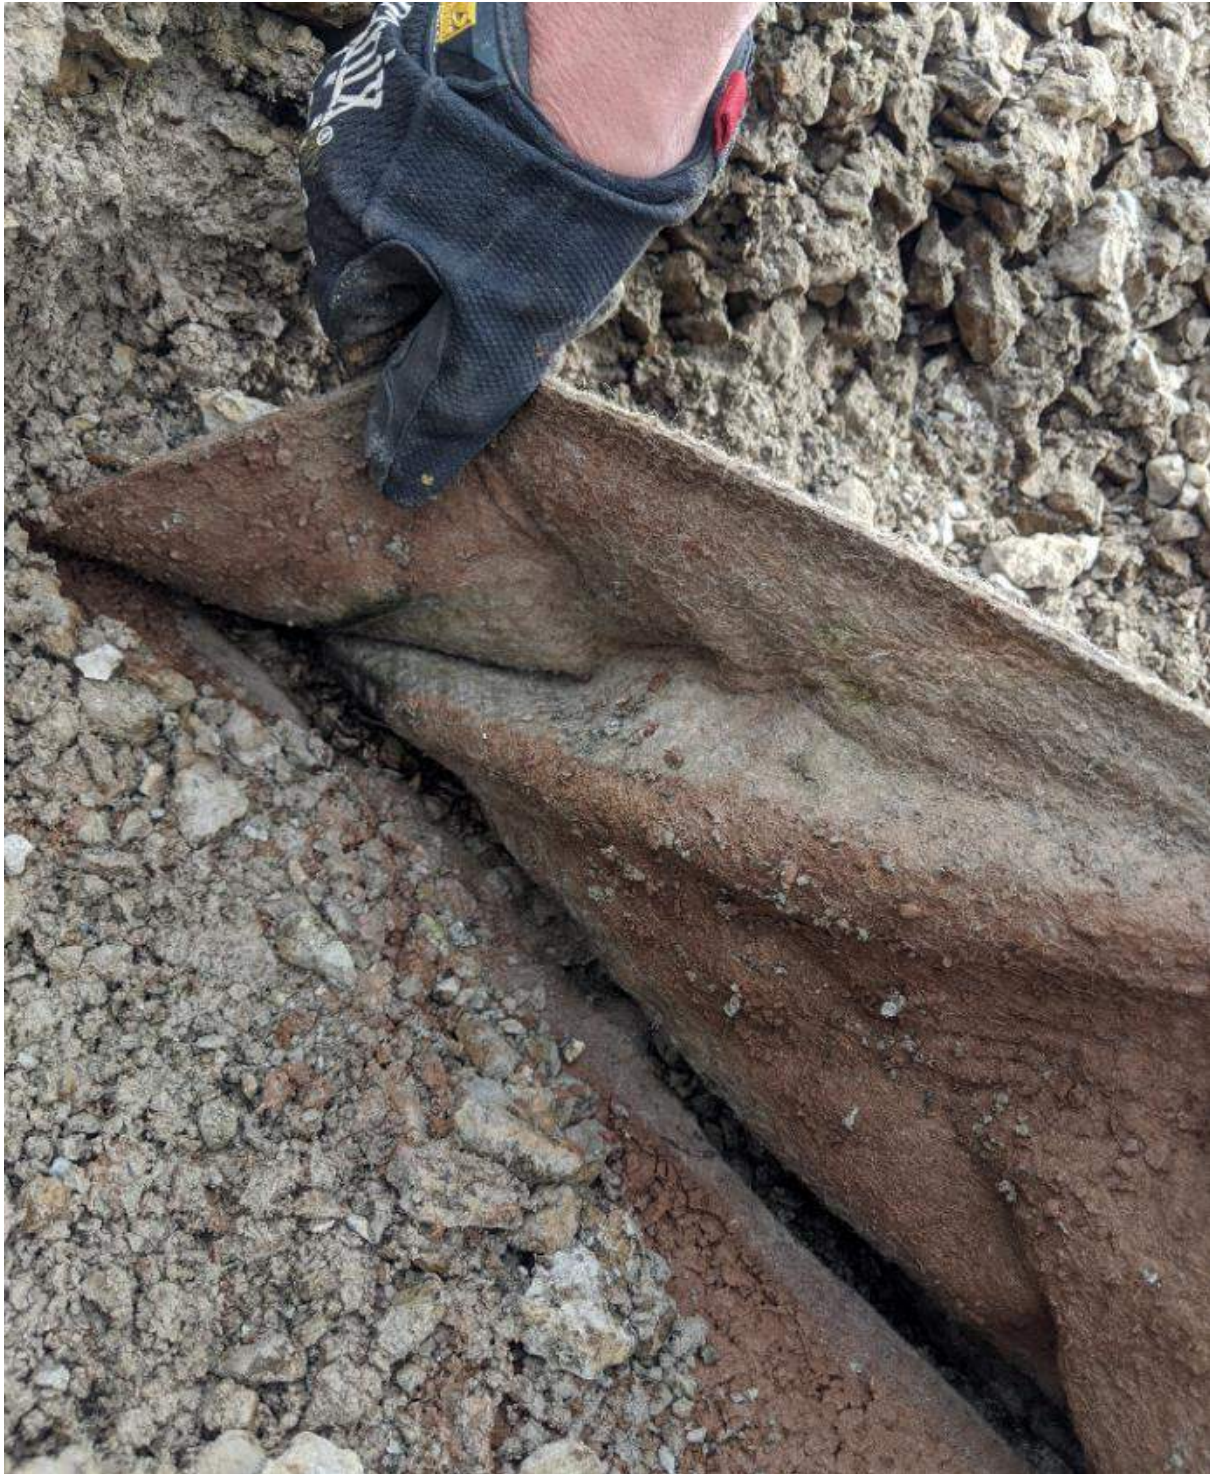
Photograph #2: Staining pattern within the seam. Note the lack of staining running along the center fold, suggesting that no bentonite was ever present in this fold, which was tightly closed and weighed down with aggregates. This fold is the one pointed to with the shovel in photograph 1.

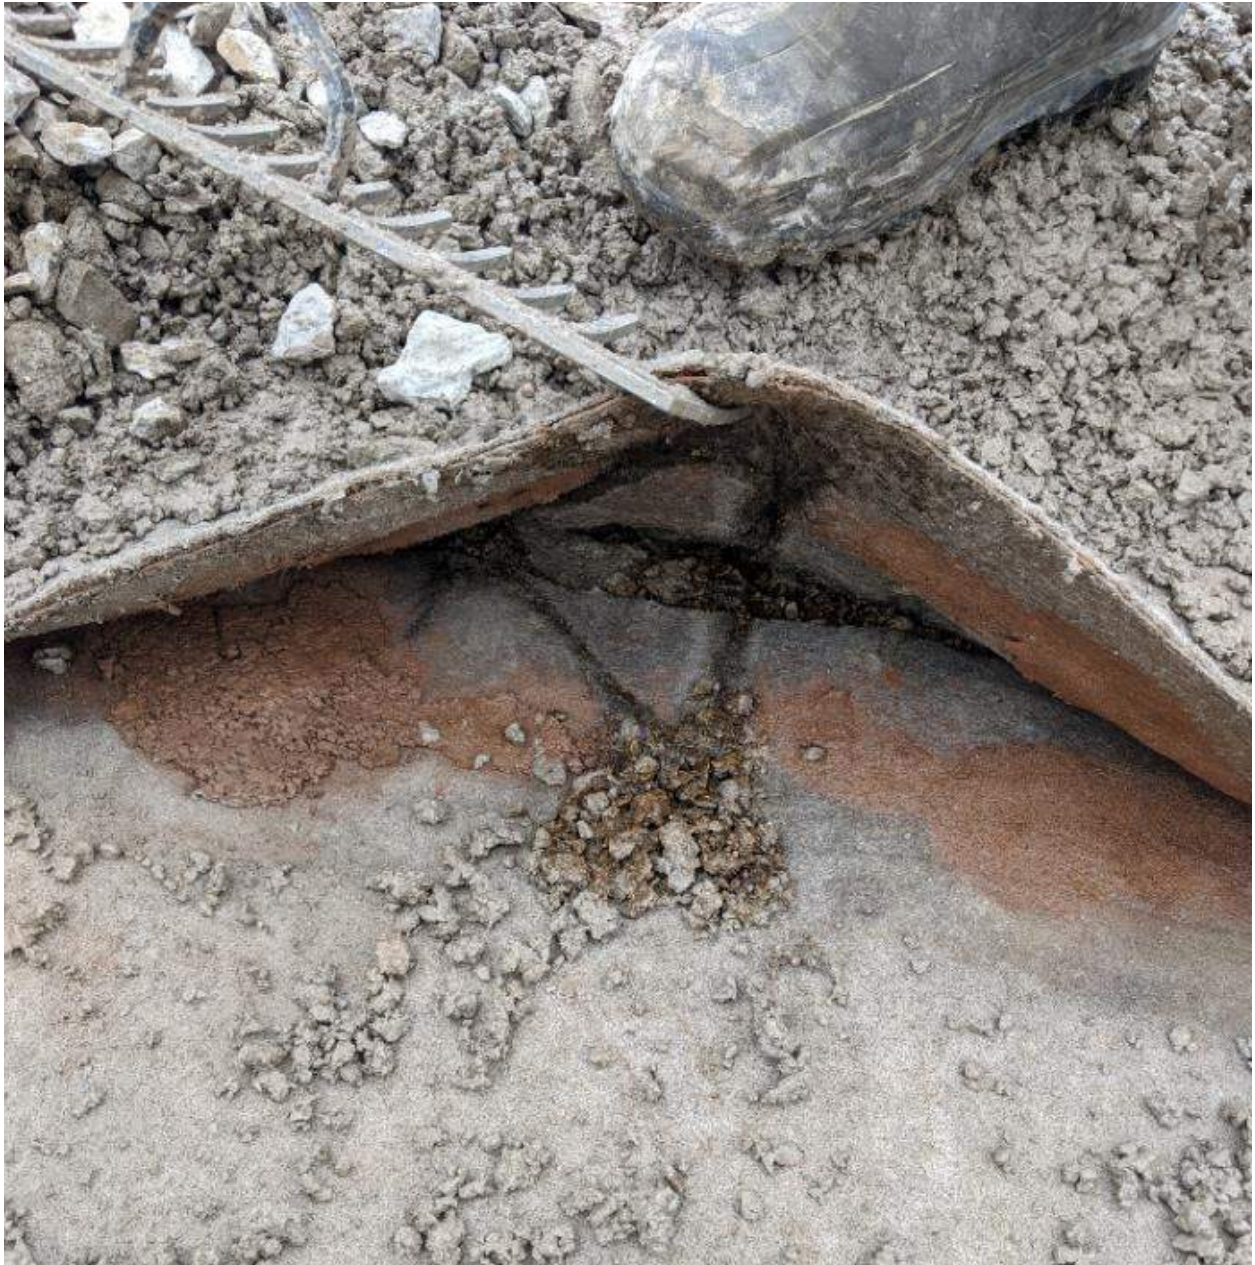
Photograph #3: Further evidence of water penetration within a liner seam. In this case, granular material was pushed within the seam, allowing water to wash out two paths into the subgrade.

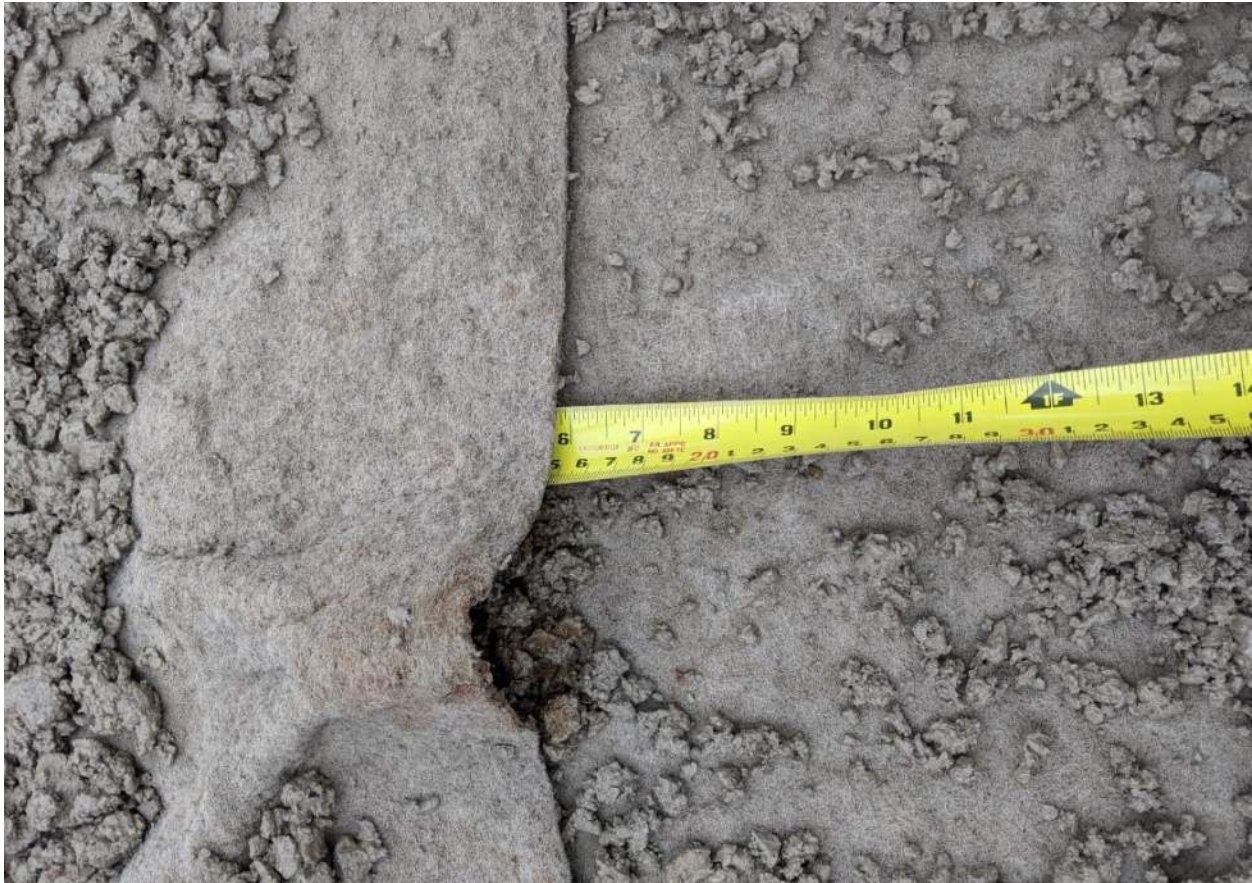
Photograph #4: Narrow lap distance in one of the inspected seams. Manufacturer recommends at least 200mm lap distance.

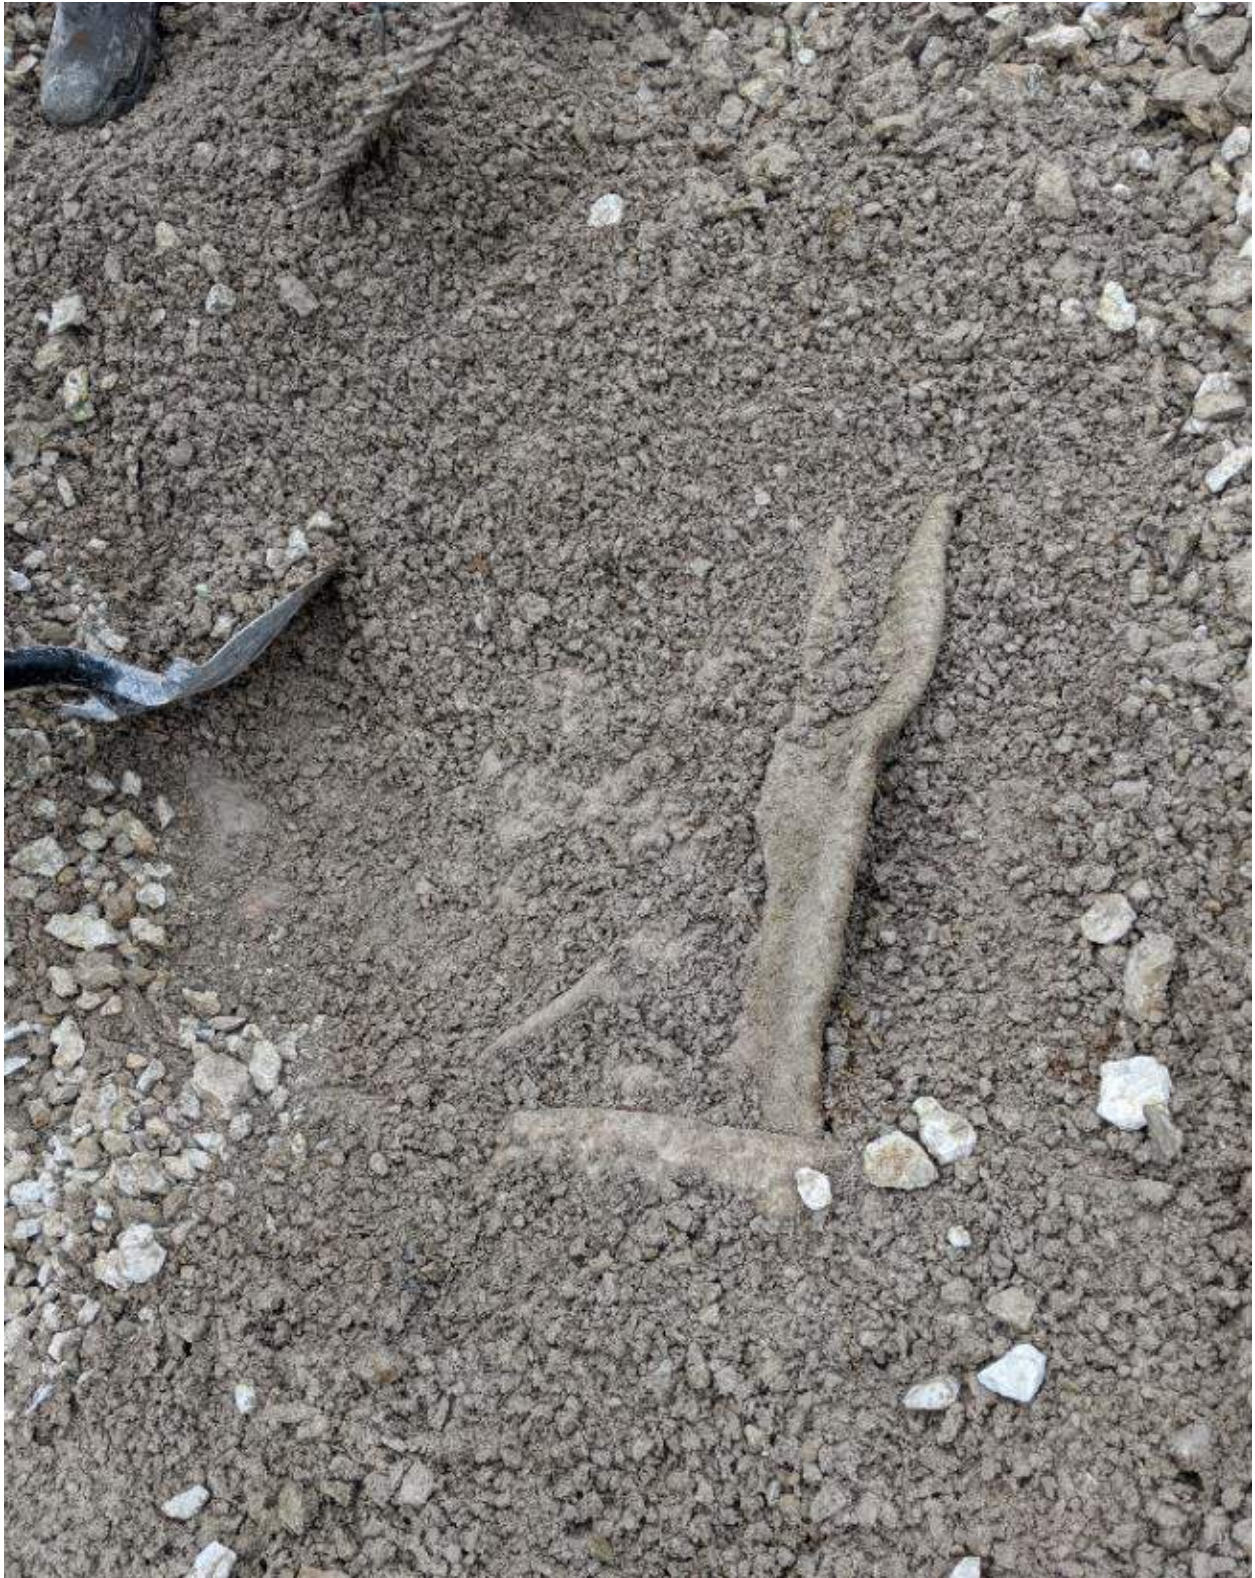
Photograph #5: Horizontal seam has rolled. Top of embankment is towards the right in this photo.

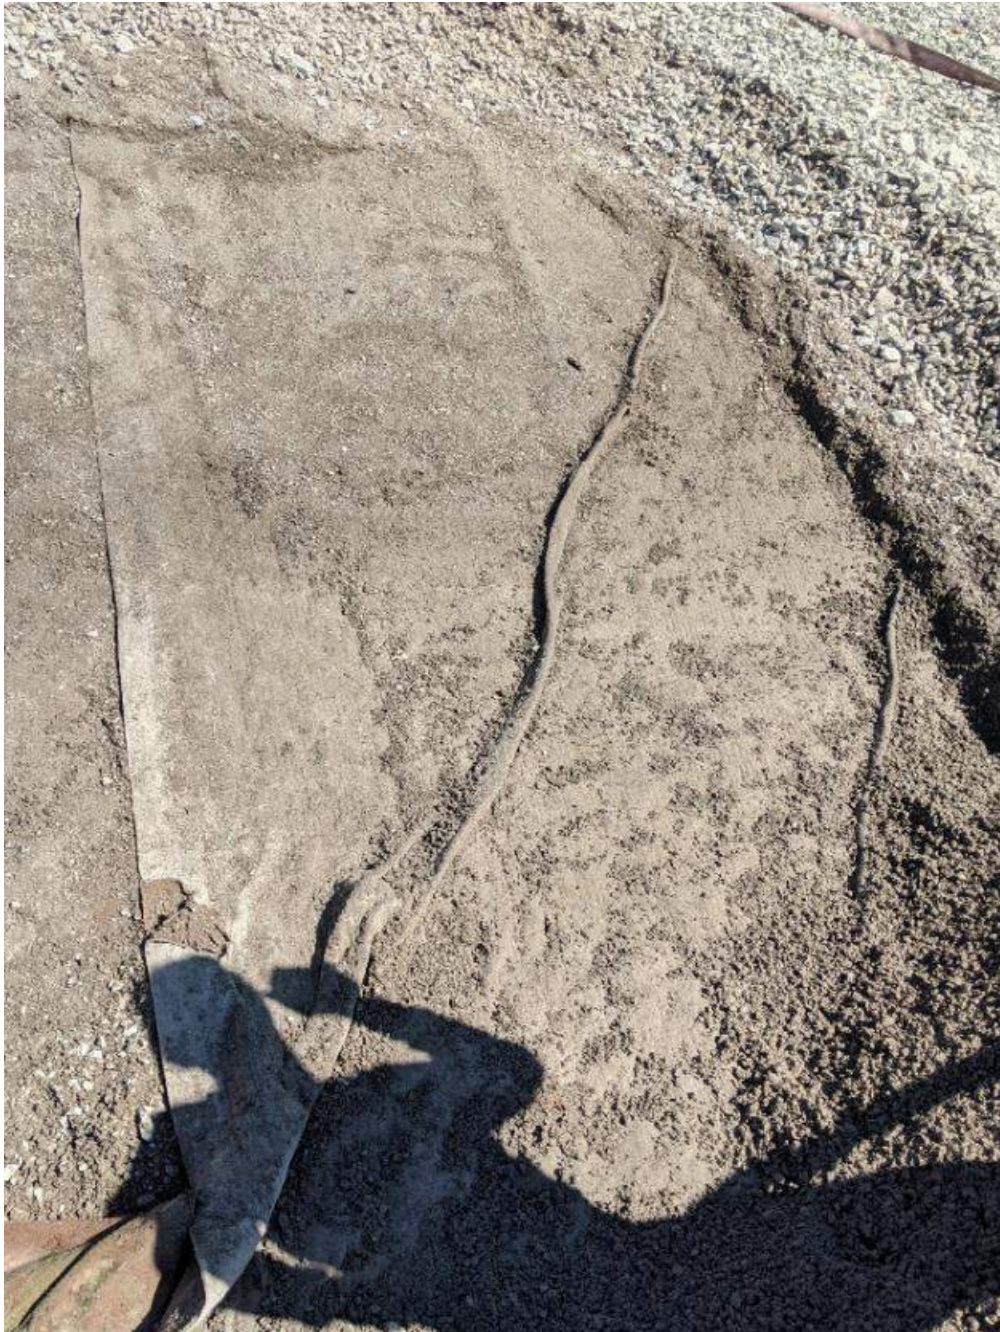
Photograph #1: Wrinkling found on a liner panel, leaving the lower left side open for water to flow under the liner.

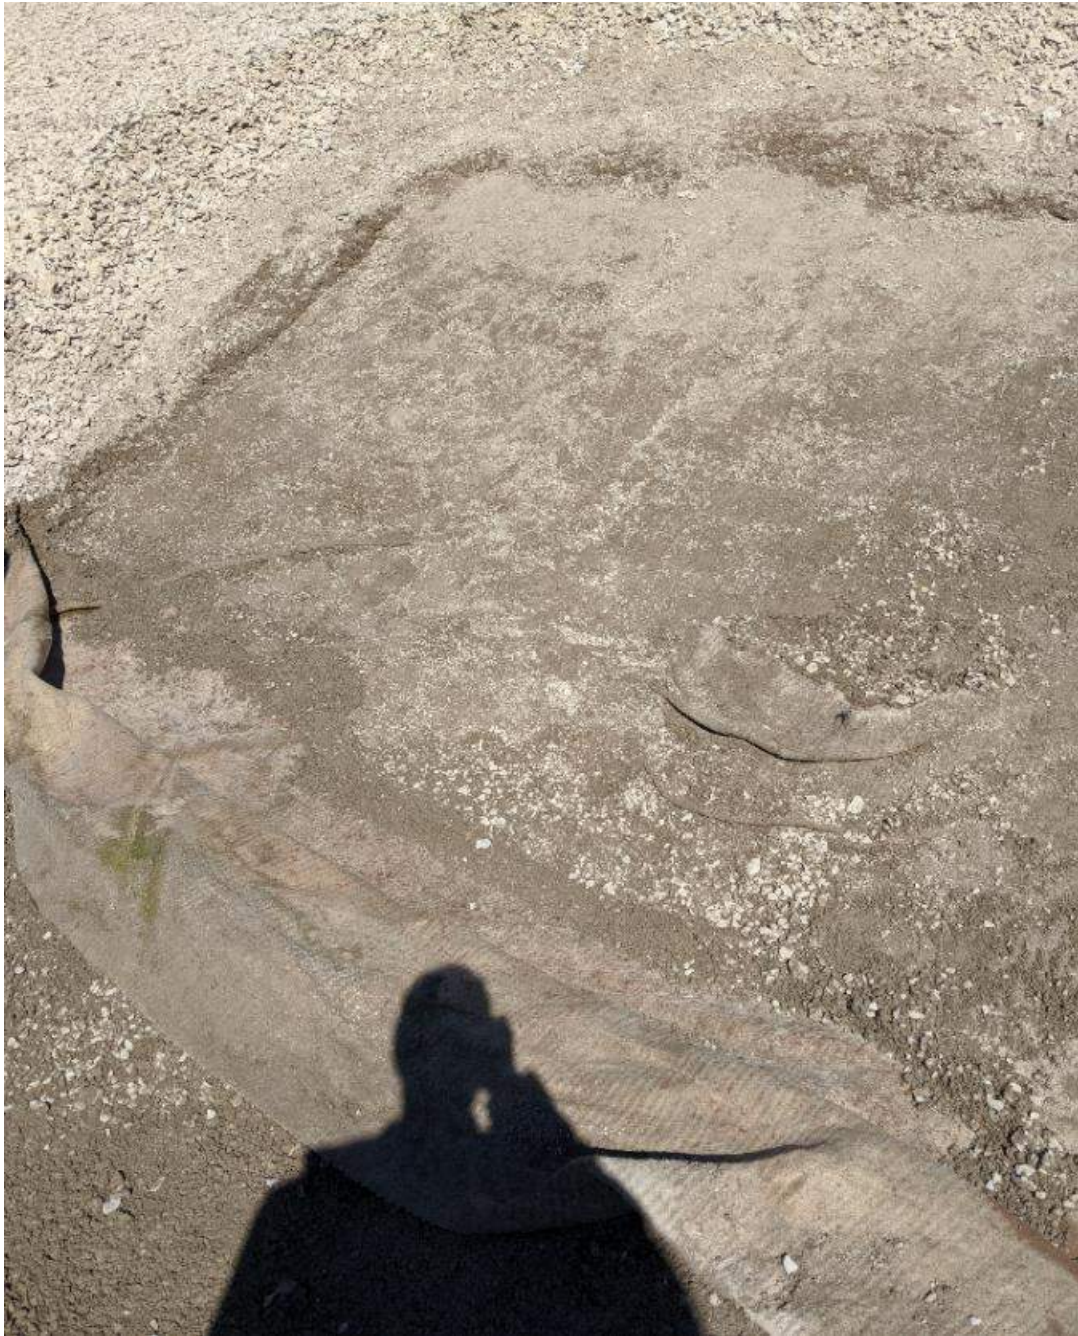
Photograph #2: Horizontal joint after peeling back. Note the boundary of the gravel is well below the edge of the liner when the latter is laying flat. Also note the algal growth on the underside of the rolled back panel, and the tear in the upper panel. The bentonite seal is located under the still-rolled-up portion of the liner, over a meter from the edge of the seam.

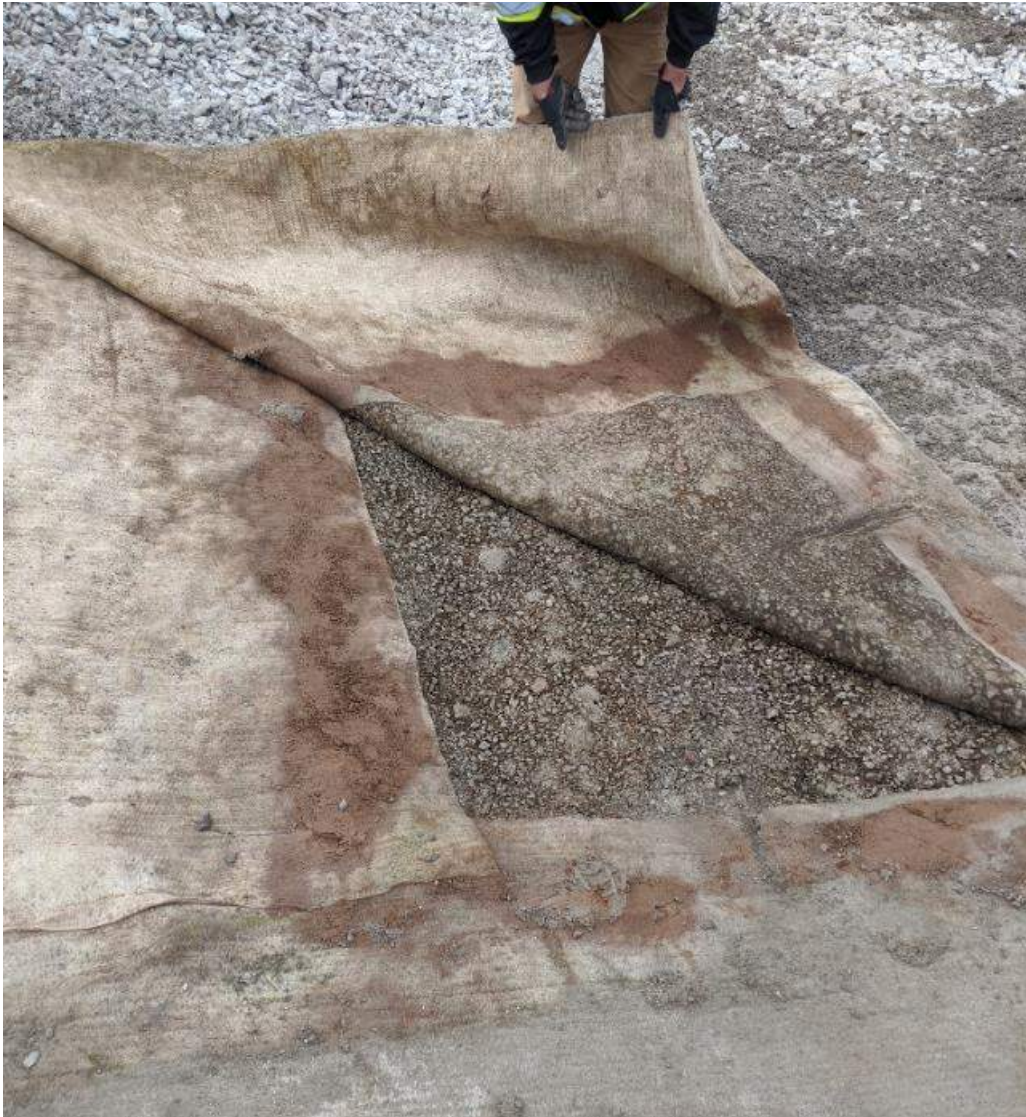
Photograph #2: Corner of a liner panel, at the bottom of the east embankment. The lower panel shows proper overlap, but the top liner seems short. The bentonite strip running horizontally on the embankment (vertically in this picture) is also quite low on the hill, considering the large overlap of the horizontal joint. This joint should also be lapped in the other direction, similar to roof shingling, as opposed to the configuration found here. The configuration found here tends to accumulate aggregates into the joint from the top (cleaned away in this picture).

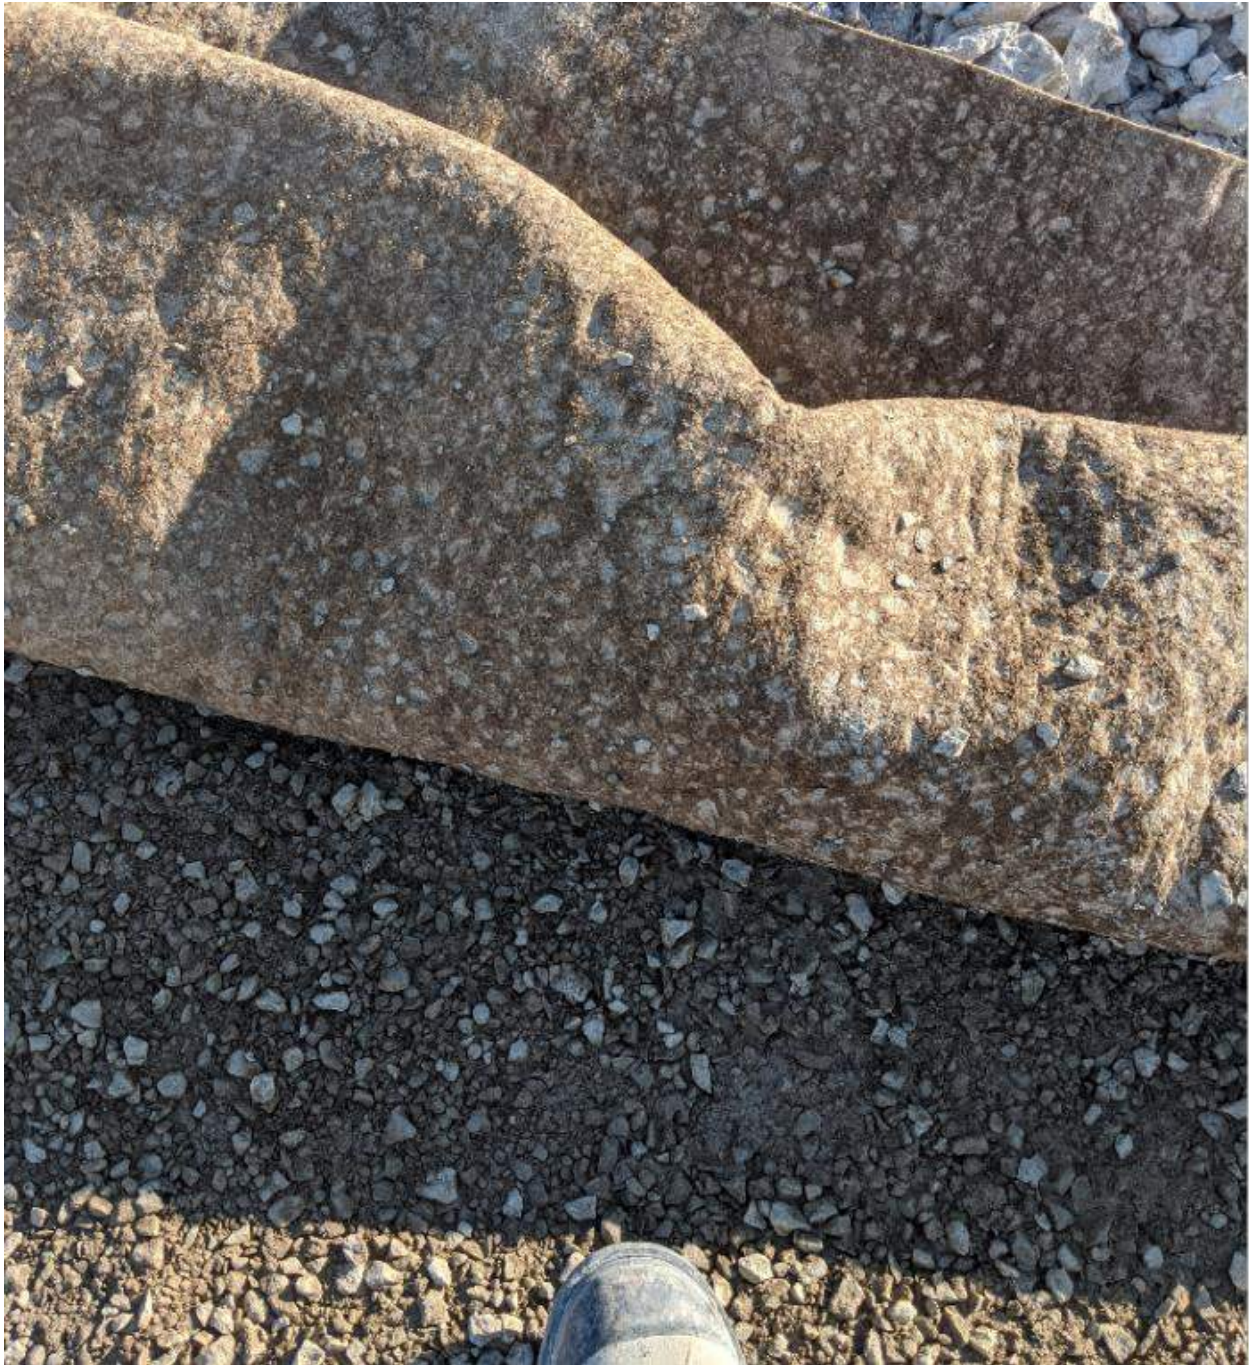
Photograph #2: The existing liner shows signs of having been wet on its underside. This color pattern is only present in the middle section of the berm, coinciding roughly with the area where seepage was observed on the outside of the lagoon.
