Summary of Work – Hall Beach 2020 Field Season

Final Report

Hall Beach Sewage Lagoon
Change Order No. 5 & Leak Detection/Resolution

OTT-220382

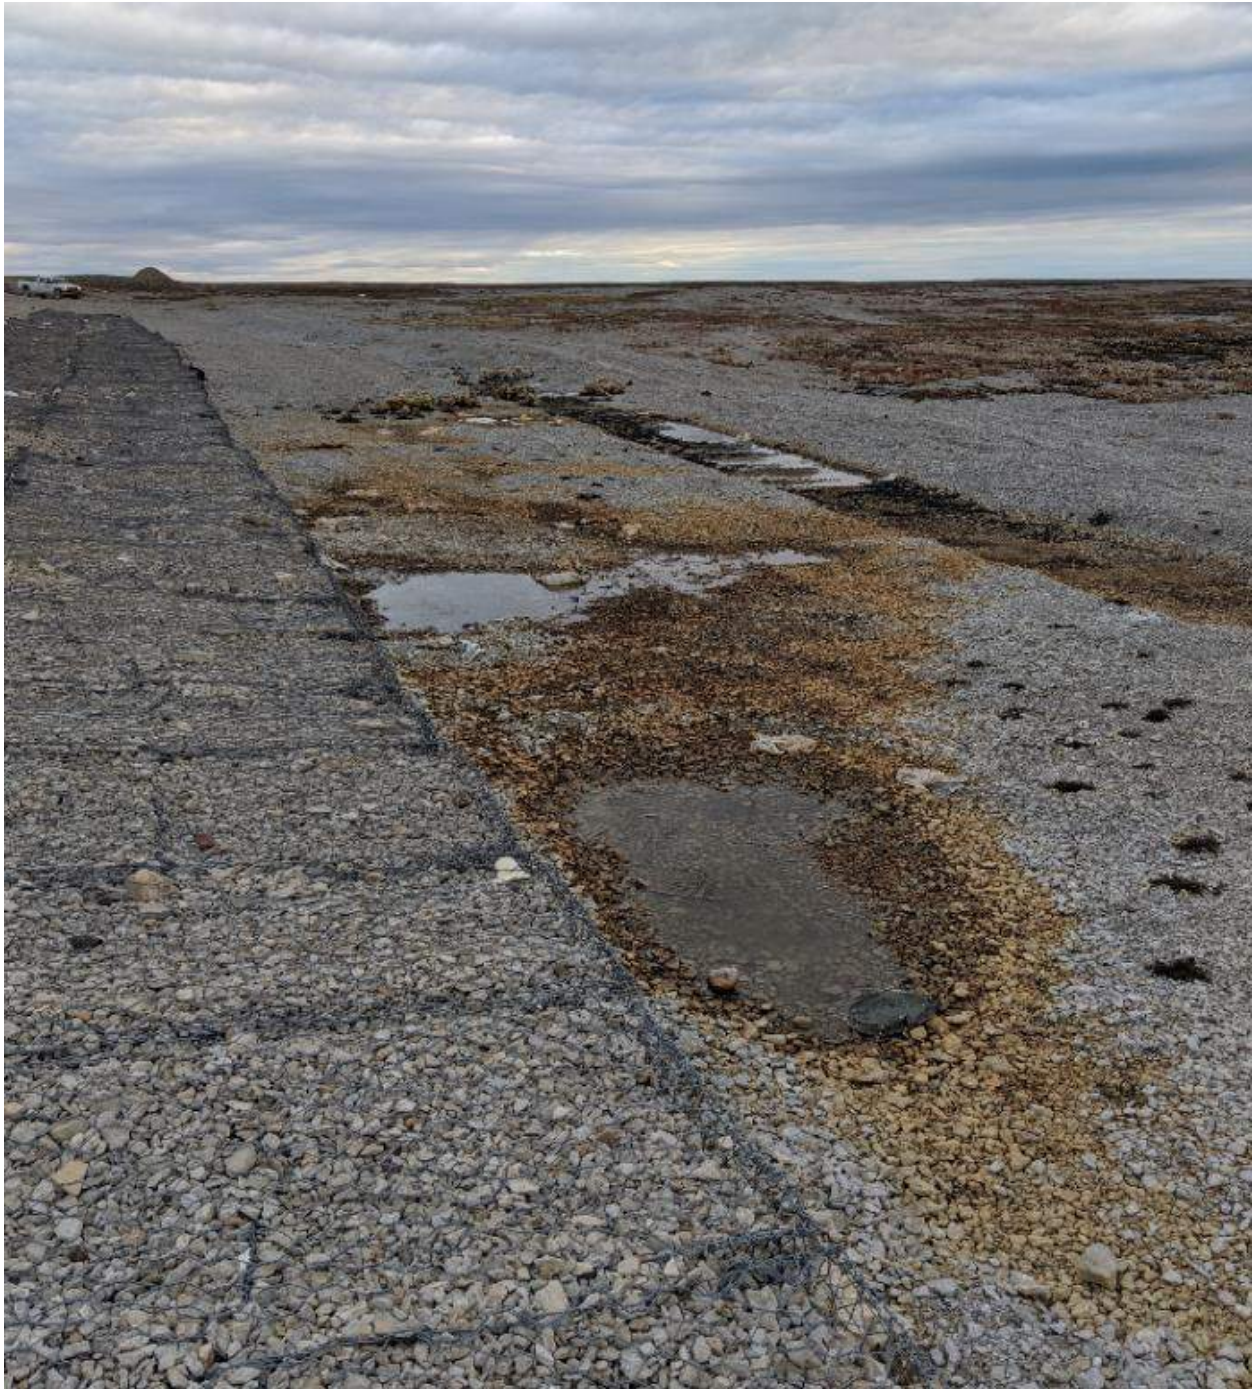
Photograph #1: New leak noted at the location of previous leak.

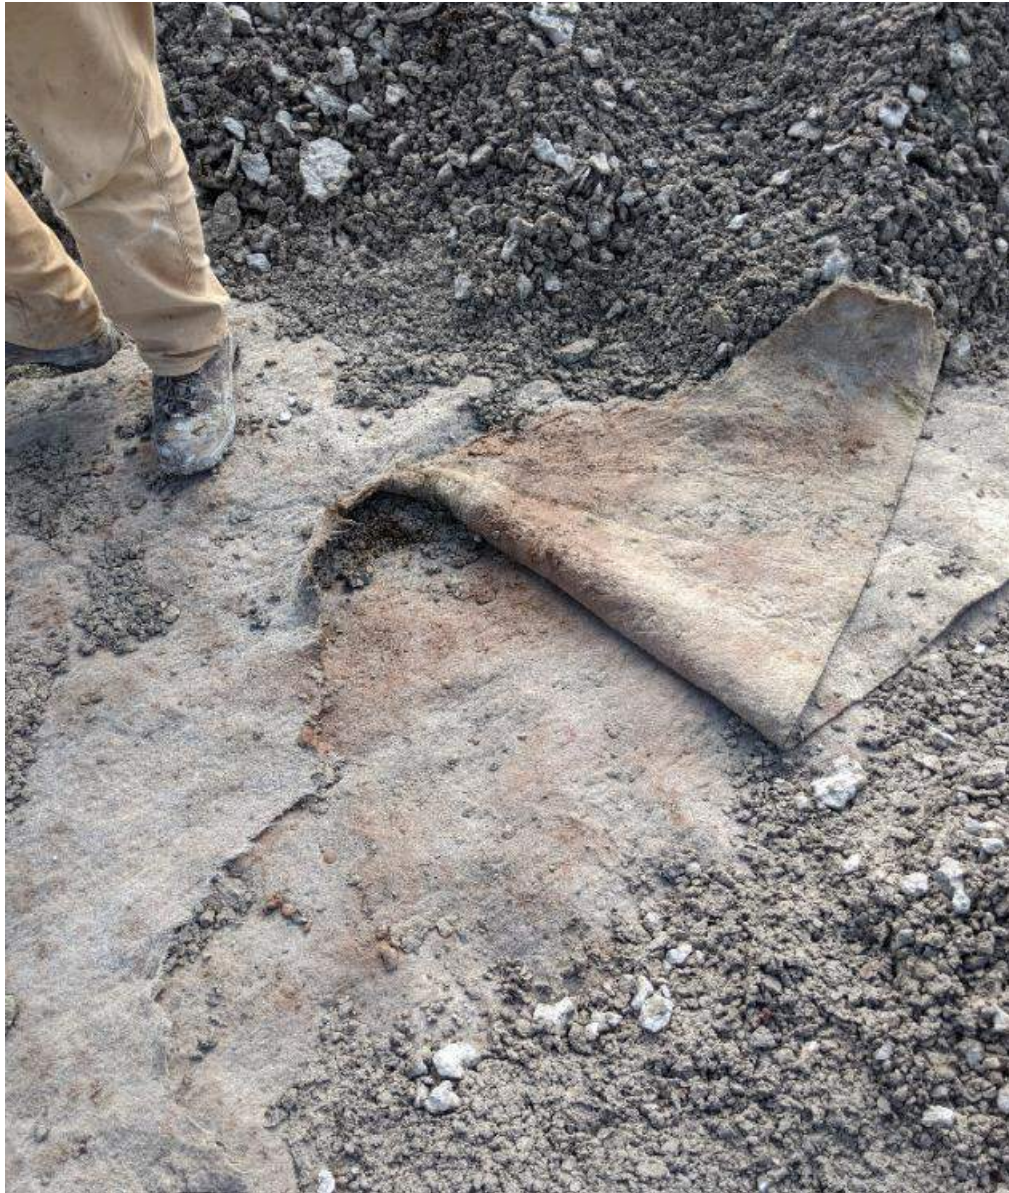
Photograph #1: Tear in the liner. While the flap has been cleaned and unfolded in this photo, the patch of subgrade visible at the back of the tear was found completely uncovered., allowing water a direct pathway into the subgrade.

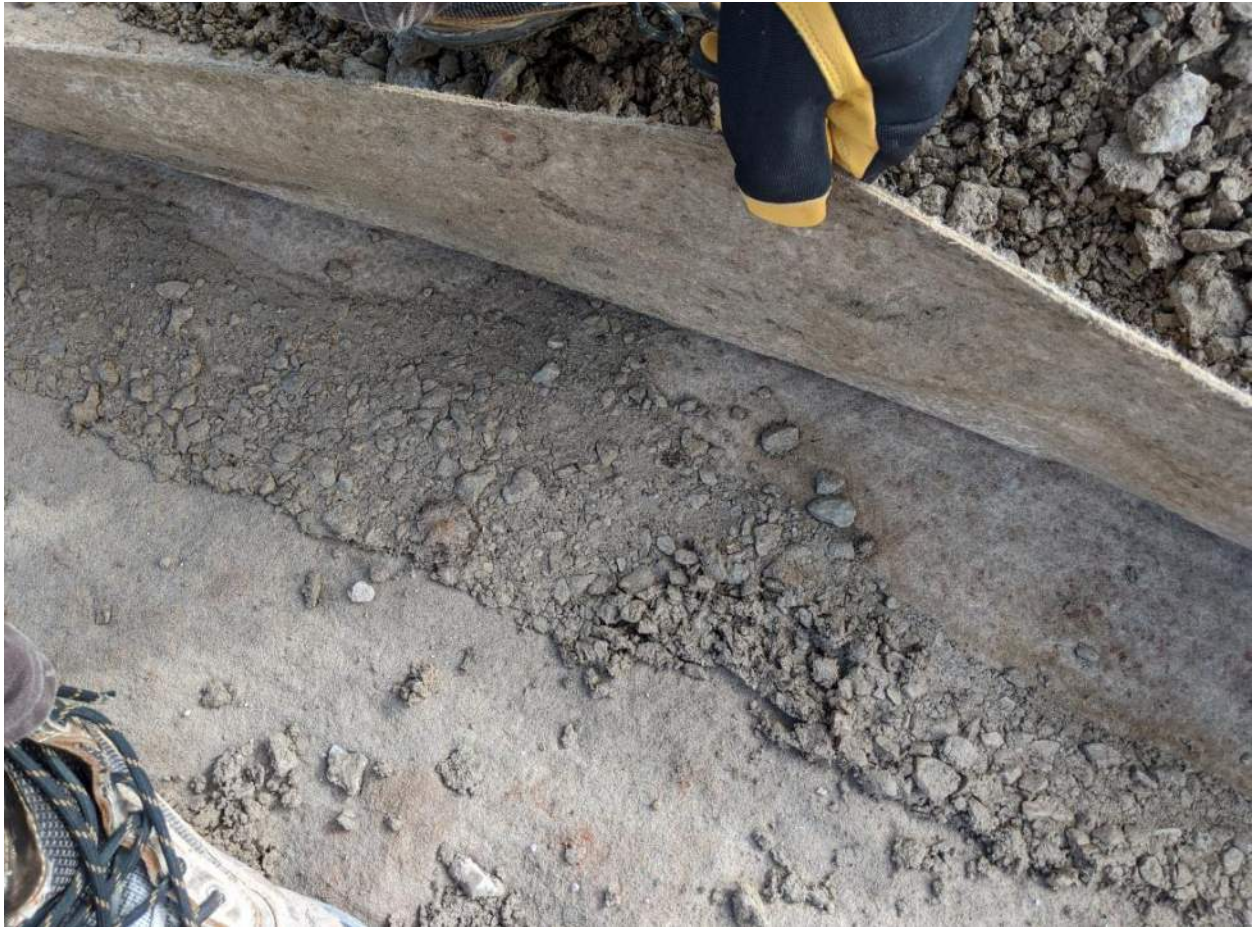
Photograph #2: Gravel compressed between the liner layers, even deep into the joint.

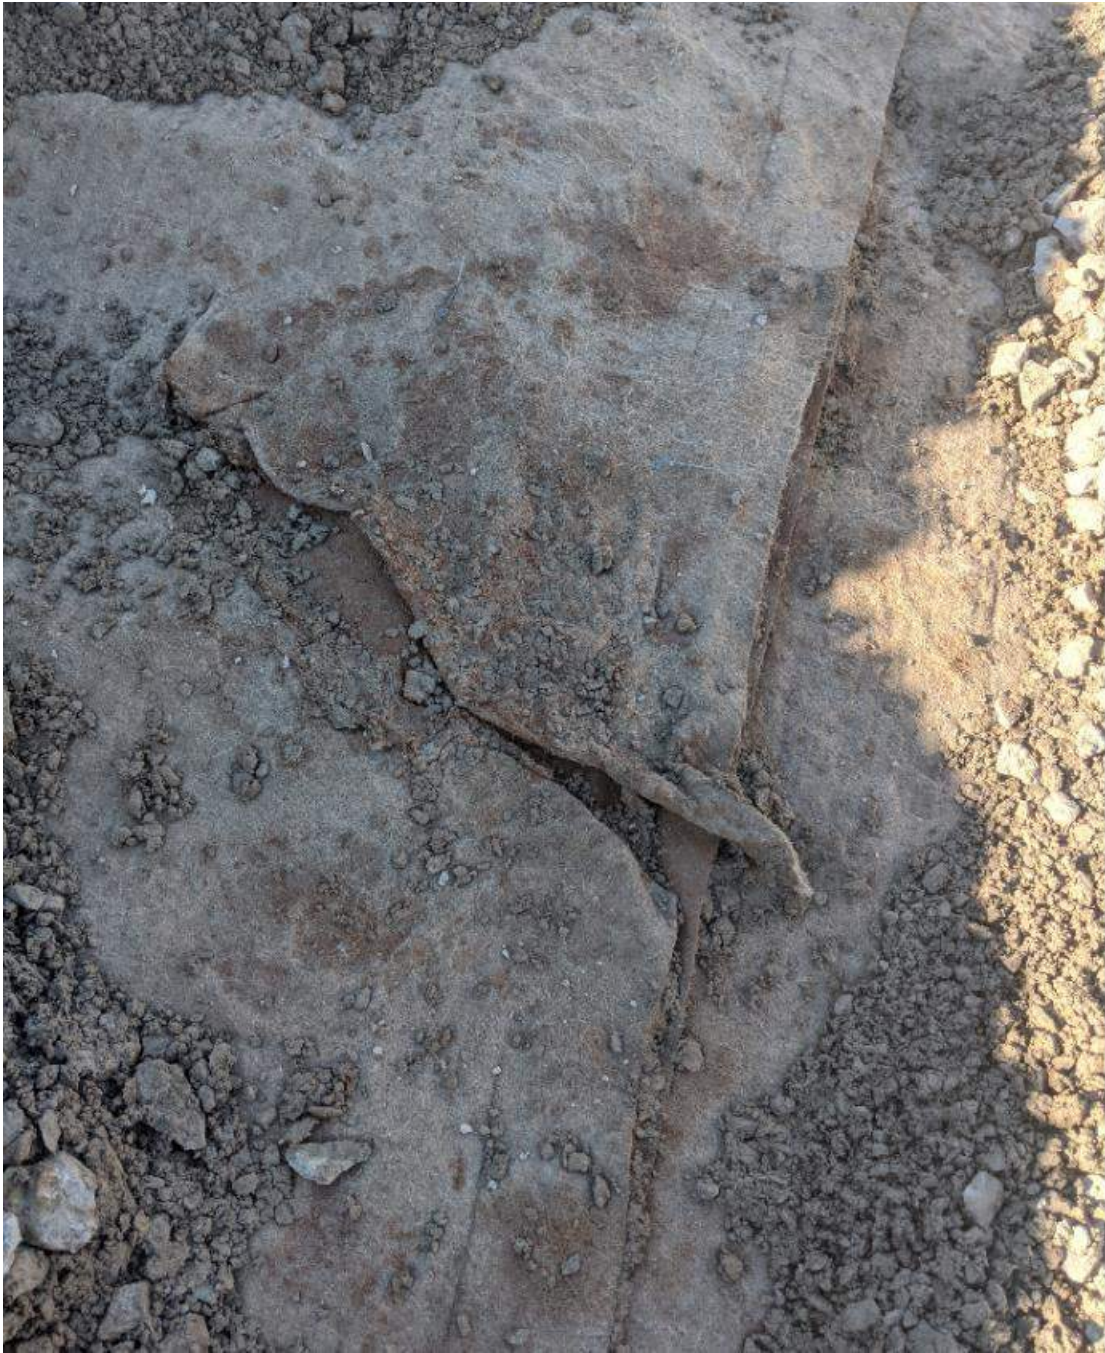
Photograph #1: Large tear found in one of the seams.

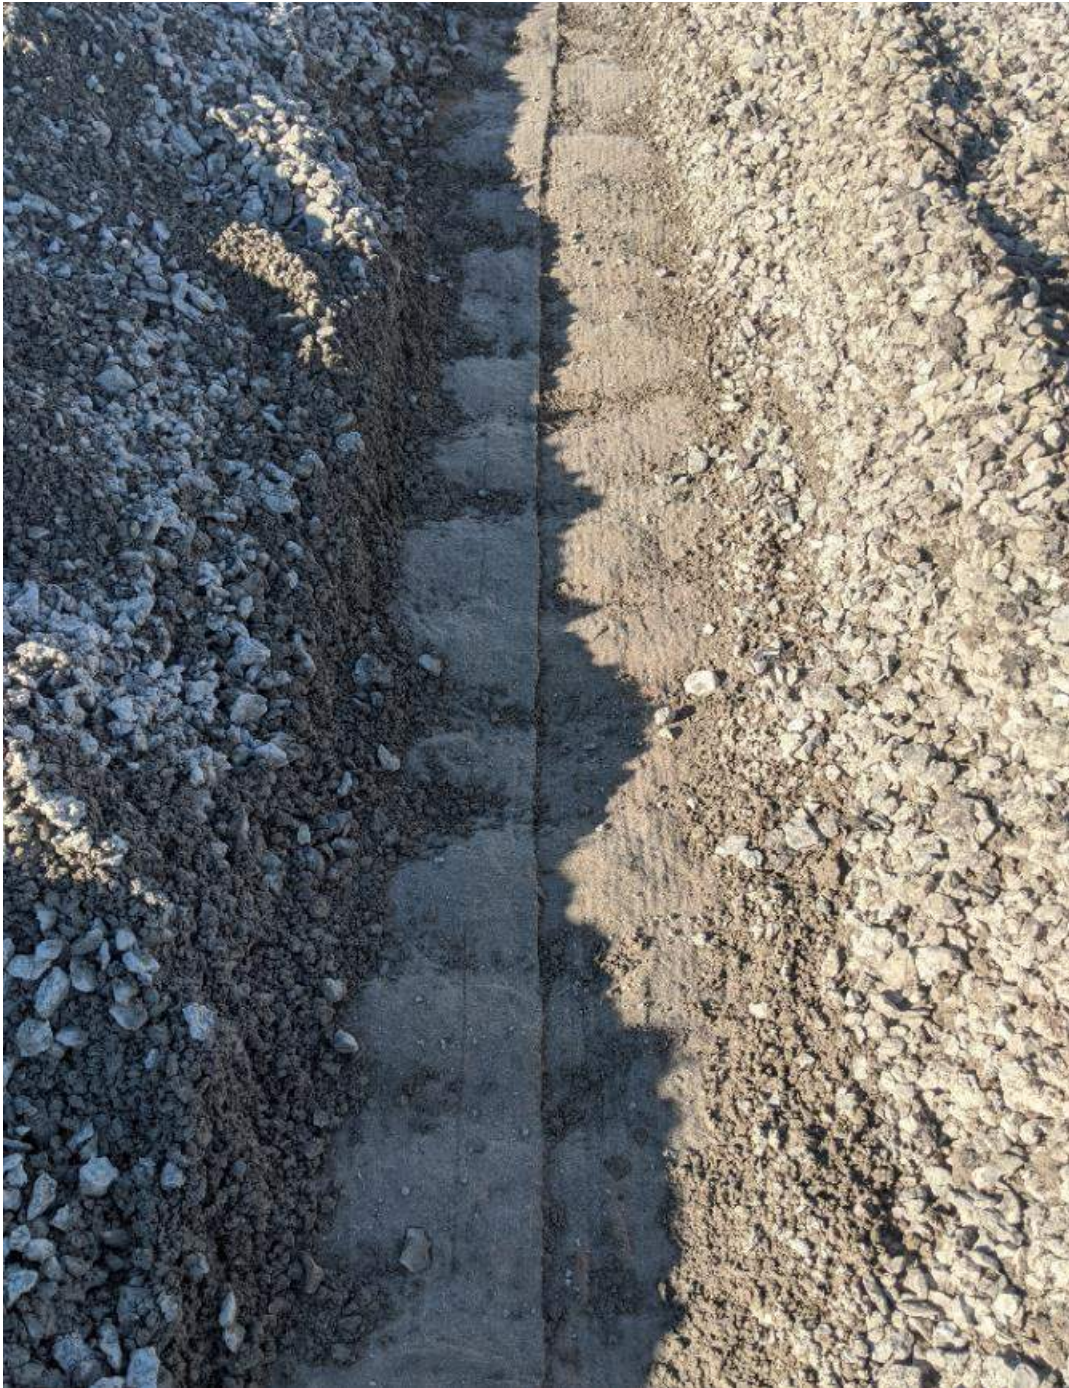
Photograph #2: Dozer tracks over the joint.

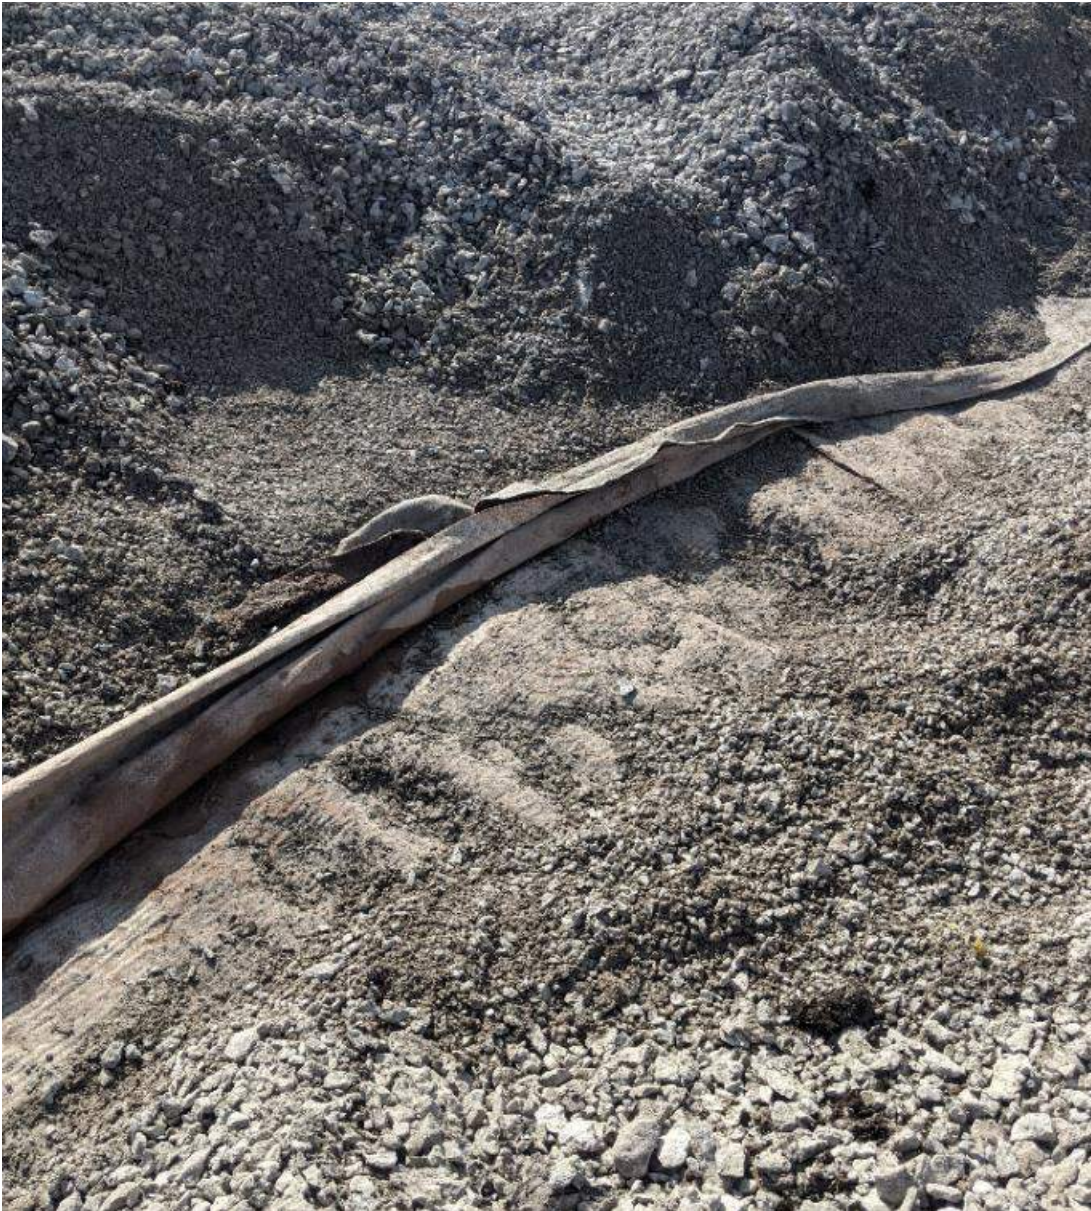
Photograph #2: In addition to damage to the seam's upper layer, gravel was present through the full width of this particular defect, creating a path for water to penetrate all the way to the bentonite seal, and potentially to the subgrade.

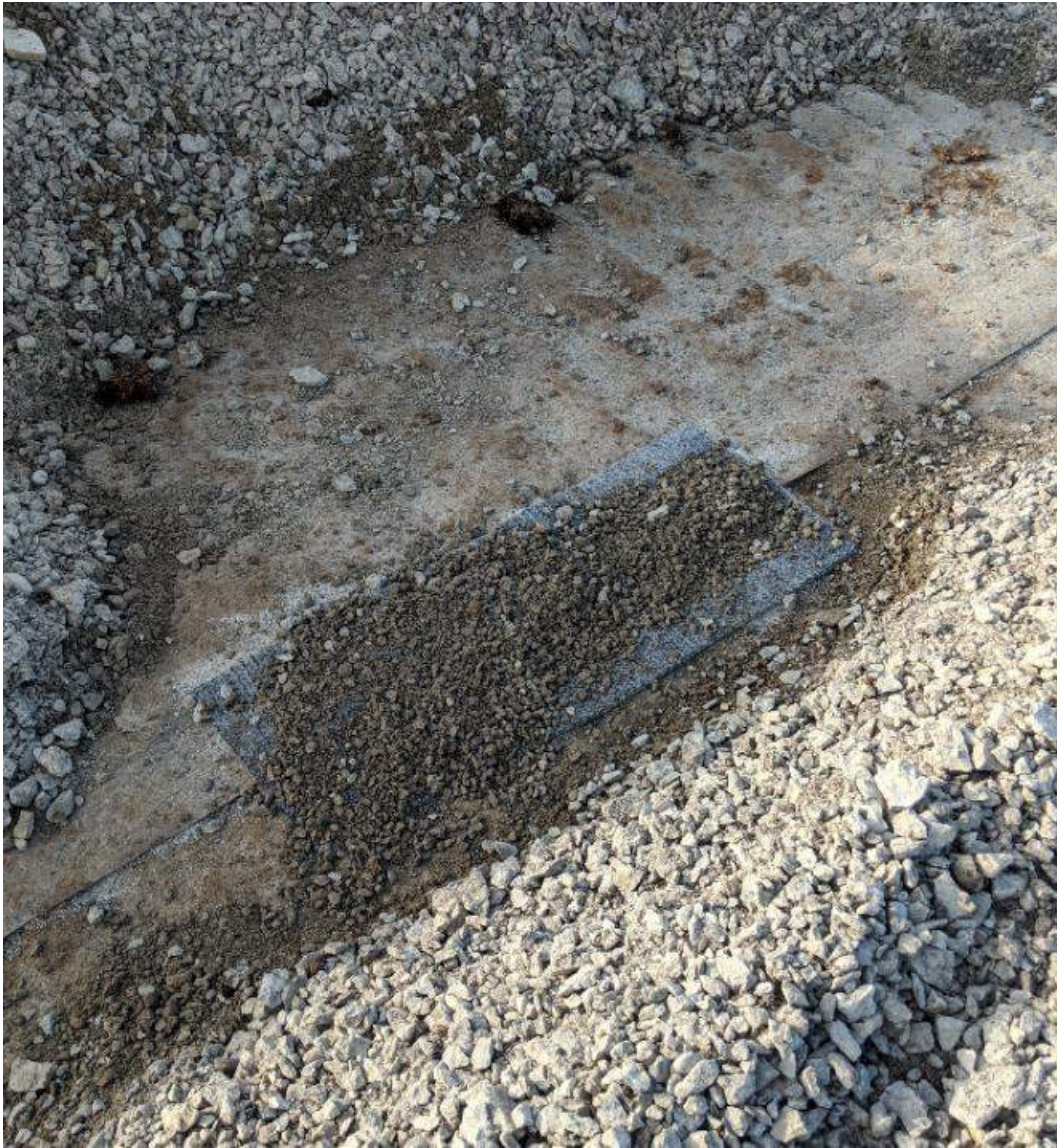
Photograph #1: Patch covering a local defect within one of the seams.
