2023 ANNUAL REPORT FOR THE MUNICIPALITY OF SANIRAJAK

YEAR BEING REPORTED: 2023

The following information is compiled pursuant to the requirements of Part B, Item 1 of Water Licence No. **3BM-HAL2025** issued to the **Municipality of Sanirajak**.

Water Licence Inspection Report

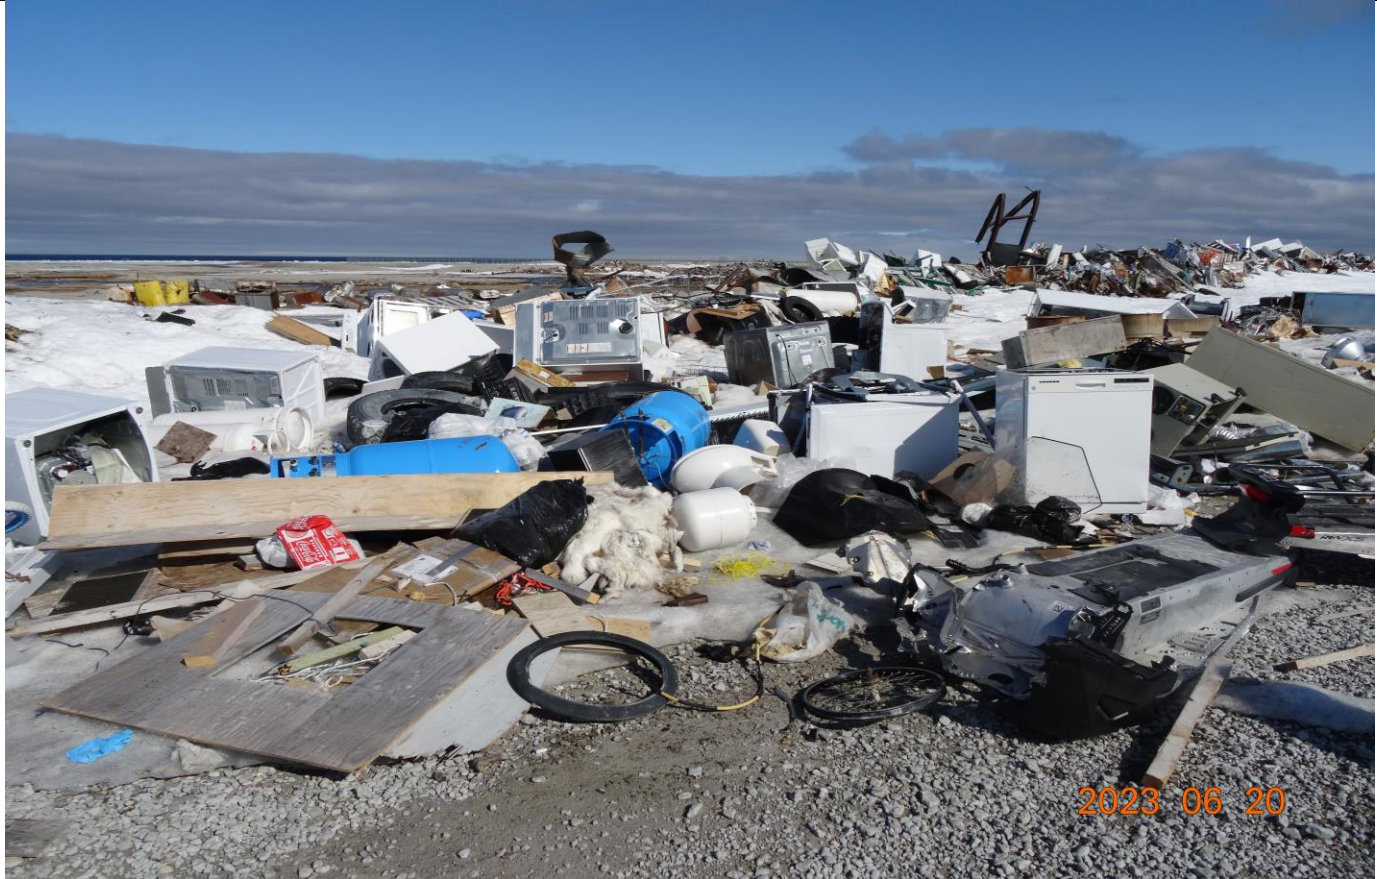
Photo No.	Lat/Long (DD.MM.SS.SS, NAD83)
Photo #1	Click or tap here to enter text.

2. Propane tanks observed in the metal dump. (photo #1)
3. Batteries found in bulk metal pile, buckets of Resin & Paste as well as gear oil (Photo #2)
4. White waste is not being segregated
5. Oil spills/Leaks observed around the metal dump. (Photo #3)
6. Fire extinguishers observed in the metal dump
7. Damaged/fallen fencing around the Burn and Cap facility (Photo #4)
8. Old garbage burn pile not capped, and is in contact with a pool of water (photo #5)
9. Buckets of Aqualock 100% acrylic water based primer and other types of paint found in the burn pit (Photo #6)
10. Signs of oil spills in the burn and cap area (sheening)
11. A 4 stroke generator was observed in the burn and cap area
12. A freezer was found in the burn and cap area

Photo Shows Propane, domestic waste, and white waste all together in the Bulk Metal facility.

Hazardous wastes should be collected from Metal Dumps, Burn & Cap facility then brought to the Hazardous Waste Berm and sorted. As Per part D, Item 9 of the 3BM-HAL2025 license: *"The Licensee shall segregate and store all hazardous materials and/or hazardous waste within the Solid Waste Disposal Facility in a manner as to prevent the deposit of deleterious substances into any water until such a time as proper disposal arrangements are made"*.

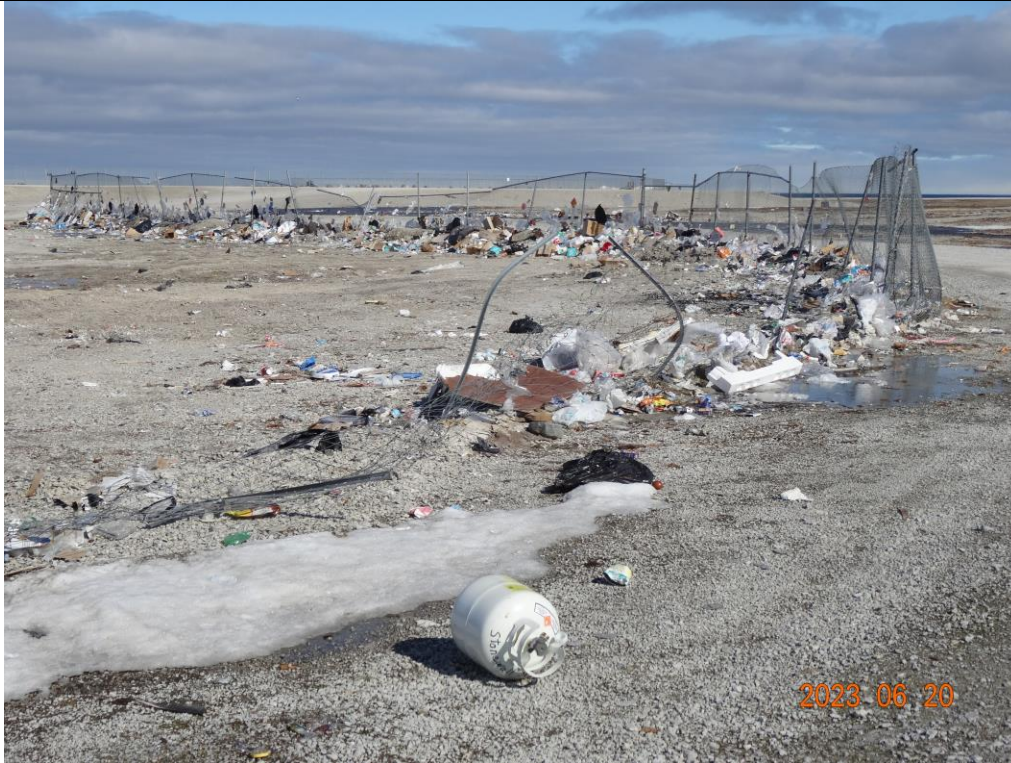
Photo #4

Photo Showing the fallen Burn and Cap facility fence

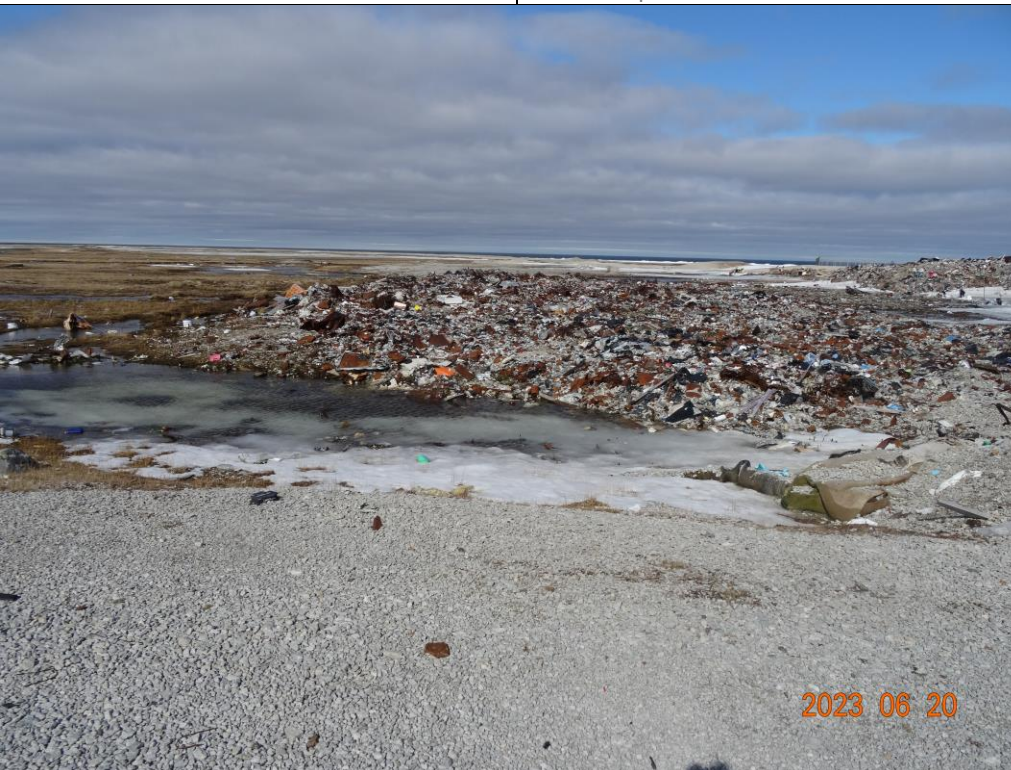
Photo #5

Photo shows Old Burn, no cap and sitting in the water.

- 2.
3. Bulk metal waste should be removed from burn and cap and sorted appropriately
4. Mitigate burning of hazardous materials in the burn and cap
5. Report oil leaks within the facilities, store contaminated soil appropriately
6. Stop, and clean up oil leak in the Hazardous Waste Berm Facility (Photo #12), treat any water within the berm before discharging to the environment
7. Sample stream for hydrocarbons, downhill from the Hazardous Waste Berm (upwelling, Photo #11) to ensure Berm wall and liner isn't compromised.

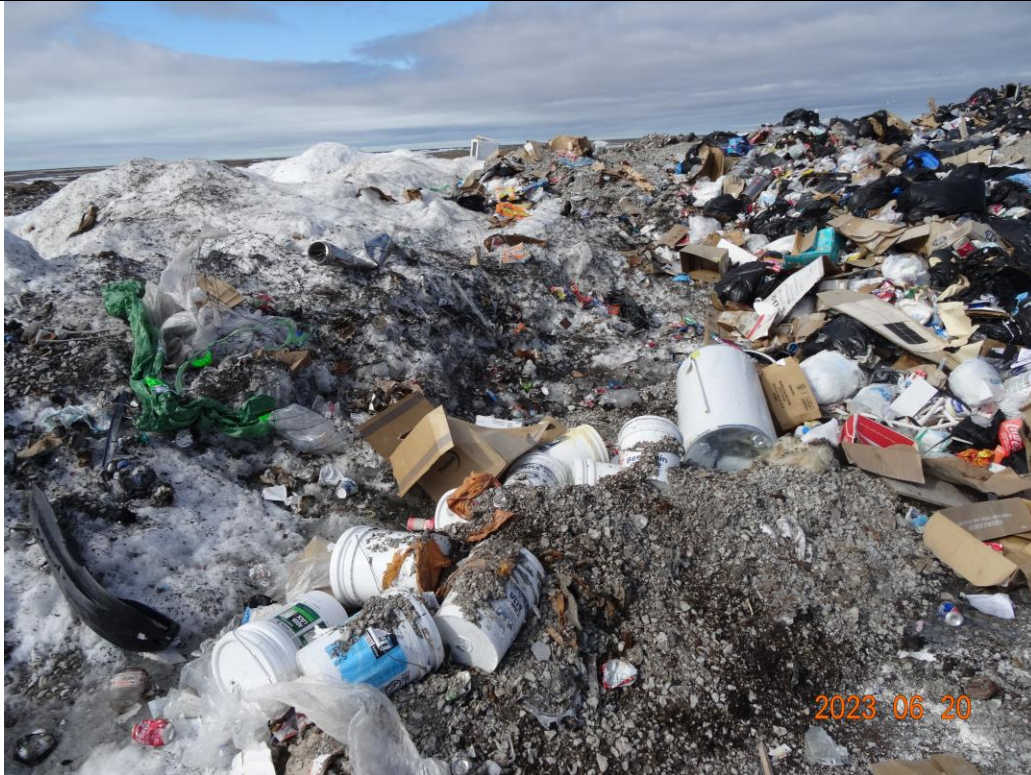
Photo #6

Buckets of primer and paint in the burn pile, along with a hot water heater, a generator and Freeezer was also found in the Burn and Cap

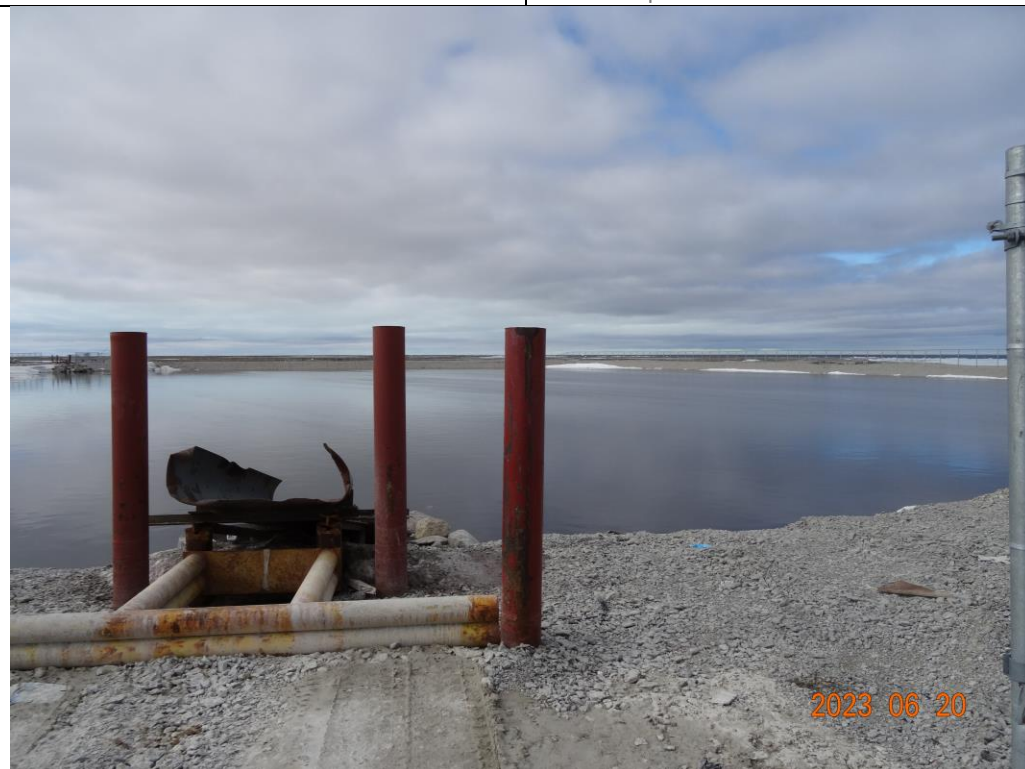
Photo #7

13. Cell 1 is very full (freeboard approx. 2M) Cell 2 looks ok.
14. No debris in or around both cells
15. Sewage truck discharge location was clean, no signs of spillage or leaking with good erosion control (Photo #7)
16. Decanting/effluent line area clean, no signs of erosion, large boulders in place as erosion control
17. Old sewage spillover (breakage of the lagoon wall) appears to contain sewage at time of inspection. (Photo #8)

Photo showing cell 1, showing the truck discharge location and the erosion mitigation.

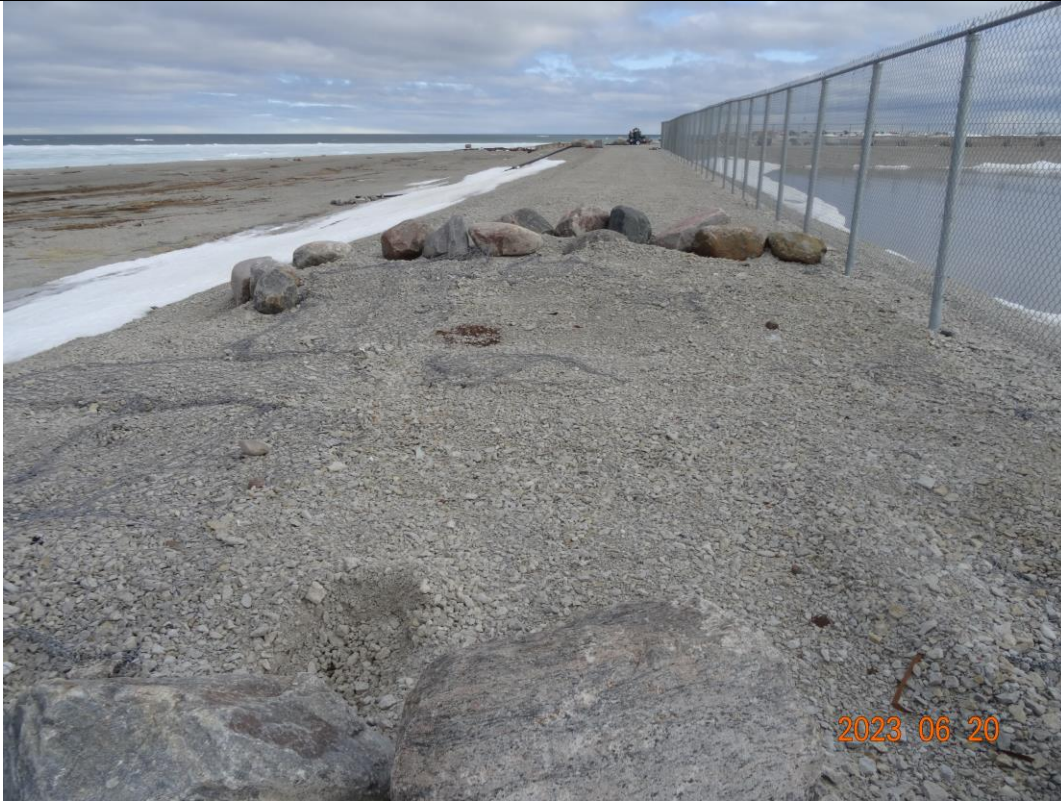
Photo #8

Photo showing Cell 1 spillage area repair. spill-2021289

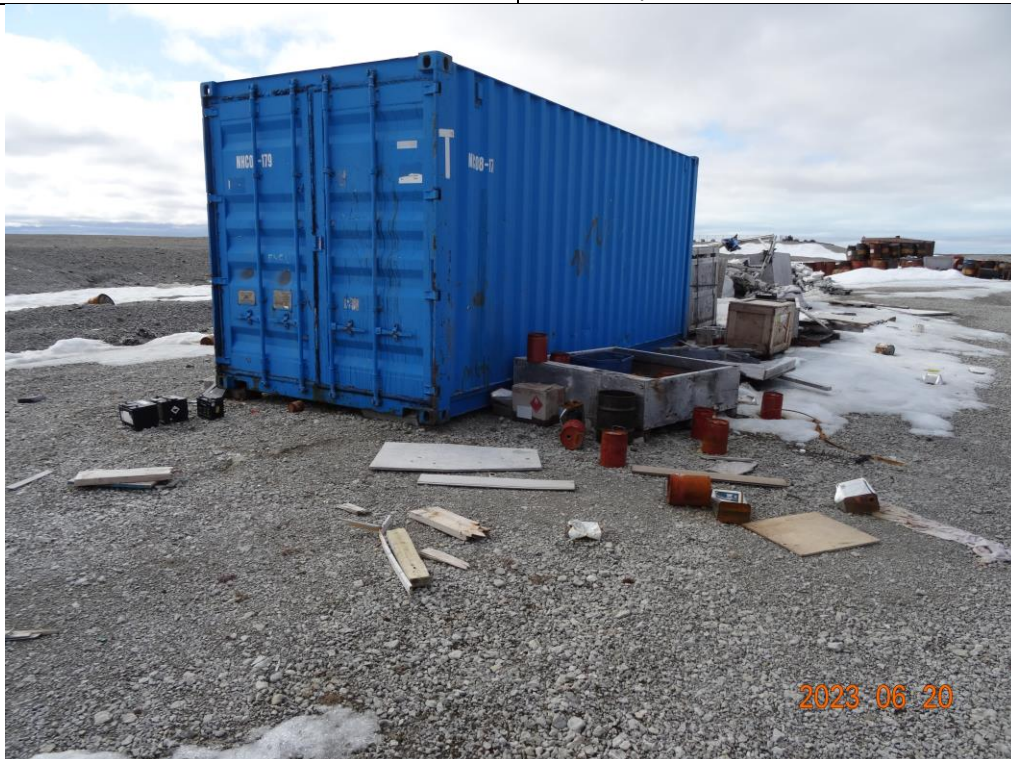
Photo #9

18. Loose debris in the Hazardous Waste Berms (wood and other garbage) (photo #9)
19. Many signs of leaks/spills inside the berm (photo #10)
20. Possible signs of outflowing water
21. Walls seem stable, and the 2021 berm wall gap noted by Joseph Monteith is fixed
22. Signs of underground water up welling from under hazardous waste berm (down hill side) (Photo #11)
23. Active Leak in Haz waste Berm (Photo#13) as well as signs of large oil staining. (Photo#12)
24. Standing water in the HWB. (photo #14)

Loose batteries, wood, oil cans, trash

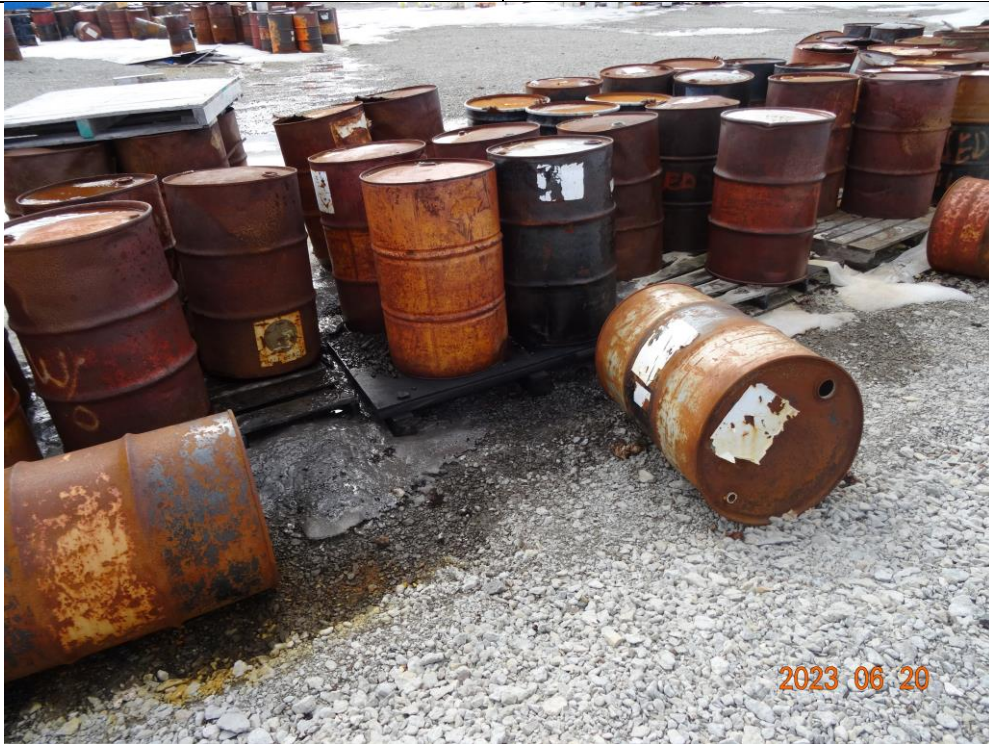
Photo No.
Photo #12

Signs of leaks and staining. Darkest Barrel in the photo is leaking actively.

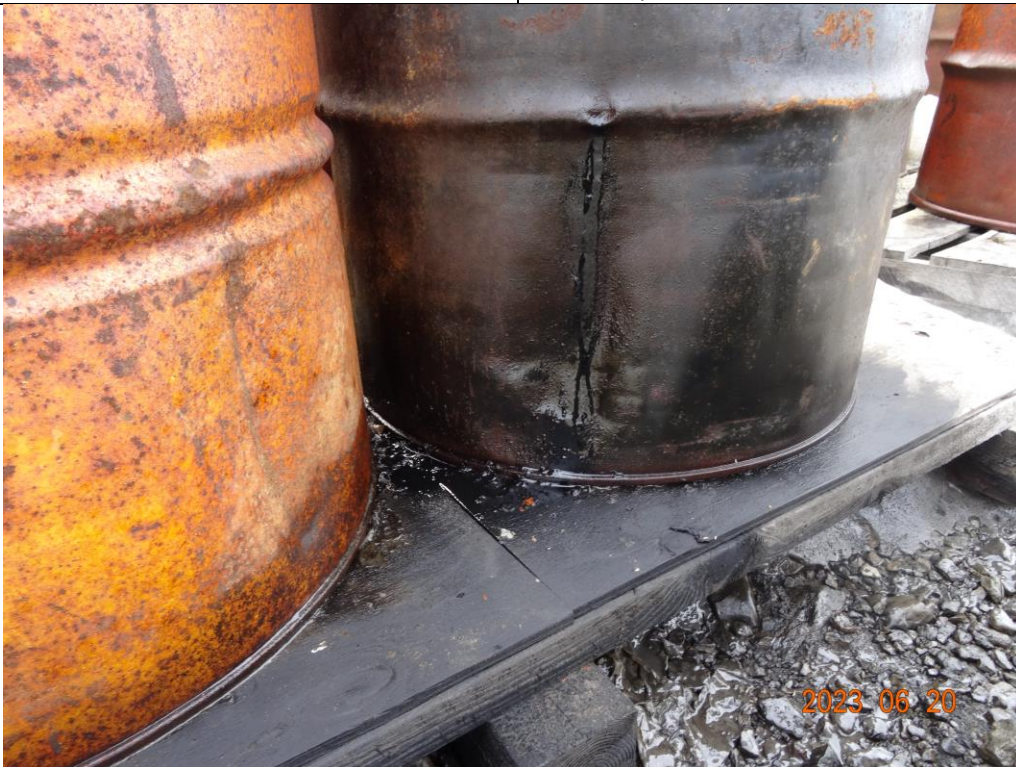
Photo No.
Photo #13

Upclose photo of an active leak inside the HWB.

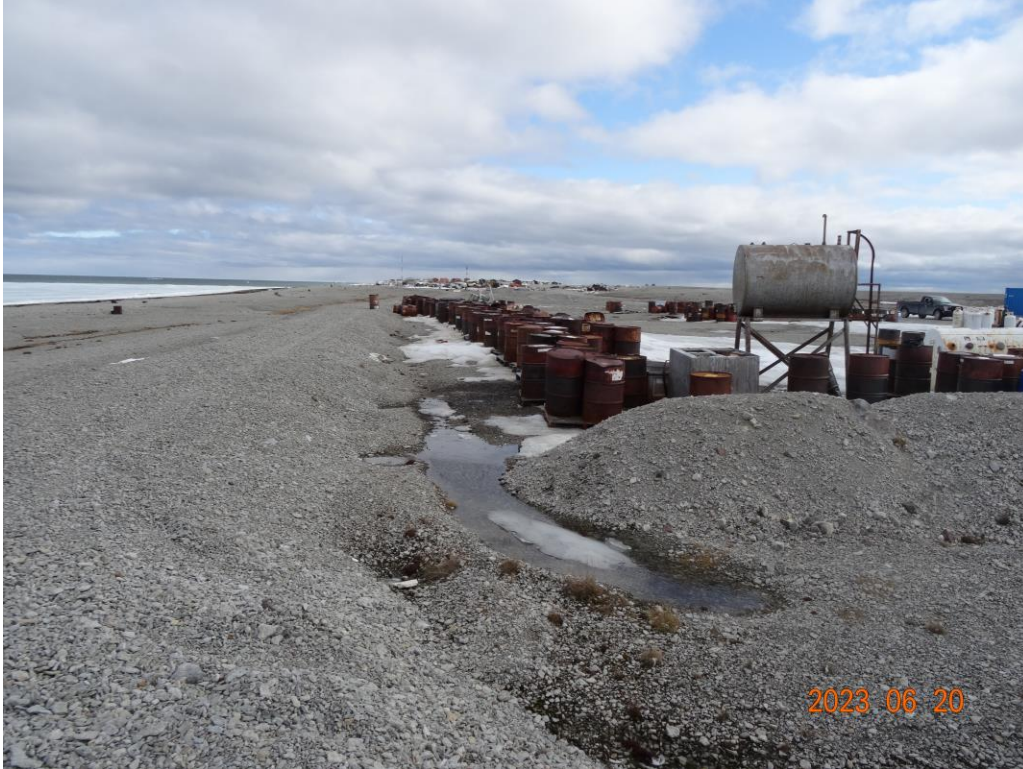
Photo #14

Photo showing standing water inside the Hazardous Waste Berm

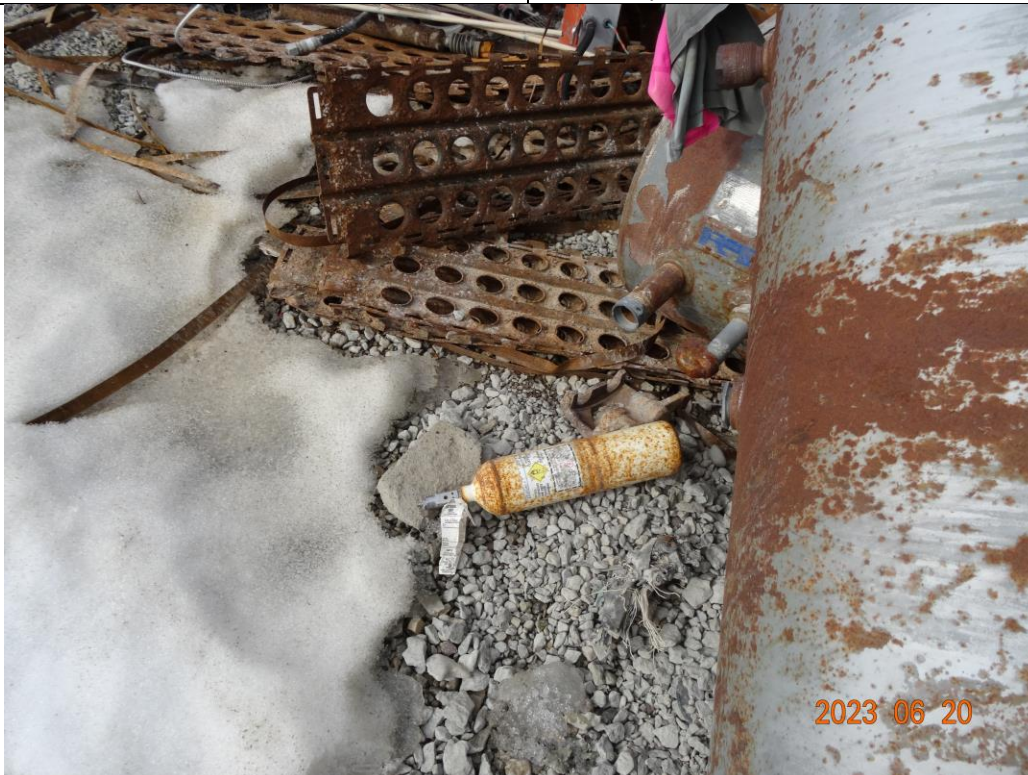
Photo #15

25. 1 compressed oxygen tank found discarded in the facility. (Photo #15)
26. Signs of domestic garbage in the dump, Oil bottles, silicone, plastics (Photo #16)

Compressed oxygen tank disregarded in 2nd metal dump facility.

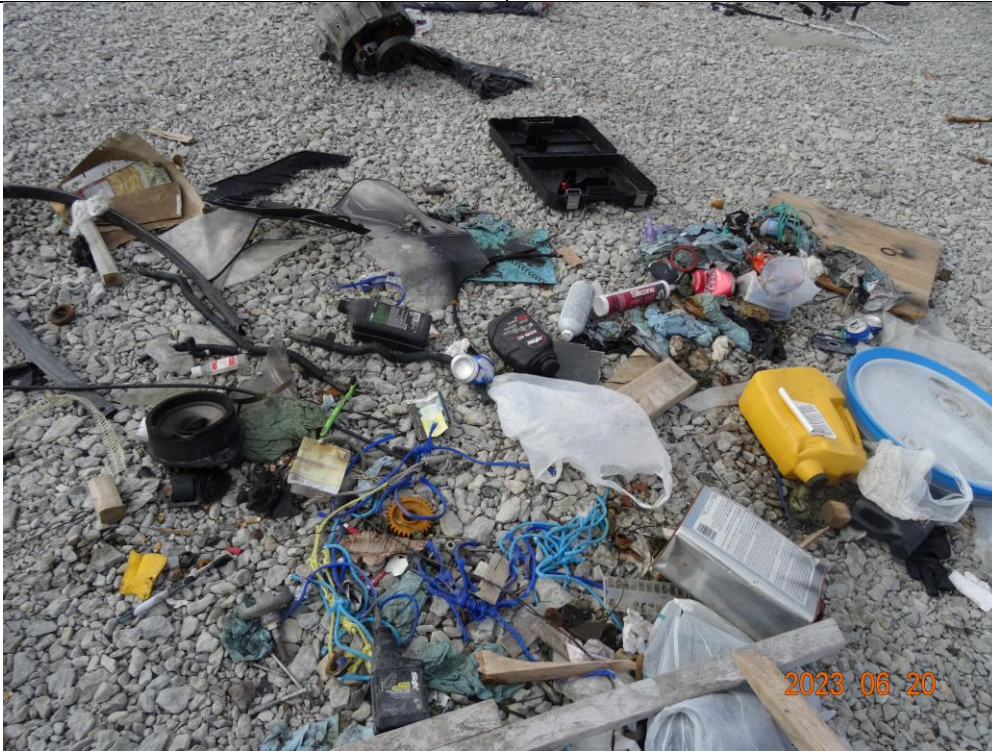
Photo No.
Photo #16

Description:
Domestic waste found at 2nd metal dump.

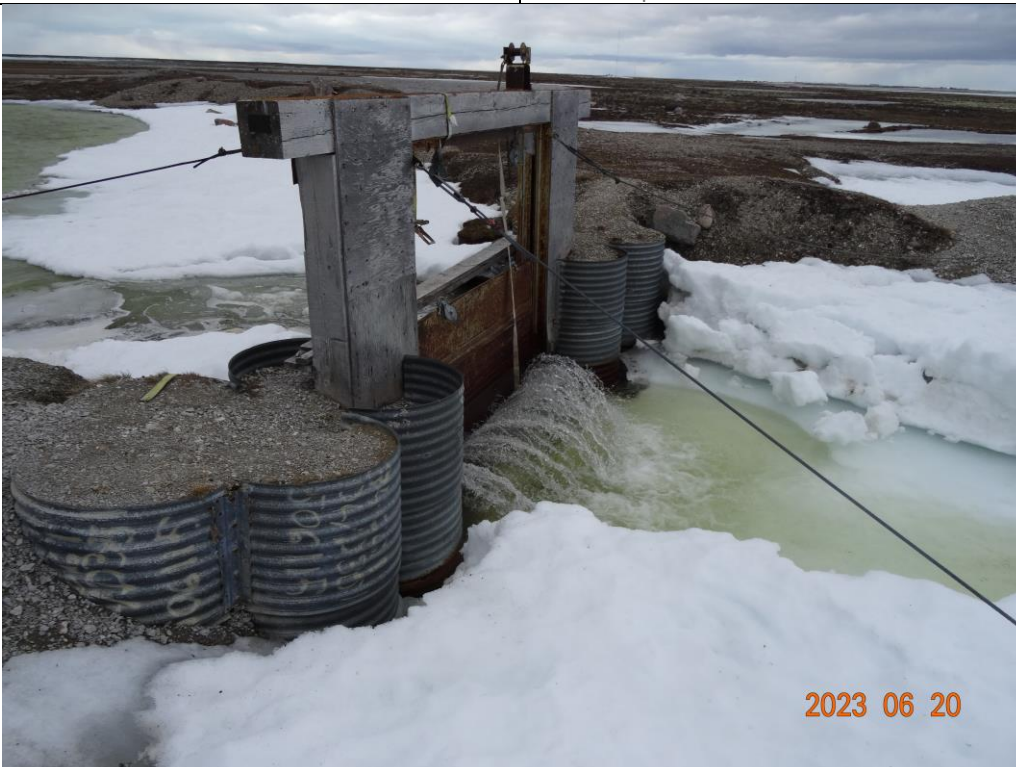
Photo No.
Photo #17

27. 5:28pm Bolt and Monteith Arrive at the Dam. The Dam structure is meant to manage water flow into South Lake to maintain the water level. (photo #17) The new water storage reservoir is elevated from the surrounding waters, it is a lined berm, and holding water. The Storage Reservoir can hold 60,00m³. Water used to be taken from South Lake but now is taken from the reservoir. The Reservoir is recharged with water pumped from South Lake.
28. 2 pump houses are situated right beside the reservoir, 1 is none operational and the other is being shared between Hall Beach and the Department of National Defense. (photo #18) DnD and the Community do not differentiate between themselves as to who is taking water from the pump house.
29. Water log photo taken (Photo # 19)
30. Chlorine is used to treat the water, that happens inside the operational pump house.(Photo #20)

Description:
Photo of the Dam that regulates flow into South Lake.

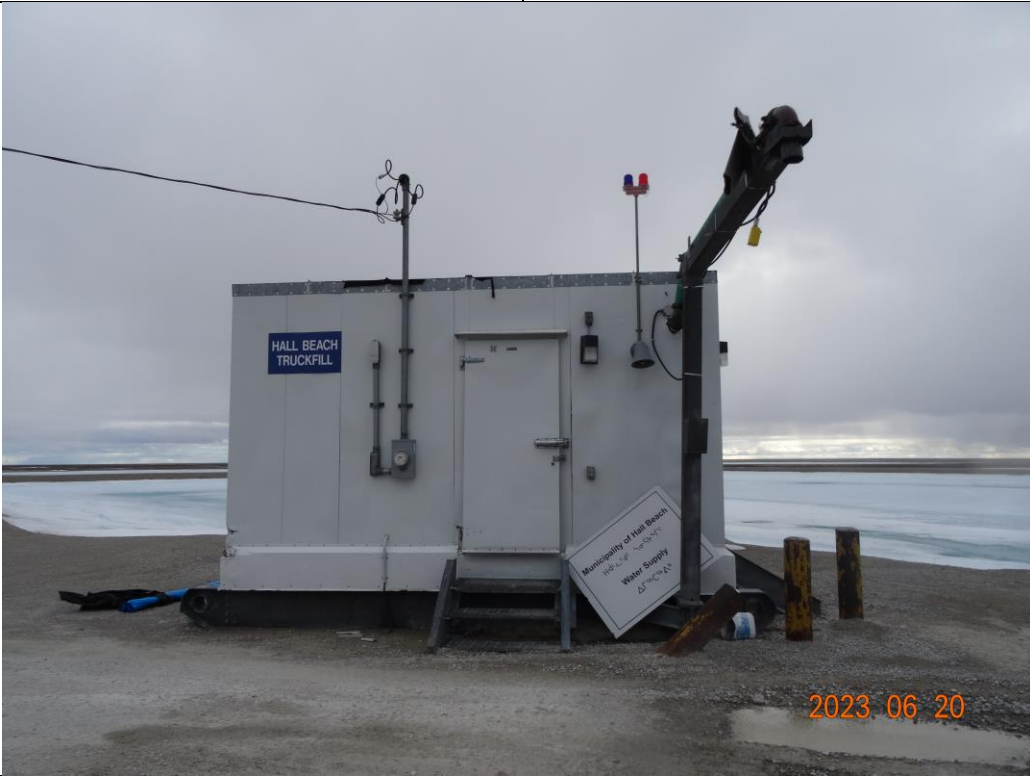
Photo No.
Photo #18

Description:
Photo of the Pump House, truck fill pipe, and Storage Reservoir in the background.

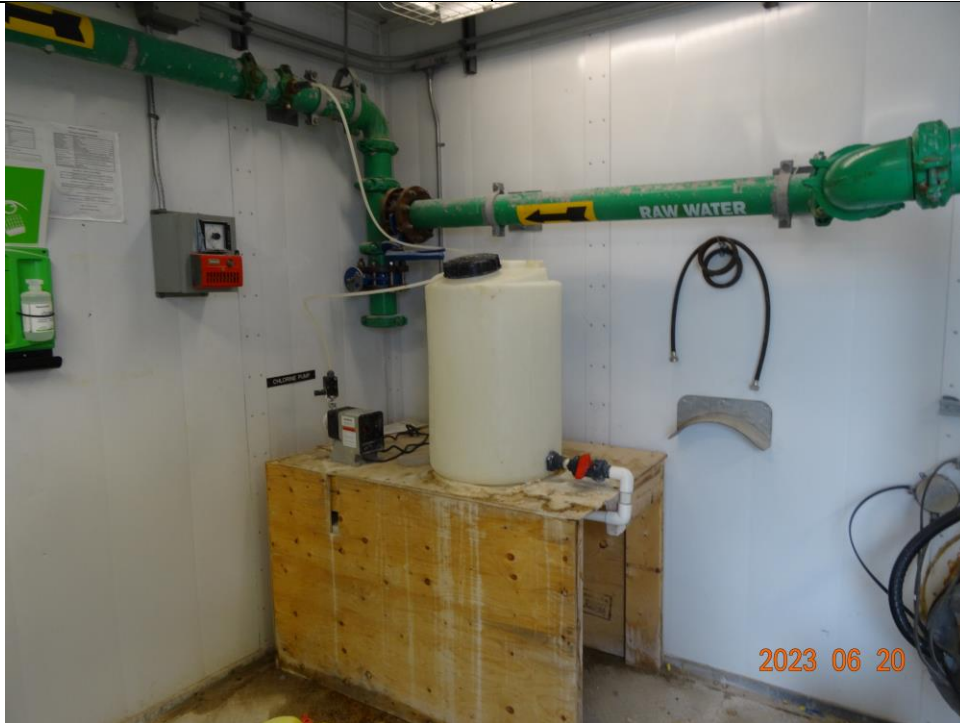
Photo #20

Photo shows the treatment of raw water. Hoses are hooked up with a large tank of chlorine and a chlorine pump to feed into the system.
