Dam Safety Review

Project Name
Dam Safety Review
Sewage Lagoon and Water Reservoir
Hall Beach, Nunavut

Project Number
OTT-00209248-A0

Date Submitted
September 9, 2013

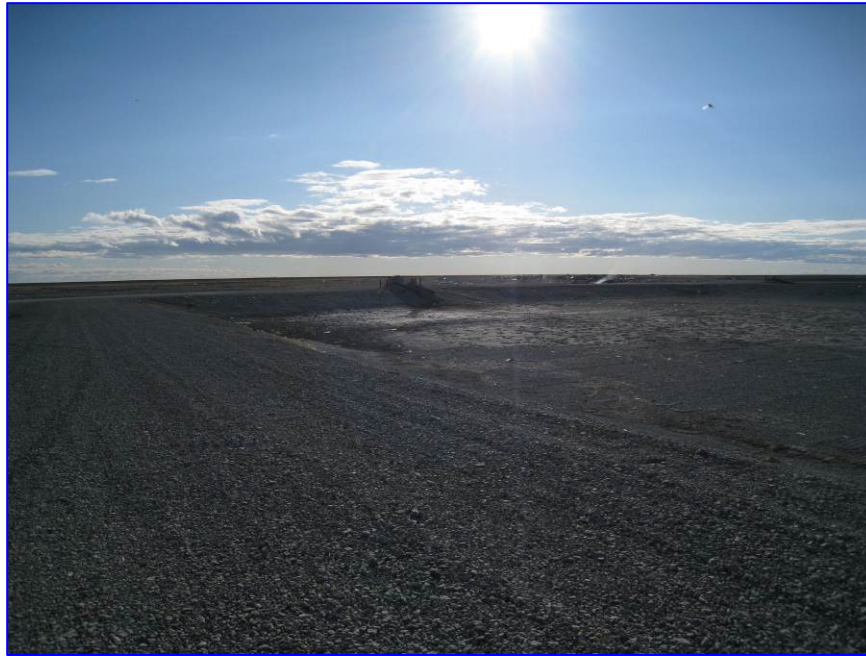
Photograph No. 1
View of cell #1

The berms of cell #1 are approximately 3 m to 3.5 m high with a crest width of 5 m to 6 m approximately and side slopes varying between 2H:1V and 3H:1V (Photos 1 and 2). Examination of the cell did not reveal any signs of erosion or slope failure. The exception to this is the south berm where a portion of the berm slope has failed and slid downhill by approximately 1 m (Photo 3). In addition, the soil adjacent to the toe of the berm has settled approximately 0.5 m over an area measuring approximately 5 m by 10 m. **Exp** visited the site in June 2013 to examine the failure and to make recommendations regarding the remedial measures. The **exp** report has been included in Appendix B and is briefly summarised below.

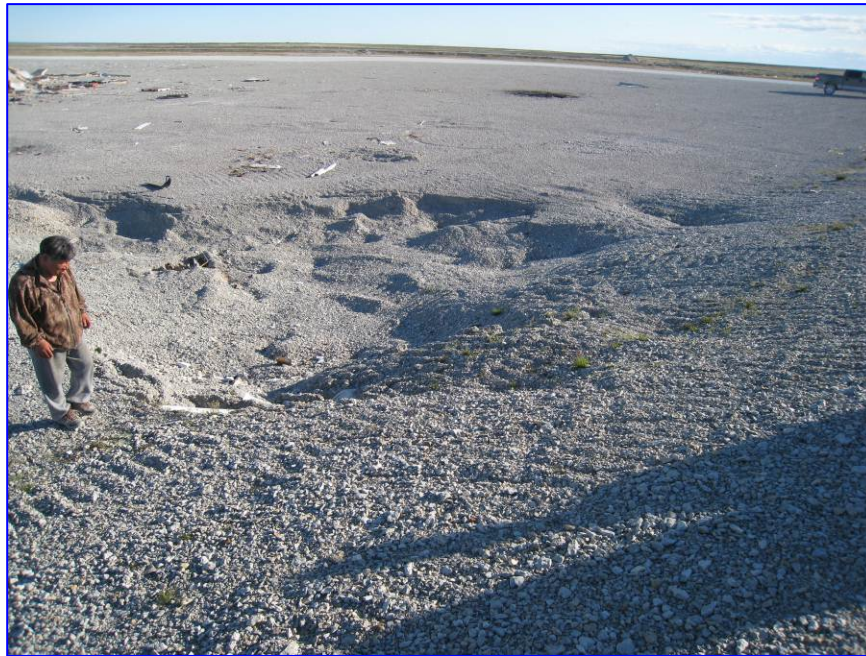
Photograph No. 3

The report indicates that a number of holes were observed in the base of the cell in 2008. The upper 1 m of the material in the base of the lagoon was excavated and replaced with sand and gravel fill. In 2010, the cell started to leak close to the southwest corner. The repair comprised of lining the corner of the cell and extending the liner along the south and east sides for a distance of 20 m approximately. It is reported that in 2011 the cell started to leak again. The leak became progressively worse in 2012 and in 2013 a portion of the berm slid and settled by approximately 0.7 m to 1 m. **Exp** reported that the 2013

failure was adjacent to the area that was repaired in 2010. The failure exposed the presence of garbage under the lagoon and the berm.

The most likely cause of the failure was identified as the garbage fill located under the berm and the lagoon. Garbage fill typically contains large voids. Seepage of water through the voids resulted in removal of fines, softening of the garbage and its collapse into the voids.

Failure of south berm of cell #1. Note: Crescent shaped scar and settlement at toe of berm.

Exp recommended that this cell should not be used until such time that the repairs have been implemented. It is noted that continued use of this cell without implementing satisfactory repairs may result in total collapse of the berm.

Option #3 was recommended as the preferred option. It is understood that the Hamlet is currently considering these options with a view to repairing the cell.

- 1.) Cell #1 of the sewage lagoon should be repaired by one of the three methods recommended in our letter report OTT-00213472-A0 dated June 27, 2013. This cell should not be used until it has been repaired. Continued use of the lagoon without repairs may result in complete collapse of the south berm of the lagoon.
- 2.) A slight bulge observed in the north berm of cell #2 is likely a result of settlement of the berm. This berm should be monitored to determine whether the settlements have stabilized. Continued bulging of the berm may necessitate remedial measures.
- 3.) The upstream slope of the west berm of the water reservoir should be re-instated.

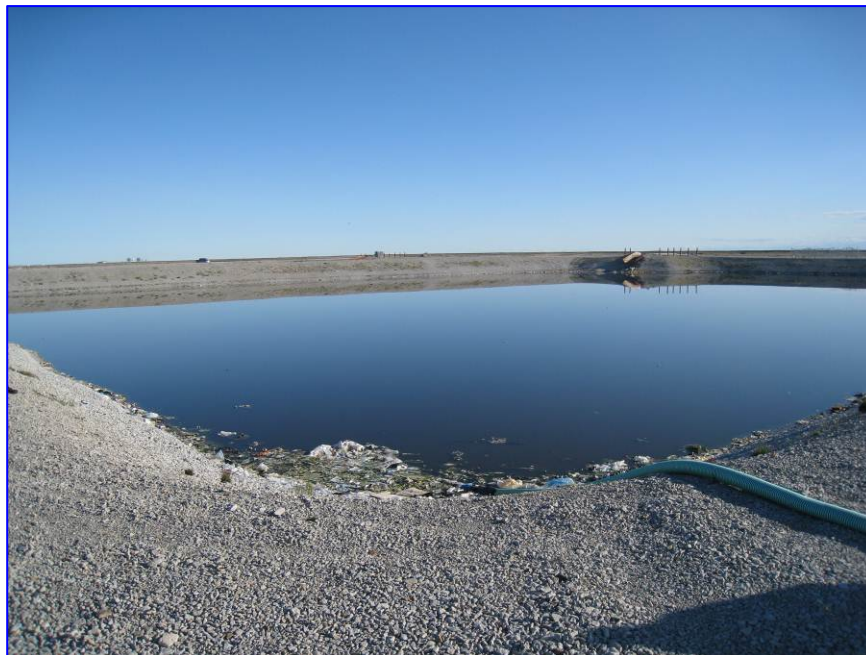
Photograph No. 4

The berms of cell #2 are also 5 m to 6 m wide with side slopes of 2H:1V to 3H:1V (Photo 4). The cell has been constructed with silty sand gravel fill.

View of cell #2 from northwest corner of berm

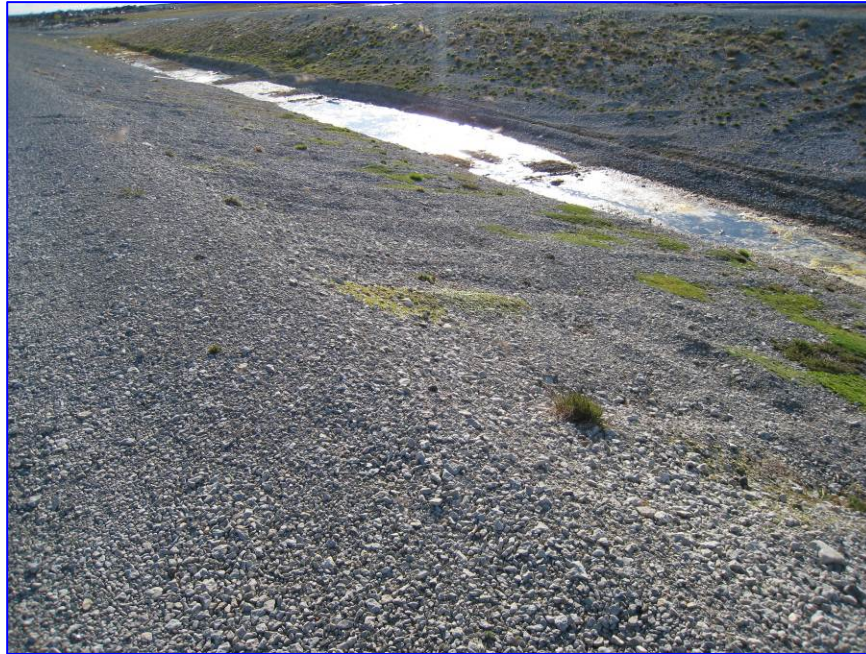
Photograph No. 5

A review of the slopes of the berm did not reveal any slope instability or erosion problems. However, it is noted that downstream slope of the north berm of the lagoon exhibits signs of some settlement and slight bulging of the slope close to the base of the berm (Photo 5). Since there have been no previous inspections, it is not possible to indicate whether the berm was constructed as such or it has settled. It is noted that this berm of the cell has been designed as an exfiltration berm and as such is subject to seepage forces. It is recommended that this berm should be monitored on a regular basis to determine if the settlements and bulging of the berm are progressive in which case remedial measures may be required.

View of north exfiltration berm of cell #2, exhibiting some settlement and bulging close to the bottom of the berm

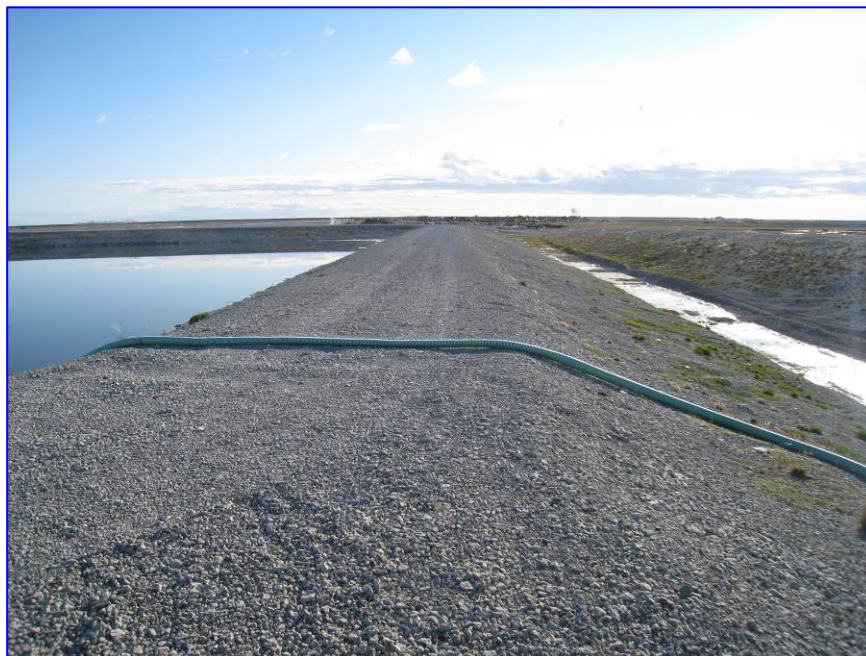
Photograph No. 6

A drainage channel and a berm are located north of the north berm of cell #2 (Photo 6). The wetlands are located north of cell #2 and consist of a land mass with several ponds. The effluent traverses through the wetlands and eventually drains into Foxe Inlet (Photos 7 and 8).

Drainage channel and berm located north of cell #2

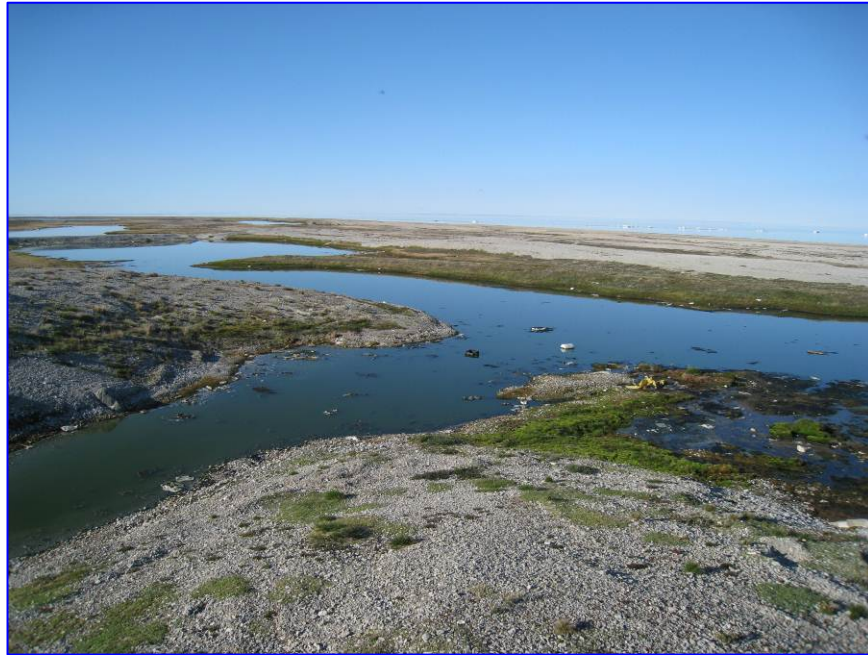
Photograph No. 7

View of drainage channel and wetlands

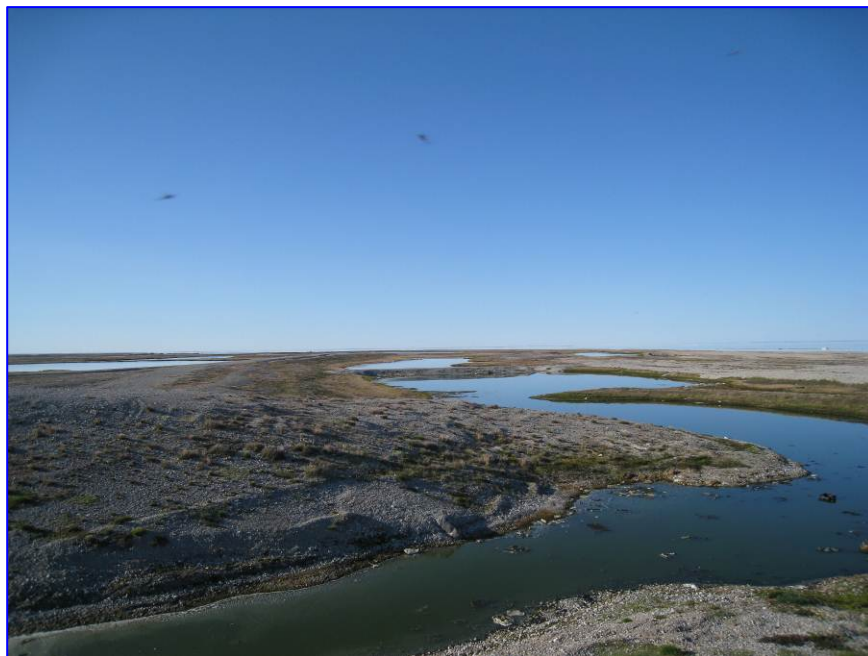
Photograph No. 8

Another view of drainage channel and wetlands

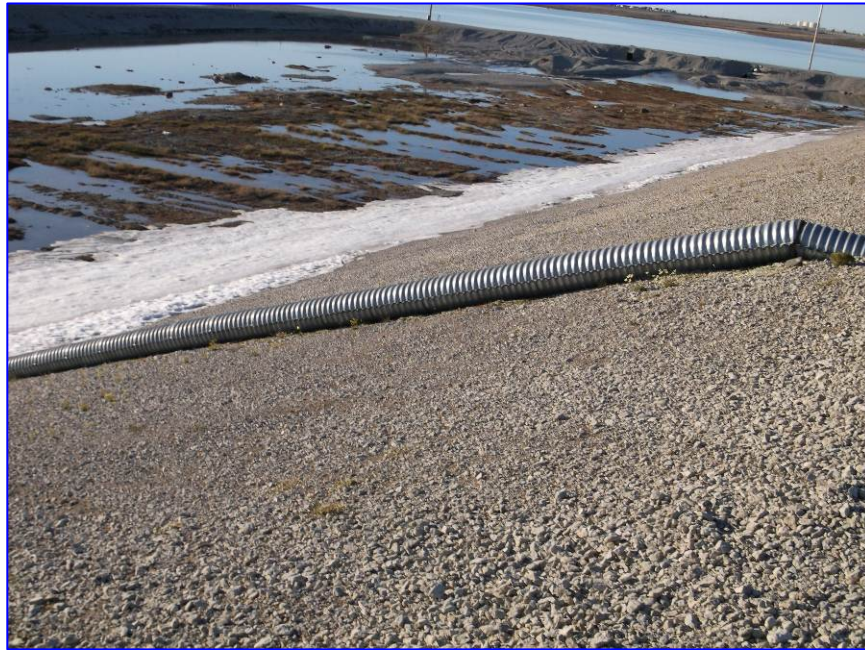
Photograph No. 11

The water supply to the reservoir is from a lake located north of the reservoir. The water is drawn into the reservoir via a HDPE pipe. A 300 mm diameter corrugated steel pipe has been provided as overflow pipe and is located close to the southeast corner of the reservoir (Photo 11). The overflow pipe drains into the area located south of the reservoir.

Corrugated steel overflow pipe located at southeast corner of water reservoir

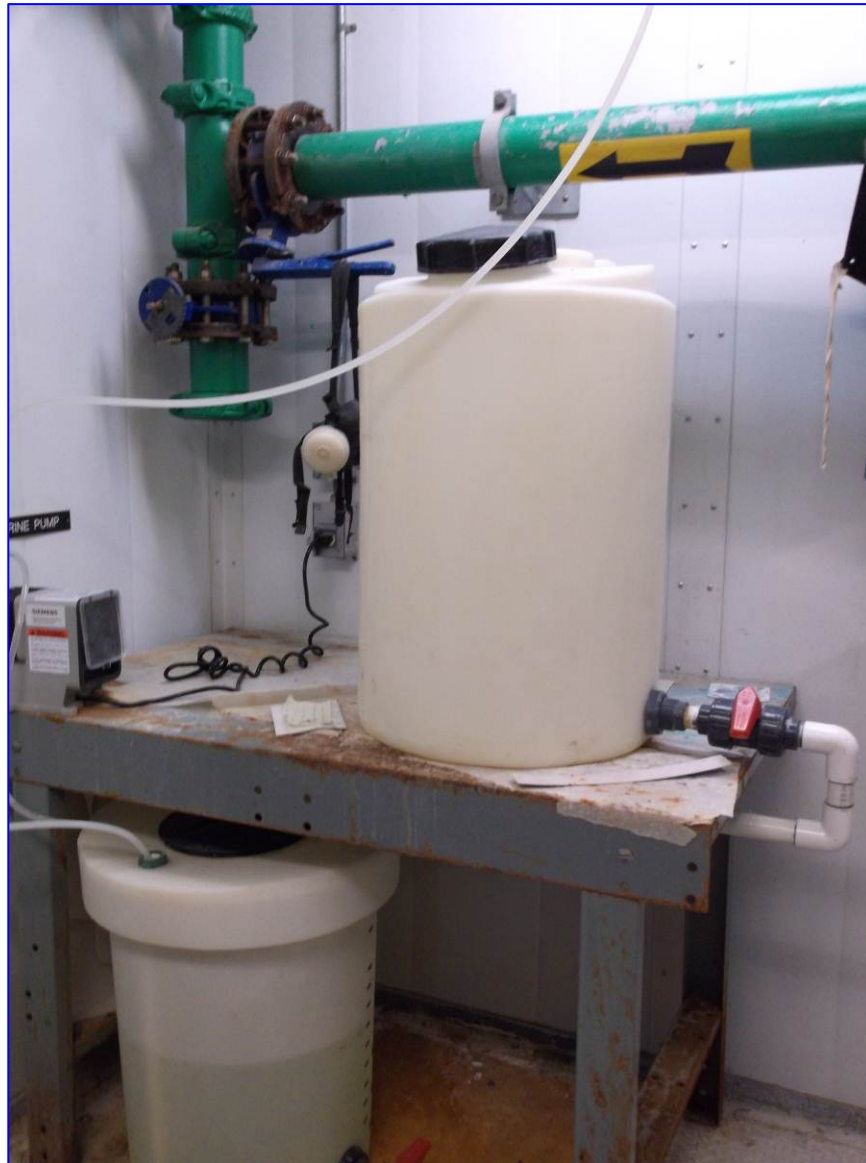
Photograph No. 13
Interior view of water treatment plant

The pump house, water treatment plant and truck fill station are located close to the northeast corner of the reservoir. Water treatment facilities comprise of chlorination and freeze prevention (Photos 12 and 13). The truck fill station is in good condition (Photo 14). The pump house and water treatment plant are in a reasonably good condition and it is reported that they function satisfactorily.

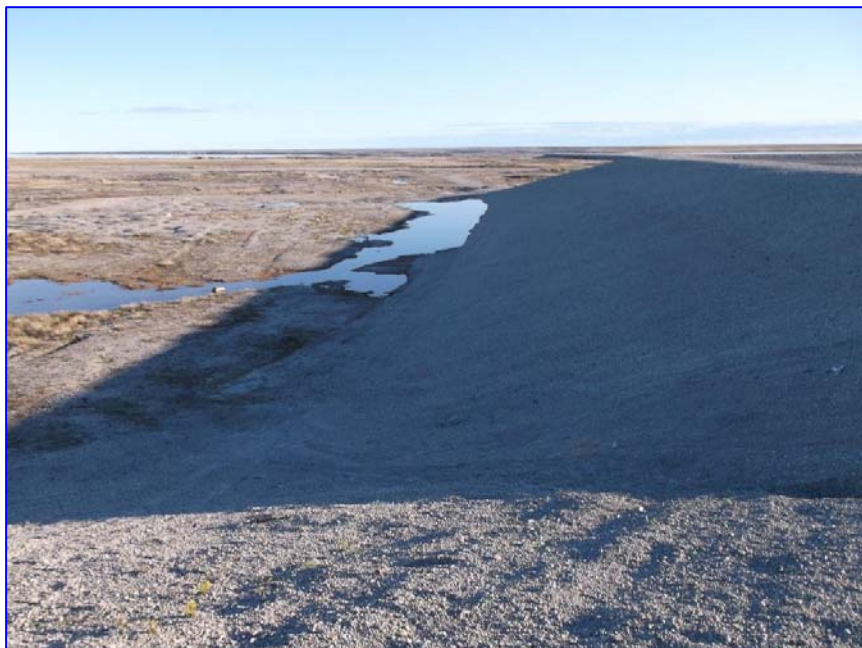
Photograph No. 15
Ponded water close to the toe of the east berm of the water reservoir

- 1.) The upstream slope of the west berm close to the northwest corner has been damaged.
- 2.) A slight bulge was observed in the south berm close so the southeast corner of the reservoir.
- 3.) Ponded water was observed close to the toe of the east berm. However, examination of the downstream slope of the berm did not reveal any signs of soil wetness or seepage from the berm. It is possible that the water has ponded in this area since it is low lying (Photo 15).
