**Geotechnical Investigation
Sewage Lagoon
Hamlet of Kimmirut, Nunavut**

Prepared for:
Bhabesh Roy
CGS Projects – GN
P.O. Box 379
Pond Inlet, Nunavut
X0A 0S0

Trow Associates Inc.

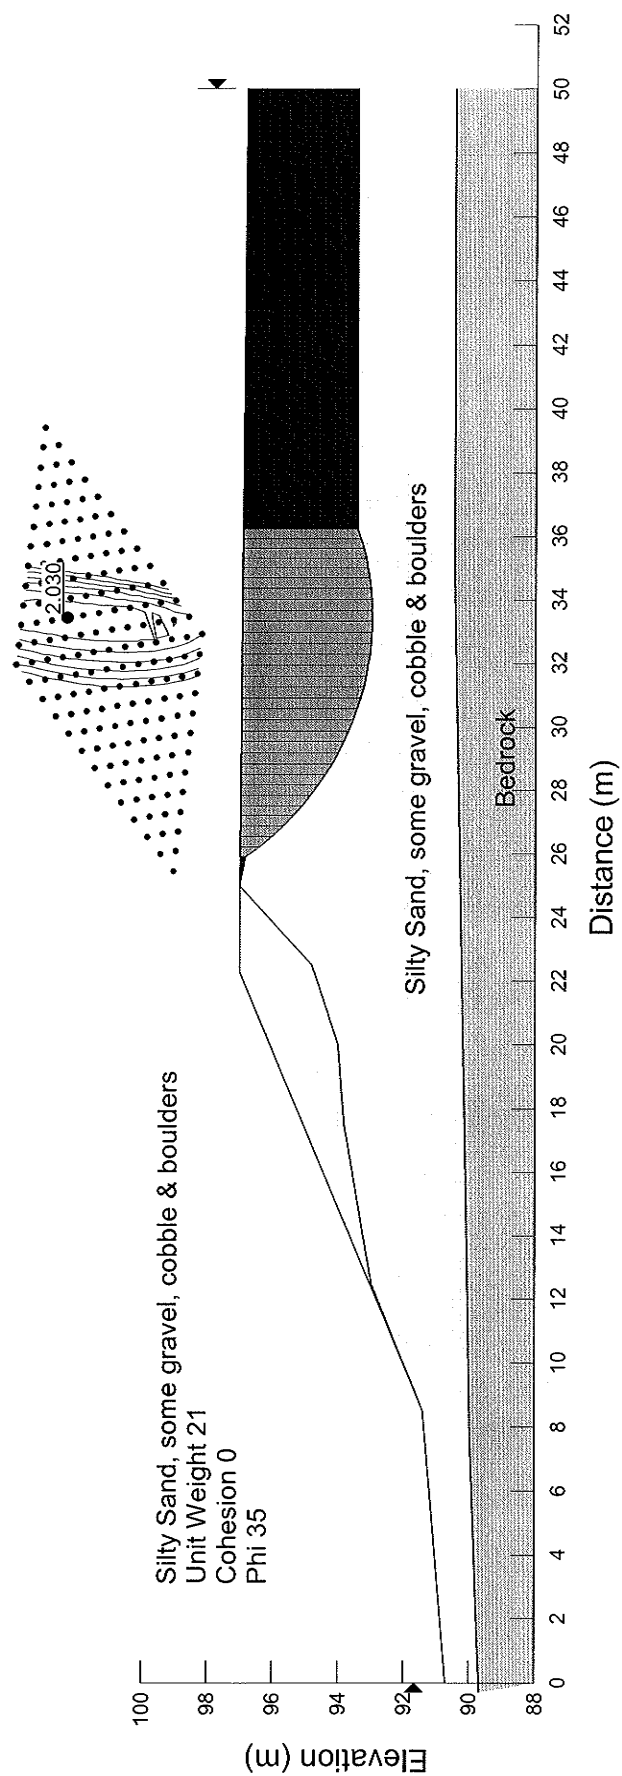
Figure 27

Slope Identification	Slope Inclination	Loading	Computed Factor of Safety	Figure #	Comments
Upstream Slope (inside)	3H:IV (existing)	Completed submerged	2.03	26	
		Completed submerged with seismic loading	1.45	27	
Downstream Slope (outside)	~2.5H:1V (existing)	Steady state seepage condition	1.40	28	Inadequate factor of safety
		Steady state seepage and seismic loading	1.12	29	
Downstream Slope (outside)	3H:IV	Steady state seepage condition	1.74	30	
		Steady state seepage condition plus seismic loading	1.31	31	
Upstream Slope	3H:IV (existing)	Rapid drawdown condition	1.35	32	Inadequate factor of safety
		Rapid drawdown condition with seismic loading	1.12	33	
Upstream Slope	4H:IV	Rapid drawdown condition	1.96	34	
		Rapid drawdown with seismic loading	1.46	35

A review of the above table indicates that the upstream slope has a factor of safety of 2.03 under static loading conditions and a factor of safety of 1.45 under seismic loading conditions. The existing downstream slope when subjected to steady state seepage conditions has a factor of safety of 1.40 under static loading conditions and 1.08 under seismic loading conditions.

Based on the conventional practice in the industry, a minimum factor of safety of 1.5 and 1.1 respectively is required for static and dynamic loading conditions. On this basis, the existing upstream slope is considered to be stable under the completely submerged conditions. The existing downstream slope (~2.5H:1V) has a lower factor of safety under static conditions than

Existing Inner Slope Stability Assessment
Geotechnical Investigation-Kimmirut Sewage Lagoon
Complete Submerged Slope

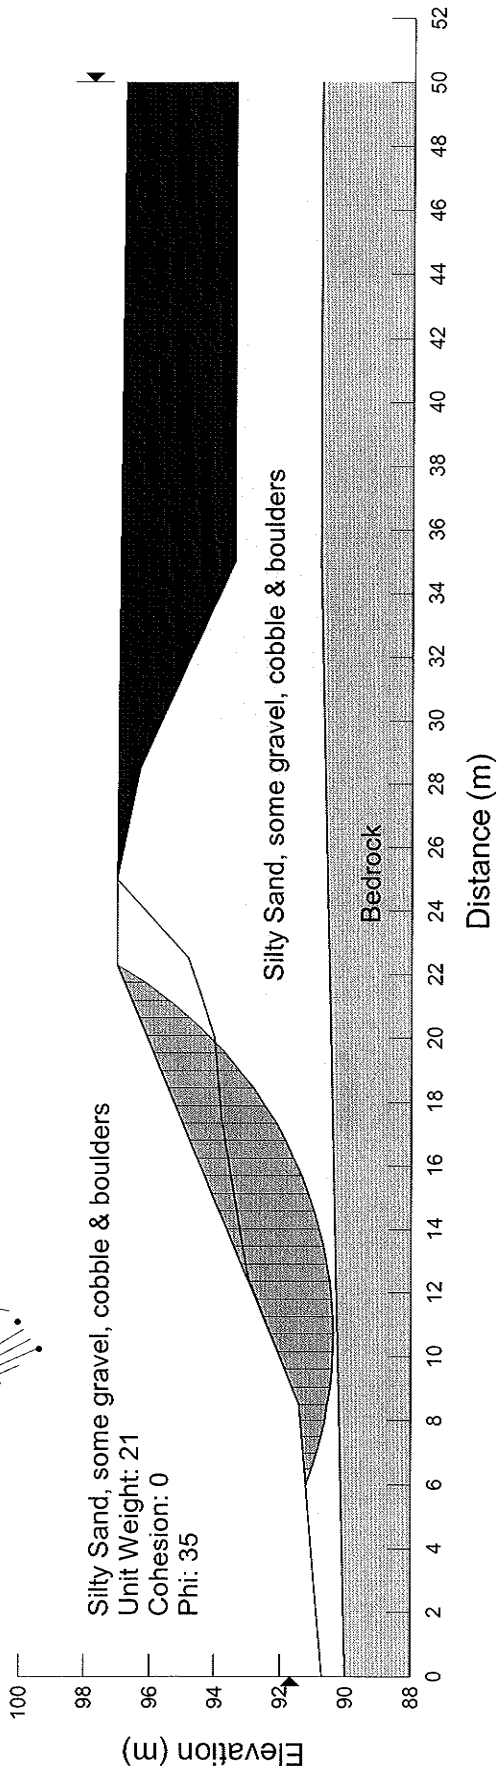
Existing Outer Slope Stability Assessment
Geotechnical Investigation-Kimmirut Sewage Lagoon
Steady State Seepage Condition
Seismic = 0.1

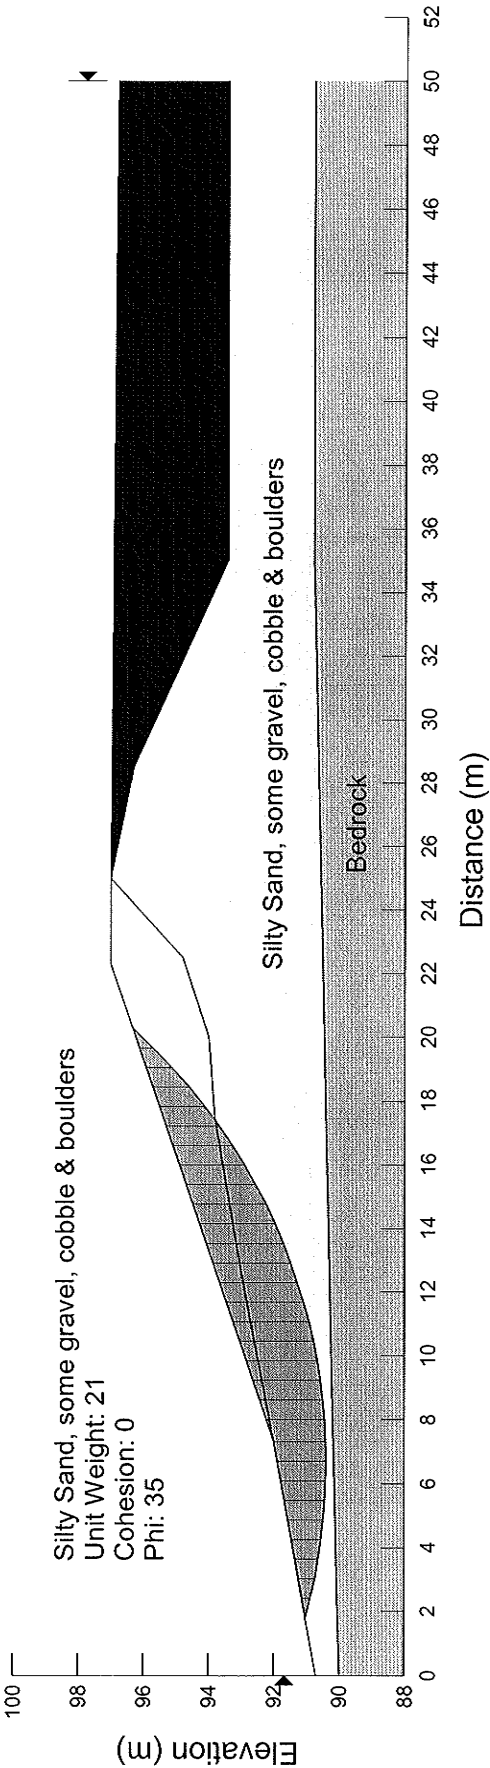
Figure 31

required. Therefore, the analysis was repeated with the downstream slope of 3H:1V and yielded acceptable factors of safety (1.74, Figure 31). It is therefore concluded that the berm slopes would be stable if constructed at an inclination of 3H:1V. It is noted that this assumes that the upstream slope will not be subjected to rapid drawdown conditions.

Outer Slope @ 3H:1V Stability Assessment
Geotechnical Investigation-Kimmirut Sewage Lagoon
Steady State Seepage Condition

It is noted that the crest width of the berm is less than the design requirements of 3 m. Therefore the berm would require widening. The widening may be achieved by extending the berm on the outside of the lagoon, since this slope receives flattening to 3H:1V.

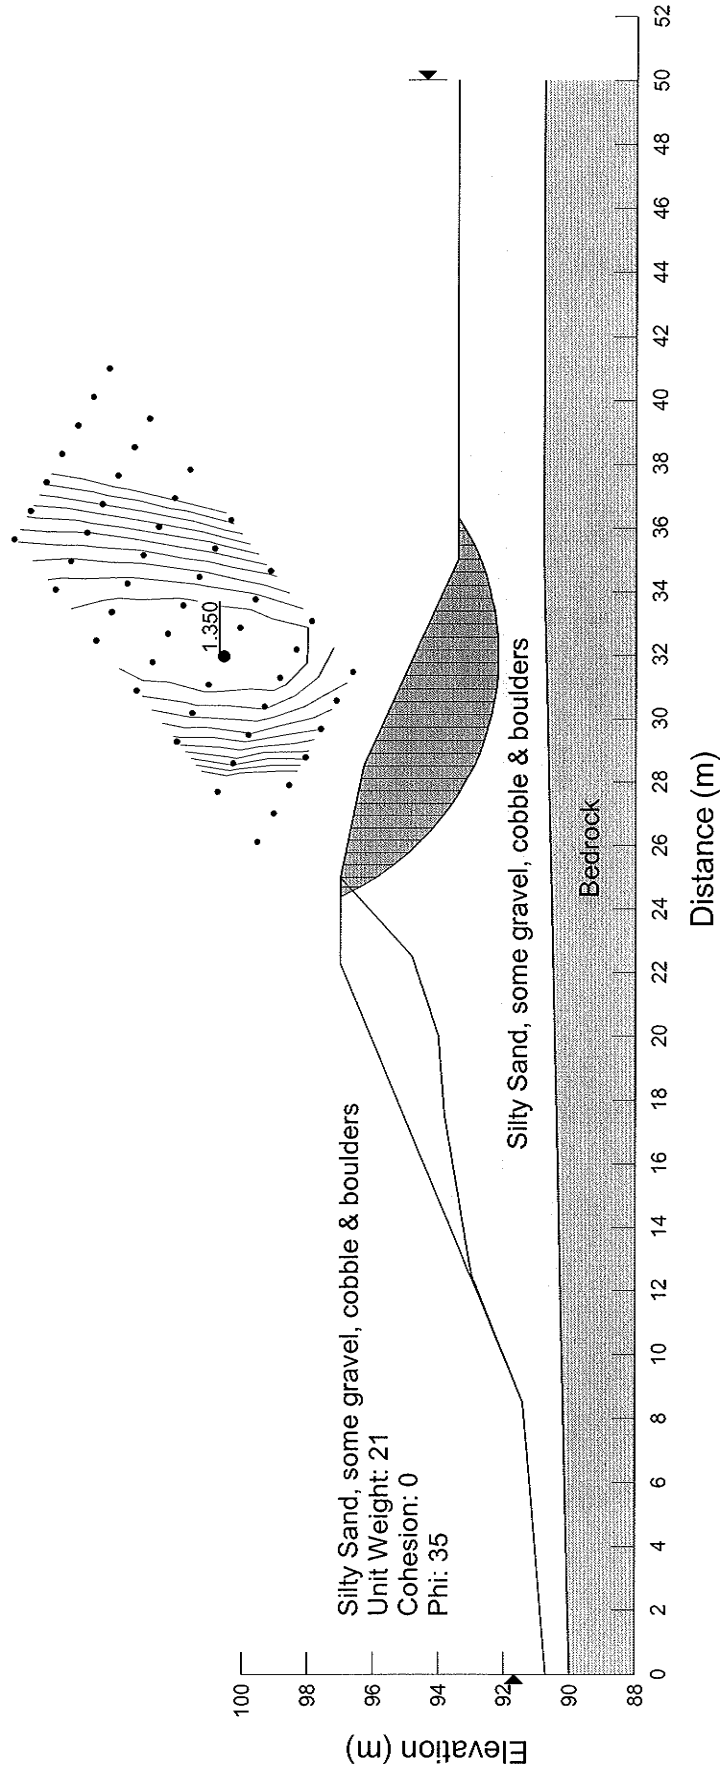
The upstream slope was also analysed for rapid drawdown condition. A factor of safety of 1.35 was obtained under static loading conditions (Figure 32) and 1.12 under seismic loading conditions (Figure 33). Additional analyses were undertaken to determine the slope that would be stable under these conditions. The analysis indicates that a 4H:1V slope would have a factor of safety of 1.96 under static loading conditions and 1.46 under seismic loading conditions. It is therefore concluded that if the berm would be subjected to a rapid drawdown condition, the stable upstream slope would be 4H:1V. It is noted that it is unlikely that this condition would be encountered in practice. The reason for this is that in warmer climates, the practice is to discharge the effluent from the lagoons once a year during spring runoff. Under these conditions, there could be potential rapid drawdown of the lagoon. However, in the Arctic Region, the berm and the effluent freeze during the winter months and the berm becomes impervious. The effluent and the berm gradually thaw in the spring and summer months. Since seepage cannot take place out of the berms until they thaw, the rate of flow of the effluent from the lagoon is very slow. Consequently, in practice, a rapid drawdown condition will not be achieved.

Existing Inner Slope Stability Assessment
Geotechnical Investigation-Kimmirut Sewage Lagoon
Rapid Drawdown Case

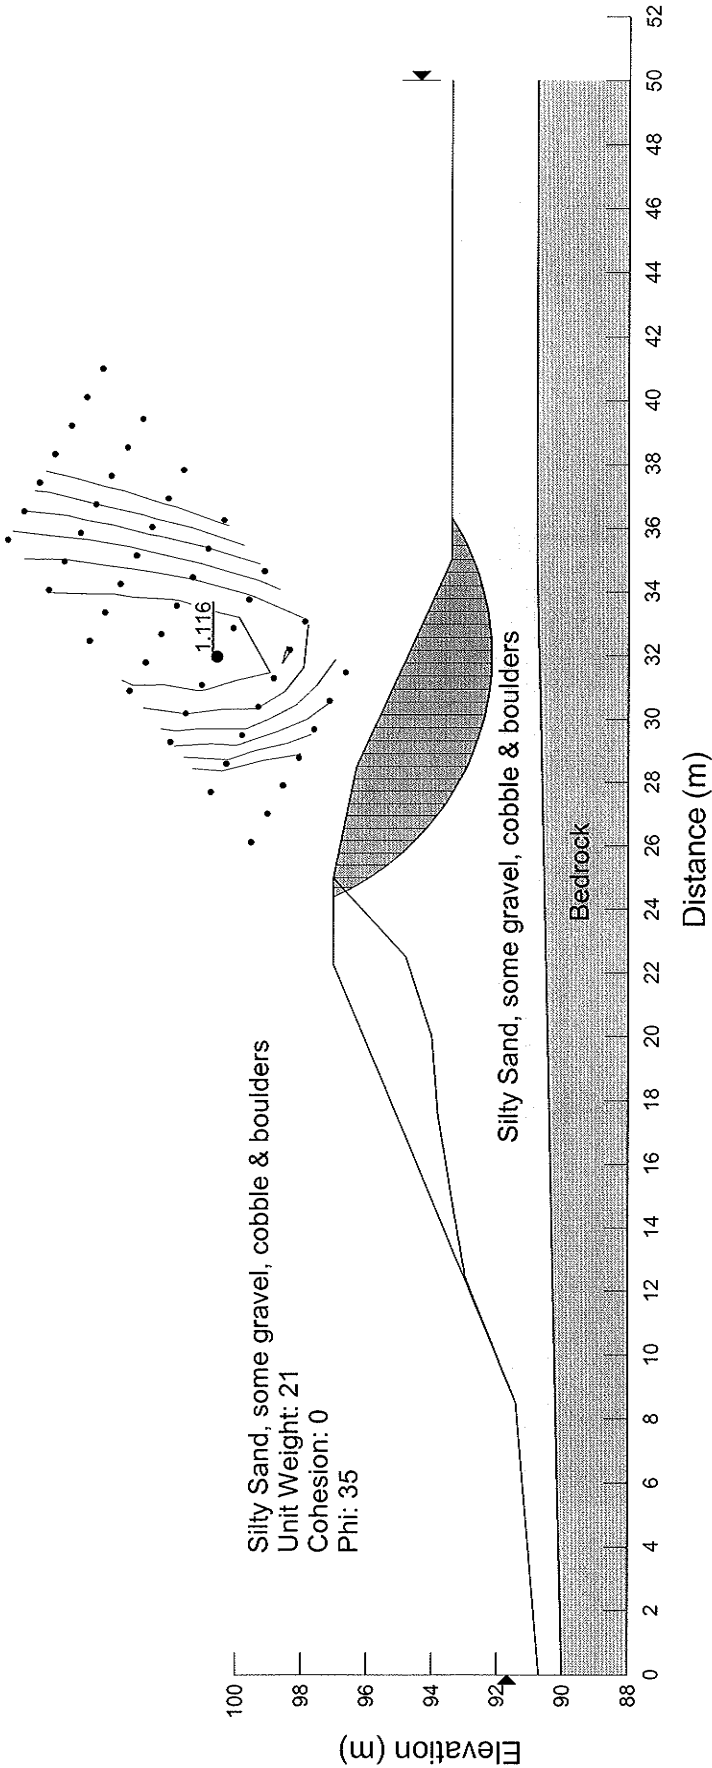
Existing Inner Slope Stability Assessment
Geotechnical Investigation-Kimmirut Sewage Lagoon
Rapid Drawdown Case
Seismic = 0.1
