## **Dam Safety Review**

**Project Name**  
Dam Safety Review  
Sewage Lagoon and Water Reservoir  
Kimmirut, Nunavut

**Project Number**  
OTT-00209248-A0

**Date Submitted**  
September 13, 2013

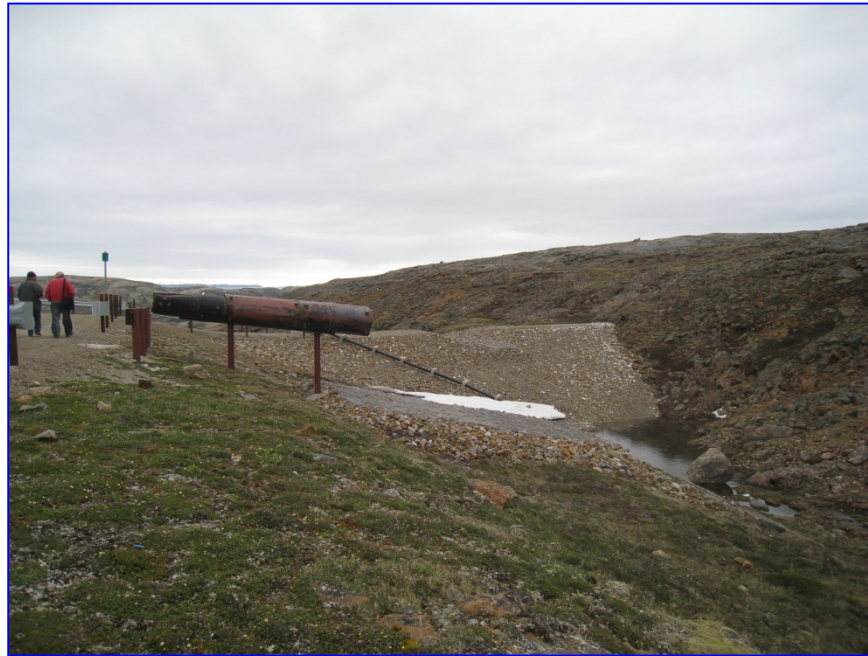
**Photograph No. 1**

The sewage disposal facility was reviewed. The upper sewage lagoon comprises a natural valley, which has been dammed by construction of an earth berm across the valley (Photo 1). The upstream slope of the berm is approximately 5 m high whereas the downstream slope of the berm is approximately 9 m high. The crest width of the berm is approximately 4 m. The berm slopes are approximately 3H:1V. The berm consists of silty sand and gravel. Visual examination of the berm did not reveal any signs of seepage, erosion or slope instability.

Upstream view of upper sewage lagoon berm

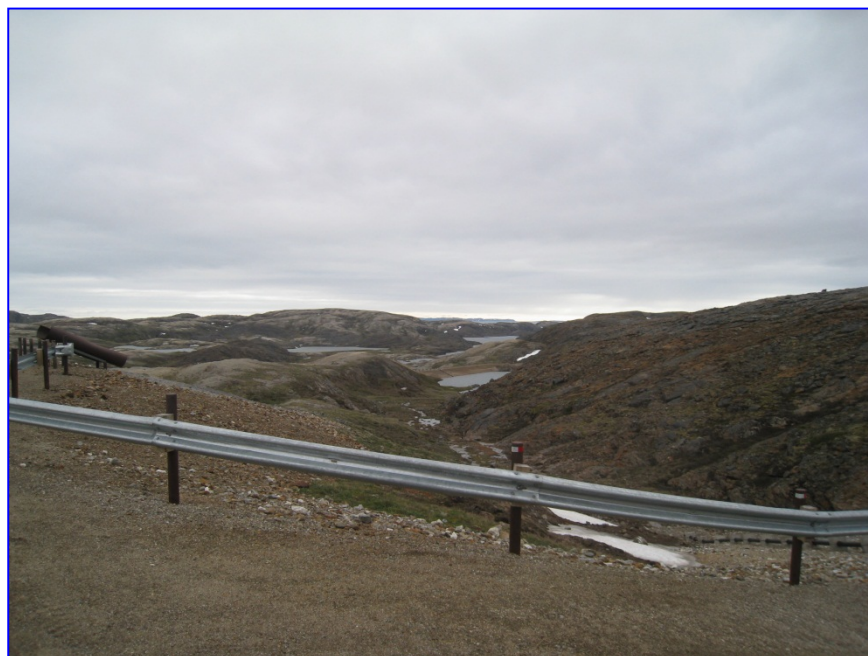
**Photograph No. 2**

A 150 mm diameter inlet pipe extending from the bottom of the lagoon to the top of the berm has been provided along the upstream slope of the berm. Similarly, a 150 mm diameter outlet pipe has been provided from the top of the berm to the gulch along the downstream slope of the berm (Photo 2). A spillway is located at the mid-length of the berm. The spillway comprises of a 1 m deep and 1 m wide channel with side slopes of 3H:1V for a distance of 1 m and 4H:1V beyond. The spillway has been lined with a 300 mm thick layer of 100 mm nominal rip rap.

Two discharge chutes have been provided at the lagoon. The summer storage discharge chute is located upstream of the berm and would discharge the effluent into the lagoon. The winter storage discharge chute is located downstream of the berm (Photo 2) and would discharge the effluent to the gulch. The discharge chutes have been provided with 3 m wide gabion mats to minimize erosion at the discharge points.

View of gulch, winter discharge chute and outlet pipe

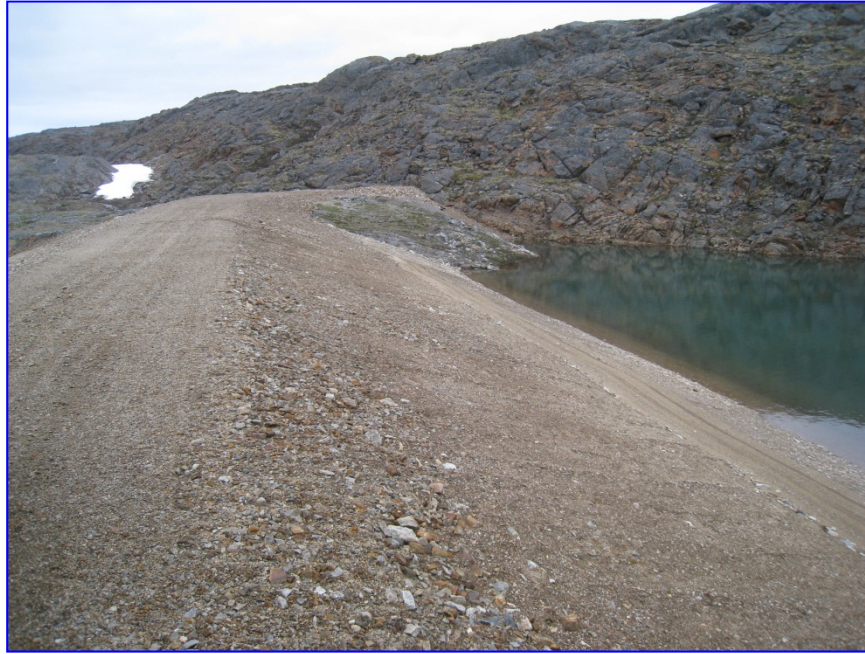
The lower sewage lagoon comprises of the gulch, which has been converted to a lagoon by construction of a berm across the gulch (Photo 3). The height of the berm is 6 m approximately. The crest width of the berm is approximately 4 m. The slope of the berm is at an approximate inclination of 3H:1V. The berm has been constructed with silty sand and gravel with cobbles.

**Photograph No. 3**  
View of lower sewage lagoon berm

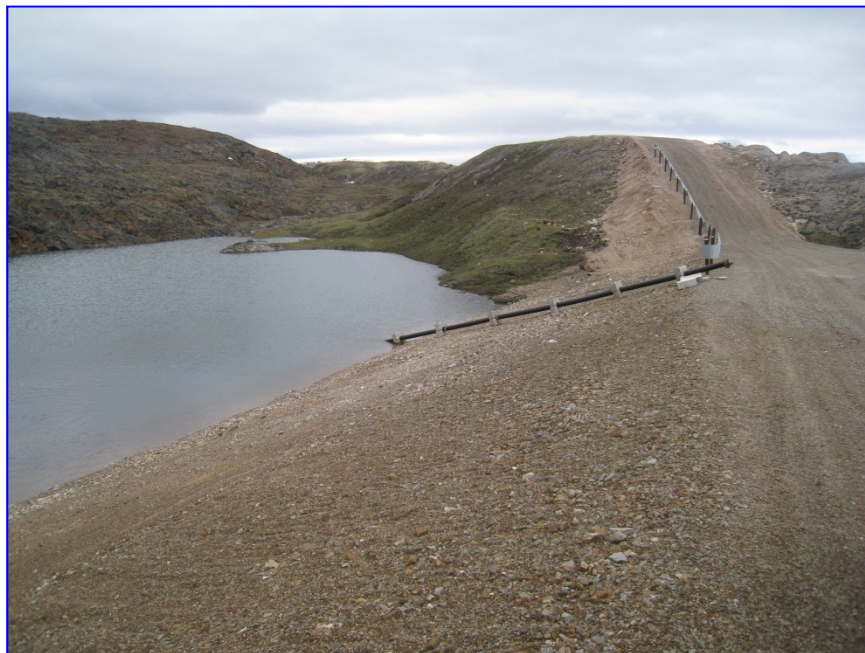
The lower lagoon has also been provided with 150 mm diameter inlet (Photo 4) and outlet pipes (Photo 5) similar to the upper lagoon. A spillway has been provided at the west end of the berm. The design of the spillway is similar to that of the upper sewage lagoon.

**Photograph No. 4**  
Inlet pipe of lower sewage lagoon

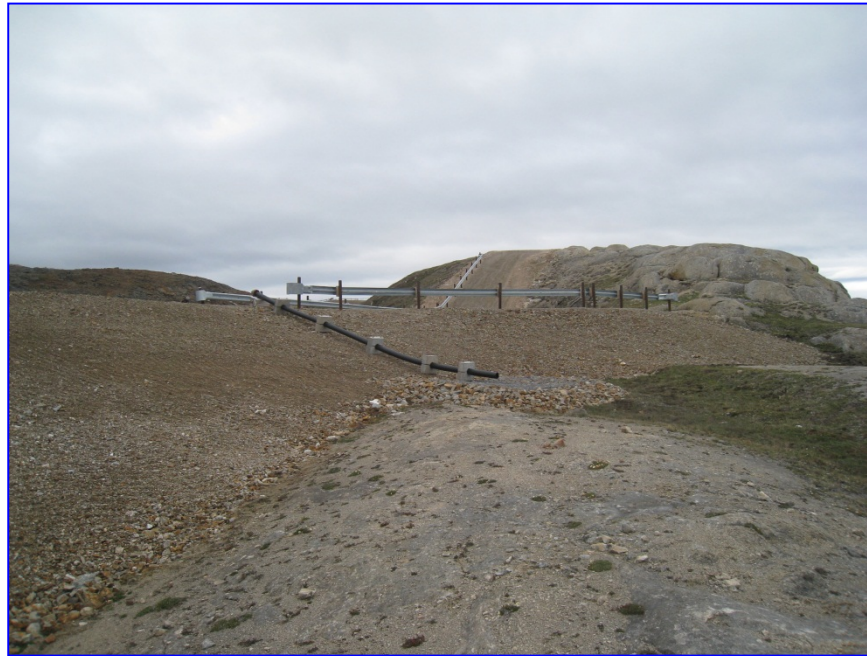
**Photograph No. 5**  
Outlet pipe of lower sewage lagoon

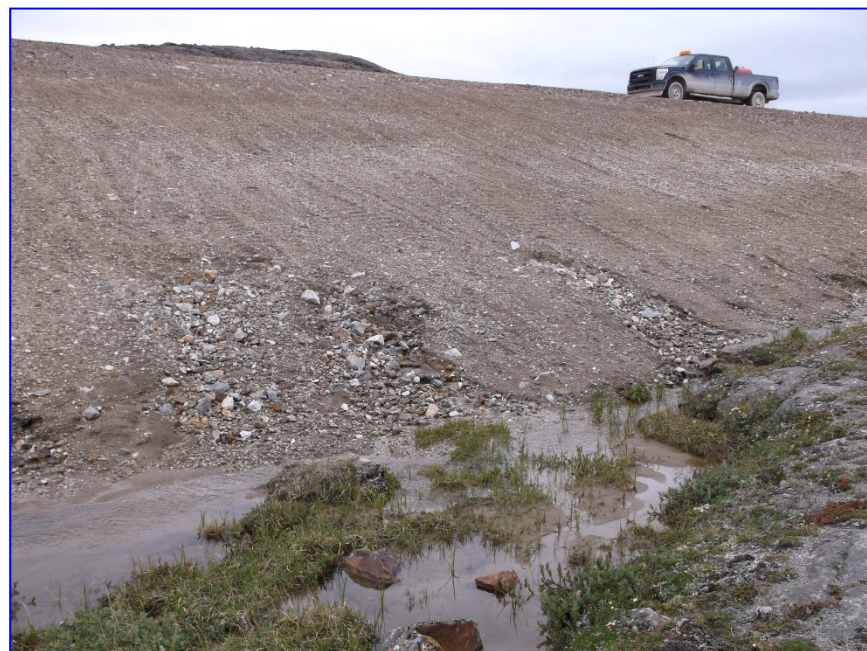
revealed that the berm is leaking. Water was observed to seep out of the berm from the bottom of the berm to a height of 1.5 m approximately at a number of locations along the length of the berm (Photo 6). Seepage of water at these locations has resulted in removal of fines from the berm and exposure of the coarse aggregate. It is understood that the berm has been designed as a seepage berm. However, concentrated zones of water seepage in the berm are a concern since, in time, these could form erosion gulleys, eventually leading to failure of the berm. The concentrated zones of water seepage are likely due to presence of pockets of coarser material in the berm.

It is understood that the berm of the lower sewage lagoon was designed as a seepage berm and a liner was not installed in the berm. As a result, seepage of effluent out of the berm is to be expected since in a completely homogeneous section, it is inevitable that seepage will emerge on the downstream slope regardless of its flatness and impermeability of the soil. The downstream slope is affected by seepage to a height of roughly one third of the depth of the reservoir pool (See Figure 6).

**Photograph No. 6**  
Leakage of lower sewage lagoon berm

In order to prevent removal of fines from the berm, it is considered that there are two options available:

- 1.) Provision of a rockfill toe of the berm;
- 2.) Construction of a rockfill bench along downstream slope of the berm.

This option would require providing a rockfill toe for the berm. For this purpose, it would be necessary to dewater the lagoon and remove the toe of the berm to a height of 2 m. The excavation should then be lined along the cut and base of the berm with a suitable filter cloth, such as Terrafix 400R or equivalent. The toe of the berm may then be re-constructed using rockfill. Construction of the rockfill toe in this manner will prevent migration of fines from the berm and it will lower the phreatic line such that it will not daylight along the slope.

The second option is to construct a rockfill bench at the downstream toe of the berm. The advantage of this approach is that it can most likely be installed without having to dewater the lagoon. This method would require placement of filter cloth, such as Terrafix 400R or equivalent along the downstream slope of berm to a height of at least 2 m and along the ground surface. A rockfill bench may then be constructed. The rockfill bench should be at least 2 m high and 2 m wide at the base.

It is noted that both the remedial measures suggested would maintain the functionality of the berm as an exfiltration berm. However, from a geotechnical perspective, the latter option of rockfill benches is to be preferred because of the following reasons:

- 1.) Construction of a rockfill toe will require undertaking excavation at the toe of the slope. This would affect the stability of the slope and may result in localized failures of the slope.
- 2.) Construction of the rockfill toe would require emptying the lagoon.
- 3.) The ability of the rockfill toe to lower the phreatic line in the berm is a function of relative permeability of the berm material and that of the rockfill toe material since it is based on the

In the case of the rockfill bench, it will not be necessary to empty the lagoon. The phreatic surface in the berm will be maintained. Placement of the filter cloth and rockfill bench will prevent the removal of fines from the berm material as well as increase the stability of the berm slope.

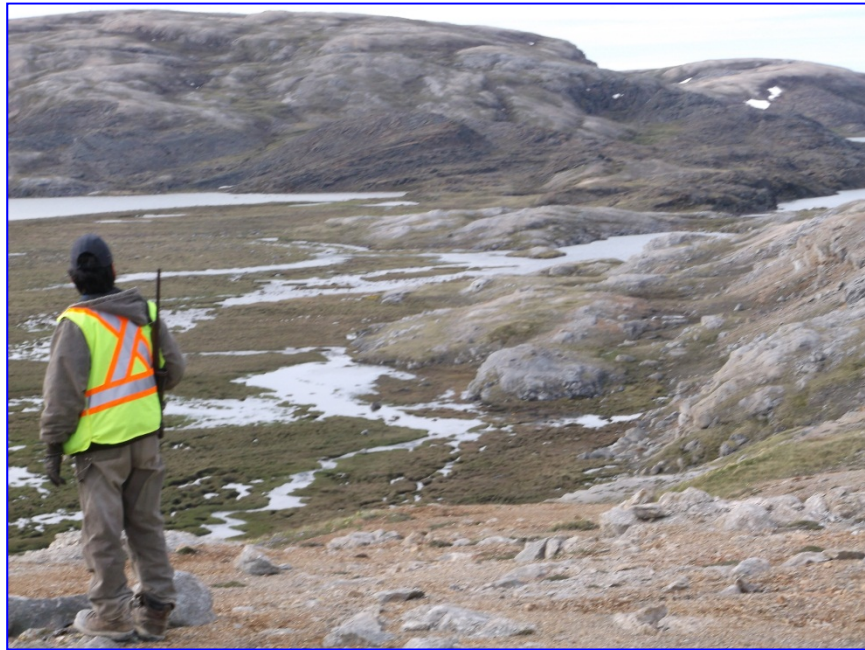
Wetlands are located approximately 150 m southeast of the lower sewage lagoon. The path of the seepage water from the lower sewage lagoon to the wetlands was traced. Based on these observations, it is considered that the effluent from the sewage lagoon would flow in a southerly direction through a number of drainage ditches and low lying areas a distance of 300 m approximately before entering the wet lands (Photos 7 and 8). The flow path has been plotted on Figure 2.

**Photograph No. 7**  
View of wetland area

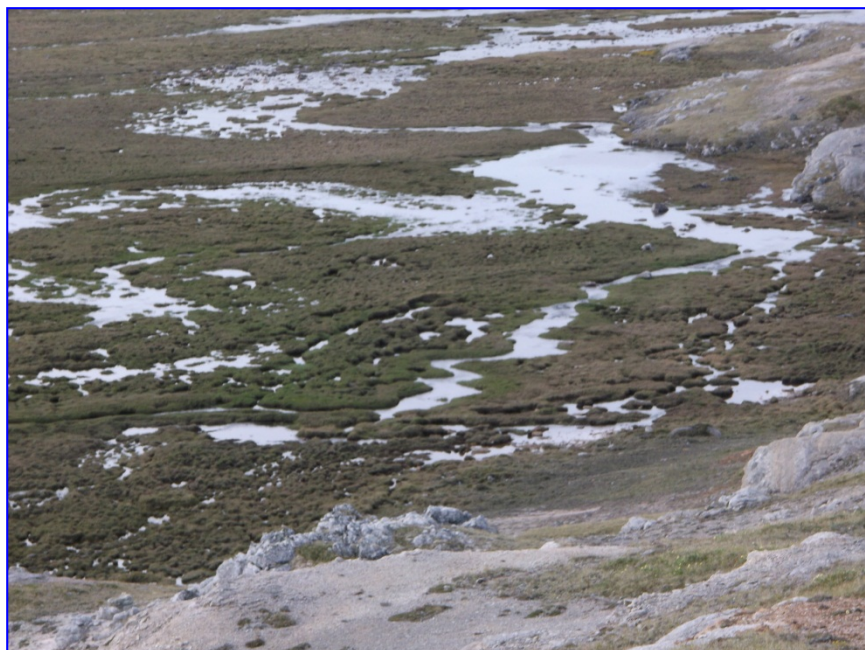
**Photograph No. 8**  
Another view of wetland area

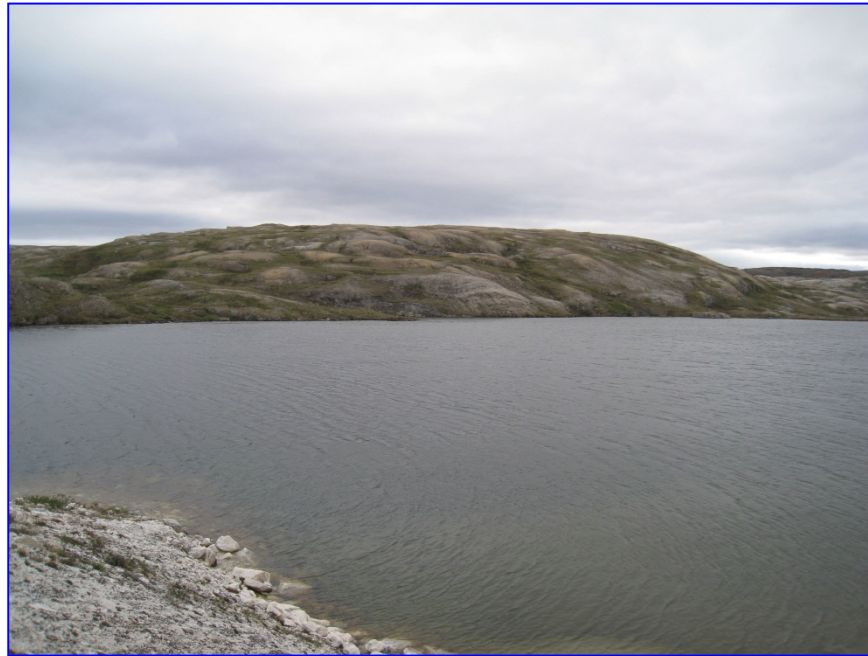
The Hamlet currently uses Lake Fundo as its water source (Photo 9). Supply is taken from Fundo Lake via an inclined shaft which is equipped with a submersible pump located below the water level in the lake. Water is pumped from the lake to the truck fill station (Photo 10). Water treatment at the truck fill station is limited to chlorination (Photo 11) and freeze prevention. The water is transported by trucks from the truck fill station to the community.

**Photograph No. 9**  
Lake Fundo (water source)

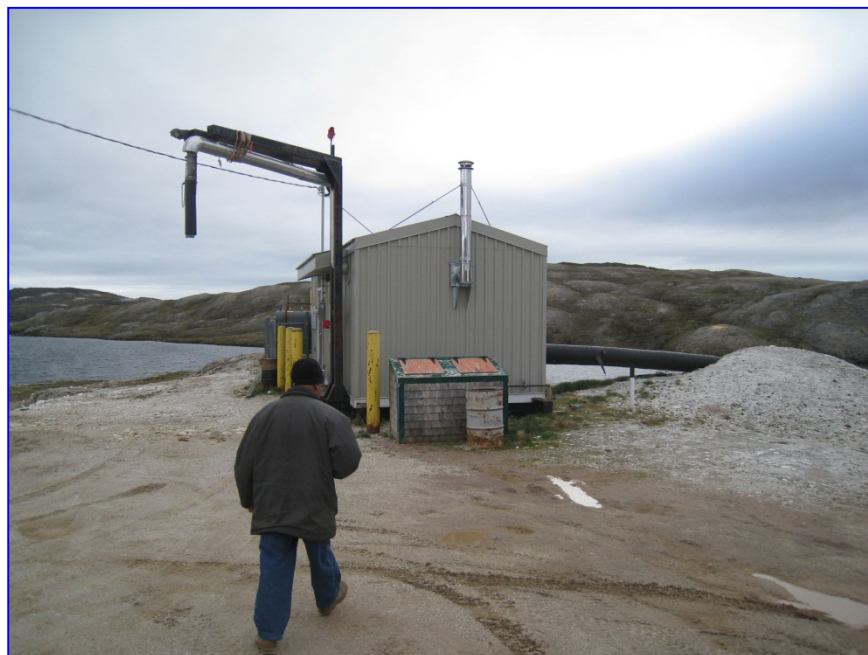
The truck fill station is generally in good operating condition and appears to be well maintained. Chlorine concentrations are logged on a regular basis and appropriate safety equipment is available within the facility.

**Photograph No. 10**  
Intake pipe and truck fill station

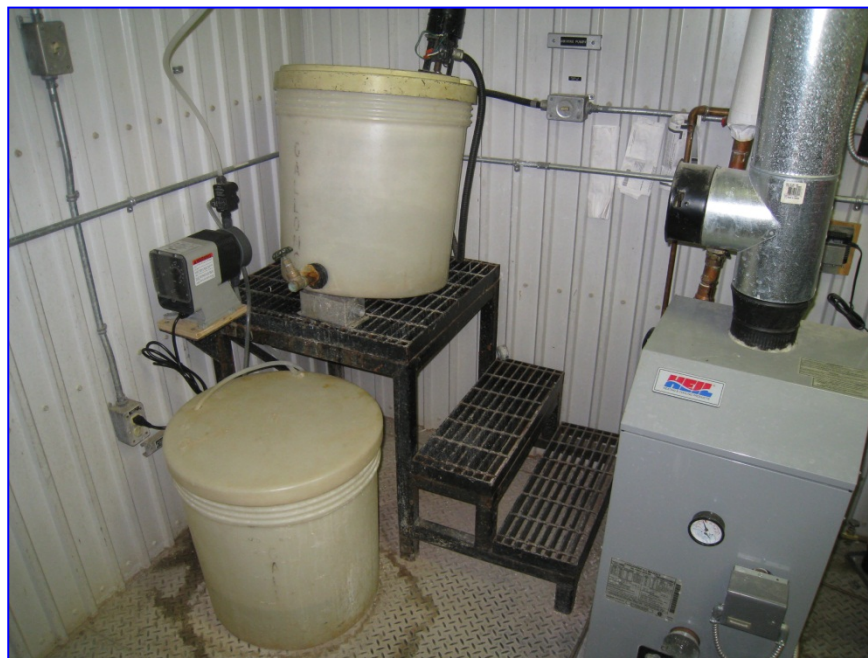
**Photograph No. 11**  
View of chlorination plant

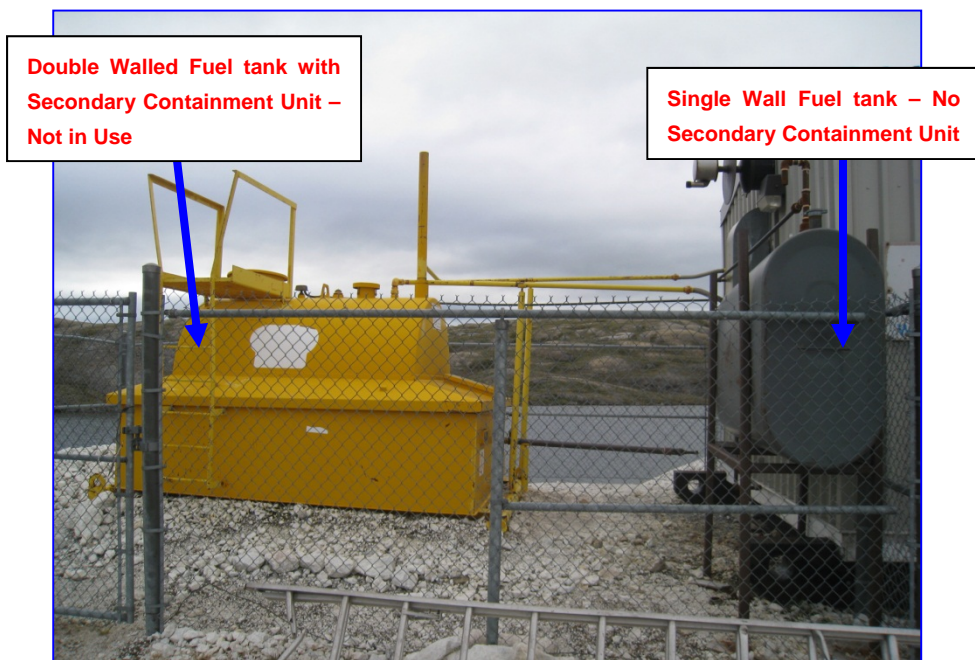
It was observed that the original exterior fuel tank which is a double walled tank has been disconnected and not used to store diesel fuel. This operating tank is provided with a containment unit so that any spills or leakage from the tank would be contained in the containment unit. A single wall fuel tank has been installed without appropriate secondary containment (Photo 12). Consequently, in the case of accidental spillage or leakage of the tank, there is a potential of contaminating the water source with hydrocarbons.

**Photograph No. 12**  
View of diesel fuel storage tank with secondary containment and single wall fuel tank
