WATER LICENCE INSPECTION FORM

Licensee	Licensee Representative
Hamlet of Kimmirut	Bhabesh Roy
Licence No. / Expiry	Representative's Title
3BM-KIM1929	Municipal Engineer
Land / Other Authorizations	Land / Other Authorizations
Date of Inspection	Inspector
August 19, 2019	Joseph Monteith
Activities Inspected	
<input type="checkbox"/> Camp	<input type="checkbox"/> Drilling
<input type="checkbox"/> Roads/Hauling	<input type="checkbox"/> Mining
	<input type="checkbox"/> Construction
	<input checked="" type="checkbox"/> Other: Potable Water Source, Waste Water Treatment, and Solid Wastes
	<input type="checkbox"/> Reclamation
	<input type="checkbox"/> Fuel Storage
	<input type="checkbox"/> Other:

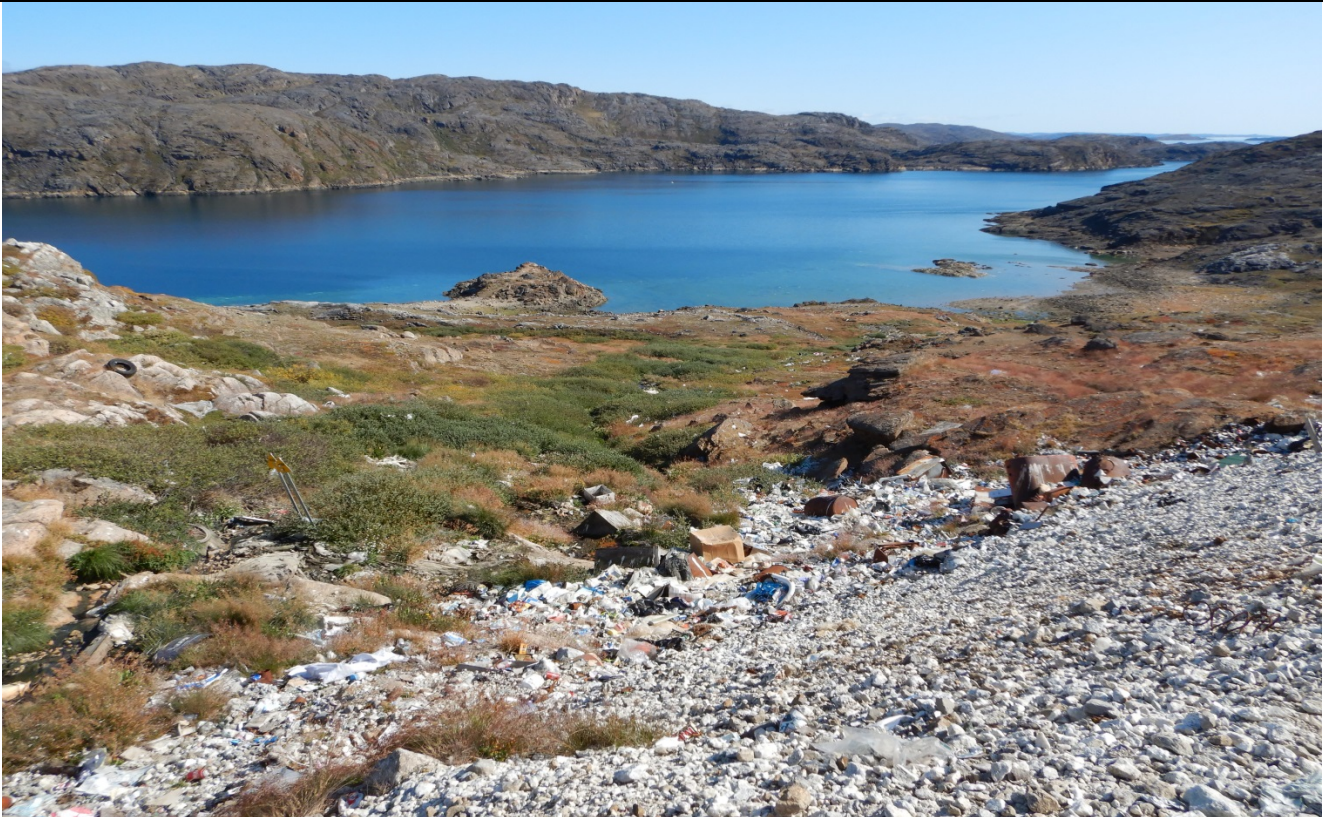
Photo Log #1	Location
Photo 3	Kimmirut

13. There are two monitoring stations at the along the discharge route titled KIM 2 & 3 (photo 3). No sampling was conducted at the time of the inspection. A sample will be conducted in the spring of 2020.

Description: KIM 2, and KIM3 posted signs down the drainage ditch of the Sewage discharge location. Wind Blown Garbage from Solid Waste Facility.

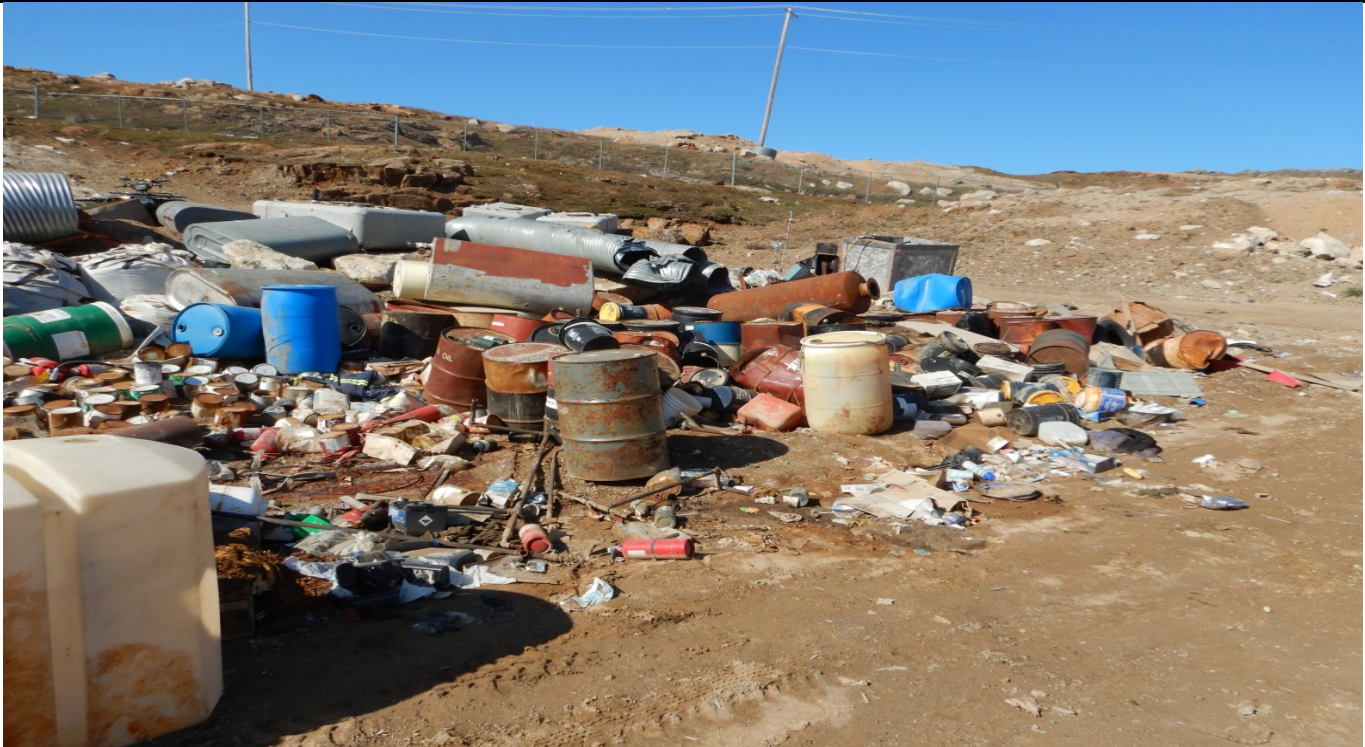
Photo 4

10. Hazardous waste is located at two locations. The Solid waste facility which had the hazardous waste was exposed to the elements (Photo 4). This site is not lined, and has the potential to mix with fresh water during rainfall, and during the freshet, and at the Municipal Garage. At the municipal garage Hazardous Waste is stored within sea cans behind the municipal garage. At the time of the inspection some of the hazardous waste was taken out the sea cans, so that sea-cans can be cleaned (Photo 7). Some hazardous waste such as waste batteries were partially stored in the outside elements (see photo 8).

Description: Hazardous waste exposed to the elements at the Solid Waste Facility

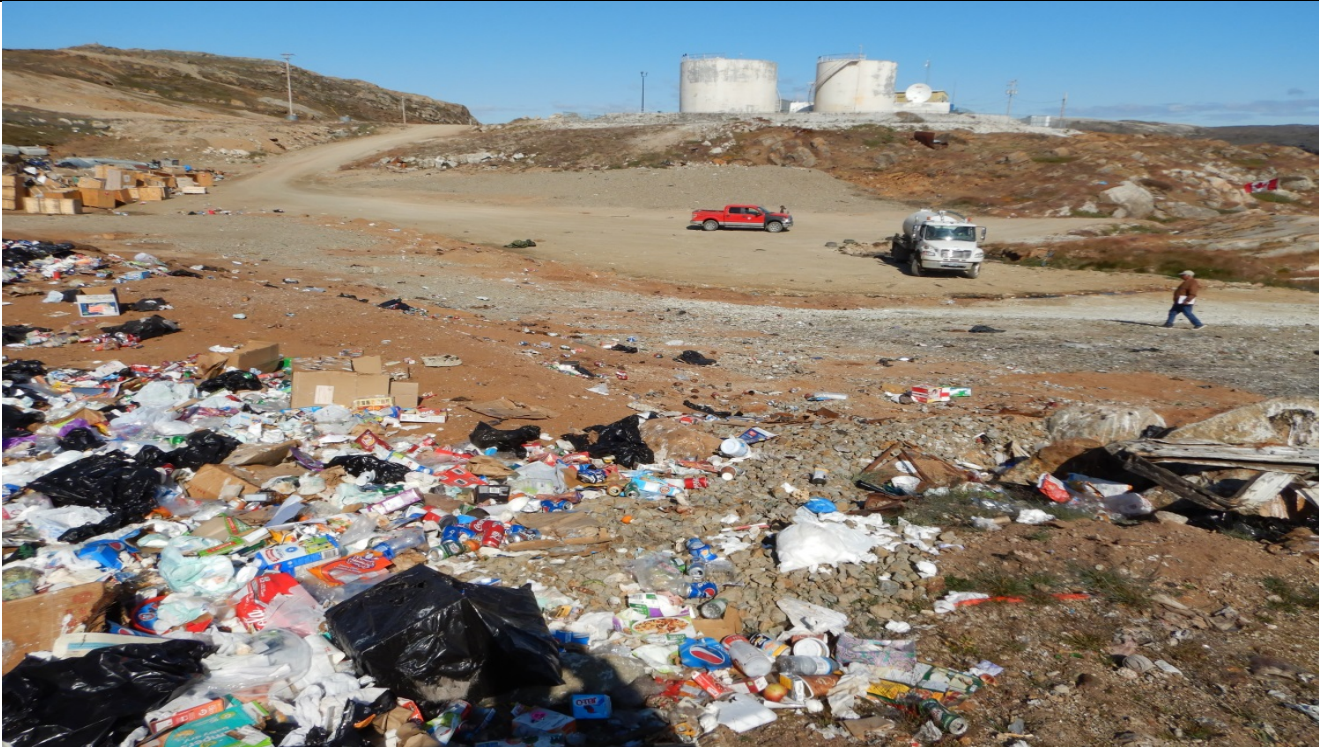
Photo 5

9. The facility isn't lined. The leachate from the Solid Waste Facility has the potential to run-off this facility at or near the discharge location of the hamlet waste water discharge location. A ditch was created to divert any leachate accumulating in the solid waste facility to the drainage ditch used to discharge sewage (see photos 5, & 9). Contrary to Part D: Item 6 Part D: Item 8, and Part D: Item 9.

Description: foreground: burn and cap, left mid ground: hazard waste, and wood. Midground centre: trench was dug from the hazardous waste site, to the sewage discharge location.

- backfill the ditch used to divert water away from the Solid Waste Facility
- Repair the damage to the fencing in the Solid Waste Facility, implement measures to control wind-blown litter at the solid waste disposal facility.
- Implement measures to control wind-blown litter at the Solid Waste Disposal Facility.
- Segregate and store Hazardous Waste including waste oil, within the Solid Waste Disposal Facility in a manner as to prevent the deposit of deleterious substances into any water until such a time as proper disposal arrangements are made
- Provide the inspector 10 days’ notice of any decants of sewage to the discharge location as per Part D: Item 4.

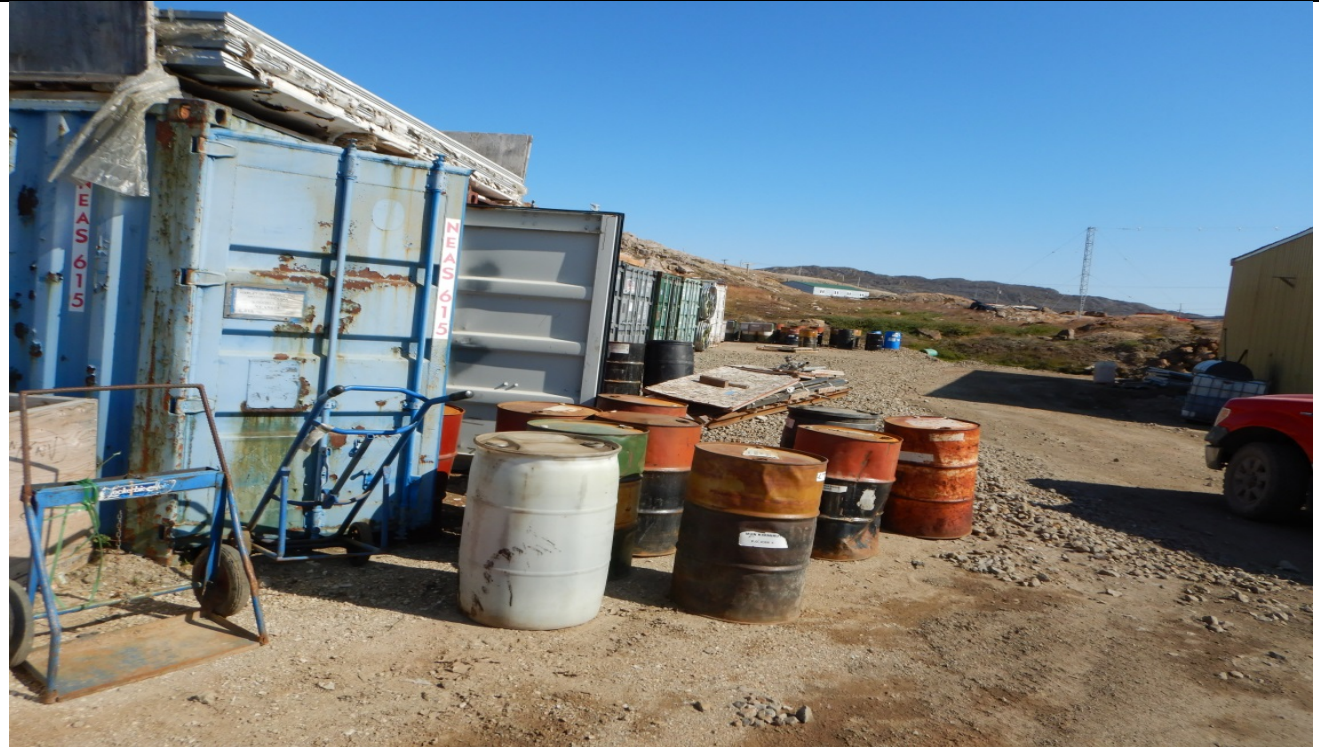
Photo 6

11. The Hamlet of Kimmirut uses a waste oil burner to heat up the municipal garage. They store waste oil to use it for their oil burner (photo 6). Some drums of waste oil was stored outside for use by the waste oil burner. The drums were stored next to fresh water next to the hamlet garage (see photo 7 and 8).

Description: Movement of hazardous waste in the sea cans behind municipal garage.

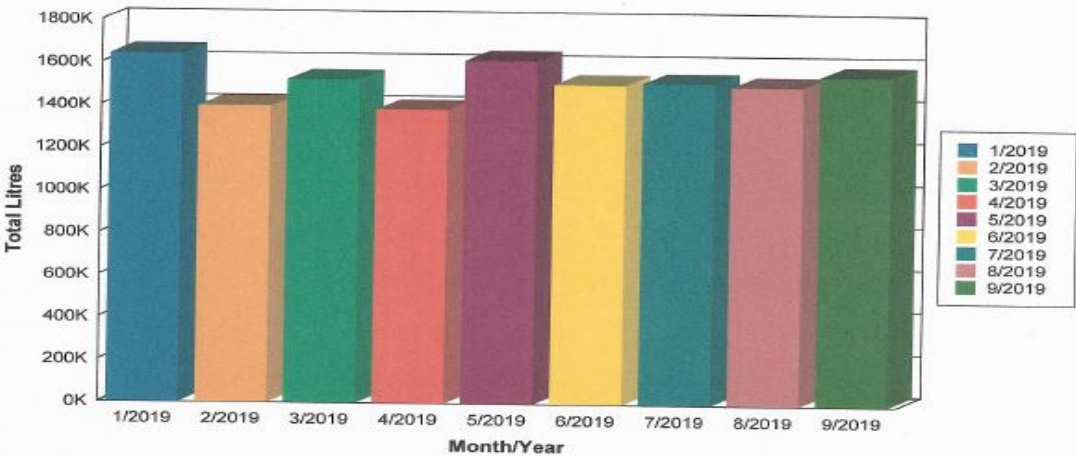
3. On October 22, 2019 William Koonoo, Municipal Technical Clerk, Government of Nunavut (GN), Community & Government Services (CGS) sent WRO Monteith a copy of the water consumption rates for the Hamlet of Kimmirut for the Months of January 2019, to September 2019 with the current annual total of 13,641,977.48 litres (13641 m³) withdrawn from Fundo Lake. This falls below the amount listed in their expired water licence. The trend shows that the Hamlet of Kimmirut might not exceed the amount approved in the expired water licence (photo 10).
4. At the time of the inspection, no evidence of drawdown from water use was evident at the lake.
5. A yellow triangle sign titled KIM1 indicting the location of a monitoring station was observed at the time of the inspection.

Description: Delivery Summary By Month and Year. Shows 13,641,977.48 Litres were withdrawn. 13641 m³
