Kimmirut August 9 2012

August 9-10/12, Kimmirut: Inspection of water licence number 3BM-KIM0911 – *Expired*

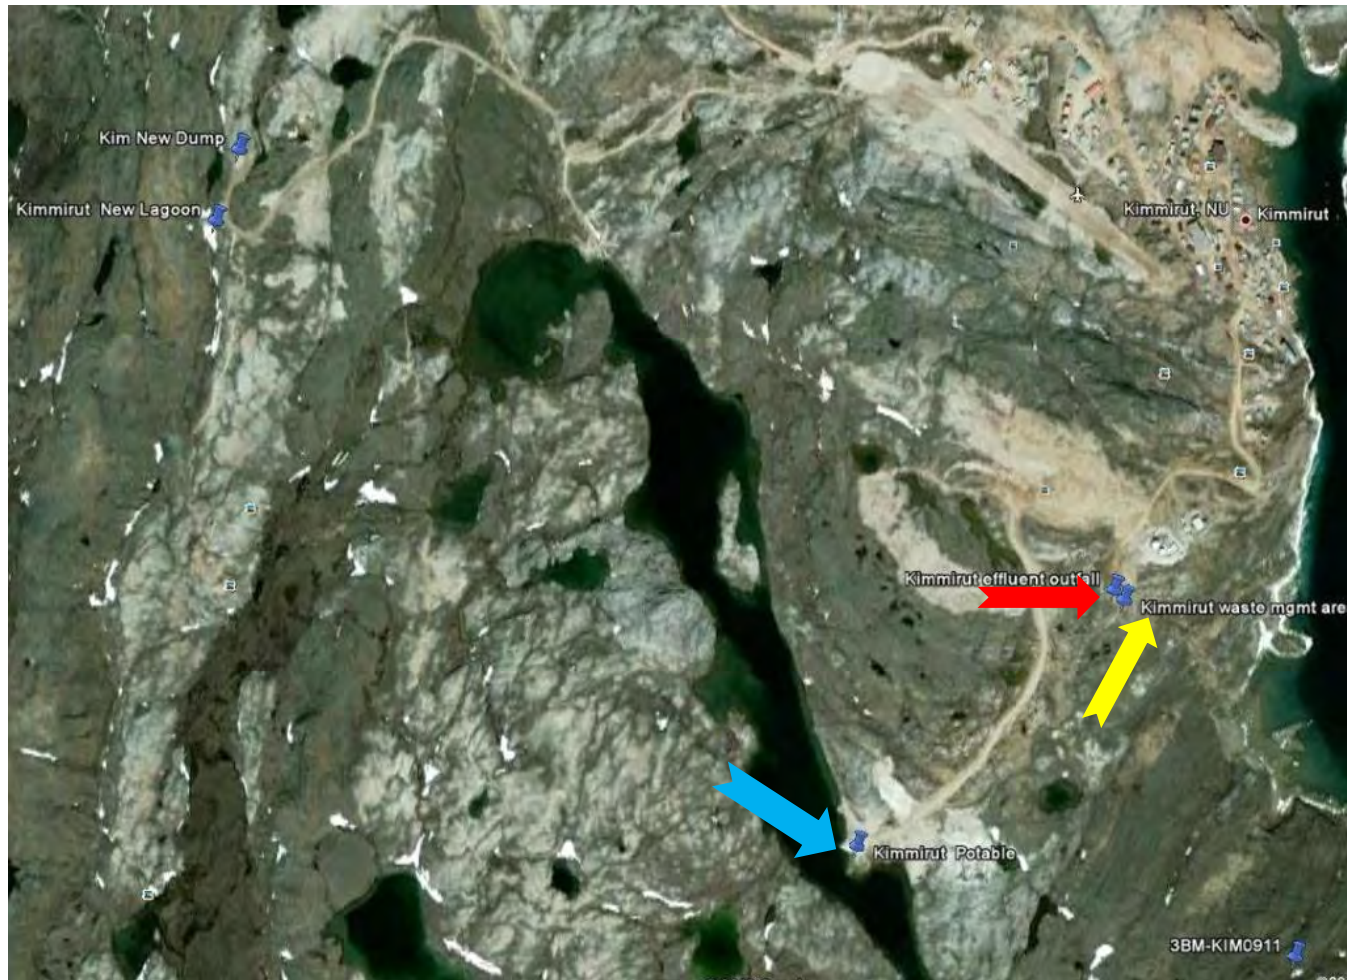
Samples taken near the water intake system at Fundo Lake (blue arrow), effluent outfall (yellow arrow) and small pond near the dump (red arrow).

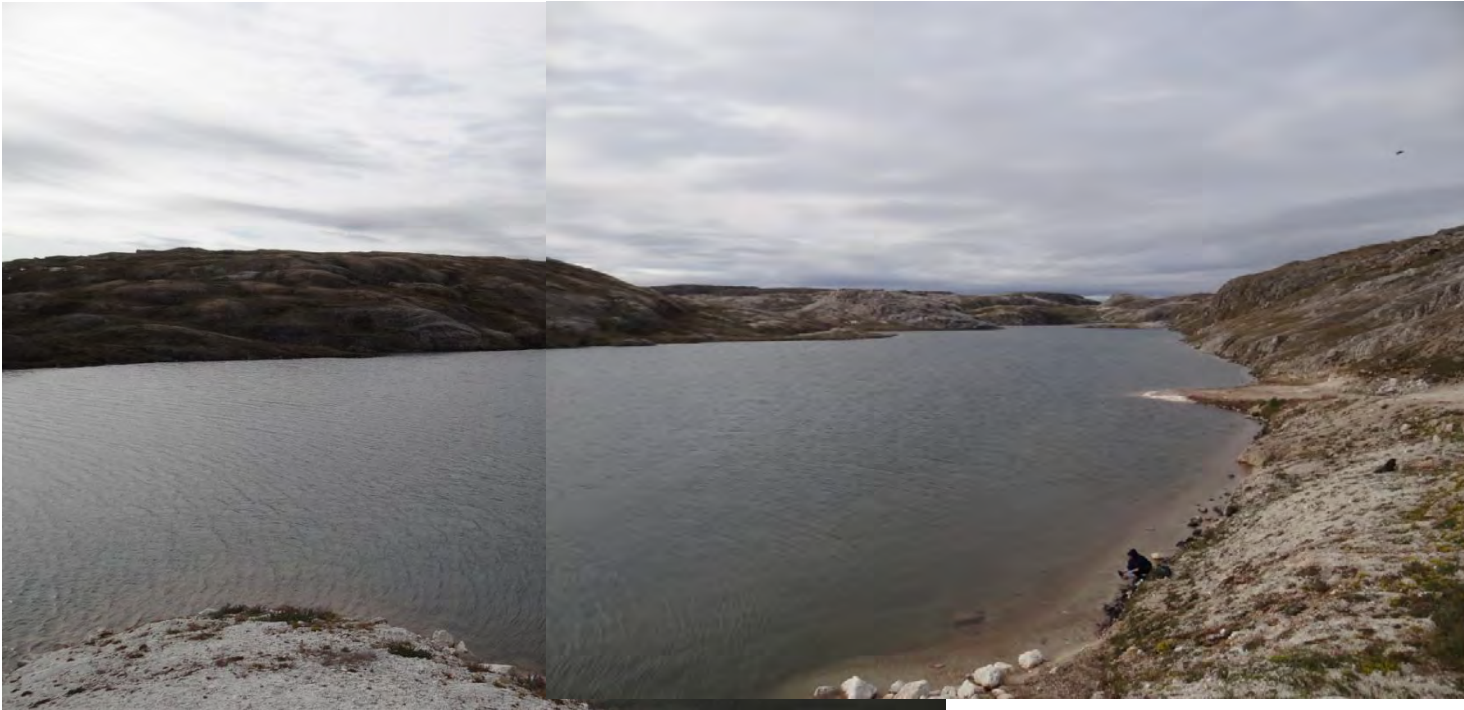
Water Supply: Fundo Lake

- A visual inspection was conducted of the pipeline and intake system at Fundo Lake.
- Samples were collected
- No issues were noted.

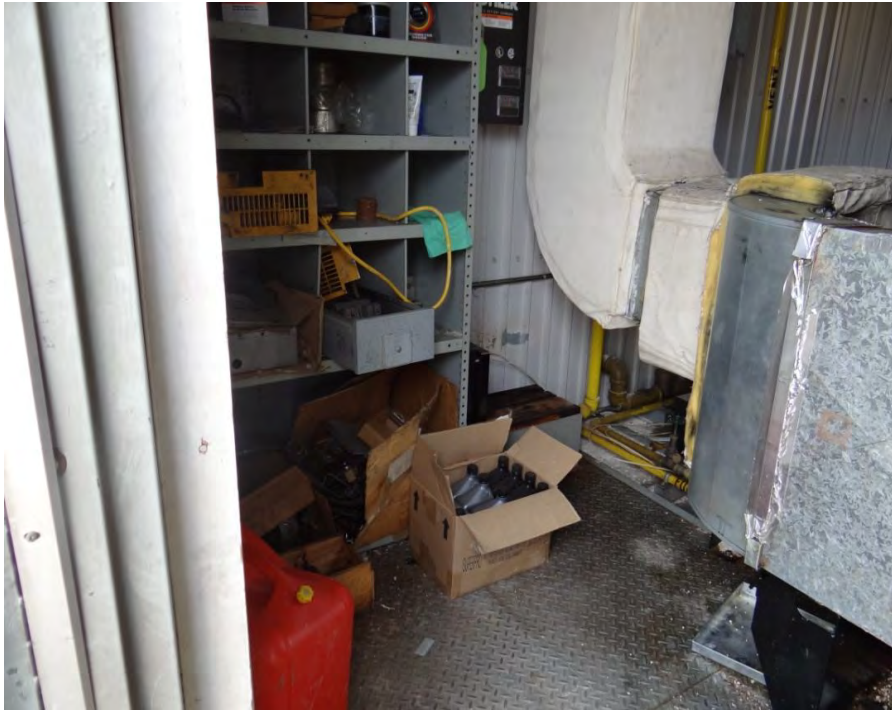
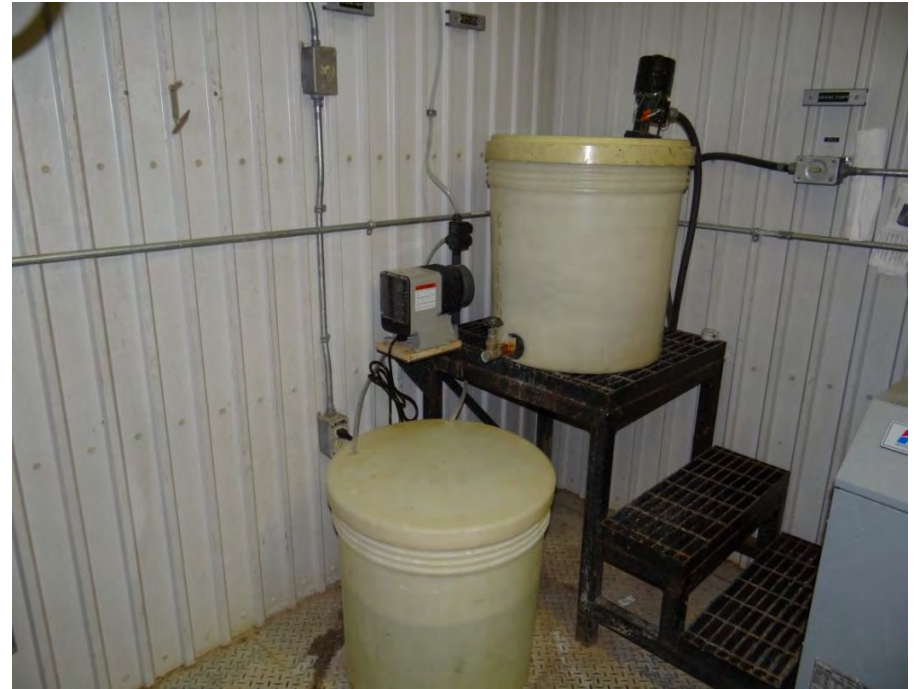
Pump House/ Chlorine Treatment Facility

- A visual inspection of the treatment facility was conducted. The chlorine tank was approximately $\frac{3}{4}$ full.
- Chlorine records were noted to be on site but the record was not specific as to what truck was being tested.
- The Inspector also noted oil was being stored in the facility in cardboard boxes.

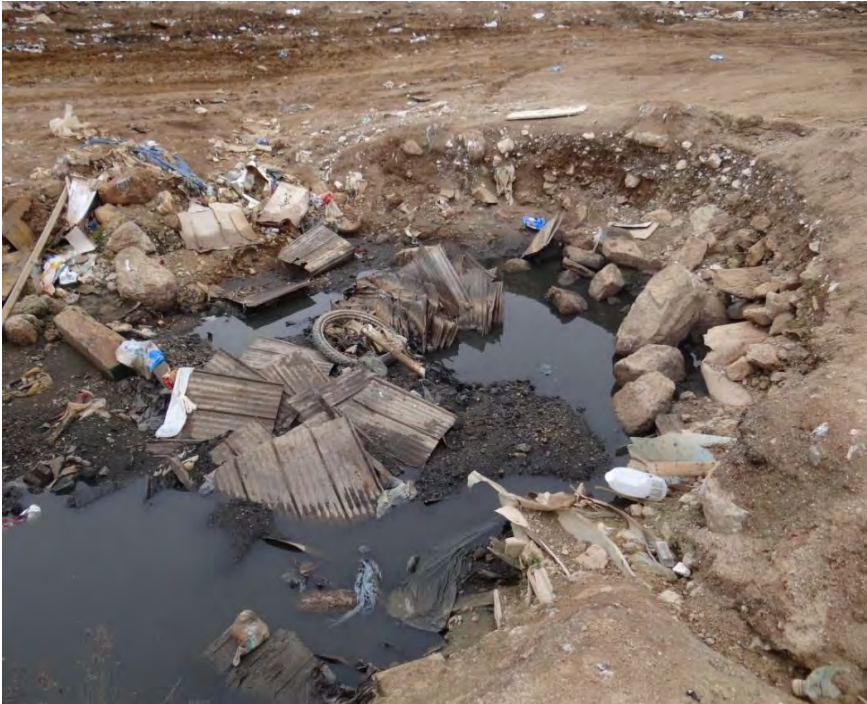
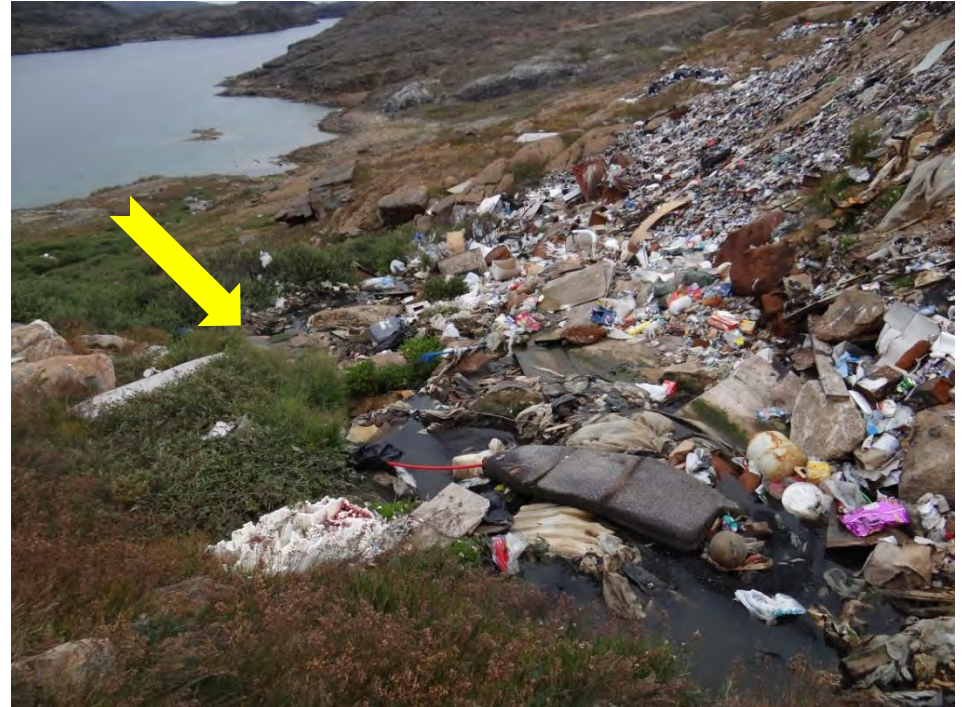
Sewage Drop Off Site

- The Hamlet of Kimmirut continues to discharge its raw effluent to a ditch in the waste management area. This ditch drains directly to the ocean. This was as issue in previous inspections as well. A new lagoon has been constructed however the safety of the road as well as leakage from the bottom of the new second cell are concerns identified by the Municipality.
- Samples were collected down slope of the ditch (yellow arrow)

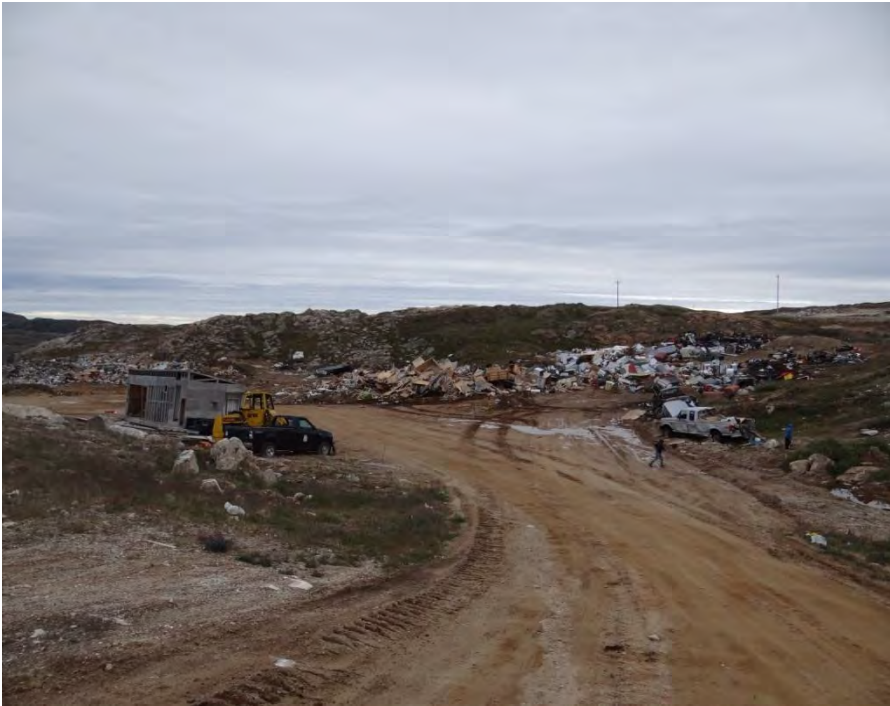
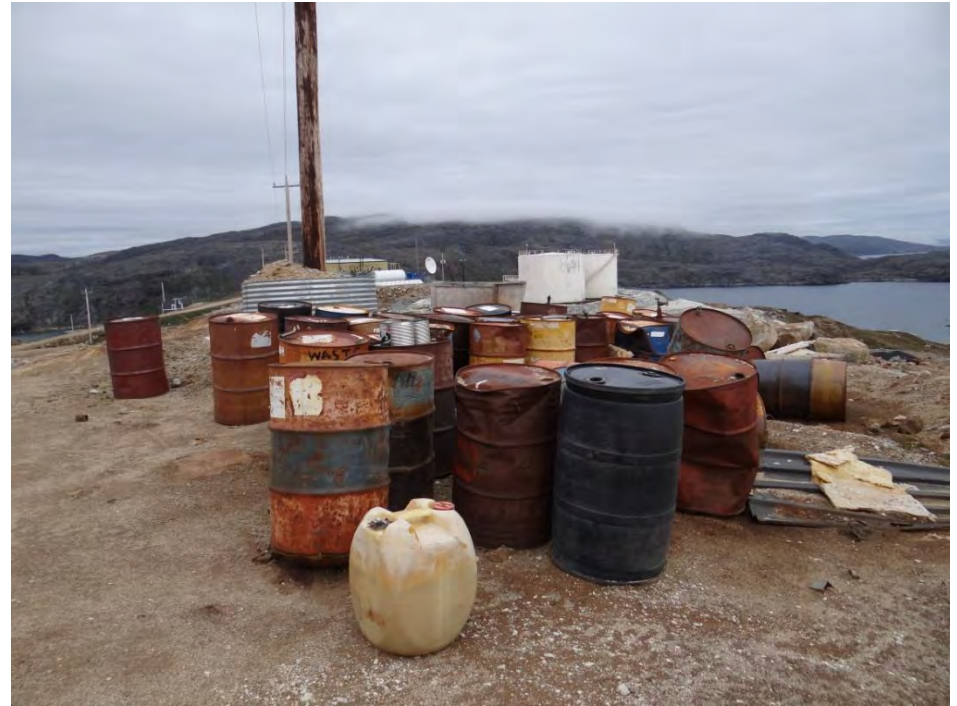
Waste Management Area

- Waste oil and other drums (belonging to the housing authority) are on the roadway outside the Municipal Waste Management Area. These are to be removed and stored properly within a lined area. Once removal has been undertaken the site must be remediated with all spilled product removed from site. This was an issue in previous inspections as well.
- Burn and bury area has maintained the practice of covering the recently burned materials with crushed rock and fill from an adjacent source.

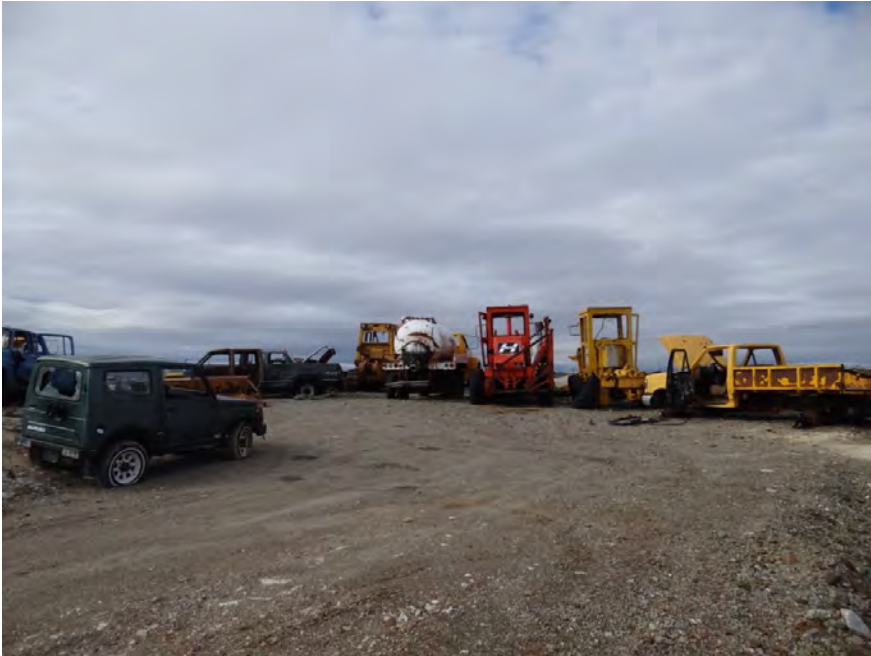
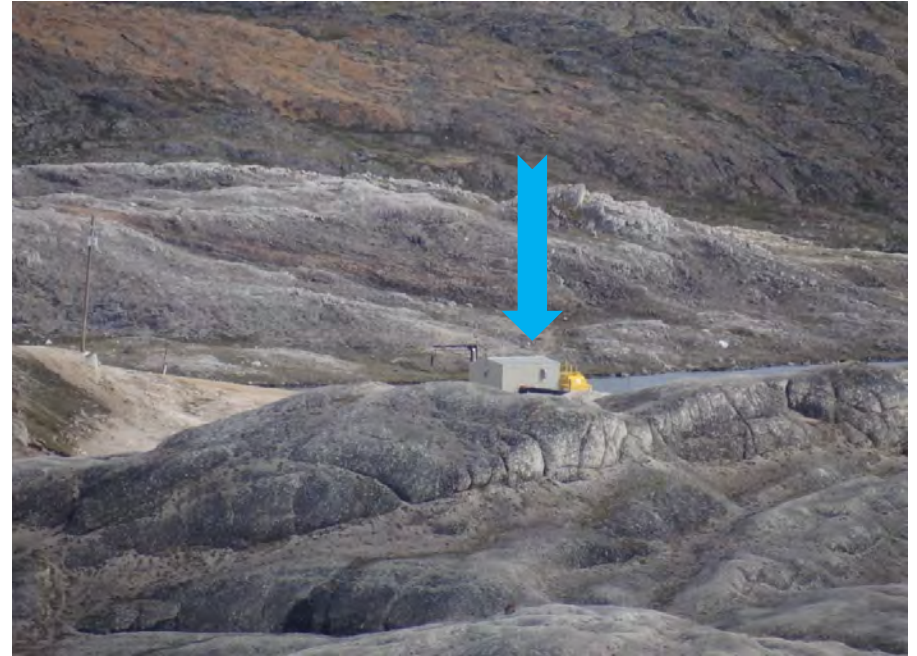
Solid/Bulk Waste Management Facility – New

- A visual inspection of the new SWMF was conducted during the inspection. While not yet commissioned old vehicles and other metals and tires were located on site. It is noted that no batteries were present as previously identified in Inspections. Licensee indicated that batteries were being packaged for shipment out of the community on this year's sea-lift.
- The new dump site is located on top of a hill above the city's water supply lake (Fundo Lake). A fence surrounds the site but any wind-blown garbage that's blown off-site may be transported into the lake. (Water treatment facility, blue arrow)

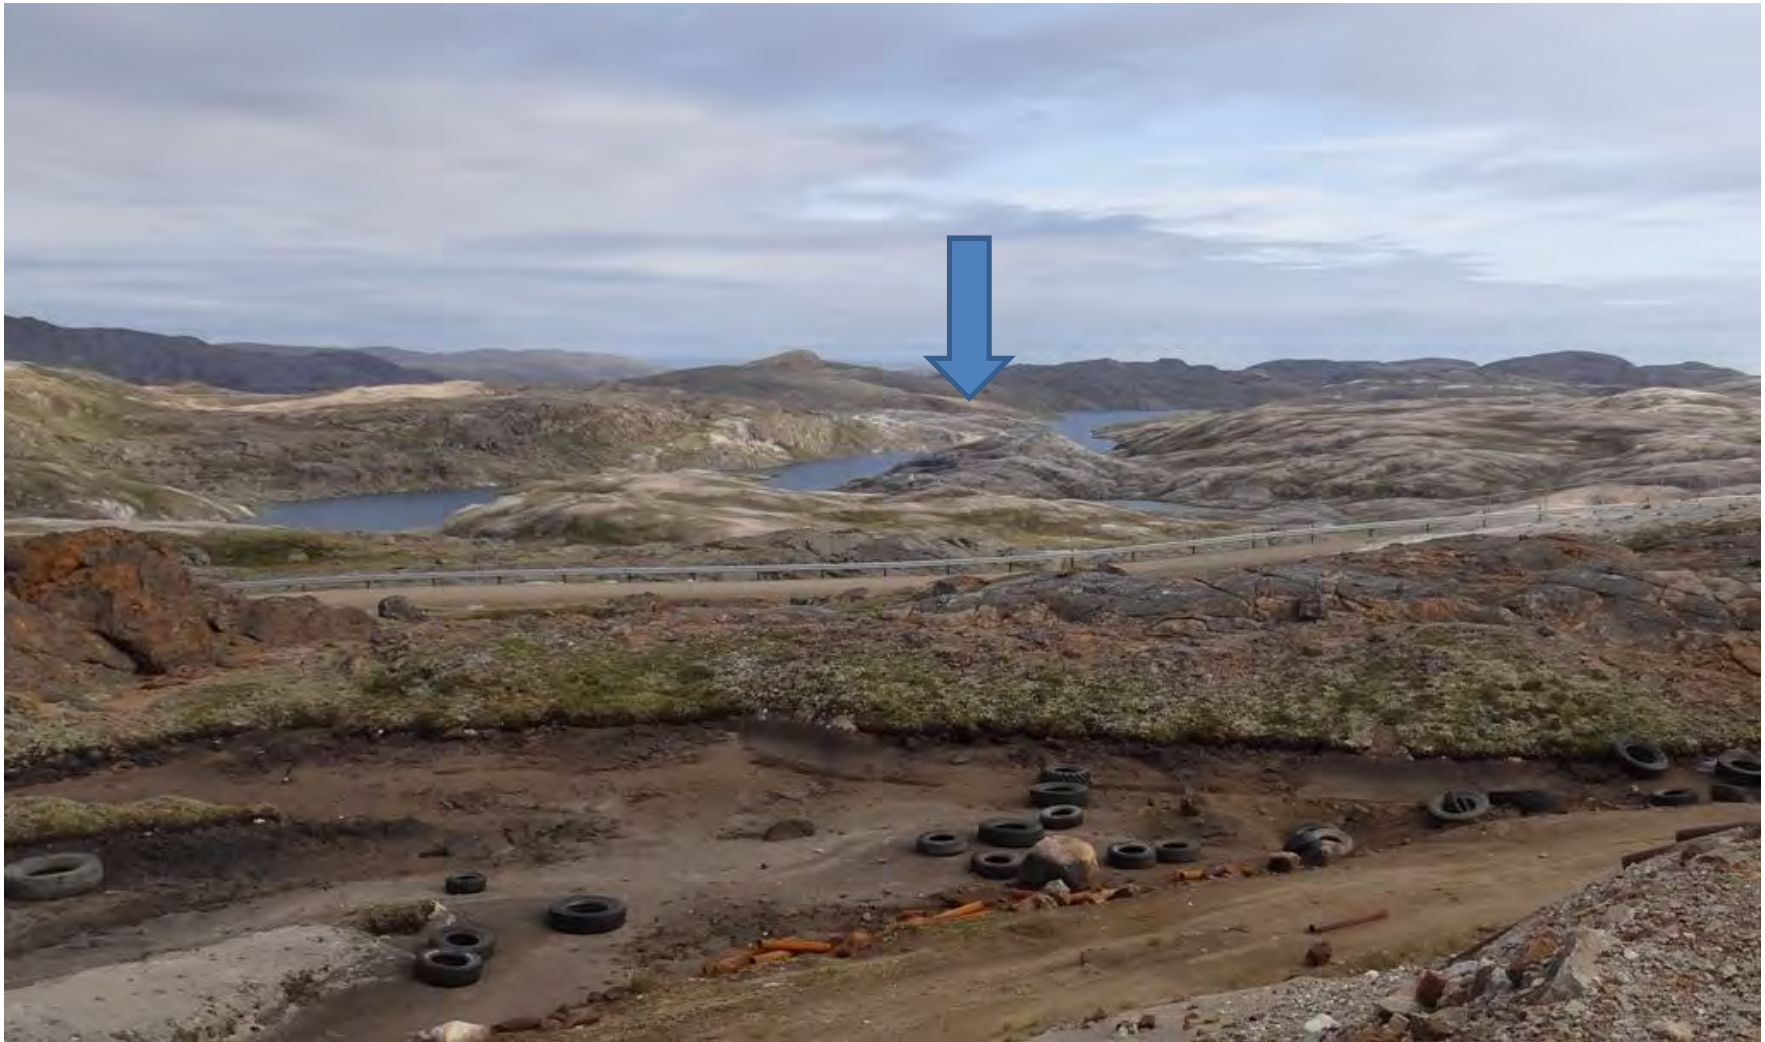
Solid/Bulk Waste Management Facility – New

Potable water/ Pump house indicated by Blue Arrow.

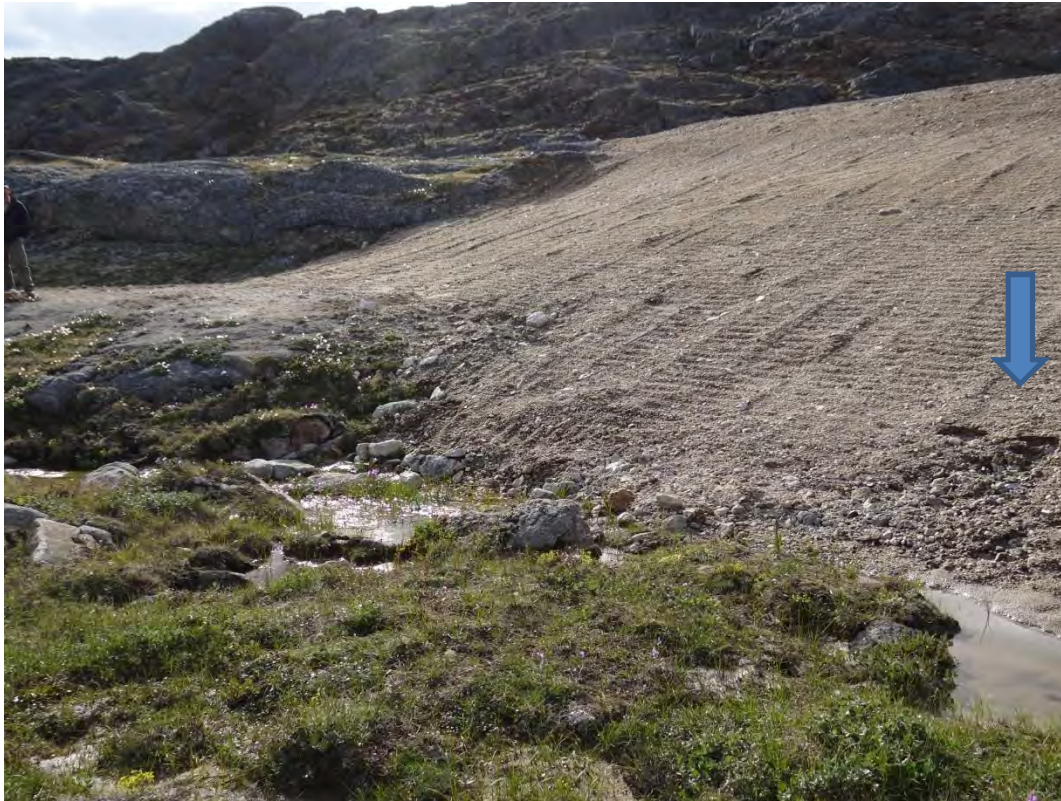
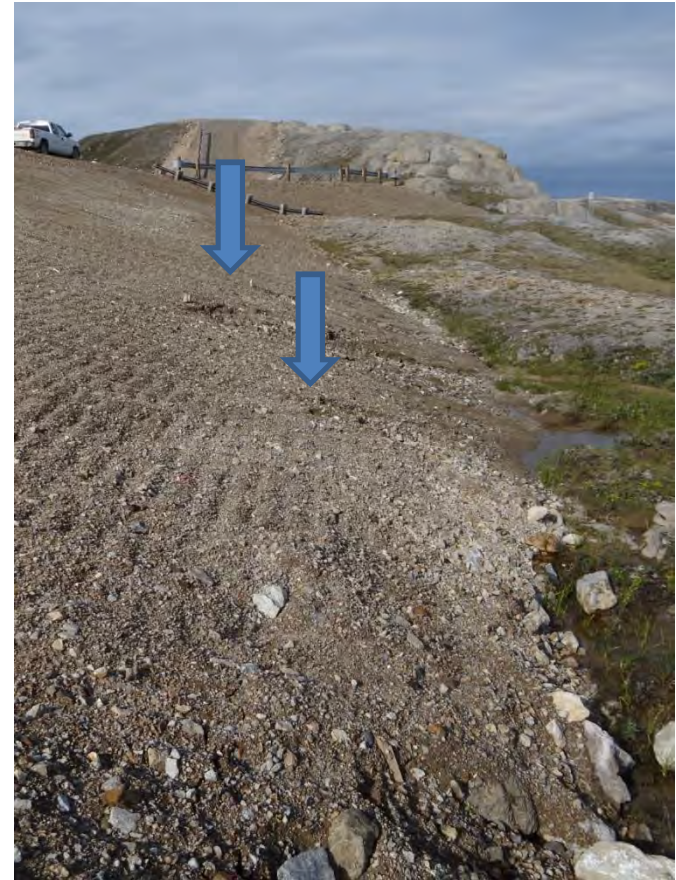
New Sewage Lagoon

- The roadway to the sewage lagoon still remains narrow in some places and this concern was identified by the Licensee.
- It was noted that the 2nd cell is not lined and there is water flowing from under the cell's wall(berm). Evidence of erosion and subsidence of the outside downstream wall of the lagoon were identified by the Inspector and the GN representative during the inspection. This was an issue identified in the 2011 Inspection as well.

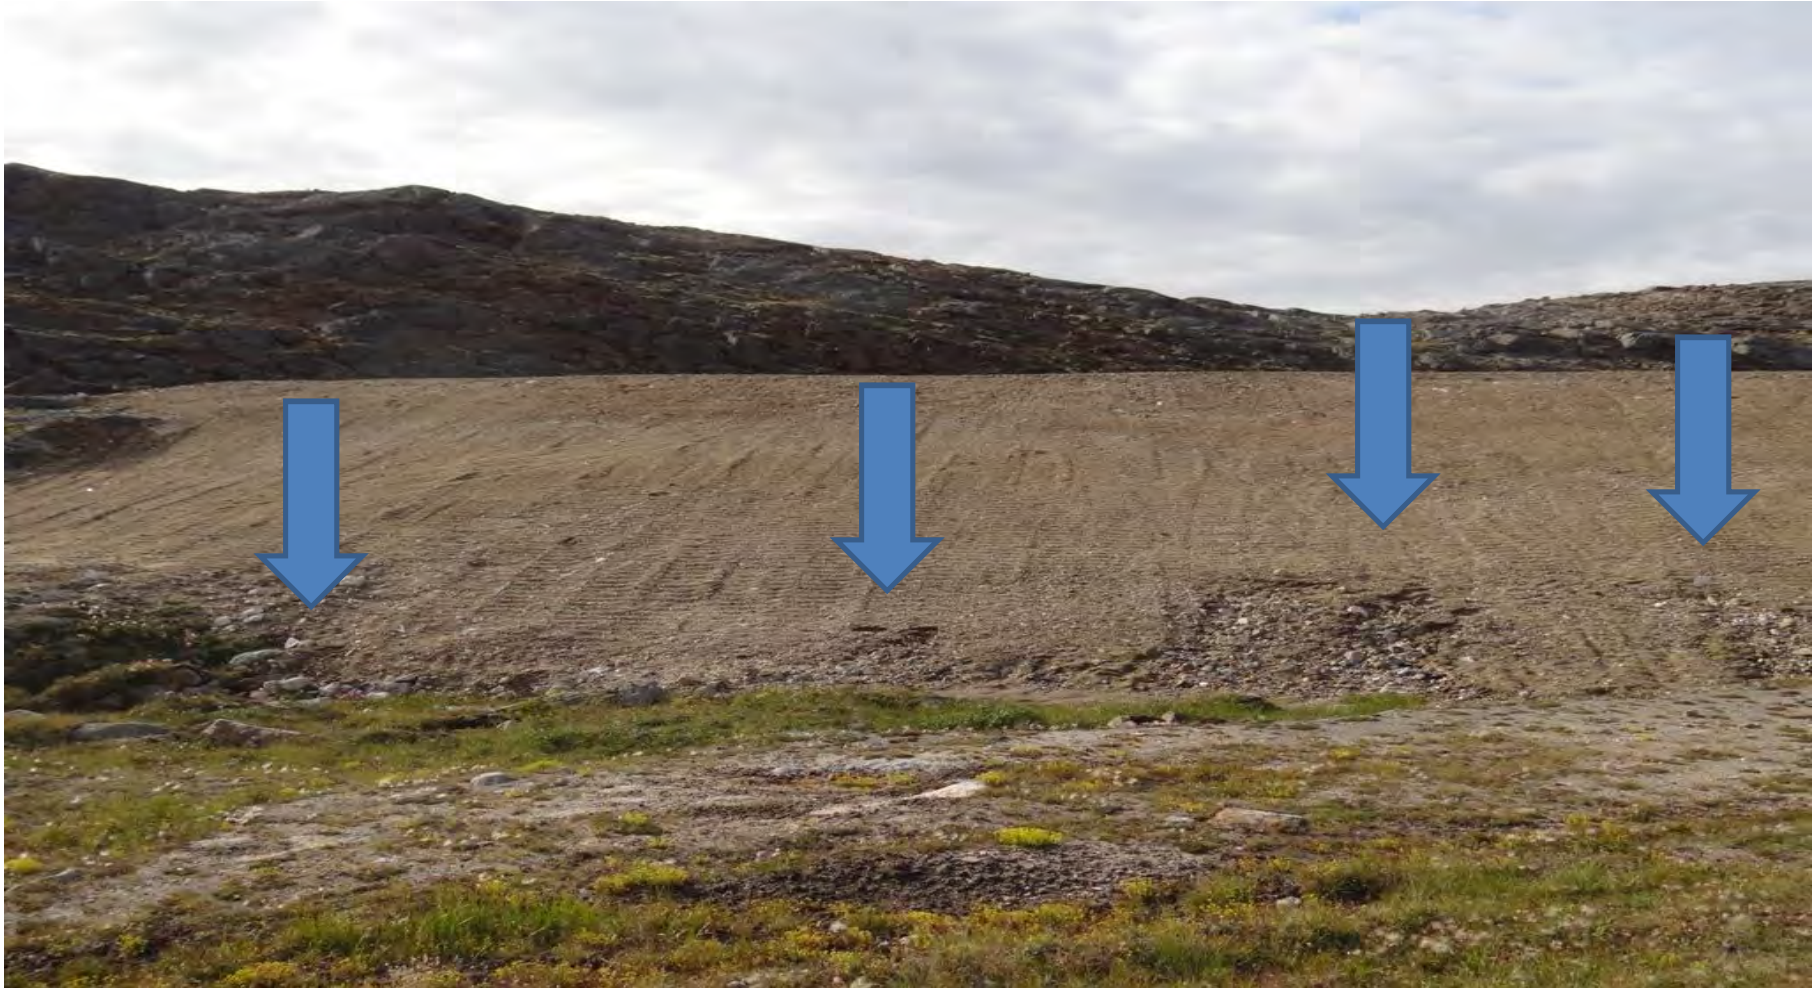
New Sewage Lagoon

- Evidence of erosion along the outside wall is identified by the blue arrows.
- Sediment and fine particles were noted in water flowing from the toe of the lagoon wall down grade from the site.
