WATER LICENCE INSPECTION FORM

Licensee		Licensee Representative	
David Alderdice Senior Administrative Officer Hamlet of Kimmirut, Baffin Region, P.O.Box-120, X0A 0N0, NU		David Alderdice	
Licence No. / Expiry		Representative's Title	
3bm-KIM0911 Exp. Jan 29, 2011		Senior Administrative Officer	
Land / Other Authorizations		Land / Other Authorizations	
Date of Inspection		Inspector	
August 11, 2014		A.Keim	
Activities Inspected			
<input type="checkbox"/> Camp <input type="checkbox"/> Drilling <input type="checkbox"/> Mining <input type="checkbox"/> Construction <input type="checkbox"/> Reclamation <input type="checkbox"/> Fuel Storage			
<input type="checkbox"/> Roads/Hauling <input type="checkbox"/> Other: Water Discharge <input checked="" type="checkbox"/> Other: Municipal

Photo Log

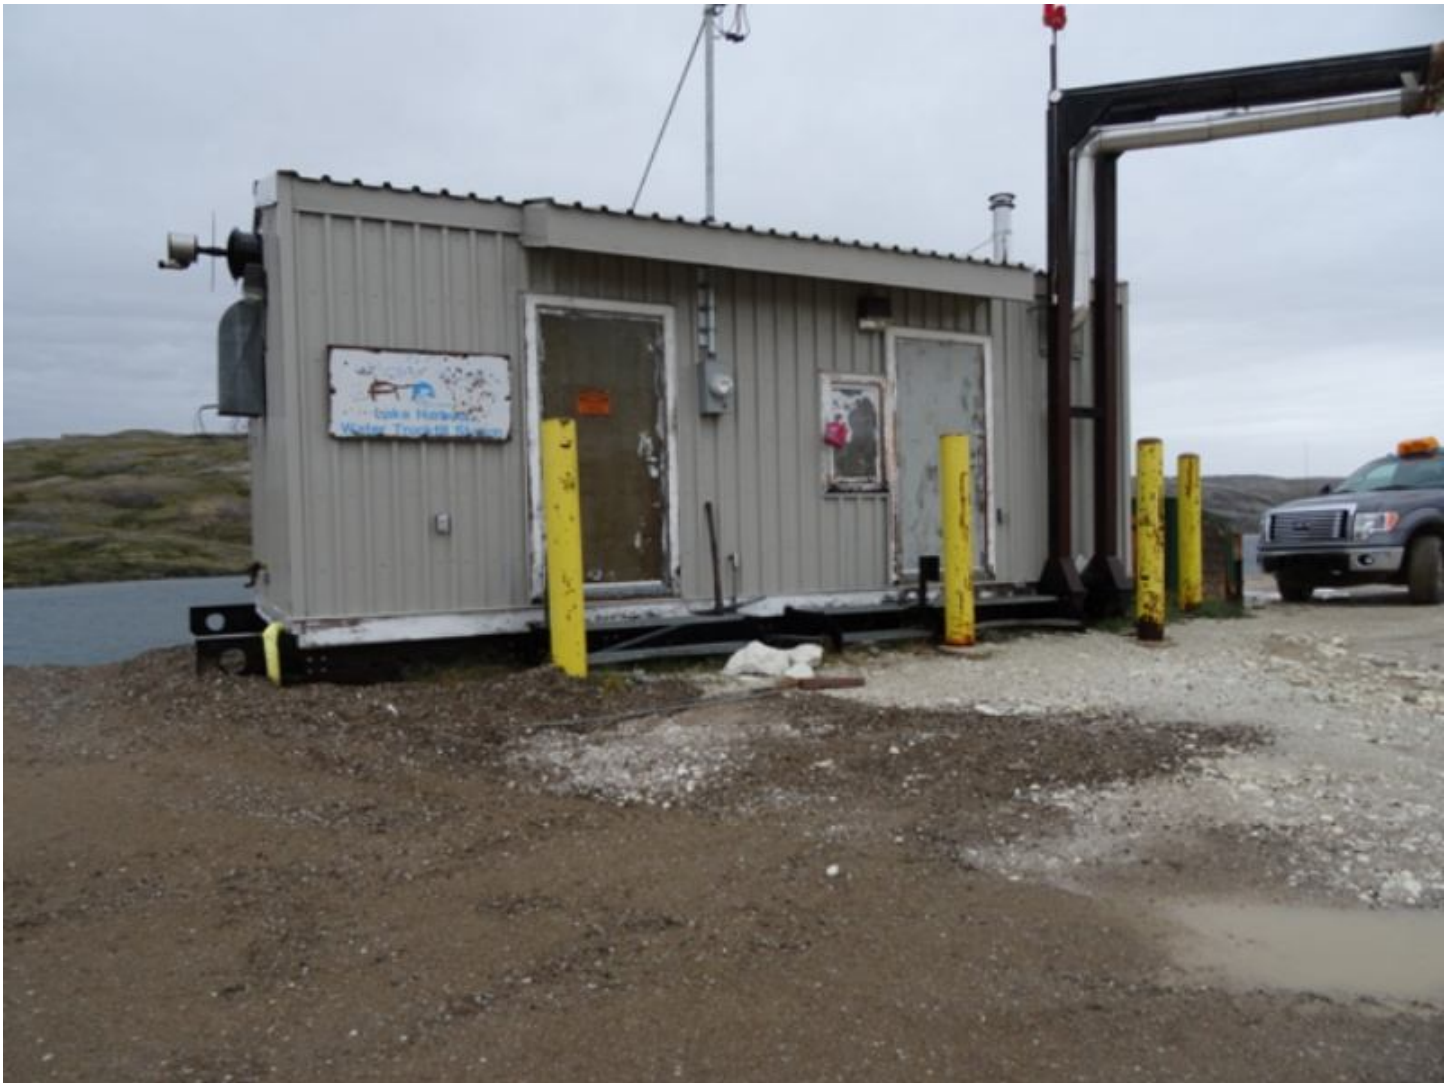
Figure 1 Kimmirut Lake Fundo pumping and intake station

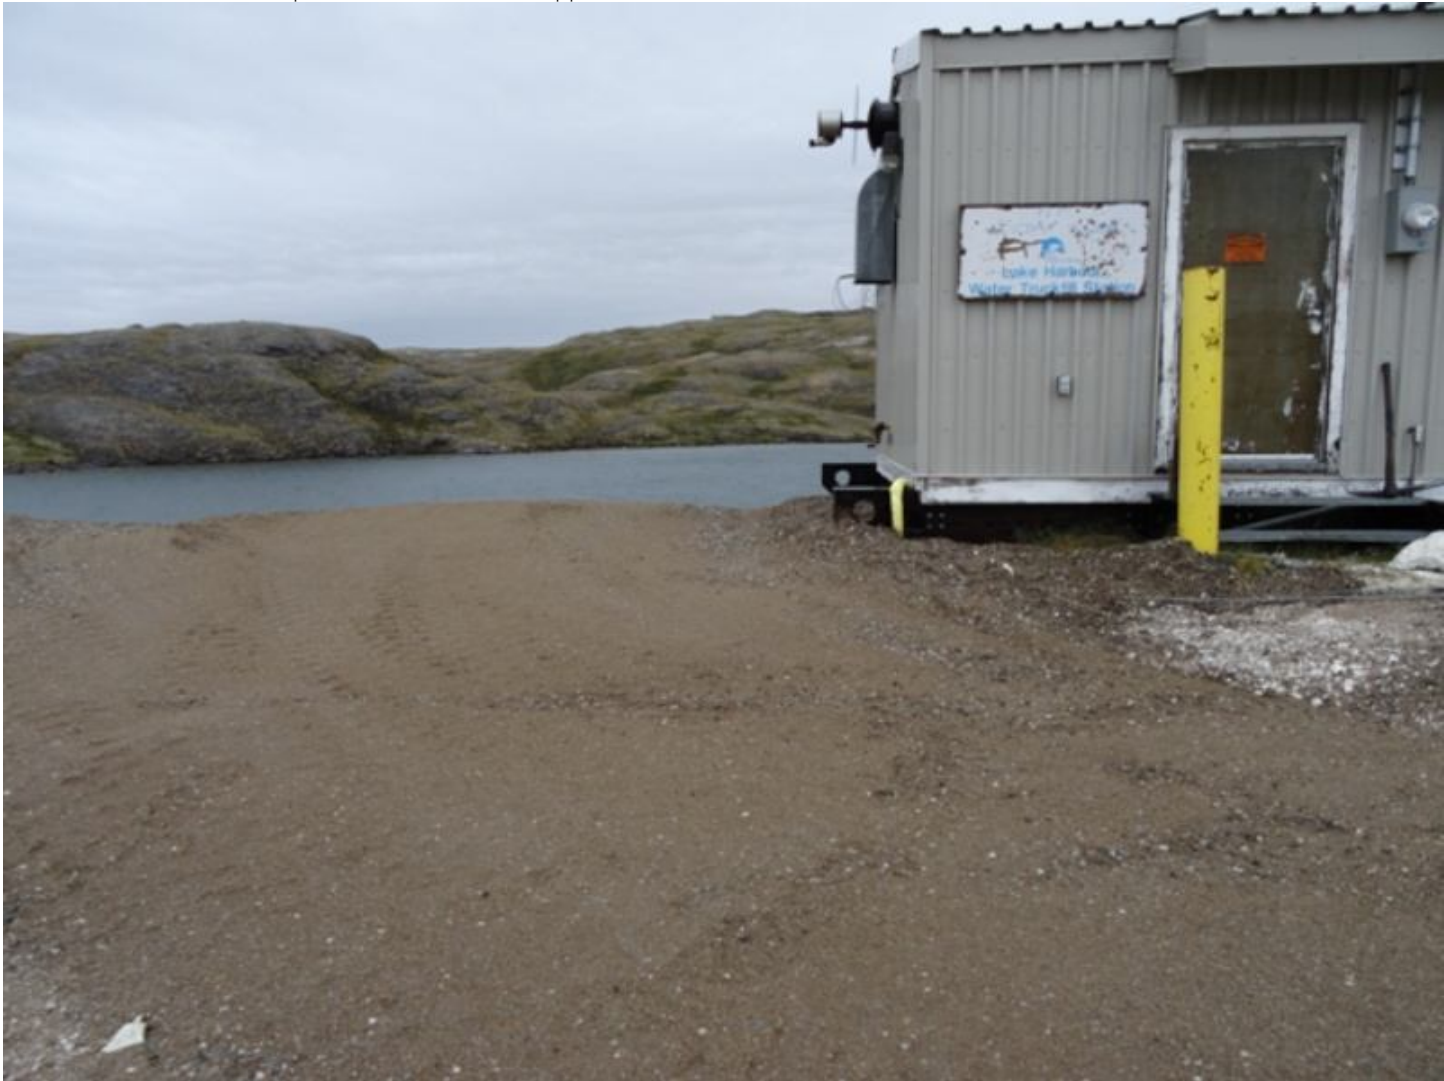
The site of the fuel spill adjacent to the Pumping station was found to have been excavated and no further contamination was noted on site at the time of the Inspection. The area had been back filled and leveled. This was documented during the Inspection. The cause of the spill was determined to be kids playing on the fuel lines into the Pumping station.

Figure 2 Intake station - Note removal of fuel tanks and re-grading of ground adjacent to building

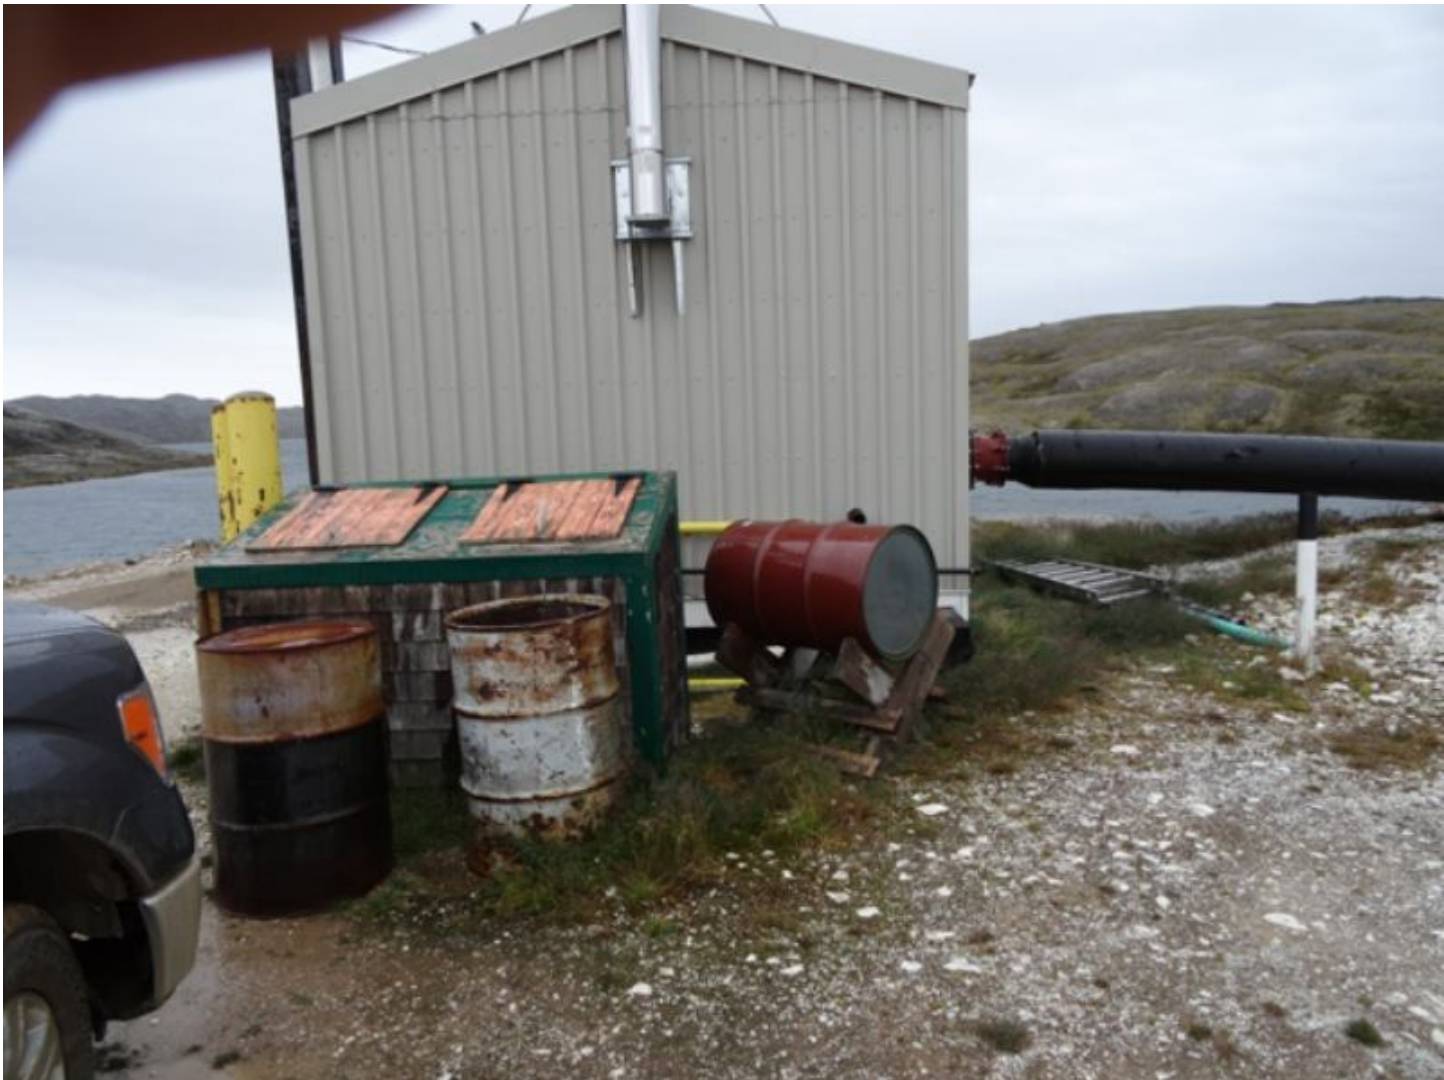
On the opposite side of the building a 45 gallon drum, full of fuel and sitting on a wooden stand immediately adjacent to the Potable water source was identified as an issue for the inspector. The fuel barrel was feeding the heater inside the building through a copper line feeding into the building. This formed an unacceptable level of risk to the Inspector and the fuel was found to be within

Figure 3 45 gallon drum of fuel on wooden tank beside building

30 m of the Potable source. As such the Inspector ordered the drum to be removed by licensee. Removal was completed by the Licensee the same day. Records for sampling and chlorine monitoring were available for review within the pumping station.

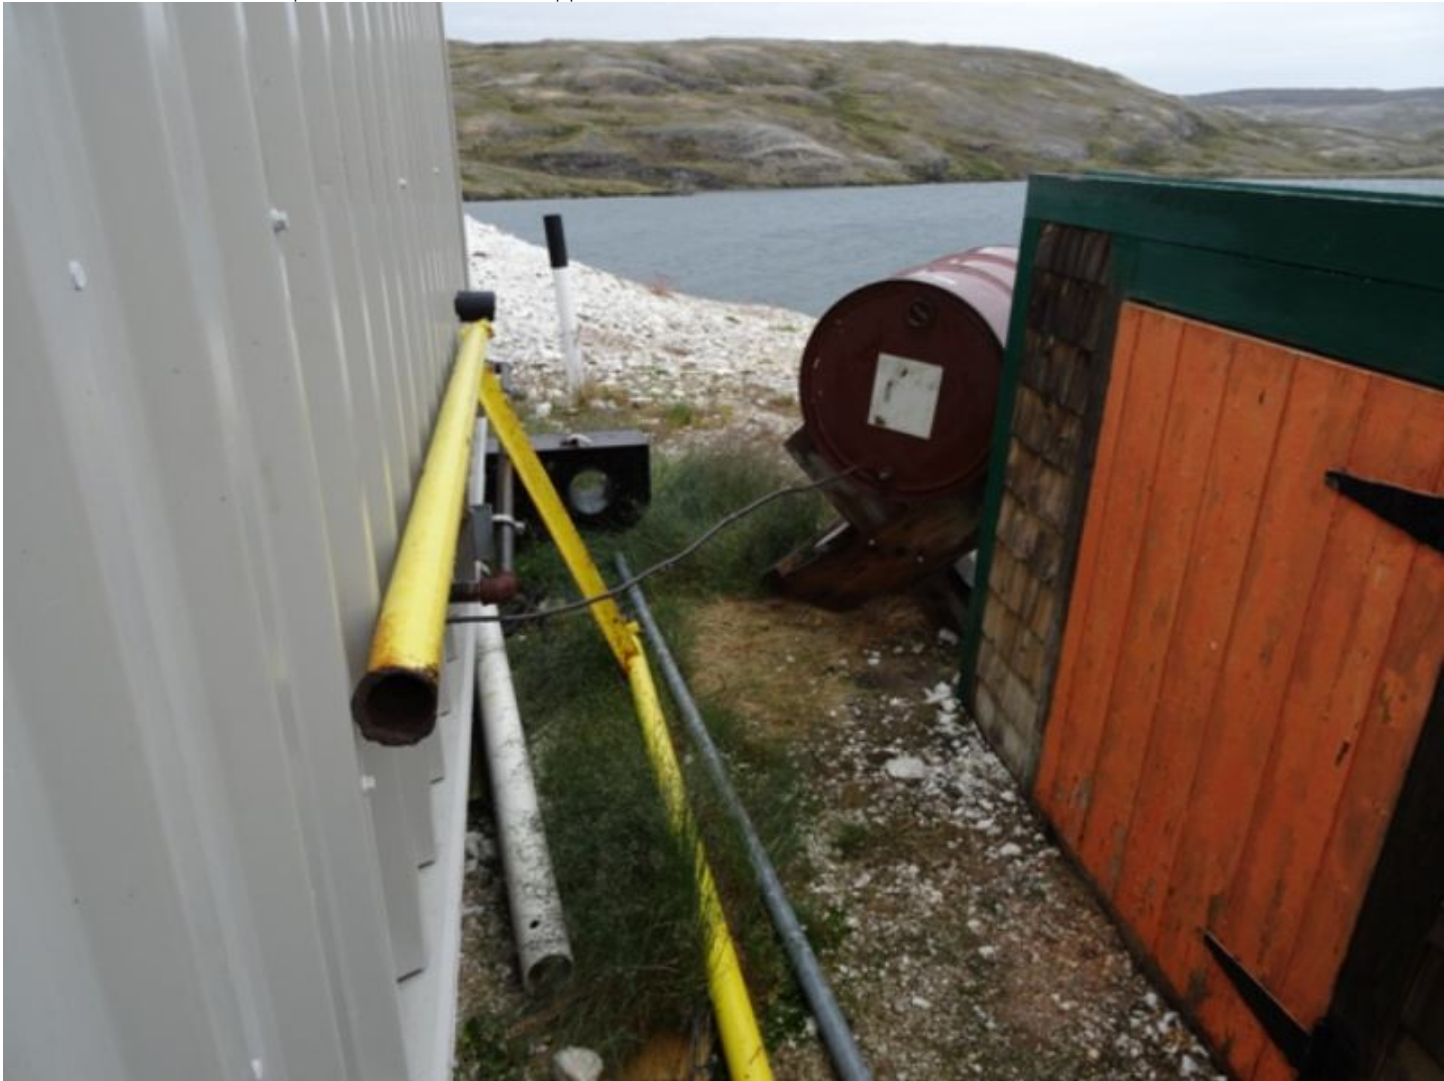
Figure 4 Drum feeding fuel oil into building

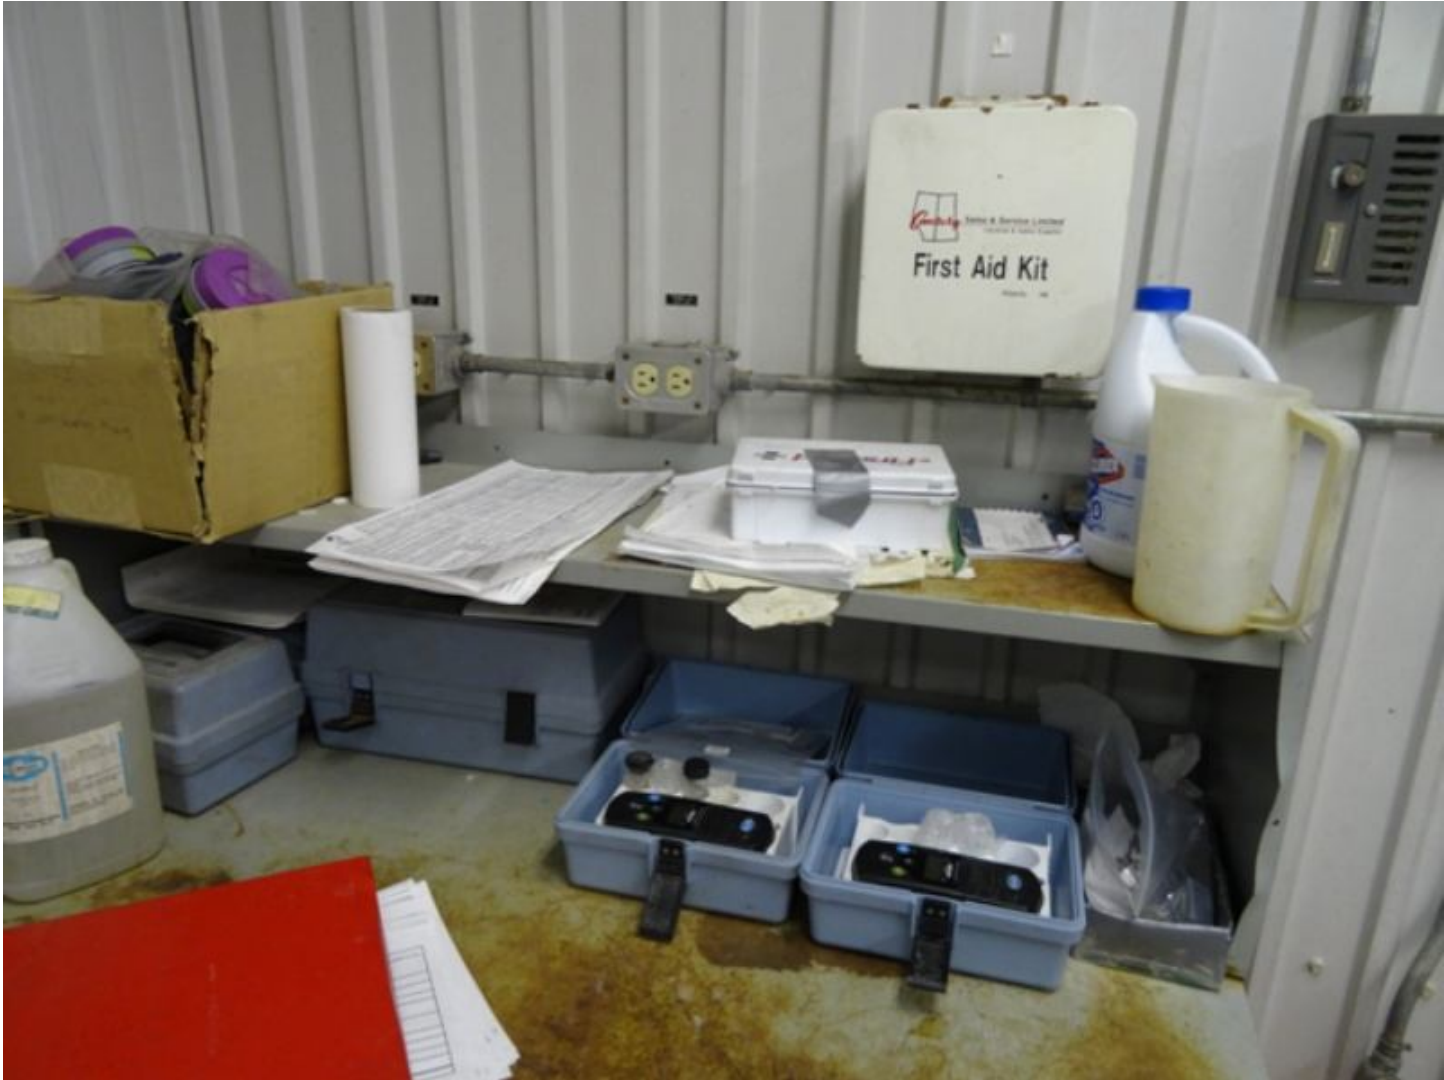
Figure 5 Testing equipment found inside building

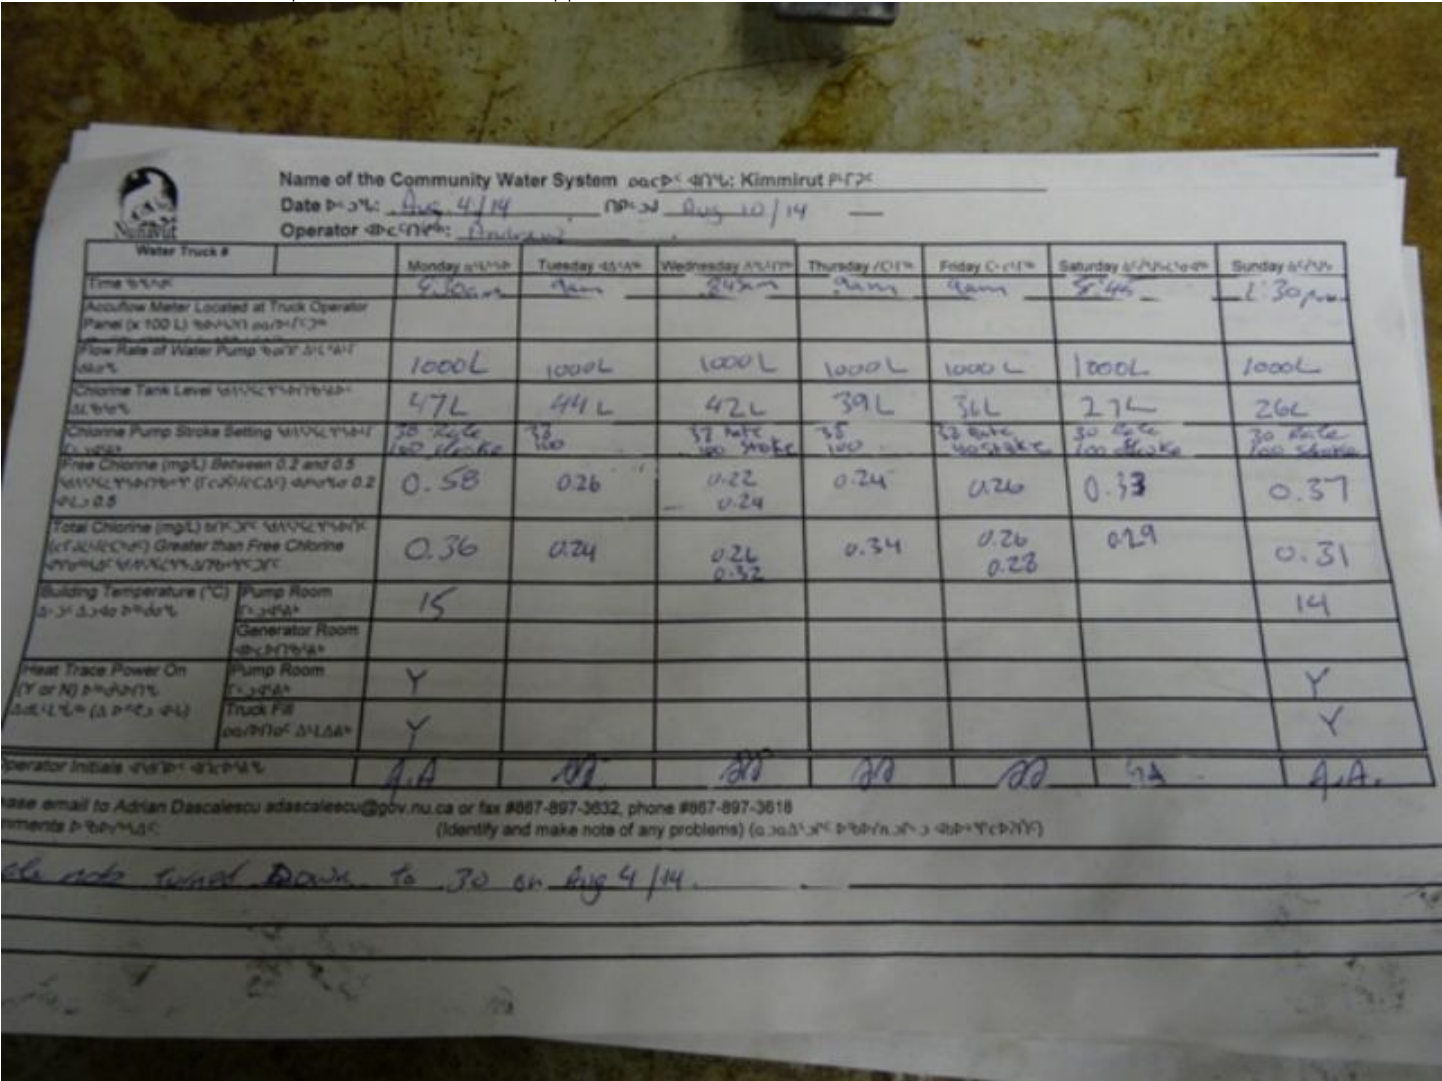
Figure 6 Records were available for review during the period of Inspection

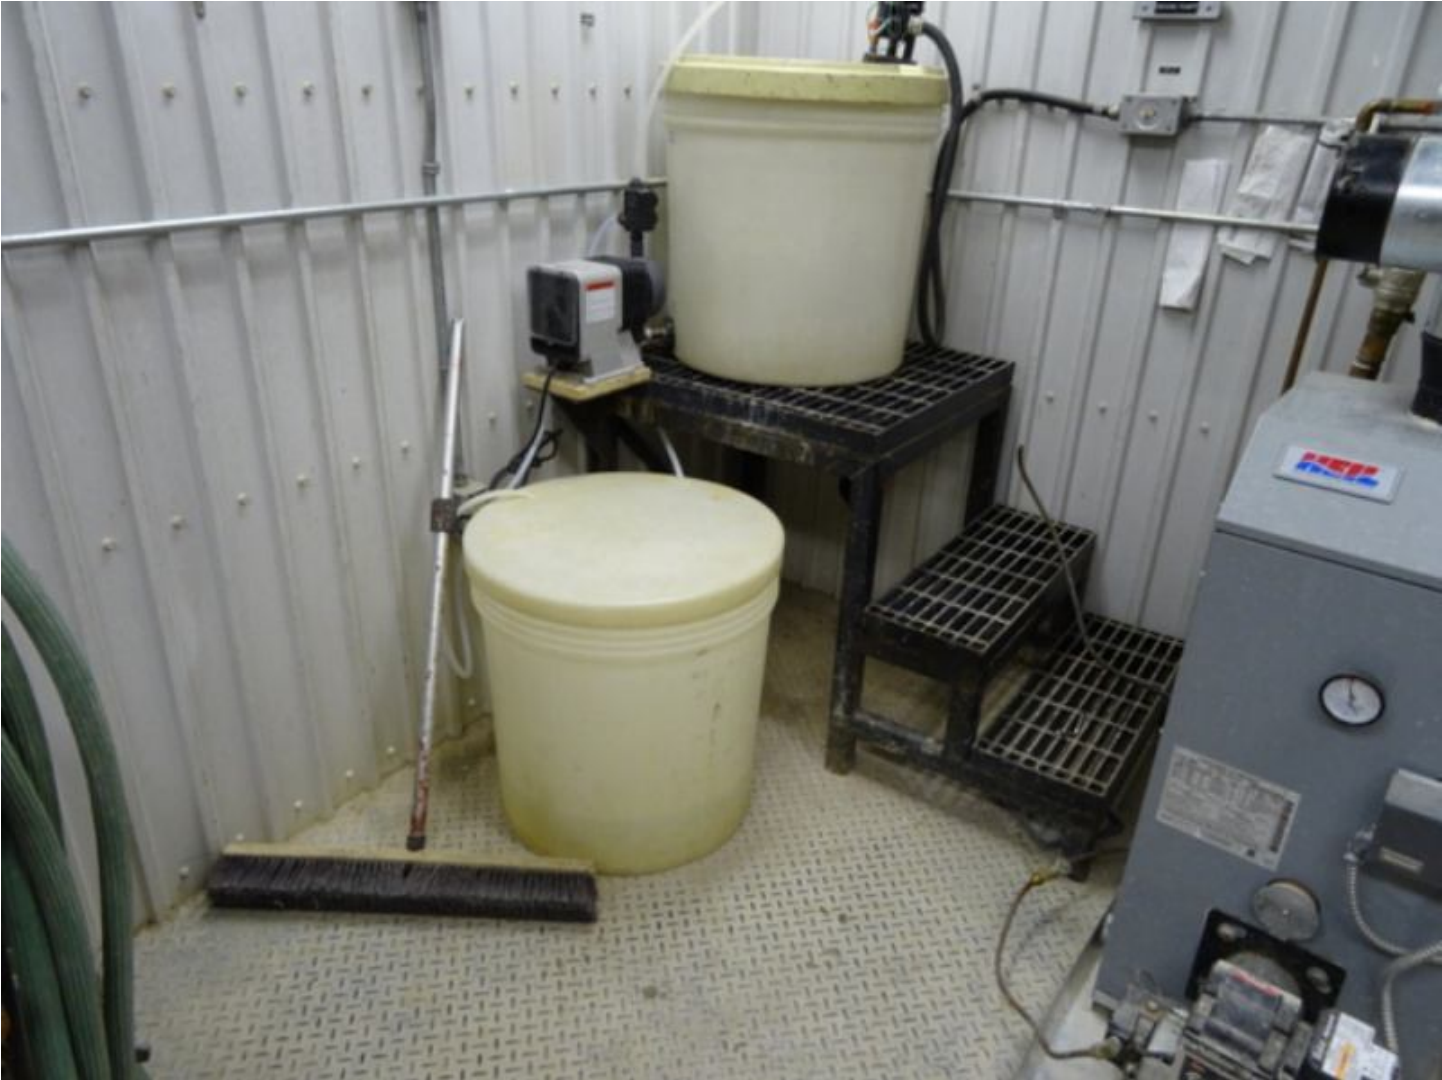
Figure 7 Chlorine system required regular monitoring to ensure it is not drawn down

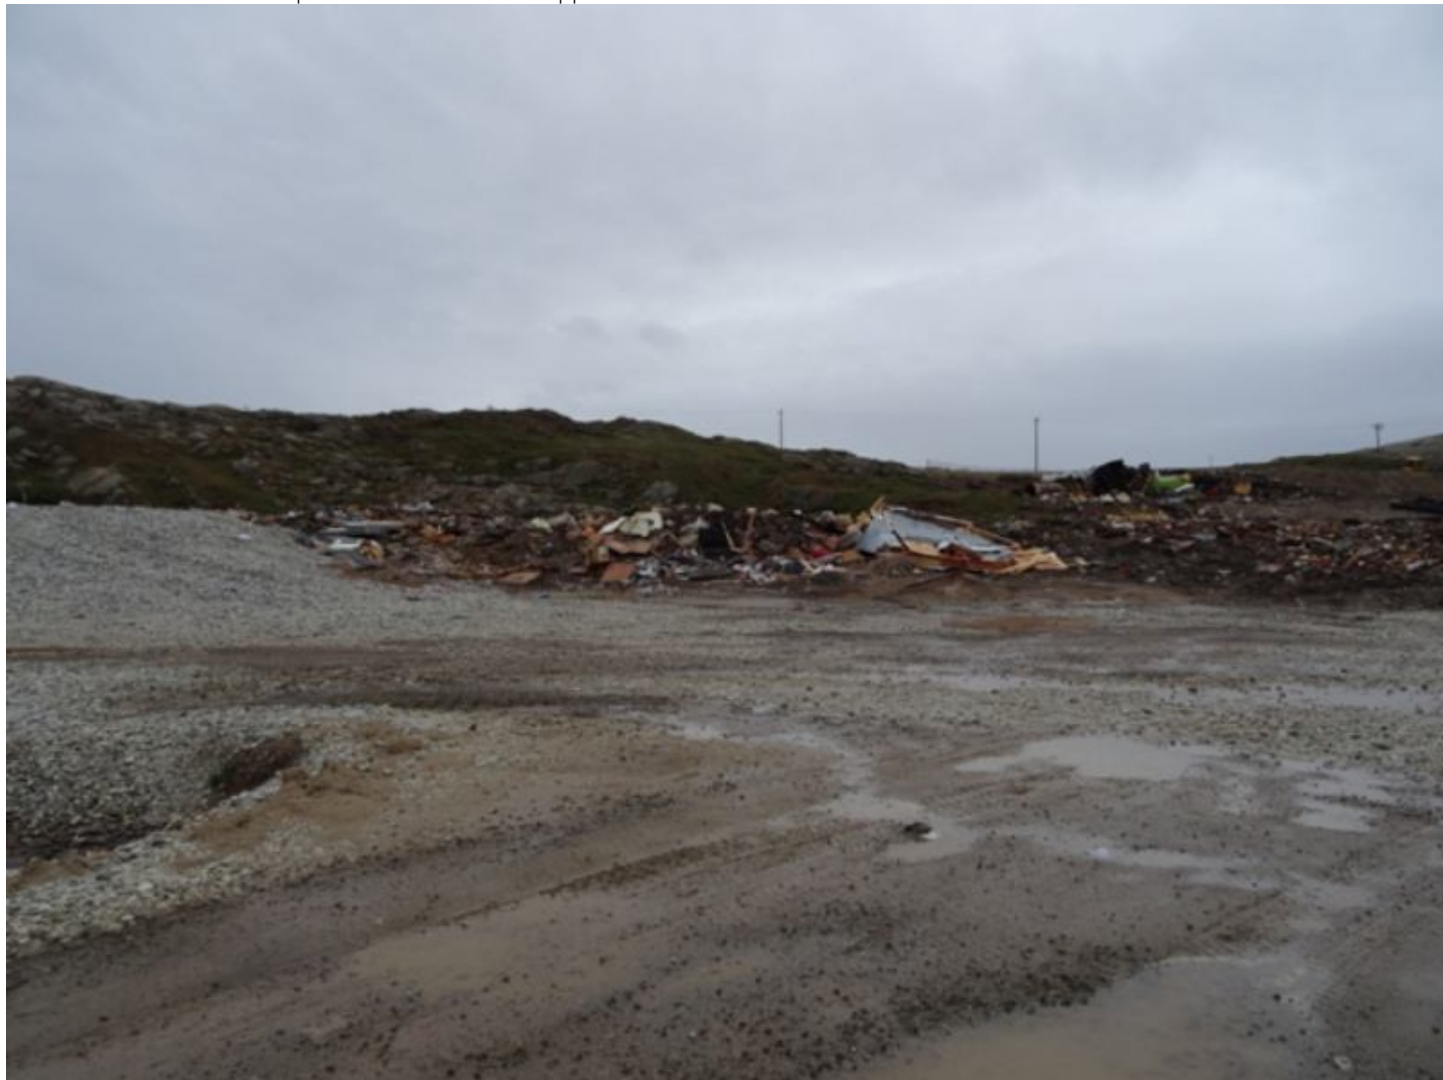
The facility was found to have recently been burned with materials moved to the adjacent side where they are placed and then covered by .25 meters of cover material that appears to have been compacted. The facility now appears to be well managed and while some metals and other items were noted within the Municipal burn and bury site, it appears that the domestic waste is being efficiently managed. Additionally, the fence on the three side of the facility was found to be free standing and in good repair without a great deal of windblown garbage attached to the fencing.

Figure 8 Bulk metals on the right and cover materials for the municipal waste management area

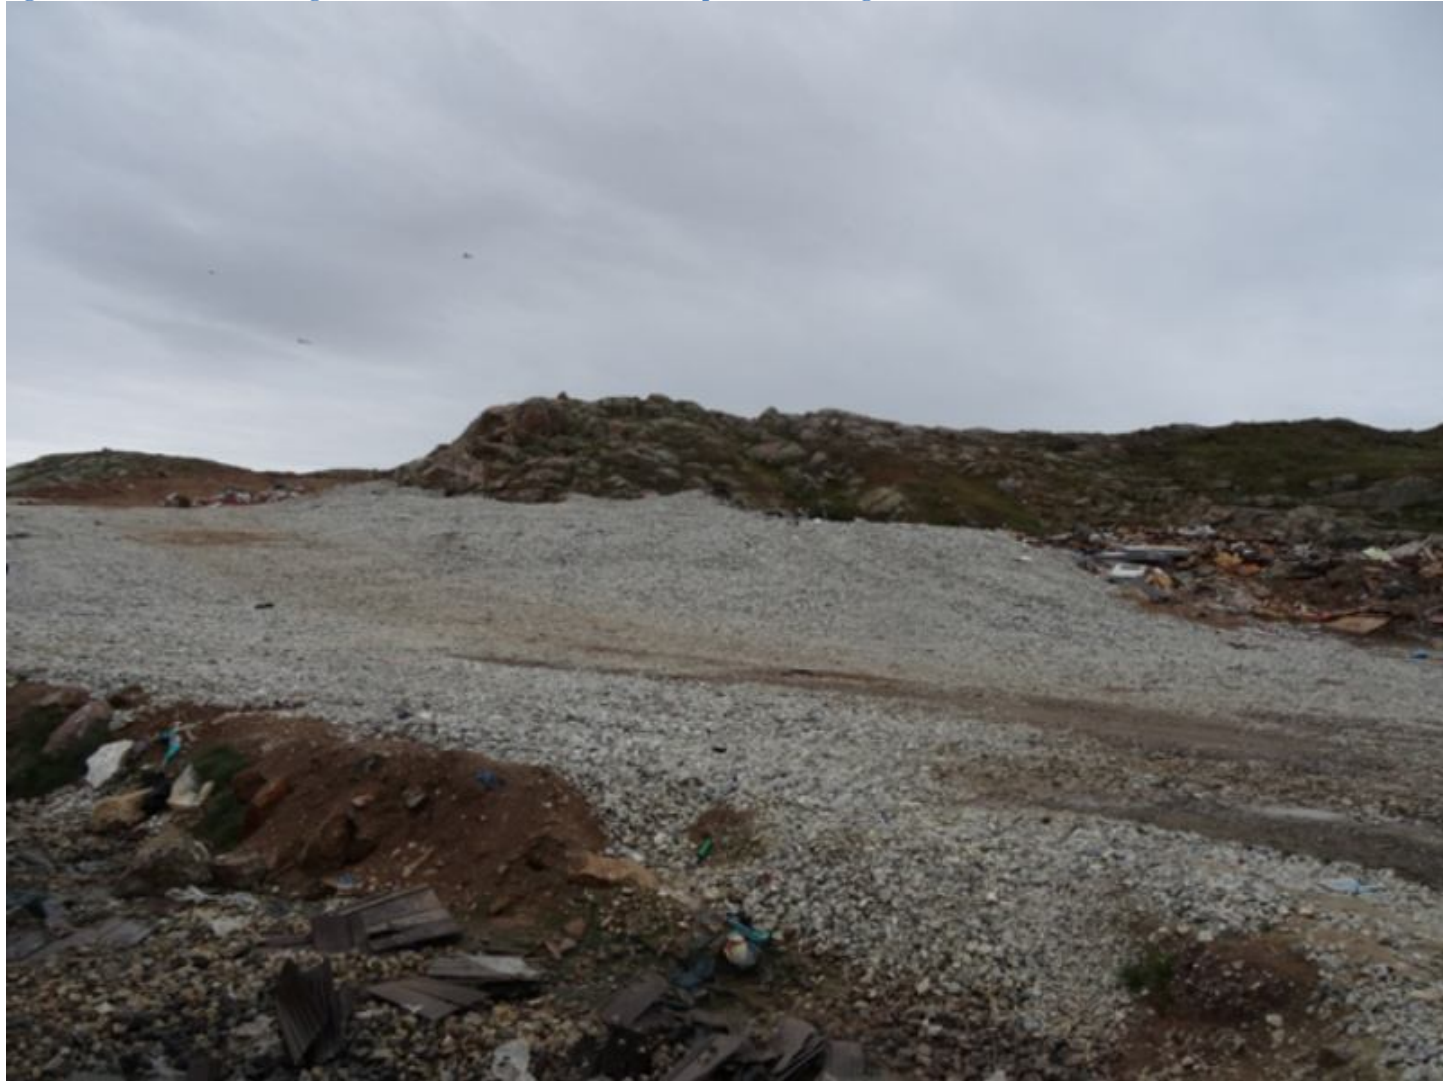
Figure 9 Municipal waste management area with new cover materials

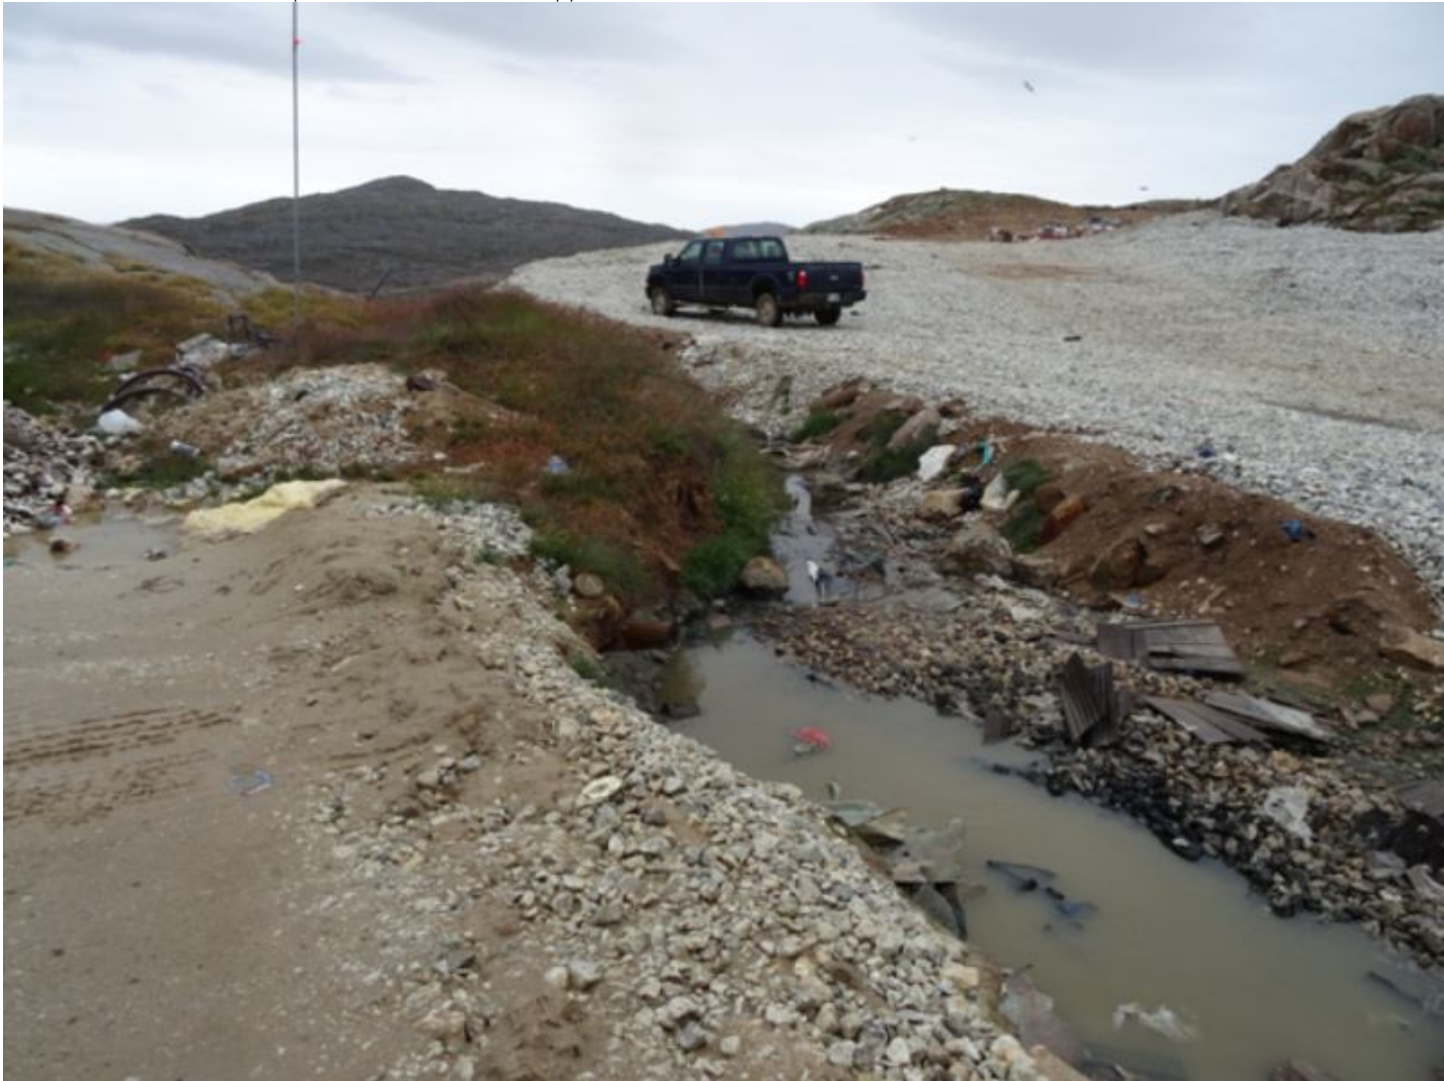
The Licensee continues to discharge the communities’ raw effluent into a ditch in the Solid Waste Management Area. Samples were collected. This practice has been on-going for a number of years within the community, and has been identified in every inspection report since 2006. The Licensee has raised this as a concern to the Inspector and even with the issuance of an Inspector’s Direction to the Government of Nunavut this issue remains unresolved. It is unclear what it will take short of judicial intervention to resolve this issue in a timely manner.

Figure 10 Ditch where raw effluent is deposited. Cover materials over the burn and bury in the back ground

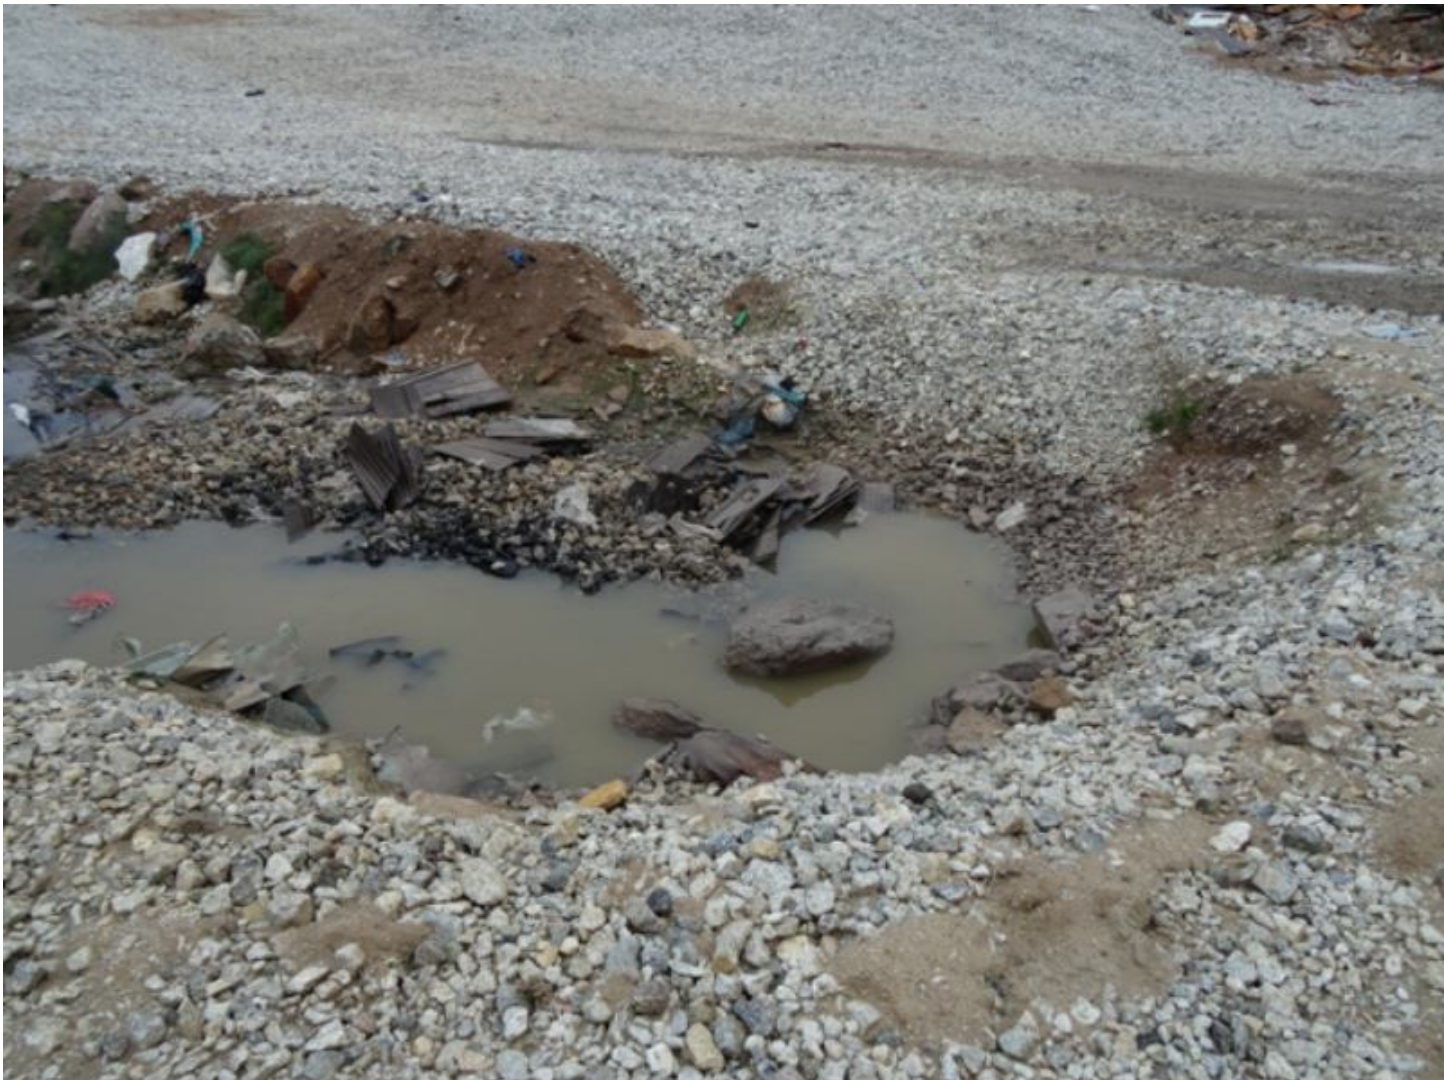
Figure 11 Ditch

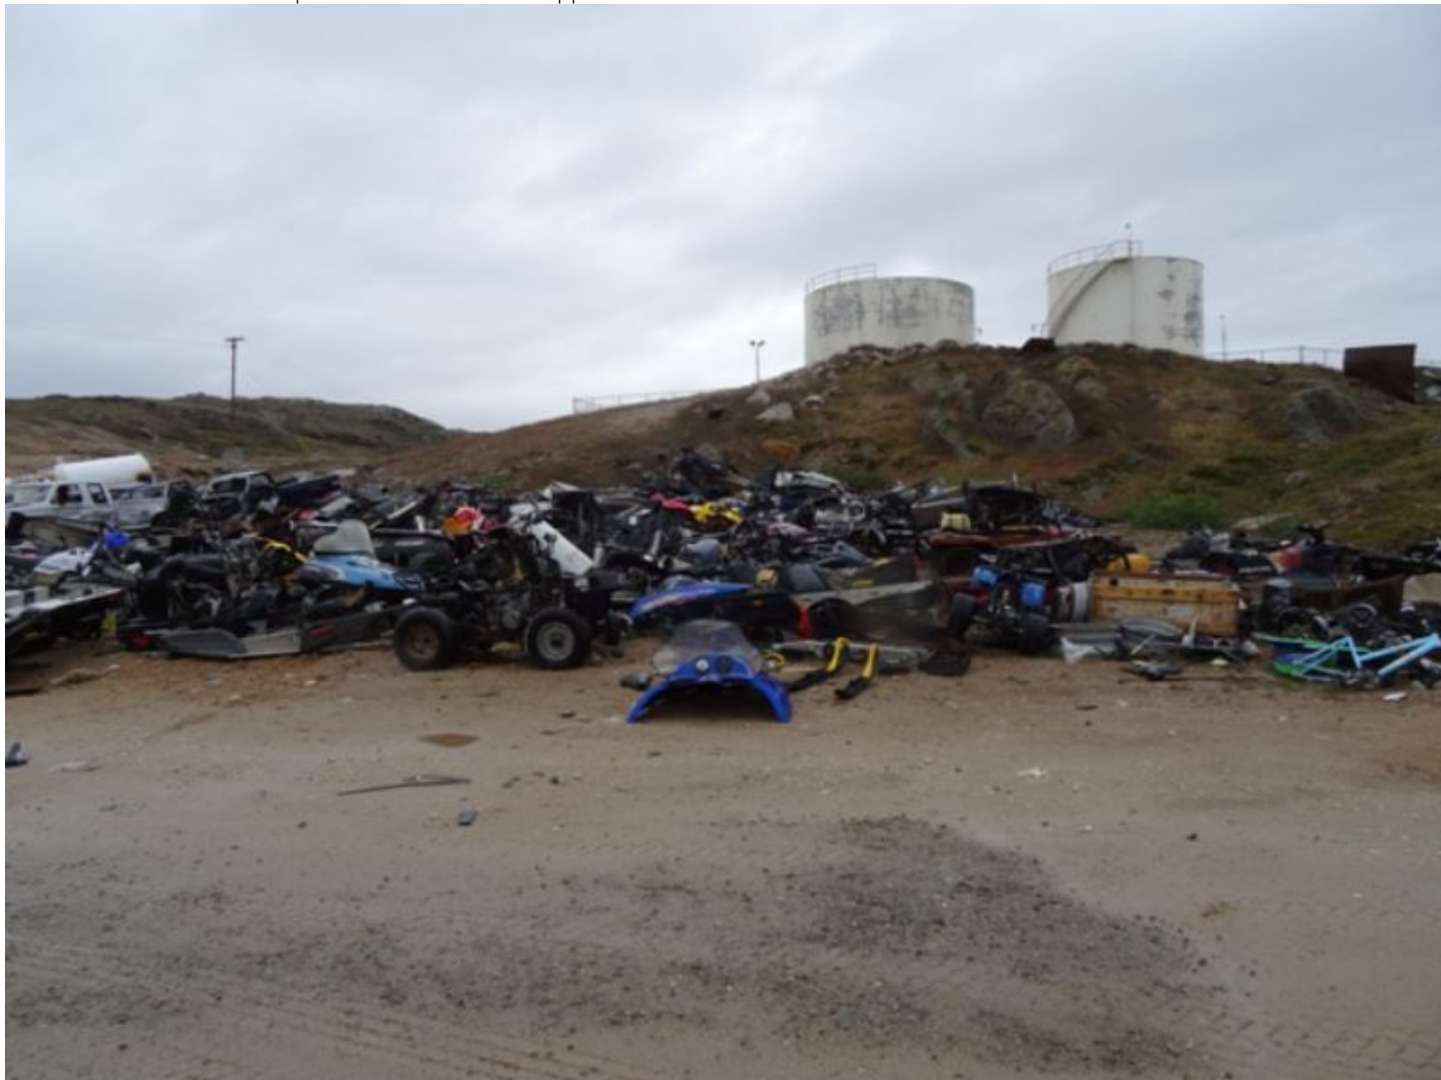
Figure 12 vehicle and snow machine graveyard

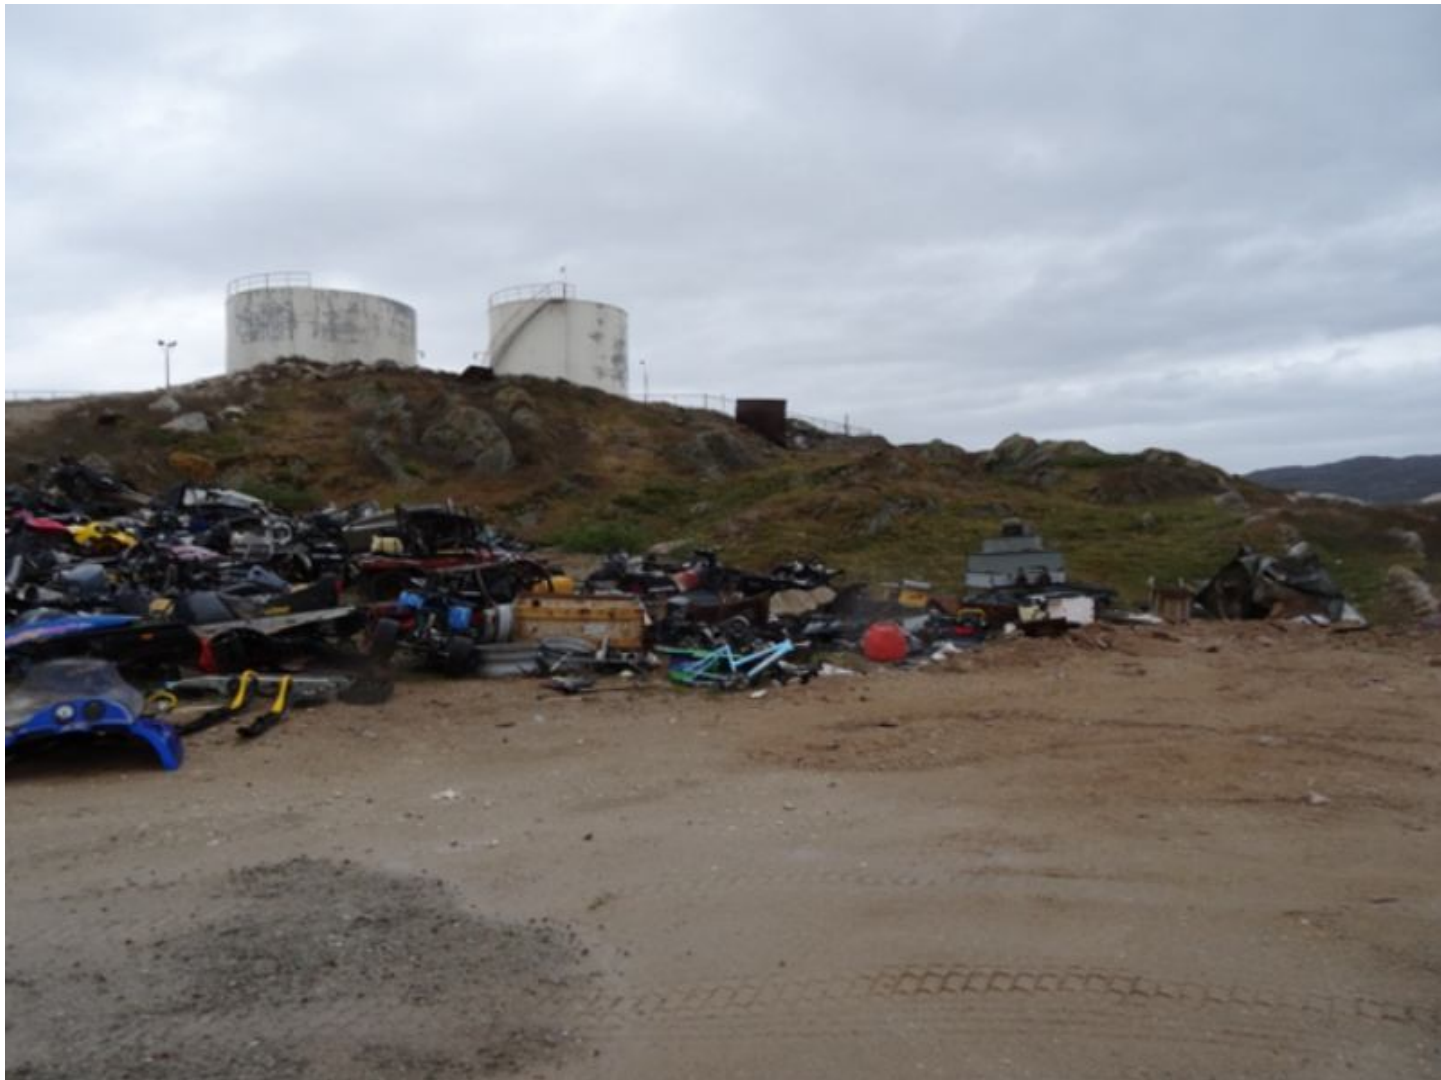
Figure 13 Snow machine grave yard with tank farm in back ground

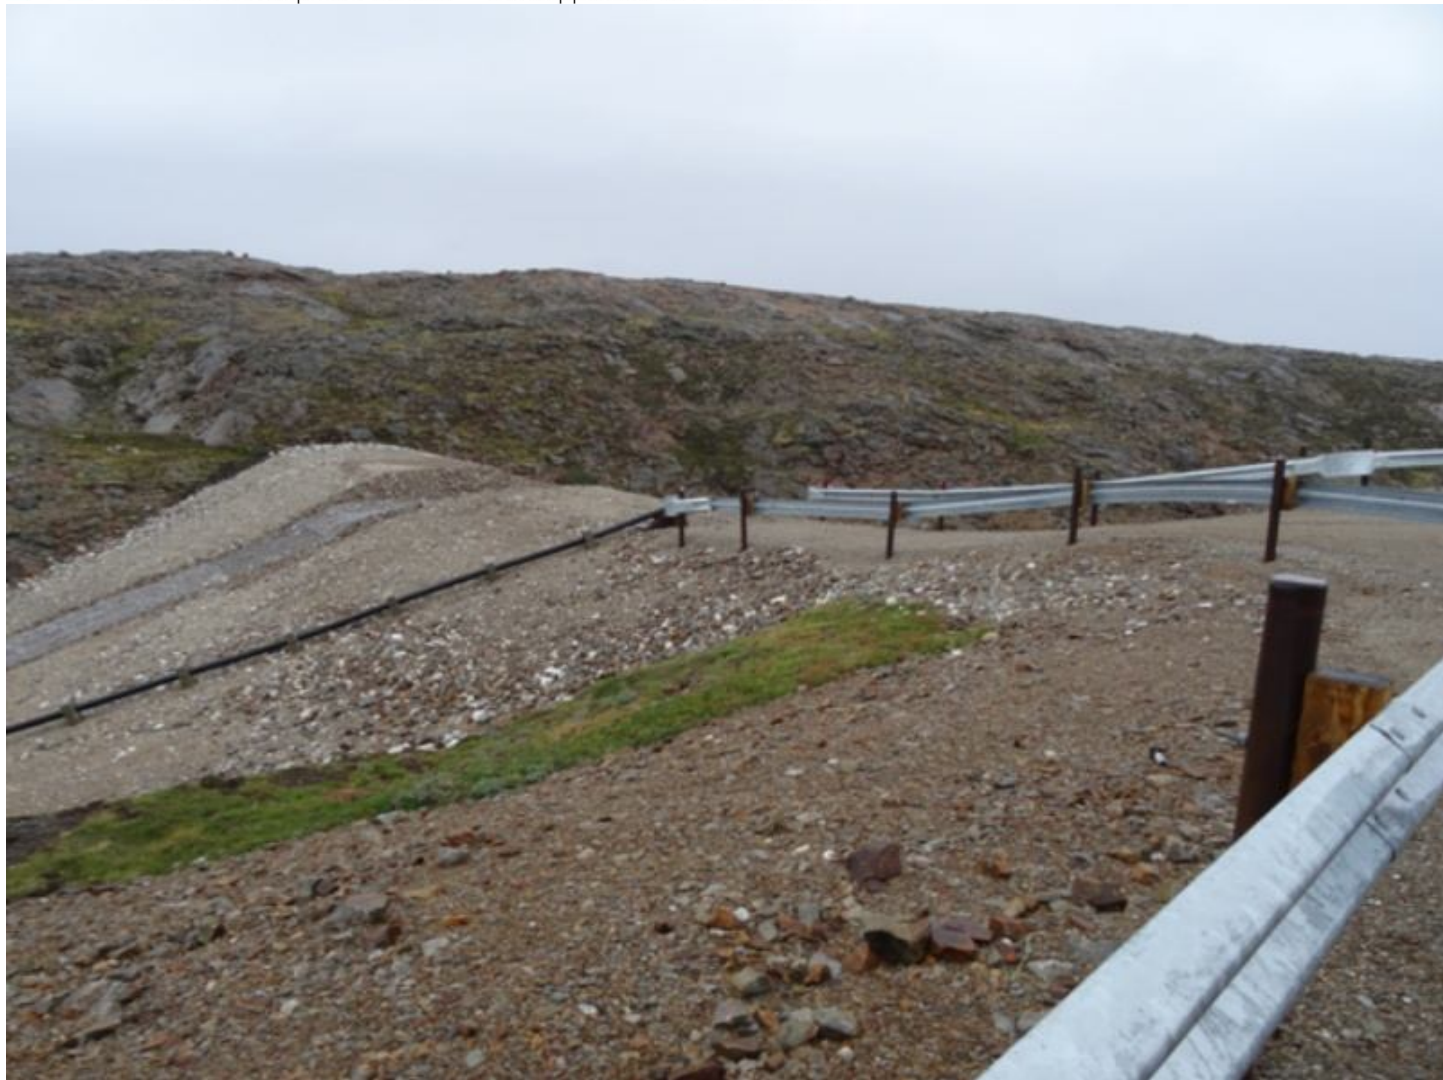
Figure 14 new lagoon with recontoured cell wall (upper cell)
