WATER LICENCE INSPECTION FORM

Licensee		Licensee Representative	
David Alderdice Senior Administrative Officer Hamlet of Kimmirut, Baffin Region, P.O.Box-120, X0A 0N0, NU		David Alderdice	
Licence No. / Expiry		Representative's Title	
3bm-KIM0911 Exp. Jan 29, 2011		Senior Administrative Officer	
Land / Other Authorizations		Land / Other Authorizations	
Date of Inspection		Inspector	
August 11, 2014		A.Keim	
Activities Inspected			
<input type="checkbox"/> Camp <input type="checkbox"/> Drilling <input type="checkbox"/> Mining <input type="checkbox"/> Construction <input type="checkbox"/> Reclamation <input type="checkbox"/> Fuel Storage			
<input type="checkbox"/> Roads/Hauling <input type="checkbox"/> Other: Water Discharge <input checked="" type="checkbox"/> Other: Municipal

Photo Log

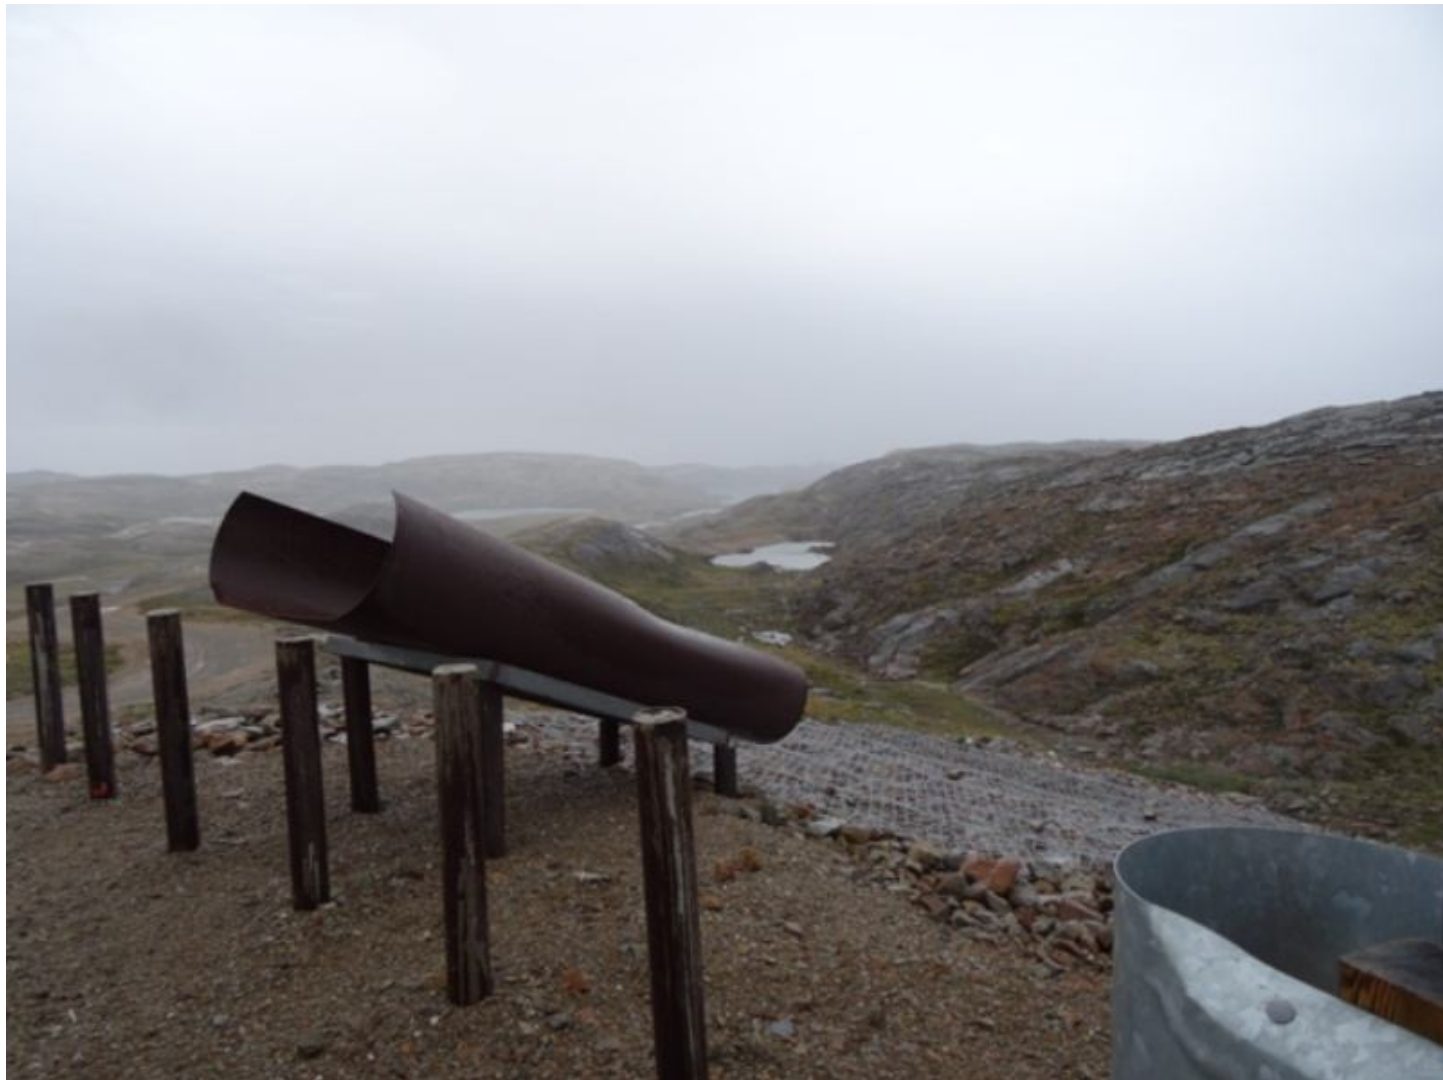
Figure 15 Upper cell of new lagoon - truck drop off. Below in background is lower cell berm wall with ponded water
