WATER LICENCE INSPECTION FORM

Licensee	Licensee Representative
Hamlet of Kimmirut	Bhabesh Roy
Licence No. / Expiry	Representative's Title
3BM-KIM1929	Municipal Engineer
Land / Other Authorizations	Land / Other Authorizations
Date of Inspection	Inspector
September 27, 2021	Joseph Monteith
Activities Inspected

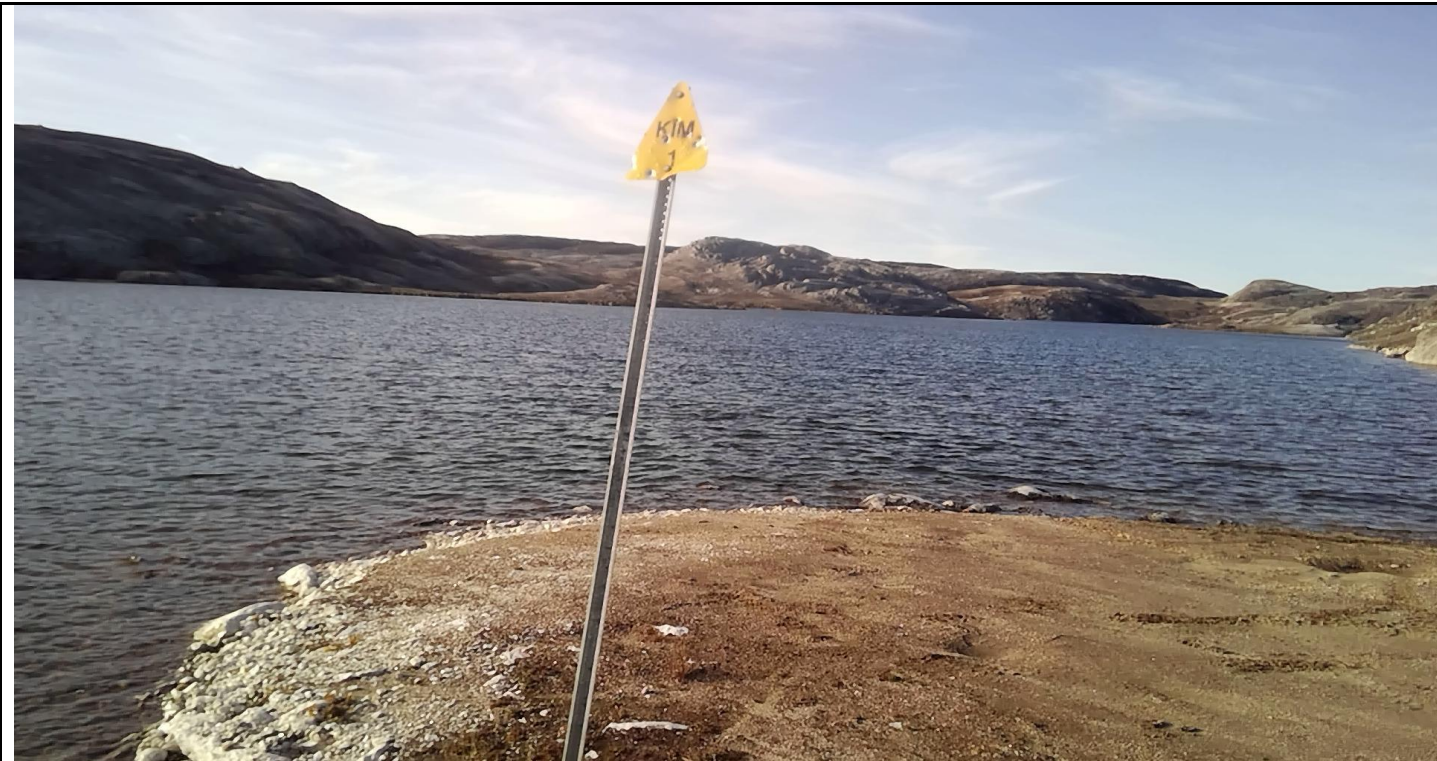
Date	Camera	Inspector	
June 30, 2020	Nikon Coolpix	Joseph Monteith	
Photo Log #	Location		
Photo 1	Kimmirut, NU

A yellow triangle sign titled KIM1 indicting the location of a monitoring station was observed at the time of the inspection (photo 1).

Description: KIM 1 monitoring site at Fundo Lake water source

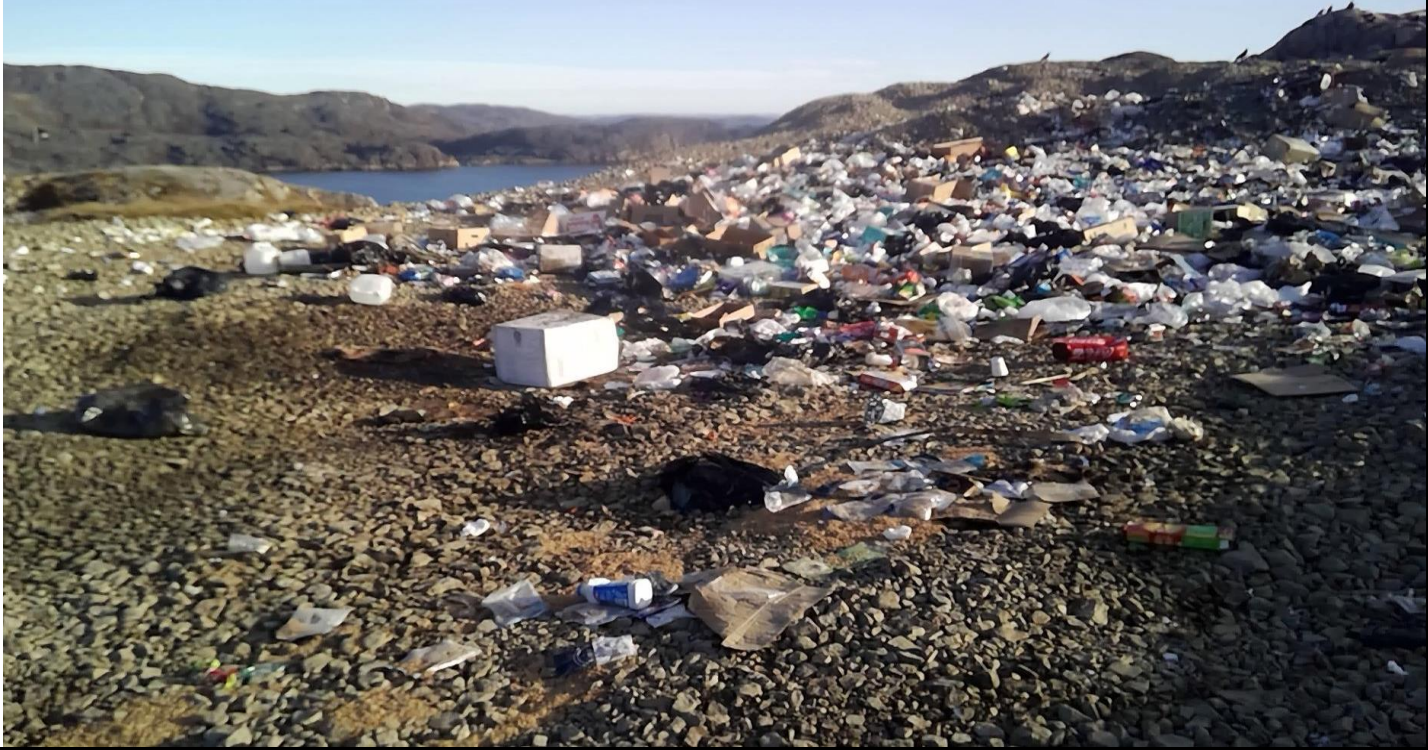
Photo 4

The Hamlet deals with solid waste by burning the burnable waste, and capping the ash with gravel obtained by their gravel pit (photo 4).
8.

The fencing did appear to be incomplete in its construction, and without maintenance and has become damaged and should be repaired.
9.

Description: Burn and cap of domestic garbage. No fencing around this section of the solid waste facility. Wind blown garbage blown across site of sewage discharge. Burn Garbage was capped between 2020, and 2021 to help mitigate the windblown debris.

-maintain and complete the construction of fencing to contain all wastes permanently in the Solid Waste Facility;

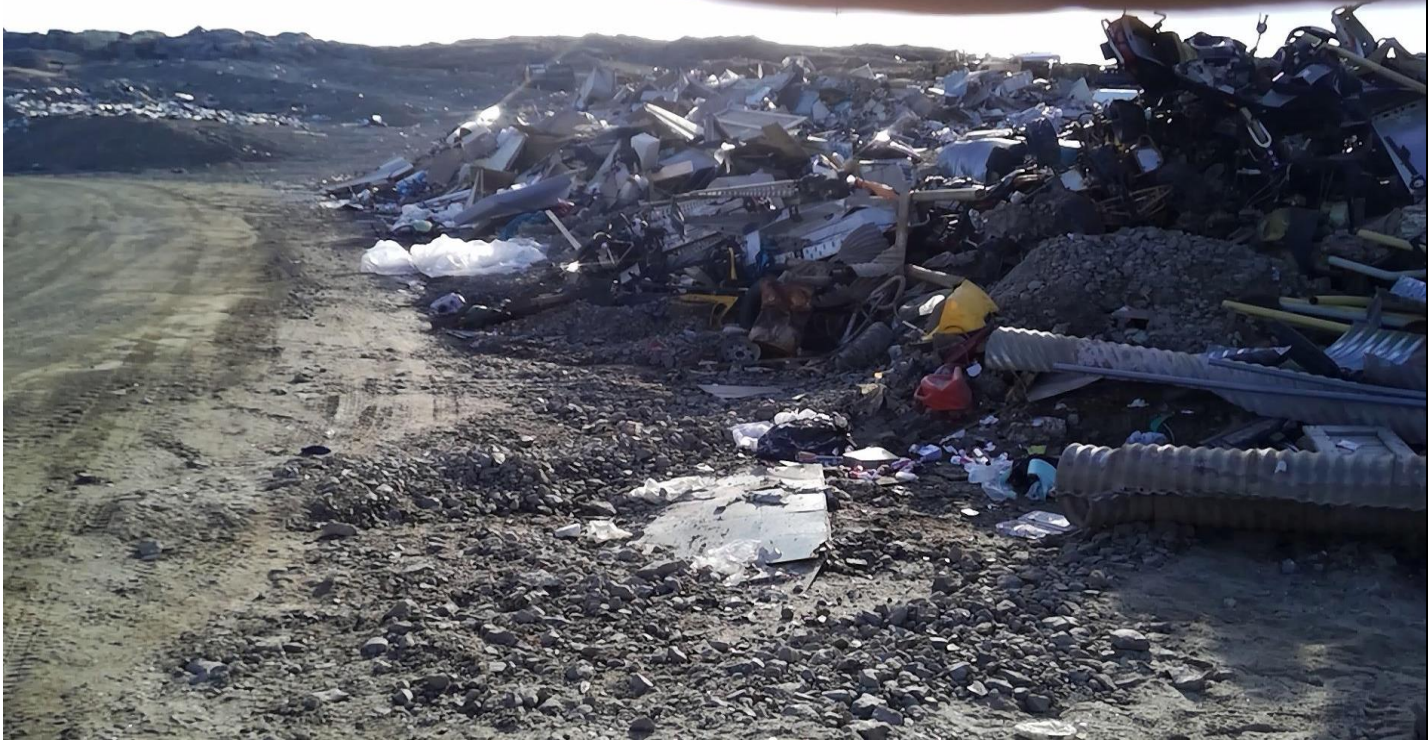
Photo 5

During the inspection it was observed that the hazardous waste was located at two locations. The Solid waste facility which had the hazardous waste exposed to the elements (Photo 5). At the municipal garage Hazardous Waste is stored within sea cans behind the municipal garage. At the time of the inspection some of the hazardous waste was taken out the sea cans, so that sea-cans can be cleaned (Photo 7,8,&9).
10.

Description: With the exception of domestic burning and capping waste, all other waste such as bulk wood, bulk metal, hazardous waste, and gravel have been deposited into the pile along the road. The trench the direct any leachate from the pile was covered as directed in 2020.

-install signage to notify the public that there are dangerous hazardous wastes on site;

-build a berm to limit the amount of water entering in the hazardous waste facility, and taking the hazardous waste with it;

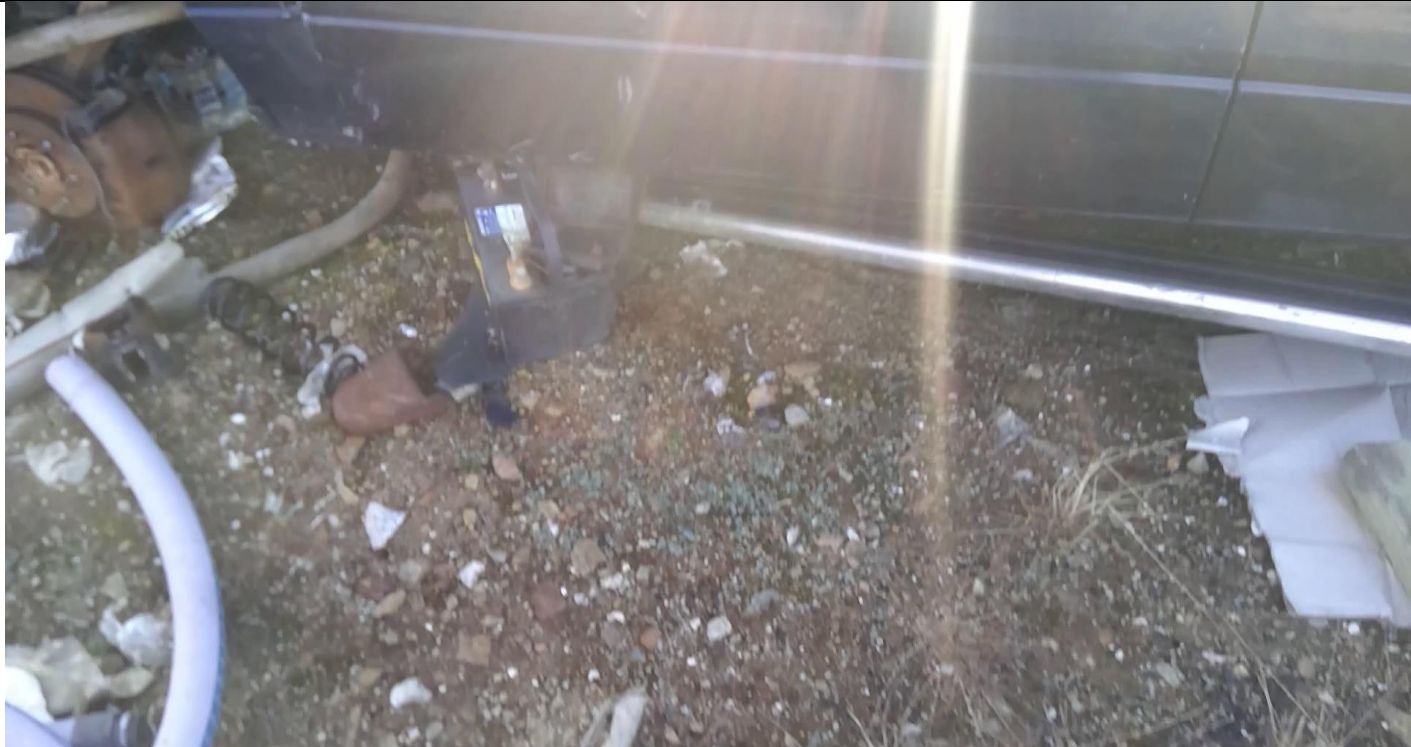
Photo 6

Description: Unsegregated hazardous waste battery sitting outside in the external elements.

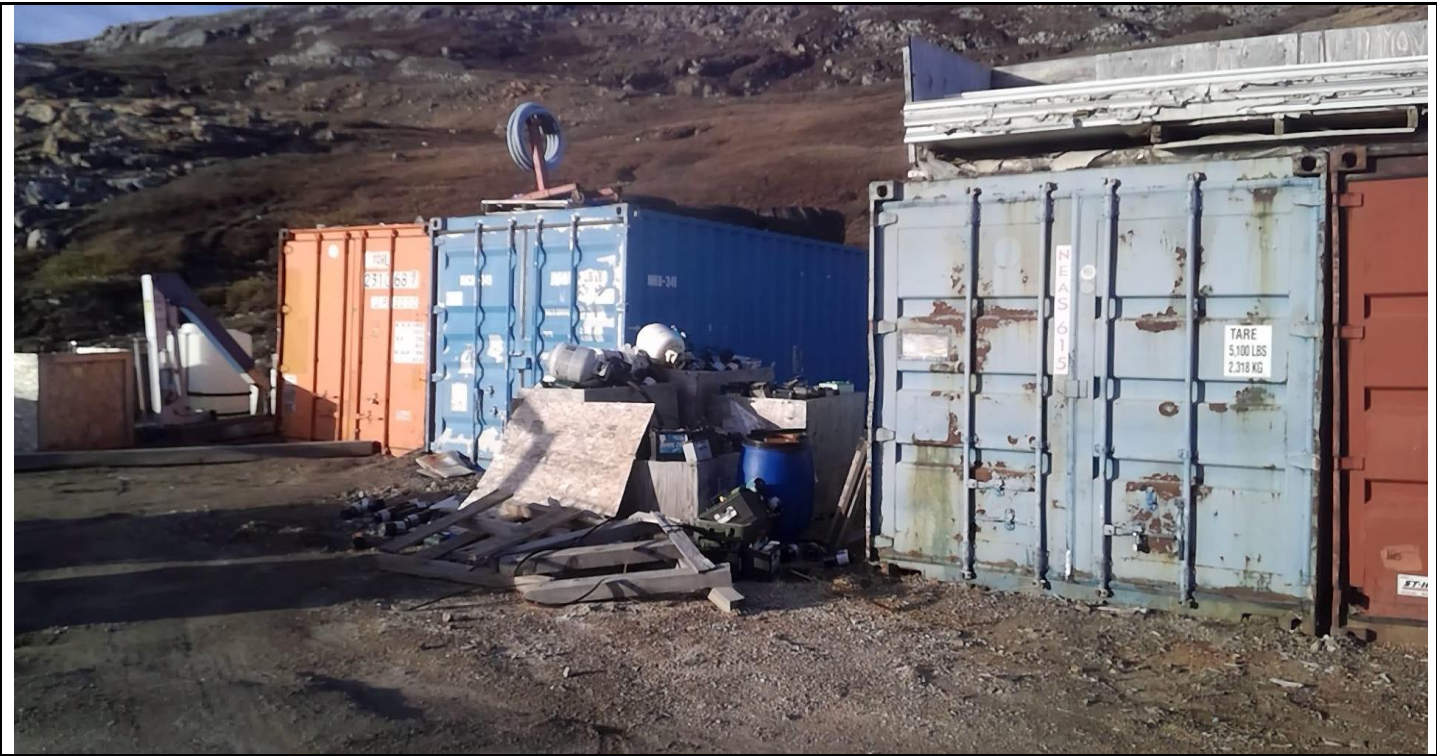
Photo 7

Description: Sea cans filled with Hazardous waste drums of used oil.

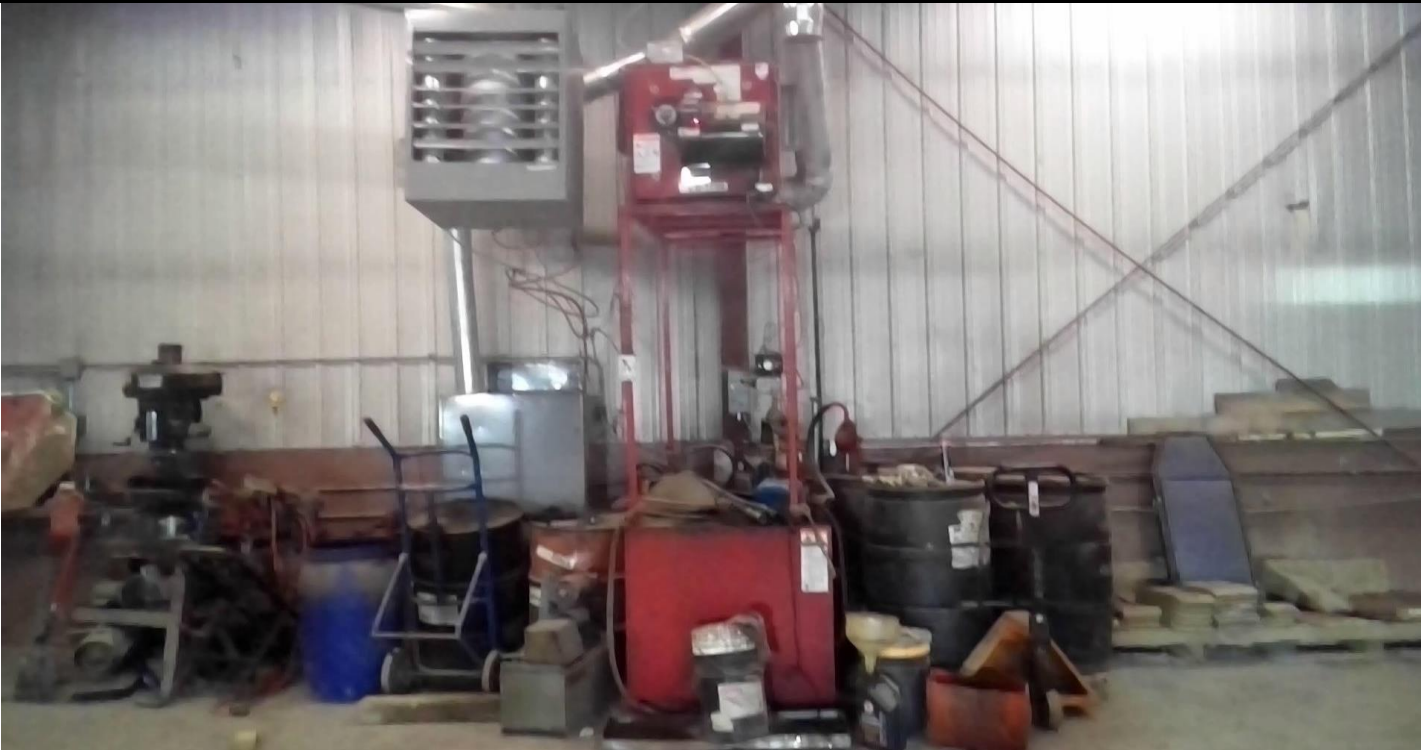
Photo Log	Location
Photo 10	Municipal Garage, Kimmirut, NU

The Hamlet of Kimmirut uses a waste oil burner to heat up the municipal garage. They store waste oil to use it for their oil burner (photo 10).
11.

Description: Waste Oil Burner in municipal garage. Out of commission requires request maintenance to operate.

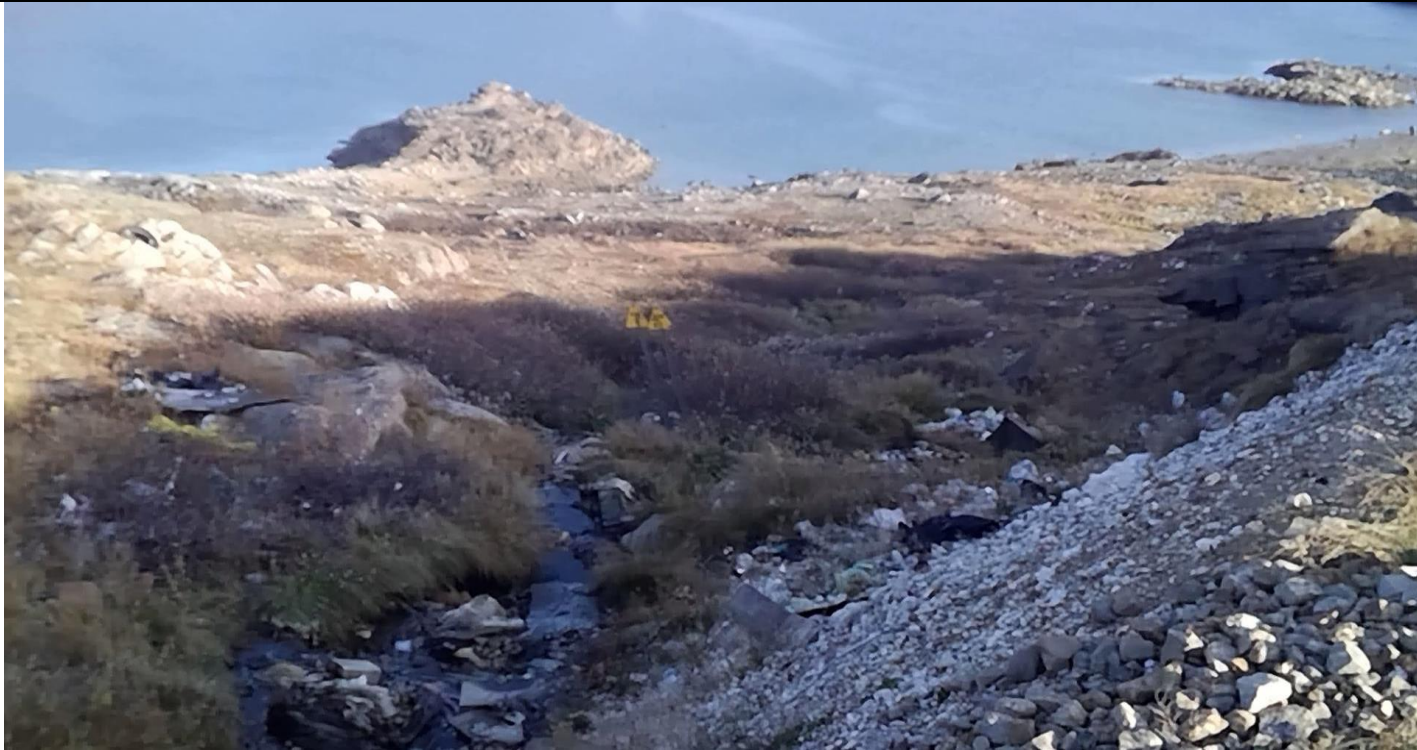
Photo Log	Location
Photo 11	Sewage Discharge, Kimmirut, NU

Garbage blown from the Solid Waste Disposal Facility was observed within the drainage ditch of the Wastewater Discharge Location. Tires were deposited to the site (photo 14).

There are two monitoring stations at the along the discharge route titled KIM 2 & 3 (photo 11). No sampling was conducted at the time of the inspection. Last sample taken on June 29, 2020
14.

Description: Monitoring Stations “KIM 2 & KIM 3”, wind blown garbage carpet the sewage drainage ditch.

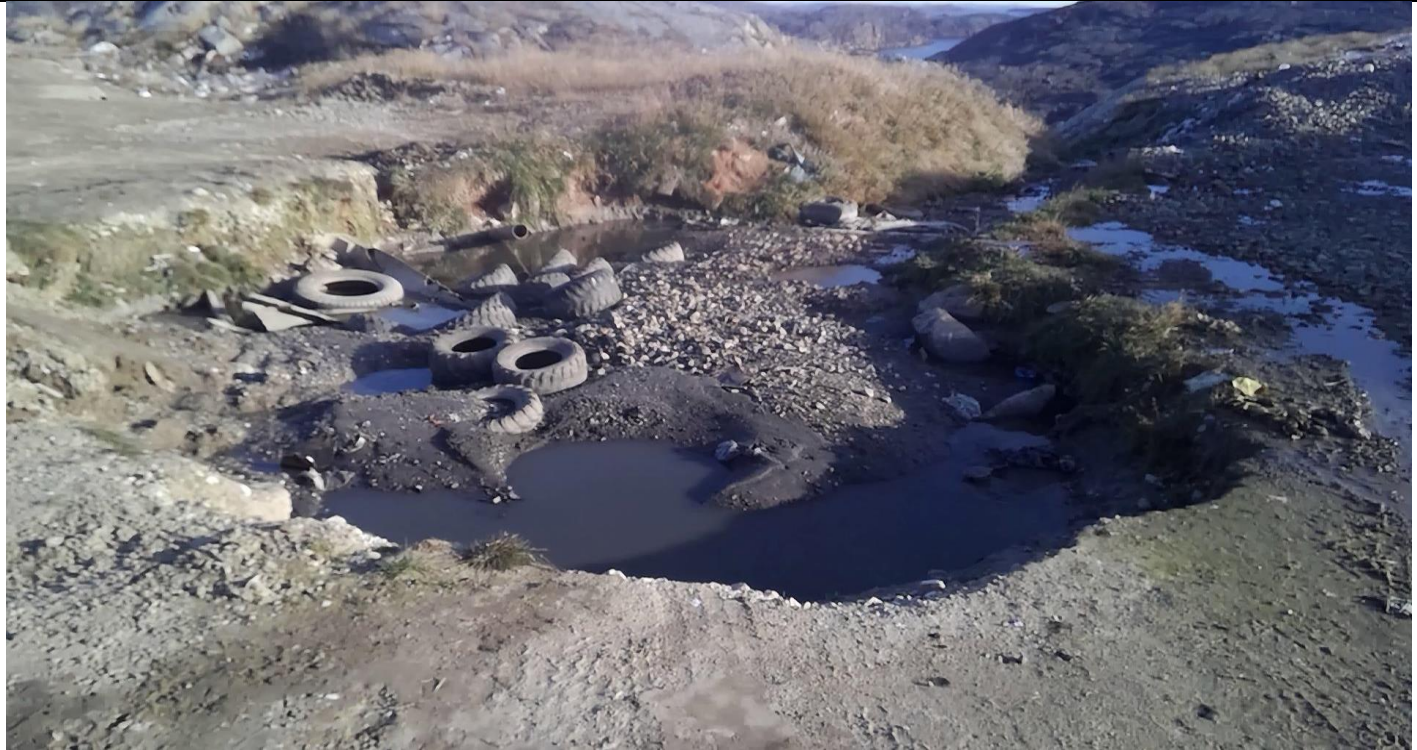
Photo 12

Municipal Wastewater is being discharged at a location approximately 300 metres from the ocean (photo 12). The wastewater flows over land before it enters the ocean. During a discharge the wastewater runs along the ditch and mixes with the rainfall and fresh water run-off during the freshet while migrating down to fresh water ponds and streams that runs along the base of the mountain ahead its final deposit to the receiving marine environment.
13.

Description: Sewage Discharge Location. Hamlet employees discharge sewage into drainage ditch.

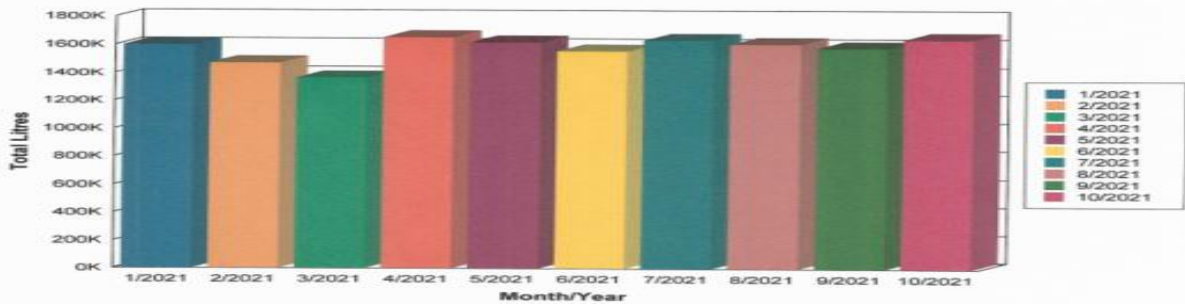
Photo 13

On November 16, 2021 The Senior Administrative Officer (SAO) Joseph Stephen Mabberi provided, WRO Joseph Monteith a copy of the water consumption rates for the Hamlet of Kimmirut for the Months of Delivery Summary By Month and Year – Date range from Jan. 1, 2021 to Oct. 31, 2021. Grand total 15748619.31 Litres withdrawn from Fundo Lake (photo13) .
5.

Description: Delivery Summary By Month and Year – Date range from Jan. 1, 2021 to Oct. 31, 2021. Grand total 15748619.31 Litres withdrawn and delivered to Municipal clients.
