YEAR BEING REPORTED: 2021

The following information is compiled pursuant to the requirements of Part B, Item 1 of Water Licence # 3BM-KIM1929 issued to the Hamlet of Kimmirut.

WATER LICENCE INSPECTION FORM

On September 27, 2021, an inspection by Water Resource Officer (WRO) Joseph Monteith was conducted at the Hamlet of Kimmirut, Qikiqtani Region, Nunavut.

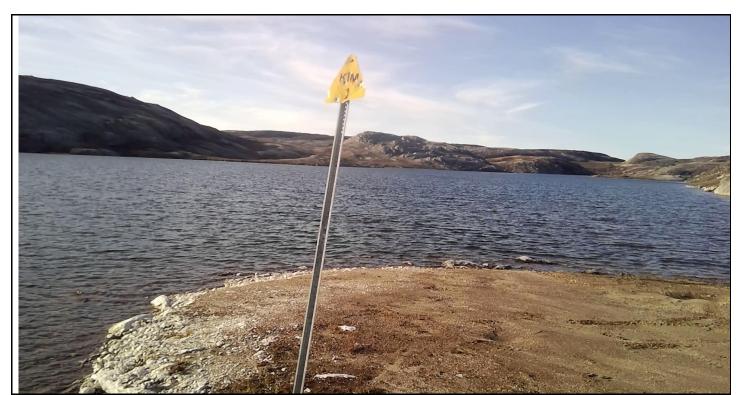
11101010			
Date	Camera	Inspector	
June 30, 2020	Nikon Coolpix	Joseph Monteith	
Photo Log #		Location	
Photo 1		Kimmirut, NU

- 1. Water is being withdrawn from Fundo Lake(photo 1) from a water pumping station (photo 2).
- 2. The quantity of water withdrawn from the lake is being accounted for by calculating the amount of water being delivered. Water meter is broken
- 3. Road washing out, and into Fundo Lake (photo 3).

Description: KIM 1 monitoring site at Fundo Lake water source

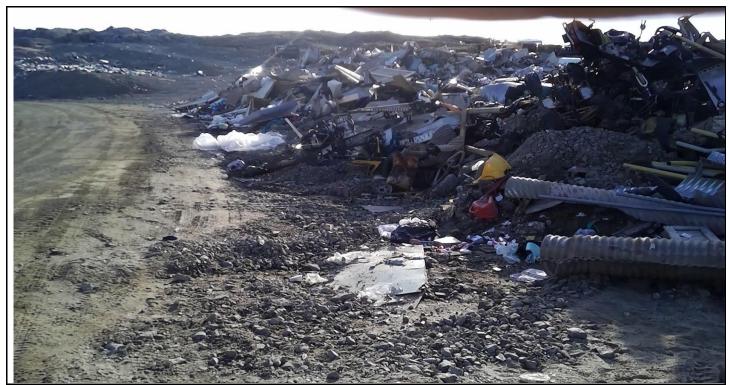
- 9. During the inspection it was observed that the hazardous waste was located at two locations. The Solid waste facility which had the hazardous waste exposed to the elements (Photo 5). At the municipal garage Hazardous Waste is stored within sea cans behind the municipal garage. At the time of the inspection some of the hazardous waste was taken out the sea cans, so that sea-cans can be cleaned (Photo 7,8,&9).

Description: With the exception of domestic burning and capping waste, all other waste such as bulk wood, bulk metal, hazardous waste, and gravel have been deposited into the pile along the road. The trench the direct any leachate from the pile was covered as directed in 2020.

- -maintain and complete the construction of fencing to contain all wastes permanently in the Solid Waste Facility;
- -install signage to notify the public that there are dangerous hazardous wastes on site;
- -consider an amendment to the water license to have all hazardous waste stored at the Municipal Garage;
- -build a berm to limit the amount of water entering in the hazardous waste facility, and taking the hazardous waste with it;
- -install Spill Kits next to the hazardous waste facility to properly clean up spills;
- -consider building a trench to mitigate the road from washing out at KIM 1 monitoring station, and the deposit of sediment into Fundo Lake.

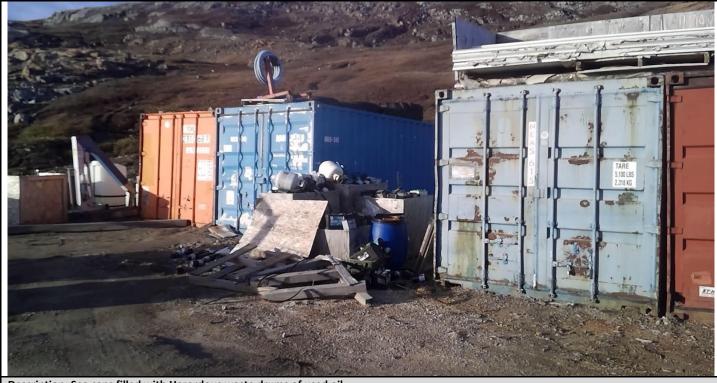
Photo Log	Location
Photo 7	Municipal Garage, Kimmirut, NU

Description: Sea cans filled with Hazardous waste drums of used oil.

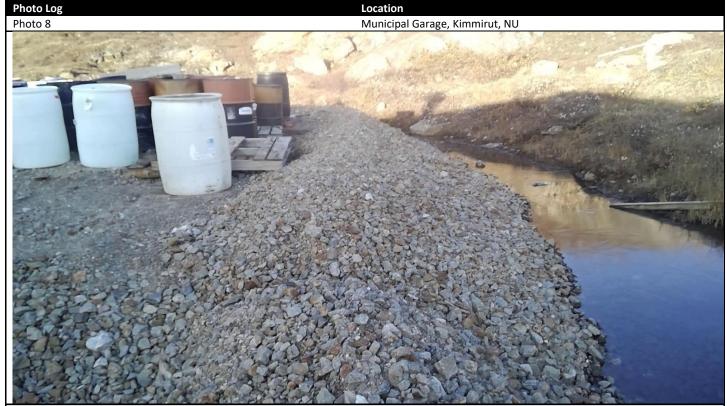
Description: some hazardous waste stored outside, exposed the outside elements. Used to fuel the oil burner in the municipal garage. Wall doesn't appear to be able to contain any liquid wastes

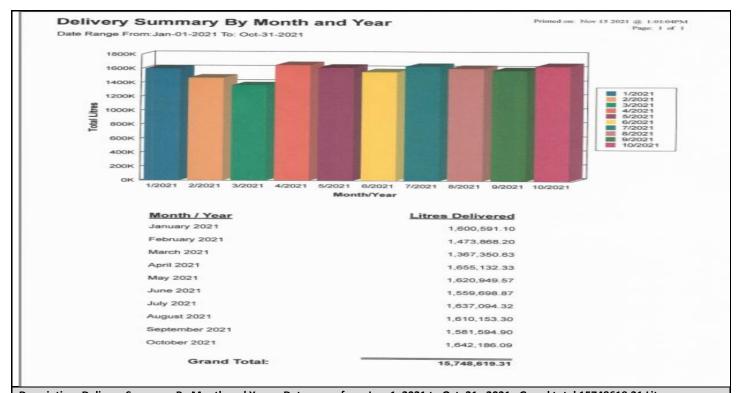
Kimmirut, NU

Description: Delivery Summary By Month and Year – Date range from Jan. 1, 2021 to Oct. 31, 2021. Grand total 15748619.31 Litres withdrawn and delivered to Municipal clients.
