RE: August 20, 2002 Municipal Water Use Inspection - Report

MUNICIPAL WATER USE INSPECTION REPORT

Licensee: Hamlet of Kugluktuk

Licence No.: N7L4-1526

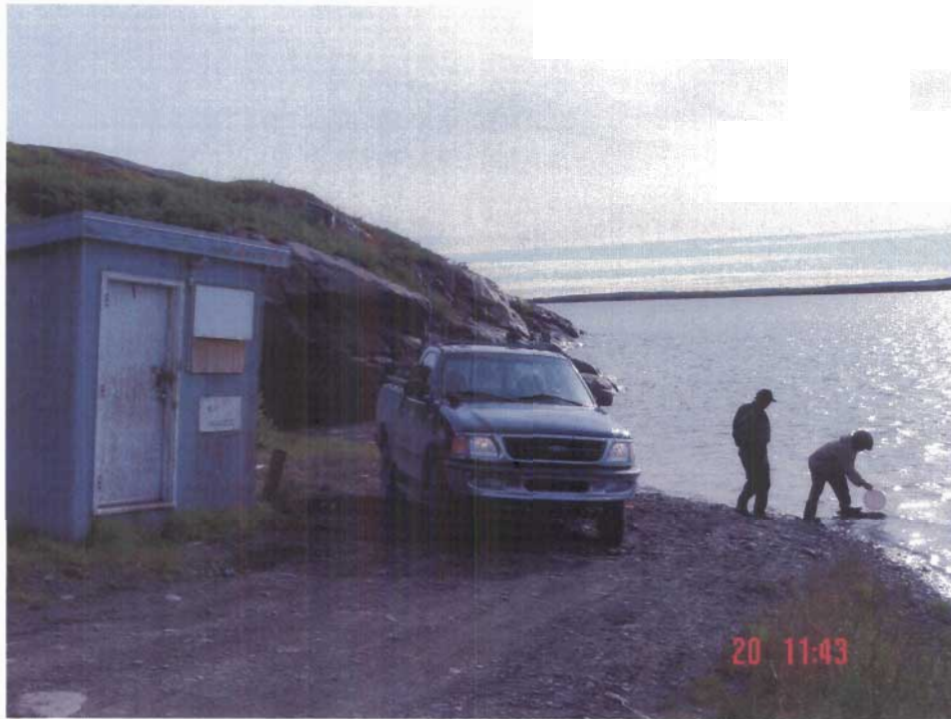
- ☐ **Water Supply:** The Water Intake Facility at the Coppermine River was locked and not accessible at the time of inspection (Photo 1). A gas powered pump was located within the water reservoir fence, no spill protection or spill equipment was located in the vicinity of the transfer pump (Photo 5). The Water Treatment Plant filtration system reportedly did not remove silt from the drinking water (Photo 3). The saline detector did not shut off the water pump when programed to do so. The chlorination system was operational at the time of inspection (Photo 4). The water tank at the Water Treatment Plant has considerable bracing on it (Photo 6). Analysis of samples taken at (SNP) 1526-1 the Water Intake Facility (Photo 1), are not available at this time due to damage incurred in the transportation of samples to the laboratory. Arraignments will be made to obtain water samples at the Water intake Facility. Analysis of these samples will be forwarded, once received by the Water Resources Officer.

Photo # 1 Potable water supply Coppermine River intake pumphouse. Intake about 150 feet off shoar.

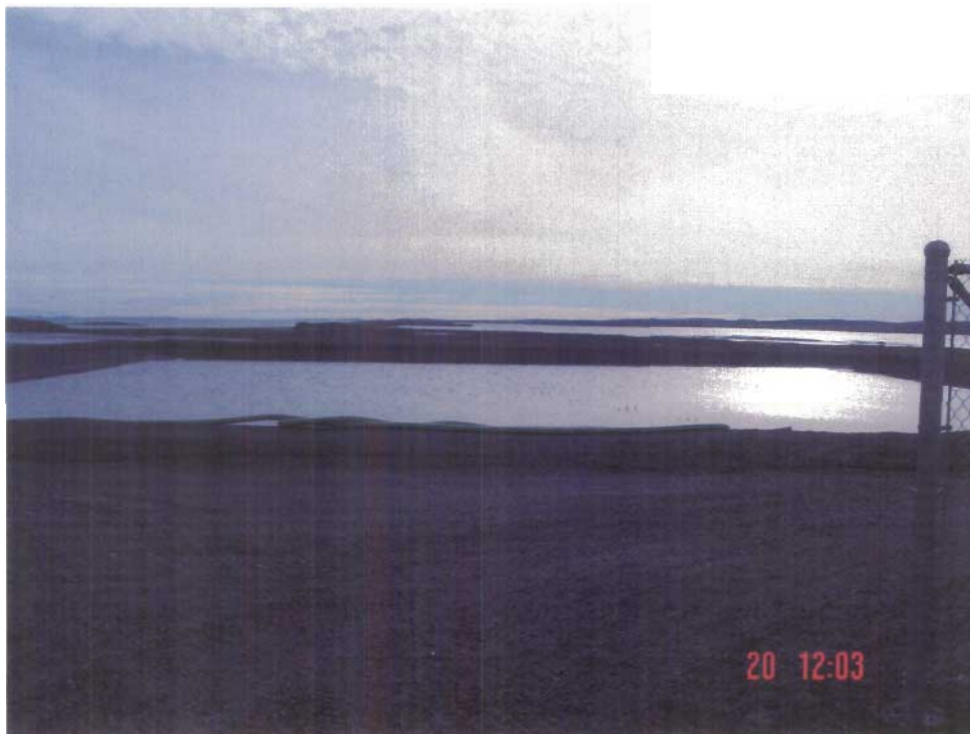
Photo # 2 Water reservoir at Kugluktuk located by Water Treatment Plant. Reservoir holds about 10 days supply for community.

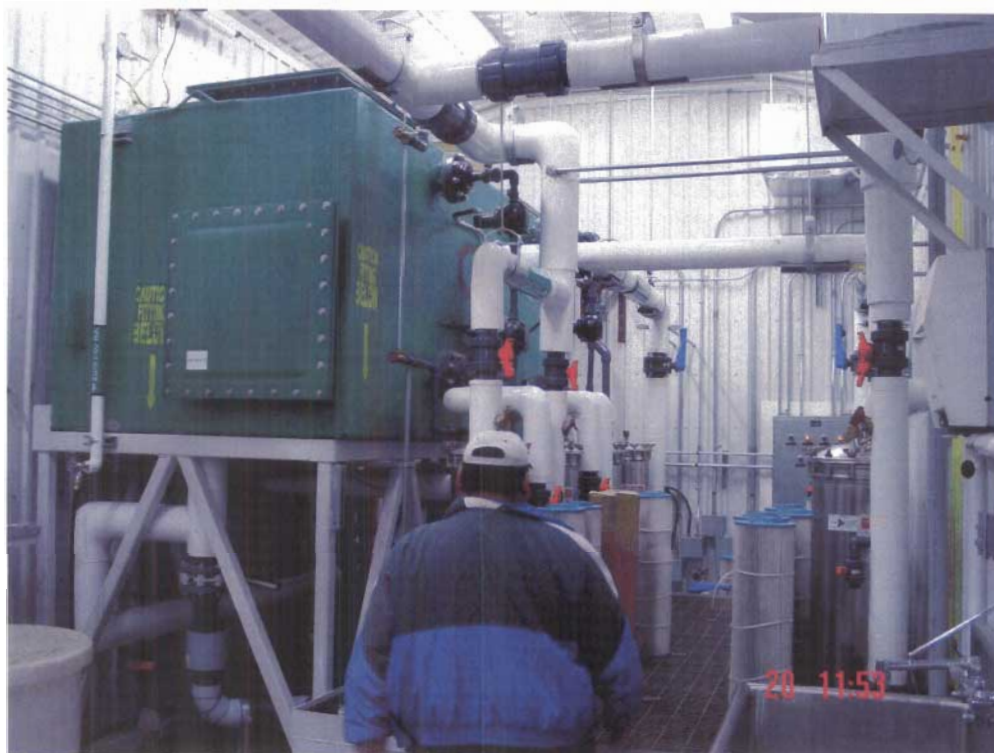
Photo # 3 Filtration system shown in Water Treatment Plant. Filters unable to remove silt from drinking water.

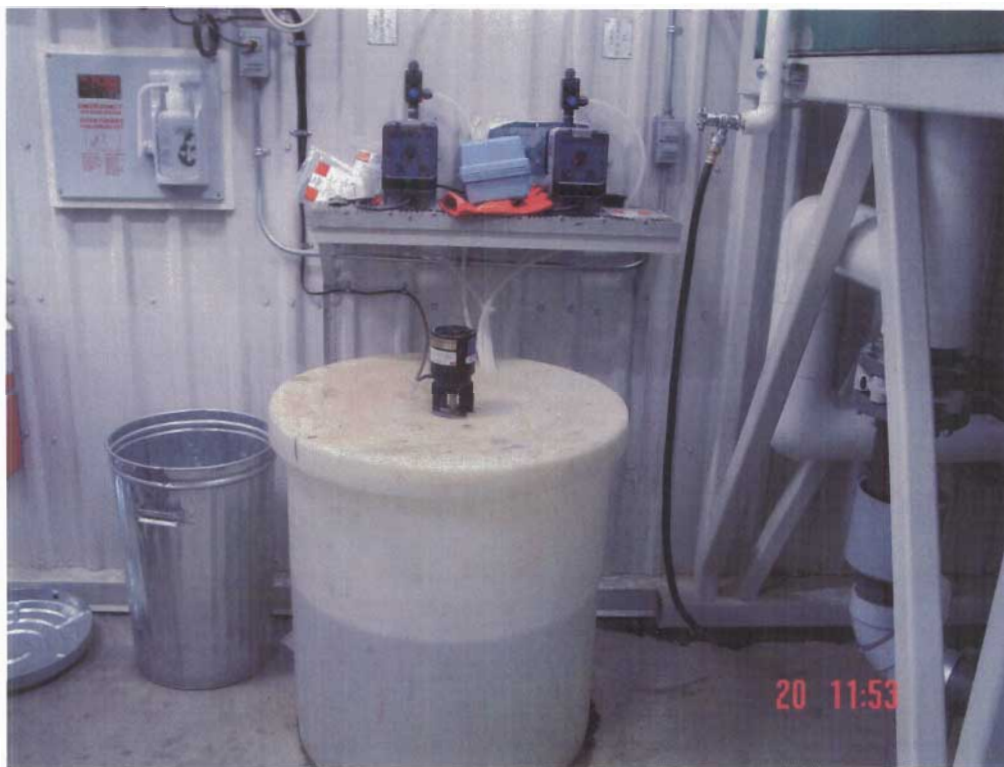
Photo # 4 Chlorination system in use at Water Treatment Plant. No formula found for concentrated chlorine mixture; Log book up to date.

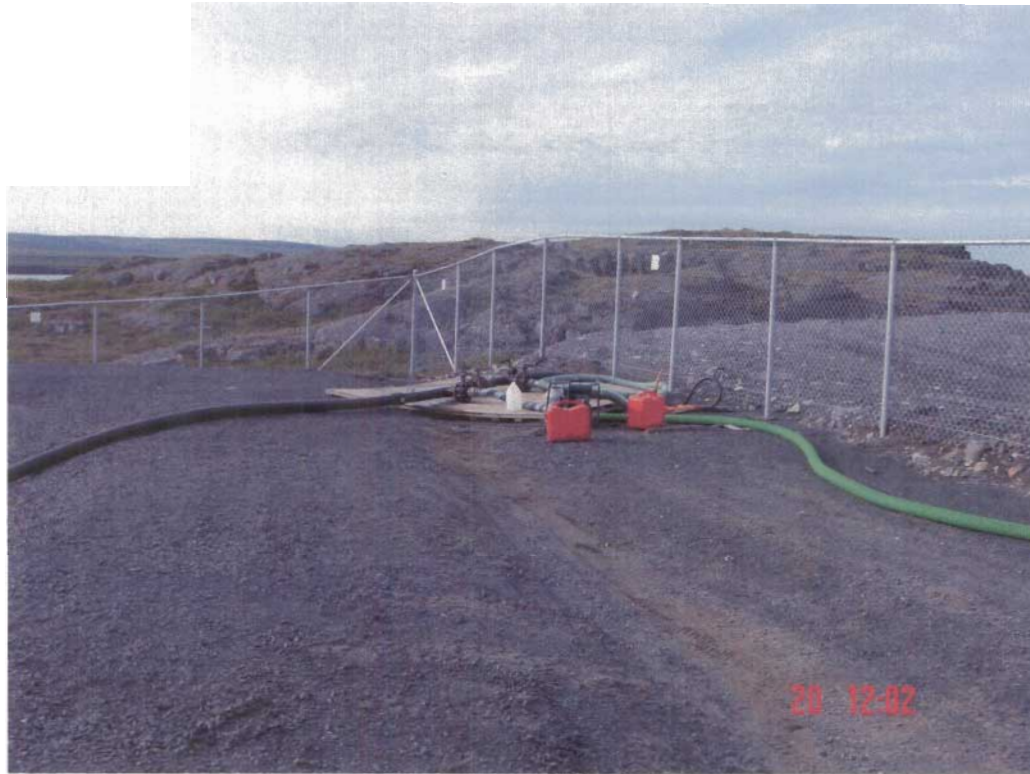
Photo # 5 Hoses shown filling water reservoir. Fuel containers shown within reservoir fenced area.

- ☐ **Non-Compliance of Licence:** Waste batteries and waste oil should be stored in an area with spill protection. No Annual Reports have been submitted for 1997, 1998, 1999, 2000 & 2001. The Hamlet of Kugluktuk had not submitted plans for construction at the Sewage Lagoon or relocation of the Water Intake Facility conveyance line as required under the *Nunavut Land Claims Agreement* and the *Nunavut Waters and Nunavut Surface Rights Tribunal Act*.

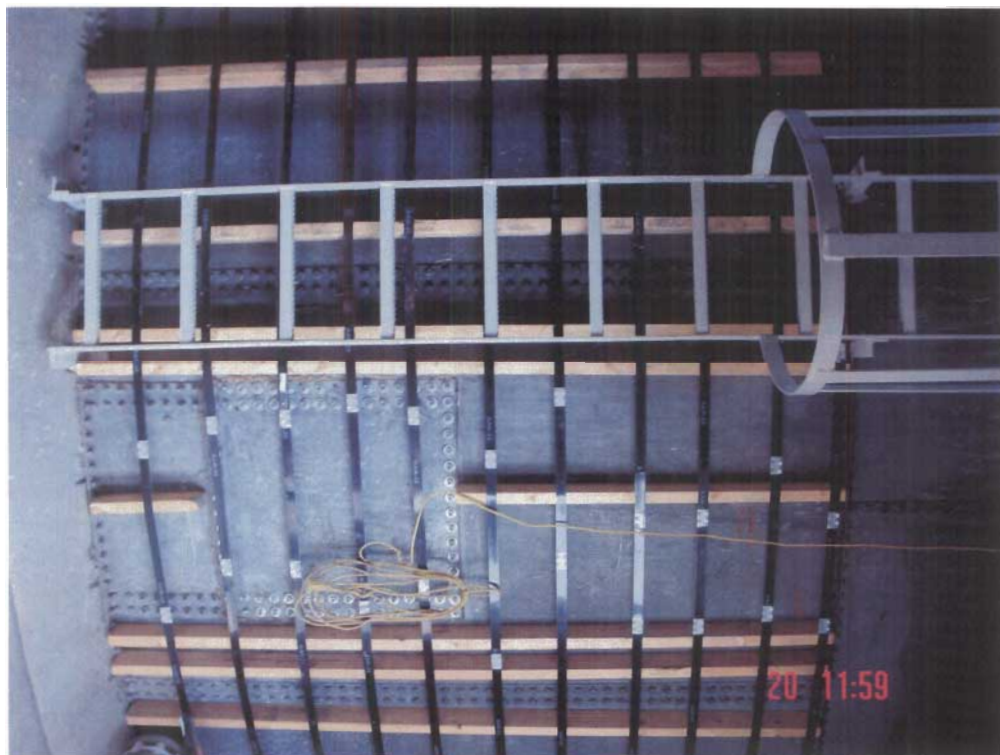
Photo # 6 Storage tank shown adjacent water treatment facility.

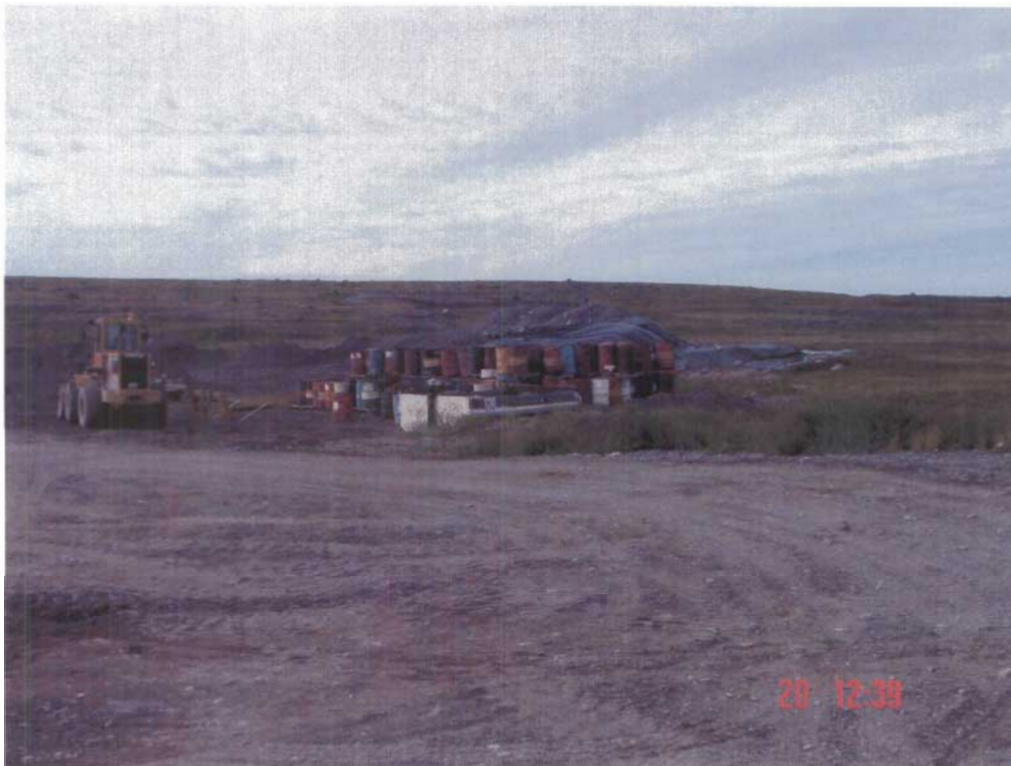
- ☐ **Solid Waste Disposal:** The totally fenced Solid Waste Treatment Facility, seemed well managed at the time of inspection. Burning of refuse is practiced on a regular basis at the dump (Photo 12). Although short, the dump perimeter fence seems to work fairly well at reducing the amount of wind blown garbage at the Solid Waste Disposal Facility. Contaminated soil is remediated at the Land Farm. It appears that contaminated soil is placed on a liner, some soil is covered with a poly material to reduce water infiltration (Photo 7).

Photo # 7 Waste oil storage area shown next to contaminated soil remediation area.

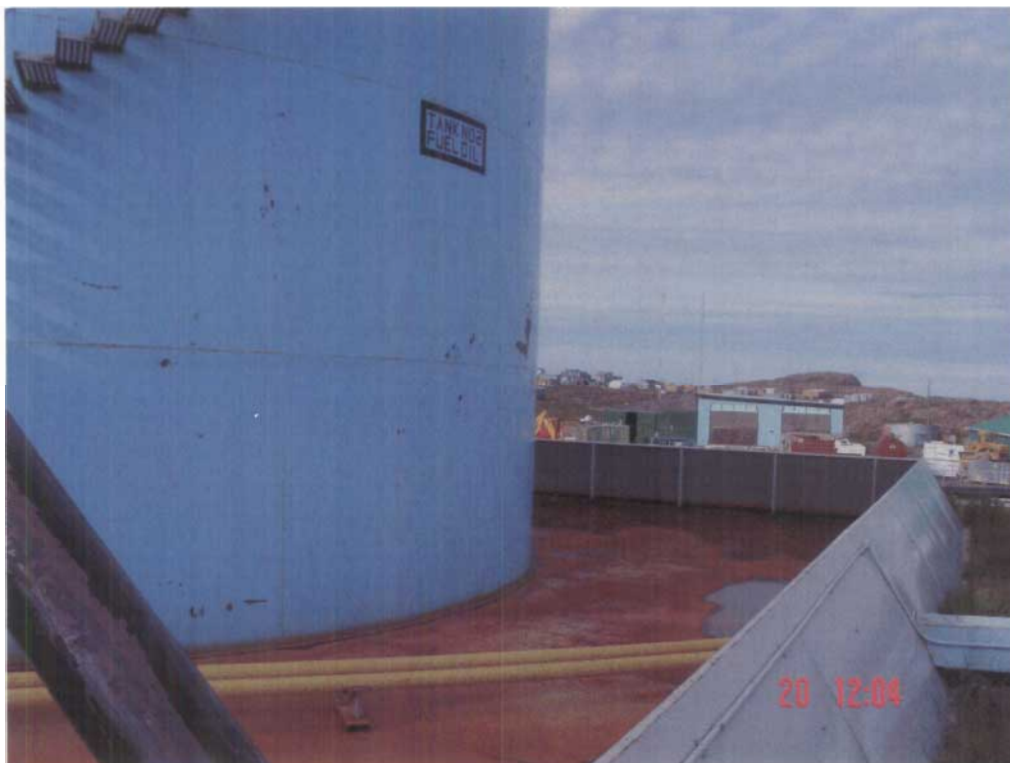
- ☐ **Fuel Storage:** At the time of inspection, the steel berm surrounding the Tank Farm appeared to be in good condition with no leaks. The area within the tank farm berm was mostly dry with no staining fuel or oil (Photo 8).

Photo # 8 Tank farm shown with metal berms no leakage noted; tank farm within 50 metres of water reservoir.

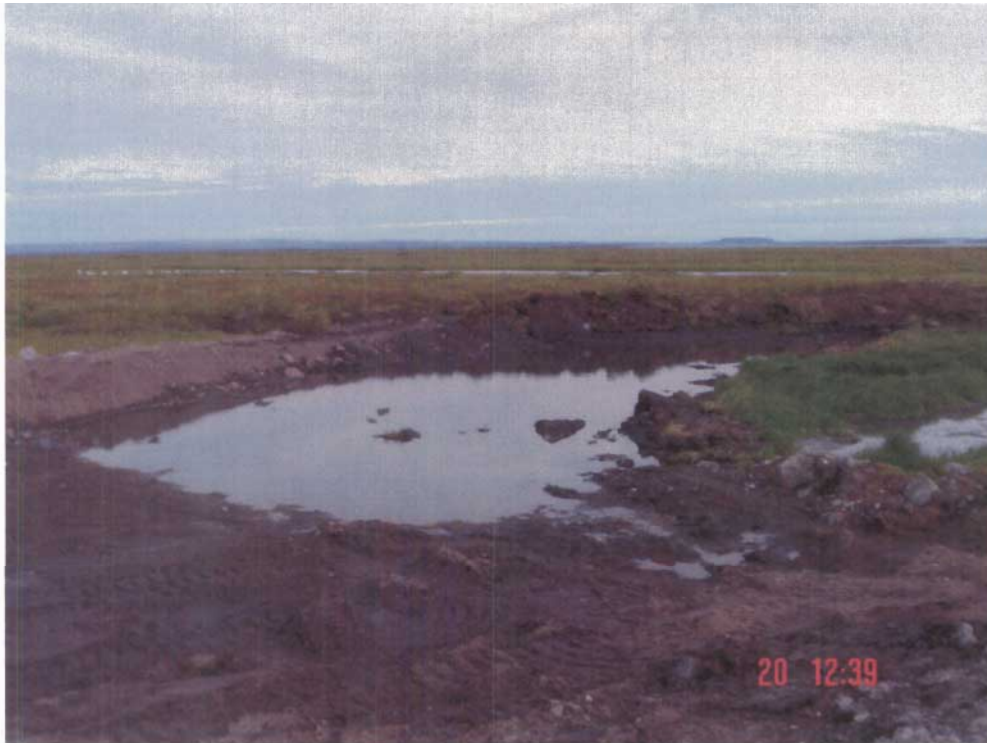
- ☐ **Sewage Disposal:** At the time of inspection, the sewage lagoon had recently undergone some expansion and reinforcement to the berm (Photo 9 & 10). The sewage effluent travels through a wetland area to a creek that discharges to the ocean (Photo 9 & 11). Enclosed analysis of sewage effluent from the Sewage Lagoon (SNP) 1526-2, indicate that Total Suspended Solids (20 mg/L vs 120

Photo # 9 Construction shown at Sewage Treatment Facility.

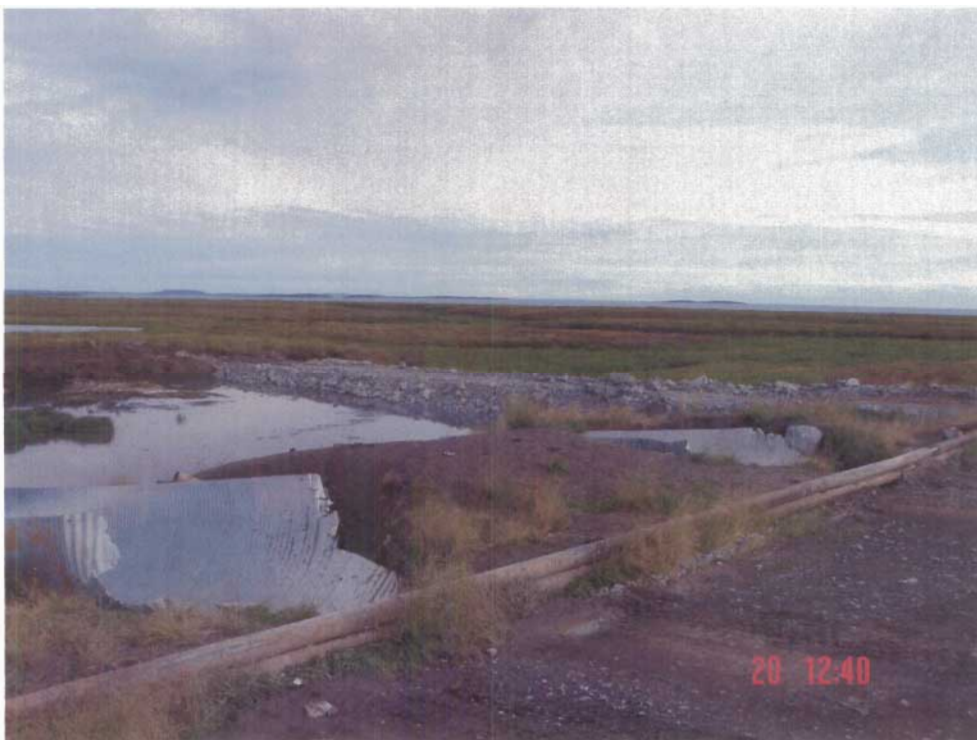
Photo # 10 Sewage truck discharge structure at sewage treatment facility; seepage berm shown to the right.

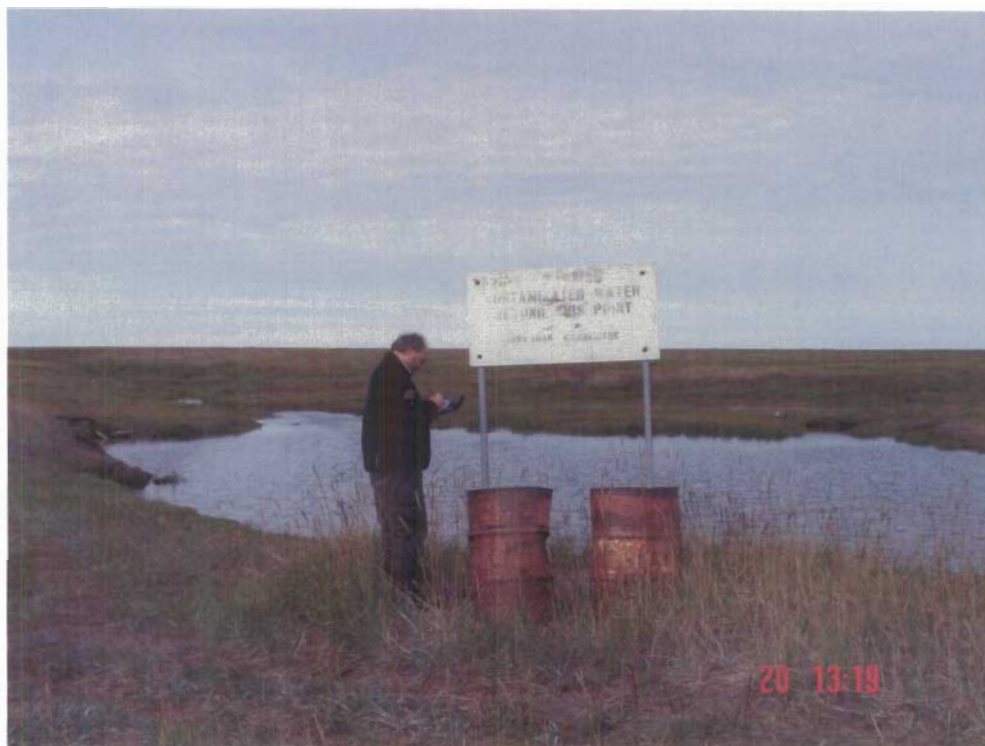
Photo # 11 Location of sewage sample; 50 metres from ocean.

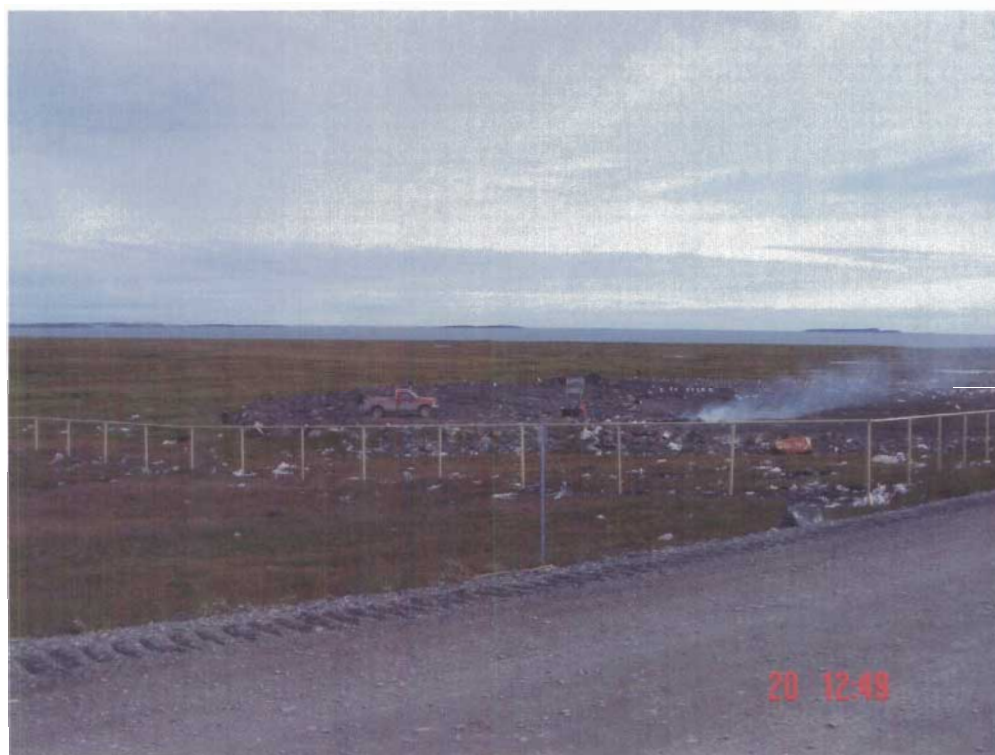
Photo # 12 Solid Waste Disposal Facility; fence in good condition but appears to be low.

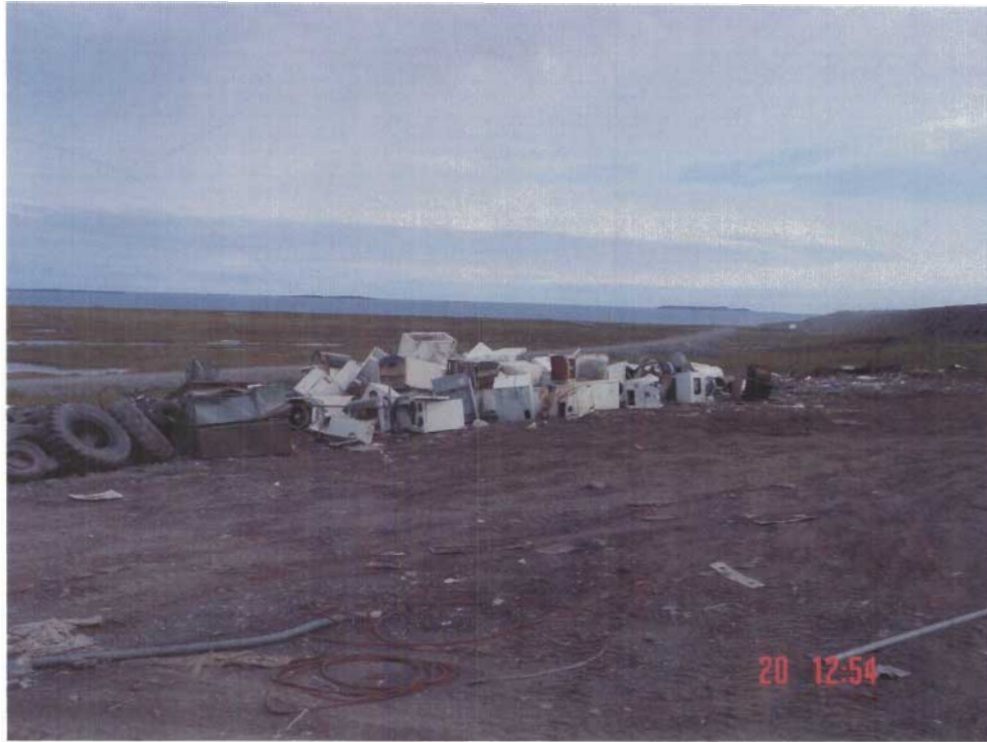
- ☐ **Bulky Metal Waste Disposal Site:** The bulky metal dump is located across the roads from the garbage dump (Photo 13). Hazardous materials (waste batteries) were noticed mixed in with general scrap, at the bulky metal dump (Photo 14). The hamlet was in the process of reorganizing the bulky metal dump at the time of inspection.

Photo # 13 Segregation of waste in progress at bulky metal.

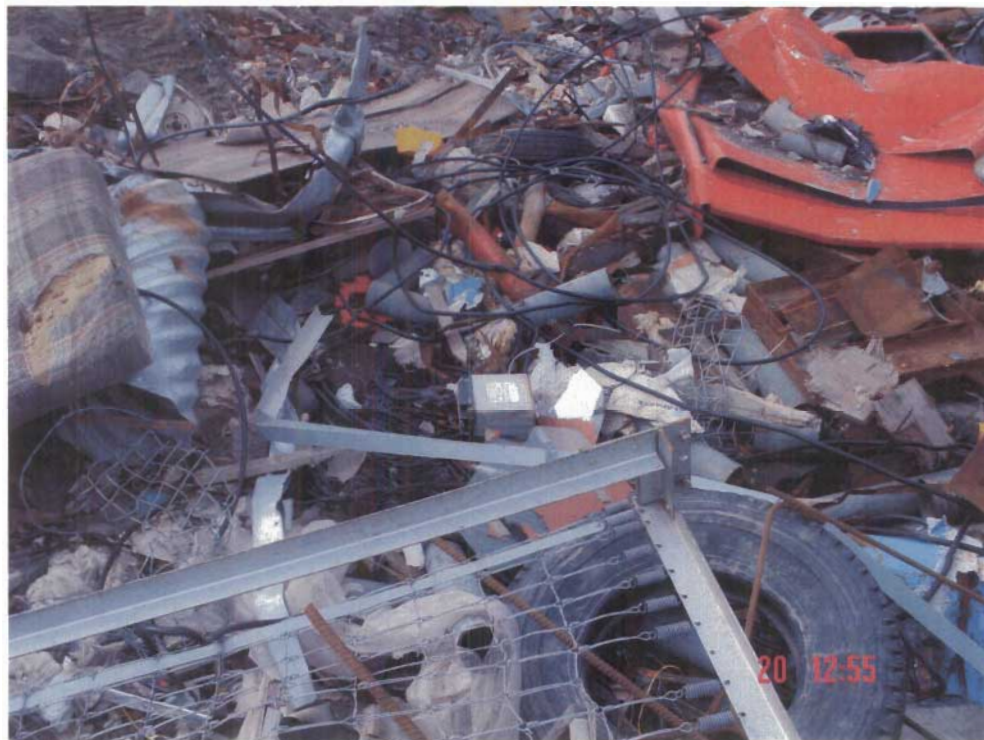
Photo # 14 Hazardous material (batteries) shown not segregated from bulky metal wastes.
