RE: August 3, 2003 Municipal Water Use Inspection Report

Kugluktuk Inspection 2003

MUNICIPAL WATER USE INSPECTION REPORT

Date: August 3, 2003 Licensee Rep. (Name/Title): Cal Shaw / SAO
Licensee: Hamlet of Kugluktuk Licence No.: N7L4-1526

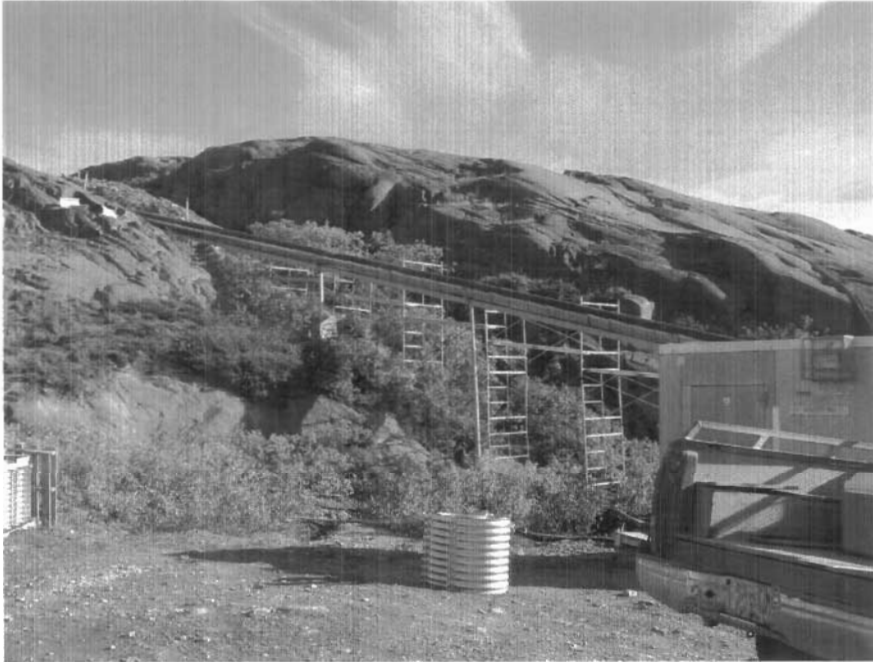
Photo 1. New water conveyance line under construction.

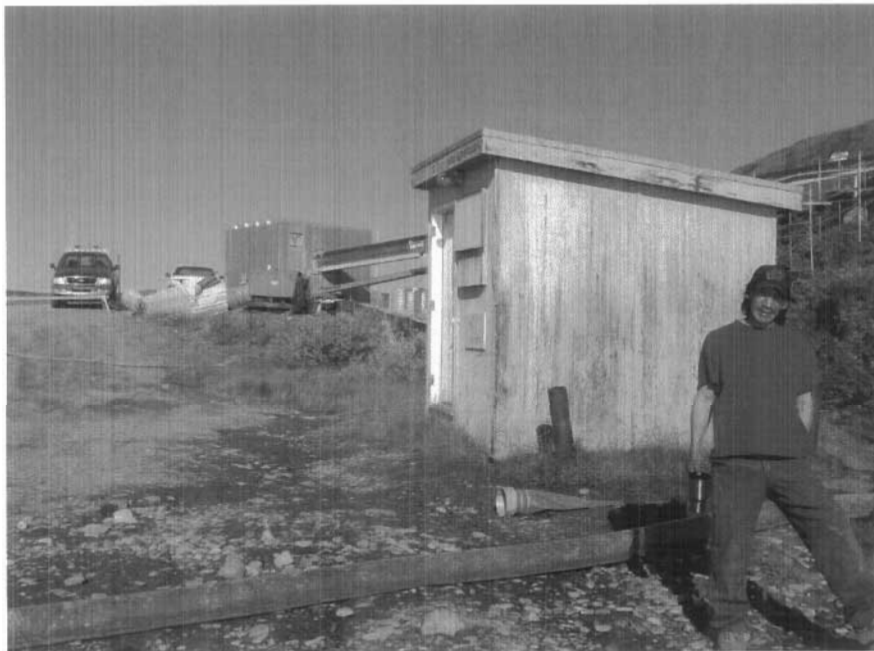
Photo 2. Temporary water intake line.

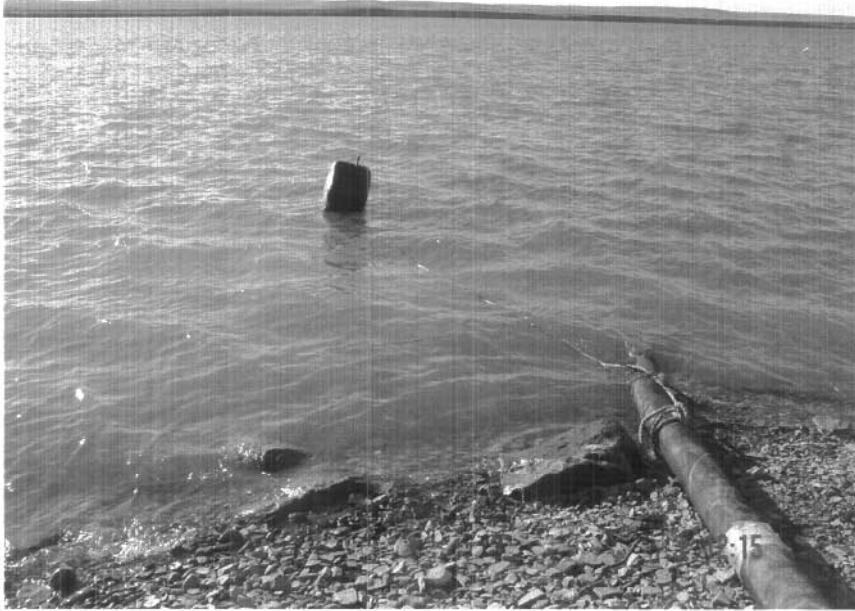
The Licencee does obtain all fresh water from the Coppermine River (photo 3). No annual quantities of withdrawn water have been submitted to verify the 70,000 cubic metre maximum allowable limit. The municipality was in the process of relocating the conveyance line from the New Coppermine River Water Intake Facility to the Water Treatment Plant (photo 1-6). The auxiliary intake pump and conveyance line were in use during the Inspection. The Water Treatment Facility was in good operational condition (photo 7-9). The gas powered water pump was not equipped with secondary containment or a spill kit (photo 10 & 11).

Photo 3. Auxiliary water intake, in use while construction is under way to permanent conveyance line, water sample 67.4911.8 W 115.0458.2.

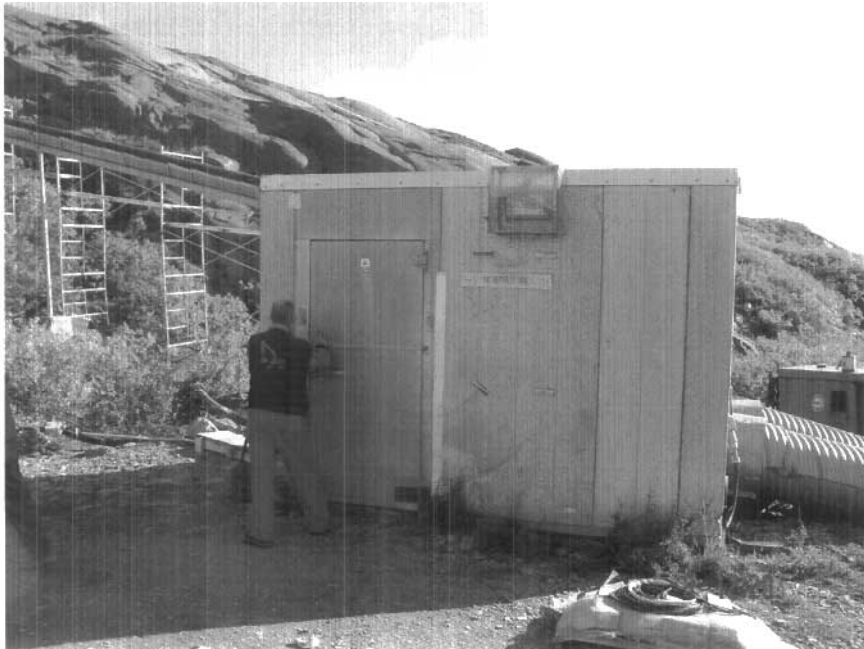
Photo 4. New water intake facility, not yet in use.

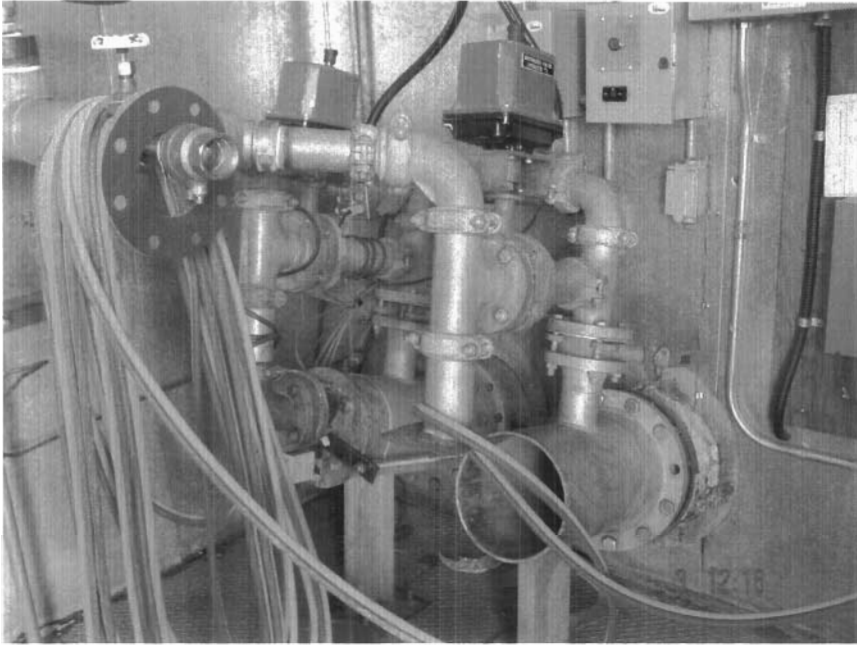
Photo 5. Interior of new water intake facility, piping for intake pump shown.

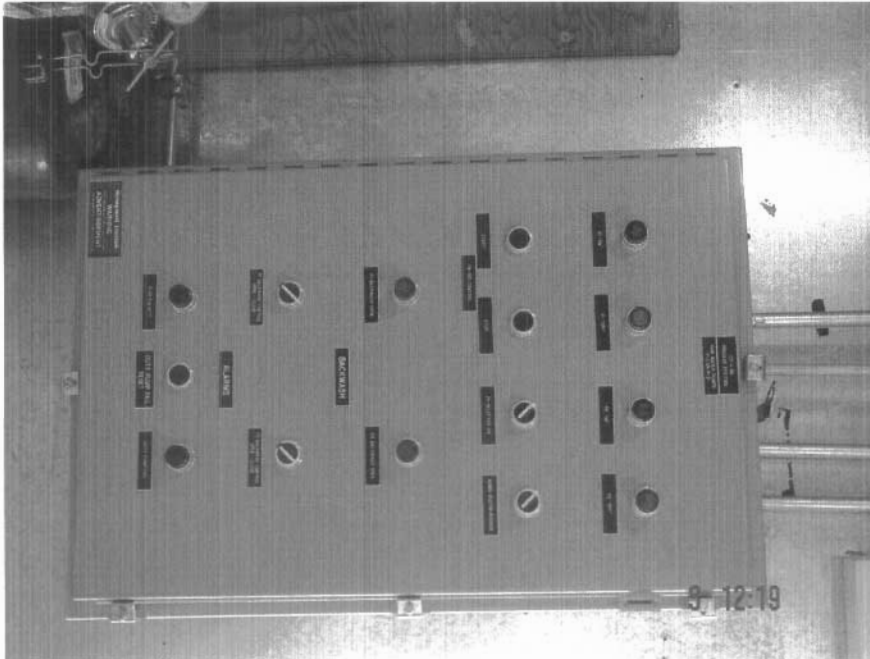
Photo 6. Control panel of new water intake facility.

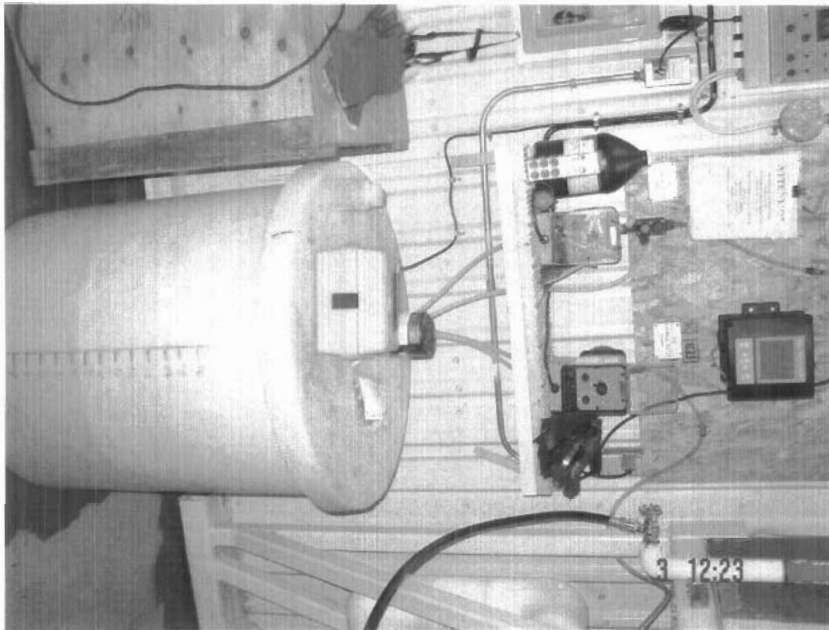
Photo 7. Saline detector programmed to stop salt water from entering reservoir.

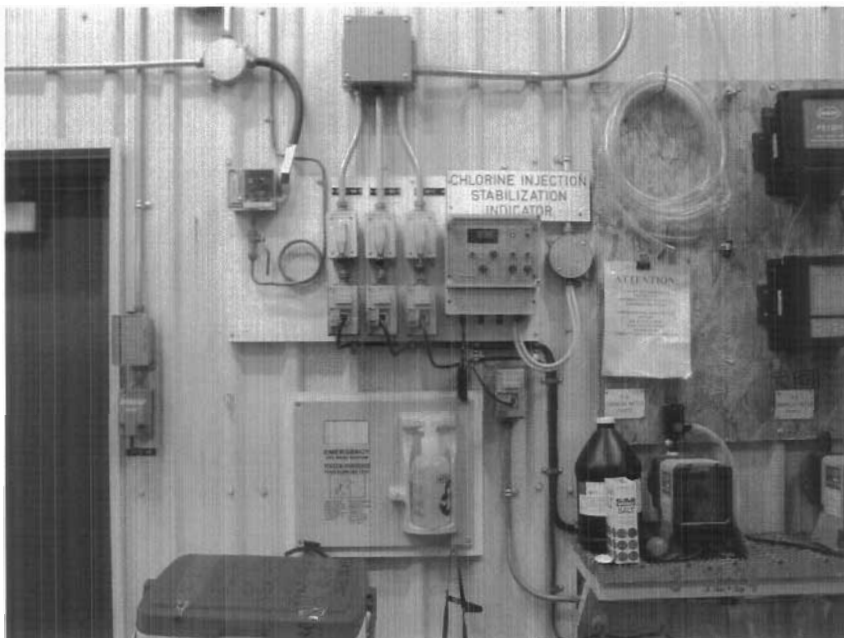
Photo 8. Chlorination system at water treatment plant.

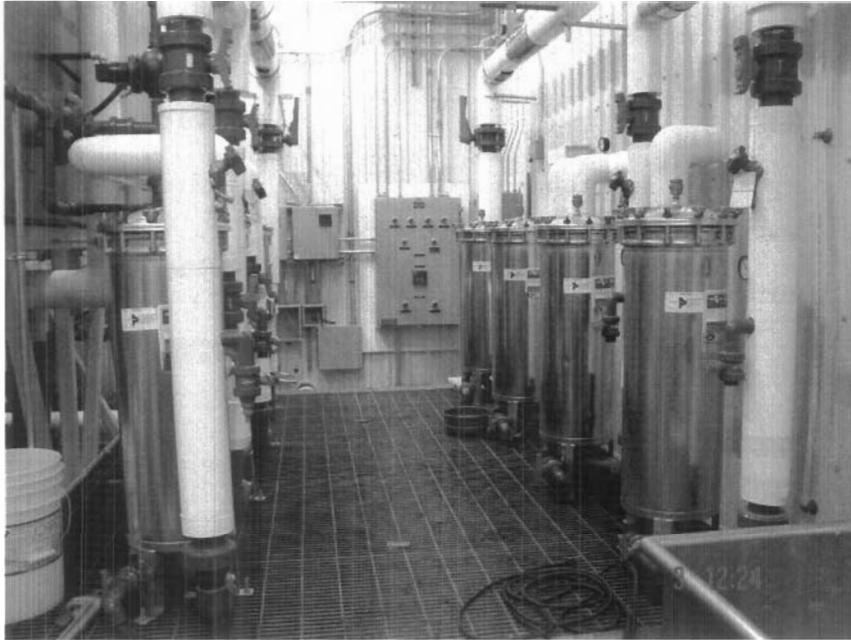
Photo 9. Filtration system at water treatment plant.

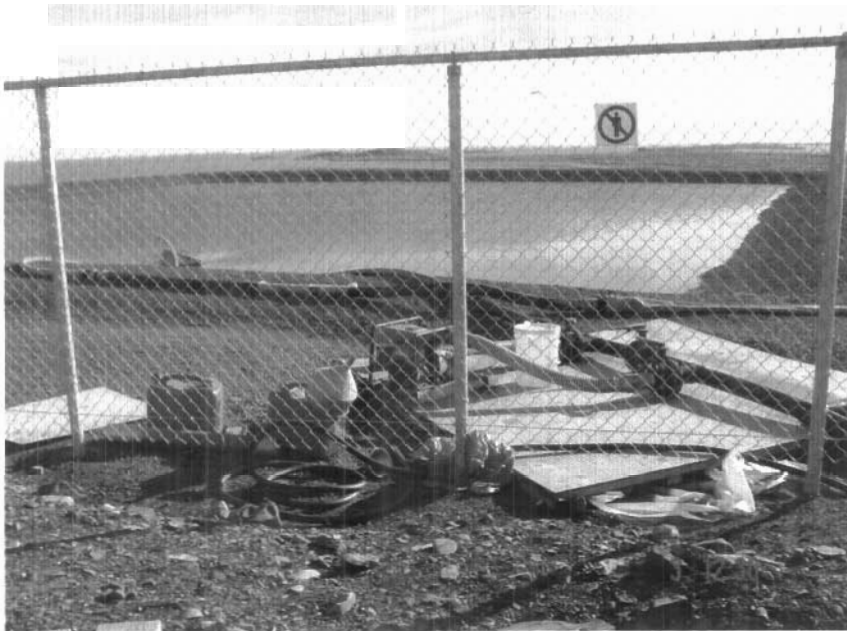
Photo 10. Water reservoir gas powered water supply pump within berm.

Comments: The conveyance line from the Coppermine River Water Intake Facility to the Water Treatment Plant was in the process of being relocated. The Water Intake Facility and pump have also been replaced but were not yet in service during the inspection. The Water Treatment Facility was clean and operational. The fenced Water Resivour berm and liner are in good condition. There was a gas powered pump located within the Reservoir berm. There is no fuel spill equipment located in the vicinity of the gas pump, this should be provided.

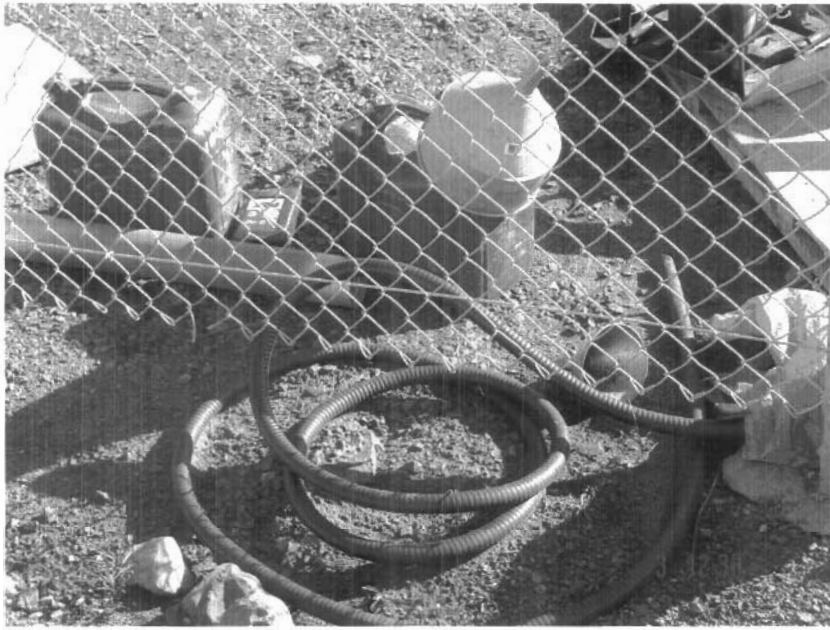
Photo 11. Gas supply for water supply pump with no spill protection or spill kit..

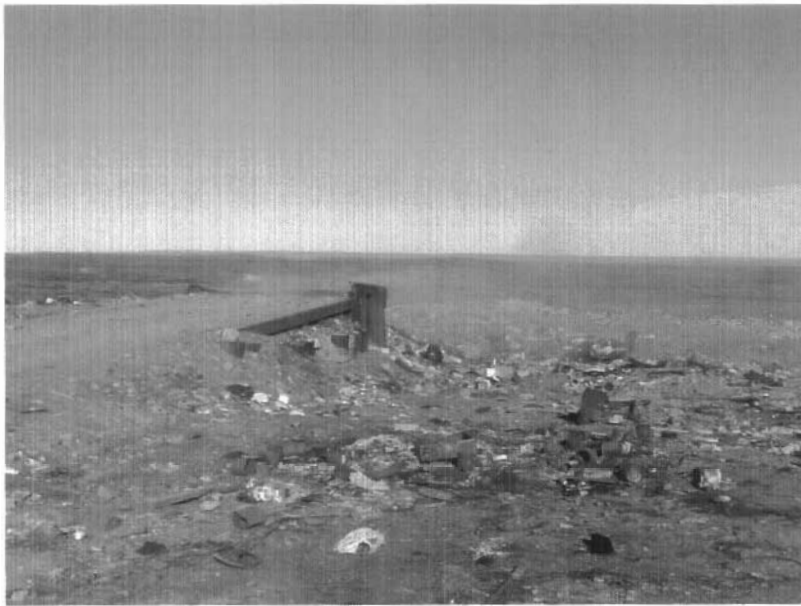
Photo 12. Garbage truck dumping structure at Solid Waste Disposal Facility.

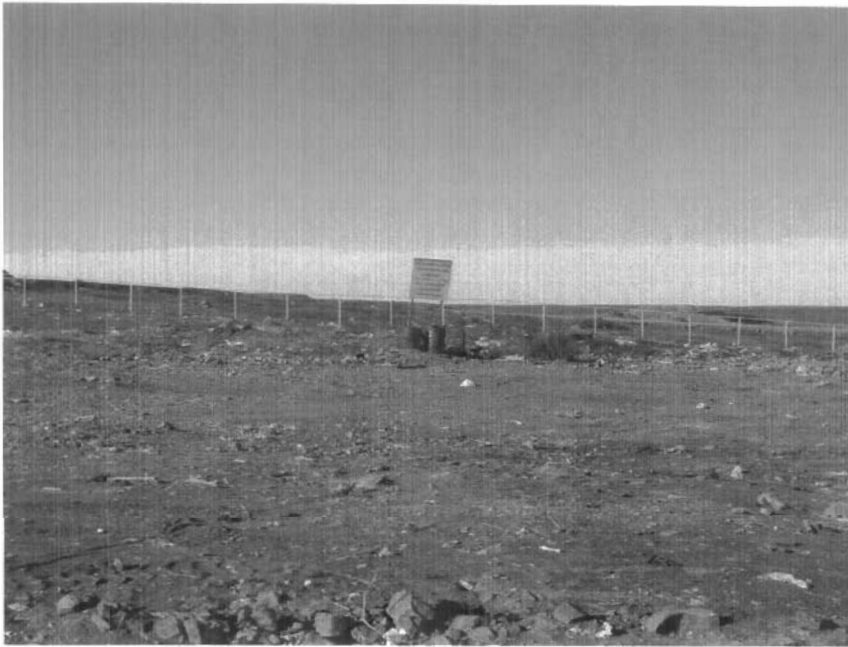
Photo 13. Sign at Solid Waste Disposal Facility.

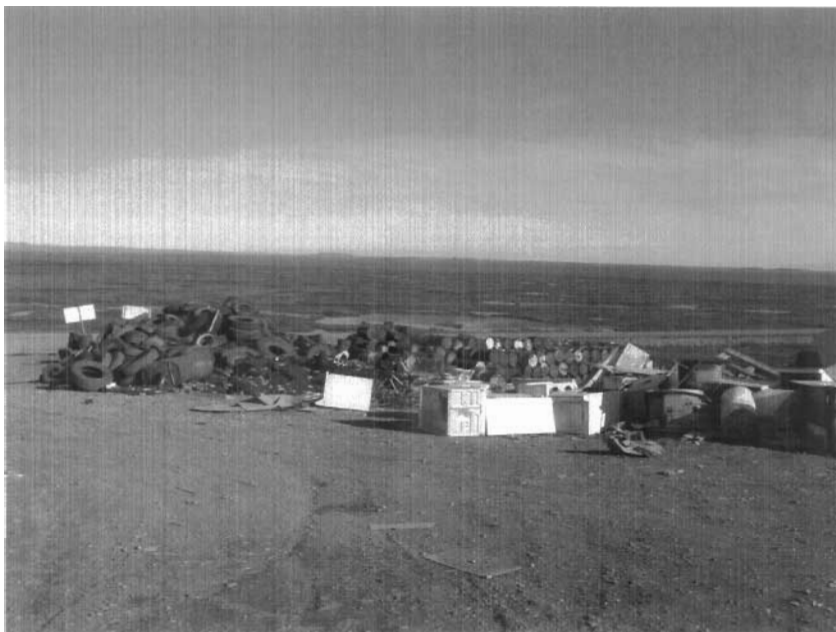
Photo 15. Metal dump. segregation of some waste shown.

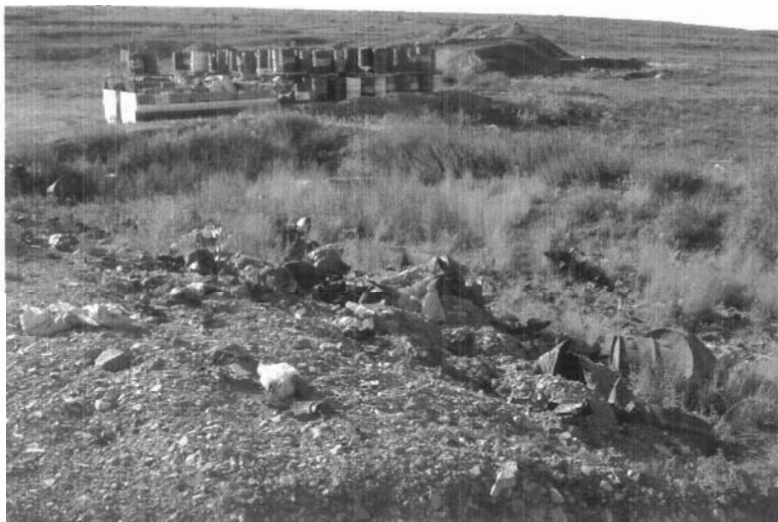
Phot 16. Land farm shown adjacent to waste battery and waste oil storage area.

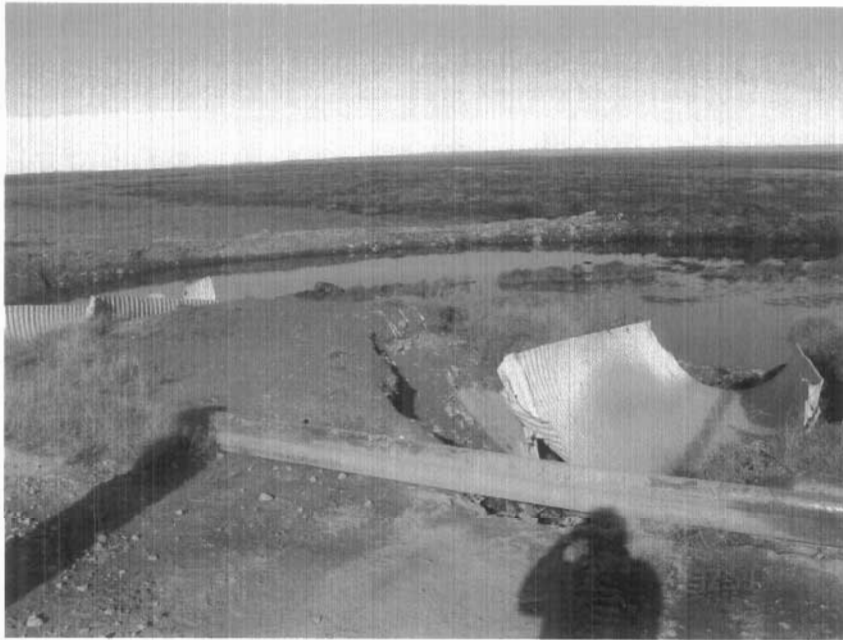
All pumped out sewage is deposited to the Sewage Disposal System (photo 19). The Licencee has not provided any plans with respect to the construction on the Sewage Lagoon in 2002 (photo 17 & 18)). The Sewage Lagoon had sufficient freeboard to accommodate the 2003 season. Seepage of the Sewage Lagoon was in excess of designed specifications. Due to the extensive wetlands the sewage effluent is exposed to considerable treatment is obtained prior to discharge to Ocean (photo 18 & 20). The disposal of graywater to overburden adjacent to dwellings was not noted. No bagged sewage was observed being used at this time. All solid waste is deposited in the Solid Waste Disposal Facilities. The metal dump is presently undergoing segregation of preexisting refuse (photo 15). The Solid Waste Disposal Facility is a fully fenced burn and burial operation (photo 13). The tipping face is well managed with the aid of a Truck Dumping Structure (photo 12). Minimal wind blown garbage was noted around the Solid Waste Disposal Facilities. Waste oil is stored adjacent to the land farm, this area is fairly well maintained with little visible oil staining and a geotextile impermeable line (photo 14). Waste batteries are stored in an open top box adjacent to the land farm (photo 16). All batteries are drained of acid prior to storage. Batteries acid is stored in plastic and metal drums. Metal drums will become fatigued with prolonged exposure to Batteries acid, resulting in leakage.

Photo 17. Sewage truck discharge structure at Sewage lagoon.

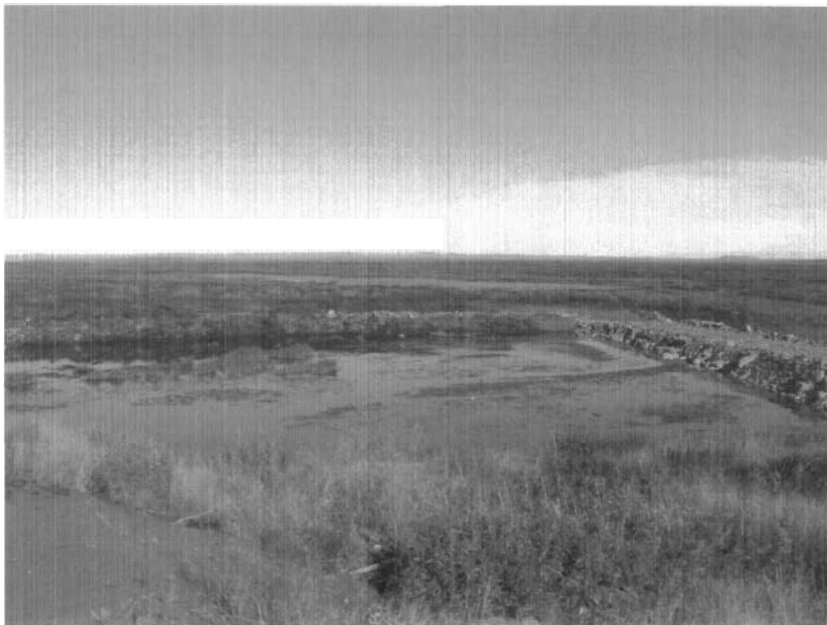
Photo 18. Construction shown to Sewage Lagoon berm to the right of photo.

Comments: The expansion of the sewage lagoon in 2002 appears to be insufficient for the community. Excessive seepage was noted at the sewage lagoon. The sewage lagoon effluent flows through a wetland prior to discharge to ocean. The Solid Waste Disposal Facility is totally fenced with little wind blown refuge noted. Regular burning of refuge was noted. Segregation of most batteries and waste oil was observed. Batteries should be stored in sea lift or similar container to minimize contamination during storage. Waste batteries are drained. Waste battery acid is stored in metal drums. Given time waste battery acid will corrode metal drums. Bulky metal dump has partially undergone waste segregation, further segregation planned for next year.

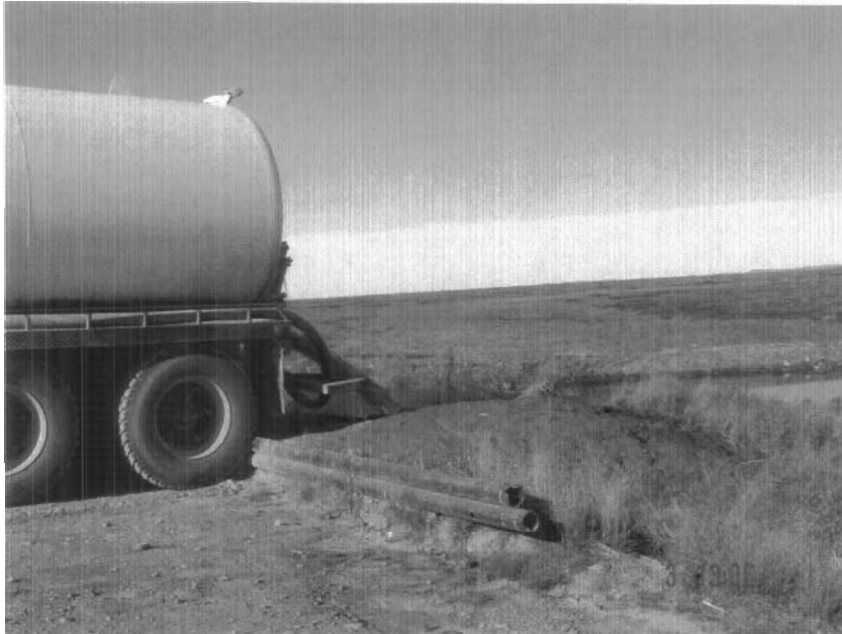
Photo 19. Sewage truck shown at sewage truck discharge structure.

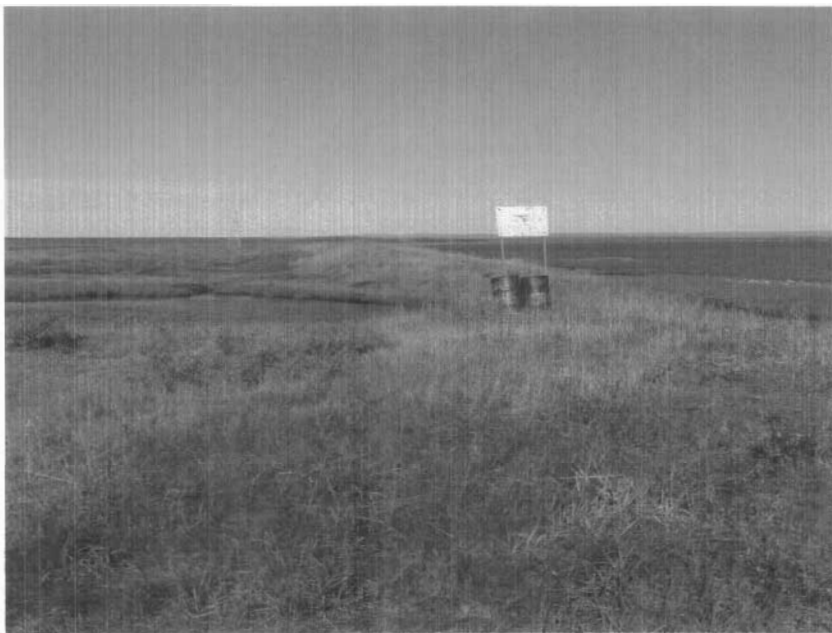
Photo 20. Location of sewage effluent sample N 67.4851.8 115.1138.6.
