WATER LICENCE INSPECTION FORM

Licensee Licensee Representative							
Licence No. / Expiry	Hamlet of Kugluktuk Shawn Fitzgerald Licence No. / Expiry Representative's Title							
3BM-KUG1520			•			trative Officer		
Land / Other Authorizations	;		Land / Oth			trative Officer		
Date of Inspection			Inspector					
2020 August 17 & 1	18		Baba Pe	edersen	<u> </u>			
Activities Inspected	□ Drilling		□ Mining □ Co	netrustion		□ Declaration	☐ Fuel Stere	~~
Roads/Hauling	□ Camp □ Drilling □ Mining □ Construction □ Reclamation □ Fuel Storage □ Roads/Hauling □ Other: □ Other: Municipal					ge		
Conditions: A - A	ccontoble		C - Concern U - Unaccep	tabla	NA	Not Applicable	NI Notin	cnoctod
	cceptable					Not Applicable	NI – Not Ins	-
Water Use	Condition	Comment	Site Conditions Water Management Structures	Condition	Comment	Haz/Mat Managen		
Intake/Screen	1		9	U	1 & 2	Storage	С	7
Flow Measure. Device	А		Culverts / Bridges			Spills		
Source:			Drainage Conditionant			Spill Plan

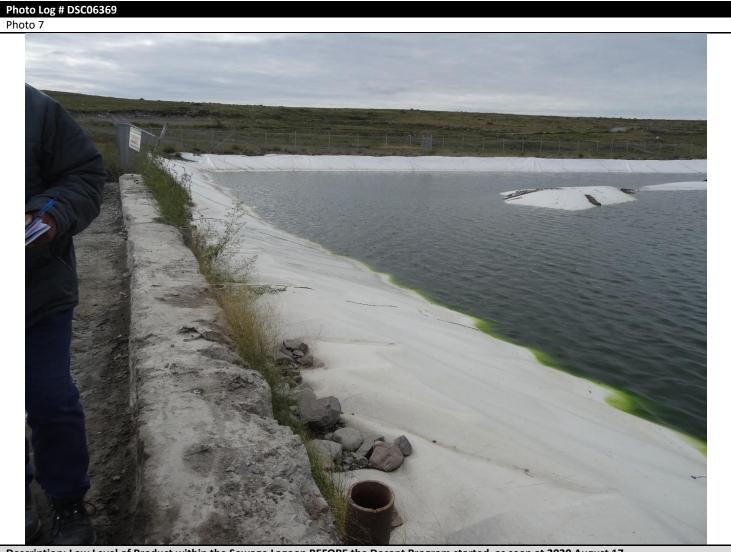
- 2. The extremely Low Level of Product within the Sewage Lagoon, with no Decant last year and this year's Decant yet to take place during the July 2 Fly-Over and the August 17 Site Visit, shows the amount of Leakage that is continually taking place. Even after the Decant Program was complete as shown in Photo 8 from October 9th, the Product Levels only went down slightly. The high amounts of ongoing, continual leakage are a major concern that requires a Permanent Solution.

Description: Low Level of Product within the Sewage Lagoon BEFORE the Decant Program started, as seen at 2020 August 17

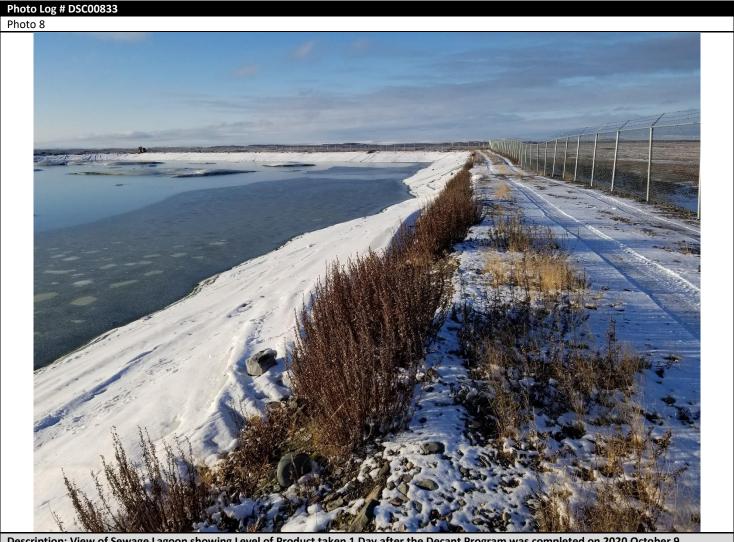
Description: View of Sewage Lagoon showing Level of Product taken 1 Day after the Decant Program was completed on 2020 October 9
