WATER LICENCE INSPECTION FORM

Licensee		Licensee Representative	
Hamlet of Kugluktuk		Kevin Klengenberg & Eugene Coady	
Licence No. / Expiry		Representative's Title	
3BM-KUG-1520			
Land / Other Authorizations		Land / Other Authorizations	
Date of Inspection		Inspector	
4 July 2016		Baba Pedersen	
Activities Inspected			
<input type="checkbox"/> Camp <input type="checkbox"/> Drilling <input type="checkbox"/> Mining <input type="checkbox"/> Construction <input type="checkbox"/> Reclamation <input type="checkbox"/> Fuel Storage			
<input type="checkbox"/> Roads/Hauling <input checked="" type="checkbox"/> Other: Municipal <input type="checkbox"/> Other:

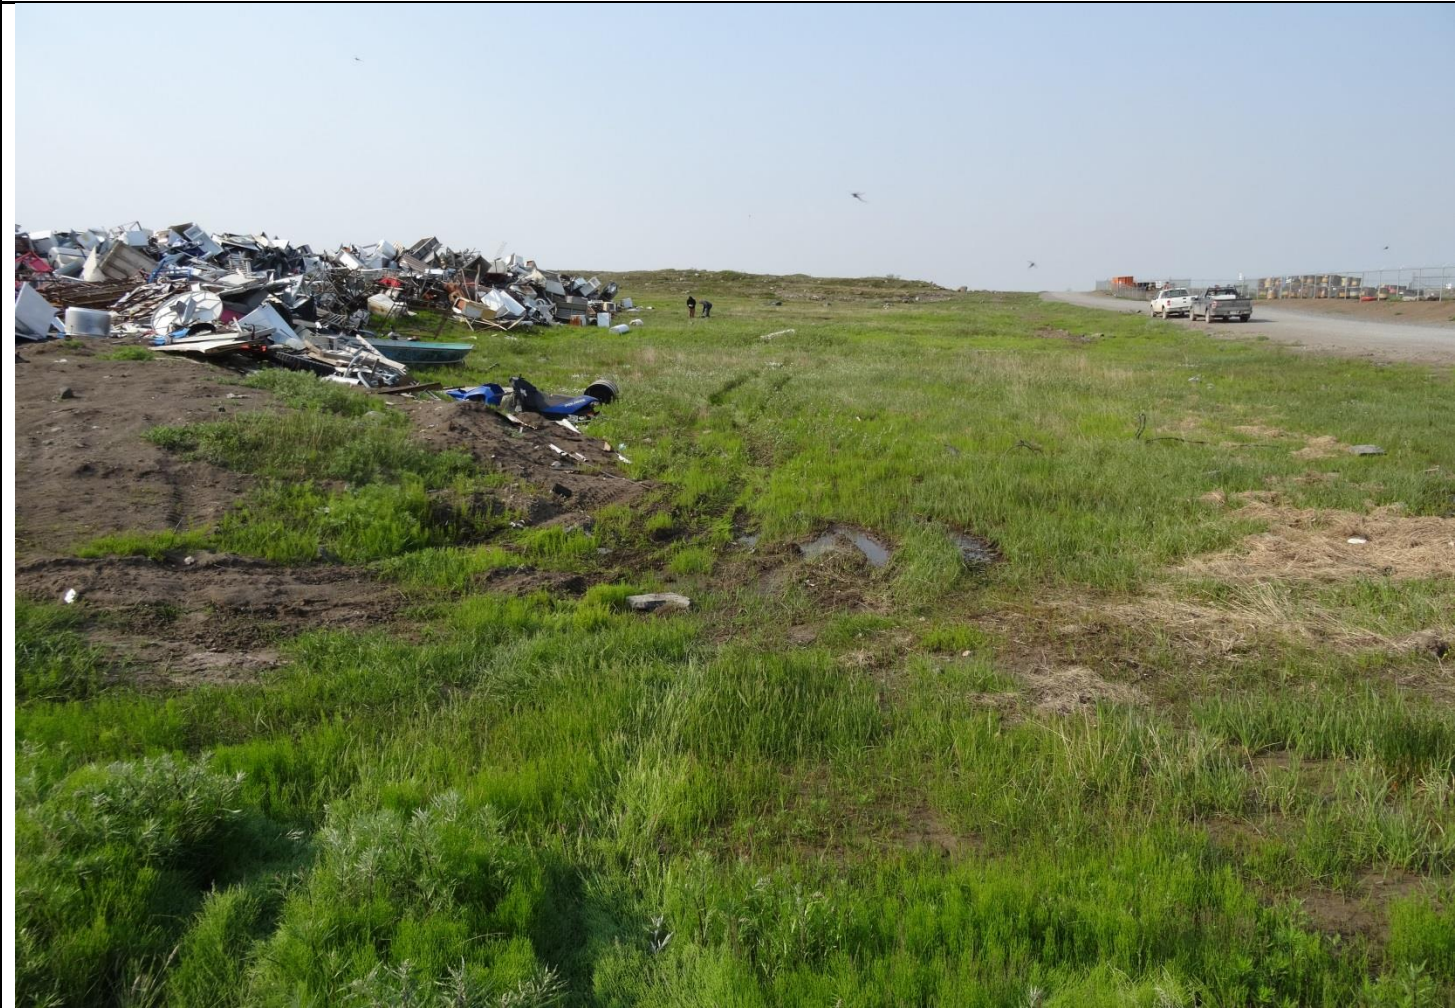
Date	Camera	Inspector	Authorization
4 July 2016		Baba Pedersen	
Photo Log # 5860

1. The Sample Location for the Metal Dump (Photo 1) should be moved further North (Photo 2) on the other side of the access road and another Sample Location should be added on the North Side of the Sewage Lagoon where the Liner is Leaking. 2. The Barrels inside the lined Land Farm area should be removed to allow the Land Farm are to be used properly as per GN Guidelines. 3. The dropping of the Sewage Lagoon Berm on the North side needs to be continually monitored and recorded until GN-CGS is able to repair it later this season and INAC shall be notified when the Buttress to the Berm is complete. 4. The Sampling Station Signage needs to be replaced and the numbering of the stations needs to be verified and correspond with the Water Licence.

Description: Existing Metal Dump Sample Location

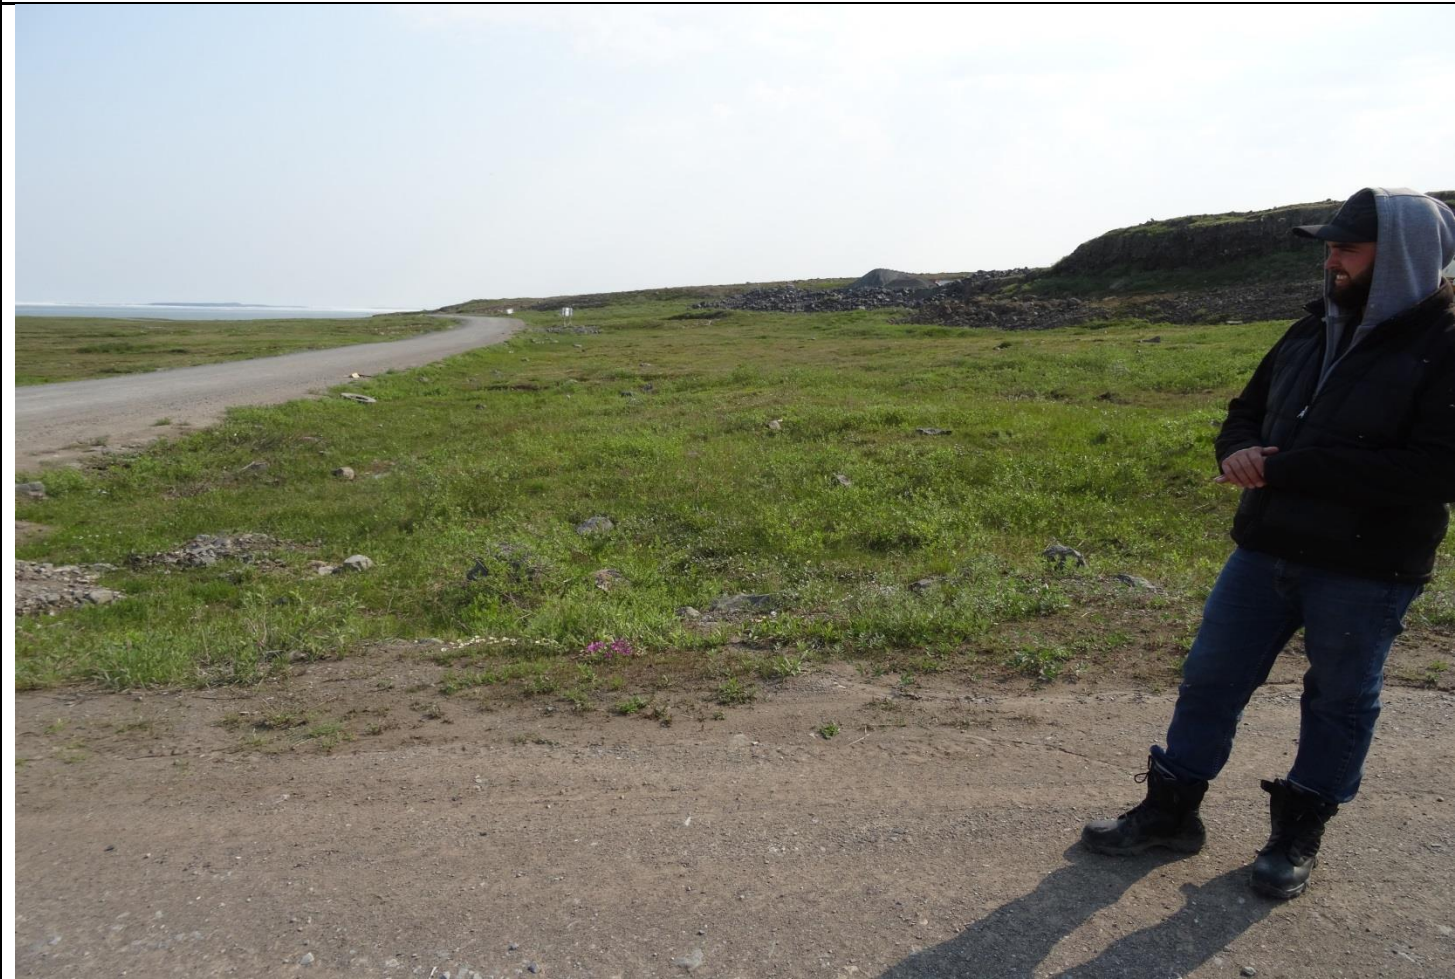
Photo Log # 5861

Description: General Area where Metal Dump Sample Location should be moved to
