WATER LICENCE INSPECTION FORM

Licensee		Licensee Representative	
Hamlet of Kugluktuk		George Egotak	
Licence No. / Expiry		Representative's Title	
3BM-KUG1520			
Land / Other Authorizations		Land / Other Authorizations	
Date of Inspection		Inspector	
July 10, 2017		Baba Pedersen	
Activities Inspected			
<input type="checkbox"/> Camp	<input type="checkbox"/> Drilling	<input type="checkbox"/> Mining	<input type="checkbox"/> Construction
<input type="checkbox"/> Roads/Hauling	<input checked="" type="checkbox"/> Other: Municipal Water License		<input type="checkbox"/> Reclamation
		<input type="checkbox"/> Other:	<input type="checkbox"/> Fuel Storage

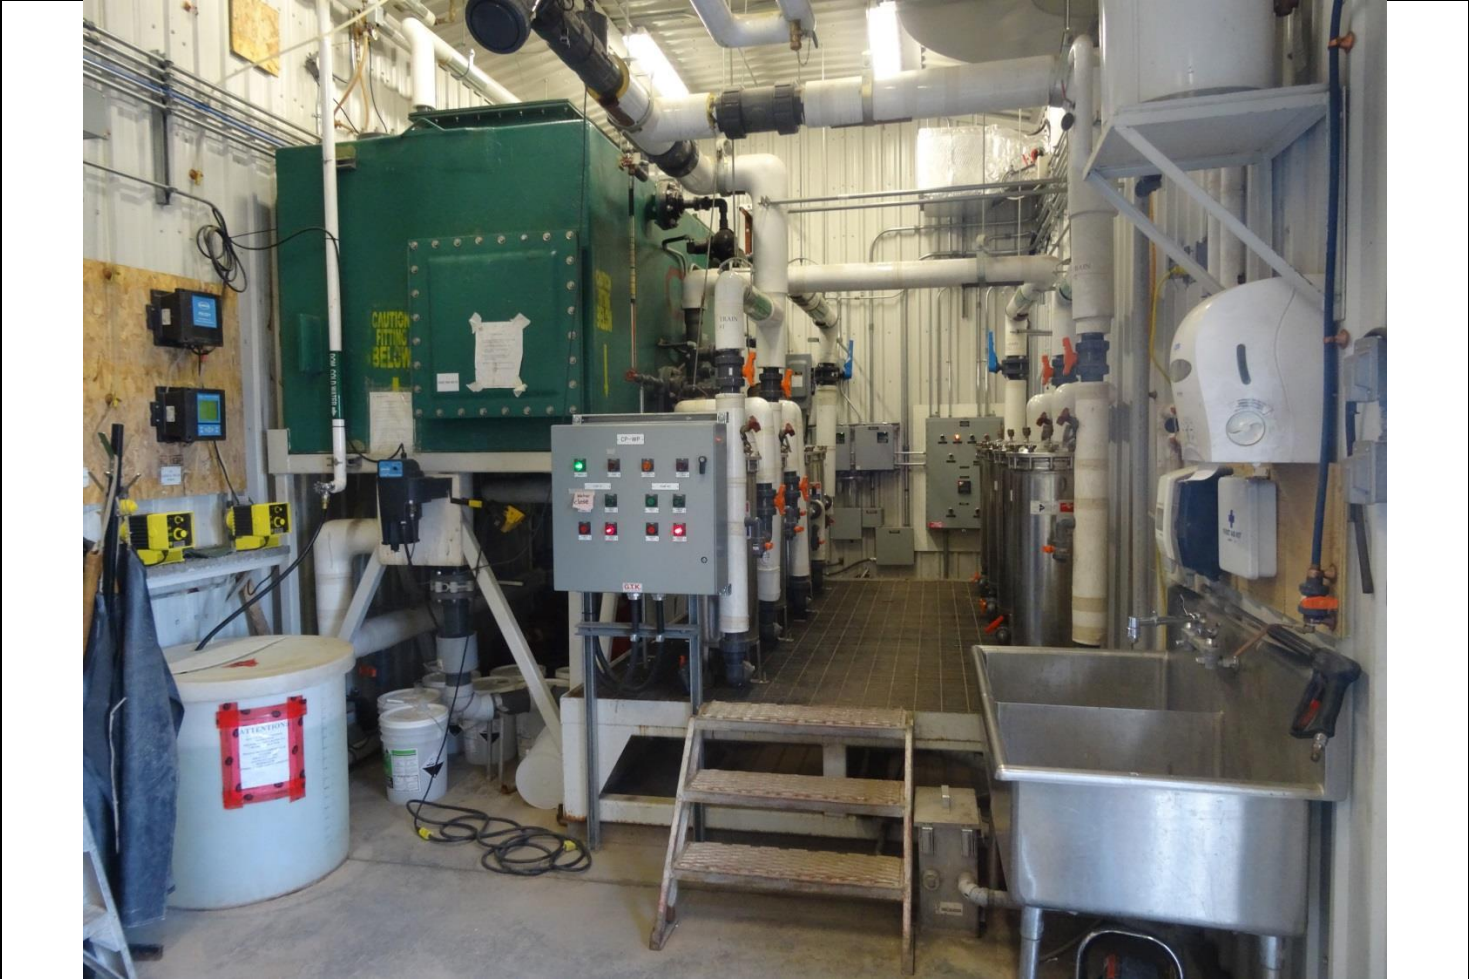
Photo 2

1. At the existing Water Treatment Plant (Photos 1 & 2) I found that there is a very large amount of Water Filters used every year and they are all thrown away in the Garbage Dump. 2. Water Consumption Records are kept every day and are readily available upon request. The Hamlet is well within authorized limits. 3. At the Sewage Lagoon I found the Leakage continues from last year (Photos 3 & 4) and 4. There were noticeable Cracks in the Buttress (Photo 5). 5. In the Main Garbage Dump area there were many Drums of Used Oil (Photo 6) waiting to be Incinerated, the Hamlet is actively working on Incinerating as much of the Used Oil in stock. 6. I also found really lots of Drums of used oil within the fenced off Land Farm area (Photo 7). 7. I also saw many old Batteries on the ground (Photo 8) in the Main Garbage Dump. 8. Within the Metal Dump there was also a large group of Full Used Oil Drums (Photo 9) being stored with no form of Secondary Containment. 9. The Paint on the Wooden Signage at the Sewage Effluent Outflow (Photo 10) at the Ocean was completely worn off.

Description: Inside view of existing Water Treatment Plant

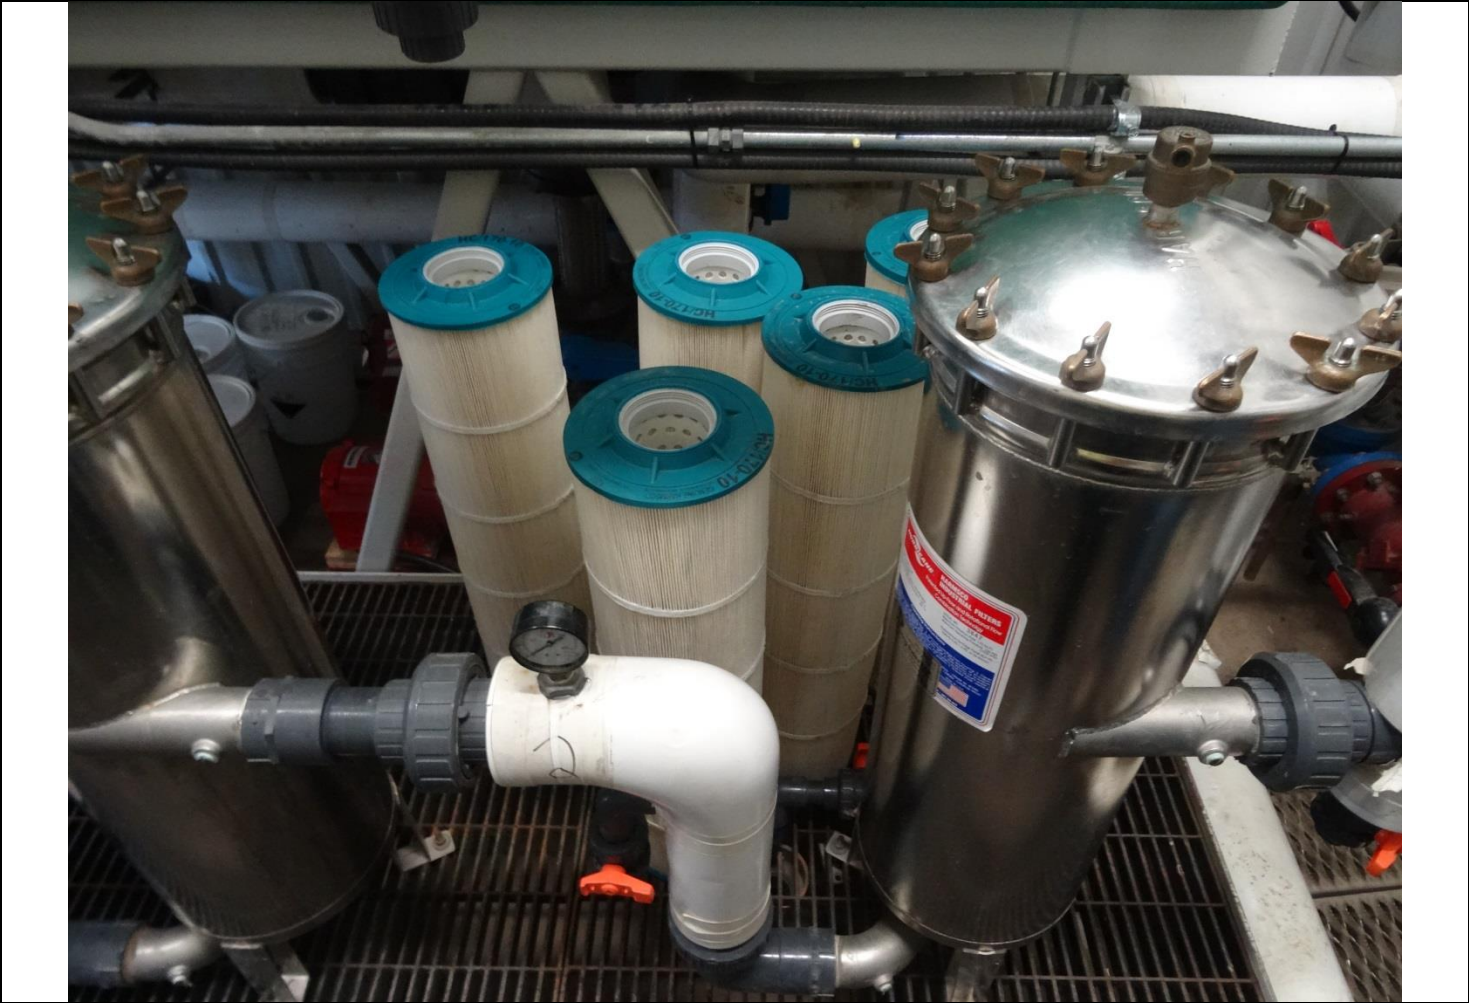
Description: Used Filters from Water Treatment Plant

1. I recommend that the Hamlet try to find a way to send all the used Water Filters South for Recycling as they produce a large number of them annually and they take up a lot of space in the Land Fill. 3 and 4.The Hamlet must continue it's efforts to have the Leaks in the Sewage Lagoon and the cracks in the Lagoon Buttress permanently repaired. 6. All Drums and Batteries must be removed from the Land Farm area in order for the Land Farm to be used properly. 7. All the old Batteries that are lying on the Ground in the Main Dump area and the Land Farm area must be put into Lined Crates inside the Sea Can Container. 8. All Used Oil Drums in the Metal Dump area must be moved into an area with proper Secondary Containment. 9. All required Signage as per the Water License needs to be Repaired or Replaced.

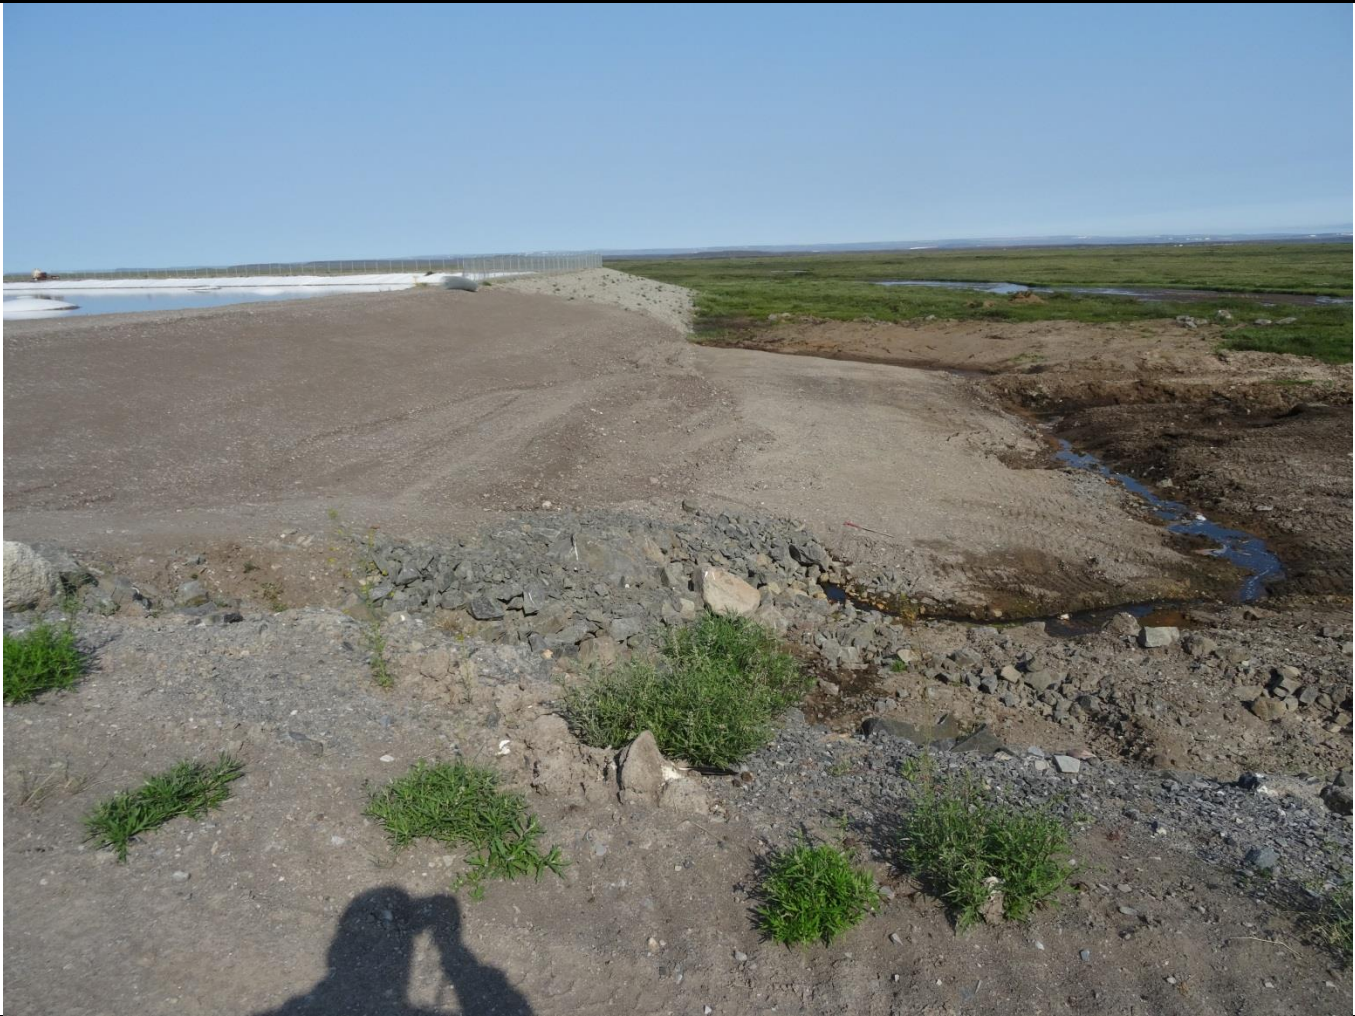
Photo 3

Description: Sewage Lagoon Leak below Buttress

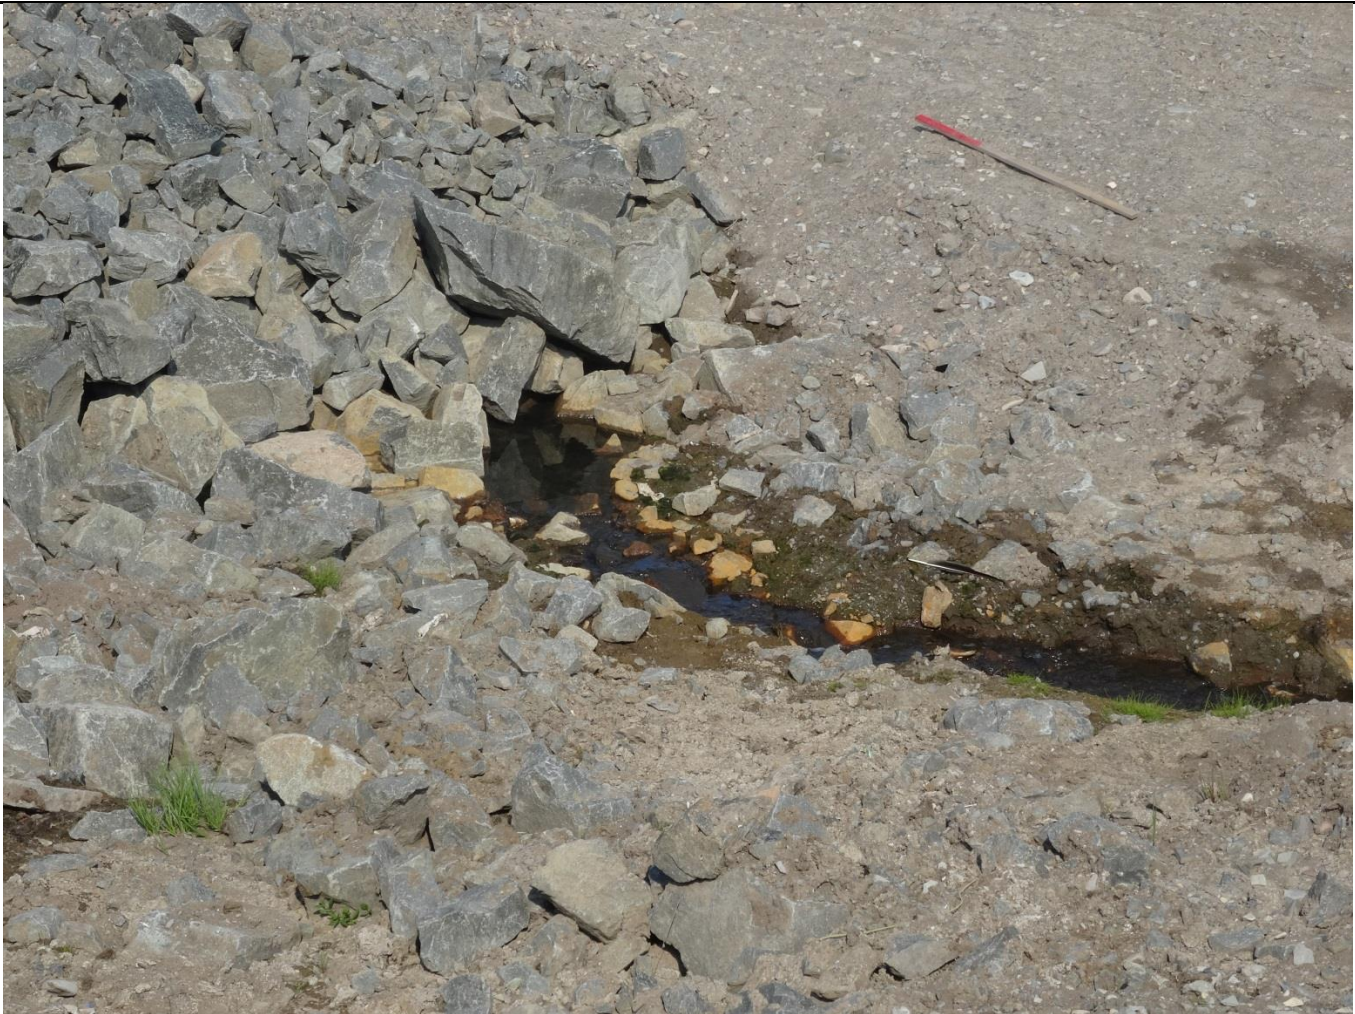
Photo 4

Description: Close up of Sewage Lagoon Leak below Buttress

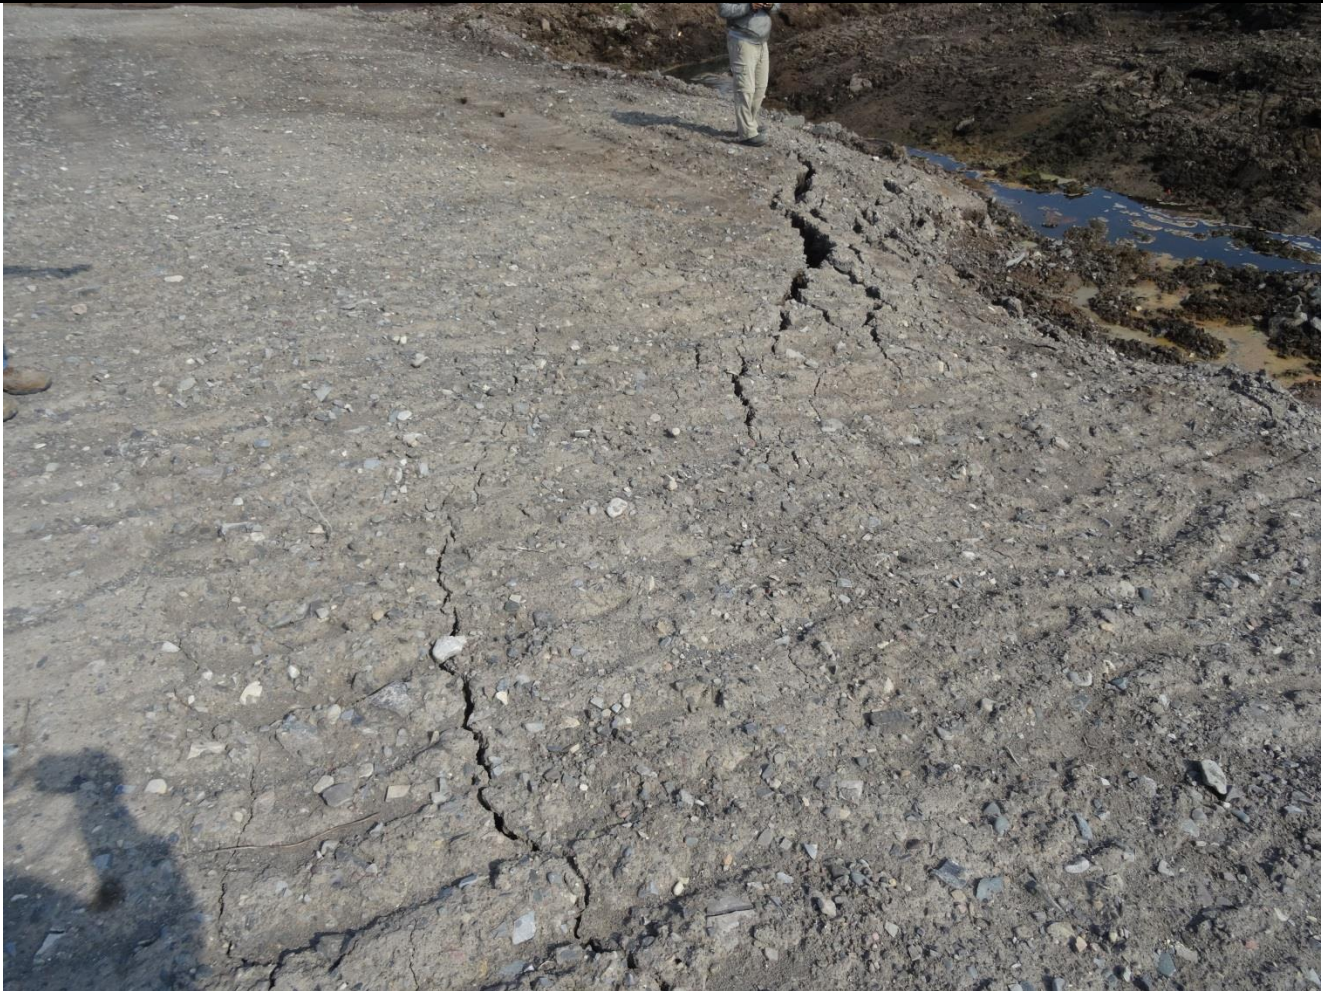
Photo 5

Description: Visible Cracking in Buttress

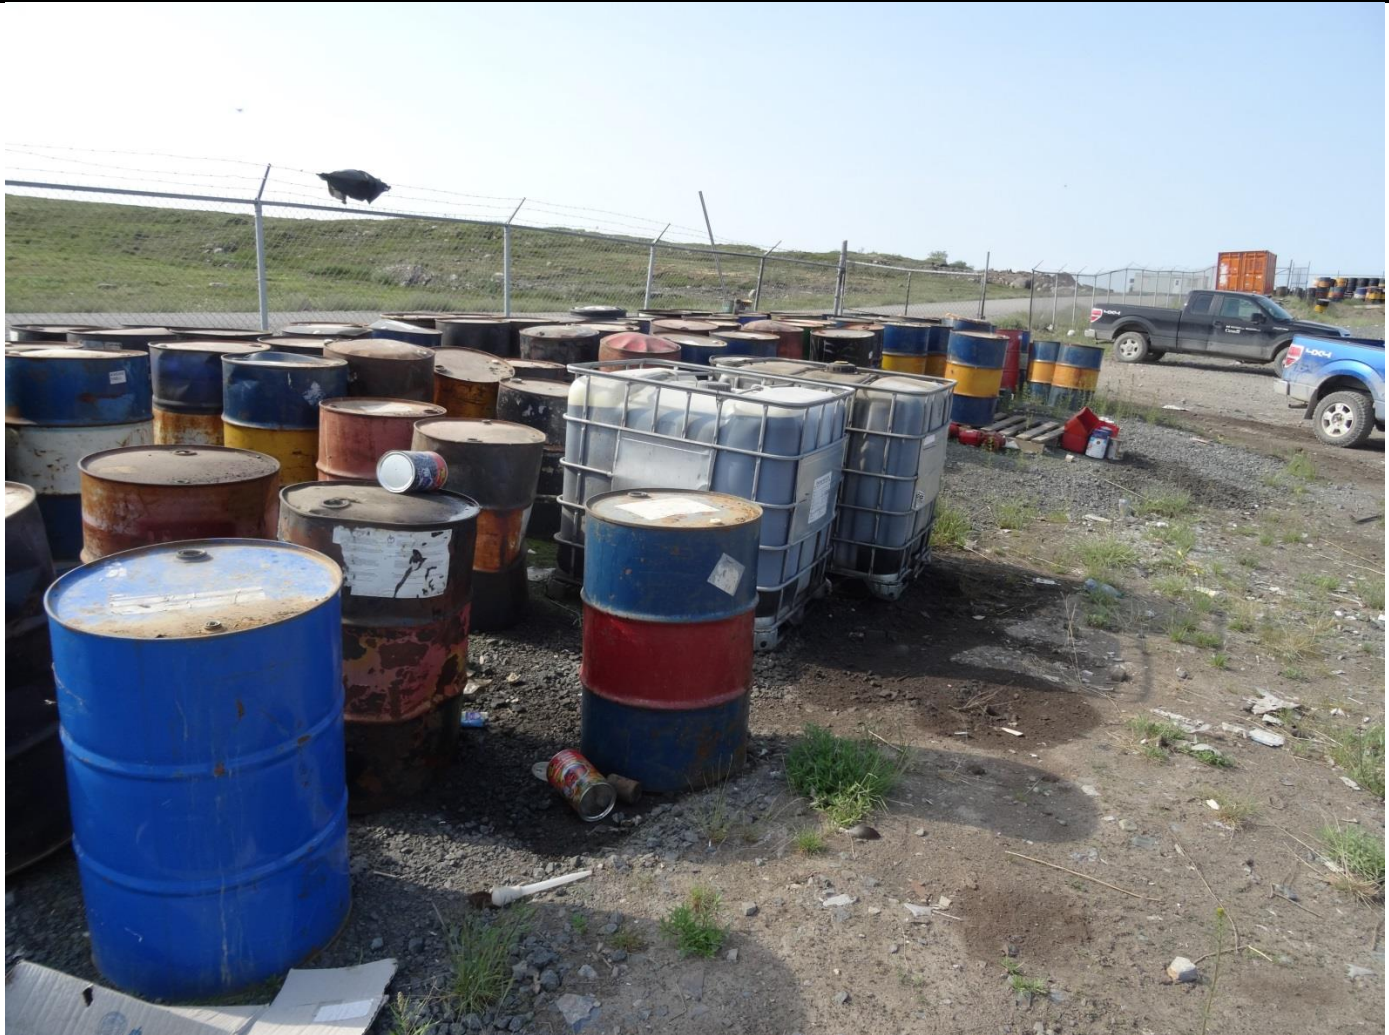
Photo 6

Description: Drums of Used Oils waiting to be Incinerated

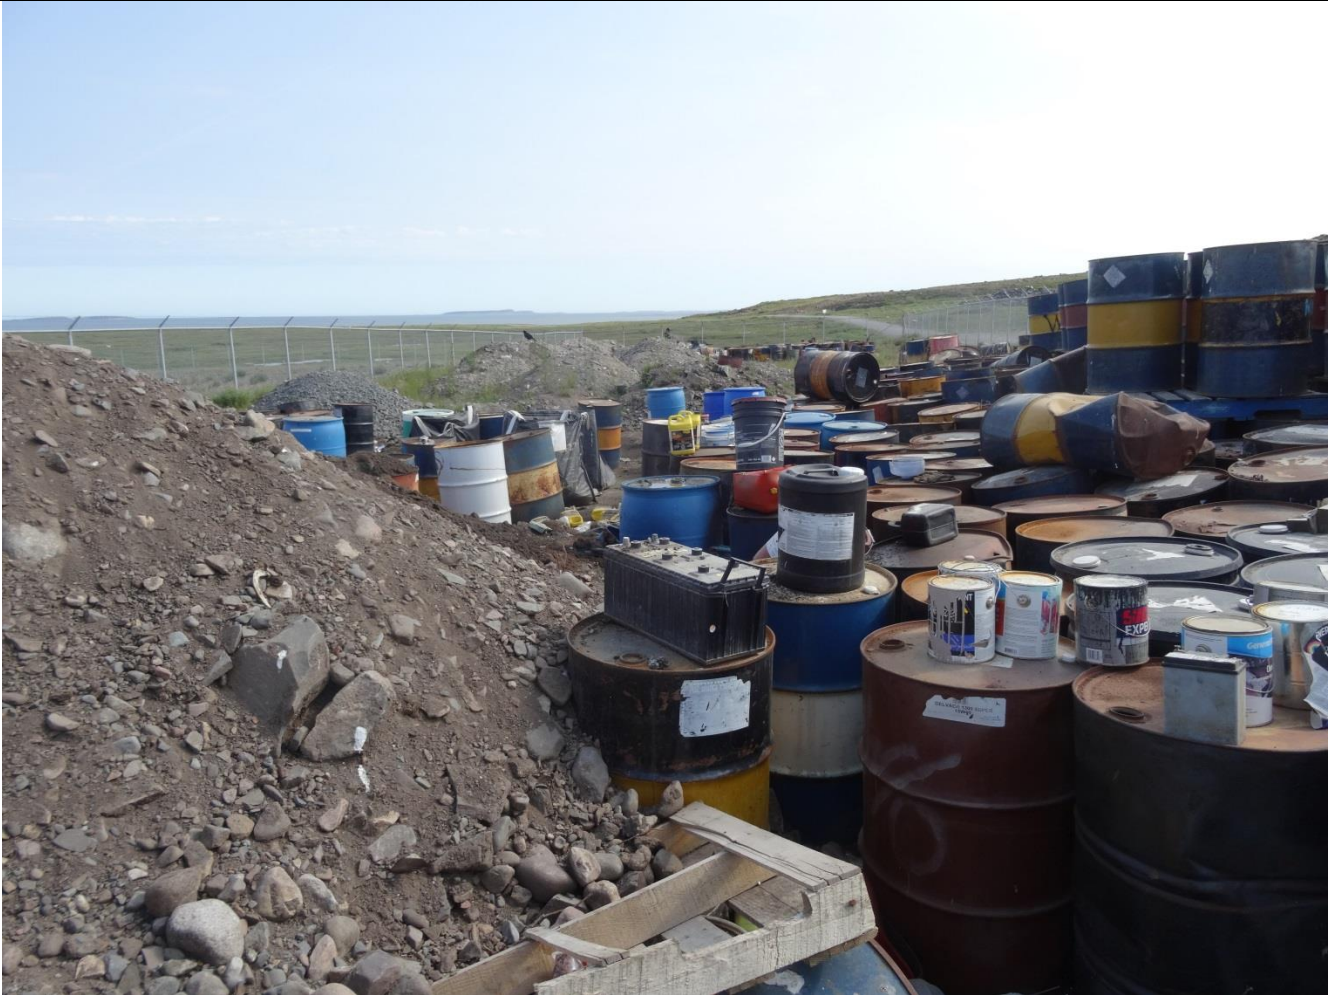
Photo 7

Description: Used Oil Drums need to be removed from Land Farm area to ensure proper use of Land Farm for Contaminated Soils

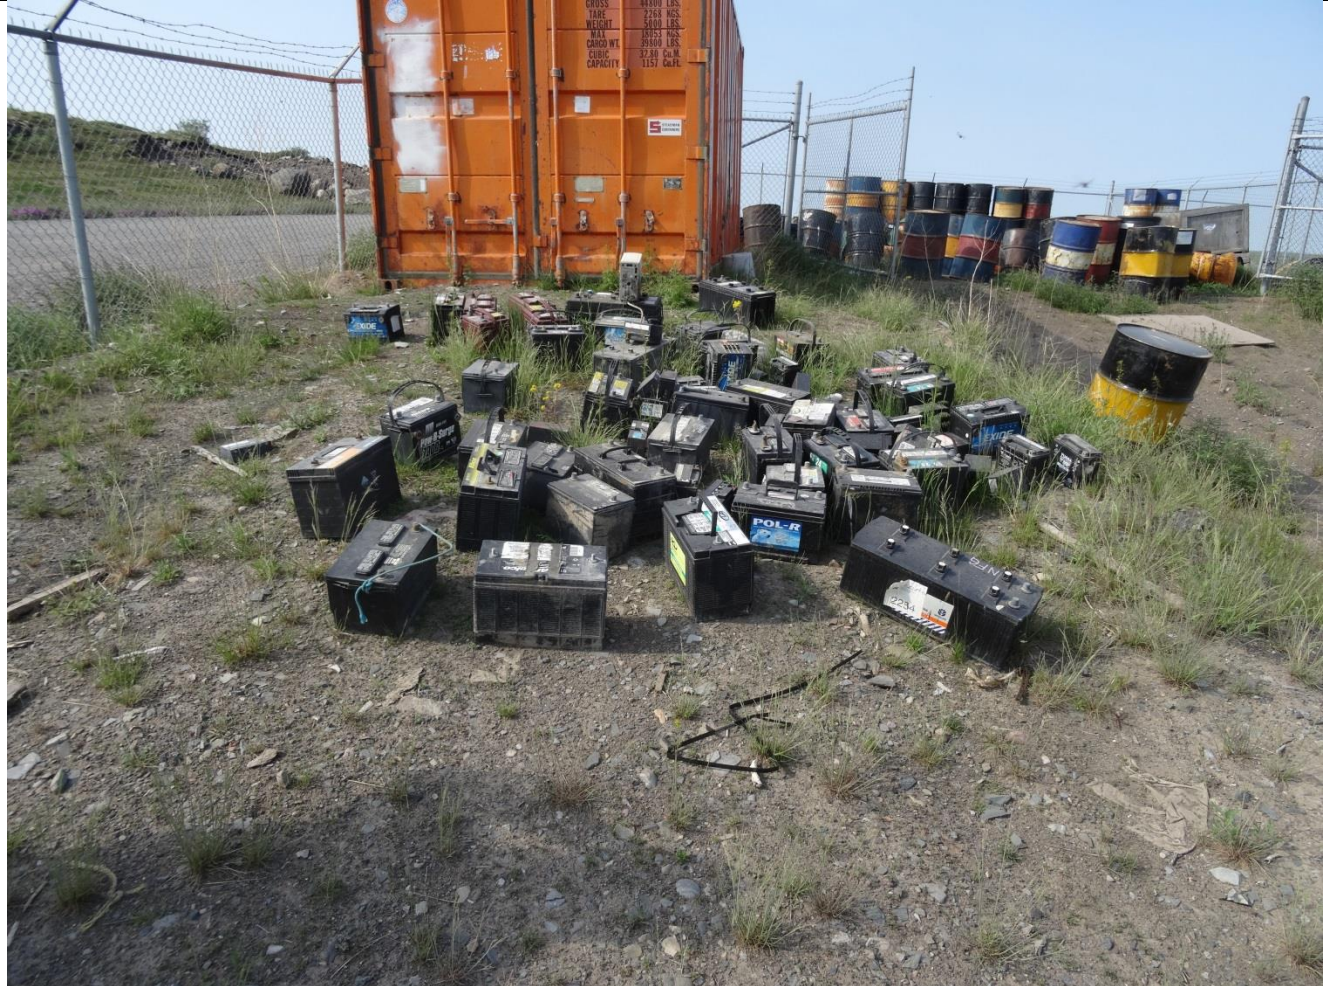
Photo 8

Description: Used Batteries on Ground need to be moved into Lined Boxes in Sea Can Container

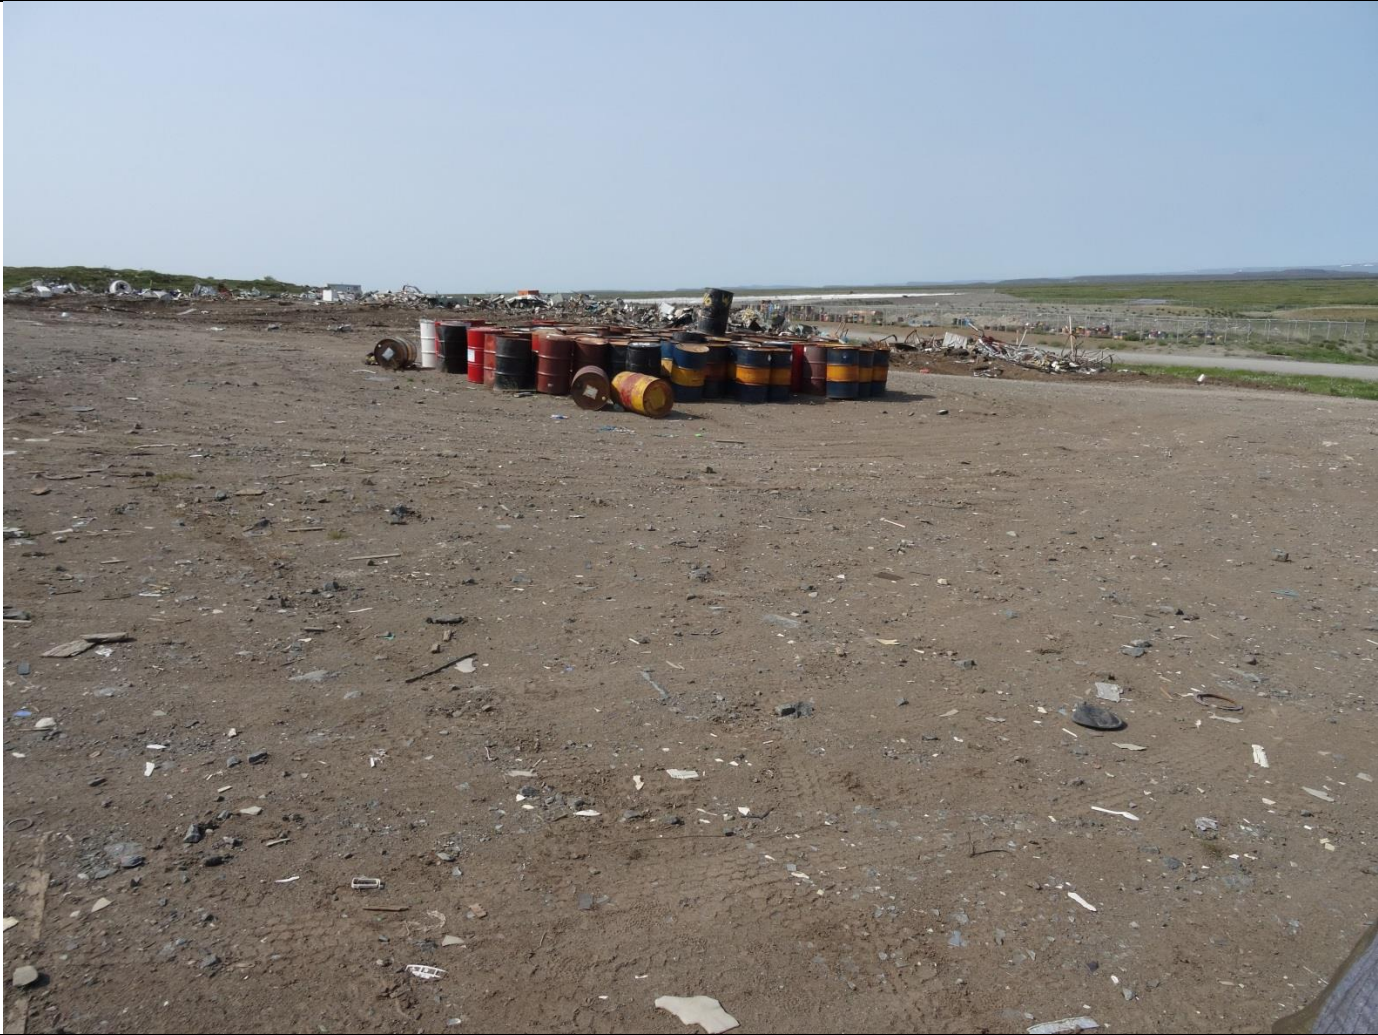
Photo 9

Description: Used Oil Drums being stored in Metal Dump with no Liner need to be moved to a contained area

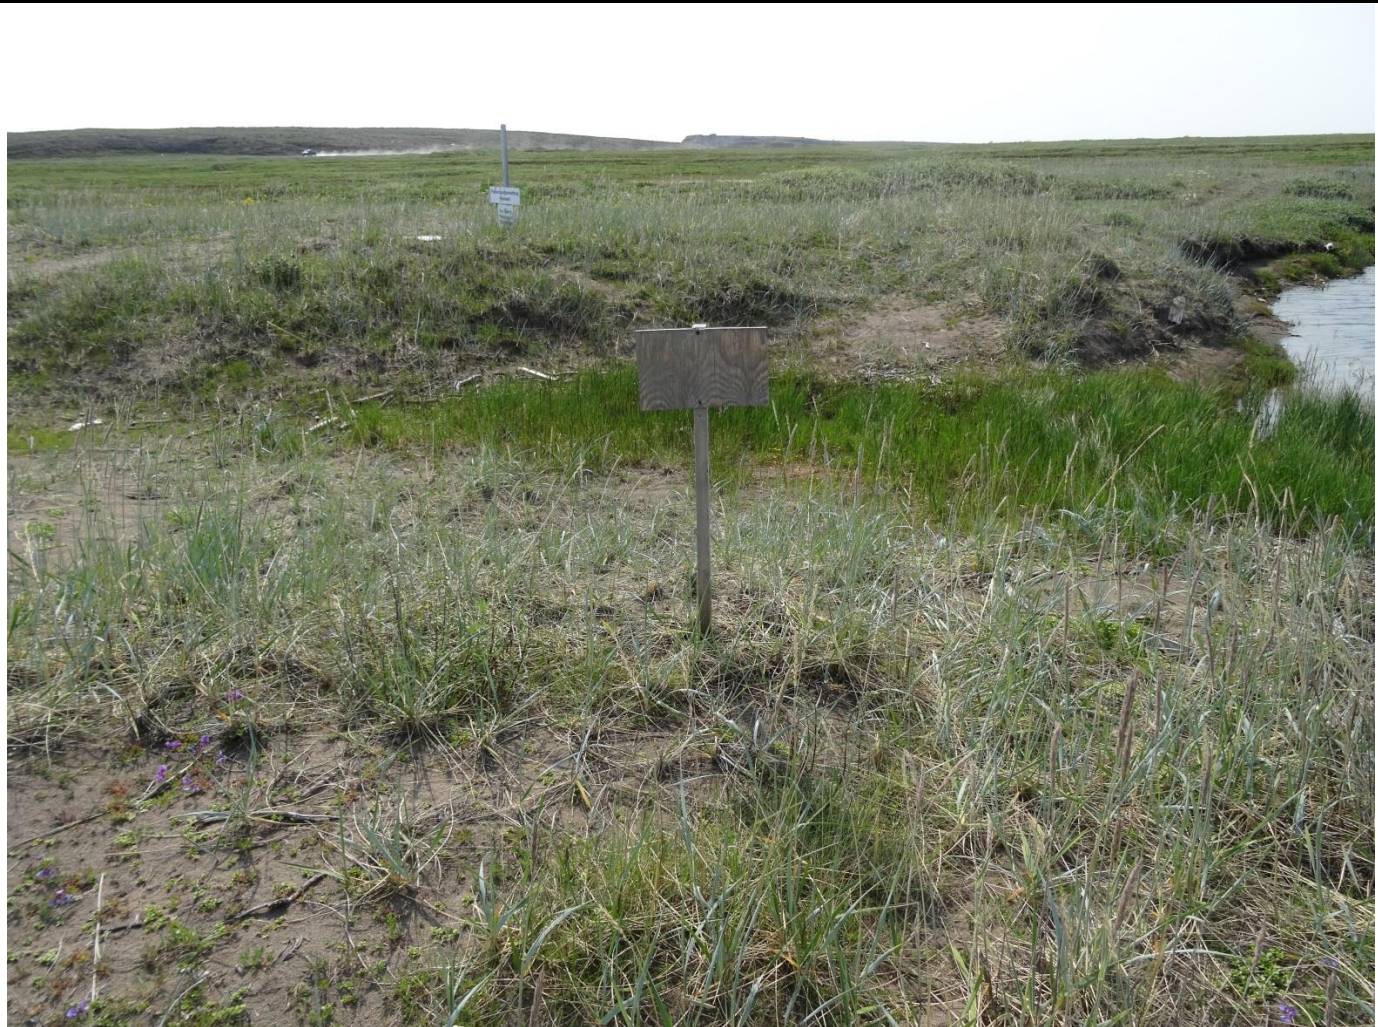
Photo 10

Description: Paint on Wood Signage has Worn Off at Effluent Outflow to Ocean
