WATER LICENCE INSPECTION FORM

Same Continue Same Sam						
Date of Inspection 2019 July 30 Baba Pedersen Cardivilue Inspected Drilling Other: Mining Construction Reclamation Fuel Storage						
Date of Inspection						
Baba Pedersen						
Activities Inspected Roads/Haulling						
Camp						
Conditions: A - Acceptable C - Concern U - Unacceptable NA - Not Applicable NI - Not Inspected Water Use Site Conditions Site Conditions Condi						
Water Use Comments Site Condition Comments Haz/Mat Management Condition Comments Comments Haz/Mat Management Comments Comm						
Water Use						
Intake/Screen Water Management Structures C 48.5 Storage U 7 Flow Measure. Device A Culverts / Bridges Spills Source: Drainage Spill Plan Water Use: Erosion / Sediment Recirculation (y /n) Mitigation Measures C 6 Administrative Recirculation (y /n) Mitigation Measures C 6 Administrative Recirculation Materials Storage Records A Reports A Waste Disposal Signage C 1,28.3 Plans Waste Water C 48.5 Notifications Solid Waste A Monitoring Other Hazardous Waste C 8 Sample Collection / Analysis A Authorization Display C 9 *The number in the comments field will correspond with specific comments provided below. Sample

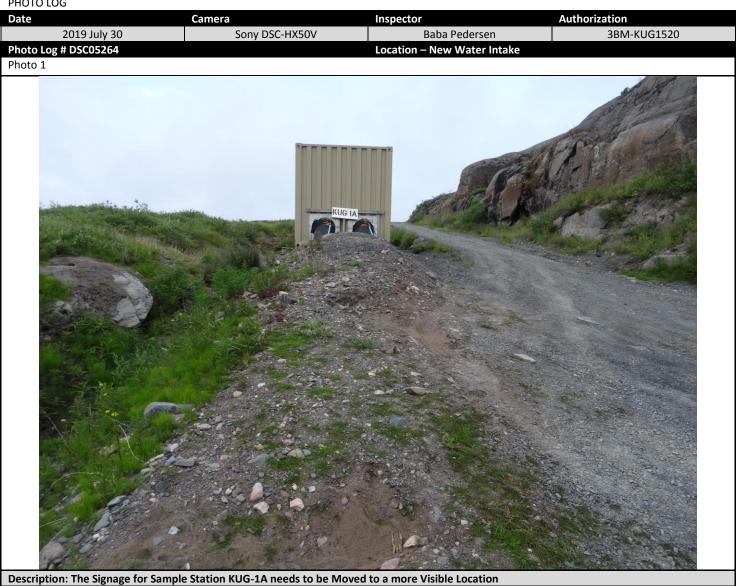
We saw 1. Signage for Sample Station KUG-1A (Photo 1), 2. The indoor Sample Station KUG-1C (Photo 2), 3. The Emergency Water Intake Pump Shack (Photo 3), at the Sewage Lagoon we saw 4. The ongoing Leak under the Buttress (Photo 4), 5. The extremely Low Level within the Lagoon (Photo 5), 6. Floating Debris and Wood inside the Lagoon (Photos 6 & 7), 7. The Contaminated Soil Land Farm Area (Photo 8), 8. The used Battery Pile in the Land Farm Area (also Photo 8), and 9. I asked to see a copy of this Water License 3BM-KUG1520. SECTION 3						
Intake Pump Shack (Photo 3), at the Sewage Lagoon we saw 4. The ongoing Leak under the Buttress (Photo 4), 5. The extremely Low Level within the Lagoon (Photo 5), 6. Floating Debris and Wood inside the Lagoon (Photos 6 & 7), 7. The Contaminated Soil Land Farm Area (Photo 8), 8. The used Battery Pile in the Land Farm Area (also Photo 8), and 9. I asked to see a copy of this Water License 3BM-KUG1520. SECTION 3

1. The Signage for Sample Station KUG-1A must be moved to a more visible location closer to the actual Sample Point. 2. The Signage for Sample Station KUG-1C must be Permanent and easily readable that identifies exactly where the Sample Point is. 3. Signage to Identify the Sample Station KUG-1D must be attached to the outside of the green Emergency Water Intake Pump Shack. If/when this is ever used, the exact GPS Coordinates must be provided to the Inspector as to where it was						
 The Signage for Sample Station KUG-1A must be moved to a more visible location closer to the actual Sample Point. 2. The Signage for Sample Station KUG-1C must be Permanent and easily readable that identifies exactly where the Sample Point is. 3. Signage to Identify the Sample Station KUG-1D must be attached to the outside of the green Emergency Water Intake Pump Shack. If/when this is ever used, the exact GPS Coordinates must be provided to the Inspector as to where it was

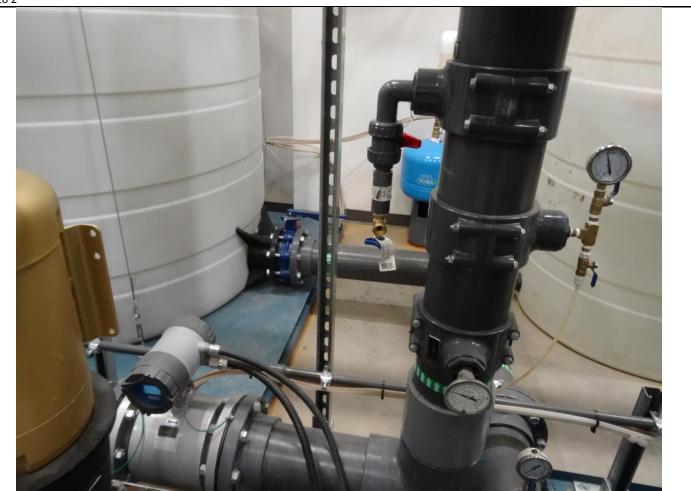
Description: The Signage for Sample Station KUG-1C needs to be Permanent, Very Visible and Easy to Read

Signage for Sample Station KUG-1C must be Permanent and easily readable that identifies exactly where the Sample Point is. 3. Signage to Identify the Sample Station KUG-1D must be attached to the outside of the green Emergency Water Intake Pump Shack. If/when this is ever used, the exact GPS Coordinates must be provided to the Inspector as to where it was						
is. 3. Signage to Identify the Sample Station KUG-1D must be attached to the outside of the green Emergency Water Intake Pump Shack. If/when this is ever used, the exact GPS Coordinates must be provided to the Inspector as to where it was						
Pump Shack. If/when this is ever used, the exact GPS Coordinates must be provided to the Inspector as to where it was						
located during use. 4. The Hamlet and the GN must work together to come up with a permanent solution to the ongoing						
leak in the lined Berm under the Buttress area on the North Side. 5. The very low level of fluid within the Lagoon BEFORE

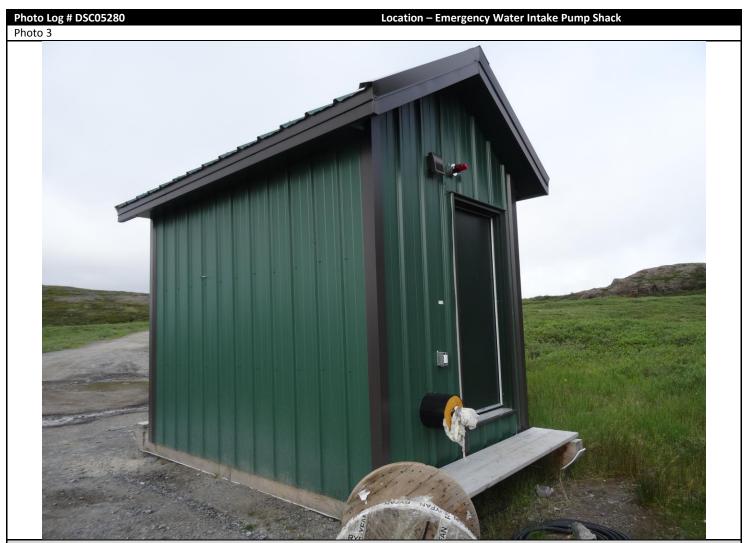
Description: Signage for Sample Station KUG-1D needs to be attached to the outside of the Green Emergency Water Intake Pump Shack

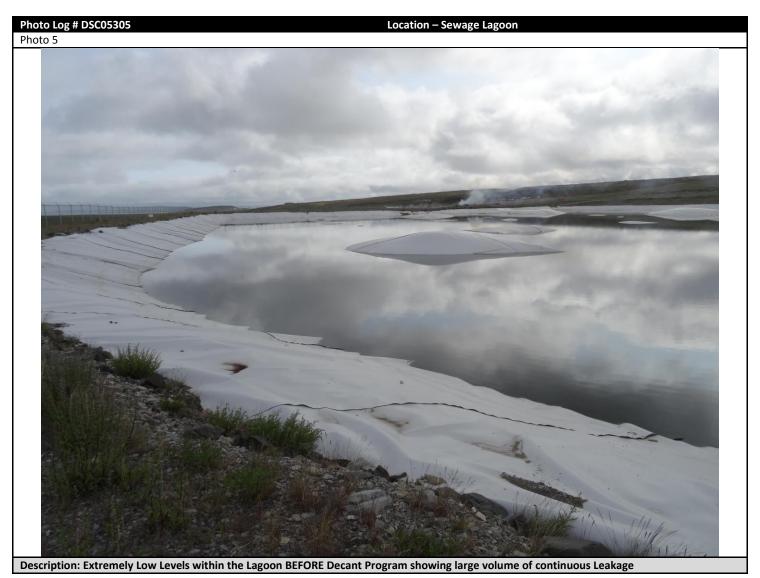
Level within the Lagoon (Photo 5), 6. Floating Debris and Wood inside the Lagoon (Photos 6 & 7), 7. The Contaminated Soil Land Farm Area (Photo 8), 8. The used Battery Pile in the Land Farm Area (also Photo 8), and 9. I asked to see a copy of this Water License 3BM-KUG1520. SECTION 3						
Farm Area (Photo 8), 8. The used Battery Pile in the Land Farm Area (also Photo 8), and 9. I asked to see a copy of this Water License 3BM-KUG1520. SECTION 3 Comments Non-Compliance with Act or Licence Action Required 1. The Signage for Sample Station KUG-1A must be moved to a more visible location closer to the actual Sample Point. 2. The Signage for Sample Station KUG-1C must be Permanent and easily readable that identifies exactly where the Sample Point is. 3. Signage to Identify the Sample Station KUG-1D must be attached to the outside of the green Emergency Water Intake Pump Shack. If/when this is ever used, the exact GPS Coordinates must be provided to the Inspector as to where it was

any Decant has taken place is an ongoing concern related to the Leakage. 6. The 2 piles of floating Debris and Wood Beams						
must be removed from the Lagoon to prevent damage to the Liner. 7. The Contaminated Soil Land Farm Area must be						
cleaned out of all items that should not be there. This area is ONLY for Contaminated Soil and nothing else. This has						
brought to the attention of the Hamlet by the Inspector numerous times and MUST be dealt with before the summer of						
brought to the attention of the Hamlet by the Inspector numerous times and MUST be dealt with before the summer of 2020 Inspection or the Inspector will have no choice but to pursue further Enforcement Action. 8. All used Batteries are to						
brought to the attention of the Hamlet by the Inspector numerous times and MUST be dealt with before the summer of 2020 Inspection or the Inspector will have no choice but to pursue further Enforcement Action. 8. All used Batteries are to be stored in Wooden Crates lined with Plastic Poly for safe keeping until they are able to be shipped south for proper
