Water Licence Inspection Report

Licensee	Licensee Representative
Hamlet of Kugluktuk	Shaun Cummins and Matthew Hokanak.
License No./Expiry	Representative's Title
3BM-KUG2030	Foreman
Other Authorizations	
Activities Inspected	
<input type="checkbox"/> Camp, Commercial <input type="checkbox"/> Drilling <input type="checkbox"/> Mining <input type="checkbox"/> Construction <input type="checkbox"/> Reclamation <input type="checkbox"/> Fuel Storage <input type="checkbox"/> Roads/Hauling <input type="checkbox"/> Winter Hauling <input type="checkbox"/> Camp, Private <input checked="" type="checkbox"/> Other Community sewage, solid waste facilities.

Section 1 Comments
<p>On September 19, 2024, I, Isaiah James Bolt, Inspector with the Crown Indigenous Relations and Northern Affairs Canada (CIRNAC), conducted an inspection of Kugluktuk's Sewage Lagoon, Land farm, Hazardous waste, and Metal Dump to ensure compliance against their water license.</p> <p>Inspection began at 9:30am on September 19 2024. I was accompanied by Shaun Cummins (foreman-projects and fleet) and Matthew Hokanak (Foreman-water/sewage and roads) for the inspection.</p> <ol style="list-style-type: none">Sewage Lagoon: At th

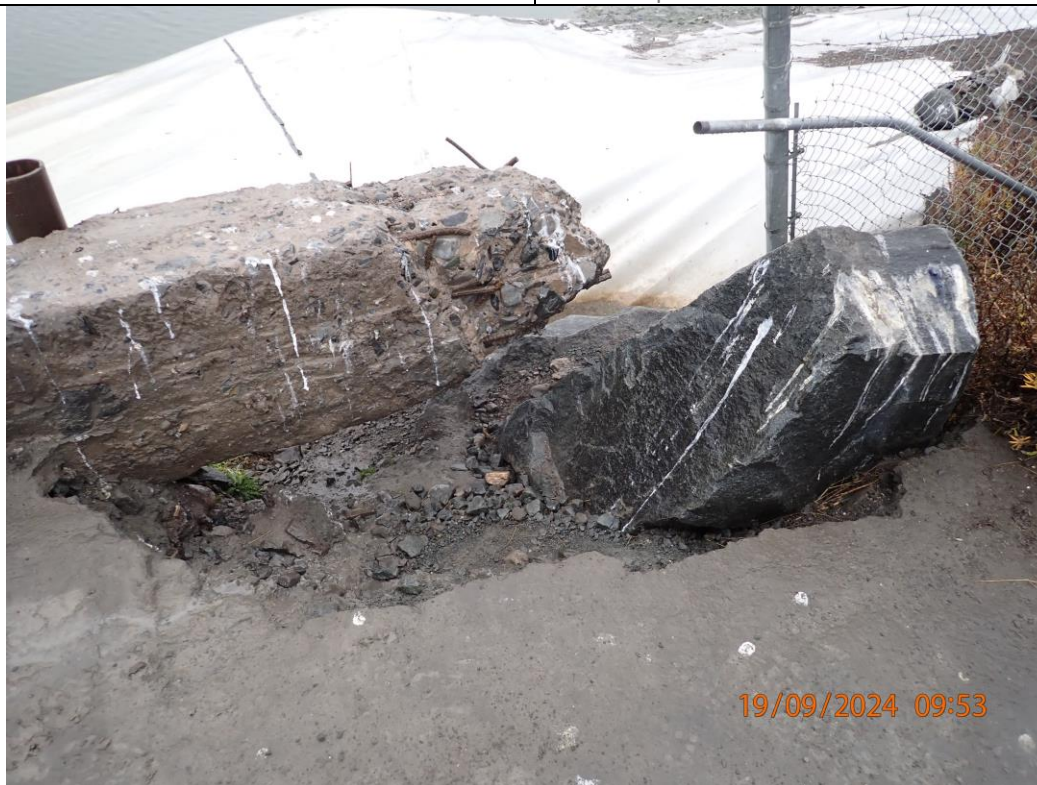
Photo #2

Another view of the erosion extent and the loss of berm structure under the concrete barrier.

1. Erosion caused by truck discharging into lagoon. Section 3.5 Point #5 of the Sewage treatment facility Operation and maintenance plan states: *"The discharge flume/spillways to the sewage lagoon shall be inspected for damage or displacement monthly, and repaired as necessary. The vehicle stop bollards located between the truck pad and discharge spillway are particularly important."*

In regards to non-compliance issue #1: Part D Item #6 of the issued water license states: *"The sewage disposal facility shall be maintained and operated, to the satisfaction of an Inspector and in such a manner as to prevent structural failure"*. Please ensure that discharged sewage is not causing erosion of the truck pad on the east side of the lagoon.

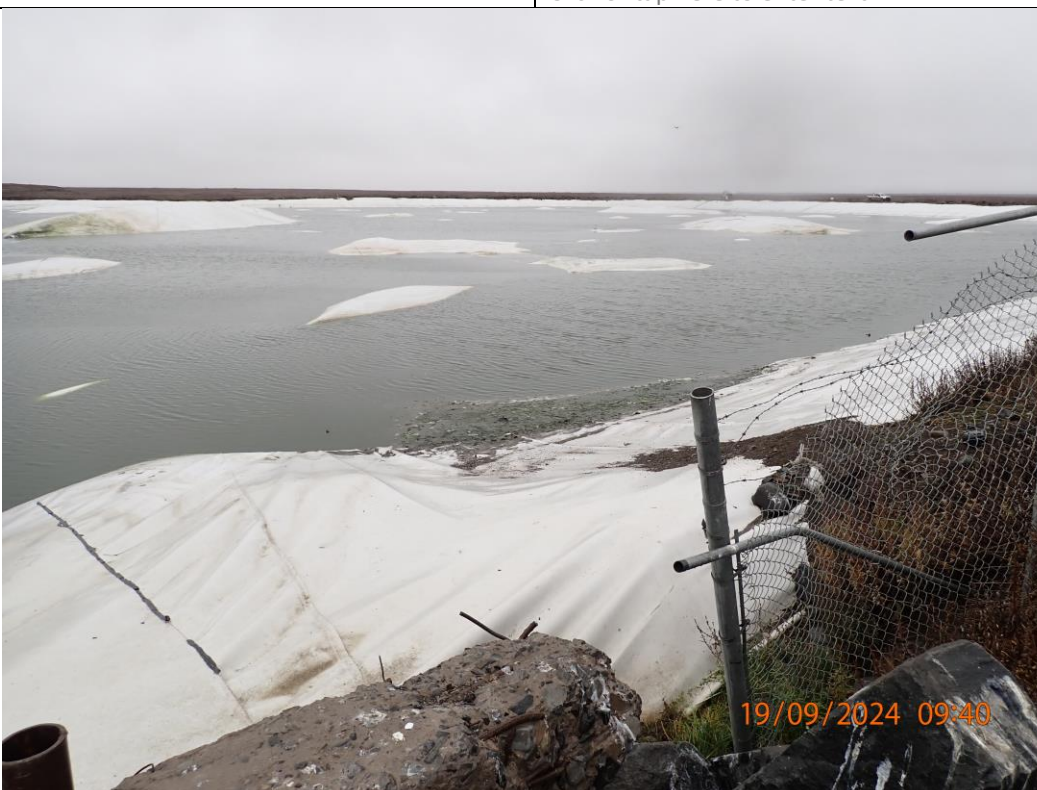
Photo #3

The image shows the broken and sunken fence and the "toe" caused by material slumping into the lagoon under the liner.

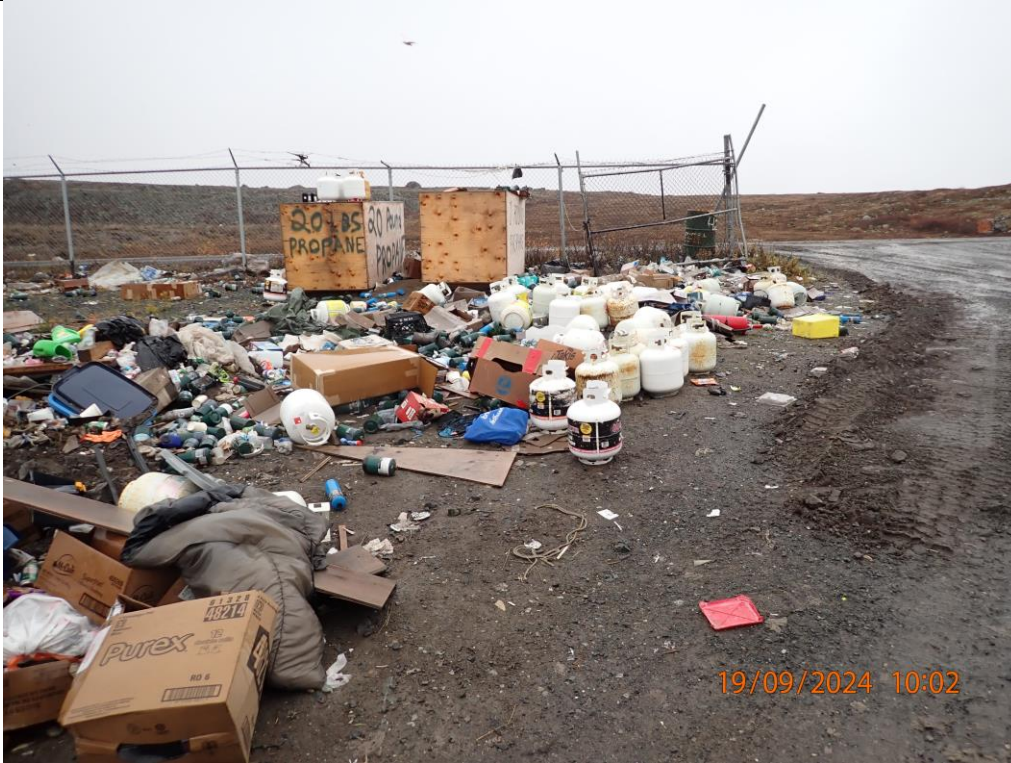
Photo #8

7. (Photo # 8) shows the propane storage location. Propane bottles, 20lbs and 1 lbs bottles are shown placed on the ground amongst trash.
8. (Photo #9) shows the waste battery location. Boxes for the batteries is shown in the back ground. Batteries are placed on the ground and exposed to the elements.

Propane bottles on the ground

3. Propane and other hazardous material stored improperly, including waste fuels and white wastes in the bulky metal facility. Part D, Item #11 of the issued water license states: *"The Licensee shall segregate and store all hazardous materials and or hazardous waste within the solid waste disposal facility in such a manner as to prevent the deposit of deleterious substances into any water, until such a time that the materials have been removed for proper disposal at an approved facility."*

In regards to non-compliance issue #3: -Propane bottles stored on the ground should be placed in boxes and stored for shipment.

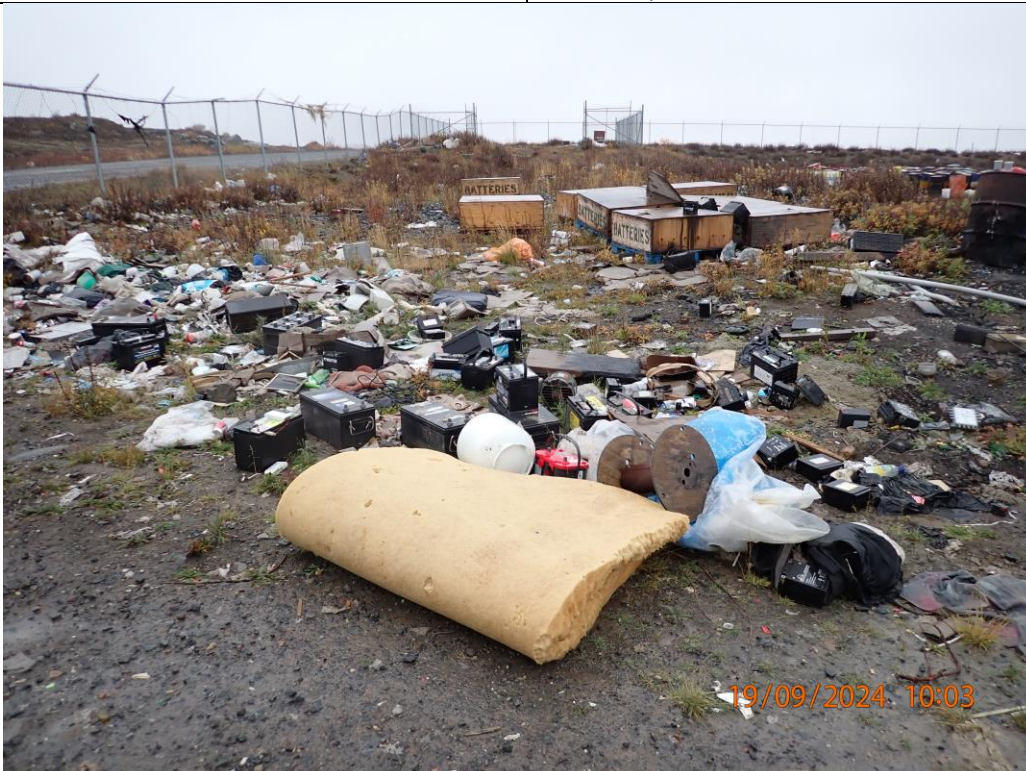
Photo #9

Batteries on the ground inside the solid waste facility.

-Batteries stored on the ground should be placed in the appropriate boxes and stored for shipment. -Hazardous waste/waste fuels stored in the Landfarm should be consolidated and placed in the appropriate hazardous waste section (South West corner of the solid waste facility). -Batteries stored in the landfarm should be consolidated with the rest of the batteries and placed in appropriate boxes and stored for shipment. -White wastes and fuel drums mixed in with bulk metals should be sorted and separated from bulky metals and placed in their appropriate areas.

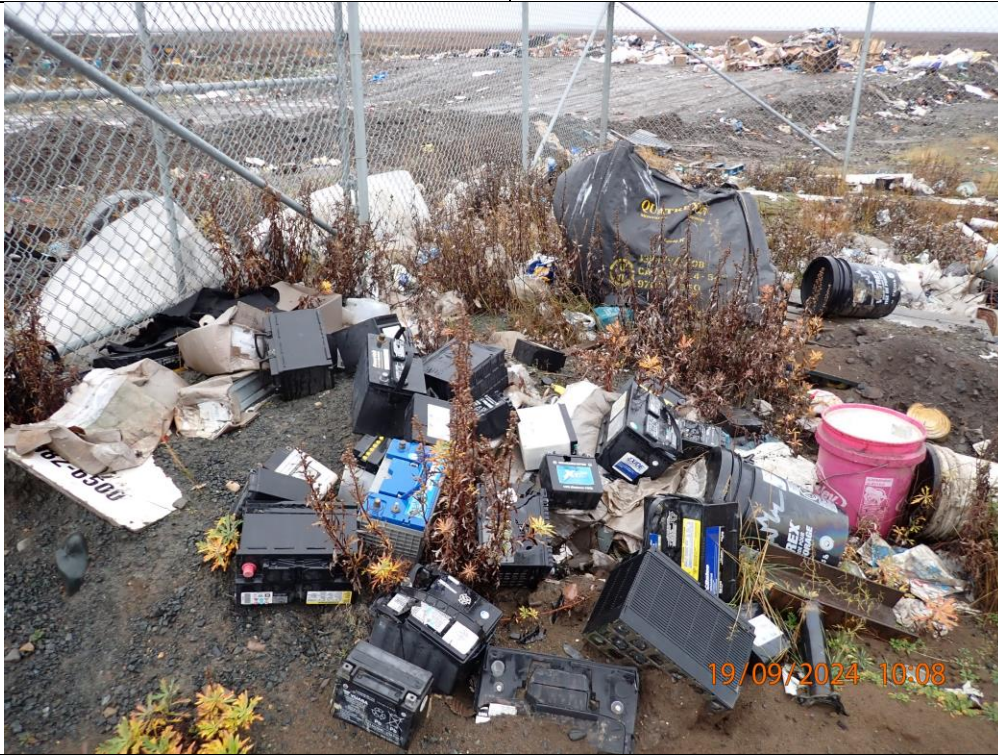
Photo No.
Photo #12

10. Waste batteries are also present inside the landfarm facility. (Photo #12)
11. (Photo #13) shows the area where the waste oil burner is located. Drums of "burnable" oil/fuel are stored near the oil burner. The oil burner has not been operational for a few years due to deterioration.

Description:
Batteries found inside the landfarm

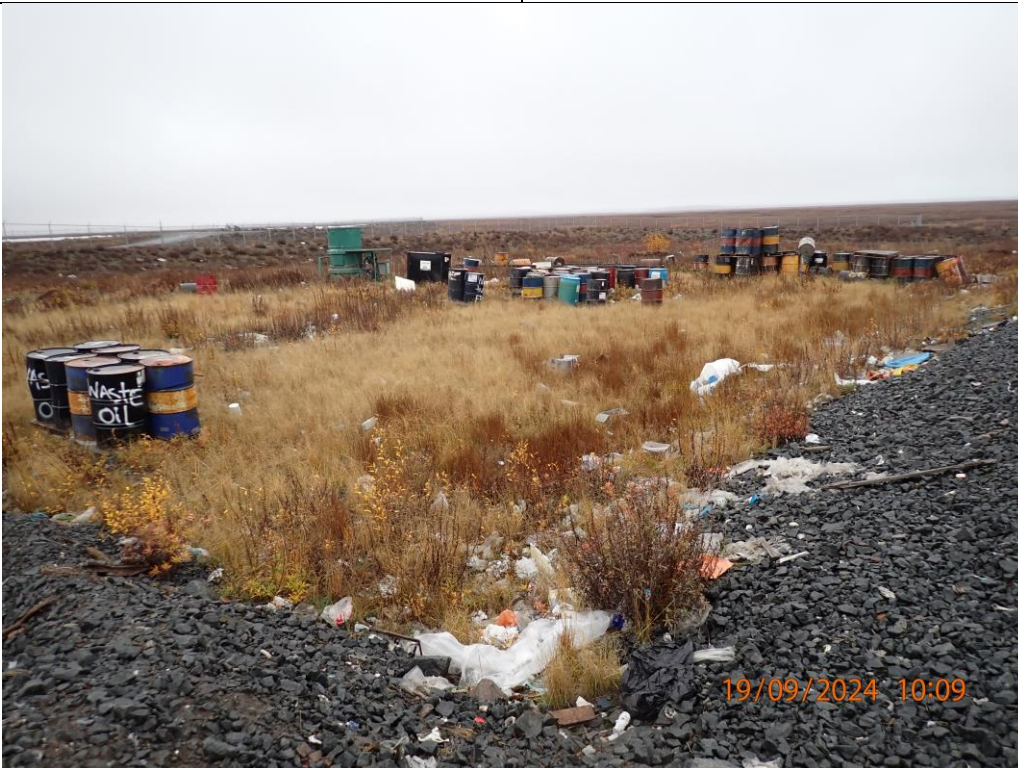
Photo No.
Photo #13

Description:
Green oil burner shown and various drums of burnable waste.

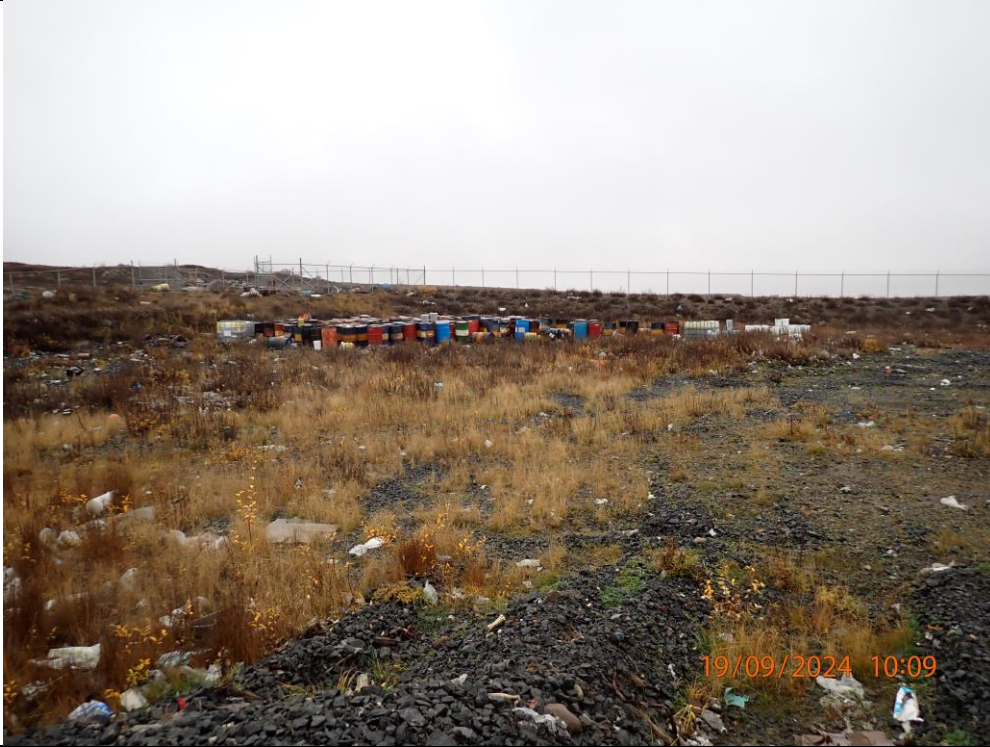
Photo #14

12. (Photo #14) shows "un-burnable" product such as glycol and other hazardous material stored away from the oil burner. These drums were tested and deemed unfit for burning. These barrels should be placed into the Hazardous waste section (south west side of the solid waste facility)

Un-burnable waste drums shown stored away from the oil burner. This product was tested and deemed unfit for burning.

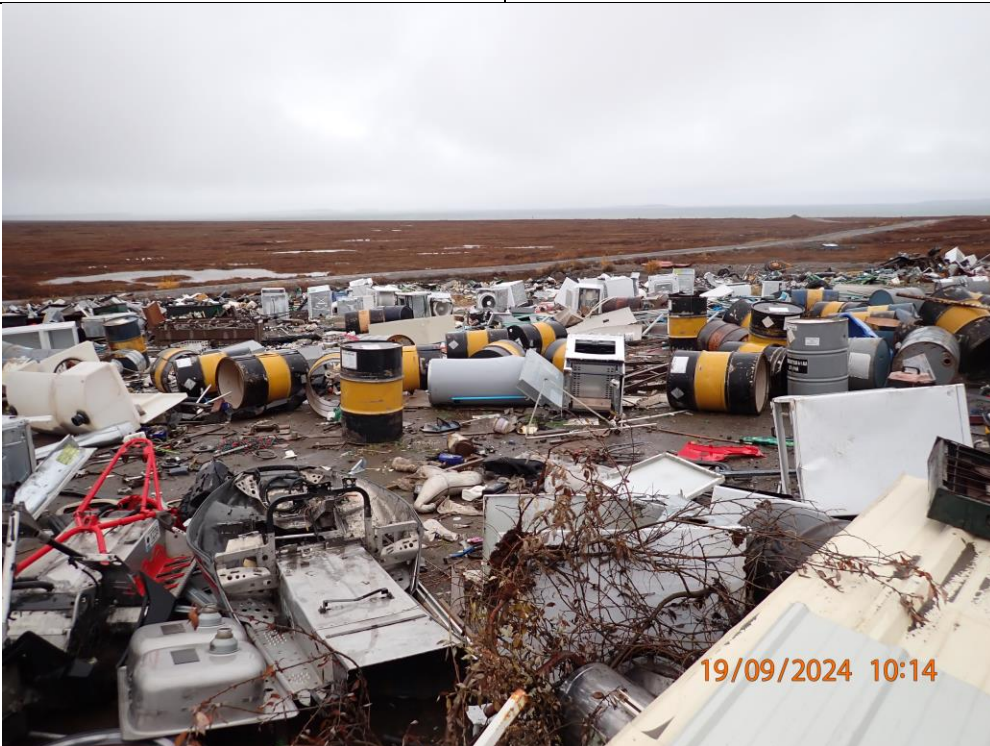
Photo #15

13. (Photo #15 and #16) The bulky metal facility was observed to have old fuel drums and white waste (fridges and freezers) mixed in with various bulky metals. Some of these used fuel drums were cut up and dismantled while others were observed to have holes poked into them and are leaking small amounts of Diesel fuel into the metal dump. The drums that are not cut up should be moved to the hazardous waste storage, dismantled drums that are shown to be clean may stay within the bulky metal facility.

Used oil drums found found inside the bulk metal facility.

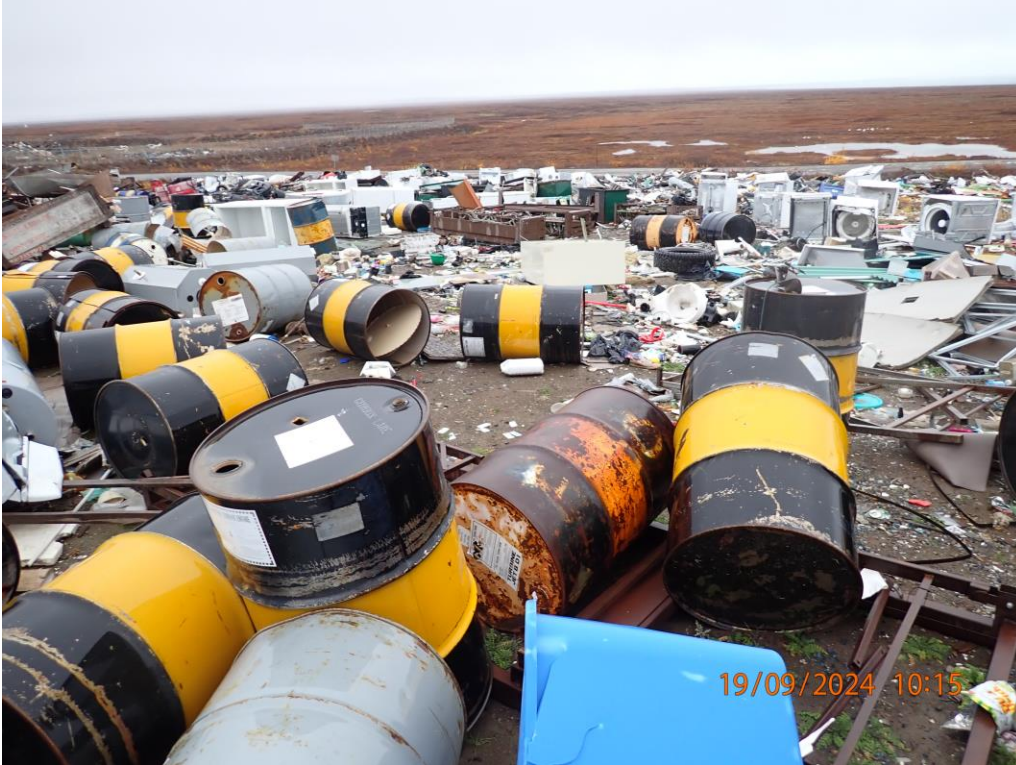
Photo #16

White wastes and fuel drums amongst bulk metal

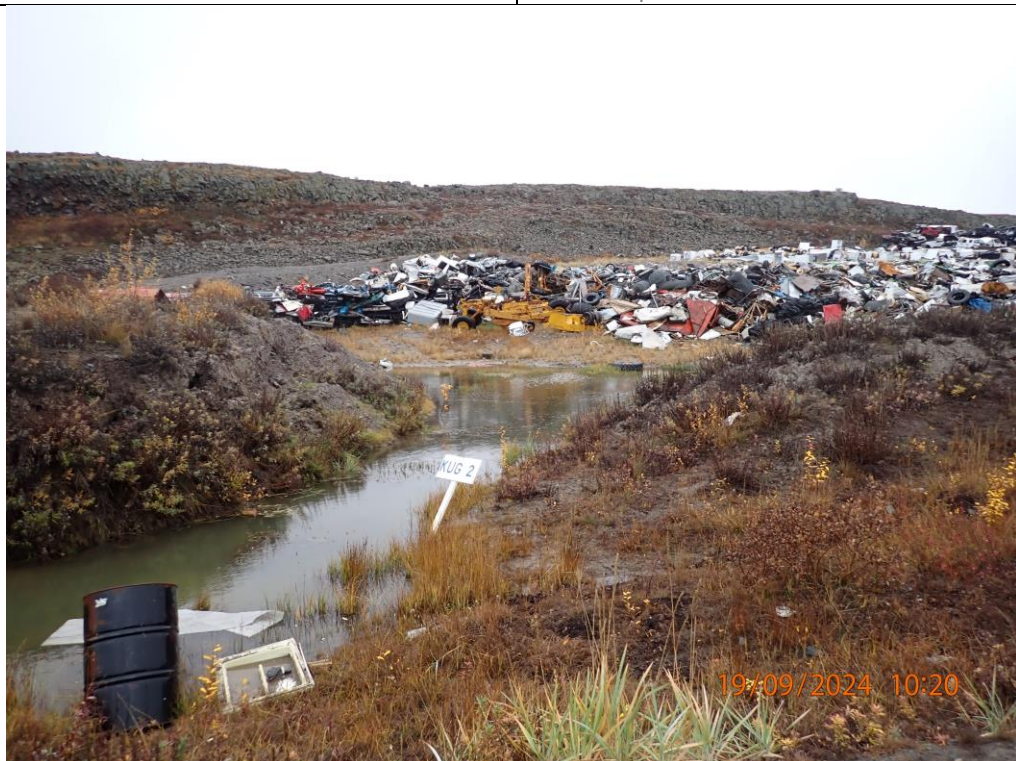
Photo #17

14. (Photo #17) shows the ponding at the lower end of the bulky metal facility. This water is stagnant and shows no sign of migration.

Kug 2 sample location at bulk metal facility. Showing stagnant water.
