PHOTO LOG

Date: Thursday, September 19, 2024	License Number: 3BM-KUG2030	Camera/Model: Olympus Tough TG-6	Inspector Isaiah James Bolt
Photo No. Photo #1	Lat/Long (DD.MM.SS.SS, NAD83) Click or tap here to enter text.

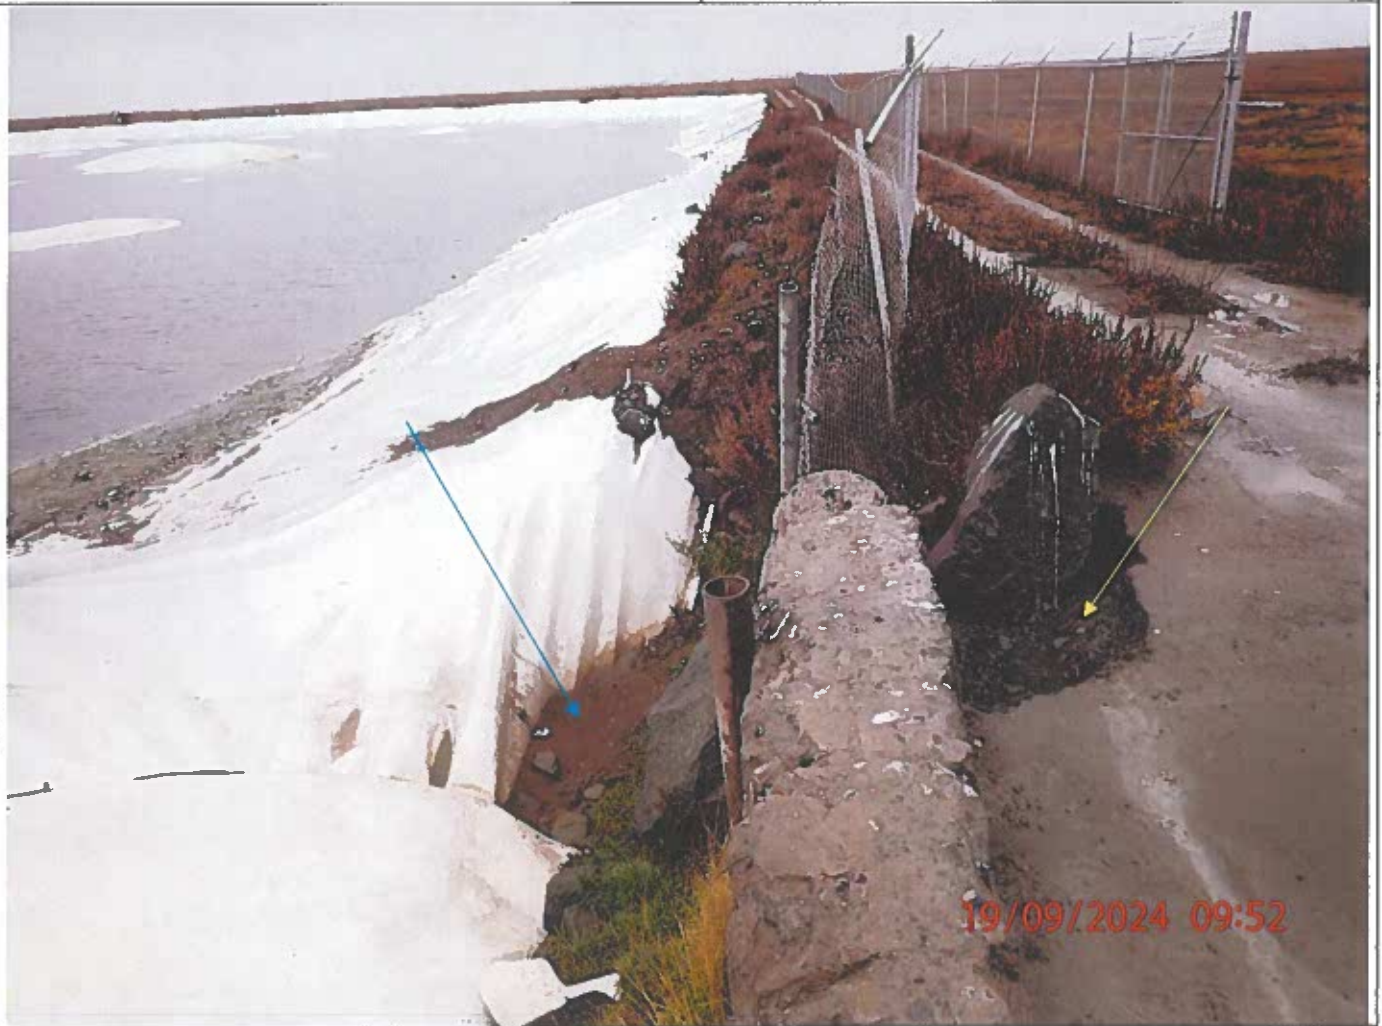
Blue Arrow shows pooling area and sediment build up potentially caused by Sewage water that has not been able to clear the distance from the concrete block to the slope of the liner and is migrating along the bank into the pooling area. Yellow arrow shows erosion caused by this effect. The fence in the photo is also effected as this whole area is being washed out by the pooling water and migrating under the liner.
