Annual Report -2019

Water Licence: 3BM-KUG 1520

Hamlet of Kugluktuk, NU

Kugluktuk Water Licence: 3BM-KUG 1520 Annual Report 2019

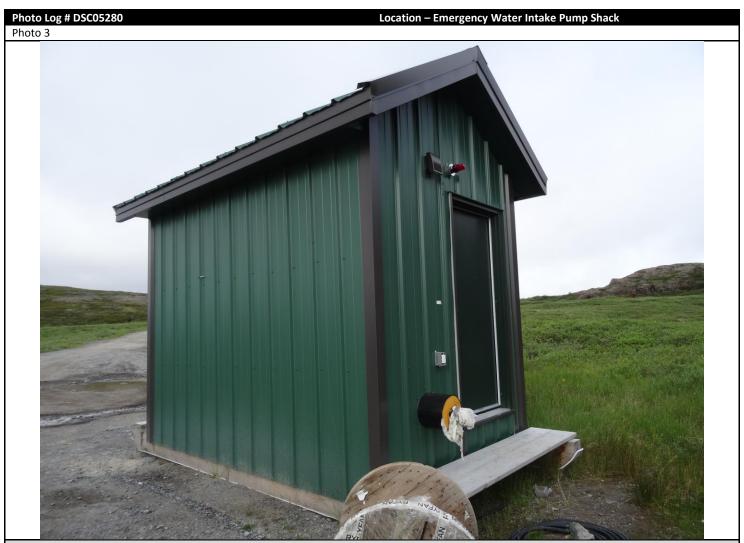
Description: Signage for Sample Station KUG-1D needs to be attached to the outside of the Green Emergency Water Intake Pump Shack
